# **FY04 Inspection Results for Wet Uruguay Fuel in L-Basin (U)**

**Philip R. Vormelker and Dennis W. Vinson**

Savannah River National Laboratory  
Materials Science and Technology

**DOCUMENT:** WSRC-TR-2005-00216

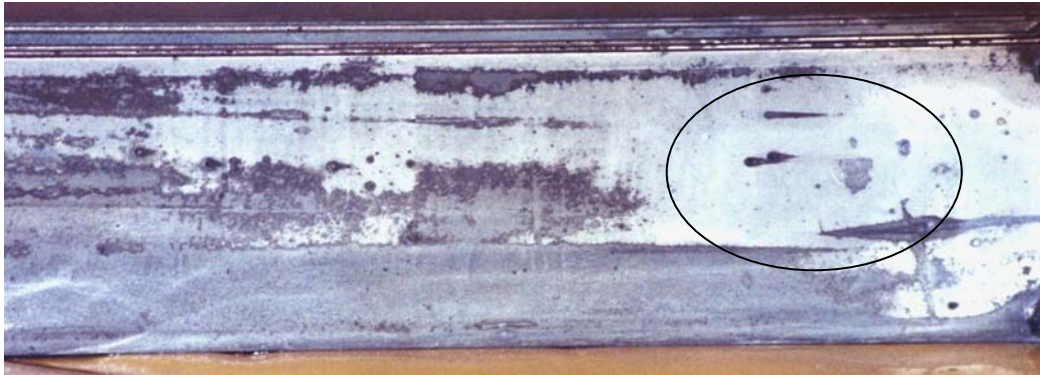
For comparison purposes, sections of the following fuel assemblies are presented as examples of the condition of all four fuel assemblies (A-5, B-2, B-3, and 5-5). The examples show that little or no fuel degradation is occurring. In Figure 4, photos of Side C (fuel assembly 5-5) from inspections in 1998 and 2004 are shown and pit locations and surface markings are repeated in the same location. Some differences in surface stains or markings may be due to light exposure at the time photographs were taken. Side A of fuel assembly B-2 is shown in Figure 5 where multiple pit locations are repeated in photographs from the first inspection in 1998 and the recent one in 2004. Similar characteristics are also noted when viewing another section of side A of fuel assembly B-3 as shown in Figure 6. The two images of Side D of fuel assembly B-3 are also very similar (Figure 7). Particles or tubercles are noted in similar locations in photographs taken in 1998 and 2004. One difference that appears is that more oxide growth around the fastener locations is visible in the 2004 photograph versus the original inspection photograph in 1998. The fasteners appear to be much cleaner in the 1998 photograph.

(A) Fuel 5-5, Side C, right end inspected October 1998 upon fuel receipt

**Figure 4.** Photo comparison of inspections performed on fuel assembly 5-5, side C (right end) in 1998 (A) and 2004 (B). Circled areas in both photos reveal pits that show little or no changes since the original receipt inspection. Pitted areas are duplicated in the 2004 inspection photograph. Differences in the appearance of surface stains or markings to the left of circled areas may be due to light exposure at the time photographs were taken.

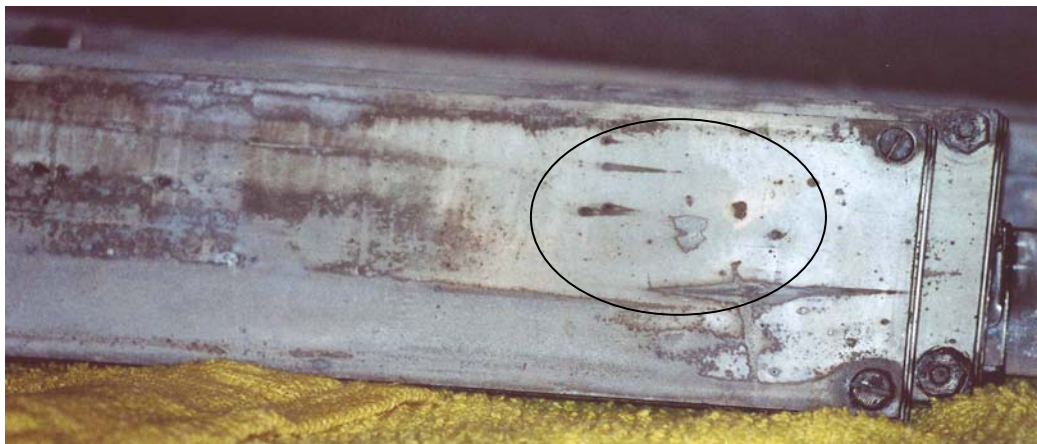
(B) Fuel 5-5, Side C, right end Inspected August, 2004

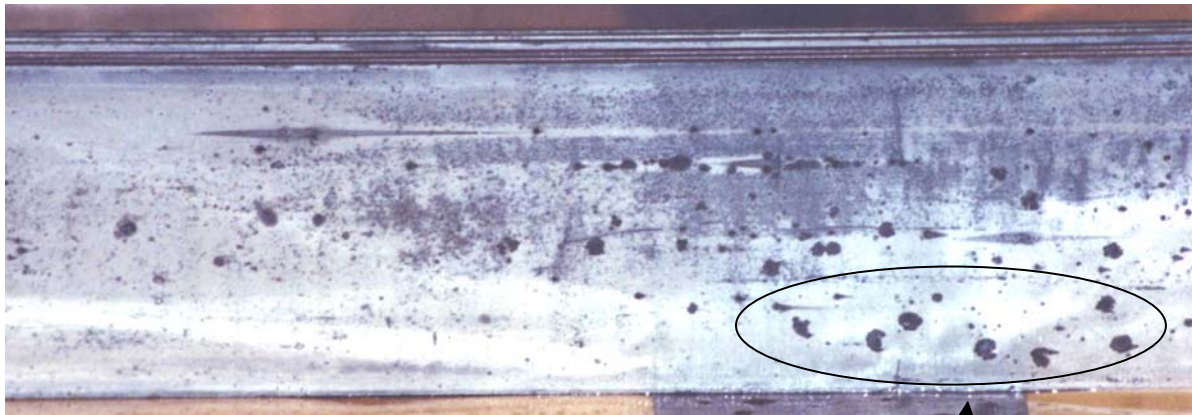
(A) Fuel B-2, side A, left of center, 1998 inspection

**Figure 5.** Photo comparison of inspections performed on fuel assembly B-2, side A (slightly left of center) in 1998 (A) and 2004 (B). Circled areas in both photos show pits and other surface marks that show little or no changes since the original receipt inspection. Pitted areas appear to have the same shape in the 2004 inspection.

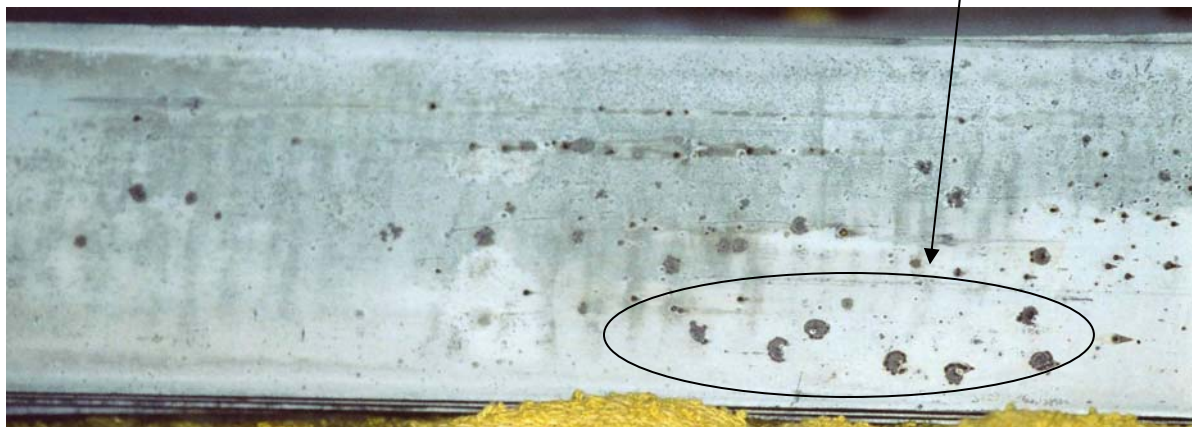
(B) Fuel B-2, side A, left of center, 2004 inspection

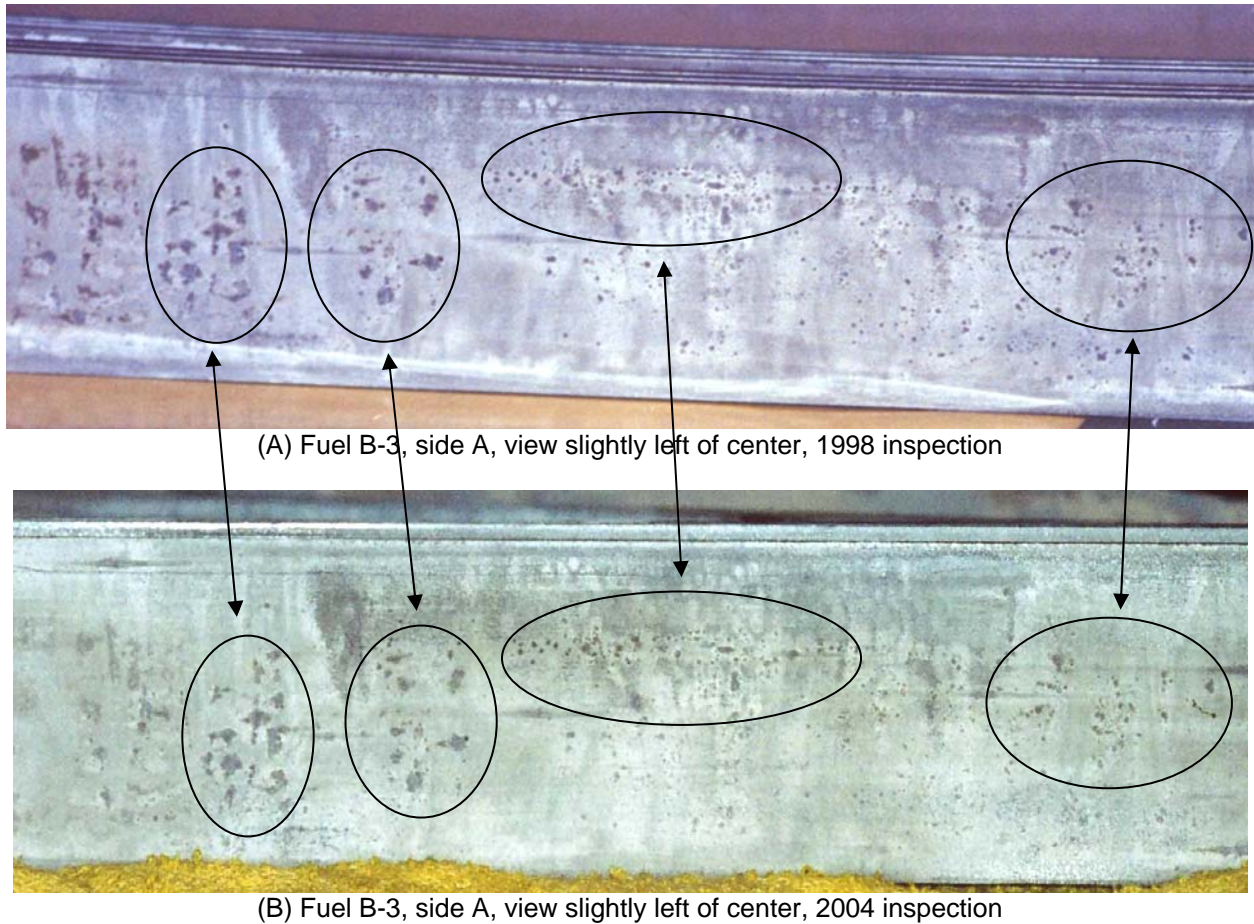
**Figure 6.** Photo comparison of inspections performed on fuel assembly B-3, side A (slightly left of center) in 1998 (receipt inspection) and 2004. Circled areas in both photos show pits and other surface marks that show little or no changes since the original receipt inspection. Pitted areas are duplicated in the 2004 inspection.

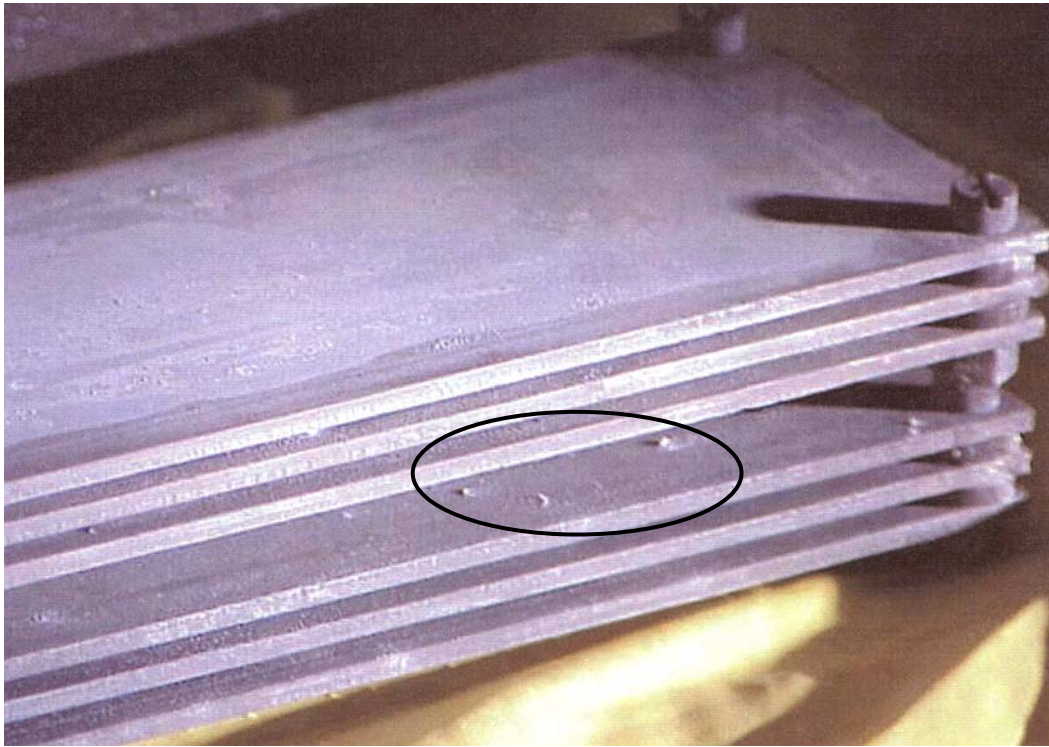
(A) Fuel B-3, Side D, Right, 1998 inspection

**Figure 7.** Photo comparison of inspections performed on fuel assembly B-3, side D, right corner in 1998 (receipt inspection) and 2004. Circled areas show similar positions of particles or tubercles although the photos are taken at different angles. They may be the same. The fasteners in the 1998 photograph appear to be much cleaner than in 2004 which appear to have more oxide. This may also be due to the lighting and differences in the photographic angle.

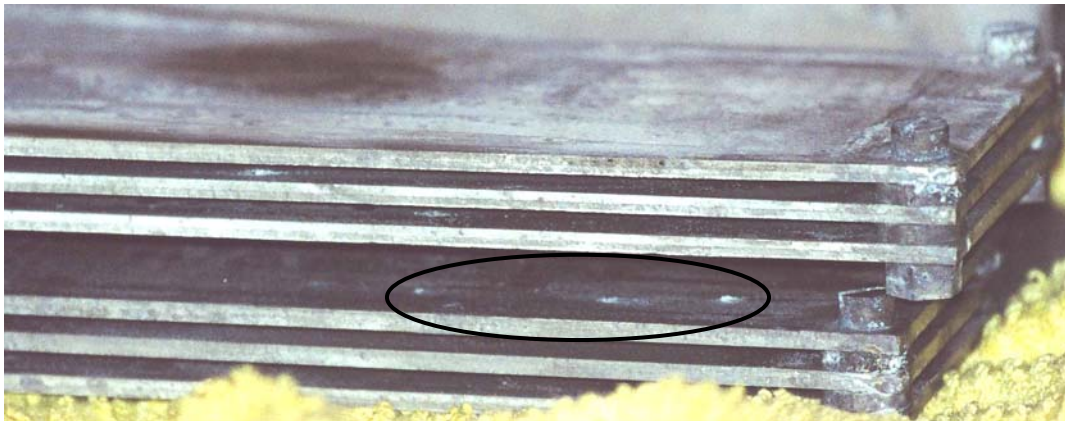
(B) Fuel B-3, Side D, Right, 2004 inspection

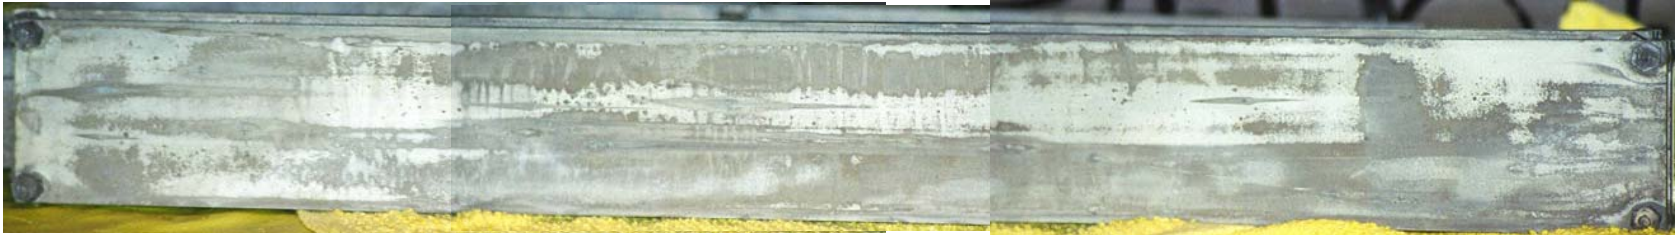
During the 2004 inspection of fuel assembly A-5, side C was photographed (Figure 8) but it was not the same side C as found in the 1998 and 2001 inspection photographs. Apparently one of the two plate assemblies was inadvertently rotated separately from the other one. This will be carefully reviewed during the next inspection.

**Figure 8.** Image of side C of fuel A-5 (from 2004 inspection) is shown without screw heads showing. This is the inside surface that was not photographed during prior inspections. A match could not be made with prior inspection photographs.

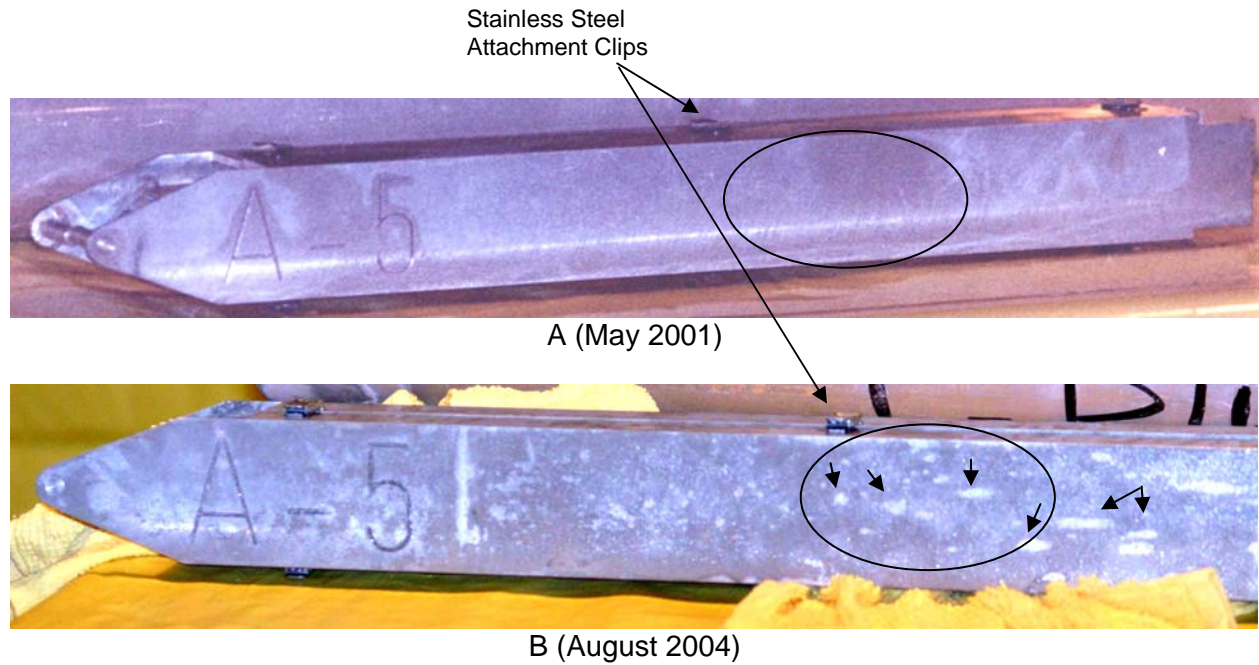
In Figure 9 and Figure 10, pitting is visible on the exterior of the A-5 clamping plates examined in 2004. This was not seen in the 2001 inspection photographs. Also, some discoloration is noted in the area around the stainless steel clips in Figure 10. The relatively small area of the clip versus the large aluminum area should prevent anodic corrosion of the aluminum. However, the stainless steel clips were riveted and there could be a crevice at the clip edges.

**Figure 9.** Exterior of clamping plates for Uruguay fuel assembly A-5 showing evidence of pitting to the right of the middle stainless steel attachment clip from 2004 inspection (B). None was visible in the 2001 inspection (A).

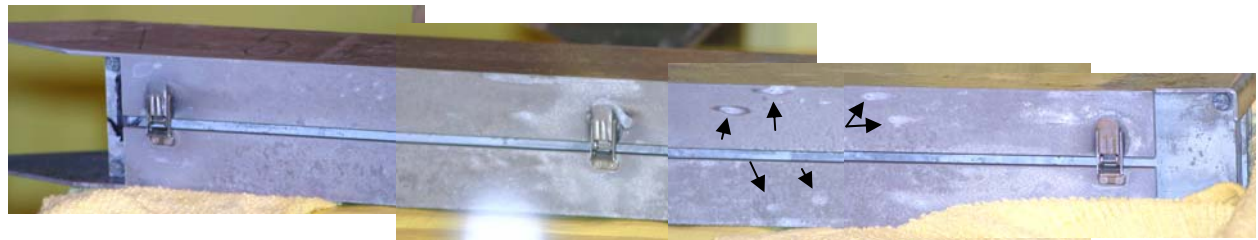
**Figure 10.** Side view of A-5 fuel assembly clamping plates with stainless steel attachment clips and evidence of pitting as photographed in August 2004 inspection.

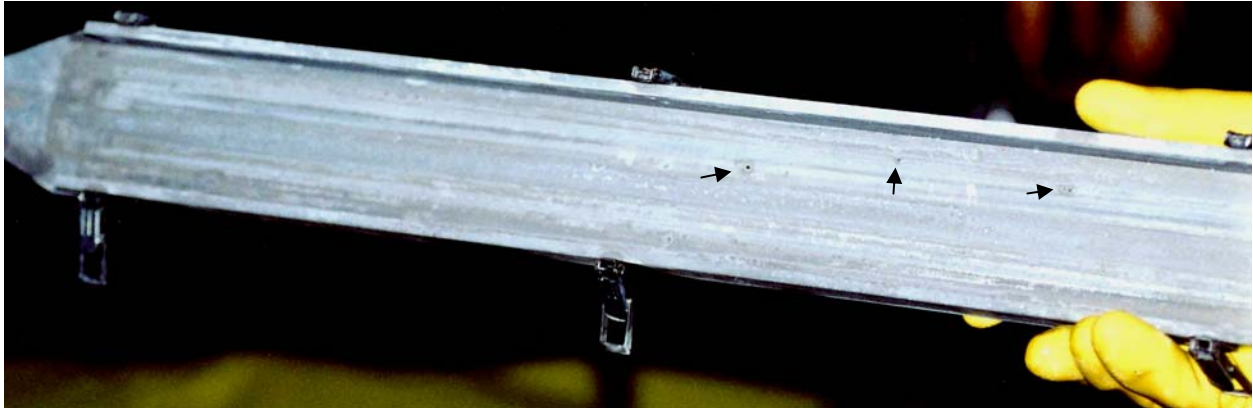
Interior views of the B-3 clamping plate surfaces, shown in Figure 11 and Figure 12, reveal individual pits that were observed during the 2004 inspection. The internal pits appear to be located in wear tracks from the fuel plates and are probably the result of crevice corrosion. Figure 11 reveals a view of the bottom of the B-3 clamping plates that shows the position of the six fuel plates. The edges of the six fuel plates contact the clamping plates but not the face (Sides A and C) of the fuel. Thus, the fuel edge in contact with the interior surface of the clamping plate creates a crevice condition. Figure 12 also shows the inside surface of the rivets

**Figure 11.** Pit locations are shown on interior surface of one clamping plate from B-3 fuel assembly in 2004. The pits appear to be in locations where fuel plates touch the clamping plate.

Visual inspection of Uruguay spent fuel is currently adequate to assess the fuel condition as long as future changes in pit depth and diameter do not occur. A quantitative inspection method is necessary to provide depth and diameter measurements for comparison between future inspection intervals.

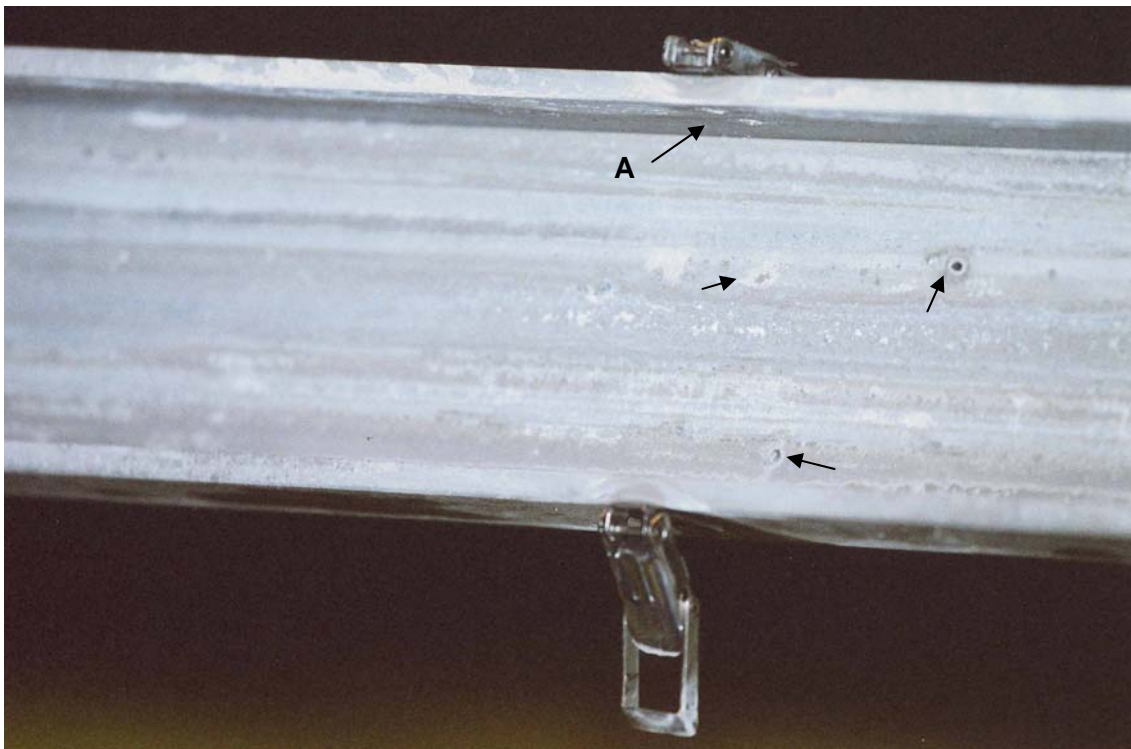
used to fasten the clips onto the clamping plate. The rivets were ground flush and appear to be intact.

**Figure 12.** Close-up photograph of a few pit locations from Figure 11 are shown in one clamping plate (B-3 fuel assembly) along with view of stainless steel clip rivet locations (A).
