DP-1102

# ANALYSIS OF FAILED 17-4 PH BOLTS FROM THE HWCTR

September 1967

**E. I. DU PONT DE NEMOURS & COMPANY  
SAVANNAH RIVER LABORATORY  
AIKEN, S. C. 29801**

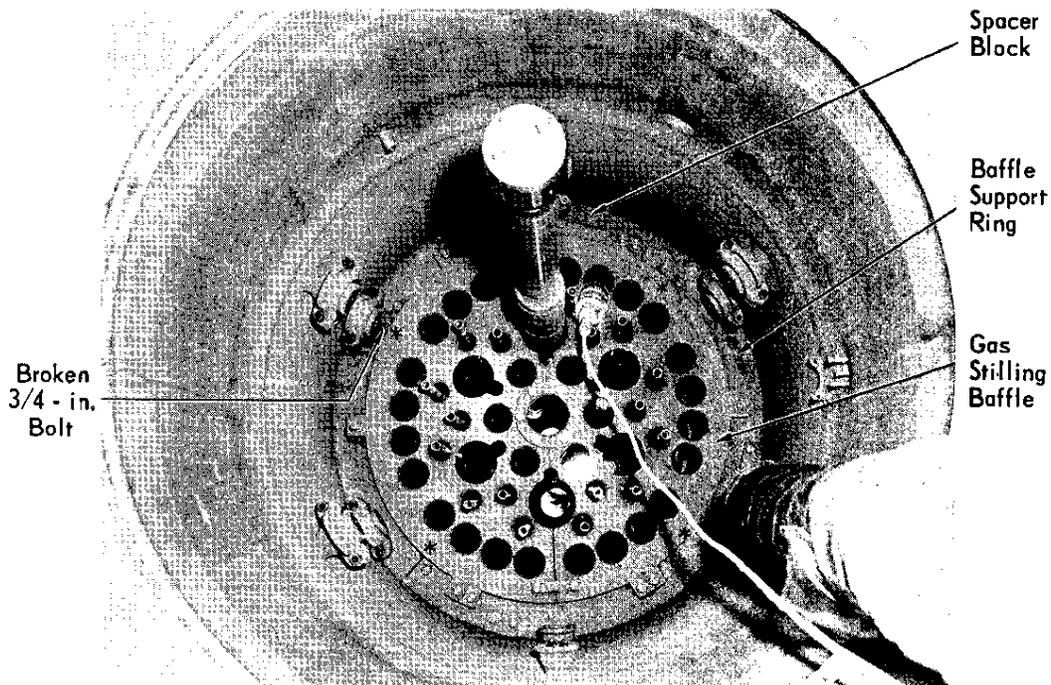
FIG. 1 GAS STILLING BAFFLE ASSEMBLY

The gas stilling baffle was a circular-shaped plate 1-1/4 inches thick and 50-1/4 inches in diameter that was bolted to a 3/4-inch-thick baffle support ring, Figure 1. Both the gas baffle and the support ring were in two sections to facilitate assembly inside the HWCTR vessel, and were bolted together with metal straps. The gas-baffle assembly was supported by four T-shaped support posts that were in turn bolted to the top of the flow-distribution baffle. The gas baffle and baffle-support ring were bolted together and to the top of the support posts with thirty-four 3/4-inch-diameter bolts. The baffle-support posts were bolted to the flow-distribution baffle with eight 5/8-inch diameter bolts. Nothing is known about the initial stresses induced in the bolts during installation. A proprietary thread lubricant subsequently found to contain chlorides may have been used during the installation of the baffle. Thus, chlorides may have contributed to the failures.

All plate material in the gas baffle including the washers was 304L stainless steel; all bolts were 17-4 PH.

\* 3/4 - in. bolts holding baffle support ring to top of support posts

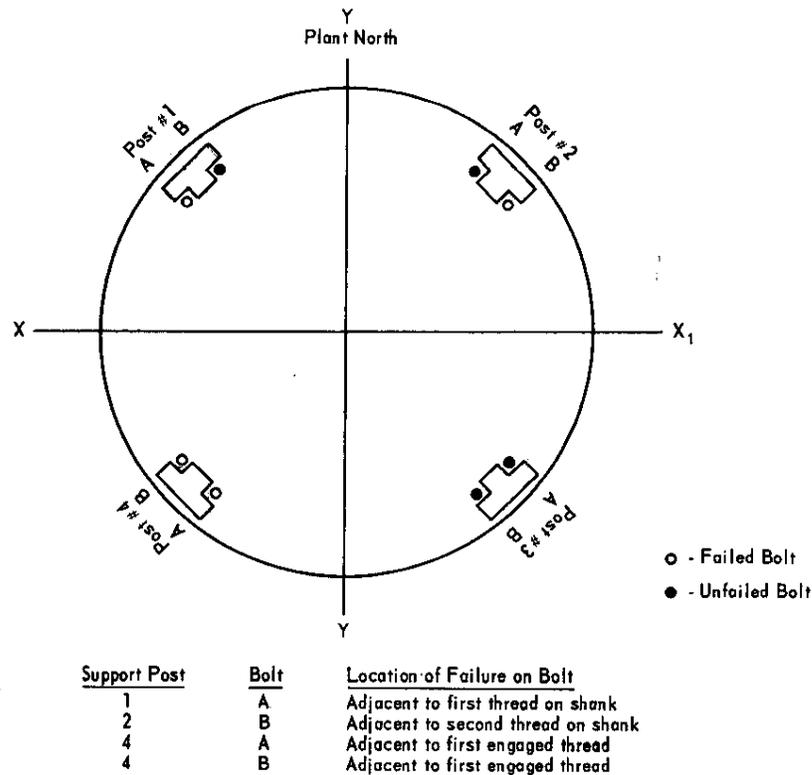
FIG. 2 POSITIONS OF BROKEN 5/8-INCH BOLTS

The four 5/8-inch bolts that failed were in support posts 1, 2, and 4 of the gas stilling baffle, Figure 2. The two bolts that were found first, 1A and 2B, had failed adjacent to the first or second threads from the unthreaded shank, Figure 3. Bolts 4A and 4B failed adjacent to the first engaged thread. No other cracks were found in the eight 5/8-inch bolts by low-magnification inspection.

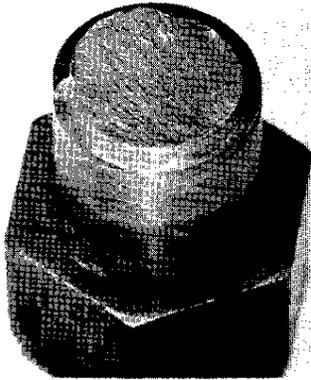
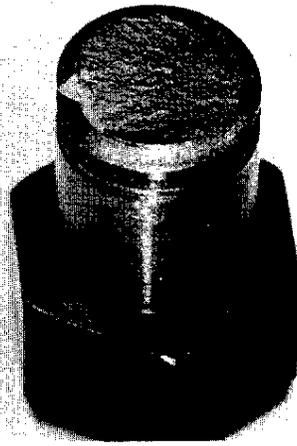
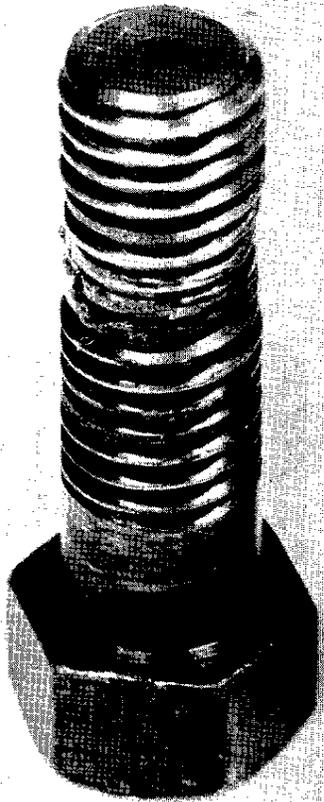
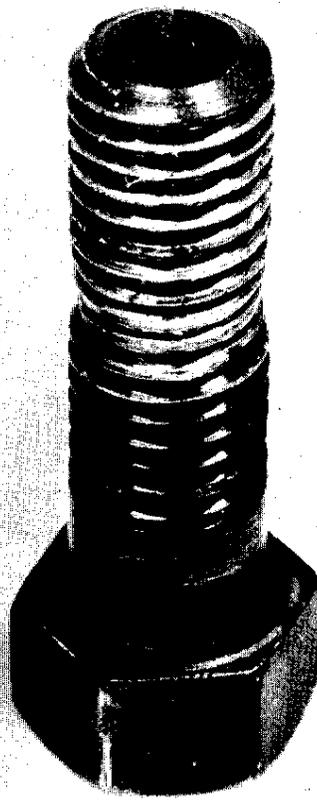
FIG. 3 IRRADIATED 5/8-INCH BOLTS

All surfaces of the eight 5/8-inch bolts were covered by a thin, black corrosion film. This film also covered the fracture surfaces of the failed 5/8-inch bolts, and showed that the fractures had occurred some time before they were discovered, which was after about 276 days of reactor operation.

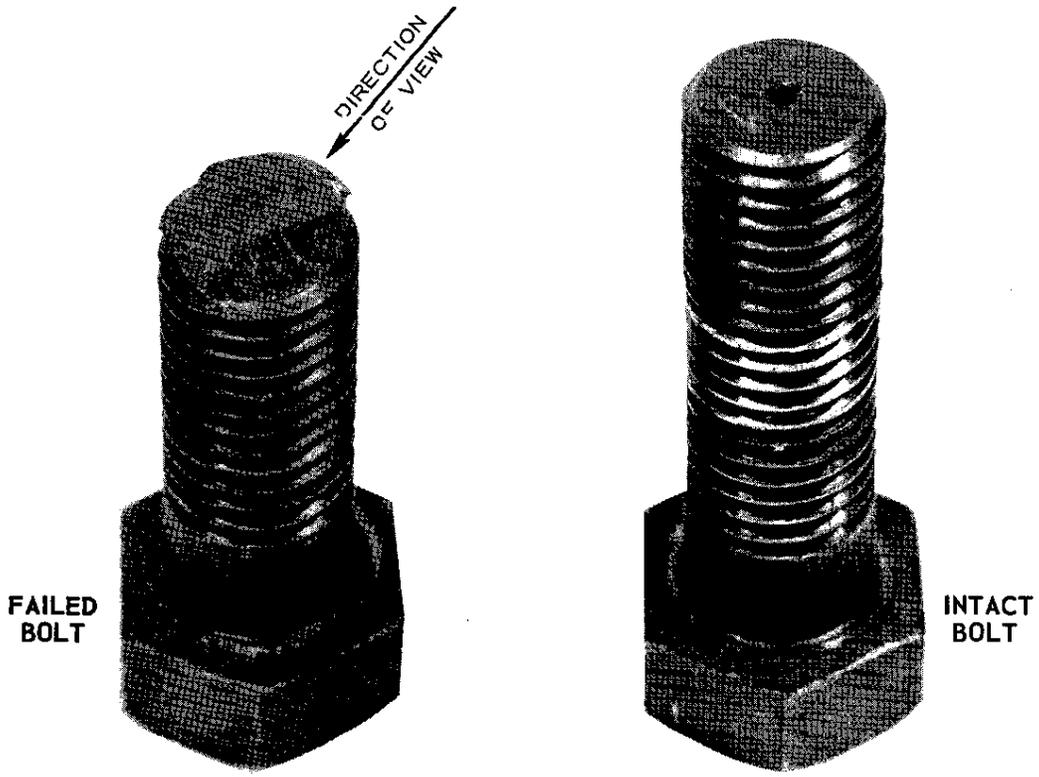
FIG. 4 IRRADIATED 3/4-INCH BOLTS

The failed 3/4-inch bolt was located in the top of post 4, position A, and held the baffle support ring to the support post. The fracture occurred adjacent to the first engaged thread, Figure 4. This bolt was also covered with the black film, but only part of the fracture surface was black. The rest of the fracture surface was light gray, denoting the area that fractured when the bolt was removed during the repair work.

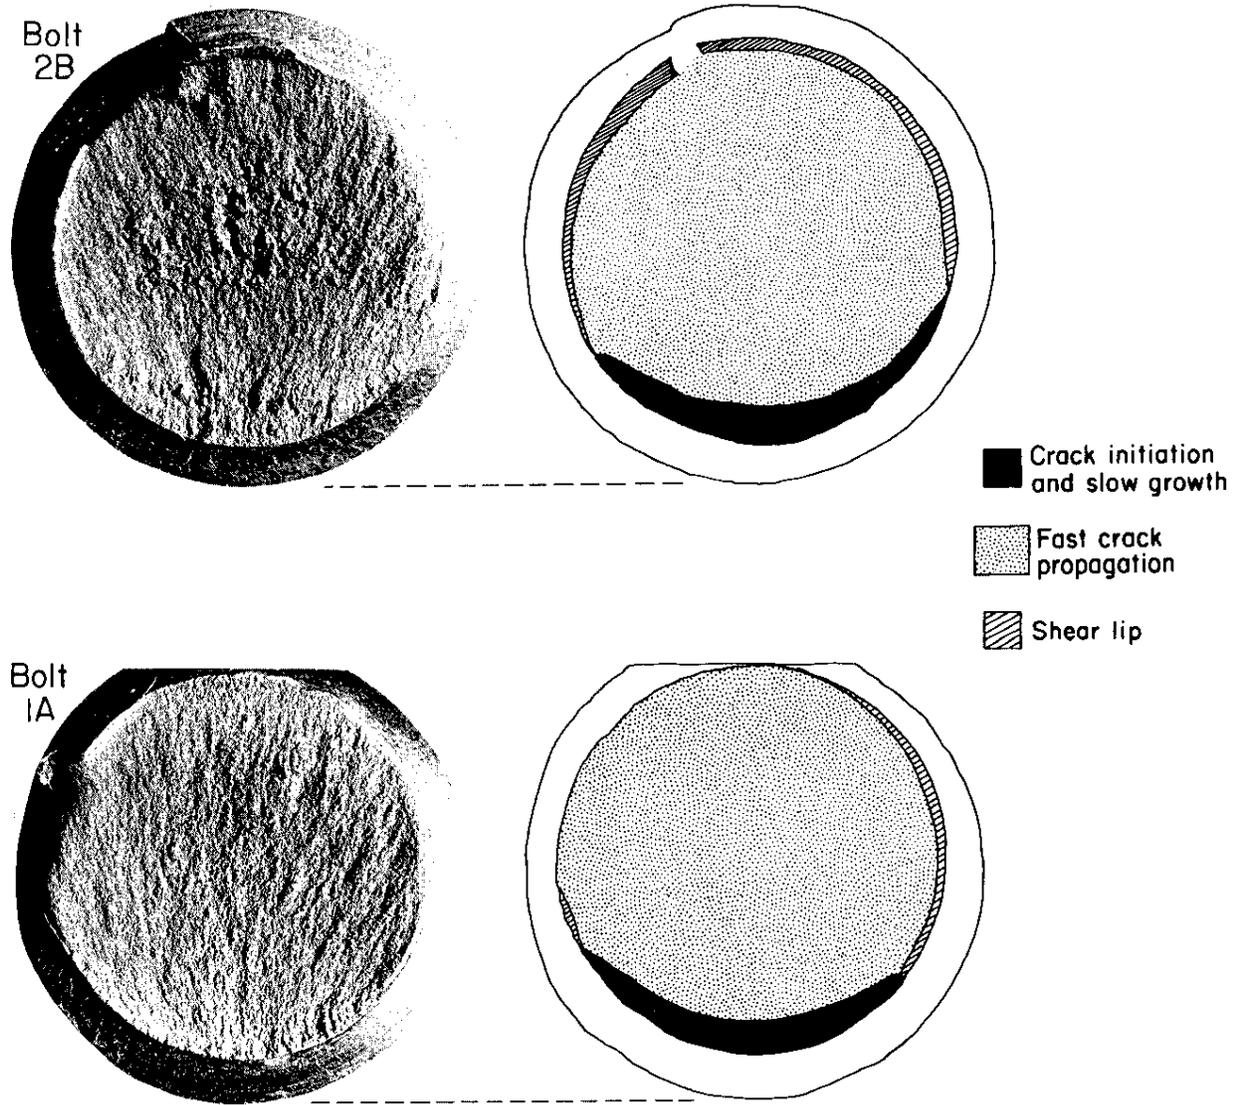
The fracture surfaces of the 5/8-inch bolts shown in Figure 5 were almost totally covered by ripples in the fan-shaped orientation. The areas of crack initiation and slow growth, indicated by the ripples and the absence of shear lip, were small and shallow, showing that the main crack had initiated and/or grew slowly about 1/3 around the circumference, while advancing only about a thread depth into the bolt, Figure 5. The extended but shallow crack, and the roughness of the surface produced during the slow growth period, suggest that stress corrosion was responsible for crack formation early in the failures. The large fraction of the surfaces covered by the ripples and the low amplitude of the ripples indicated a high applied stress during failure.

The fracture surfaces of bolts 4A and 4B appeared very similar to the fracture surfaces of bolt 1A (Figure 5) even though the bolts fractured in different places (see p. 5).

None of the areas of crack initiation exhibited any of the macroscopic features characteristic of fatigue failures. At first glance, the "half-moon" mark about midway through bolt 2B (Figure 5) may appear to be a fatigue feature. Such an interpretation is discounted, however, by the morphology and excellent

definition of the features surrounding the "half-moon" mark. For example, ripples were clearly formed and continuous across the "half-moon" mark; and the surface inside the "half-moon" contained ripples, instead of being smooth as would have been the case for a fatigue fracture. The "half-moon" mark was probably caused by a change in temperature or stress during the brief period of crack propagation.

FIG. 5 FRACTURE SURFACES OF FAILED 5/8-INCH BOLTS  
Ripples point to the area of crack initiation

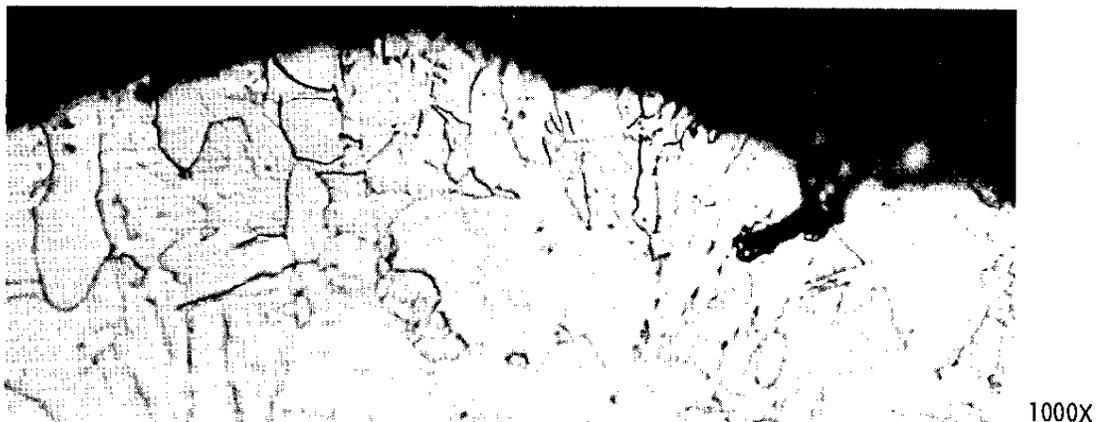
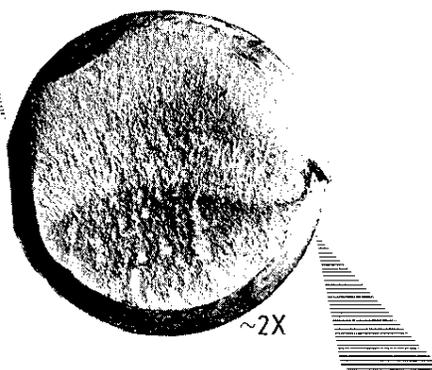
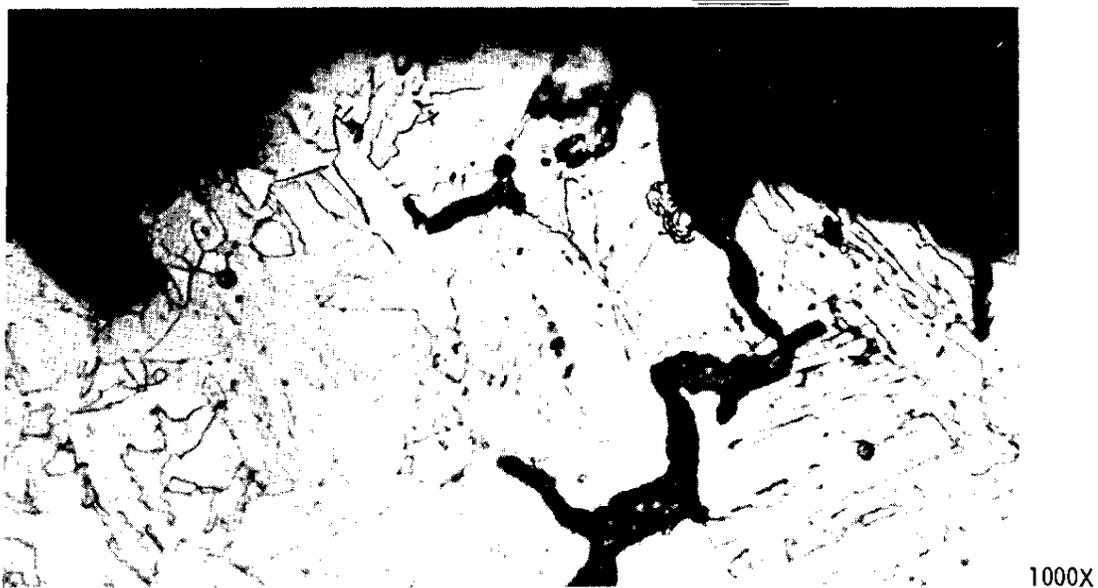
FIG. 6 FRACTURE SURFACES OF FAILED 3/4-INCH BOLT

The fracture surface of the 3/4-inch bolt was generally similar to the surfaces just described, except for the relatively larger area covered by the in-service fracture, Figure 6. The area of in-service fracture (dark area) was rough and generally featureless, suggestive of a stress-corrosion crack. The greater roughness (compare with Figure 5) and the fact that the crack had arrested long enough for the black film to form by general surface corrosion both indicate that the applied stress was low. The ripples produced during removal of the bolt are typical of fast fracture in this material in the hardened condition and compare well with similar features observed in the failed 5/8-inch bolts.

The fractures of bolts 1A and 2B and the 3/4-inch bolt were sectioned approximately parallel to the ripples and examined metallographically. The fracture surfaces were smooth and almost totally transcrystalline across the fracture surfaces of the 5/8-inch bolts and the light area of the 3/4-inch bolt, Figure 6. In contrast, the in-service part of the 3/4-inch fracture surface was much rougher and exhibited more intercrystalline fracture. Many comparatively short, branching cracks oriented approximately 90° to the surface were observed in the 5/8-inch bolts and the in-service part of the 3/4-inch bolt, Figure 6. These cracks were transcrystalline and intercrystalline, and were the same average length (depth) from one side of the bolt to the other. These secondary cracks probably formed by stress corrosion cracking from residual quenching stresses after complete failure of the bolts. These observations confirmed the results of the macrofractography, namely that most of the main fracture occurred during fast tensile fracture.

PROFILE OF FRACTURE PRODUCED DURING REMOVAL OF BOLT

PROFILE OF FRACTURE PRODUCED BY STRESS CORROSION DURING HWCTR OPERATION

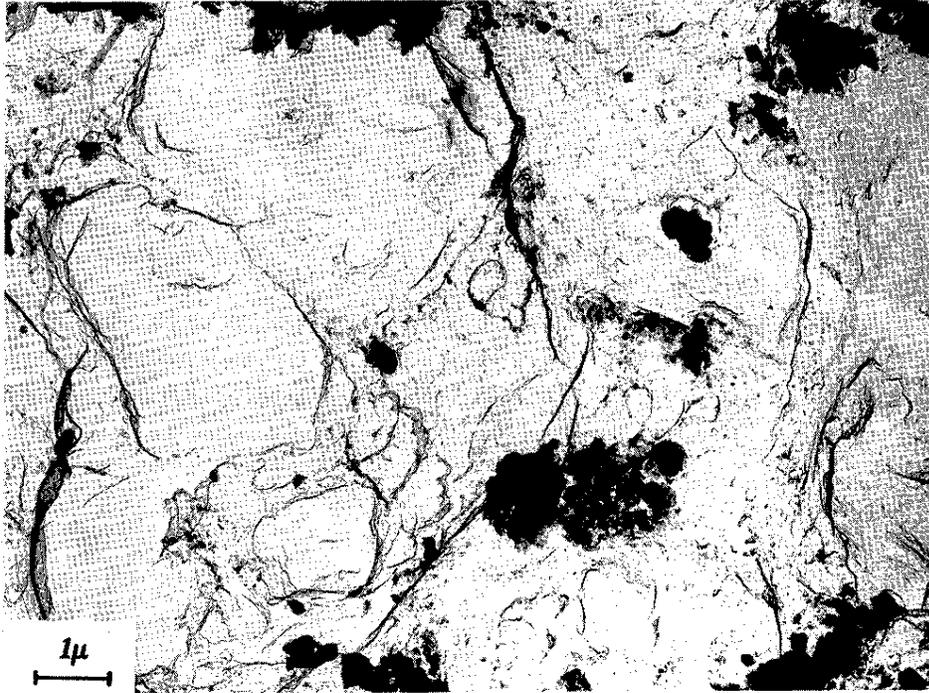
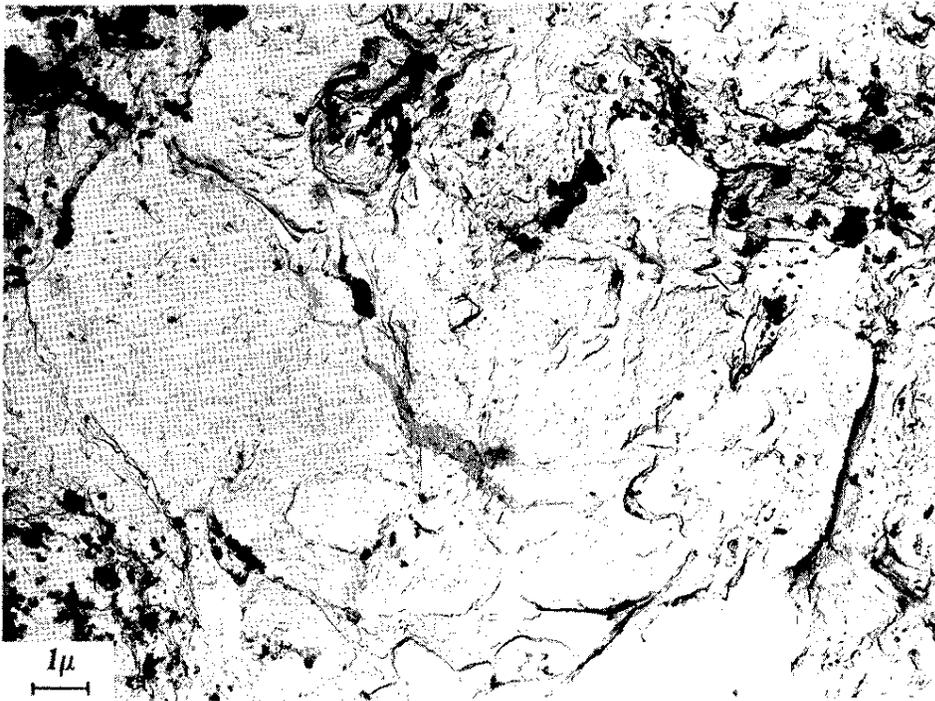
The fracture surfaces were replicated for electron microscopic examination by the cellulose acetate-carbon technique. Electron micrographs are shown in Figure 7. Microscopically the fracture surfaces were composed largely of various sized dimples, indicating ductile rupture, and some "orange peel" and irregular microcracking, which are evidence of stress corrosion. These fractographic features showed that the fractures had occurred by tensile rupture. The low ductility suggested by some of the features, secondary cracking and discontinuous cleavage, may have been caused by the plane strain conditions set up by the notch effect of the threads and the low fracture toughness of highly hardened 17-4 PH. Detailed searches revealed no microscopic arrest lines characteristic of fatigue.

FIG. 7 DIMPLED RUPTURE AND INTERGRANULAR FRACTURE IN 5/8-INCH BOLTS  
Large areas of the fracture surfaces were covered by corrosion products (black spots)  
and small pits from general surface corrosion after failure
