DP-971

PERFORMANCE OF HWCTR SAFETY ROD AND CONTROL ROD DRIVE SYSTEMS

October 1965

E. I. DU PONT DE NEMOURS & COMPANY
SAVANNAH RIVER LABORATORY
AIKEN, SOUTH CAROLINA
CONTRACT AT(07-2)-1 WITH THE
UNITED STATES ATOMIC ENERGY COMMISSION

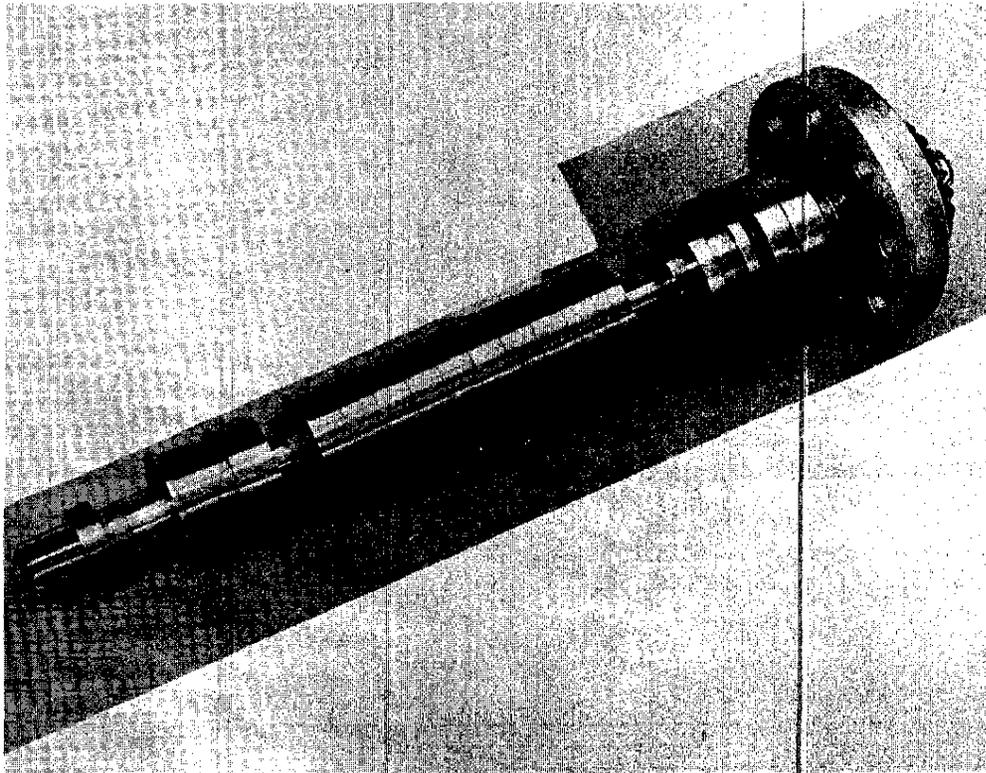
FIG. 4 SEAL SHAFT ASSEMBLY AFTER ONE YEAR OF SERVICE

In April 1963, and December 1964, rod drive assemblies and shaft seal assemblies were removed for inspection. Very little wear was found and no deposits or foreign matter were found in the close-fitting seal rings. Parts fabricated from 17-4 PH stainless steel showed no stress corrosion cracking.

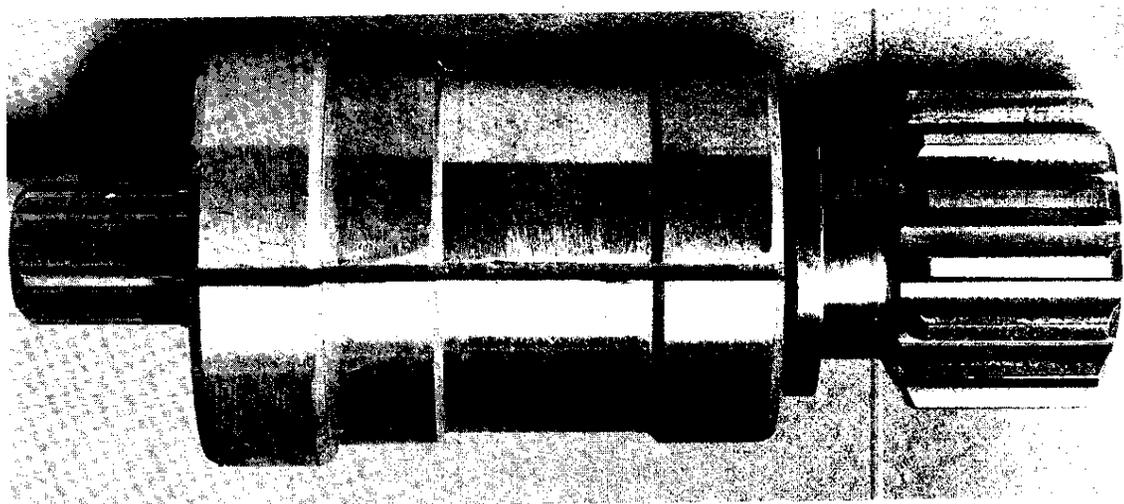
FIG. 11 RACK PINION AFTER ONE YEAR OF SERVICE

The control rod assembly was tested for 100 cold cycles and 2900 hot cycles, with only minor electrical difficulties. The condition of all parts, except the pinion, was satisfactory at the conclusion. Although pinion wear was excessive during the test, a control rod pinion showed no significant wear after three years of reactor operation.

To obtain further assurance that the parts were not cracking, one control rod drive and two seals were inspected in April 1963, and another control rod drive and seal assembly were inspected in December 1964. The 17-4 PH parts, together with type 304 parts, were inspected with dye penetrant. No cracks were found. Photographs of the inspected parts are shown in Figures 10 to 17.

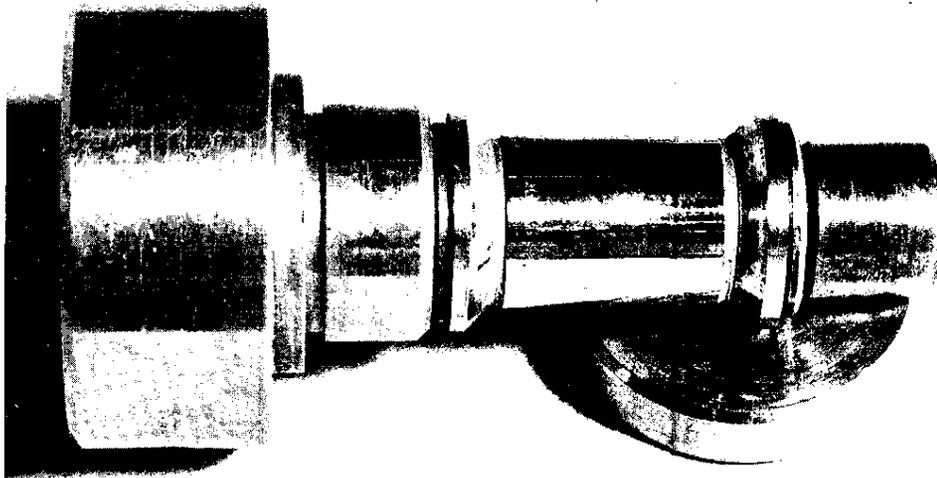
FIG. 17 BACKUP ROLLER AND STUD AFTER ONE YEAR OF SERVICE

Personnel errors are believed to be responsible for three other mechanical failures, items 2 and 3 of Table III. The seal shaft galling was caused by improper assembly of the seal and prevented the rod from dropping completely into the reactor core. It is probable that lubricant was improperly applied to the backup roller and stud. In the reactor atmosphere it became sticky and prevented the roller from rotating freely on the stud. Galling between the rack and roller resulted.
