DP-MS-87-66

**REMOTE REACTOR REPAIR: GTA WELD CRACKING CAUSED BY
ENTRAPPED HELIUM**

W. R. Kanne, Jr.

**HELIUM EMBRITTLEMENT CAUSED WELD TOE CRACKING ON THE IRRADIATED
WALL OF A NUCLEAR REACTOR TANK**

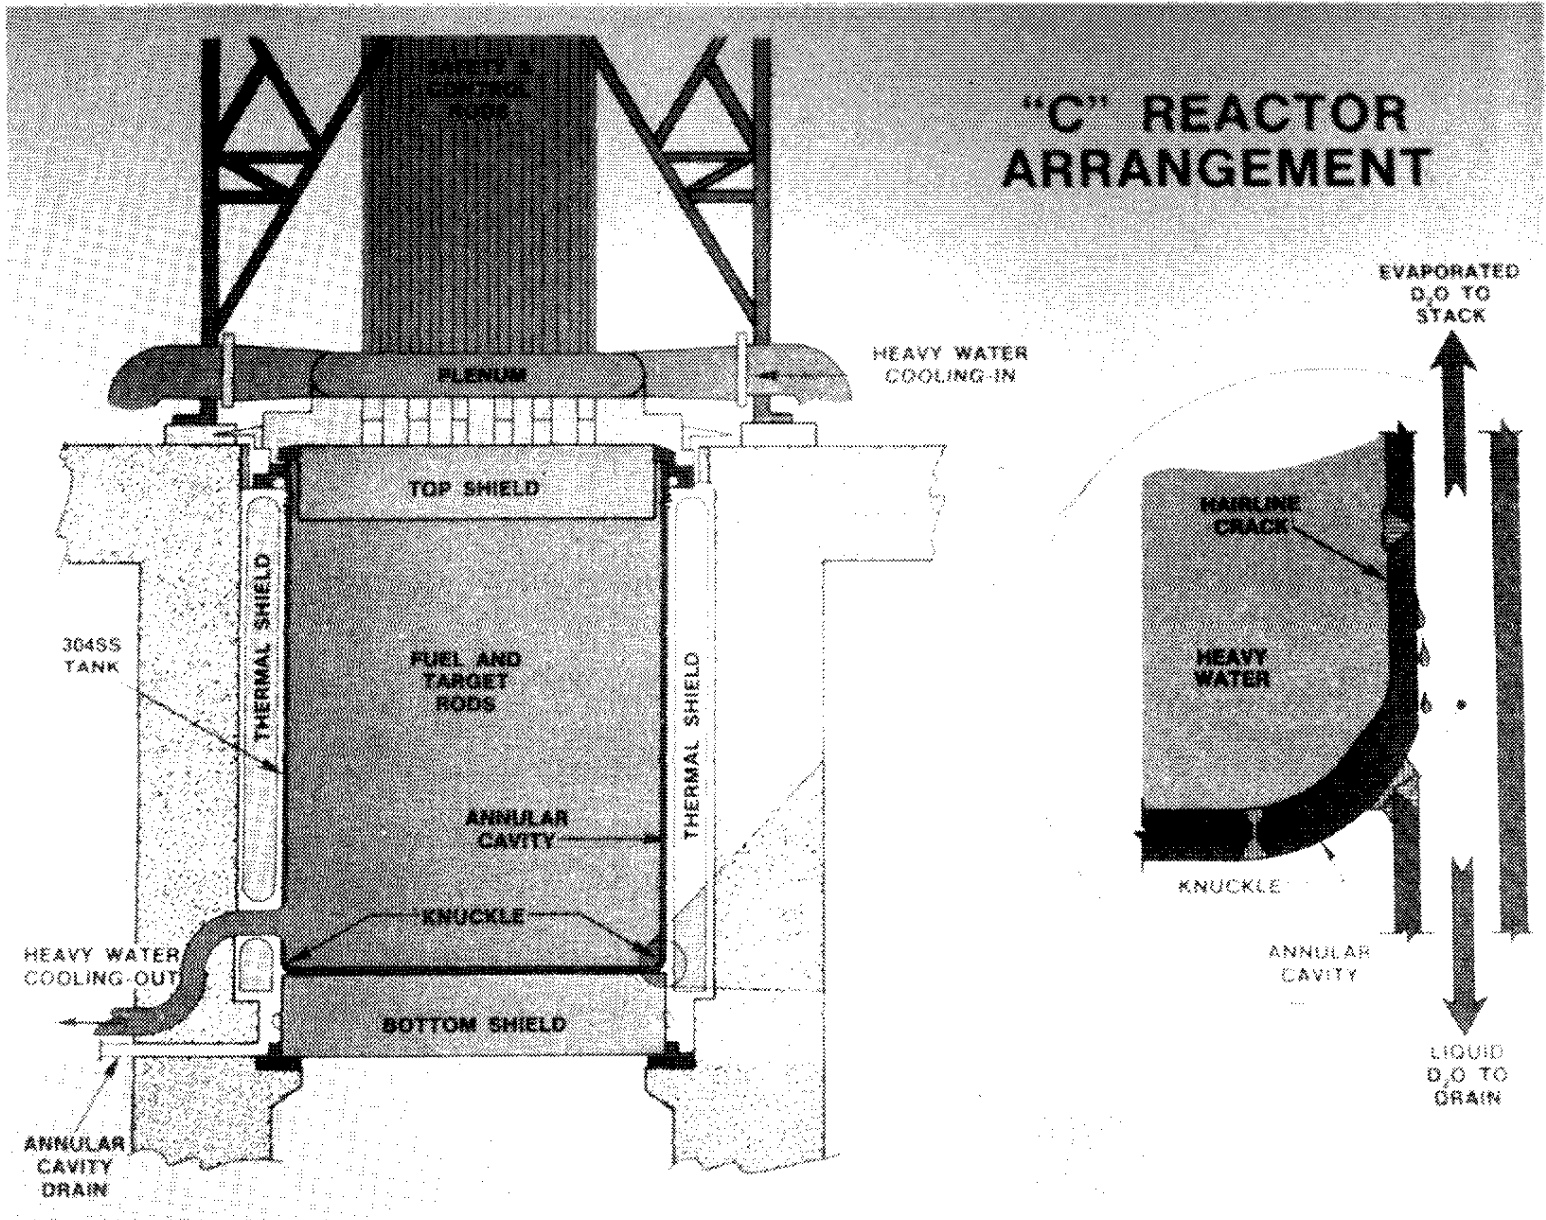
One of the reactors not presently operating is uniquely different from the other four in that it has a curved knuckle transition piece joining the tank side wall to the bottom. This region was sensitized during tank fabrication and developed stress corrosion cracks during service (Fig. 1). Cracks resulted in leaks that were first repaired in 1968 (Ref. 1) using GTA welding to place 0.25-inch-thick patches on the tank wall. The tank leaked again in 1984 and a program was initiated to repair the new leaks.

Leaks were first indicated by the loss of heavy water moderator, at a rate of less than one drop per second, during reactor operation. Leak sites were located by a combination of visual examination, helium leak testing, bubble testing, and ultrasonic testing. Leaks were found to be through the knuckle region. Placement of patches over crack areas in the knuckle was, as in 1968, determined to be the best repair method. Repair was carried out in the 10^5 R/hr radiation field of the reactor.

FIGURE 1. SAVANNAH RIVER NUCLEAR REACTOR SCHEMATIC SHOWING LOCATION OF MODERATOR WATER LEAKS THROUGH "KNUCKLE" REGION.

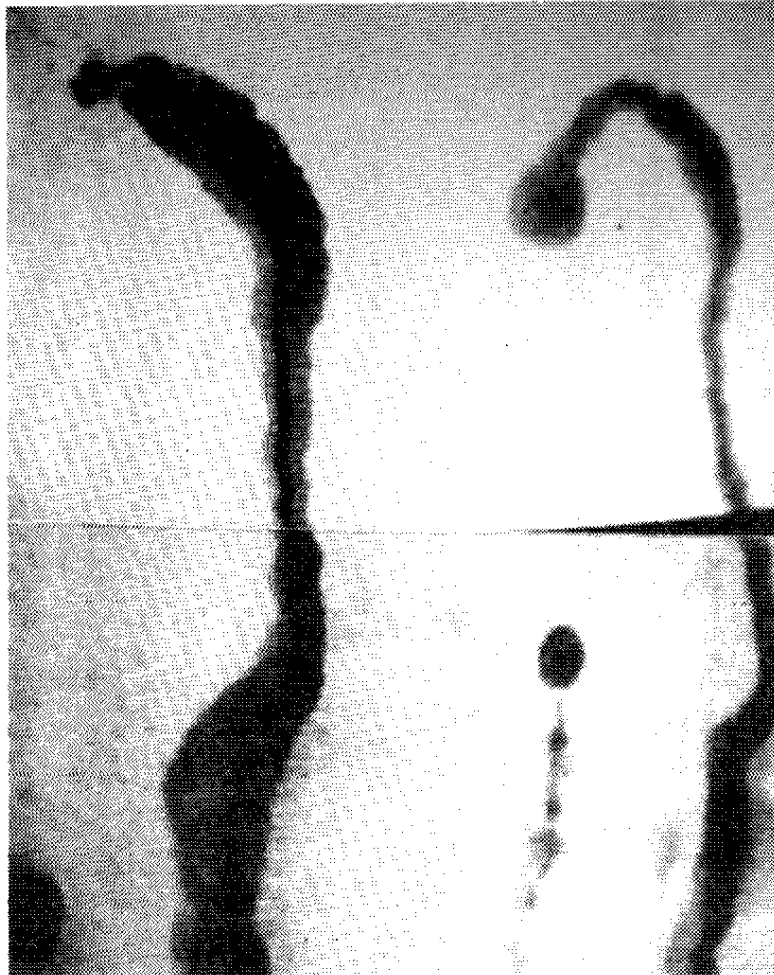
introduced new sites. Dye-penetrant testing showed the presence of cracks around half the circumference of the patch in the weld HAZ on the tank wall side. The extensive nature of the dye indications showed that the leaks were not isolated but were part of a crack network. Cracks were along the edge of the weld bead on the tank wall side. No cracks were found on the patch side of the welds. Parallel bead test welds were made on the tank wall in both the knuckle and in unsensitized material above and below the knuckle. In all areas the test welds showed dye-penetrant indications (Fig. 9A) that, along with direct camera observations of the cracks, showed them to be toe cracks in the heat-affected zone of the welds. A piece of the tank wall was later removed and metallographically examined (Fig. 9B) showing the intergranular nature of the cracks.

GTA welds on the helium-containing surface of this material produced cracks identical to those observed during reactor tank repair. Compare the dye-penetrant results in Fig. 10B with those shown for the reactor tank in Fig. 9A. The cracks were largest toward the end of the weld, but did not necessarily occur on both sides of the weld. Cracks were not visible with the unaided eye, but were visible at magnifications above about 25X, Fig. 11. Cracks were present in the pre-existing GTA weld where the double bead welds crossed it, but these cracks were not continuous. Welds on the back surface of the sample, with no helium, did not crack.

A. DYE PENETRANT TEST OF PARALLEL BEAD TEST WELDS ON TANK WALL (2x).

FIGURE 9. TOE CRACKS IN THE HEAT AFFECTED ZONE OF TEST WELDS ON IRRADIATED NUCLEAR REACTOR TANK WALL.

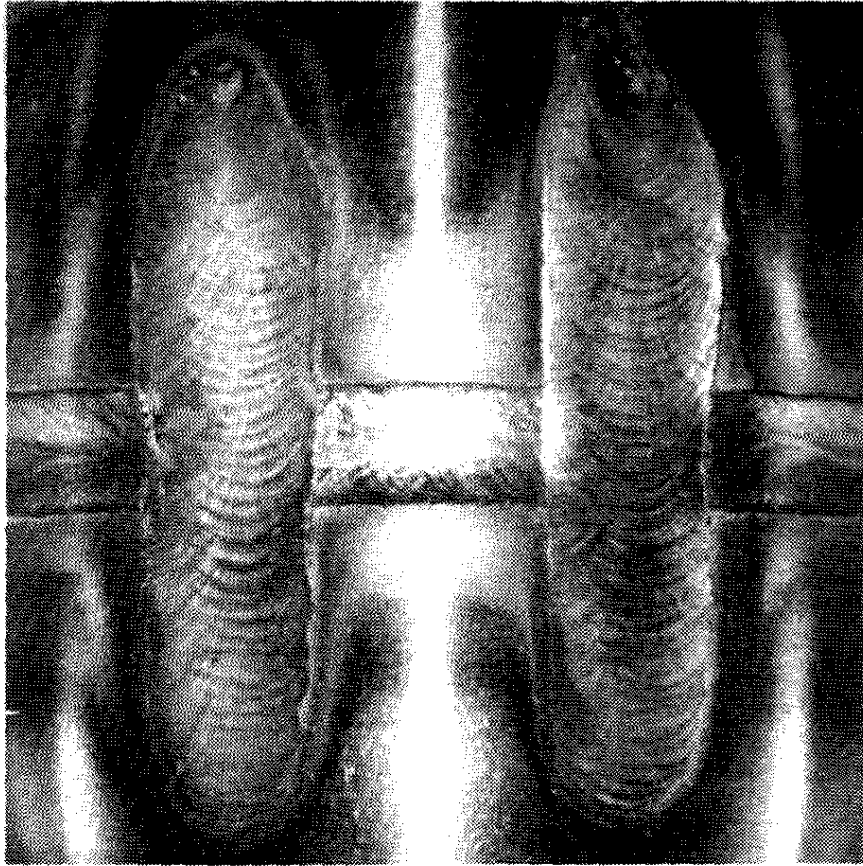
To demonstrate the role of helium in reactor repair weld toe cracking, test welds were made on 304L stainless steel that contained dissolved tritium and deuterium with helium present from tritium decay. The helium concentration was high on the tritium exposed surface and decreased to zero within the material. A pre-existing (therefore helium charged) gas tungsten arc (GTA) weld was present across the center of the samples. Parallel bead GTA test welds, Fig. 10A, were made at parameters chosen to duplicate the test weld conditions in the reactor tank.

A. VERTICAL TEST WELDS.
(HORIZONTAL WELD MADE PRIOR TO
CHARGING.)

FIGURE 10. TEST WELDS ON HELIUM CHARGED 304L TEST PIECE (2x).

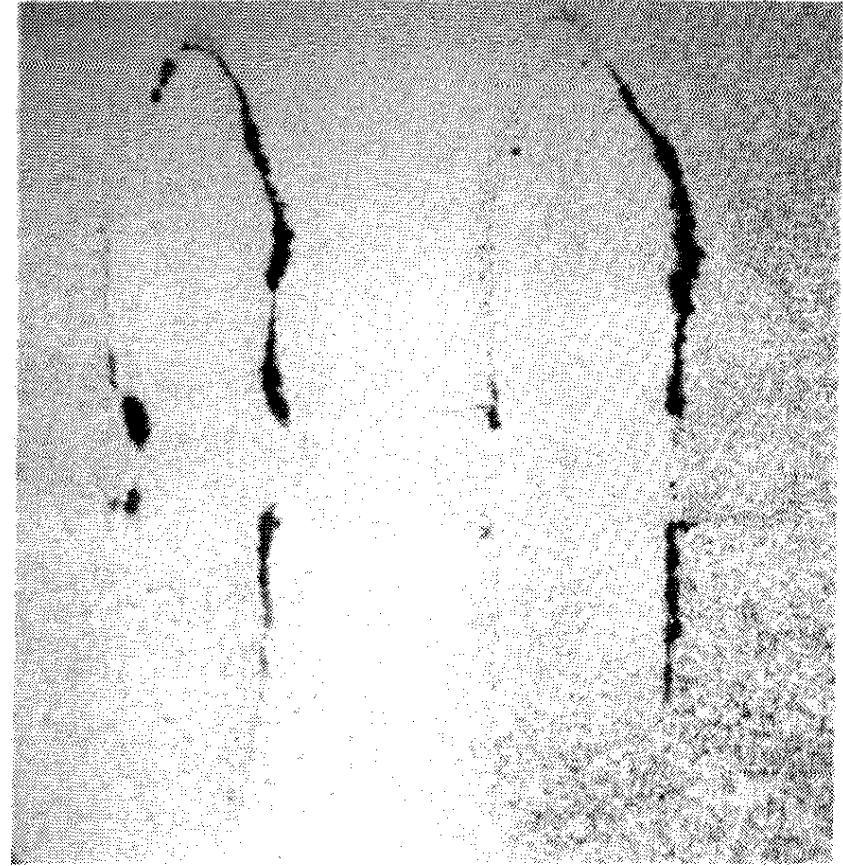
B. DYE PENETRANT TEST.

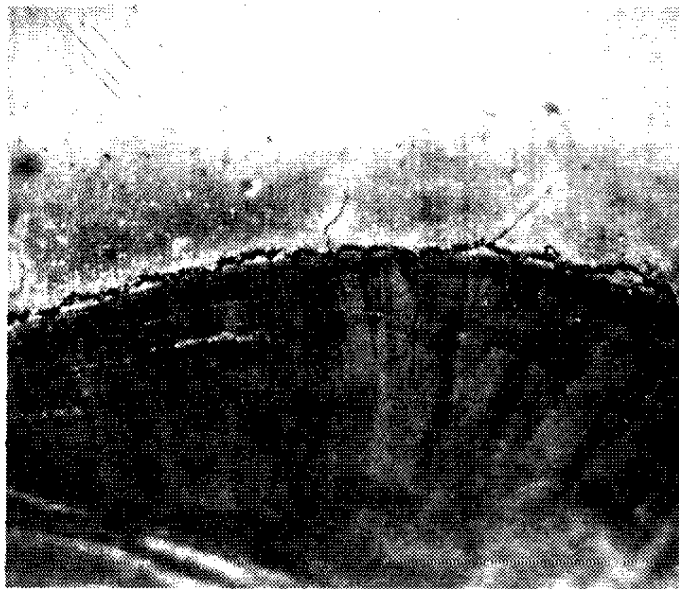
← CRACK

FIGURE 11. SURFACE APPEARANCE OF WELD TOE CRACK (40x).

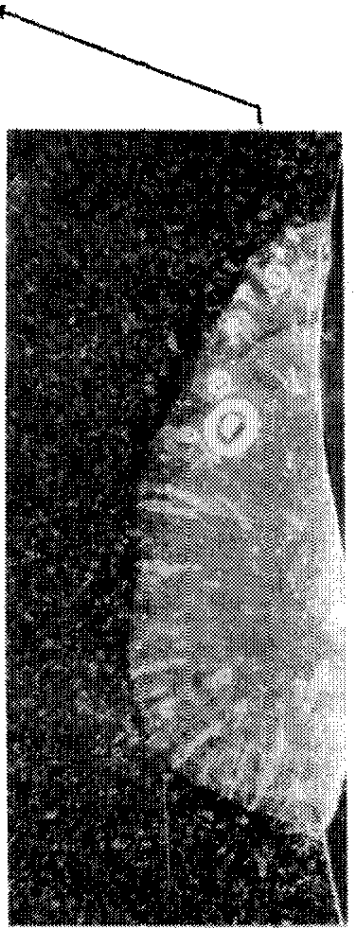
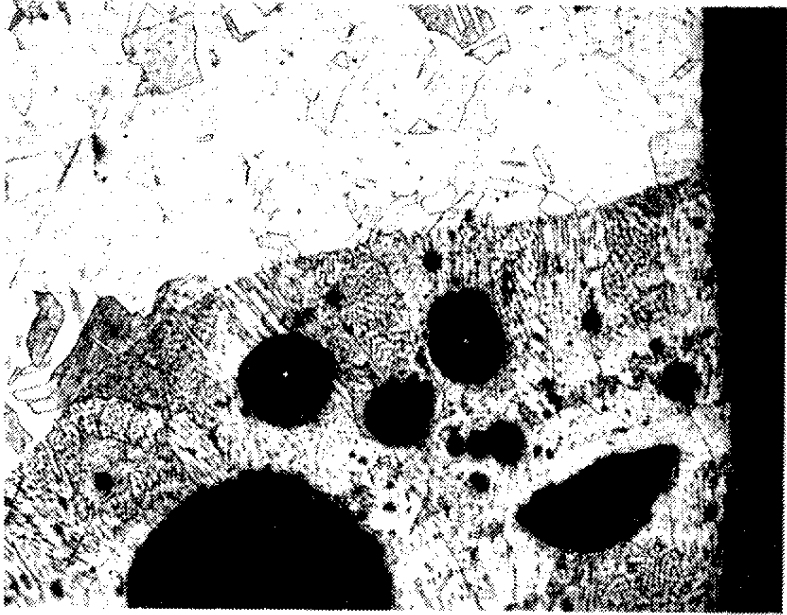
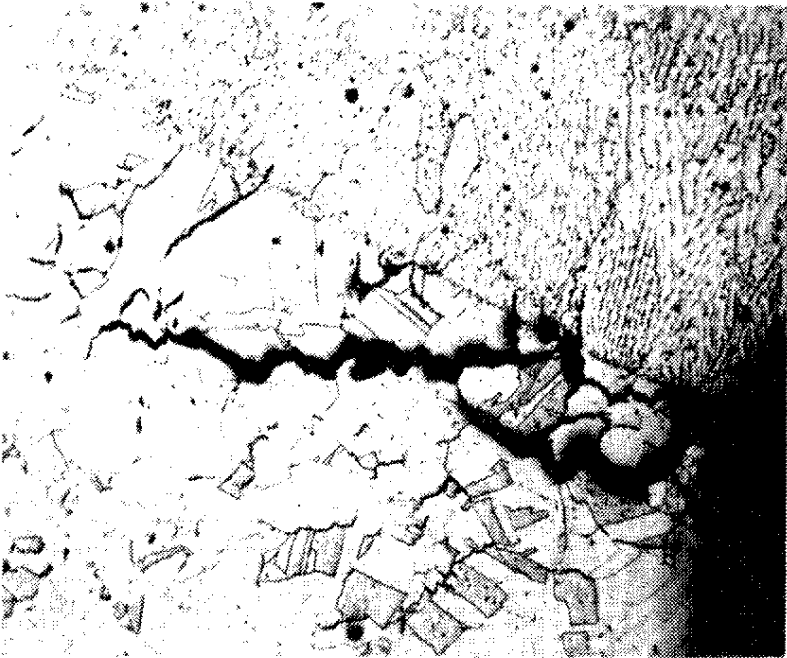
Microscopically (Fig. 12), the cracks were intergranular and generally perpendicular to the material surface. Porosity was present within the weld beads. The similarity of the crack microstructure in the test samples to that in the reactor tank can be seen by a comparison with Fig. 9B.

FIGURE 12. POROSITY AND TOE CRACKS IN TEST WELD ON HELIUM CHARGED MATERIAL (8X, 100X, 100X).

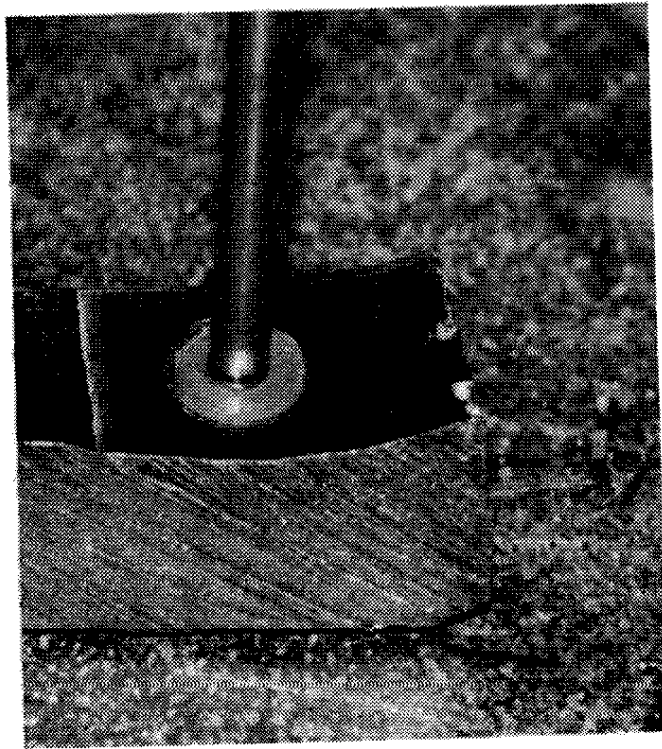
Cracks were not produced by resistance welds or by a low heat GTA pass that did not produce melting. Resistance welds were made by projection welding tubes (Ref. 10) to the surface. No cracks formed in either the solid-state-bonded region or around areas of molten weld flash (Fig. 13). This result is consistent with successful solid state welding of 304 stainless steel with entrapped helium reported previously (Ref. 9). Low tensile stress techniques (e.g., resistance welding) or nonmelting techniques (e.g., brazing) may therefore be satisfactory for joining material with entrapped helium.

A. TUBE PROJECTION WELDED TO HELIUM CHARGED SURFACE (2X).

FIGURE 13. CRACK FREE RESISTANCE WELD.
