IJTC2007-44017

RELATIONSHIP BETWEEN VIBRATIONS AND MECHANICAL SEAL LIFE IN CENTRIFUGAL PUMPS

Robert A. Leishear

Washington Savannah River Company
Aiken, South Carolina, 29803
803-641-6753, Robert.Leishear@SRS.gov

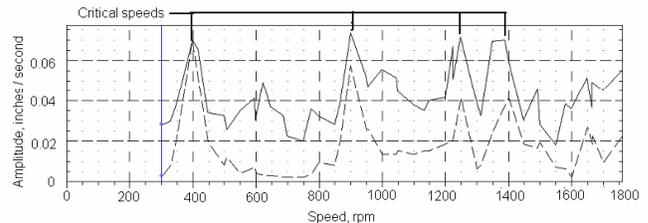
Several seal failures were investigated at SRS. One specific investigation resulted in a failure analysis of a failed seal, which included electron microscopy of the fracture surfaces of the failed seal. Note that several critical speeds are indicated by the vibration peaks shown in Fig 3. At each critical speed the vibration increases. The pump was operated at one of the critical speeds (1400 rpm), during testing and a seal was damaged.

Figure 3: Critical Speeds of a Long Shaft Pump

For the cracks to grow into the face, tensile stresses must exist on the seal face. Vibration provides an explanation for the tensile stresses. As the shaft deflects due to vibrations, the rotating seal face effectively wobbles with respect to the stationary seal face creating an impact load to the faces on each revolution of the shaft. An exaggerated depiction of the impact is shown in Fig. 5. The magnitude of the impact load depends on the film thickness which damps any impacts between the faces. As the film thickness is reduced during impact, damping is also reduced. The life of this specific pump was increased by avoiding operation at critical speeds.

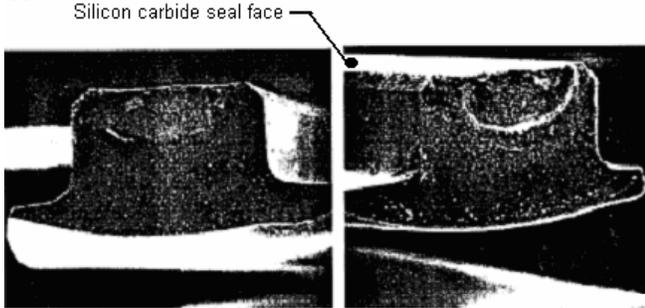
W. Daugherty [4] performed electron microscopy on this damaged seal. Spalling is observed at the seal surface shown in Fig. 4. These spalls, or chips, provided nucleation sites for the cracks to commence and extend into the seal face. At the time the crack was investigated, the crack had not fully extended through the seal. That is, the crack was still in progress.

Crack propagation. The crack shown in Fig. 4 is characteristic of cracks observed during Mode I fatigue testing. During Mode I testing, a specimen is cyclically stressed in direction perpendicular to the crack surface. The similarity between the crack observed here and typical crack propagation indicates that Mode I fracture is the probable cause of failure. Furthermore, cracks are known to propagate only with the application of a load to the crack.

Figure 4: Opposing Fracture Surfaces of a Damaged Mechanical Seal, W. Daugherty, SRS

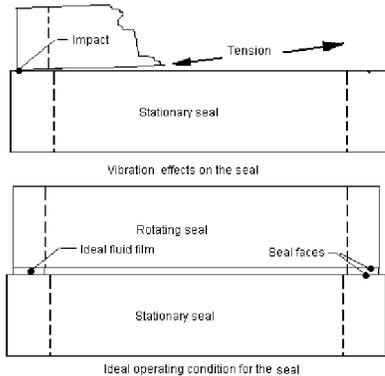
Figure 5: Impact of Seal Faces

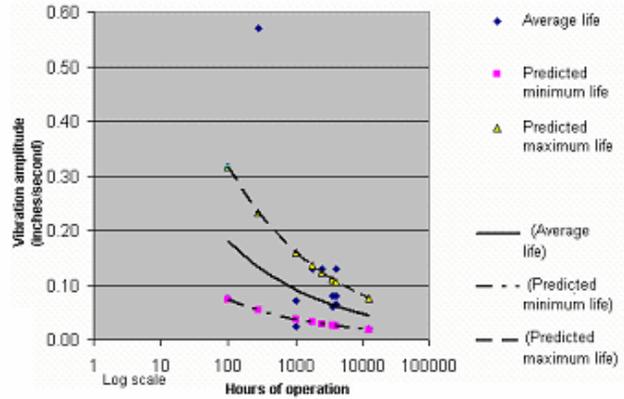
Vibration data and seal life data was available for numerous vertical pumps, and a comparison was made between vibration and life span. A question needed to be answered. What is the magnitude of a vibration needed to cause failure? This question is answered for this style of pump by Fig. 6. This figure shows the results of an evaluation of seal failures with respect to vibration. In fact, the figure may be used to predict seal life on these pumps when a measured whirl vibration is available. A failure analysis was performed on numerous pumps built by different manufacturers, and a common problem was discerned [5]. The magnitude of the vibration due to whirl was related to the time until failure of the seal.

While this data may not be generally applicable to all centrifugal pumps, the data indicates a definite relationship between vibration and seal life. Coupled with the fact that the seal failure mechanism is fatigue of the seal surfaces, a general conclusion can be reached with respect to seal failures. A reduction of the vibration by a factor of two increases the pump life by a factor of ten.

Figure 6: Prediction of Mechanical Seal life
