Excitation of Structural Resonance Due to a Bearing Failure

ABSTRACT

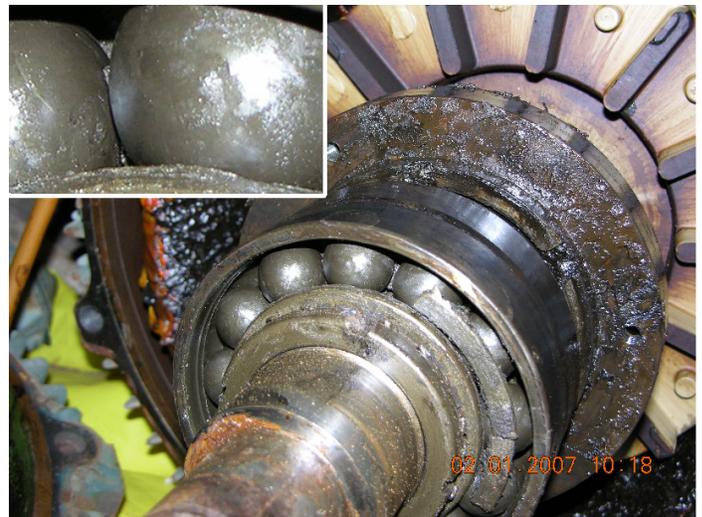
The motor was disassembled and inspected for damage. To do so, the upper thrust bearing was cut from the shaft. The upper, double row, thrust bearing had a damaged cage as shown in Fig. 5, and the races and balls were damaged as shown in Figs. 6 and 7. Spalling, or pitting, of the ball surfaces and inner race was quite obvious. The race was loose with respect to the balls. Improper lubrication was suspected as the initial cause of bearing failure. The lower radial bearing shown in Fig. 8 was undamaged, and the race was still tightly fitted to the balls. To further evaluate the bearing damage, a short discussion of resonance provides a sense of direction for the remainder of this paper.

Figure 5: Damaged Outer Bearing Cage on the Upper Motor Thrust Bearing

The motor was replaced and the vibrations were reduced as shown in Figs. 19 - 20. Using traditional vibration analysis acceptance criteria, the bearing vibration would have been considered acceptable. If the resonant condition was not identified, and the equipment was not removed from service, damage to other bearings and pump components was imminent. The vibrations inside the waste tank could not be measured, and the excitation of the massive pump would have caused impacting on other components.

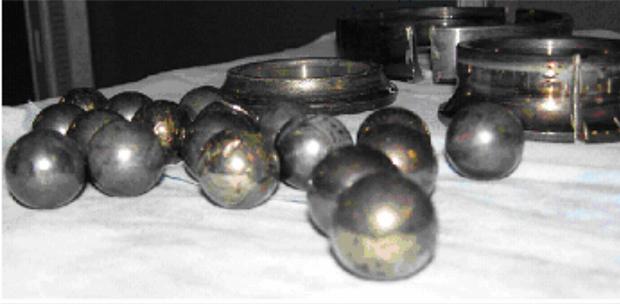
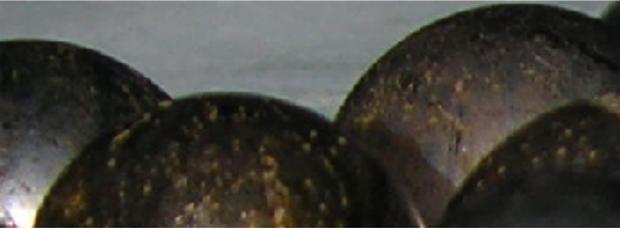
Figure 6: Ball Damage on the Thrust Bearing

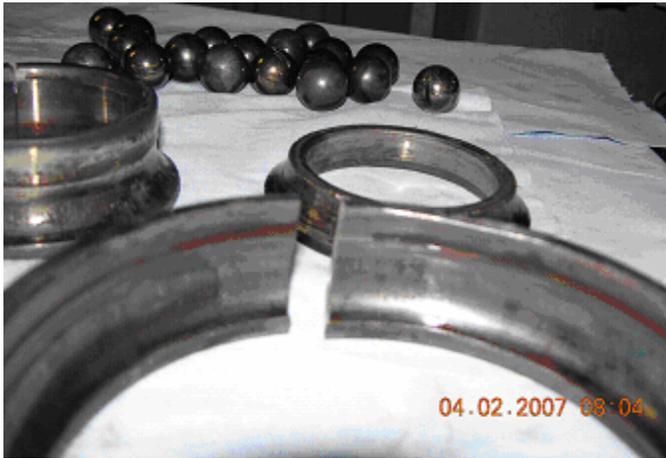
Figure 7: Races on the Thrust Bearing

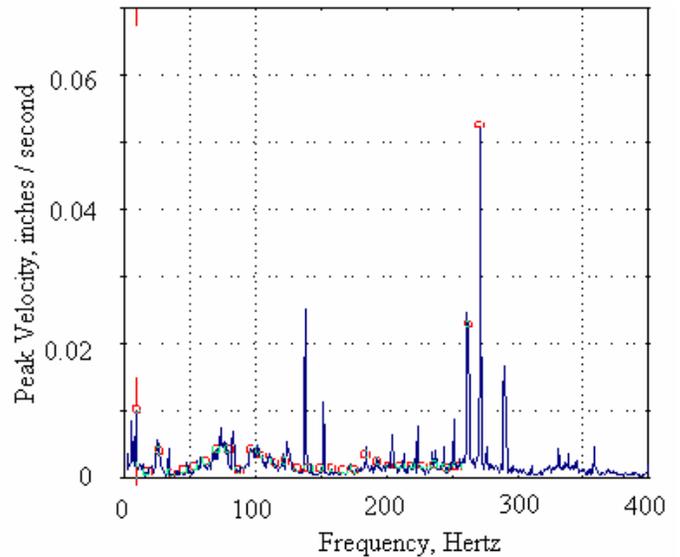
Lower Motor Radial Bearing. Vibrations at the radial bearing were comparable to other vibrations on the motor, and the maximum vibration occurred at 271 Hz, as shown in Fig. 10. This vibration resulted from the axial vibrations of the pump, which in turn were a direct result of thrust bearing vibrations.

Figure 10: Radial Vibration Near the Lower Motor Radial Bearing, MLX

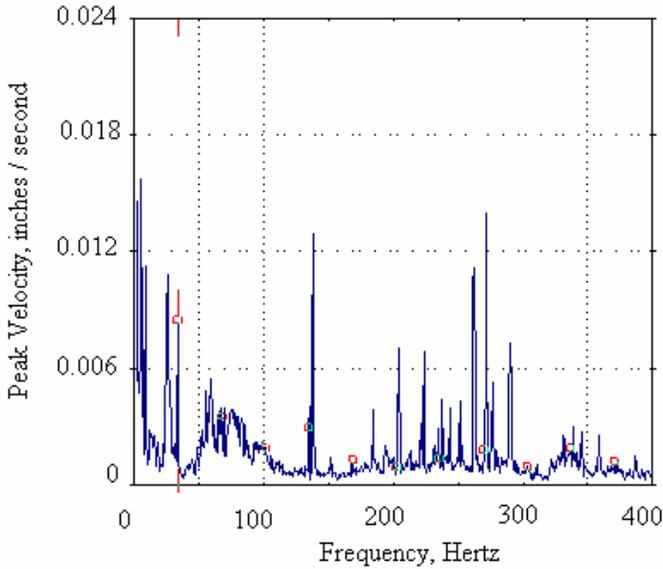
Axial and Thrust Bearing Vibrations. The vibrations at the top of the motor are displayed in Figs. 11 and 12, where the measurement locations are shown as MZ and MUX for the axial and radial vibrations respectively. Note that in Fig. 11 the radial vibrations are about a quarter of the axial vibrations shown in Fig. 12. The thrust bearing was significantly damaged, and the races of the double row bearing were effectively worn to a larger diameter as the predominant forces on the bearing became axially downward. The radial load would ordinarily be expected to be approximately 75% of the axial load (Mark [4]). Apparently, higher radial vibrations existed when the major damage to the races was in process. Figure 12 is of particular importance since it presents the axial vibrations related to the resonant condition and also presents the axial vibration at the thrust bearing. The thrust bearing was absorbing most of the load in the axial direction when the pump was removed from service. At that time, the vibrations were within acceptable limits for the thrust bearing as noted. Since the vibration levels are low, what caused the platform to vibrate? This question is related to the bearing, pump, and platform frequencies. The vibration of concern occurred at 271 Hz with a magnitude of approximately 0.034 inches / second.

Figure 11: Radial Vibration Near the Top of the Motor at the Thrust Bearing, MUX

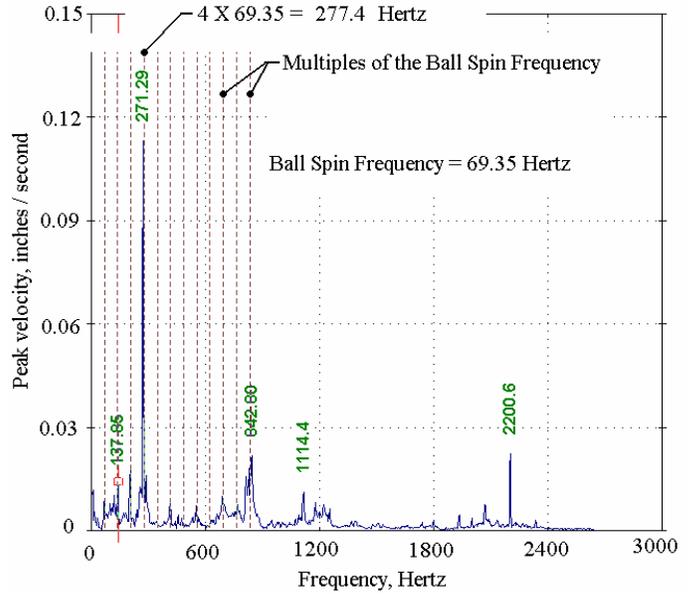
Figure 13: Ball Spin Frequency, Radial Motor Vibration, MLX

Each of the components within a bearing has a natural frequency at which it vibrates, i.e., the races, the cage, and the balls each vibrate at characteristic frequencies. The ball bearing frequency in operation is referred to as the ball spin frequency, which was obtained from the bearing manufacturer and is shown in Fig. 13. The ball spin frequency was noted in the figure to be coincident to most of the peak axial vibrations measured on the failing motor bearings. The vibrations shown in Fig. 13 were measured at the bottom of the motor, and the largest vibrations occurred at 271.29 Hertz, which are nearly coincident to a multiple of the ball spin frequency. The fourth mode of the bearing was excited by system vibration.

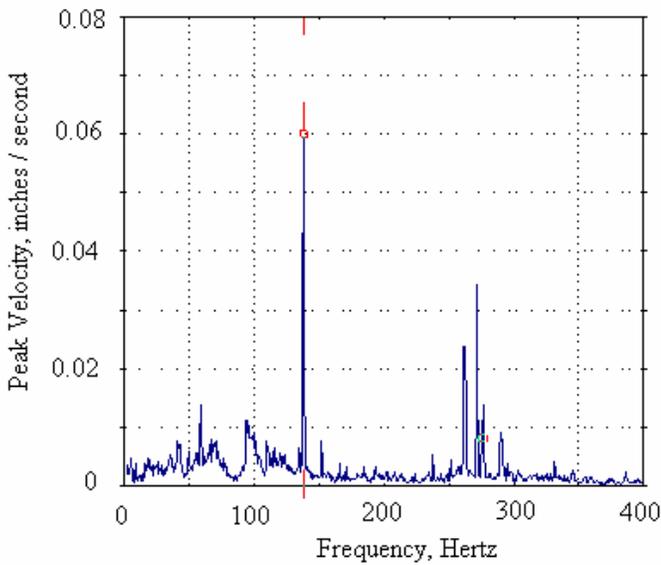
Figure 12: Axial Vibration Measured on the Motor, MZ

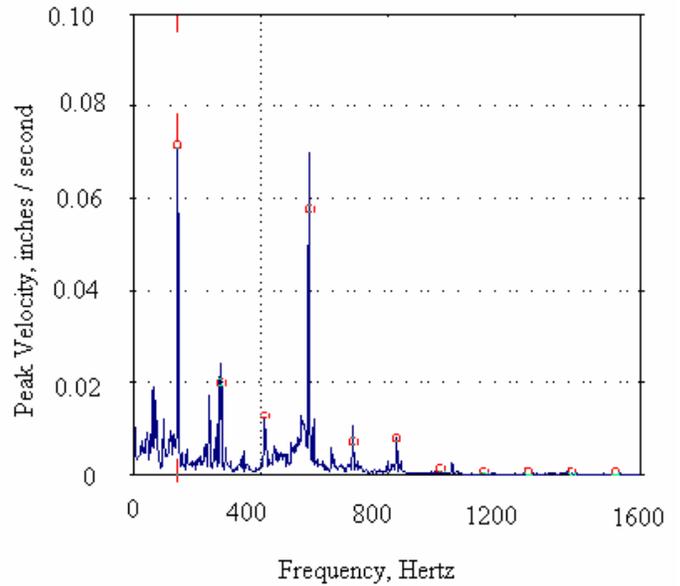
As mentioned, vibrations during operations can only be measured at the top of the pump. Referring to Fig. 14, vibrations were measured at the location labeled PUZ to obtain the results shown in Fig. 14. Numerous vibrations are excited in the pump. Of interest is the vibration at 271 Hz, which has a small magnitude at PUZ of approximately 0.025 inches / second.

Figure 14: Axial Vibration Measured on the Pump During Operation, PUZ

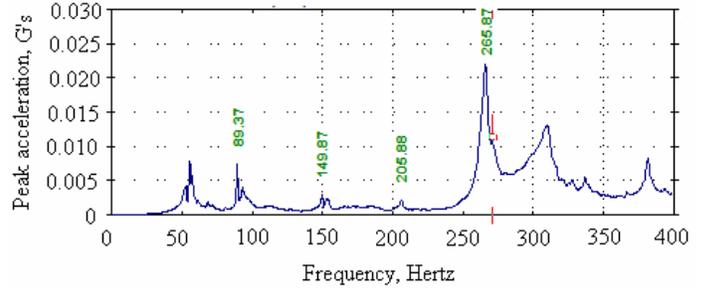
Platform frequencies were also identified by a bump test and are shown in Fig. 17. Numerous measurements were taken at different locations on the platform, and different natural frequencies occurred at different locations. Several locations had natural frequencies near the natural frequency of interest on the pump. Note that one of the platform natural frequencies at 265.87 Hz is nearly coincident to the pump natural frequency of 271.3 Hz. This frequency was measured at location SZ shown in Figs. 3 and 4.

Figure 17: Structural Steel Platform Frequency, SZ

The platform was certainly excited at 271 Hz, as shown in Fig. 17, and the forcing frequency was due to the bearing vibration. The question is, what magnitude of vibration was transmitted to the beam?

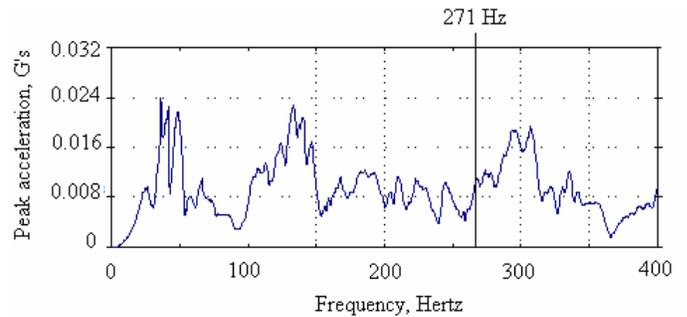
Gratings are bolted to the platform to walk on, and the grating vibrations are typically quite random as shown in Fig. 14. The grating vibrated in response to structural vibrations of the platform. The loud, low frequency noise observed during operation resulted simply from the rattling of the gratings. The vibration response (GZ) of one of the gratings is shown in Fig. 14.

Figure 18: Grating Vibration, GZ

Grating vibrations resulting from the 271 Hz excitation can be explained using Fig. 18. Resonance does not occur since a natural frequency for the grating does not occur at 271 Hz. However, vibrations are transmitted from the vibrating beam to the grating in accordance with Fig. 9. For frequencies below 271 Hz, the transmissibility approaches zero and the effects of a high frequency excitation are negligible. For grating frequencies above 271 Hz, the transmissibility approaches one, and all of the higher frequencies will be affected. In other words, deflections of at least $\pm 1/16$ inch will occur at the grating at frequencies above 271 HZ. The low frequency vibrations heard from the grating were caused by the loose grating banging into the structure as the grating vibrated up and down at high frequencies. The lower frequency random vibrations seen in Fig. 18 created random noise at those frequencies, which interfered with speech frequencies. Consequently, conversations could not be heard near the pump.

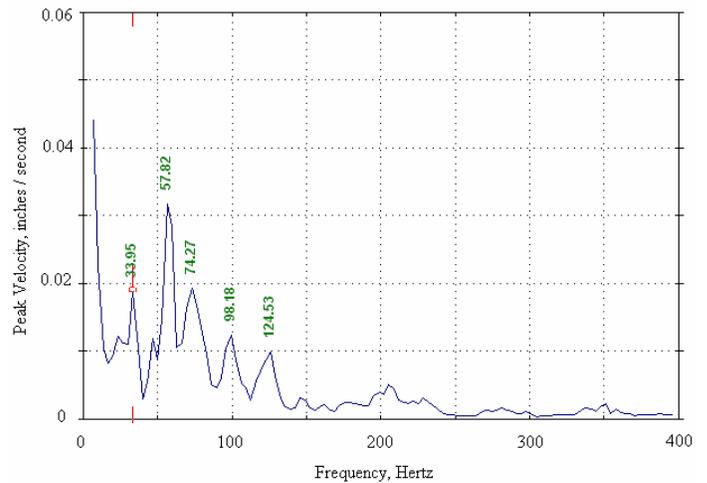
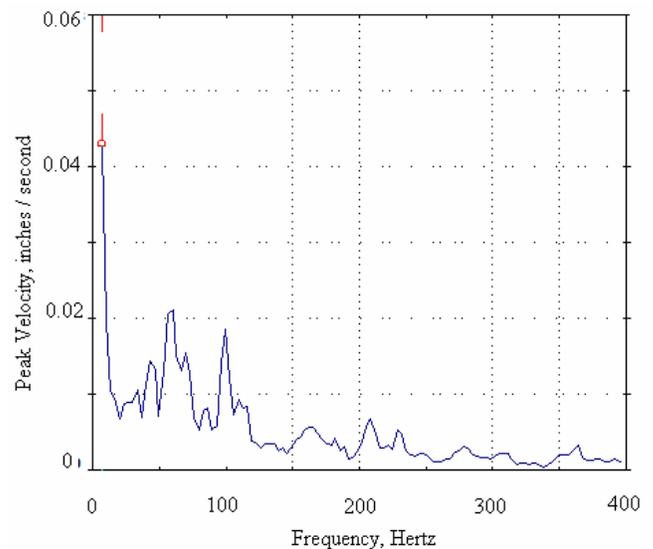
Figure 19: Radial Vibration Near the Lower Motor Bearing After Motor Replacement, MLX

Figure 20: Axial Vibration Measured on the Motor After Motor Replacement, MZ
