Evaluation of Flaws in BTSP Containment Vessel Materials

Savannah River National Laboratory
Materials Science & Technology

Publication Date: July 2009

Document No. SRNL-STI-2009-00444

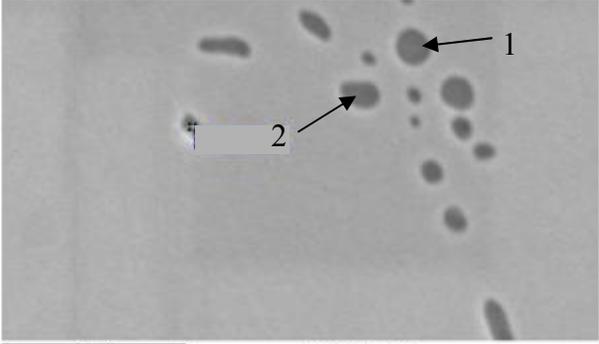
<p>Electron Image 1</p>	<p>Location 1: S 26 wt% Cr 7 wt% Mn 52 wt% Fe 14 wt% Ni 1 wt%</p>	<p>Location 2: S 10 wt% Cr 15 wt% Mn 19 wt% Fe 48 wt% Ni 6 wt%</p>
<p>Top surface, new leak site</p>

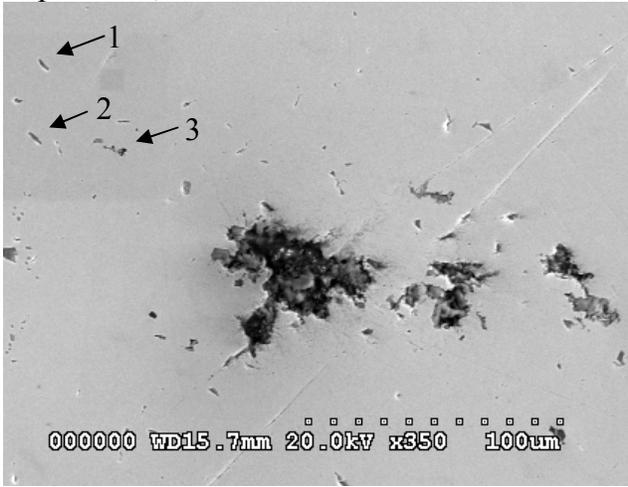
<p>000000 WD15.7mm 20.0kV x350 100µm</p>	<p>Location 1: Si 34 wt% Cr 13 wt% Mn 2 wt% Fe 47 wt% Ni 4 wt%</p> <p>Location 2: Si 14 wt% Cr 15 wt% Mn 2 wt% Fe 57 wt% Ni 8 wt% Dy 4 wt%</p>	<p>Location 3: Al 2 wt% Ca 2 wt% Ti 5 wt% Si 2 wt% Cr 17 wt% Mn 4 wt% Fe 60 wt% Ni 8 wt%</p>
<p>Top surface, new leak site</p>

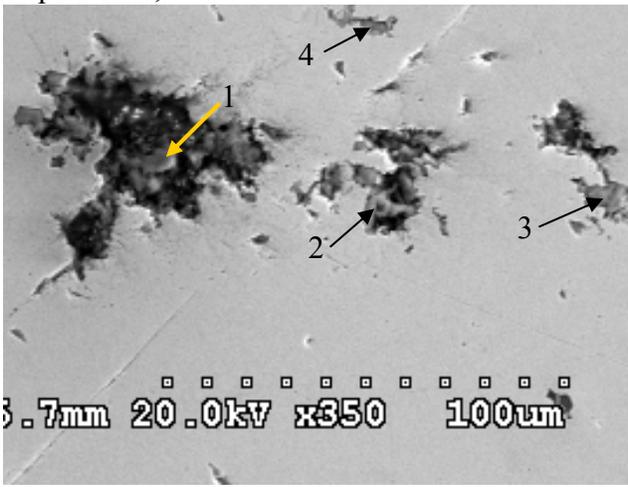
<p>15.7mm 20.0kV x350 100µm</p>	<p>Location 1: Mg 1 wt% Al 58 wt% Ca 10 wt% Ti 18 wt% Cr 6 wt% Mn 7 wt%</p> <p>Location 2: Al 15 wt% Ca 3 wt% Ti 71 wt% Si 2 wt% Cr 3 wt% Mn 4 wt% Fe 1 wt%</p>	<p>Location 3: Mg 1 wt% Al 20 wt% Ti 21 wt% Cr 20 wt% Mn 35 wt% Fe 2 wt%</p> <p>Location 4: Mg 1 wt% Al 20 wt% Ca 1 wt% Ti 16 wt% Si 1 wt% Cr 21 wt% Mn 35 wt% Fe 6 wt%</p>

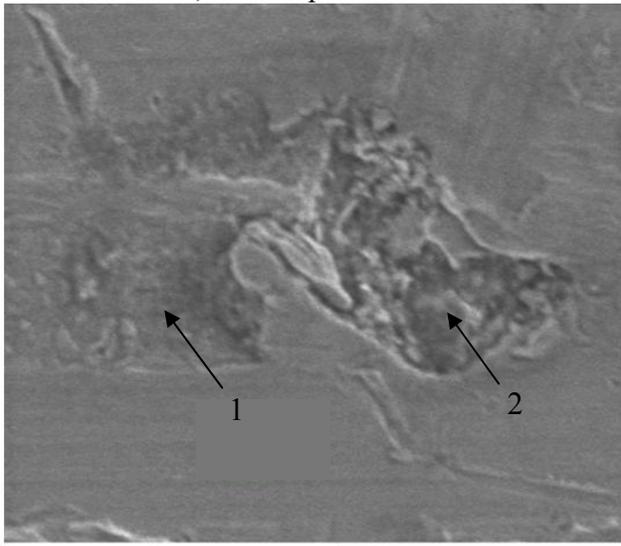
<p>60µm Electron Image 1</p>	<p>Location 1: Al 6 wt% Ti 6 wt% Cr 22 wt% Mn 11 wt% Fe 55 wt%</p>	<p>Location 2: Al 22 wt% Si 6 wt% Ti 10 wt% Cr 23 wt% Mn 29 wt% Fe 10 wt%</p>
<p>Bottom surface, weld-repaired leak site 2</p>

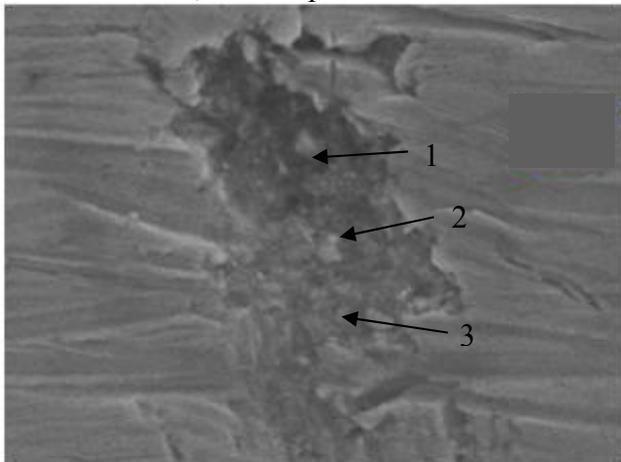
<p>20µm Electron Image 1</p>	<p>Location 1: Al 14 wt% Ti 47 wt% Cr 17 wt% Mn 22 wt%</p> <p>Location 2: Ti 77 wt% Cr 12 wt% Mn 12 wt%</p>	<p>Location 3: Al 8 wt% Ti 16 wt% Cr 18 wt% Mn 11 wt% Fe 47 wt%</p>
<p>Bottom surface, weld-repaired leak site 3</p>

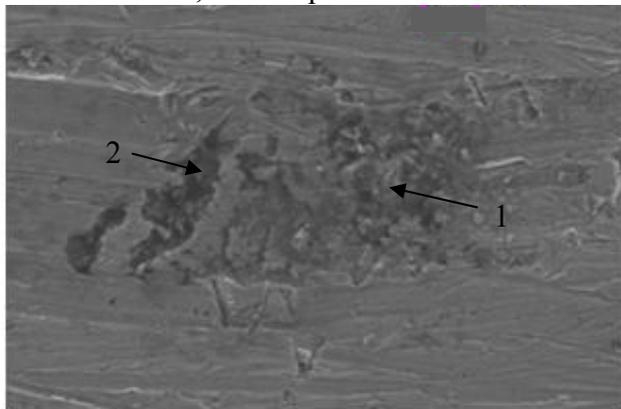
<p>60µm Electron Image 1</p>	<p>Location 1: Al 18 wt% Si 2 wt% Ca 4 wt% Ti 45 wt% Cr 9 wt% Mn 9 wt% Fe 13 wt%</p>	<p>Location 2: Al 7 wt% Si 4 wt% Ca 2 wt% Ti 41 wt% Cr 10 wt% Fe 14 wt%</p>

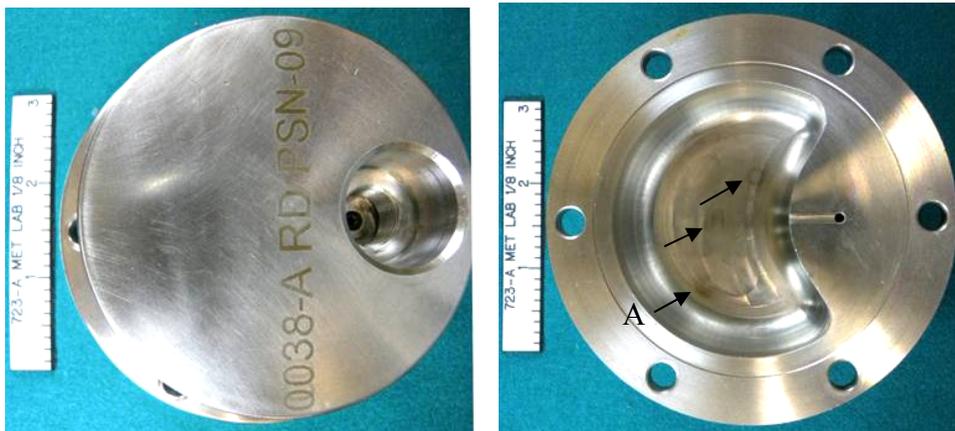
On the inside surface, opposite the repair welds, a faint heat tint was visible (Figures 2 and 3). The top portion of cap 9 was cut off to provide better access to examine the heat tinted areas for

Figure 2. Cap 9, as-received for examination. The welds are not visible in the as ground condition. Note the heat tint on the underside (arrows) from 3 of the 4 repair welds. The leak location labeled “A” was subsequently sectioned.

Weld repairs were made where leaks had been identified. A small weld bead was made over the leak and the weld ground flush and polished. All of the protective caps passed the post weld-repair leak test.

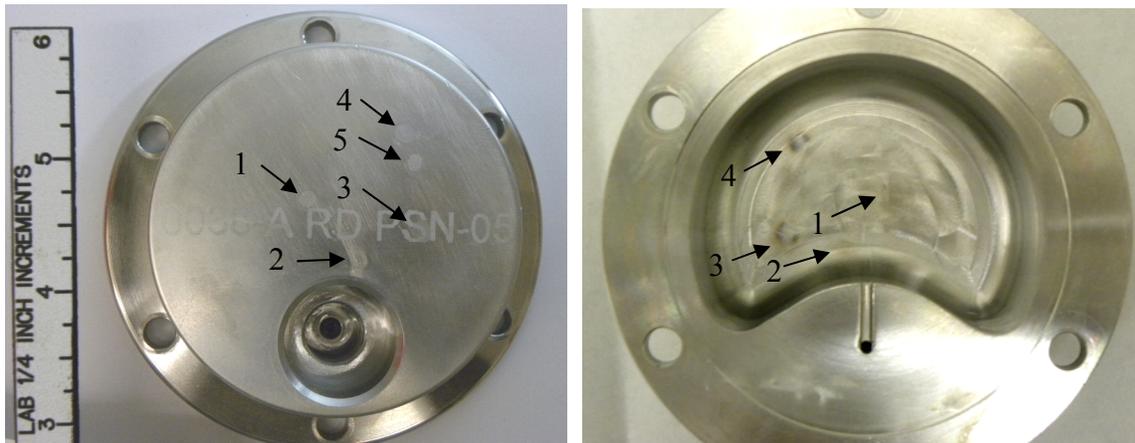
Figure 3. Cap 5, after the top was etched to reveal five repair welds (arrows). Note the heat tint on the underside is visible from 4 of the repair welds.

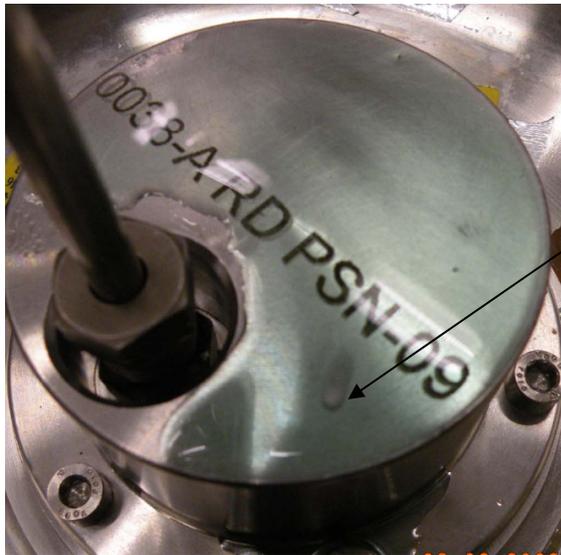
Two of the weld-repaired caps (caps 5 and 9, Figures 2 and 3) were subjected to non-destructive and destructive examination to determine the nature of the leaks. Both were initially leak tested again by the SRNL IE&S High Pressure Laboratory to verify the effectiveness of the weld repairs. Figure 4 illustrates a cluster of bubbles that was detected from a leak on cap 9 [2]. No further leaks were noted on cap 5.

Bubble Indication 2×10^{-6} ref cc/sec overall leak rate, 90 psig helium pressure
 Leak appeared when pressure was increased from 85 to 90 psig. Under magnification a string of the bubbles can be observed.

Figure 4. Cap 9 during leak testing. The cloud of bubbles originated from a leak location that was not repaired originally.

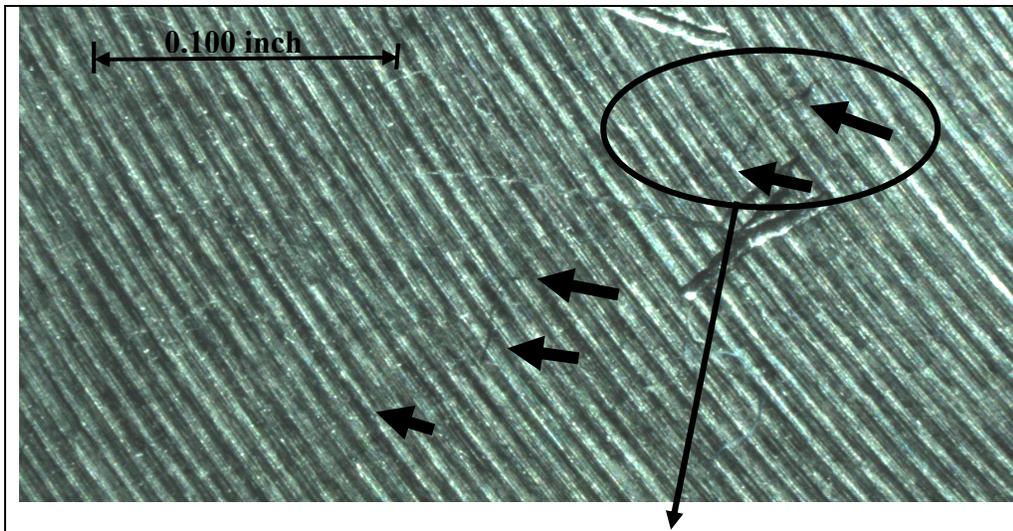
Initial post test examination of the caps under magnification suggested that the source of the leaks may have been from through wall cracking of the caps. Examples of early inspection of the outside of the cap are shown in Figure 5. The surface finish of the cap surface is approximately 75 micro-inch. The upper two arrows approximate the leak location indicated in Figure 5. Further examination of the cap revealed that the apparent cracks were only superficial and not through-thickness cracks.

Figure 5. Top surface of cap 9 at the location of the new leak (circled). The short scribe marks were made to identify the leak location. The three non-circled arrows highlight a possible surface crack.

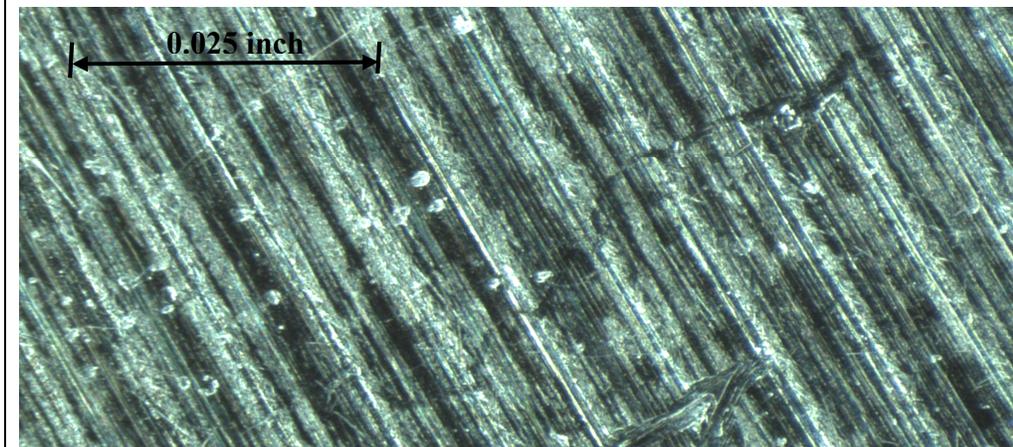
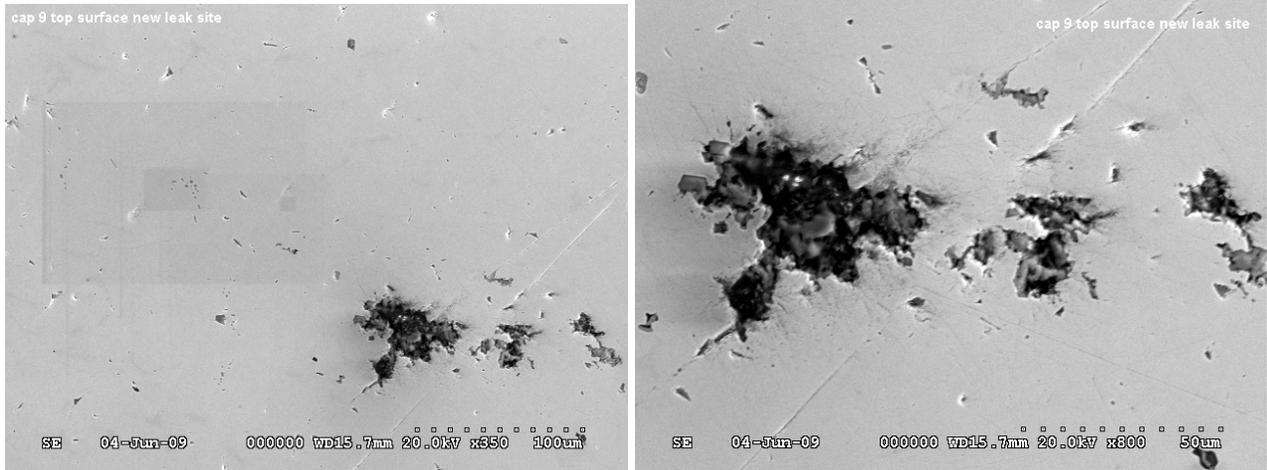
Figure 6. SEM image of cap 9 top surface (after polishing), at the new leak location.

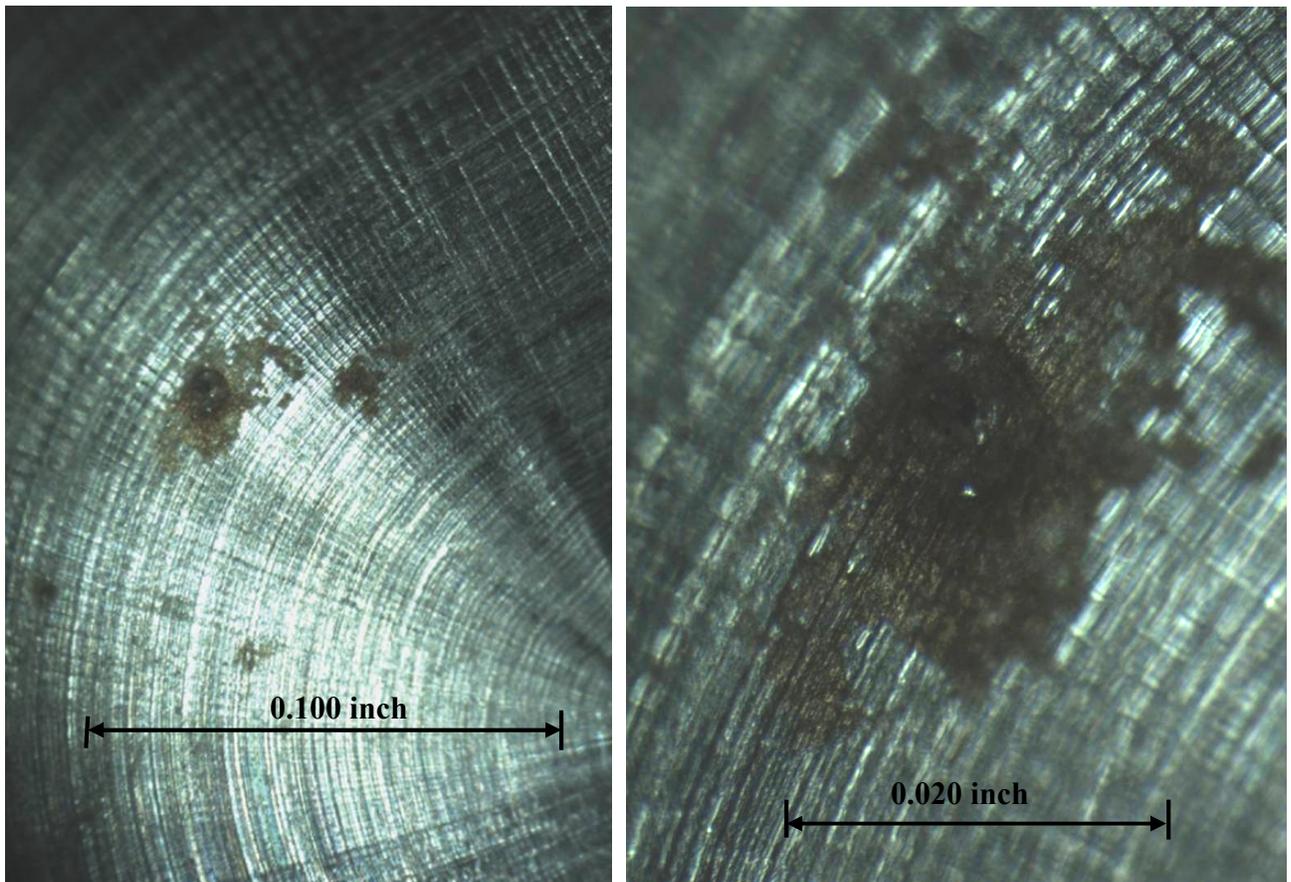
Figure 7. Underside of cap 9, at the location of the new leak.

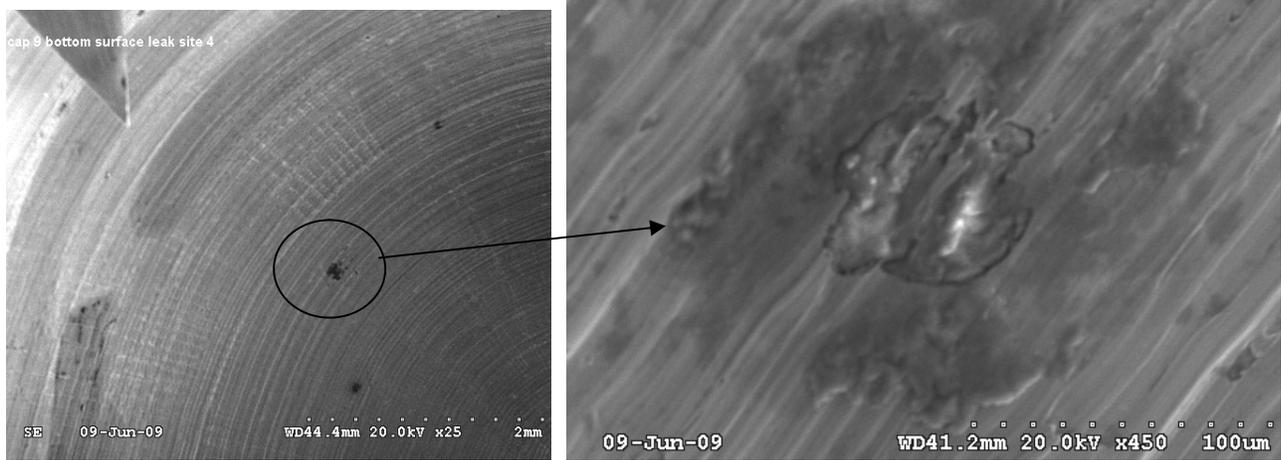
Figure 8. SEM image of cap 9 underside, at the new leak location.

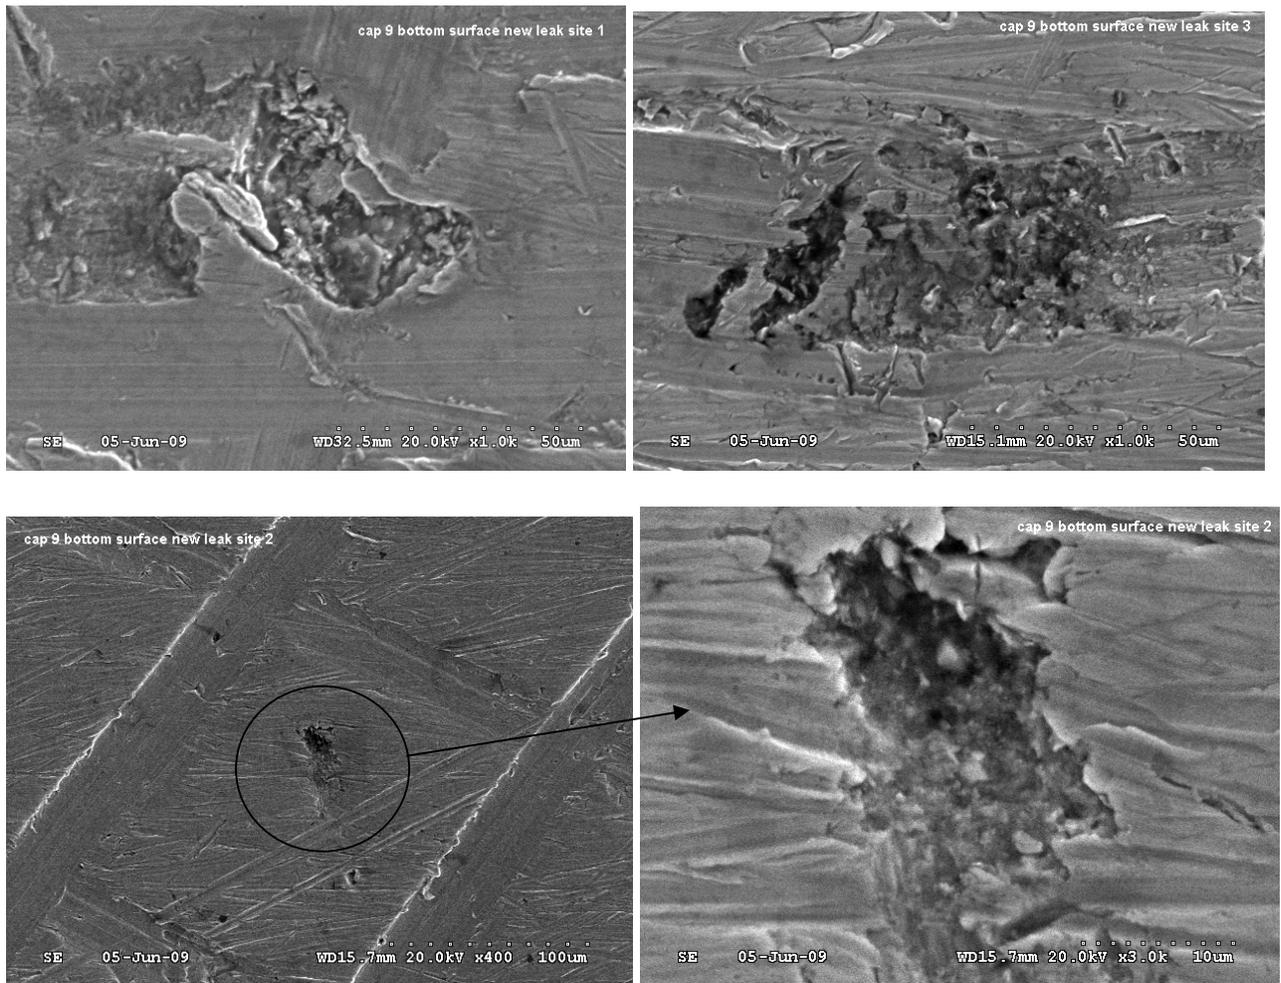
evidence of the leak sites. Using this as an indication of the original leak locations, the inside surface was examined at each of these locations in the scanning electron microscope. A number of inclusions were found and analyzed using energy dispersive x-ray spectroscopy. They typically contained silicon, manganese sulfide, and aluminum / titanium / calcium compounds. Cracks were observed in some of these inclusions, suggestive of a potential leak path. These locations are shown in Figure 9. Composition results from the spectroscopy are shown in Table 1. The base metal was also examined using energy dispersive x-ray spectroscopy at several locations near the inclusions. On average, the composition at these locations was consistent with the requirements for Type 304L stainless steel, with the exception that the manganese is slightly elevated (2.2 wt% vs 2 wt% max allowed).

Figure 9. SEM micrograph of the inside surface of cap 9, at the three repaired leak locations.

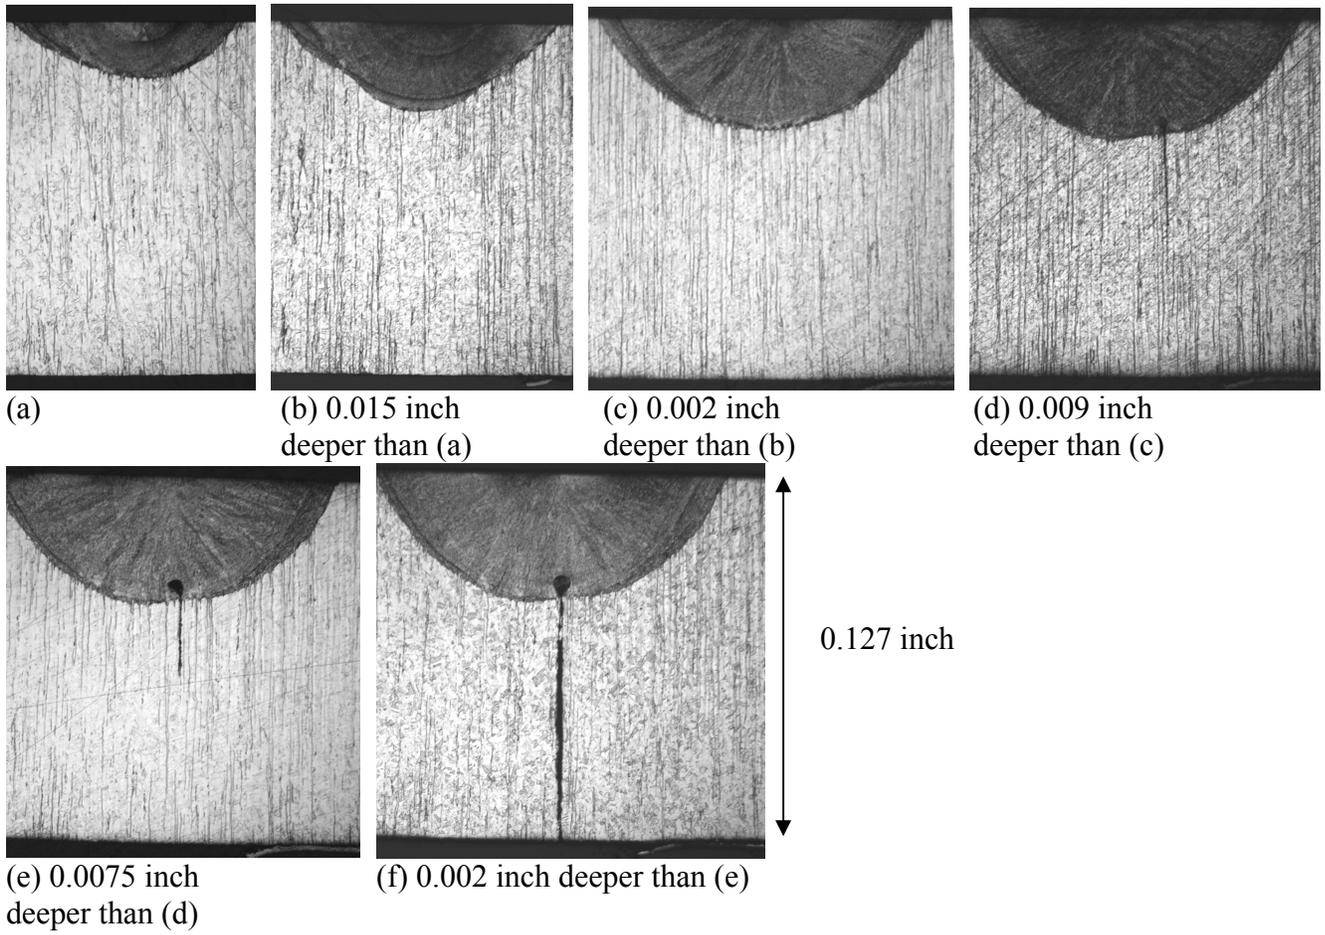
Two leak locations in cap 9 were further sectioned to examine the leak path through the cap cross section. These included the repaired leak identified as “A” in Figure 2, and the new leak. Leak path “A” is shown in Figures 10 and 11. The cross section pictured is the full ~1/8-inch thickness of the top of the cap. The leakage path was exposed sequentially by grinding approximately 0.002 – 0.015 inch of material at a time. The weld bead applied to seal the leak path is clearly visible.

In Figures 10 (f) and 13 (d), the leak path is typically up to 0.002 inch wide (Figures 14 and 15). However, portions of the leak path are visible in Figures 10 (d - f), giving this leak path a width perpendicular to the viewing plane of at least 0.010 inch. The leak path is not an open void, but contains a series of inclusions. These are similar in composition to those seen from the surface – mostly aluminum / titanium / calcium compounds. Compositional details are given in Table 2. Note also in Figures 10 and 11 the large concentration of stringers throughout the material. Many of these extend for a significant distance, up to or beyond the nominal 1/8 inch thickness of the cap. Most of these individual stringers appear consistent with manganese sulfide, which is often observed in this type of steel. They are largely crack-free and are not likely to cause leakage. However, their length and concentration are symptomatic of the high degree of impurities that did lead to the leak paths.

Figure 10. Series of metallographic cross sections through weld-repaired location “A” in cap 9. Section thickness = 0.127 inch.

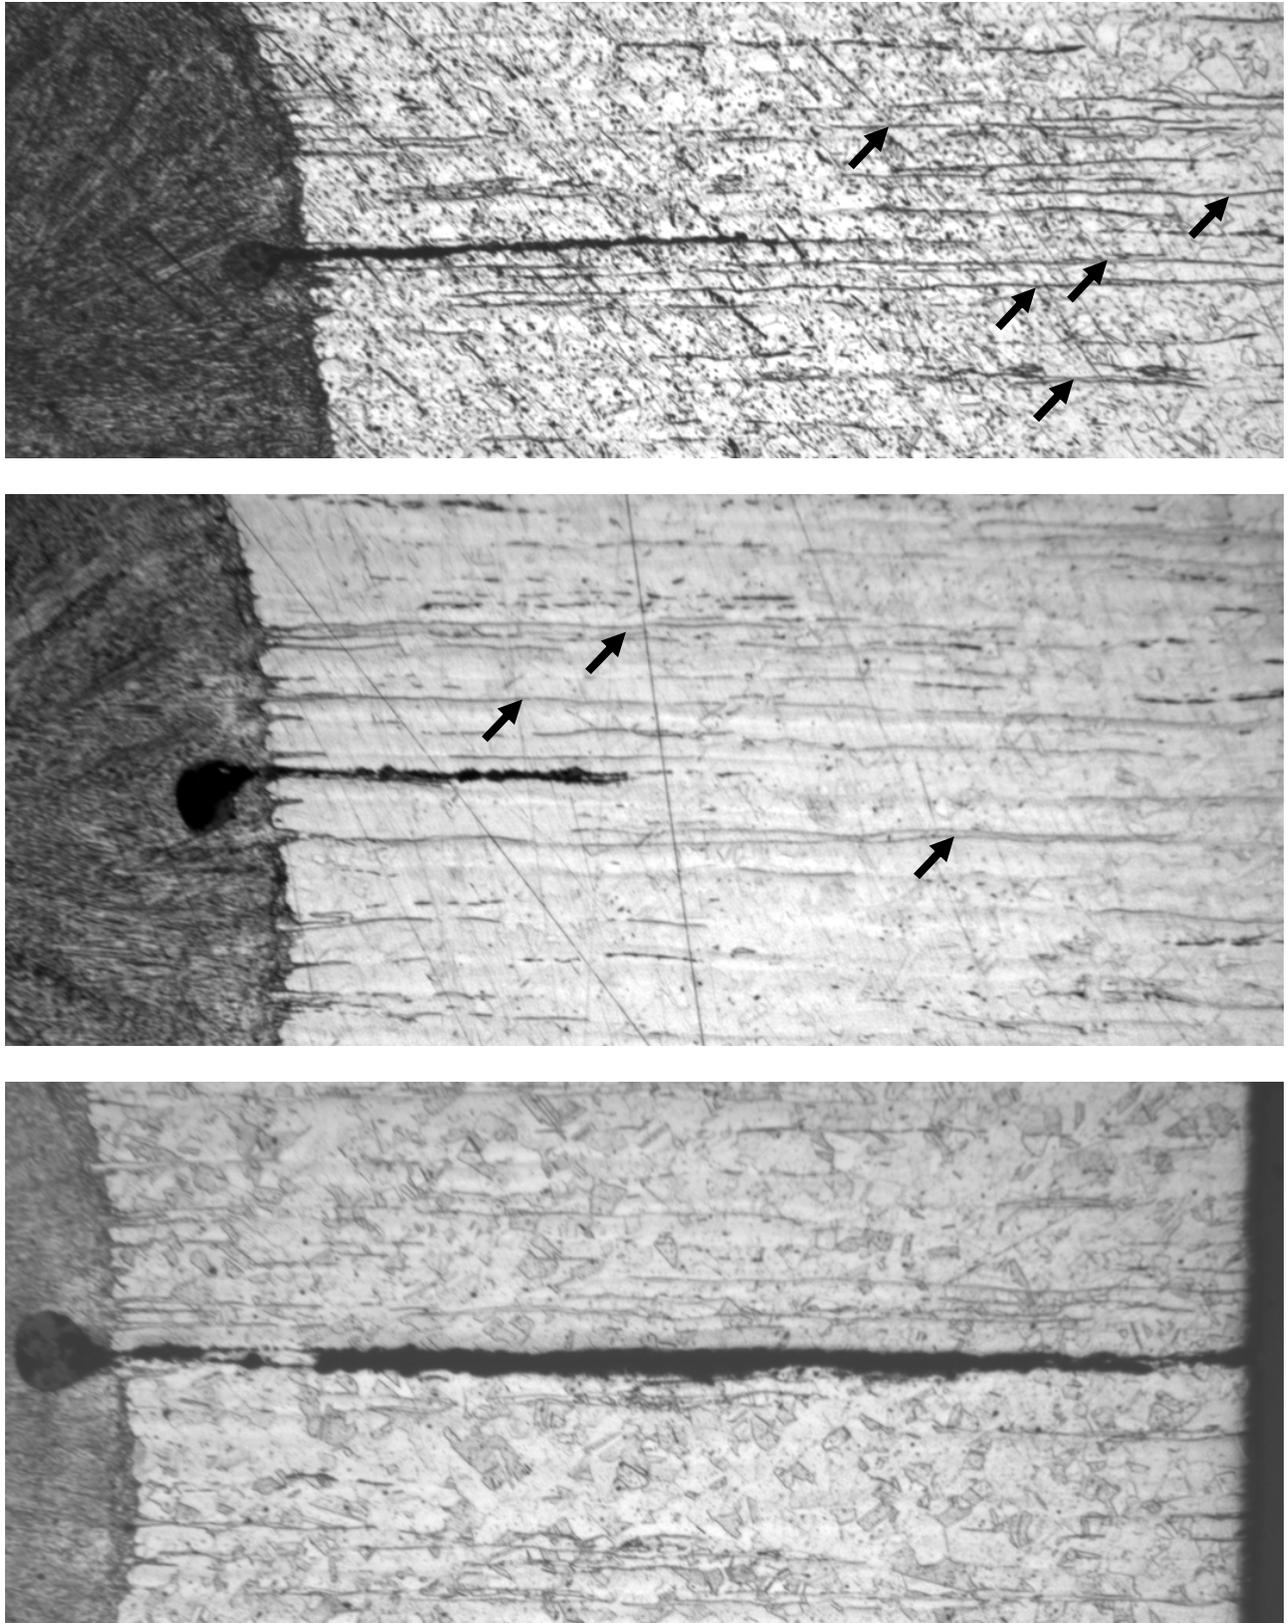
Figure 11. Detail of leak path from the last 3 sections shown in Figure 10. Some of the stringers not associated with the leak path are highlighted (arrows).

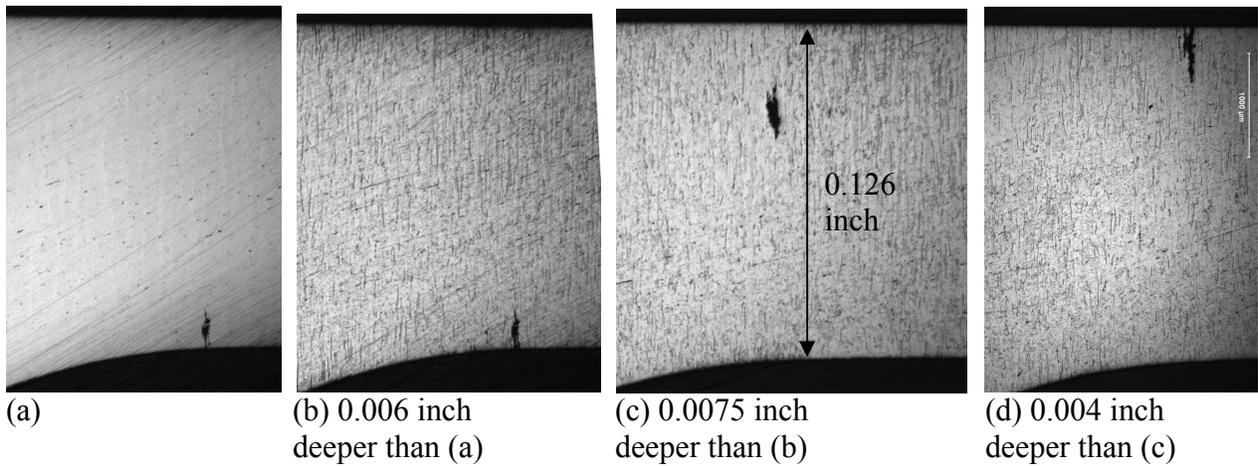
Figure 12. Series of metallographic cross sections through one of the weld-repaired locations in Cap 9. Section thickness at leak = 0.126 inch.

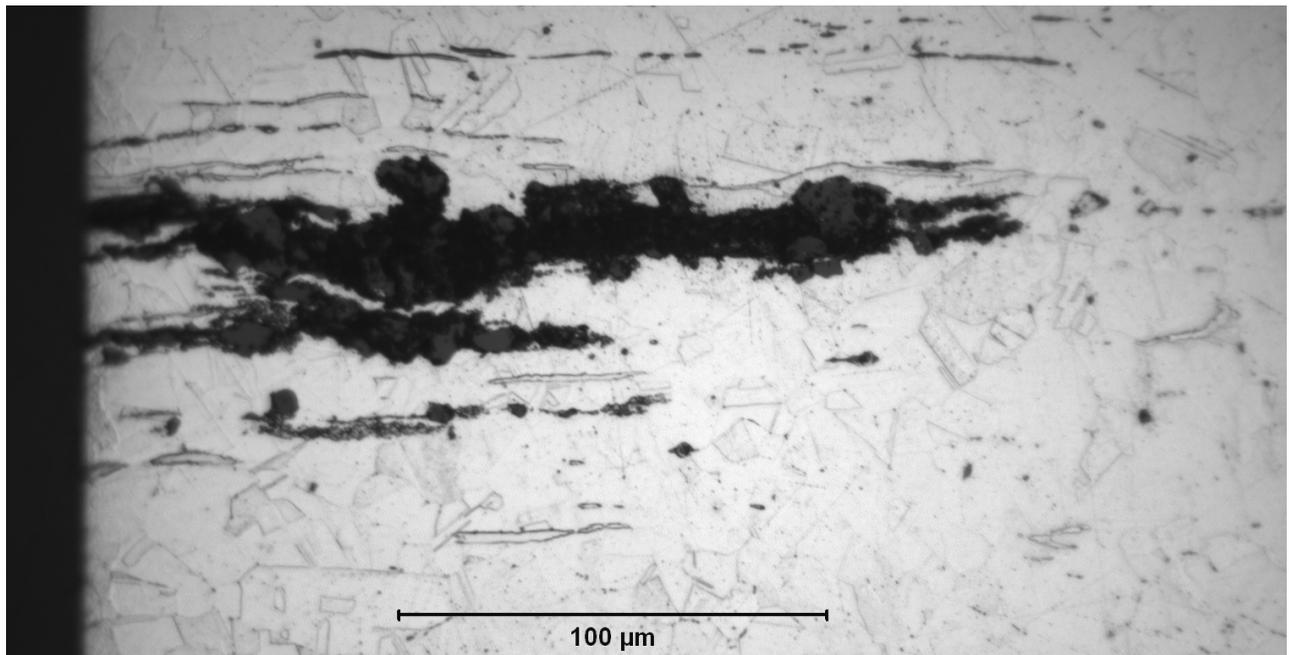
Figure 13. Detail of leak path from the last section shown in Figure 12.

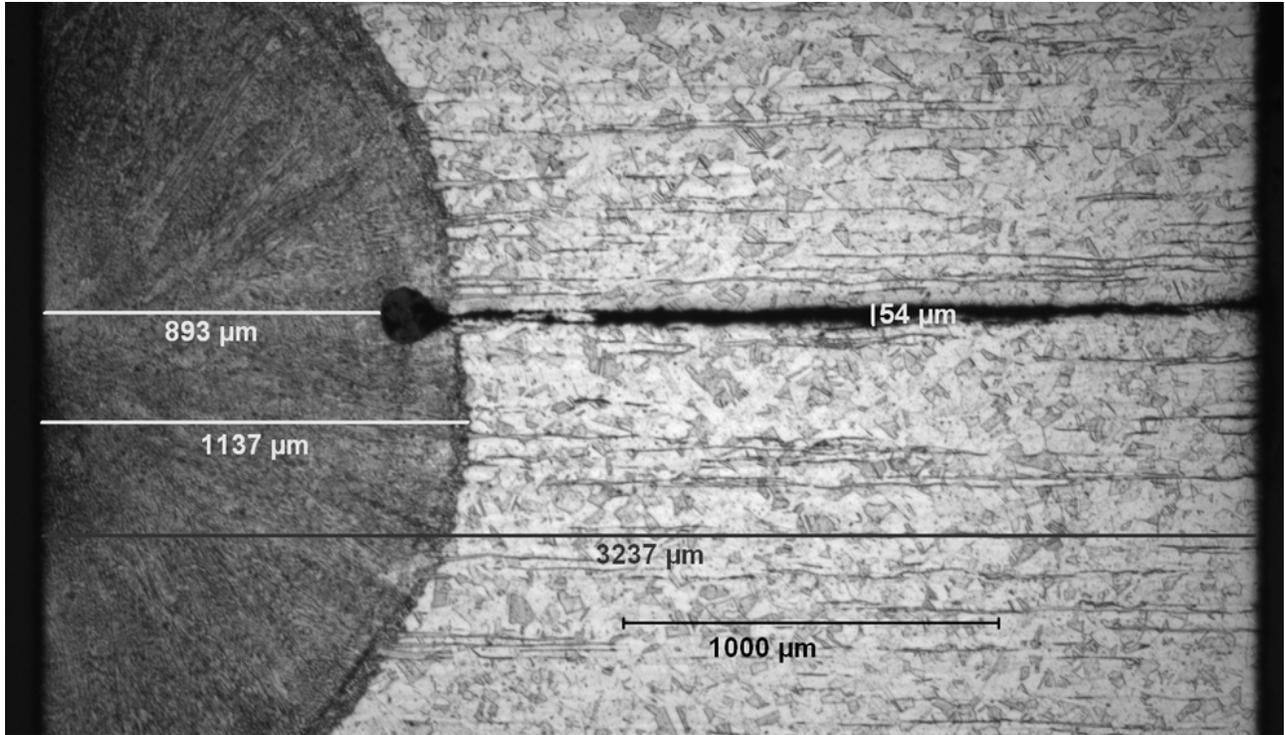
Figure 14. Measurement of inclusion features from leak path shown in Figure 10.

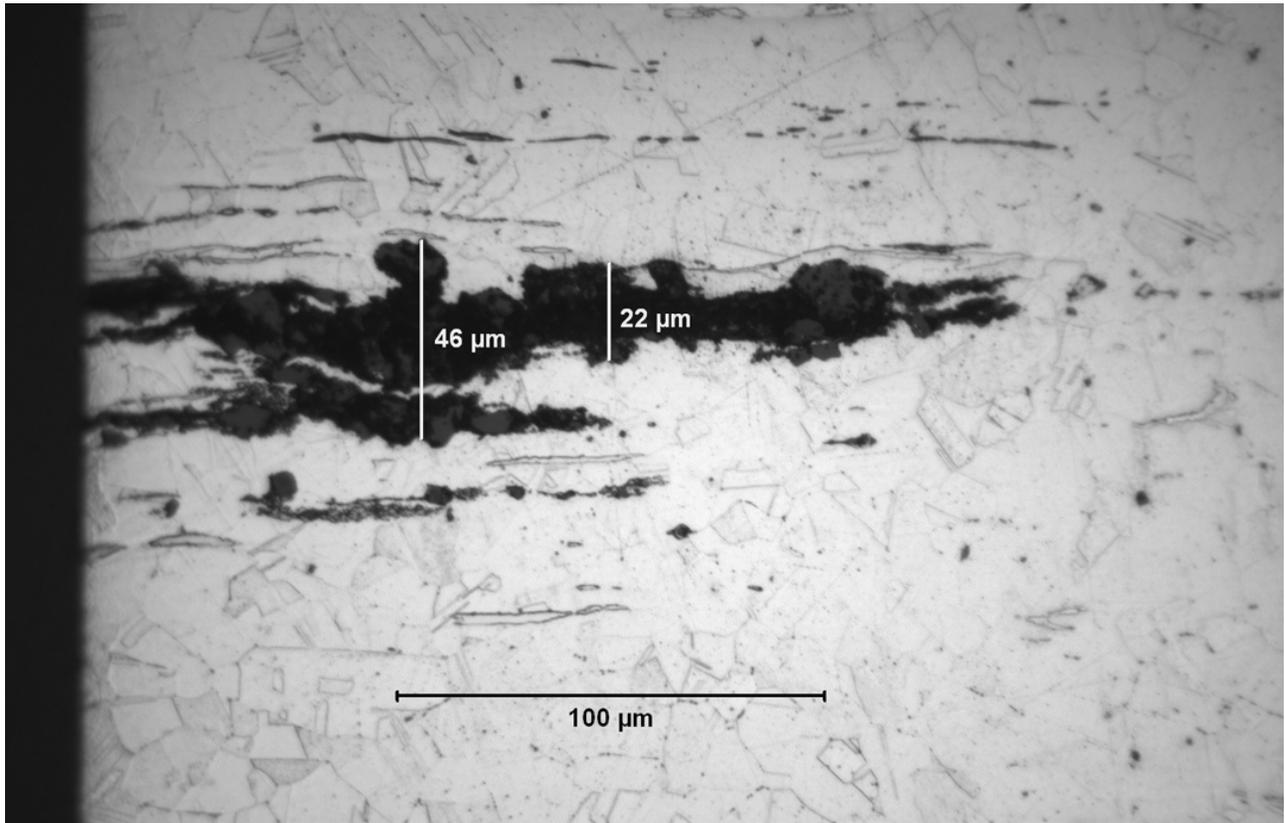
Figure 15. Measurement of inclusion features from leak path shown in Figure 12.

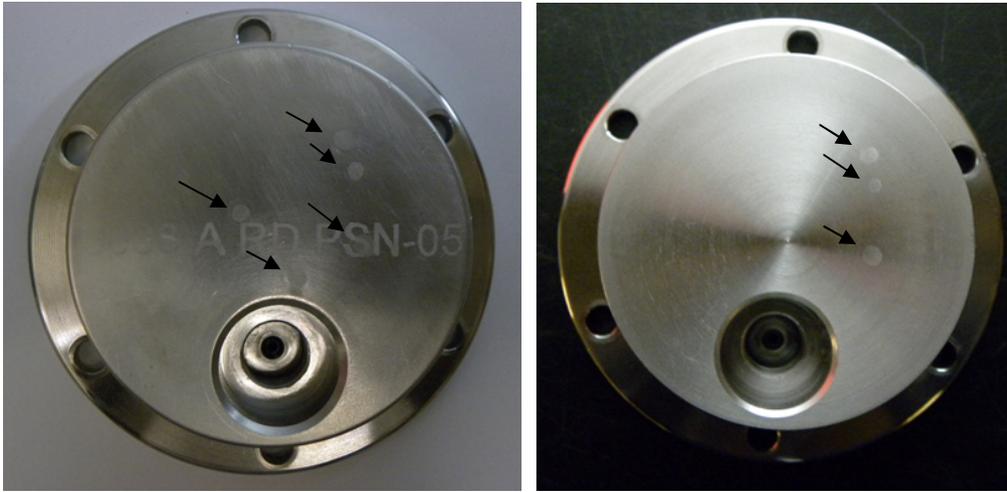
The top of cap number 5 was etched to reveal five repair weld locations (Figure 16). Subsequently, a total of 0.010 inch was machined from the top, and it was re-etched. With this minimal material removal, the top was re-etched and 2 of the 5 repair welds were no longer visible (i.e. they were less than 0.010 inch deep). After a vacuum bake to remove cutting oil and other liquid contaminants, a number of leaks were identified in this cap using the method described above (Figure 17). Somewhat surprisingly, none of these locations correspond to the 2 repair weld locations that were machined away. This indicates there are numerous defects throughout the material, with some stopping just short of the original machined surface. It is possible that the machining operation smeared over the previous leak paths just enough to preclude them from leaking at a noticeable rate.

Figure 16. Protective cap number 5, after etching to reveal repair weld locations (at arrows). After machining 0.010 inch from the top surface, two of the five repair welds had been removed.

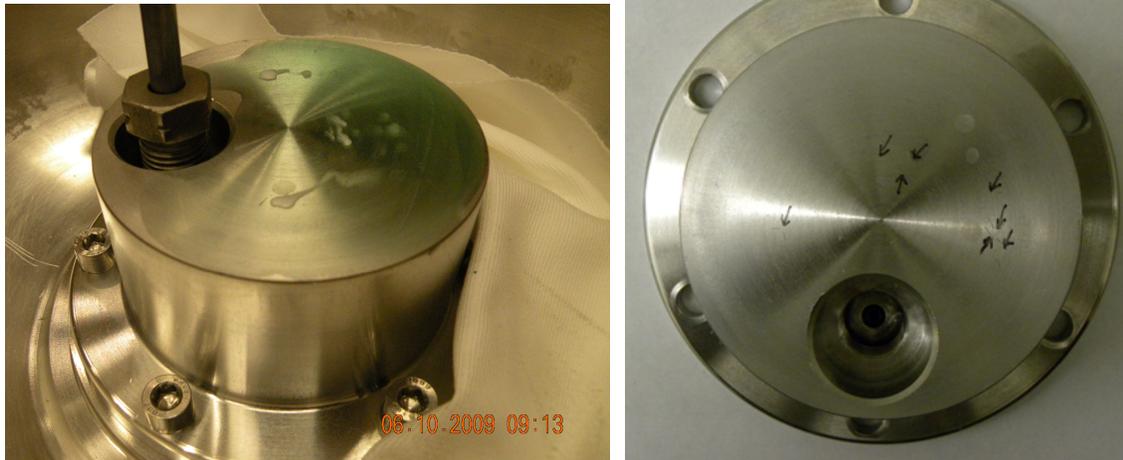
Figure 17. Leak locations identified in cap 5 after machining 0.010 inch from the top surface (arrows). Note that none of these locations correspond to the original weld repair locations seen in Figure 16.
