Residual Stresses in 3013 Containers

J. I. Mickalonis and K.A. Dunn
Savannah River National Laboratory¹
Aiken, SC 29808

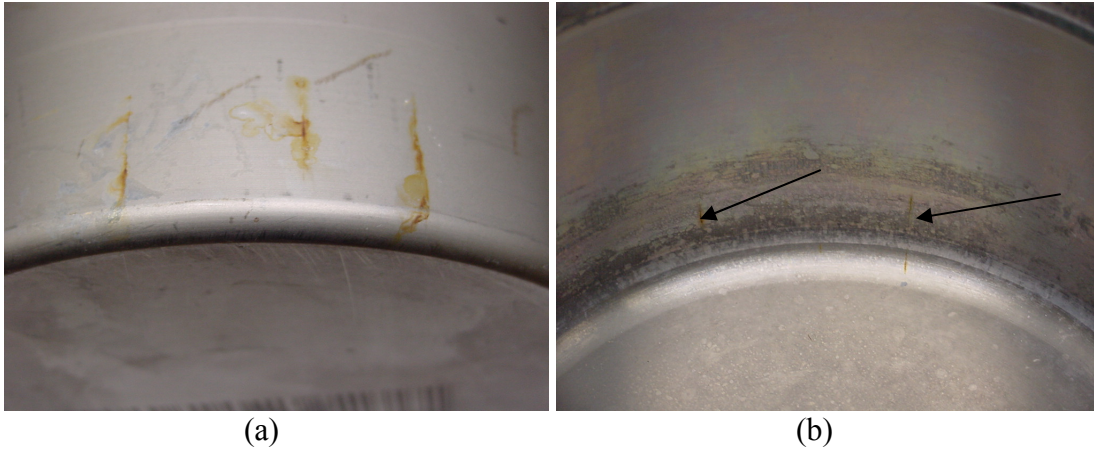
Through wall cracks were observed in the bottom half of the as-fabricated container specimen after 48 hours of testing in boiling magnesium chloride solutions, Figure 3. Other cracks were observed on the interior of the container specimen that did not appear to propagate through the wall. Five through wall cracks which ranged in length from 0.38-2.06 cm (0.15-0.81 in) were visible. All of the cracks observed were generally perpendicular to the base-to-container fabrication weld. Metallographic examination of one crack showed that the cracking initiated in the HAZ and grew into weld and base of the container specimen, Figure 4. The cracks were typical of stress corrosion cracks with regions of branching along their length and some areas of cracking 90° from the main crack. The location and orientation of the cracks are consistent with the residual stresses expected as a result of the base-to-container weld and indicate that the residual stress state is significant in the weld region of the as-fabricated container.

Figure 3. Bottom of as-fabricated 3013 outer container after boiling Magnesium Chloride test: a) Exterior through wall cracks; b) Interior cracks, arrows indicate cracks

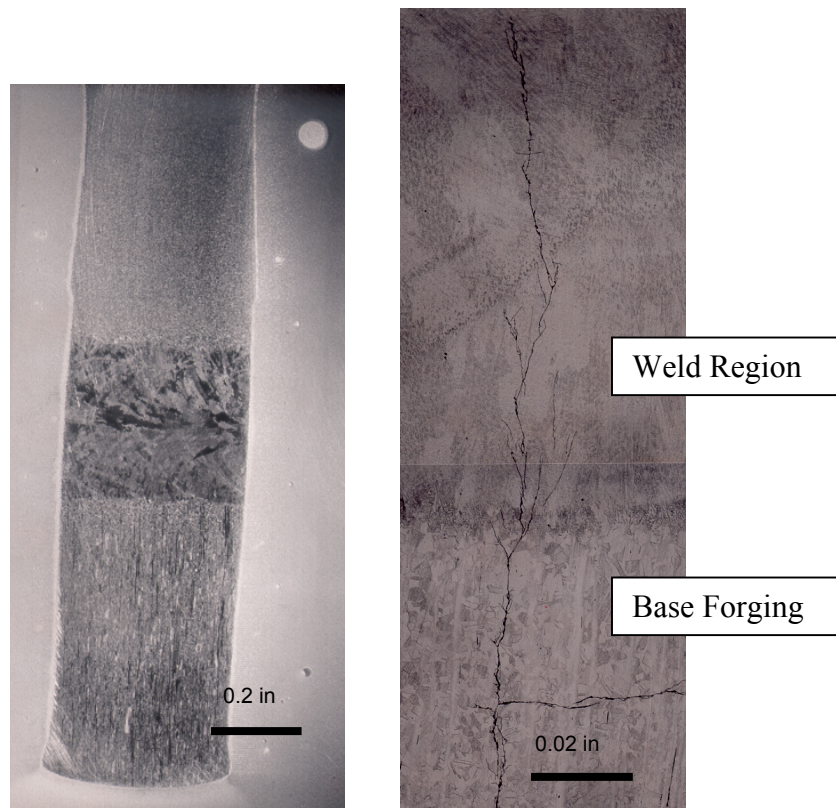
Figure 4. Metallographic cross section of through wall crack at the container to base fabrication weld in 3013 outer container after boiling magnesium chloride test: a) Overall macrograph showing base of container through fabrication weld and container body; b) Stress corrosion crack from sample shown in (a). Note the crack branching and the position of the crack, beginning in the weld region and propagating into the base of the container

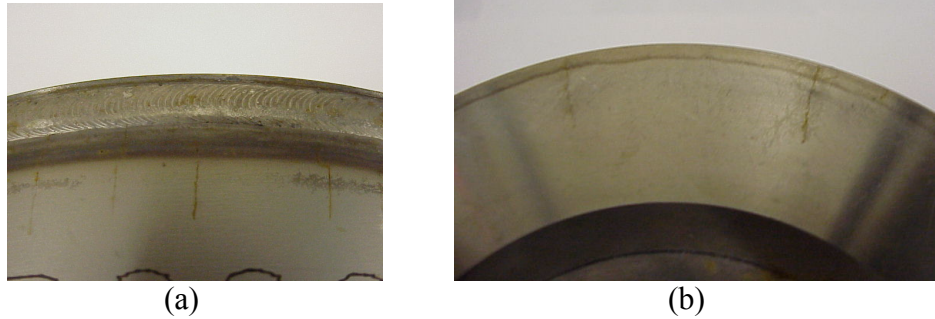
Through wall stress corrosion cracks perpendicular to the GTA closure weld and along the length of the container specimen body were observed after 48 hours of testing in boiling magnesium chloride solutions, Figure 5 (a). Through thickness radial cracks were also observed on the lid, Figure 5 (b). All of these cracks are consistent with the residual stresses expected as a result of the GTA closure weld. A crack that grew perpendicular to the weld while in the weld metal turned to be parallel to the closure weld in the heat affected zone was also observed using dye penetrant testing. The external cracks in the lid and through the weld along the length of the container specimen (Figure 5) were not

imaged using dye penetrant testing. This observation indicates that the external crack was insufficiently open to allow the dye penetrant to move into the crack even though the cracks penetrated through the container wall.

Figure 5. Top half of GTAW closure welded 3013 outer container section with through wall cracks after boiling magnesium chloride test: a) Exterior of container with cracks perpendicular to GTAW weld and running into container body (b) Exterior of lid showing appearance of cracks perpendicular to GTAW weld in lid

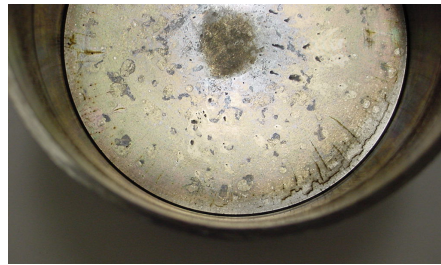
Through wall cracks perpendicular to the weld and along the length of the container specimen body were observed in a sample containing a laser closure weld. These cracks were observed after the sample was exposed to boiling magnesium chloride solution for 48 hours. Radial cracks on the lid were also observed, Figure 6. All of these cracks are consistent with the residual stresses expected as a result of the laser closure weld. Pits were also observed inside the container specimen, Figure 6. The pits may be chloride induced pits that are exacerbated by the high residual stresses developed during the closure weld. Dye penetrant testing of the exterior of the container specimen showed that the cracks in both the lid and the body were through wall cracks and ran continuously from the lid into the body

The 3013 outer, inner, and convenience containers all had sufficient residual stresses to crack in the boiling magnesium chloride solution, although in some tests where leaking did not occur the time to failure is not known. For the 316L outer containers, leaking did not occur during the test, but cracks were evident in the as-fabricated container specimen after 48 hours. The closure welded regions of the outer container specimens also developed similar cracks. The cracks observed in the as-fabricated outer container specimen, however, were not as numerous as those observed in the closure welded container specimens. Cracks observed in the laser closure welded container specimens were numerous and appeared to be more severe when compared to those observed in the GTA closure welded specimens.

Figure 6. Laser beam closure welded 3013 outer container after boiling magnesium chloride test with interior pitting on lid as well as crack indications

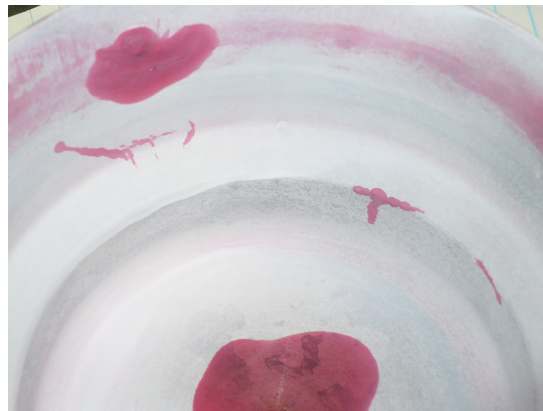
Post-test water leak checks showed leaks only from the bottom and the sidewall drilled hole. Dye penetrant testing on the container interiors however showed a circumferential crack near regions of the container where the diameter changed, Figure 7. Small portions of these cracks were through wall. One inner container bottom section did not develop any cracks other than those associated with the drilled holes. This variability in cracking for the inner container bottom may be associated with differences in container fabrication as well as testing variability.

Figure 7. Dye penetrant testing of 3013 inner container bottom section; pink lines indicate crack locations and pink spots are the drilled hole locations

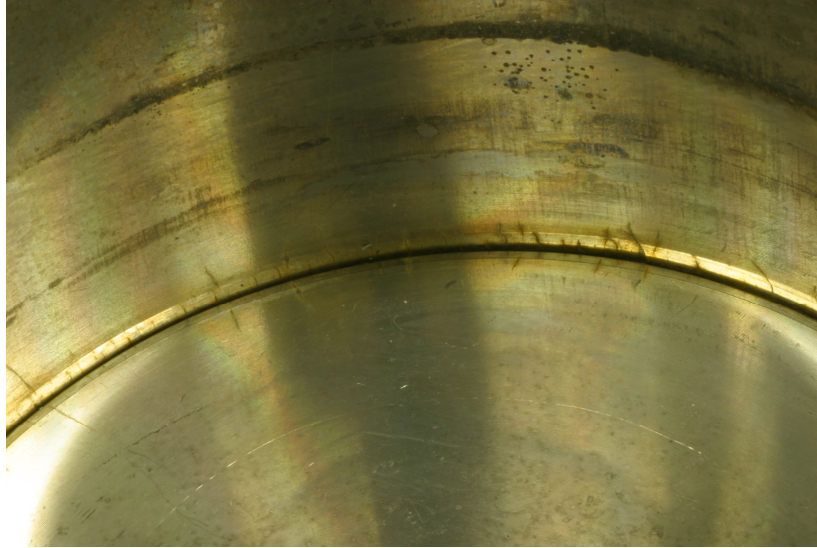
The welded tops on the inner container specimens cracked after 2 and 3.5 hours exposure in the boiling magnesium chloride. Testing was stopped because large amounts of the test solution were leaking from the cracks. The cracks were along the weld, perpendicular to the weld along the container specimen axis, and radial from the plug perimeter, Figure 8. The crack along the weld occurred in the container specimen which was exposed for the longer time and covered approximately 60% of the perimeter. The cracks in the sidewall were greater in number than those in the plug. Additionally, the cracks were longer (0.5-0.9 cm (0.2-0.35 in) length) and a greater number of the cracks had propagated through wall. The radial and perpendicular cracks were straight and unlike the cracks typically generated at the drilled holes.

Figure 8. 3013 inner-container welded-top section after exposure to boiling magnesium chloride showing container interior with sidewall and plug cracks

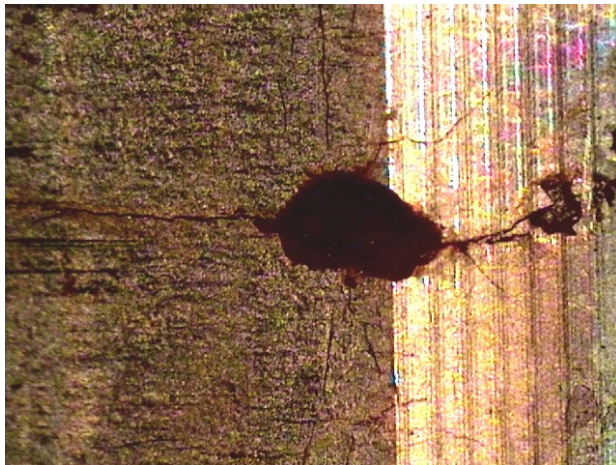
The welded top of inner container #1 was sectioned to look for evidence of corrosion within the crevice formed by the top plug and sidewall. Although large pits were found in the plug and sidewall there was no evidence of crevice corrosion. In many cases the pits which were observed were associated with the cracks as shown in Figure 9. The small cracks had multiple orientations relative to the pits. The growth patterns for these cracks indicated a complex stress state near the weld.

Figure 9. 3013 inner-container welded-top section after exposure to boiling magnesium chloride solution showing pit associated with cracking in sidewall

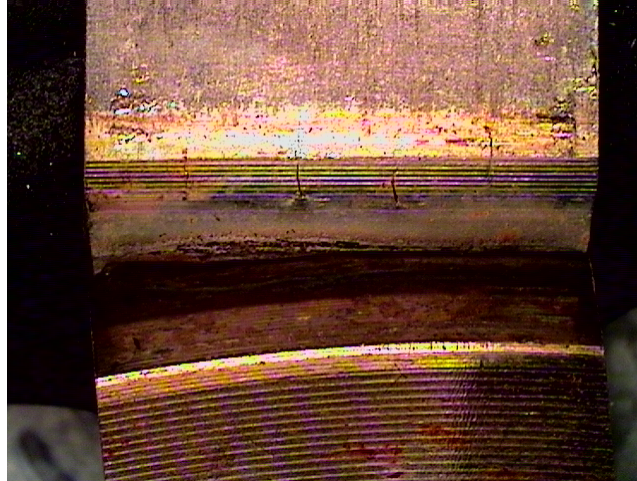
The welded tops of the inner container specimen exposed to the vapors of the boiling magnesium chloride solution had small cracks in both the sidewall and top after five days of exposure. The cracks were not through wall. The container specimen interior showed only a small degree of corrosion although the surface was wetted during testing. The container specimen was sectioned by EDM so that the interior surface of the crevice could be inspected for pitting and cracking since the use of dye penetrant testing was unsuccessful. Several pie-shaped sections were cut from the container specimen. The crevice was revealed by flattening. Large pits and small axial cracks were found inside the crevice and when the sample sections were flattened to open the crevice, the cracks also opened up, Figure 10. Additional cracks were found on the side of plug.

Figure 10. 3013 inner-container welded-top section exposed to vapors of boiling magnesium chloride solution: interior container crevice between the side wall and seal plug spread open showing small cracks

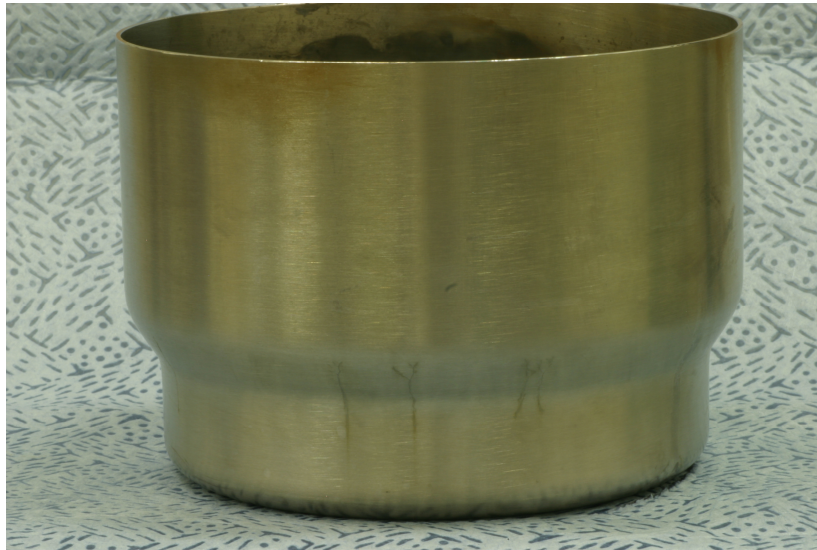
The two convenience container specimens both cracked in the boiling magnesium chloride test. One container did not leak after 48 hours while the other leaked to such an extent that the test had to be stopped after only 5.5 hours of exposure. Most of the cracks were in the region of the diameter change of the container specimen, Figure 11. No cracks were found on the bottom of one convenience container specimen, while the other had radial cracks. The convenience container specimens that lasted for 48 hours showed only minimal leaking during the post-test leak check, but leaked severely after tapping to loosen the cracks.

The times to cracking for the convenience container specimens were approximately 5.5 hours. Fabrication stresses for the convenience container may thus approach those resulting from welding since times to failure were similar to the welded tops of the inner container specimens.

Figure 11. Convenience container section after exposure to boiling magnesium chloride solution: container exterior with axial cracks in sidewall

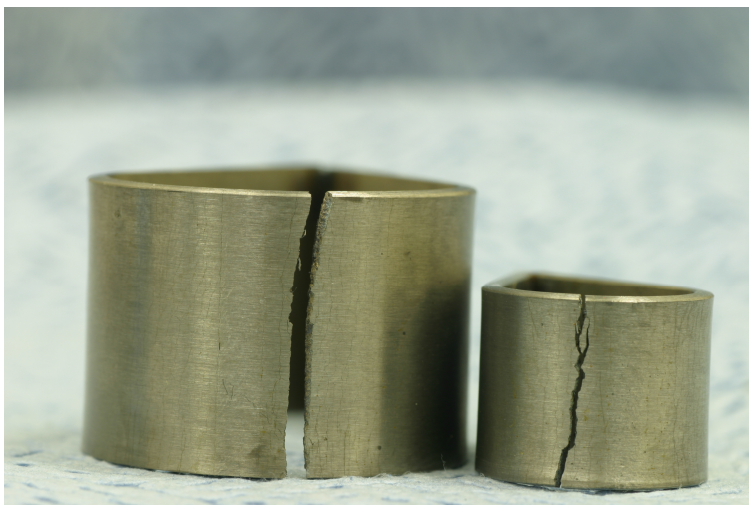
304L teardrop coupons with autogenous welds were exposed to plutonium-oxide-bearing material with 0.2 % calcium chloride in simulated 3013 corrosion tests performed at room temperature. These specimens cracked after 166 hours of exposure [6]. The relationship of corrosion susceptibility of these teardrop coupons to flow formed 304L containers has not been established. As a measure of this relationship, teardrop coupons identical to those used in the small scale test were tested in boiling magnesium chloride solution. The teardrop coupons failed after approximately 1.3 hours of exposure with a full-width through wall crack, Figure 12. The crack was near the weld but outside the HAZ. The small-sized teardrop coupon failed in approximately 2 hours with a through wall crack at a similar location to the cracks in the large teardrop coupons.

The 304L teardrop coupons had a very short time to failure (approximately 1.3 hours) and clearly provide a conservative estimate for the behavior of the 3013 containers. The stress levels in a teardrop coupon have been shown to exceed the yield stress and approach levels equivalent to the ultimate tensile strength [8]. By comparison a welded top of an inner container specimen failed in 2 hours, which suggests that the residual stresses in the weld may be lower than the stresses in the teardrop coupons. The other welded top of an inner container specimen was tested for 3.5 hours and had a more significant degree of cracking with a circumferential crack running parallel to the weld. The perpendicular and parallel cracking near the weld indicate a complex stress state in the weld region. The inner container bottom section appears to have lower stress levels than those in the seal welds since the degree of cracking was less (i.e. smaller number of through wall cracks) and the time to cracking is greater (i.e. one container tested for 48 hours had no cracks in the sidewall).

Figure 12. 304L teardrop coupons after exposure to a boiling magnesium chloride solution
