**EXAMINATION OF SHIPPING PACKAGES 9975-01818, 9975-01903
AND 9975-02287**

W. L. Daugherty

Savannah River National Laboratory
Materials Science & Technology

Document No. SRNL-STI-2009-00742 **Rev. No.** 0

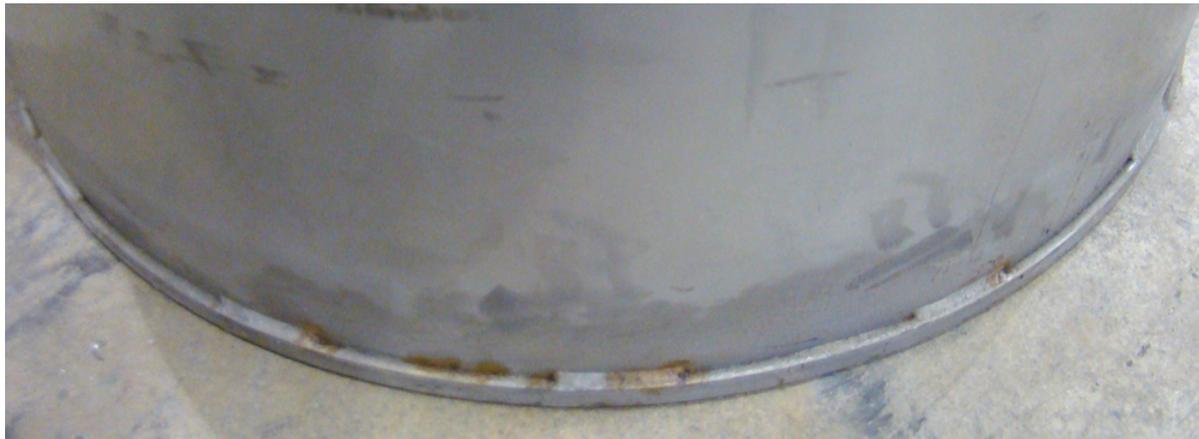
Packages 9975-01903 and 9975-02287 had a normal appearance from the outside, with no apparent degradation. Package 9975-01818 had several rust spots along the bottom chime of the drum, particularly at the ends of the tack welds (see Figure 1).

Figure 1. Rust spots along the bottom chime of 9975-01818 drum. Photograph provided by NMM (Hackney).

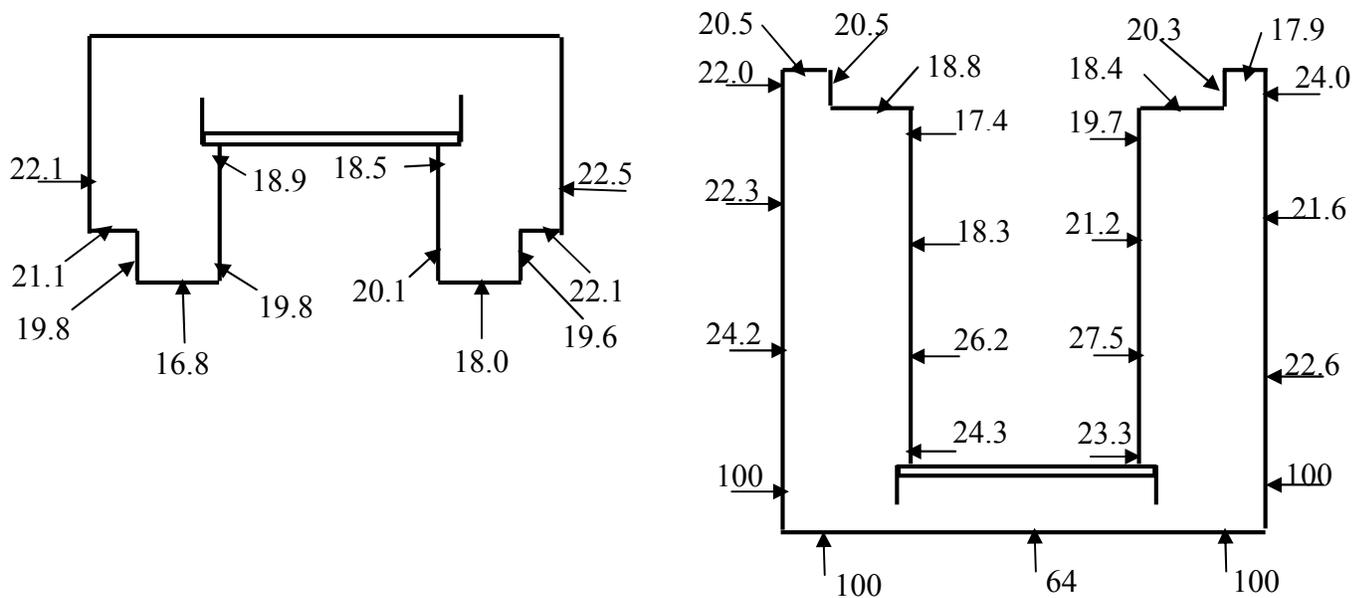
The moisture content data for each package are presented in Figures 2-4. Package 9975-01818 had the highest moisture content, and also had extensive mold growth. The exterior of the lower assembly was completely covered with mold (Figure 5), and regions of the upper assembly contained mold (Figure 6). Significantly lower moisture content was measured on the other two packages, although the higher values measured on these packages are slightly greater than seen on other "typical" packages. Package 9975-01903 contained several small patches of mold near the bottom of the lower assembly (Figure 7), while no mold was observed on 9975-02287. The mold on 9975-01903 appeared dormant, with an absence of the fine filament structure typical of active mold.

Figure 2. Summary of fiberboard moisture content for 9975-01818. All values are % wood moisture equivalent (%WME).

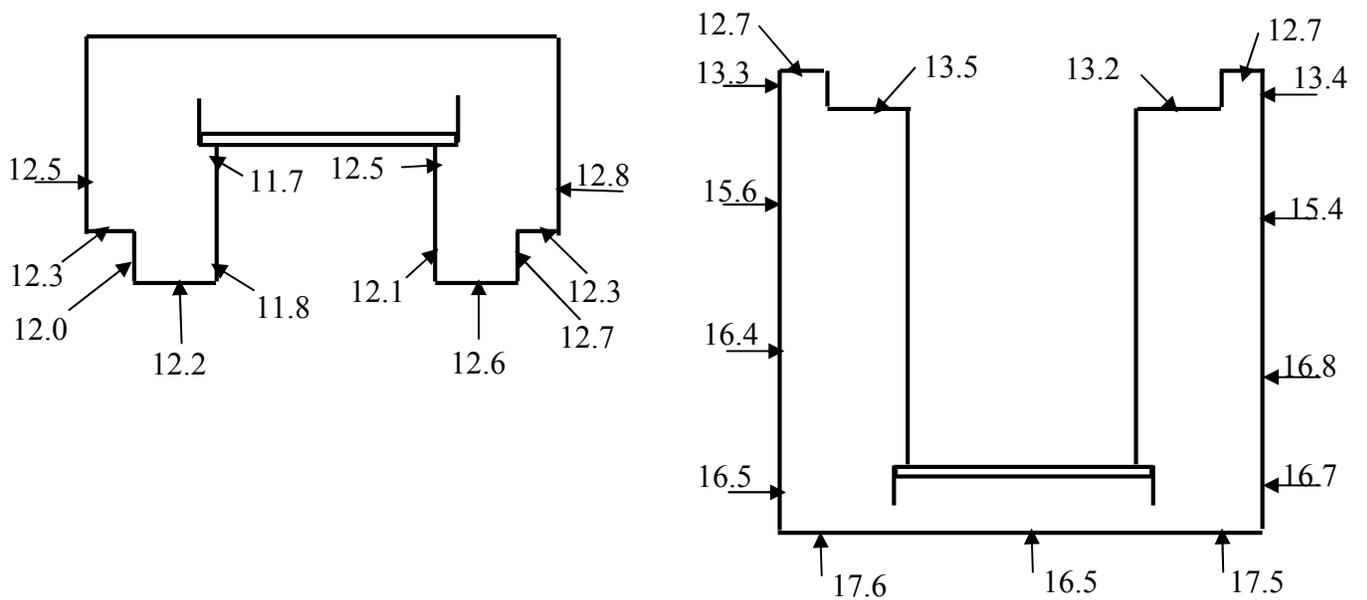
Figure 3. Summary of fiberboard moisture content for 9975-01903. All values are % wood moisture equivalent (%WME). Interior surfaces of the lower assembly were not accessible for measurement.

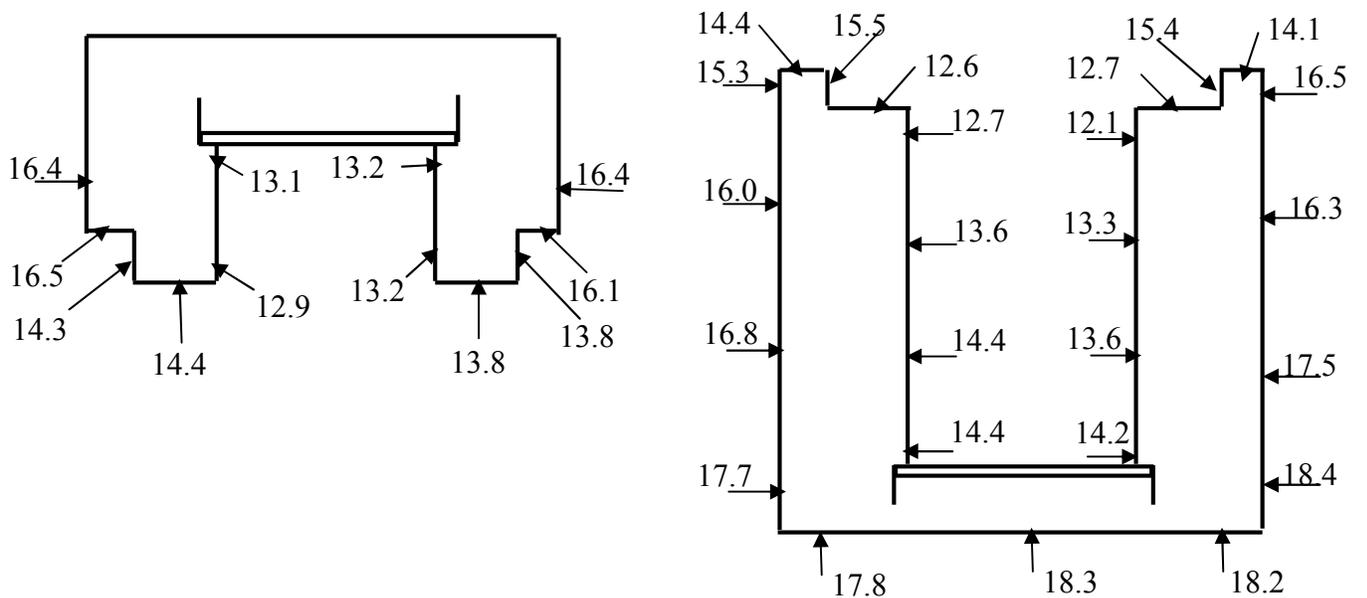
Figure 4. Summary of fiberboard moisture content for 9975-02287. All values are % wood moisture equivalent (%WME).

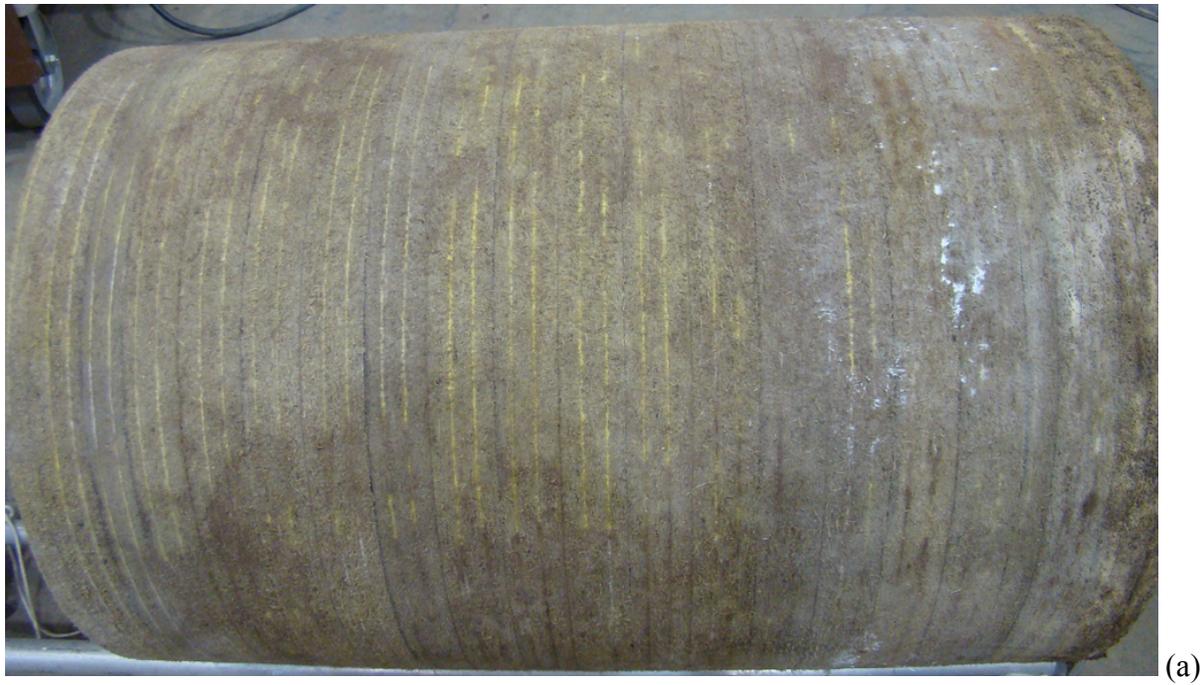
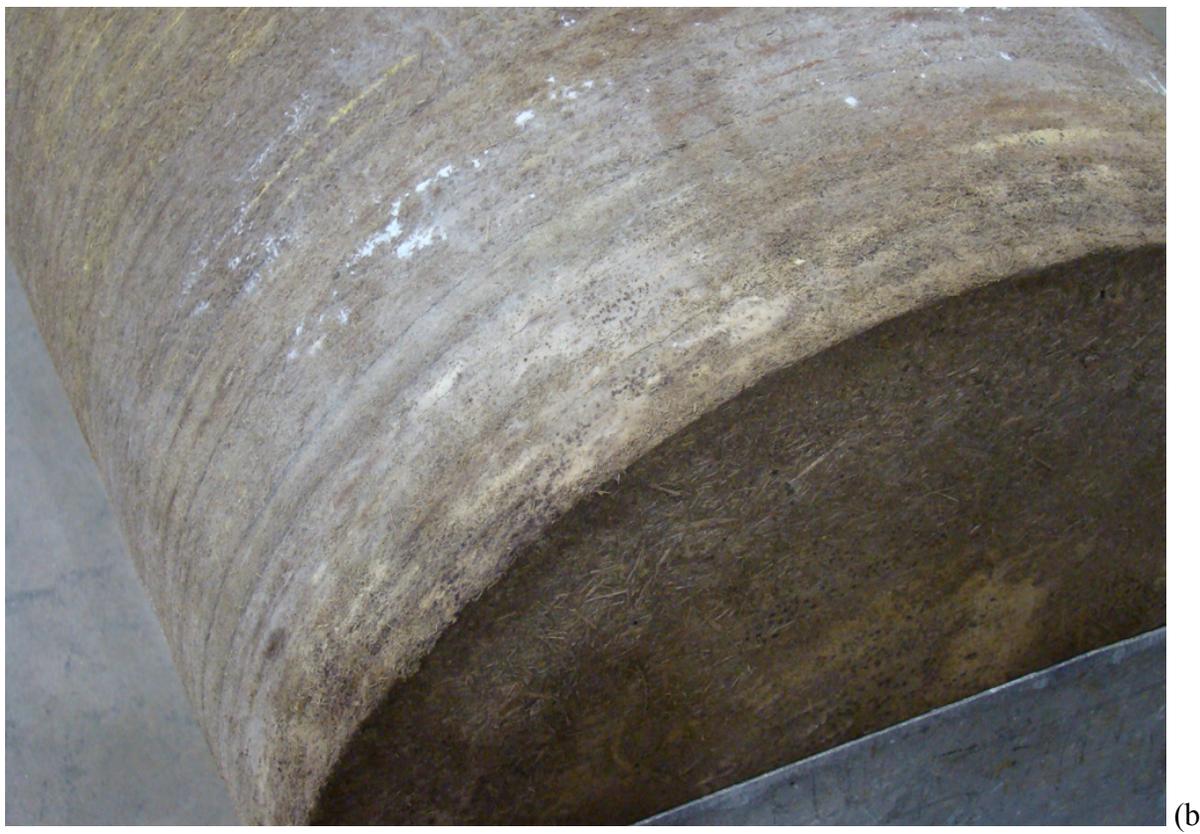
Figure 5. Mold on 9975-01818 lower fiberboard assembly. Photographs provided by NMM (Hackney).

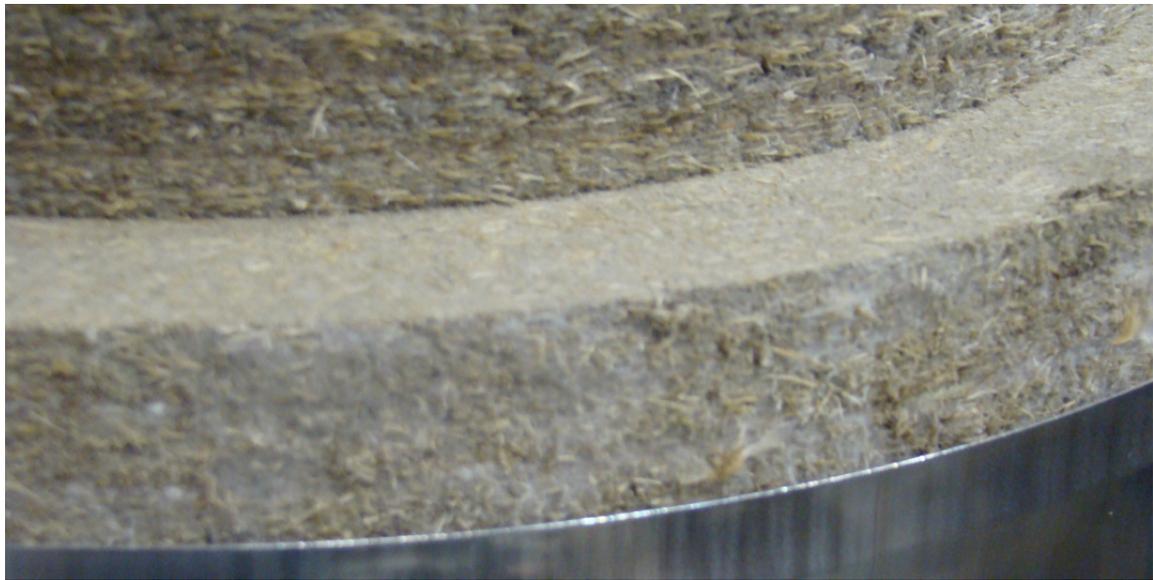
(a)

Figure 6. Mold on 9975-01818 upper fiberboard assembly. Photographs provided by NMM (Hackney).

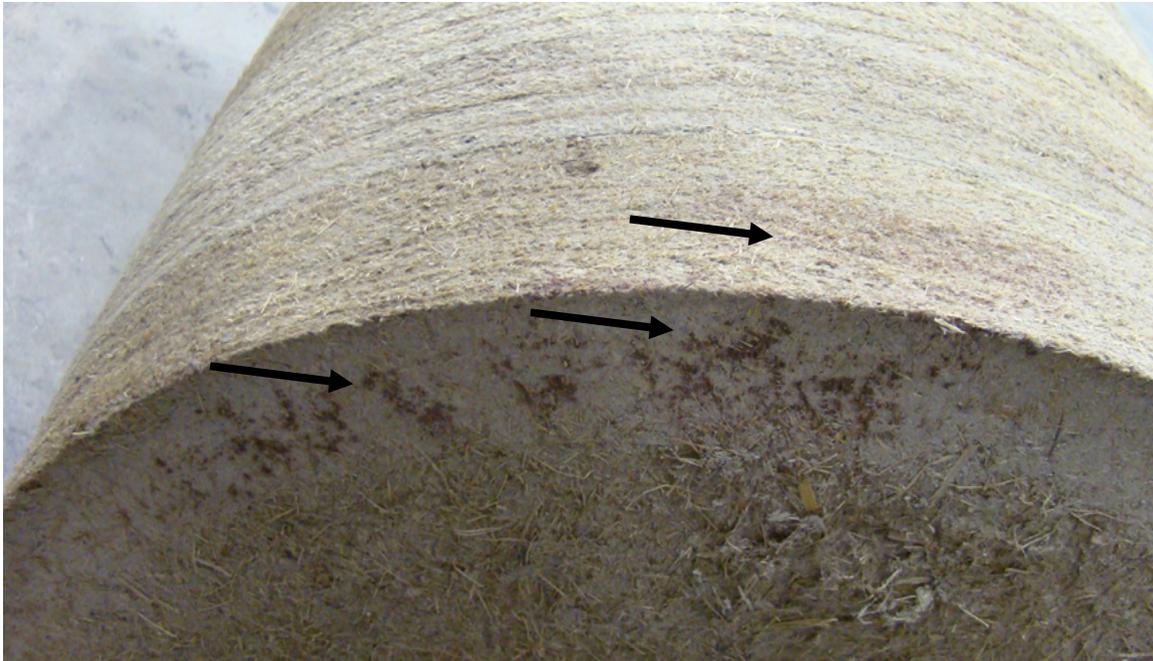
Figure 7. Mold on 9975-01903 lower fiberboard assembly. Photograph provided by NMM (Hackney).

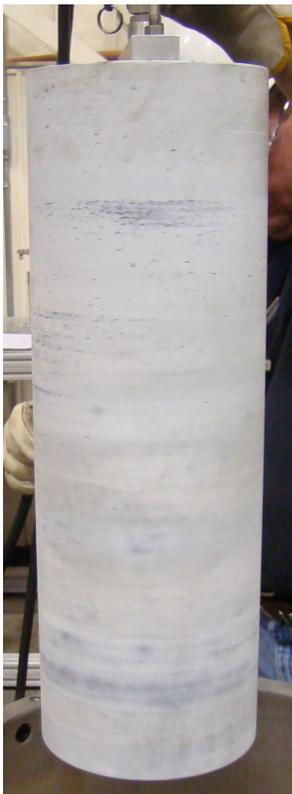
(a) 9975-01818

Varying degrees of corrosion were seen on the lead shield of each package, and the variation was not necessarily in proportion to the moisture content of the fiberboard. Each shield is shown in Figure 8 for comparison. The shield from 9975-02287 had a heavy band of corrosion around the bottom several inches, and light corrosion elsewhere. The shield from 9975-01818 had a more uniform moderate corrosion over its entire surface. The portion of the 9975-01903 shield which protruded from the lower fiberboard assembly was relatively heavily corroded.

Figure 8. Lead shield from each package showing the relative extent of corrosion. Photographs provided by NMM (Hackney).

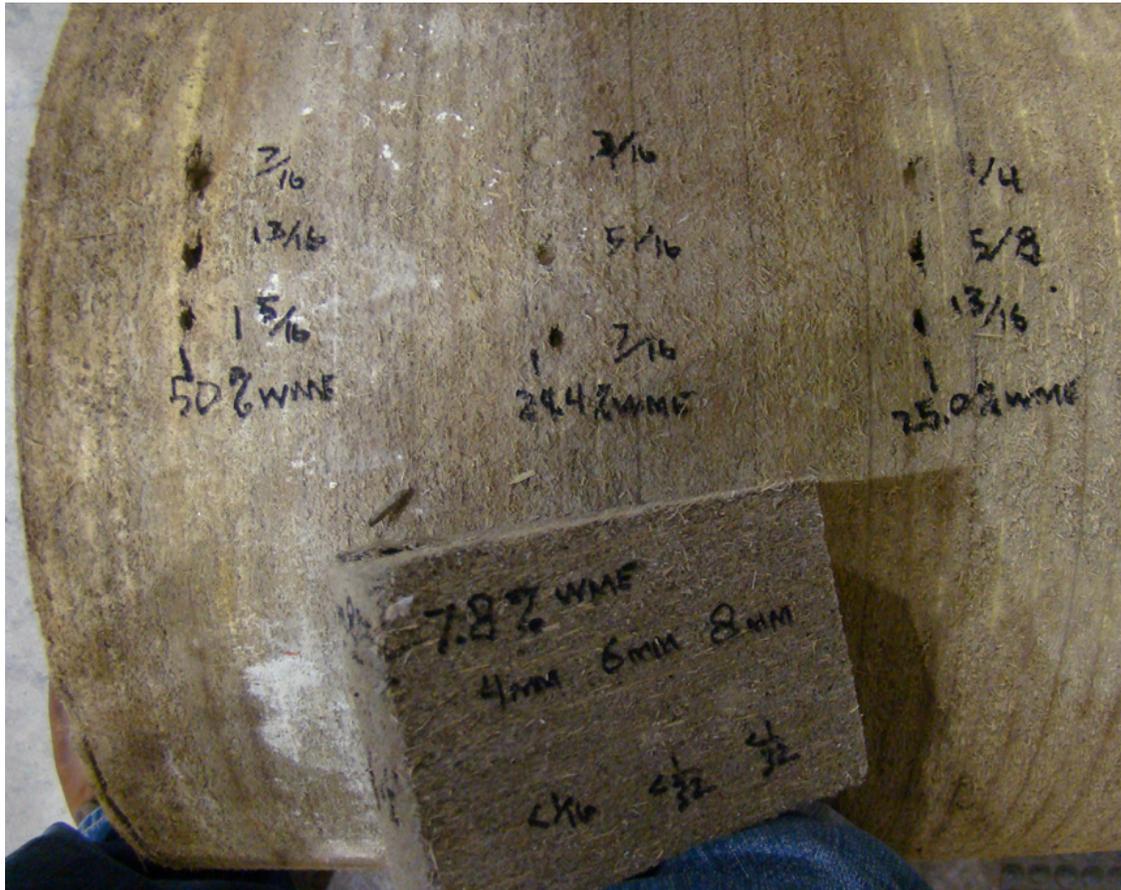
(a)

At several locations along the OD and bottom surfaces, each of 3 allen wrenches was pressed into the fiberboard with approximately the same force. Each impression on the side was located between glue joints. The wrenches were 4, 6 and 8 mm in size. See Figure 9. The depth of impression was recorded at each location, along with the moisture content. The same steps were performed on a separate section of relatively dry fiberboard (7.8 % wood moisture equivalent, WME), for comparison. Results are summarized in Table 3. While these results cannot be converted directly into a measure of the fiberboard compressive strength, they do illustrate that significant loss of strength has occurred.

Figure 9. Lower fiberboard assembly from 9975-01818 after penetration test. The moisture content and depth of penetration are indicated next to each impression.

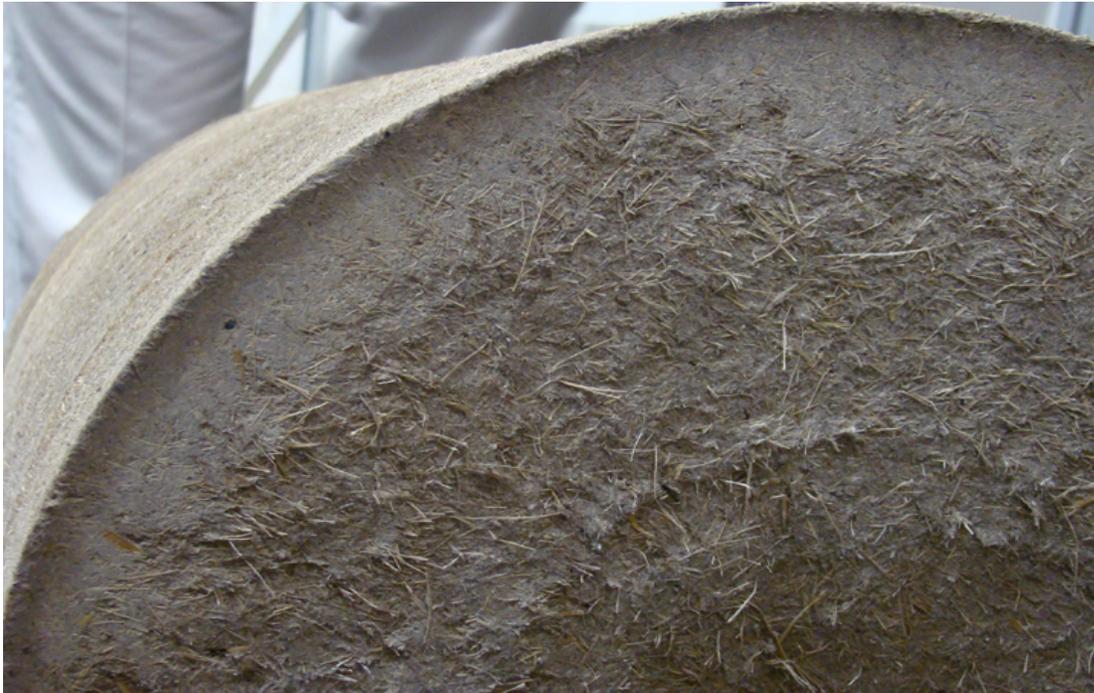
The bottom of the drum is dished, such that the bottom of the lower fiberboard assembly contacts the drum around the outer edge. Some portion of the fiberboard is compressed to increase the contact area and reduce the contact stress. Typically, this compressed region is roughly 2 inches wide, consistent with the observations of 9975-01903 and 9975-02287 (Figures 7 and 10). In contrast, the entire bottom of 9975-01818 lower fiberboard assembly had conformed to the bottom of the drum (Figure 11), as seen by the impression of lettering from the drum. The convexity of the drum bottom is required to be at least 0.37 inch [4].

Figure 10. Band of compression around the bottom of 9975-02287 lower fiberboard assembly.

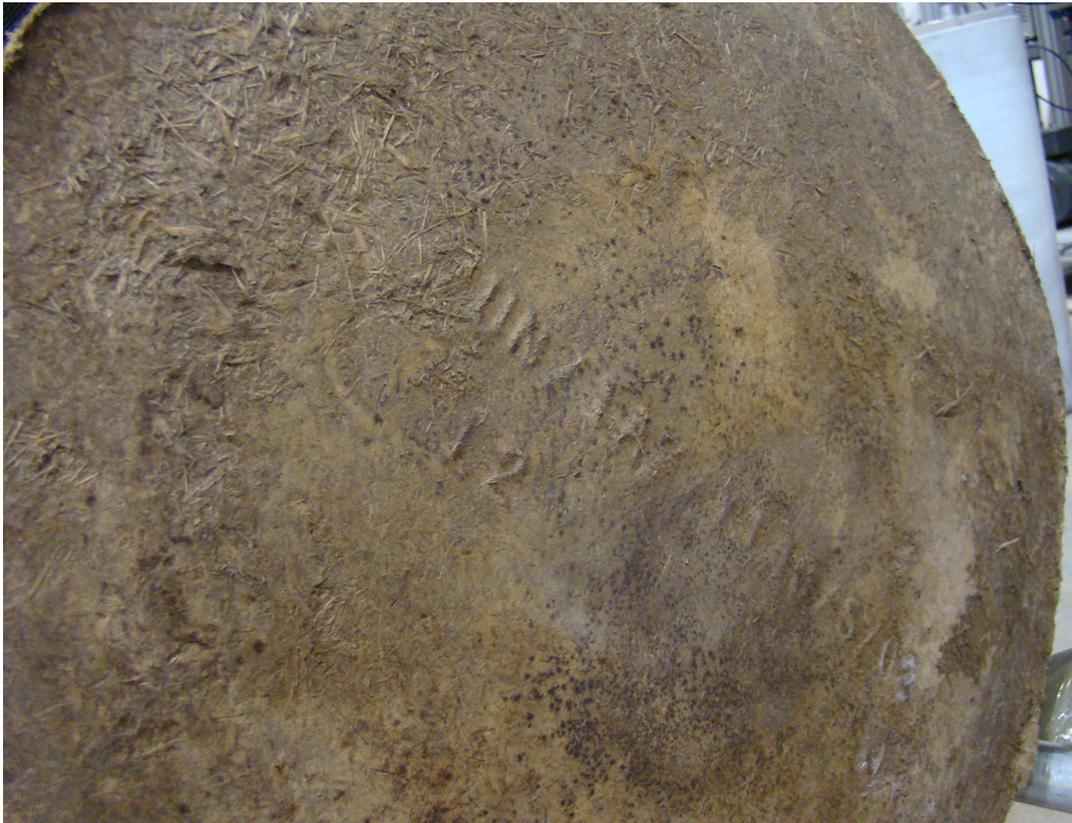
Figure 11. Compression of the entire bottom of 9975-01818 lower fiberboard assembly, as indicated by the lettering transferred from the drum bottom.
