Journal of Nuclear Materials Management

**Stainless Steel Interactions with Salt Containing Plutonium
Oxides**

D.Z. Nelson¹, G. T. Chandler¹, K.A. Dunn¹, T.M. Stefek¹, M.E. Summer¹
Savannah River National Laboratory¹
Aiken, SC 29808

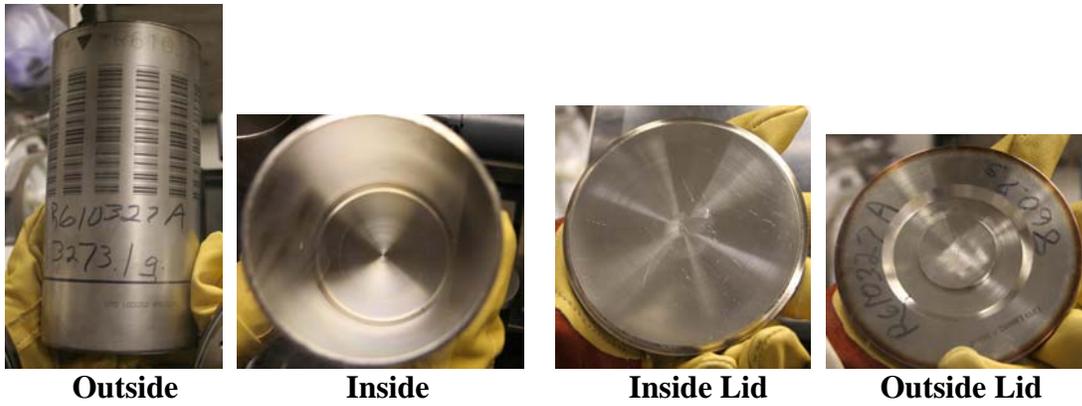
The outer container is a standard design and is used at all the packaging sites. It is the barrier credited to contain the plutonium-bearing materials while in a storage configuration. One or two other stainless steel containers in the nested system provide separation between the plutonium-bearing materials and the outer container which is neither in contact with the plutonium-bearing materials nor the headspace gas. Because of this lack of contact with the plutonium-bearing materials, little to no degradation of the outer container was expected [11] and a typical outer container visually examined as part of the DE showed no indication of degradation, Figure 2. Additionally, the metallurgical examination of the outer containers corroborates the visual observations and showed little or no storage induced degradation of the container welds, lids or walls.

Figure 2. Typical outer container examination.

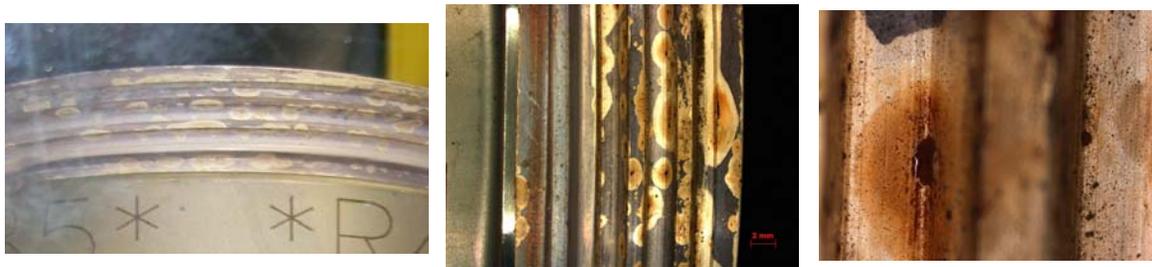
Analyses of several convenience containers from the stored 3013 packages showed evidence of corrosion but nothing significant enough to affect the integrity of the container. For example, two RFETS convenience containers showed signs of pitting corrosion on the silver coated threads of the convenience container body, as shown in Figure 3. The silver coated threads, specific to the RFETS convenience containers, were used to ensure galling did not occur during packaging and unpackaging operations. Although discreet particulates of the chloride containing plutonium oxide appear to be associated with the pitting, initial observations of the threaded region did not provide evidence for the pitting. Subsequent evaluation suggests that the pitting happened after the container was opened for surveillance because seasonal high temperatures and humidities were experienced during the surveillance process. These conditions coupled with the high chloride content of the container were the primary contributory factors for this pitting.

Figure 3 Examination of silver coated threads from RFETS convenience container body. Superficial corrosion pitting observed at threads.

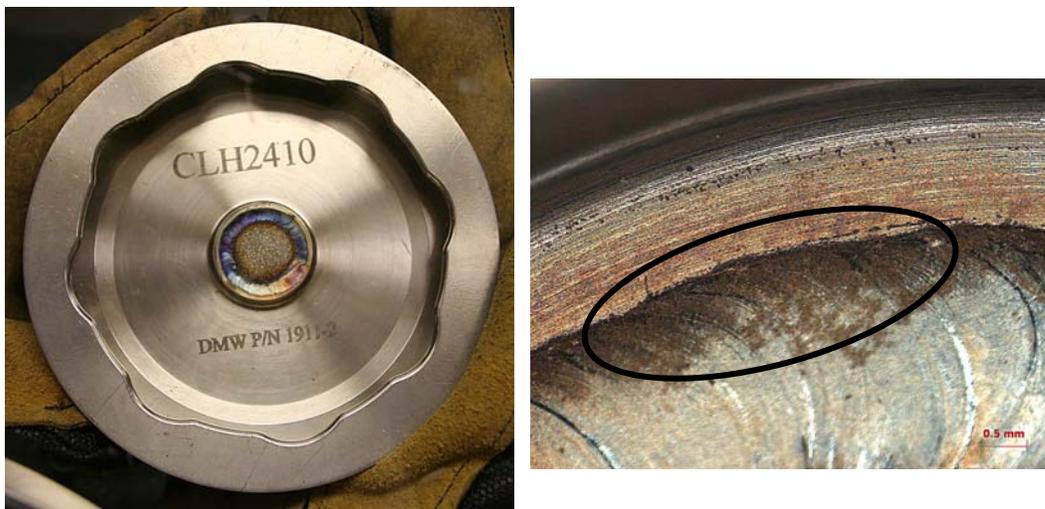
Three filter sections were examined to evaluate unanticipated features observed during the visual examination. Ultimately, it was decided that the observed features were inherent to the welding process used to install the filter into the convenience can lid and did not represent storage induced degradation. Figure 4 shows a typical weld interface for a filter housing and because this feature was shown to be typical of the welding process, no anomalous conditions are attributed to this visual observation.

Figure 4 Typical examination of filter area from Hanford convenience container lid. Discoloration (circled) caused by oxidation from weld process. No degradation observed.

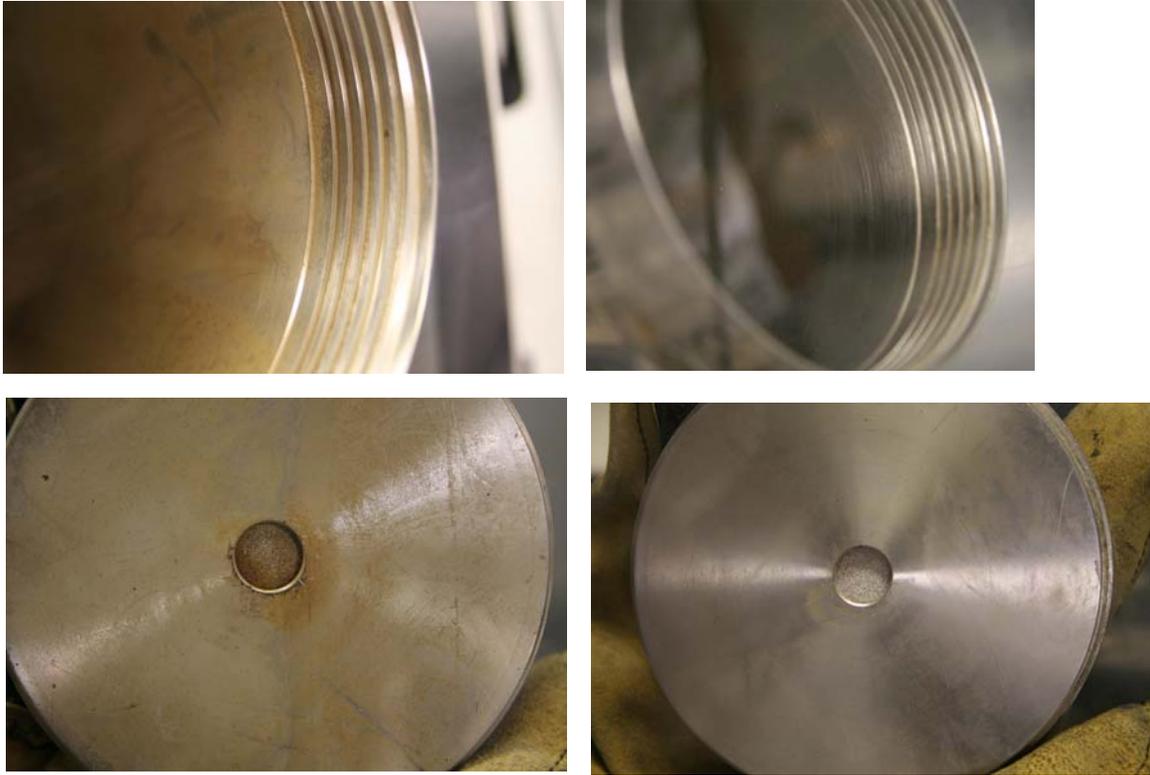
The most common observation evaluated as part of the DE metallurgical examination was the presence of particulates and coatings on the inside surface of the convenience container walls and lid. In several cases the particulates and coating were easily removed by gentle wiping with a clean cloth and no degradation of the stainless steel was observed. This is illustrated in Figure 5 which shows the steel surface after coating removal. The fact that the coating was so easily removed is consistent with a conclusion that the particles simply deposited on the surface and that there were no interactions with the underlying metal. However, one convenience container had evidence of minimal corrosion beneath the coating.

Figure 5. Typical examination of particulate and coating on interior of convenience container.

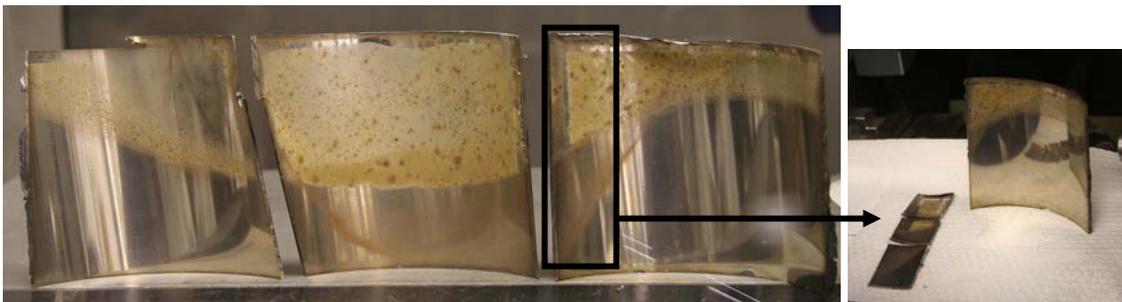
Visual examination photographs from the inside walls of the convenience container that showed evidence of corrosion are shown in Figure 6. The coated surface was in the headspace region of the container and the coating easily flaked off the wall when the can was sectioned for further analysis. This is seen in Figure 6 as the clear edge around the perimeter of the cut sections. This particular 3013 container was an engineering judgment sample chosen for DE because it had one of the highest moisture and chlorides content in the packaged materials. The analyses performed on this container included SEM and EDX of the container surface, Figure 7. The regions of the sample surface where the coating flaked off during sectioning are readily observed in the SEM and, in general, the coating is chloride rich with no evidence of the alkaline salts being present. X-ray diffraction and Fourier Transform Infrared Resonance analysis of the coating identified it as ammonium chloride (NH_4Cl). This coating formed during storage and condensed onto the cool surface of the container above the oxide material [12]. Beneath the NH_4Cl coating the surface of the container is nearly void of machining grooves and irregularly oriented fissures are seen across the surface, Figure 8. These features are artifacts from the flow forming process used to manufacture the container. The bottom of this same convenience container was also sectioned for SEM/EDX examination of the inside surface, as shown in Figure 9. A network of regularly shaped pits across the bottom inside surface of the container was observed. The depth of pitting is superficial at approximately $5\ \mu\text{m}$ and is not severe enough to affect the integrity of the convenience container.

Figure 6. Visual examination photographs from the inside walls of the convenience container. Coated looking surface of convenience container is the headspace region. Sections cut for SEM and EDX examination were taken from region in the box. Portion of coating flaked off during cutting of sample for SEM, as seen in box on left.

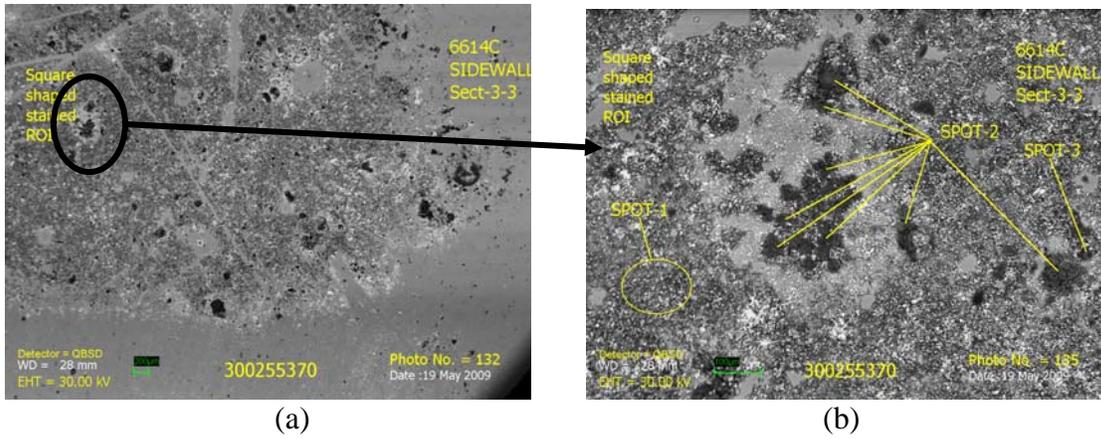
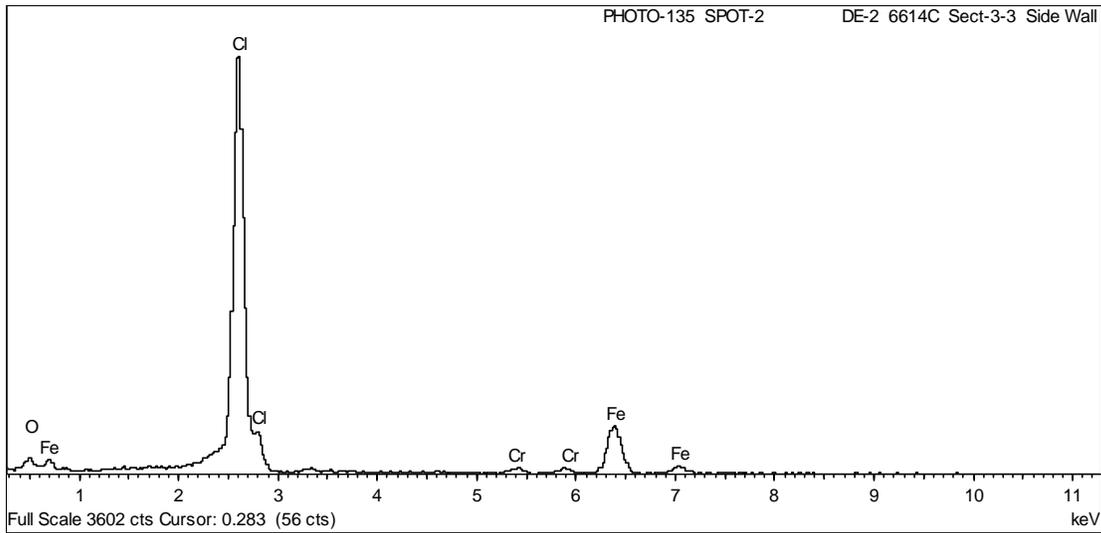
Figure 7. SEM examination and EDX spectrum from convenience container section seen in Figure 6 (a) Shows coating flaked off of sample around perimeter (b) Shows higher magnification of coating still adhered to surface. EDX spectrum shows chlorine rich peak typical of coating on surface.

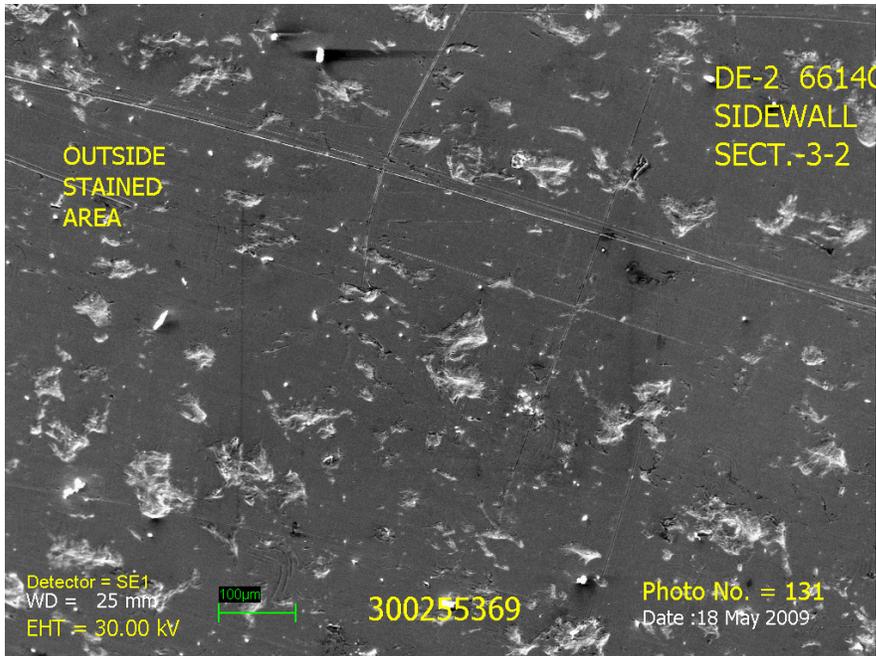
Figure 8. Shows irregularly oriented fissures at location where coating flaked off as seen on SEM.

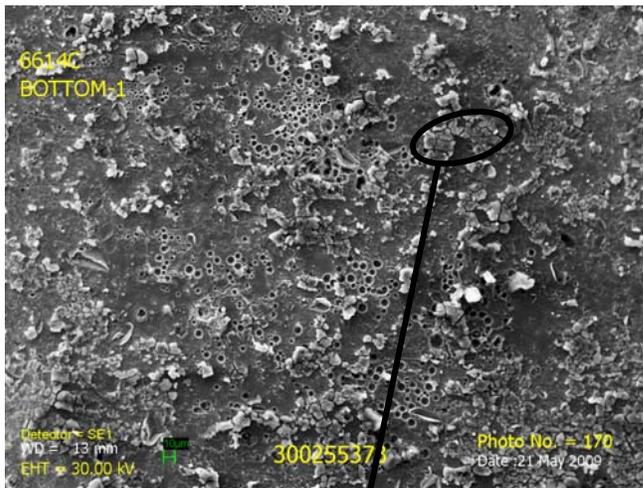
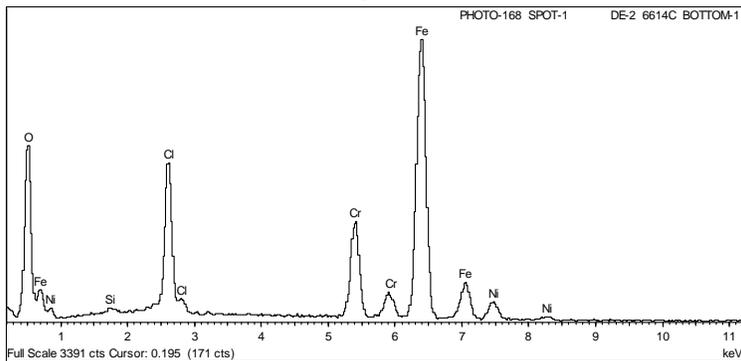
Figure 9. Bottom of convenience container (a) shows regular network of small pits (b) shows EDX spectrum of cracked looking debris rich in chlorine.

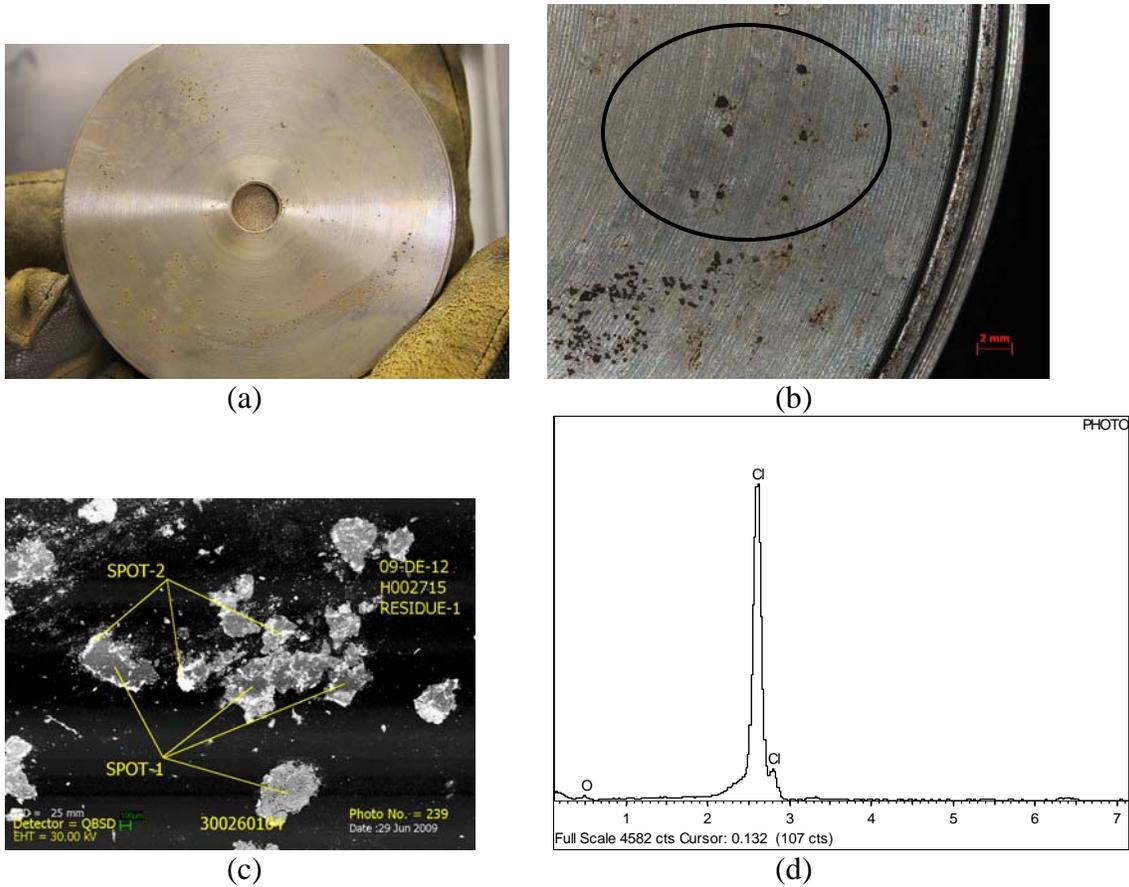
The inside lid from another convenience container showed particulate matter adhering to the surface. Samples of the particulate were collected for SEM/EDX analysis and pits were noted on the underlying surface. No evidence of alkaline earth salts was seen and the particulate was identified by EDX to contain chlorine, Figure 10. Further evaluation of this convenience container is in progress with emphasis on determining the extent of the degradation resulting from chloride rich particulates.

Figure 10. Chlorine rich particulate analyzed from inside lid of convenience can. (a) inside convenience can lid (b) Area where particulate was obtained for analysis (circled) (c) Particulate analyzed (d) EDX spectrum of particulate

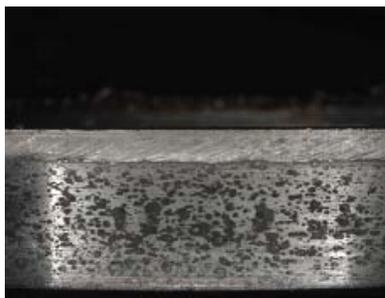
One RFETS inner container showed the presence soot from the closure welding operation, Figure 11. This observation was consistent with RFETS reports that there were times when excessive soot developed during welding of the inner containers. No corrosion and/or corrosion product was observed in the sooted region. This observation was therefore considered a pre-storage condition and no evidence of container degradation was attributed to the soot.

Figure 11. Examination of RFETS inner container. The presence of soot from the welding operation was observed. No contact with salt containing Pu oxide.

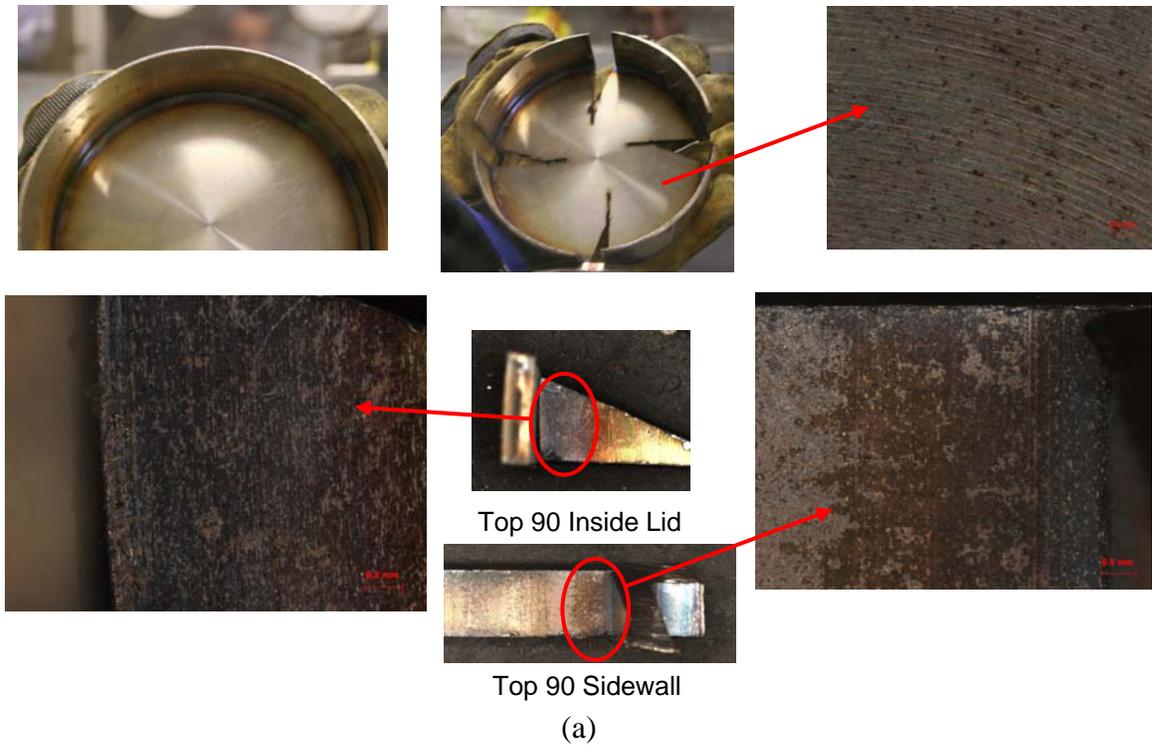
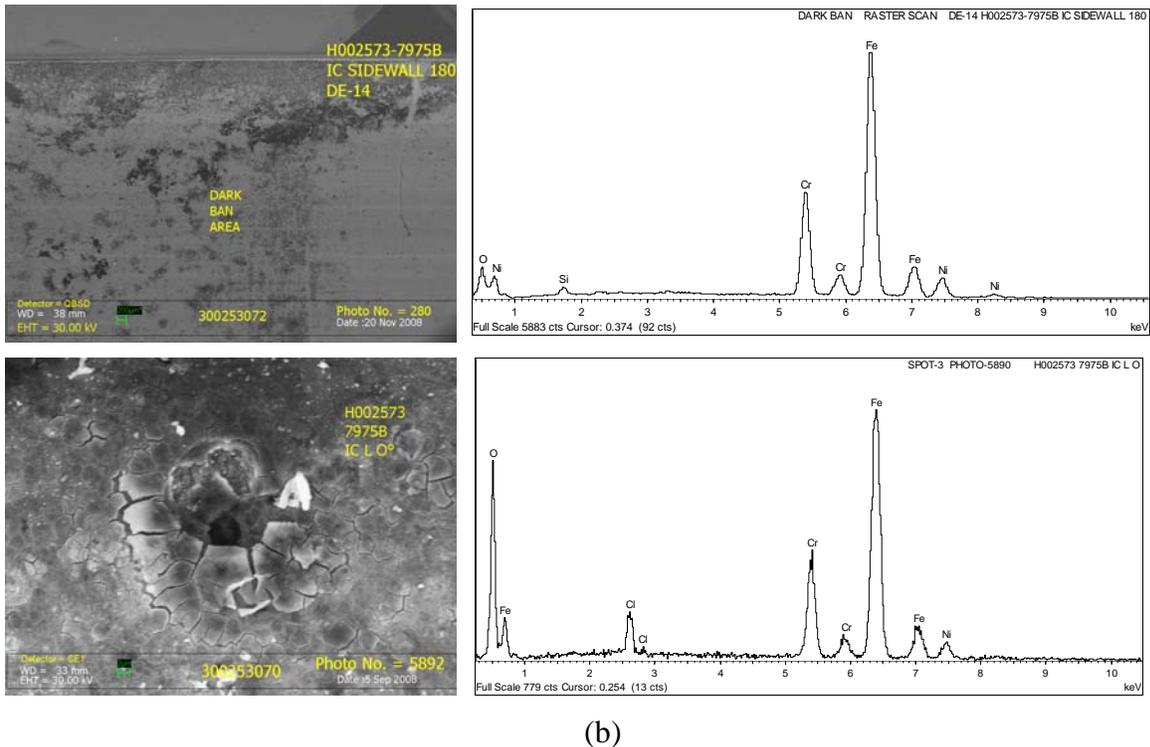
Detailed analyses were conducted on several Hanford inner containers which showed evidence for corrosion and/or corrosion products during the DE visual examination. In the majority of examinations, SEM/EDX identified a heavy coating on the container walls and/or chloride rich particulates adhering to the inside lid surface, as shown in Figure 12. The SEM examination of these lids showed no significant depth to the observed corrosion.

Figure 12. Additional sections from inner container for further analysis during DE. (a) Appearance of corrosion particulates and “coating” adhering to surface of lid and side wall. No corrosion depth was seen by SEM (b) Coating product on sidewall likely an iron oxide product with the oxide peak shown in the EDX Spectrum at top right. Bottom photo and corresponding spectrum at bottom right shows a chloride peak from corrosion product within incipient pit.

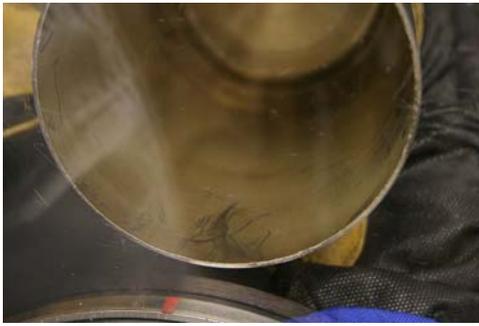
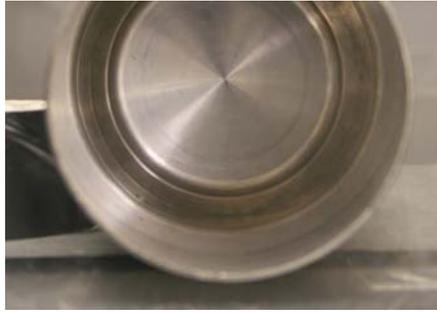
Additionally, several of the inner containers examined by DE had a thin powdery coating adhering to the surface. This observation of coating development was similar to what was seen in the convenience containers, but the coating developed to a lesser extent. The coating and particulates were easily removed by wiping the surface and no pitting or surface corrosion was seen. Figure 13 shows the container surface beneath a layer of particulates that was removed during the DE inspections.

Figure 13. (a) Presence of adherent layer on inside inner container surface and (b) layer removed through light wiping with clean cloth.

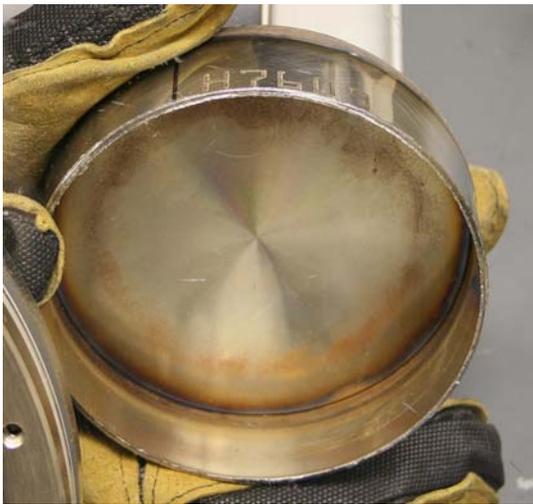
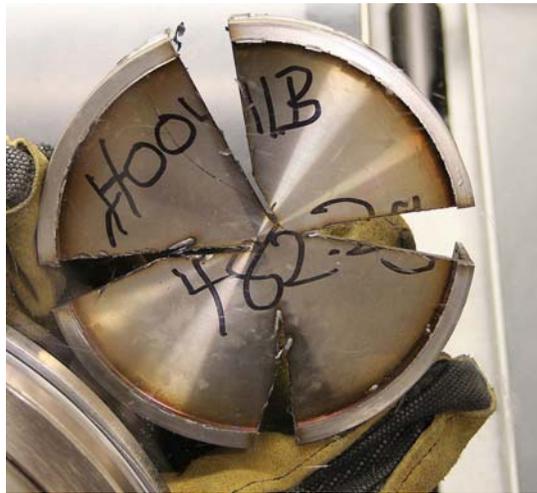
One inner container was analyzed because of the unusual features observed on the inner surfaces of the convenience container, Figure 6. These features suggested the presence of chloride on the inner container surfaces. To evaluate the possibility of chloride transport to the inner container, sections were obtained from the closure weld region, as shown in Figure 14, where a gap exists between the can sidewall and the lid, Figure 15. This gap and associated weld region are of interest because these areas are more susceptible to corrosion, including SCC, than other regions of the container [8, 9]. In order to better examine this region of the inner container, each section was cut to remove the weld ligament thereby creating two samples, one of the lid and one of the sidewall. The examination emphasized the gap and weld region but no evidence of corrosion or surface coatings was seen except on the lid region adjacent to the gap. However, examination of the surface of the inner container lid including the lid region adjacent to the gap showed the presence of small, closely spaced, and coalesced pits which formed along the machining grooves, Figure 16. The maximum pit depth observed was approximately 23 μm which is more conservative than the depth predicted by laboratory studies of pit growth in stainless steel exposed to the headspace gas of plutonium bearing oxides [10].

Figure 14. Sections cut from inner container for SEM and EDX analysis.

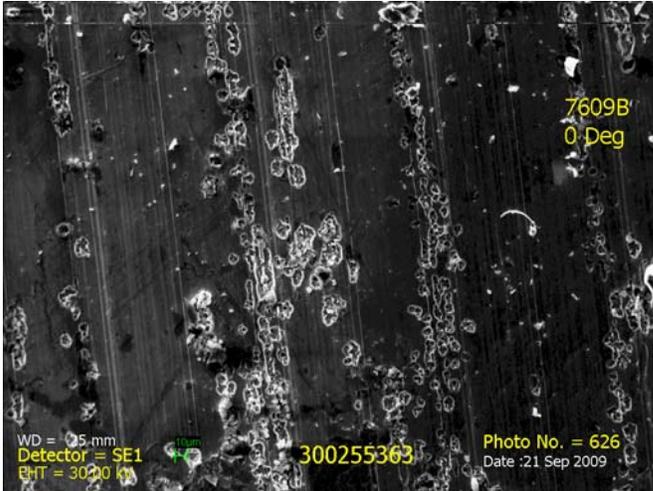
Figure 16. Small coalesced pits on the machining grooves of inner container lid.
