MODEL 9975 LIFE EXTENSION PACKAGE 2 – FINAL REPORT

Savannah River National Laboratory
Materials Science & Technology

Publication Date: April 2010

Document No. SRNL-STI-2010-00185 **Rev. No.** 0

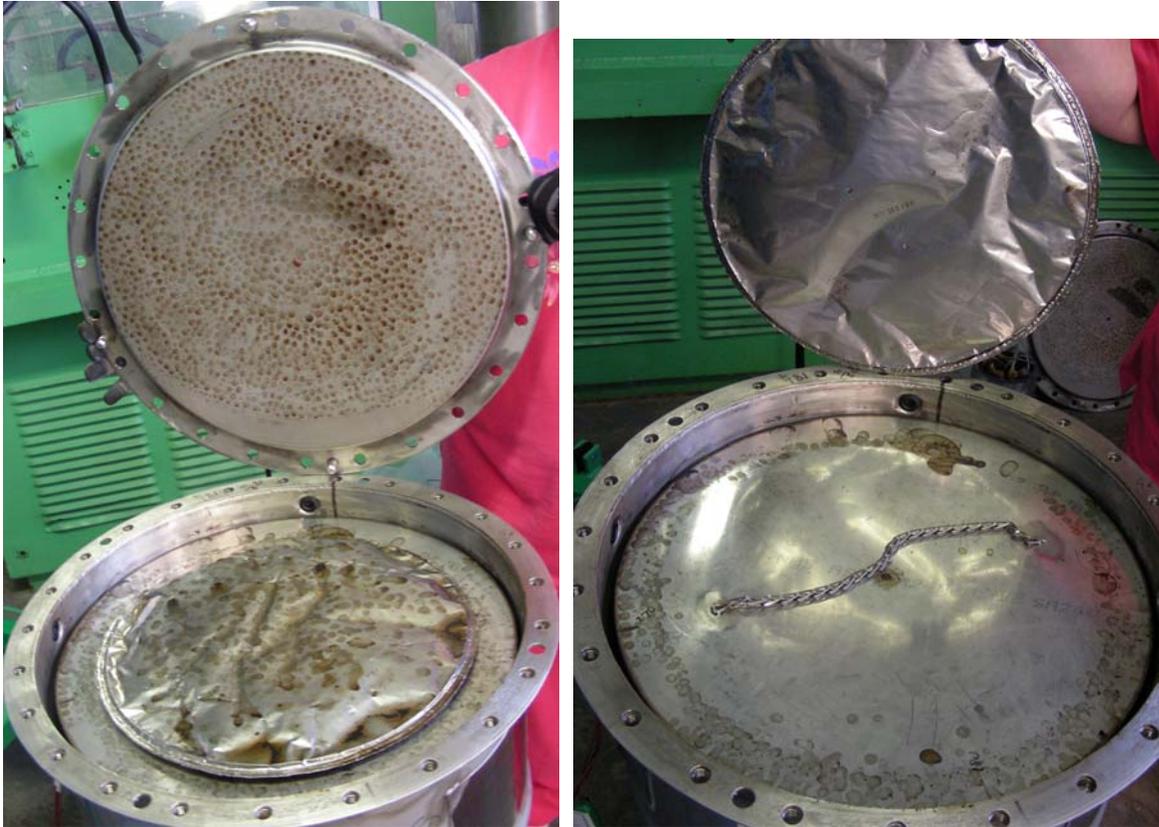
- Stains from the drying of liquid water remained on the underside of the drum lid and the top of the components immediately below the lid. (Figure 3)
- Additional axial shrinkage of the fiberboard produced an axial drop at the view port of ~1 inch.
- Significant corrosion was observed on the shield. (Figure 4)
- Dark stains were observed on the fiberboard ID surface (apparently related to shield corrosion). (Figure 5)

Figure 3. Stain on LE2 lid and other upper components from initial condensation activity, observed after 19 weeks in test.

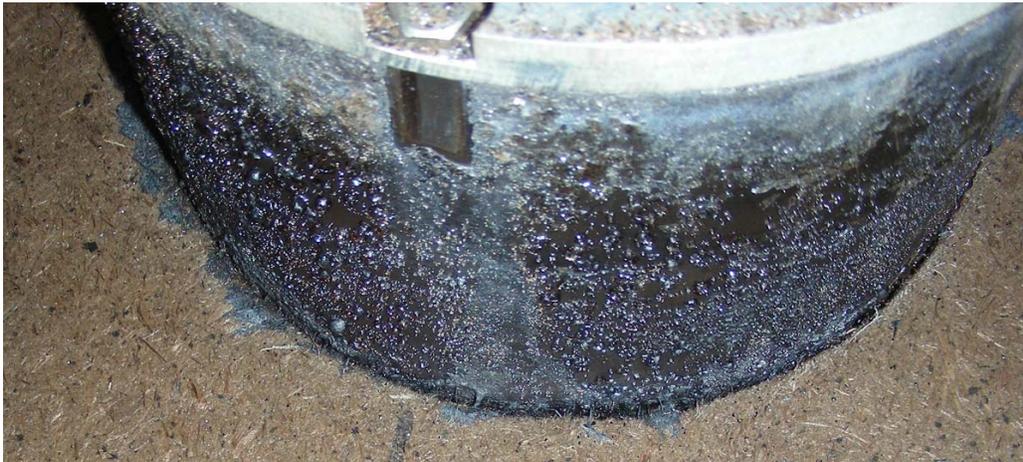
The corrosion of the lead shield is also of interest. In LE2, the corrosion product was observed during the first inspection, after 19 weeks in test, and was dark gray / black and nodular (Figure 4). This is in sharp contrast to the corrosion typically seen on a 9975 shield (smooth white surface). Chemical analysis of corrosion product collected from LE2 showed that it was generally consistent with the lead carbonate seen on other packages. However, elevated levels of chlorine (varies between ~2 to 10 wt%) were also present. Although unconfirmed, the chlorine most likely leached from the fiberboard. Figure 12 shows the appearance of the shield at the end of testing. With little obvious change in appearance since week 19, it is likely that most of the shield corrosion occurred in the first few weeks of test when significant moisture re-distribution was occurring.

Figure 4. Corrosion product on the LE2 shield, after 19 weeks in test.

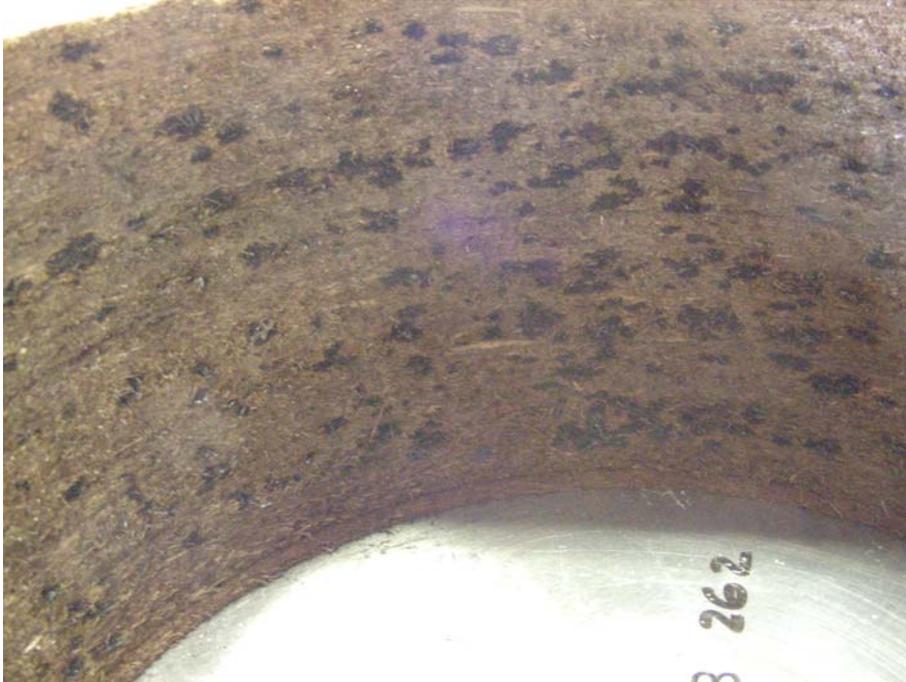
Figure 5. ID surface of upper fiberboard assembly, showing stains apparently from shield corrosion product after 19 weeks in test.

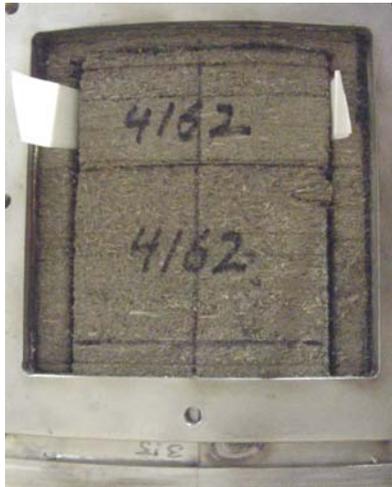
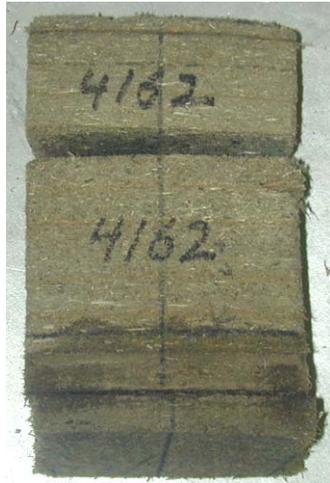
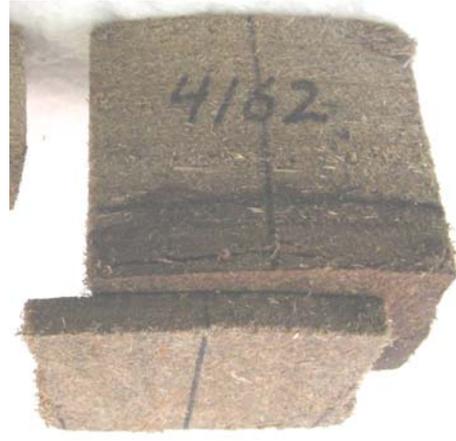
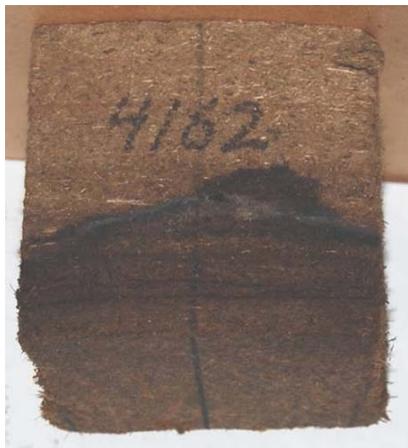
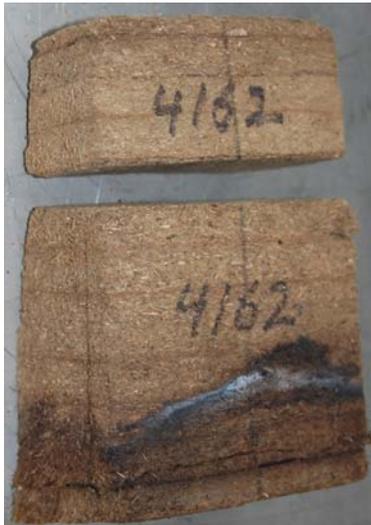
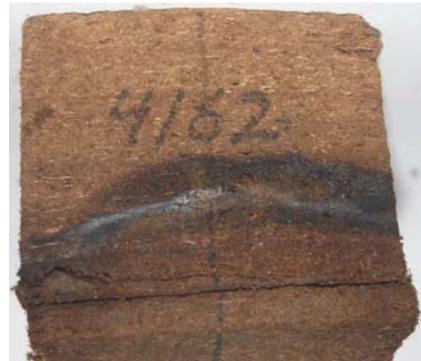
Figure 9. Sequence of photographs of small removable fiberboard sections from test LE2.

With test LE2, the bottom layers of the removable sections (as well as the rest of the lower fiberboard assembly) darkened significantly as they accumulated excess moisture. The bottom layers were observed to be saturated during the first inspection (after 3 weeks at temperature, 8 weeks total exposure), and a strong odor of decaying vegetation was noted after 19 weeks in test.

A steep moisture gradient existed at the bottom of LE2; the saturated layers had a moisture content of 100 %WME, while approximately ½ inch above this region the moisture content was typically 17 %WME or less. The temperature of the removable sections within the conditioning environment was not recorded.

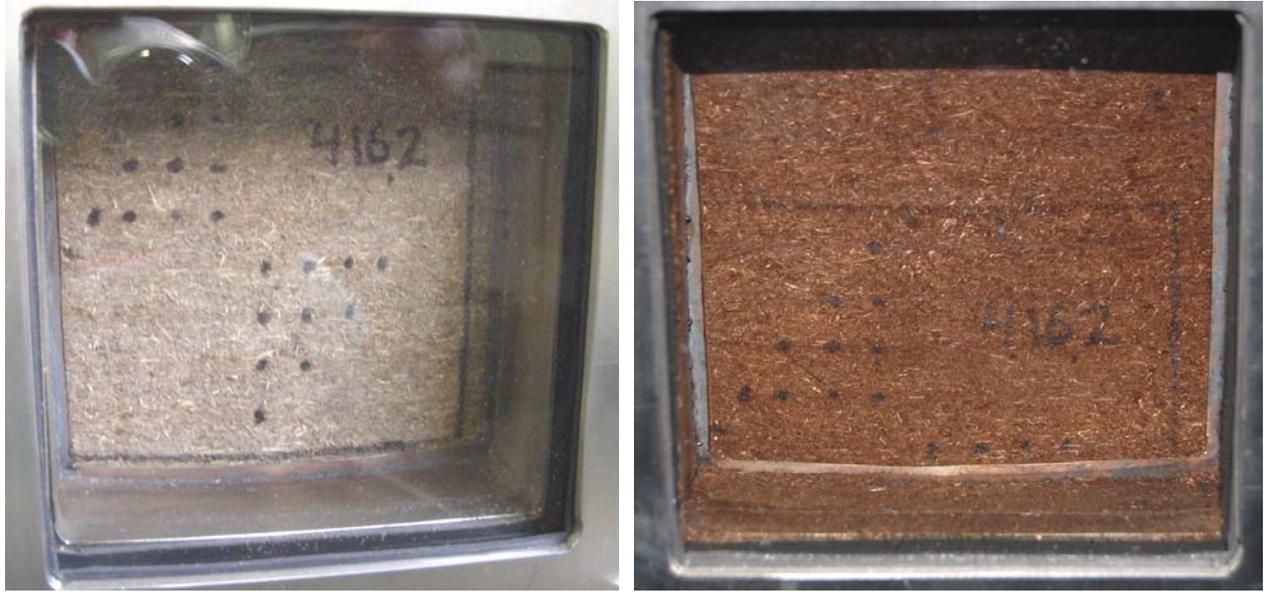
The drum was modified to include a view port on the side. A pattern was marked on the lower fiberboard assembly to be viewed through the view port, and identify the extent to which the fiberboard moved. Typical photographs of this pattern through the view port are shown in Figure 10. As observed through the viewport, the overall fiberboard height was reduced, as indicated by the pattern shifting downward. Measurements were made from photographs taken at each inspection interval to estimate the amount of fiberboard movement. These measurements are summarized in Figure 11.

(a) baseline (b) after 81 weeks in test
Figure 10. View of the side of test LE2 through the view port

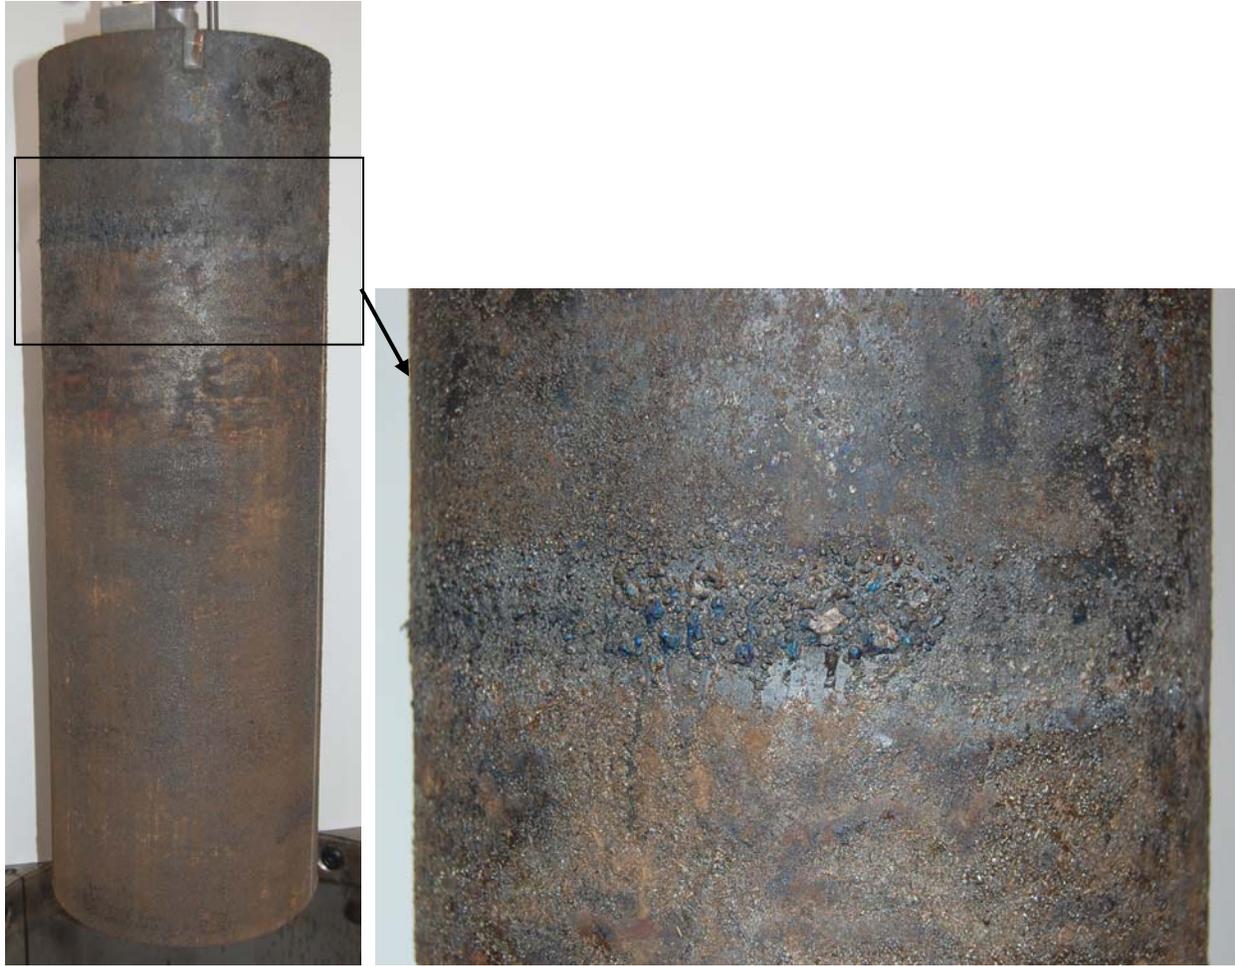
The data in Table 2 indicate the possibility that creep of the lead shield occurred in LE2, although this conclusion is complicated by the fact that the shield dimensions were also changing due to corrosion. Creep of the lead would be manifested by a reduction in wall thickness at the top of the shield, and an increase in wall thickness near the bottom. The observed corrosion on the shield was generally uniform over the entire surface.

At the top of the LE2 shield, the average radial thickness remained relatively constant (maximum increase of 0.008 inch). In the absence of creep, it would be expected to increase due to the accumulation of corrosion product. In contrast, the average radial thickness at the bottom increased by 0.032 – 0.034 inch. Corrosion alone would be expected to produce a similar increase in shield thickness at the top and bottom. It is not obvious why the measured radial thickness (at either top or bottom) is greater after 36 weeks than after 81 weeks, but this may reflect measurement uncertainty.

Figure 12. LE2 shield with corrosion product after end of test (81 wks)

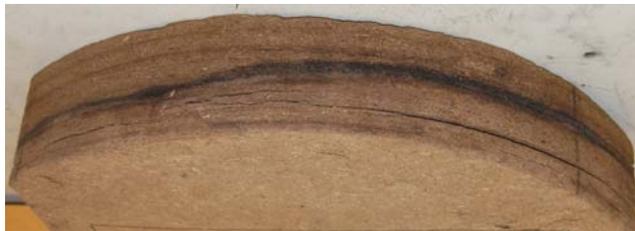
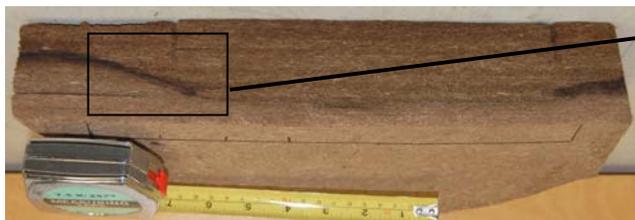
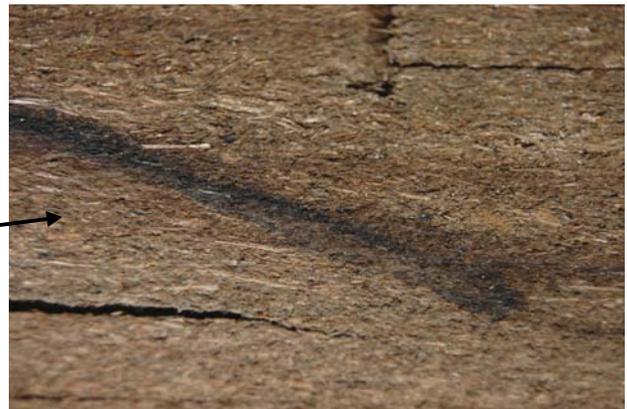
Figure 17. Cross section through the bottom layers of the lower fiberboard assembly, showing 3 distinct regions.

Samples were removed from the lower fiberboard assembly for thermal conductivity, specific heat capacity and compression testing. During cutting, it was noted that the sidewall material (above the lower bearing plate) was very soft, and cut easily with a hand saw. Rather than the typical

release of recognizable fibers, cutting produced a fine powder. In contrast, the bottom layers of fiberboard (below the lower bearing plate) displayed progressively less damage, with three distinct regions (see Figure 17). The bottom region appears similar to undegraded fiberboard, and is typically $\frac{1}{2}$ - $\frac{3}{4}$ inch thick. The upper region is darkened, and appears somewhat weakened, but retains distinct fibers. The middle region is heavily darkened, and is much harder than undegraded fiberboard. It appears to have a significant quantity of embedded particulate material, and is suggestive of leachable material deposited at a “high water” mark. This middle region is thickest around the outside perimeter, and decreases towards the fiberboard interior.

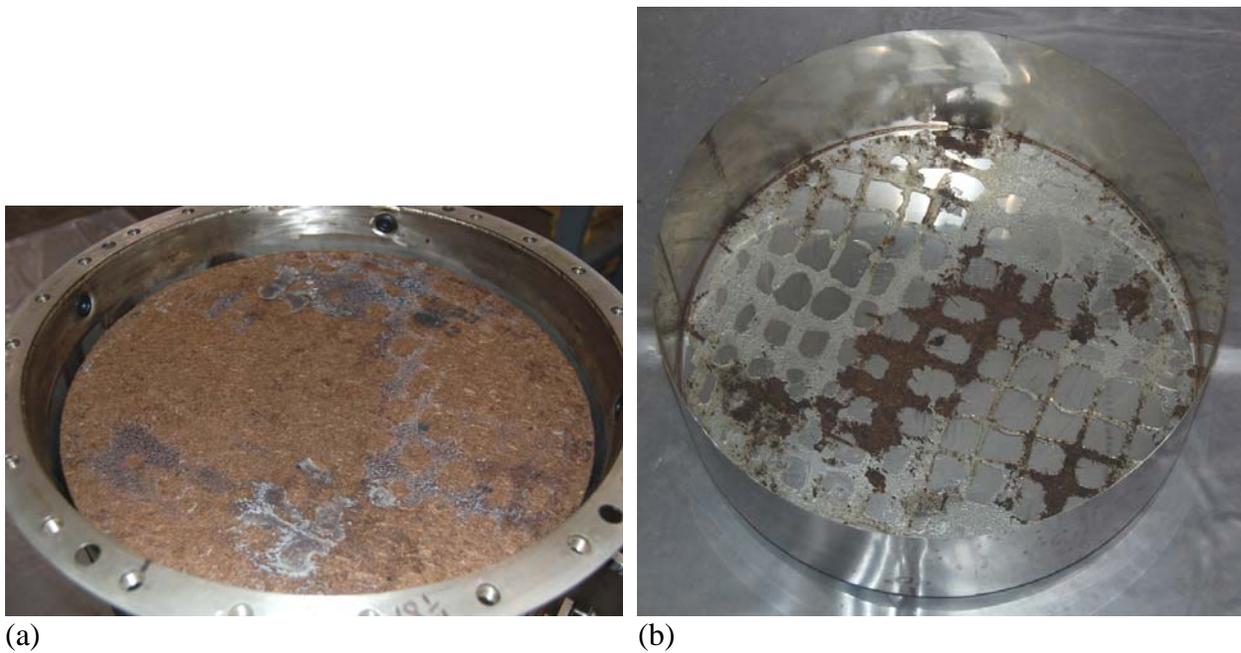
During the last inspection, package LE2 had the air shield detach from the upper fiberboard assembly. It detached with very little force as the assembly was being removed from the package. Several wire hooks were improvised to pull the upper fiberboard assembly from LE2, leaving significant impressions in the degraded fiberboard. The air shield is attached to the fiberboard with silicone adhesive. Upon separation, some adhesive remained on the fiberboard, while most separated with the air shield. A region of the silicone on the air shield also had fiberboard still attached. This dual behavior (fiberboard remaining on the silicone, and silicone still attached to the fiberboard, see Figure 21) indicates that failure of both the fiberboard and silicone contributed to the separation.

Figure 21. LE2 upper assembly after air shield came loose (a), and underside of air shield (b)
