**EXAMINATION OF SHIPPING PACKAGES 9975-01968, 9975-04353
AND 9975-06870**

Savannah River National Laboratory

Publication Date: April 2010

Document No. SRNL-STI-2010-00233

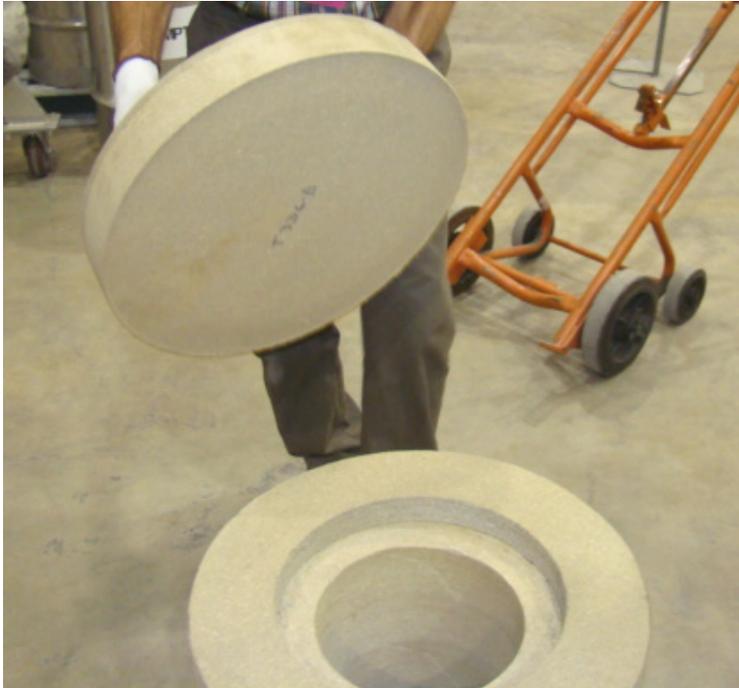
The axial gap in this package ranged up to 1-1/8 inch. The fiberboard moisture content was drier than normally observed (8.4 %WME and less). The lower fiberboard assembly separated approximately 3.5 inches above the bottom (Figure 1). This separation did not appear to be associated with a glue joint. Otherwise, the softwood fiberboard appeared undegraded. The axial gap was reported on nonconformance report 2010-NCR-29-0005. K-Area will be requested to update the nonconformance report for the fiberboard separation.

Figure 1. Separation of 9975-06870 lower fiberboard assembly.

(a) Both pieces of lower assembly separated

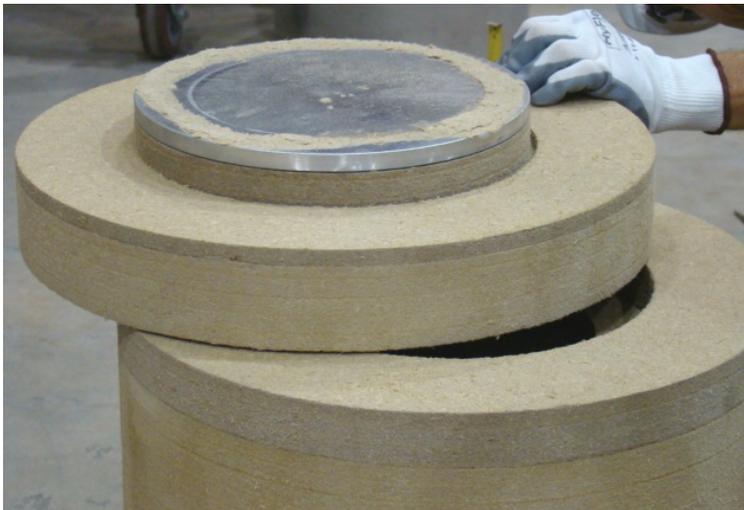
(b) Lower separated piece (in upright position) on top of inverted larger section

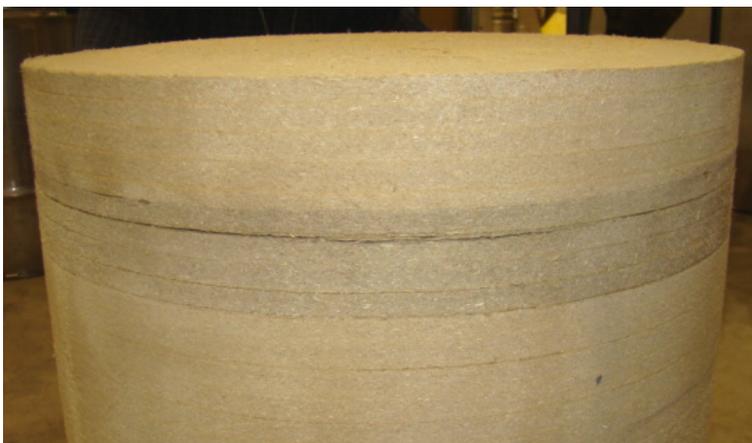
(c) Lower piece inverted and placed on upper piece. (The entire lower assembly is inverted in this view.)

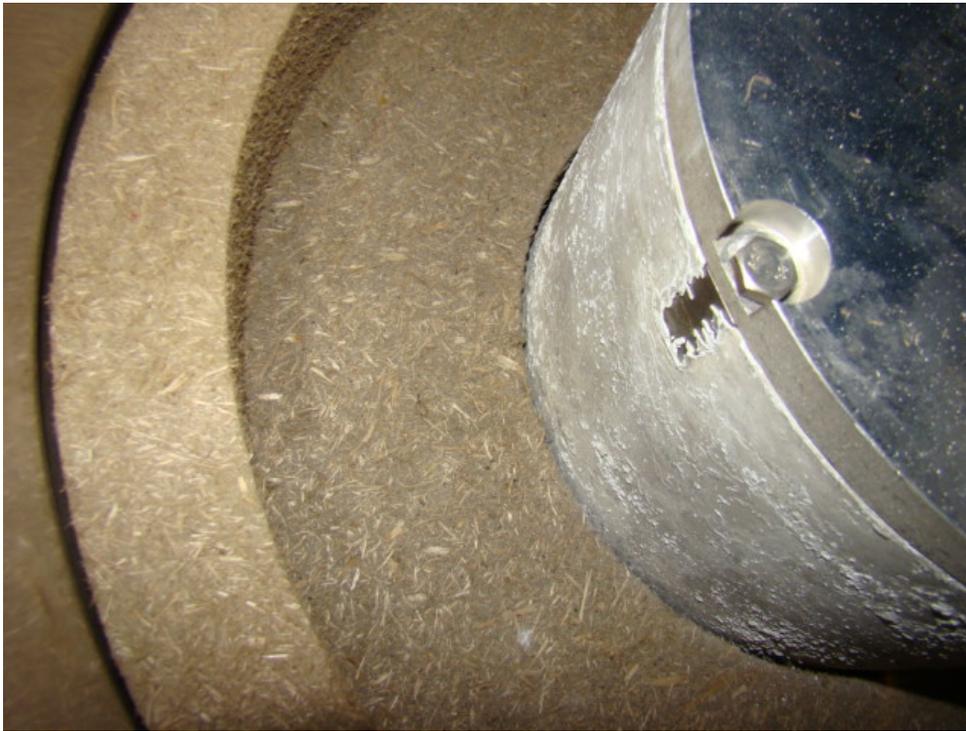
The axial gap in this package barely exceeded 1 inch at the center, and was 1 inch or less elsewhere. The lower fiberboard assembly could not be removed from the drum, due to a tight fit at the top of the drum. In regions accessible for measurement, the fiberboard moisture content (8.8 – 11.8 %WME) was consistent with other conforming packages. The cane fiberboard was in good shape and appeared undegraded (Figure 2). Heavy corrosion of the lead shield was observed, with local nodules of corrosion in several areas (Figure 3). K-Area will be requested to initiate a nonconformance report for the excessive axial gap condition.

Figure 2. Fiberboard assembly from package 9975-04353

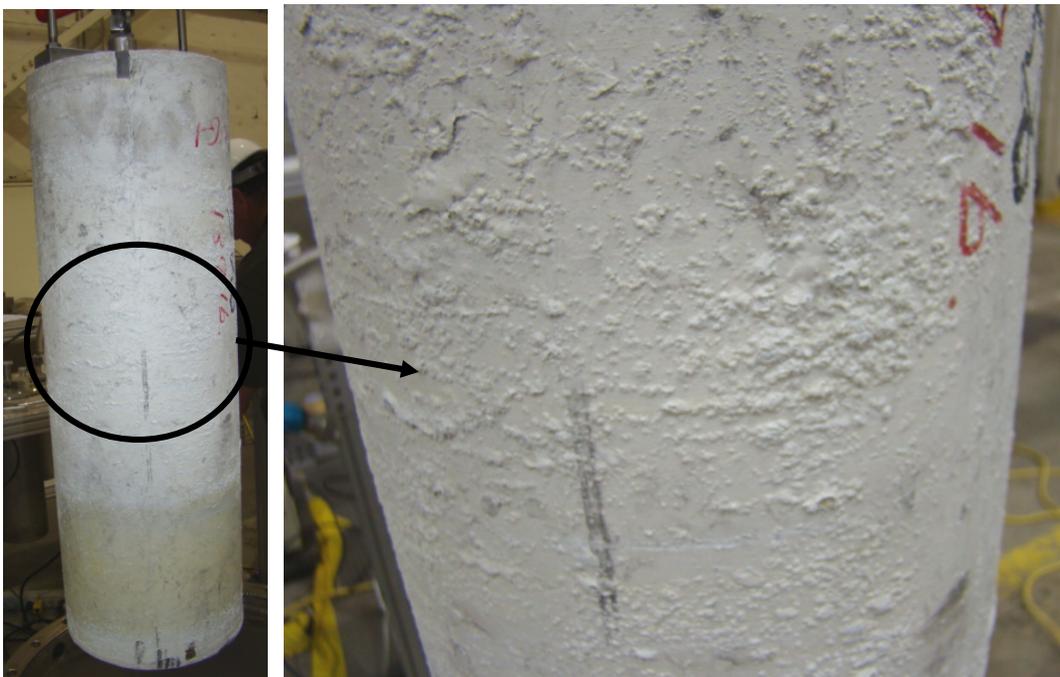
The lead shield from 9975-04353 was heavily corroded, while the shield from 9975-01968 had very little corrosion. In the case of 9975-06870, the shield was covered by a stainless steel sleeve, and the condition of the lead was not observed. No other conditions of concern were observed in these three packages.

Figure 3. Lead shield from 9975-04353 showing heavy corrosion

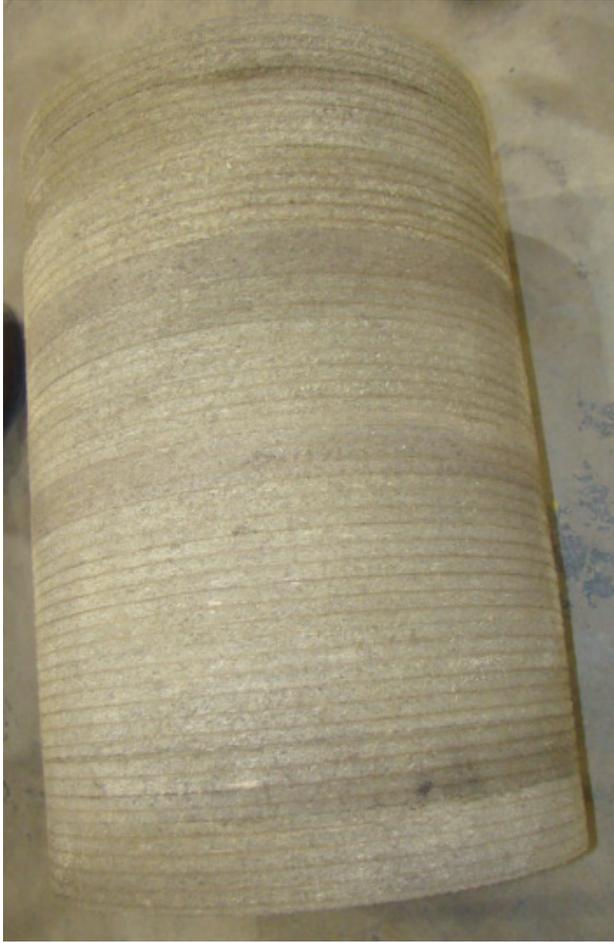
The axial gap in this package barely exceeded 1 inch at the center, and was 1 inch or less elsewhere. The fiberboard moisture content (10.0 – 14.2 %WME) was consistent with other conforming packages. The cane fiberboard was in good shape and appeared undegraded (Figure 4). Very little corrosion of the lead shield was observed (Figure 5). The axial gap was reported on nonconformance report 2010-NCR-29-0004.

Figure 4. Fiberboard assembly from package 9975-01968

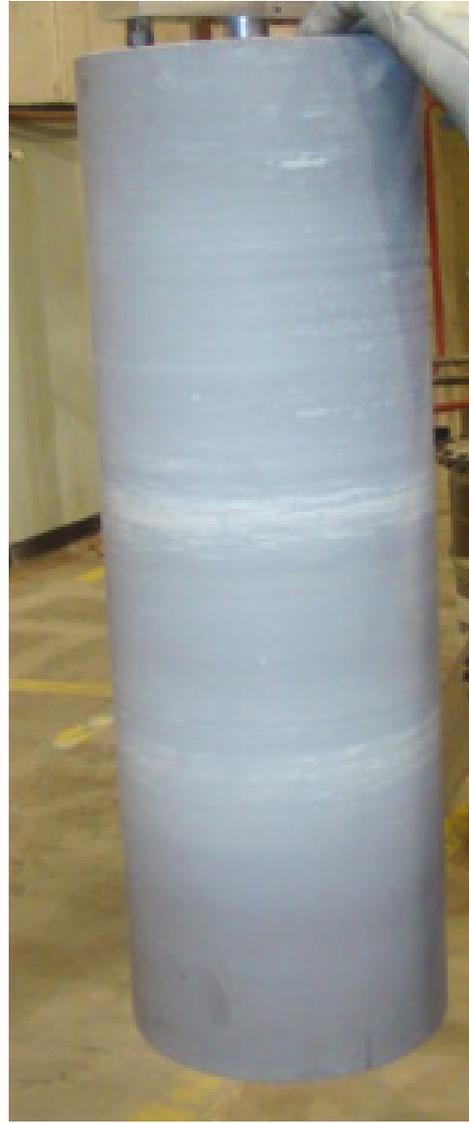
Figure 5. Lead shield from 9975-01968 showing light corrosion
