**DESTRUCTIVE EXAMINATION OF SHIPPING PACKAGE 9975-02168**

Savannah River National Laboratory  
Materials Science & Technology

Publication Date: November 2010

**Revision Log****Document No.** SRNL-STI-2010-00654 **Rev. No.** 0**Document Title** Destructive Examination of Shipping Package 9975-02168

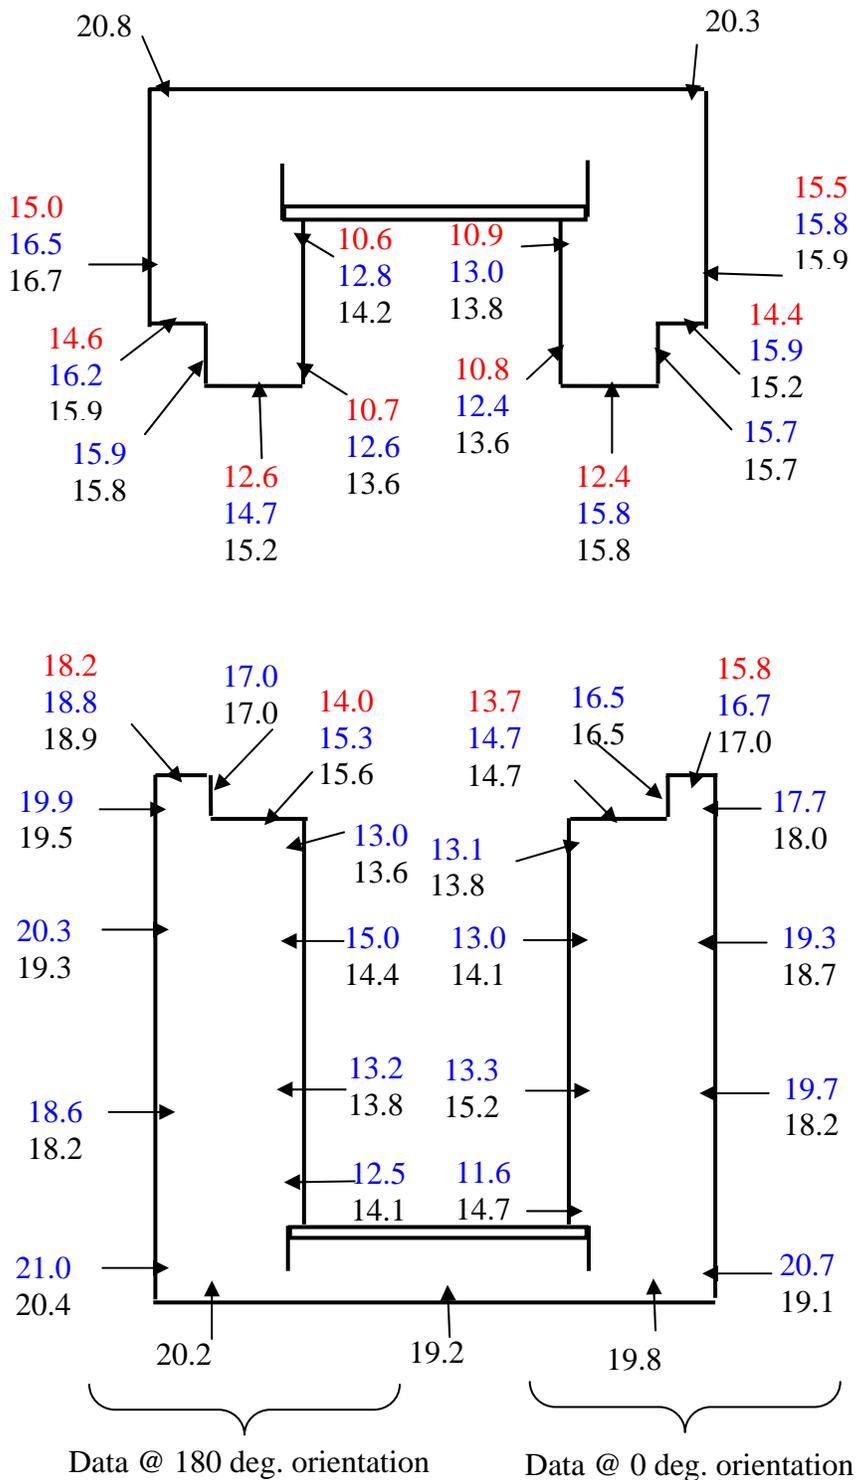
Moisture measurements were compared to those taken during previous destructive examinations [8 – 12]. The readings on 9975-02168 are higher on average than seen on previous packages, although most of the readings fall within the range previously observed. The moisture content of the 9975-02168 fiberboard most closely resembles that of 9975-02028 (among the packages previously examined destructively); both have similar patterns of moisture distribution, although the moisture content at most locations is slightly higher in 9975-02168. Despite the higher moisture content of 9975-02168, no mold was observed, while mold was present in 9975-02128.

Figure 1. Fiberboard moisture content data. The values in red were measured during field surveillance. The values in blue were measured 8 days later, while the values in black were measured 51 days after field surveillance. All values are % wood moisture equivalent.

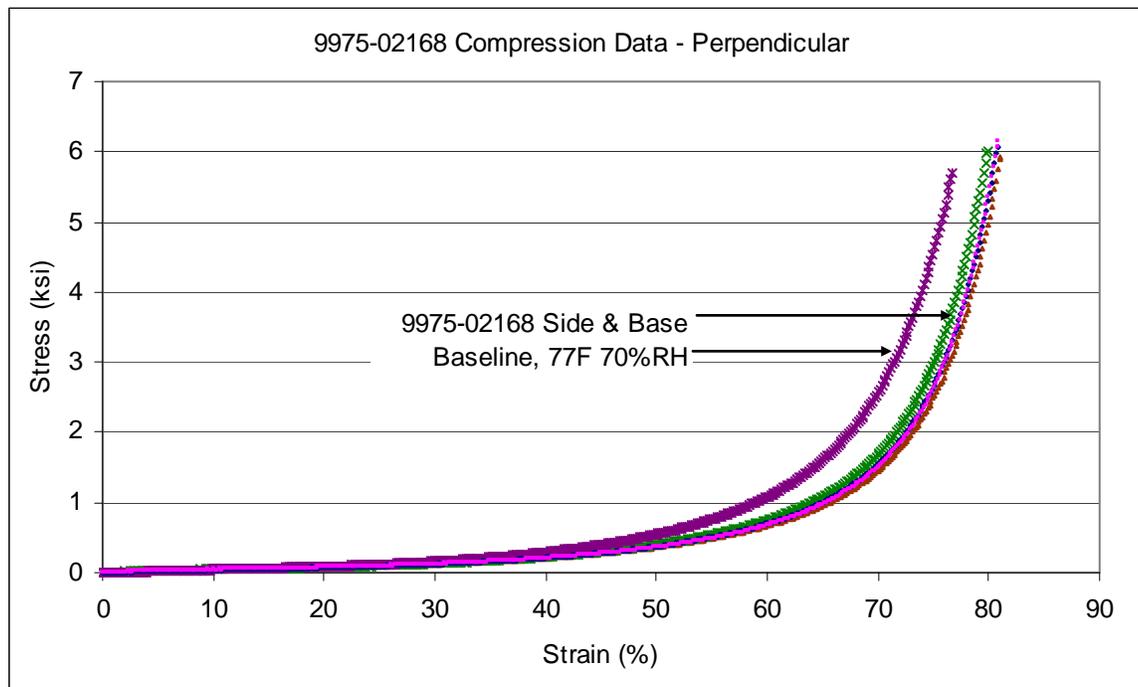
The compression test data are shown in Figures 4 and 5, along with select baseline data. For both the perpendicular and parallel orientations, the compression strength of the 9975-02168 samples is similar to the baseline samples conditioned at 77°F and 70% RH. A series of photographs showing typical compression behavior under parallel loading is shown in Figure 6.

Figure 4. Fiberboard compression test data, compared with typical baseline (77°F, 70% RH) data, in the perpendicular orientation (i.e. load applied perpendicular to the fiberboard layers).

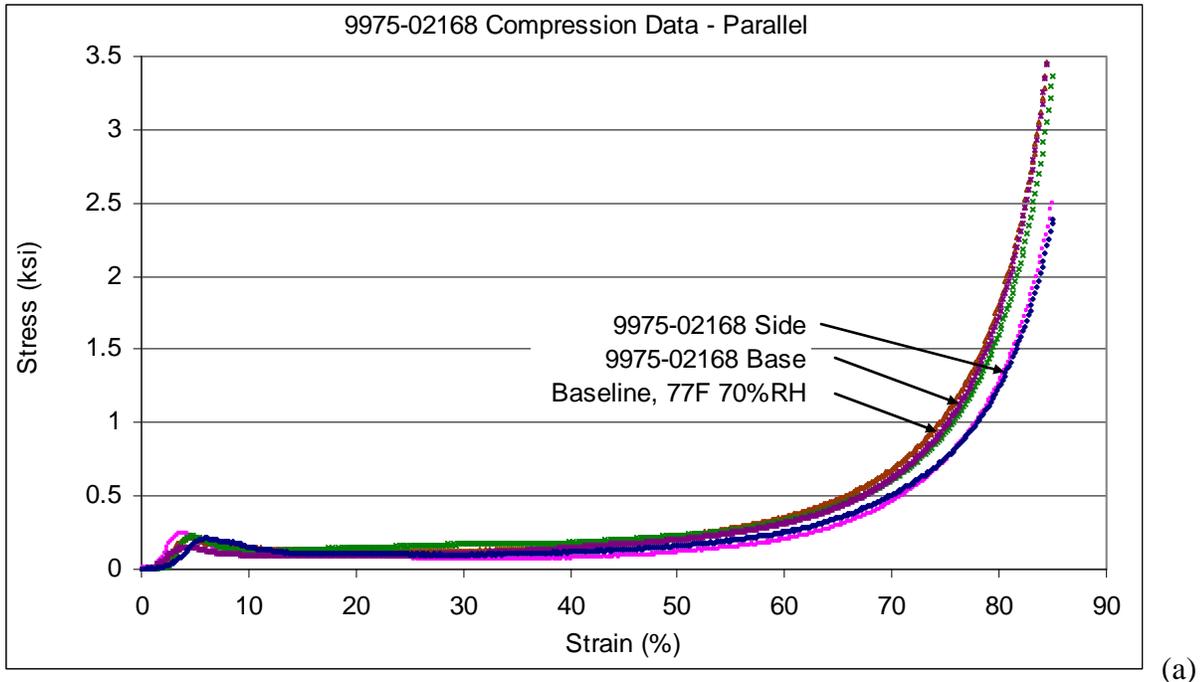
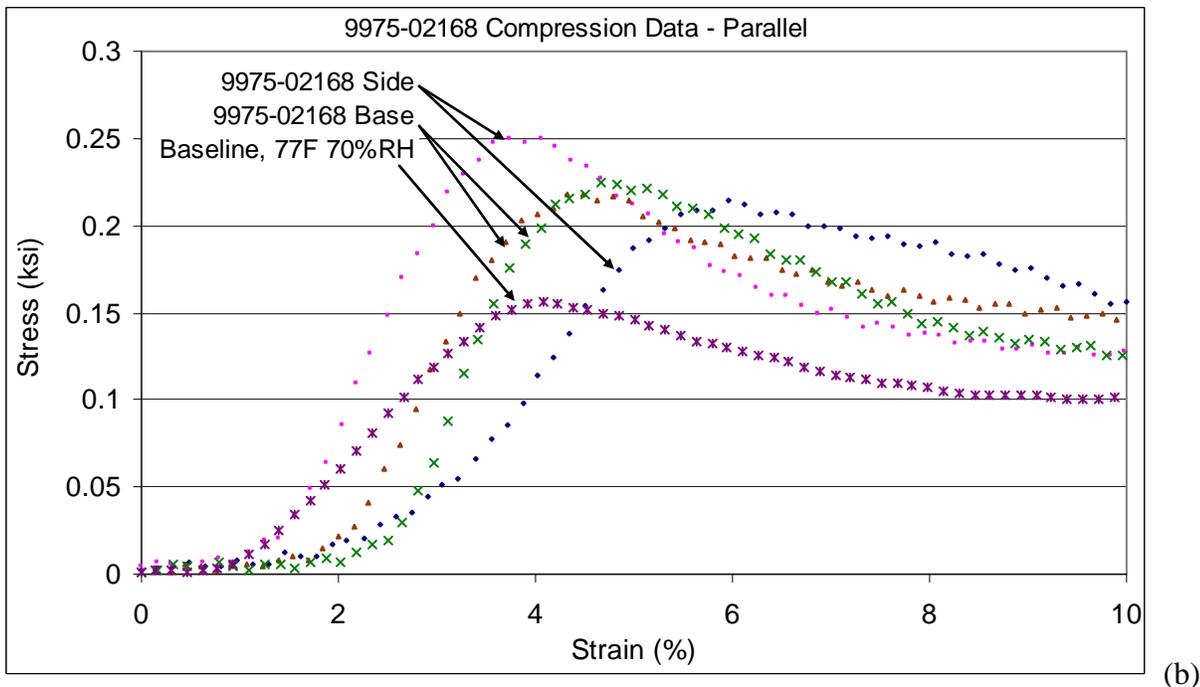
Figure 5. Fiberboard compression test data, compared with typical baseline (77°F, 70% RH) data, in the parallel orientation (i.e. load applied parallel to the fiberboard layers). The full curves are shown in (a), while the initial buckling region is expanded in (b).

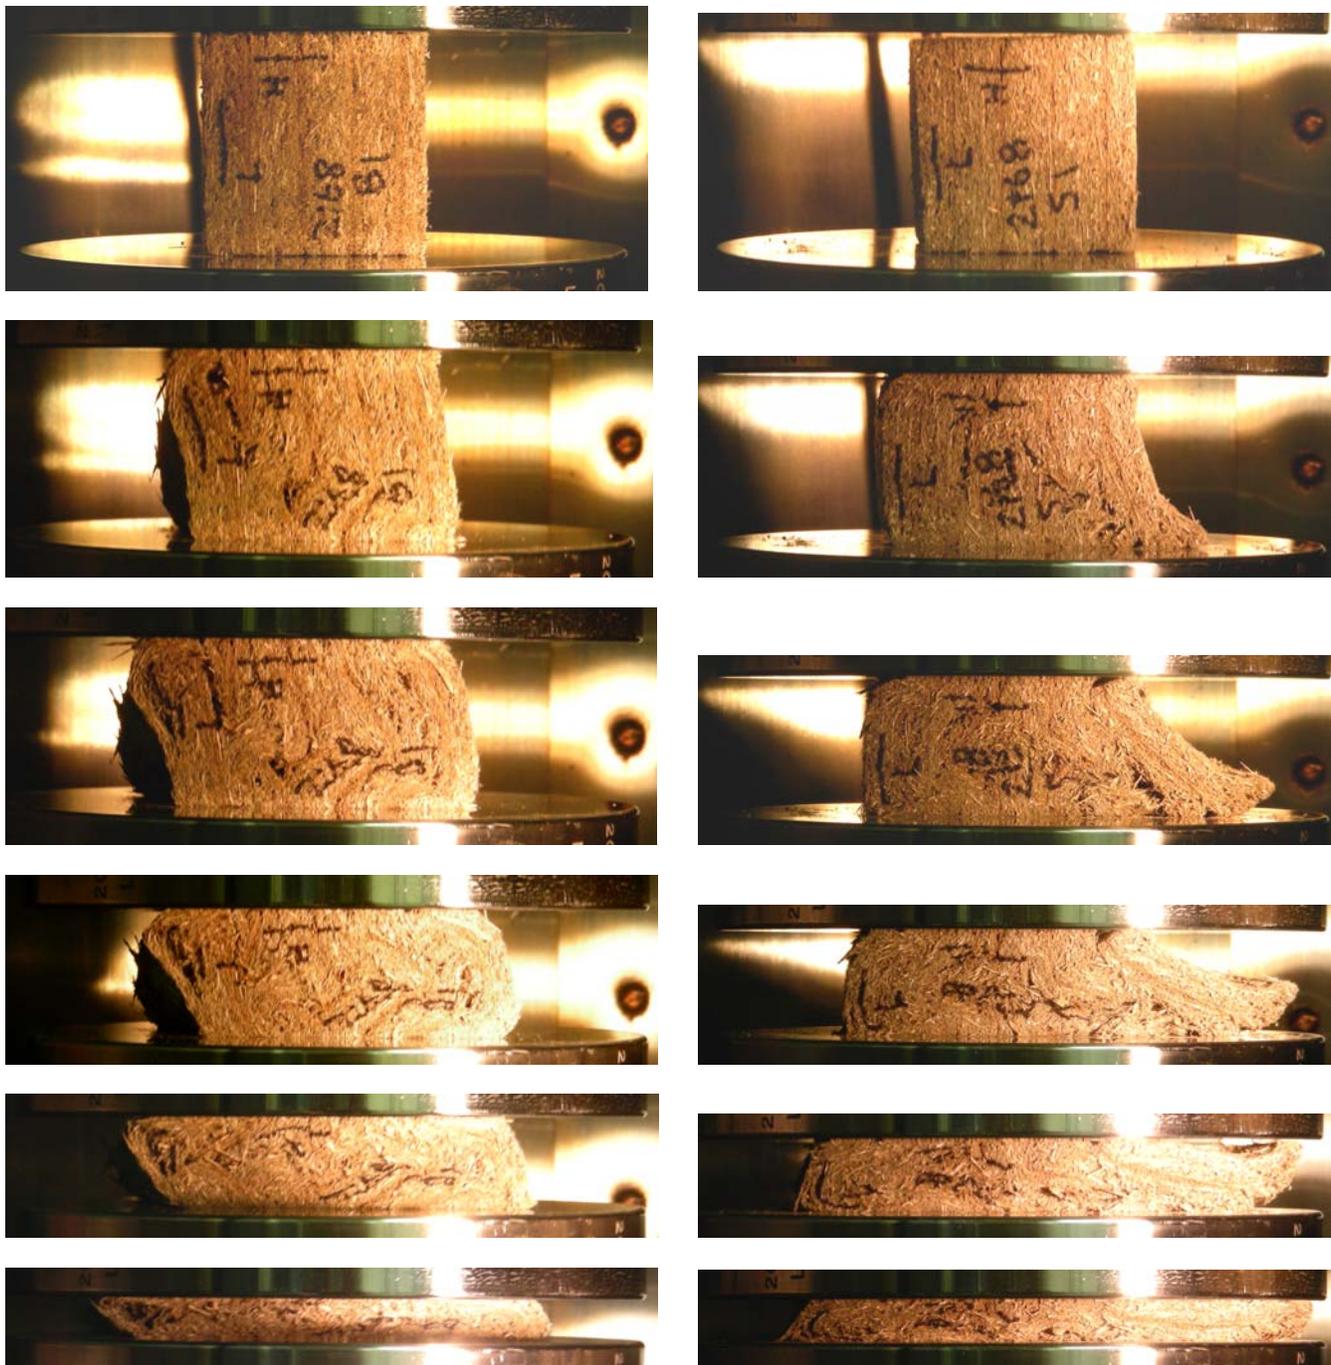
Figure 6. Photographs of fiberboard samples during compression testing, parallel orientation

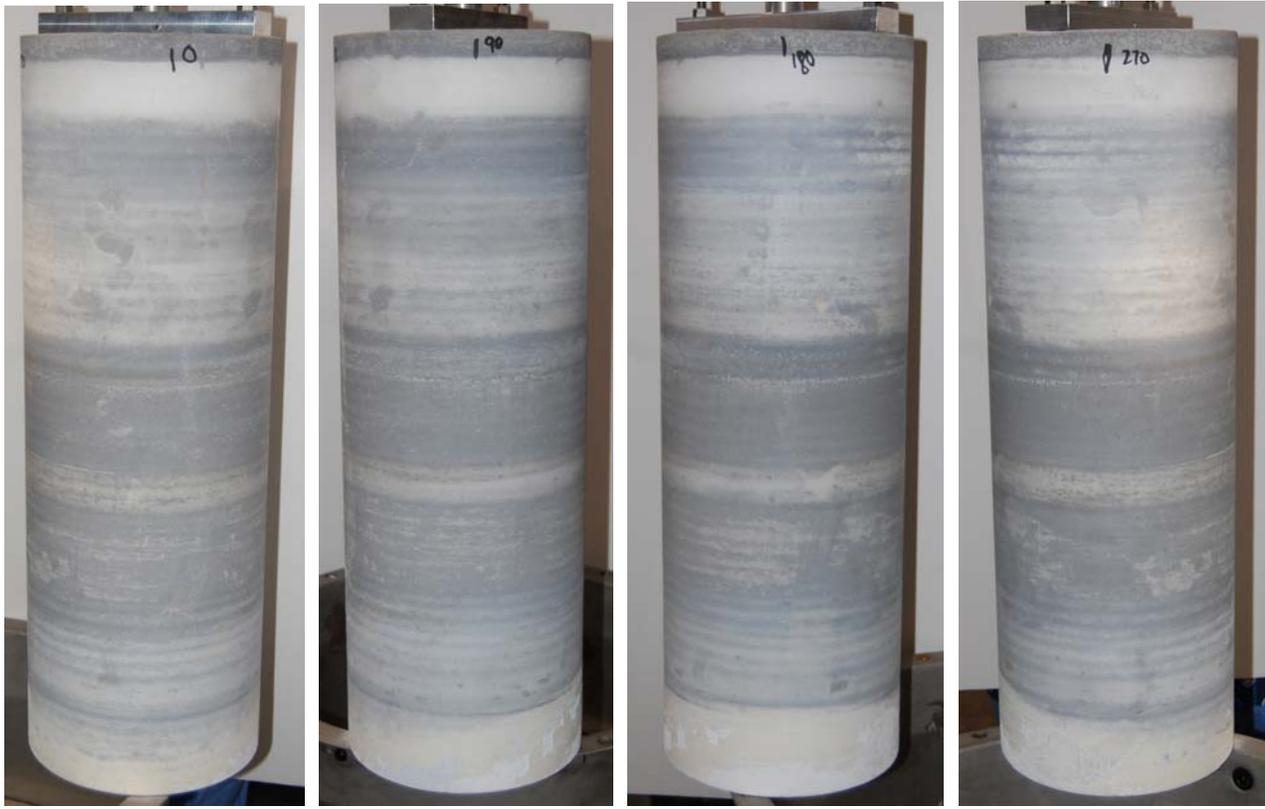
The entire surface of the lead shield was visually examined. It was found to be free from significant deformation and physical damage, but much of the outside surface (in contact with the fiberboard) was covered with a white corrosion product (Figure 7). Areas of corrosion product near the bottom of the shield were flaking off when handled. Reference 4 identifies the presence of corrosion on the shield as an unsatisfactory condition. In contrast, current field surveillance criteria allow the presence of corrosion product, so long as there is no flaking, blistering or spalling [6]. The flaking observed near the bottom of this shield during destructive examination would not have been noted during field surveillance since the shield was not removed from the package at that time. From prior examination of the shield from package 9975-02234, the corrosion product was identified as basic lead carbonate (hydrocerrusite),  $Pb_3(CO_3)_2(OH)_2$ . No further characterizations of the corrosion product were performed.

Figure 7. Lead shield with corrosion product.

Comments: Slight lead carbonate noted on exterior of lead shield (field surv.). Bands of corrosion on shield – some bands heavier than others (DE).

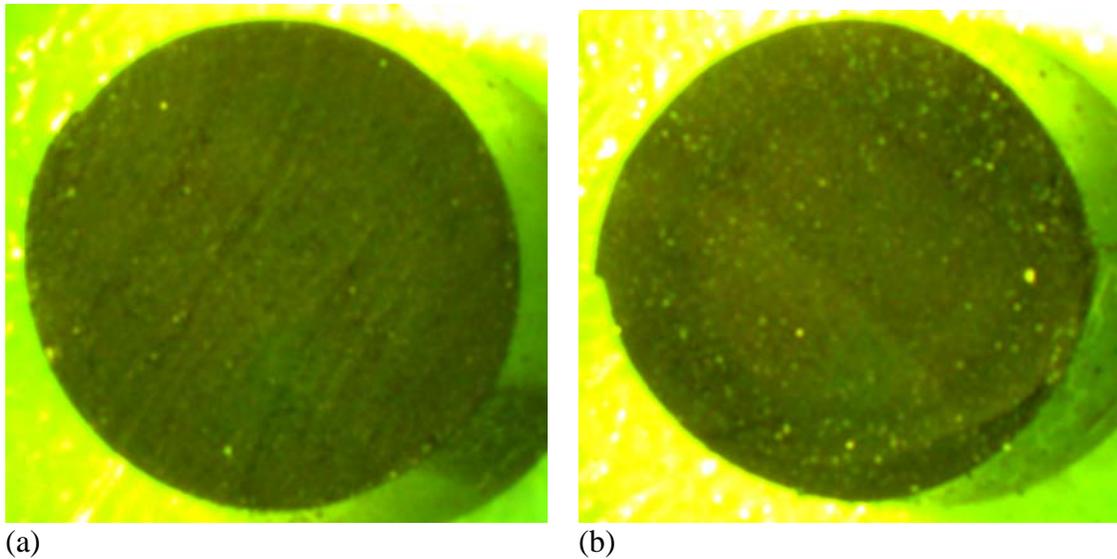
As with previous destructive examinations, visual (Figure 9) and SEM (Figure 10) examination of the cross sections identified a distribution of very small particles throughout each O-ring. Aside from carbon and fluorine (which are the primary constituents of Viton<sup>®</sup>) the SEM identified aluminum, silicon, oxygen, zinc, calcium and bromine. These elements are present in small amounts, and are generally associated with the particles. Though the actual compound is proprietary, zinc, calcium and oxygen are consistent with Viton<sup>®</sup>-type fluoroelastomer compounds, which typically contain MgO, CaO, Ca(OH)<sub>2</sub>, ZnO or lead compounds as acid acceptors and heat stabilizers [15]. Aluminum is present in hydrotalcite, which is used in both GLT and GLT-S compounds as a filler reinforcing agent Silicon may be present as a trace contaminant.

Figure 9. Optical cross section of the (a) PCV outer and (b) SCV outer O-rings.

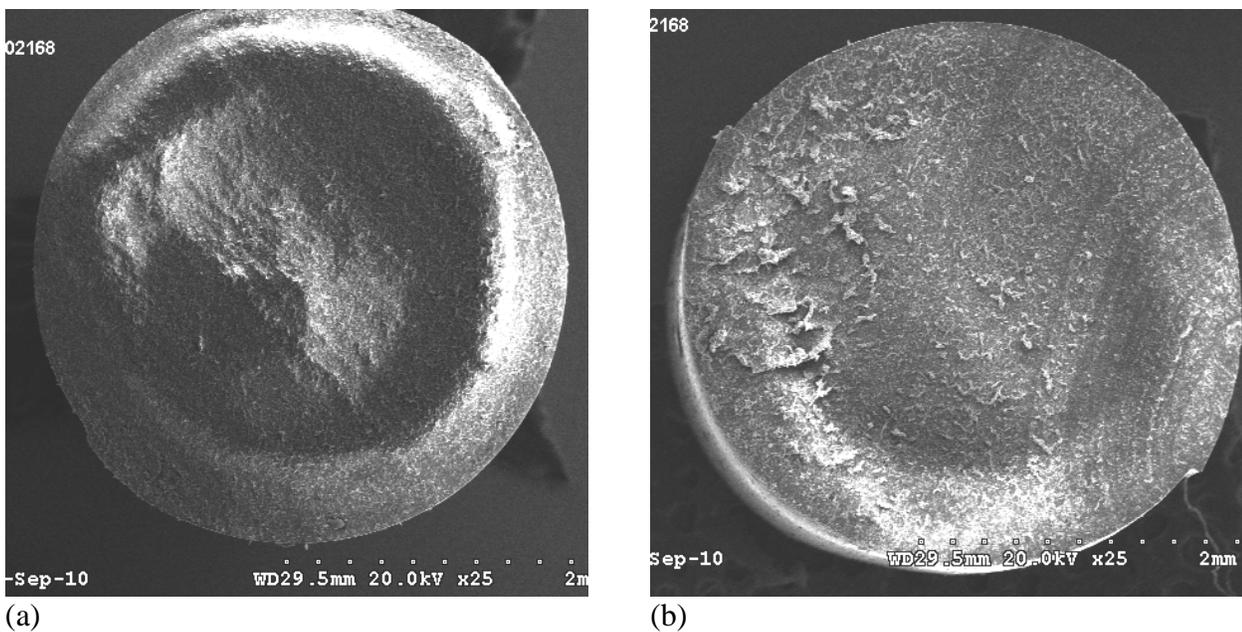
Figure 10. SEM cross section of the (a) PCV outer and (b) SCV outer O-rings.

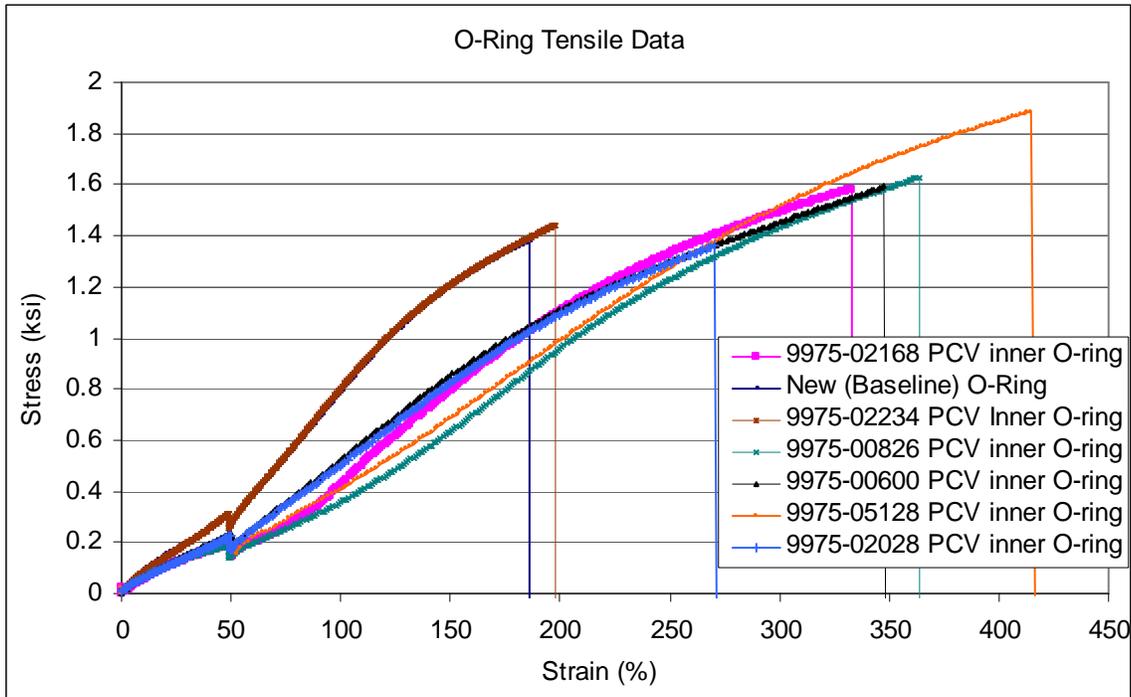
The PCV inner O-ring was tensile tested in accordance with ASTM D1414, using a cut (single strand) sample. The test was interrupted at 50% strain to visually examine the O-ring for signs of cracking or other degradation. None were observed. The stress-strain curve for the PCV inner O-ring is shown in Figure 11 along with curves from a new O-ring and from previous destructive examinations. The O-ring from package 9975-02168 displayed tensile properties (strength and elongation) consistent with that observed in previous examinations. The elongation (333%) of this O-ring exceeds the minimum value specified in AMS-R-83485 for new O-rings (120%), while the tensile strength (1.6 ksi) matches the minimum value specified (1.6 ksi) [14]. While Parker Seals does not change the formulation of these O-rings, there are batch variations.

Figure 11. Tensile data for PCV inner O-ring from 9975-02168, compared to a new O-ring and the PCV O-rings from previously examined packages.

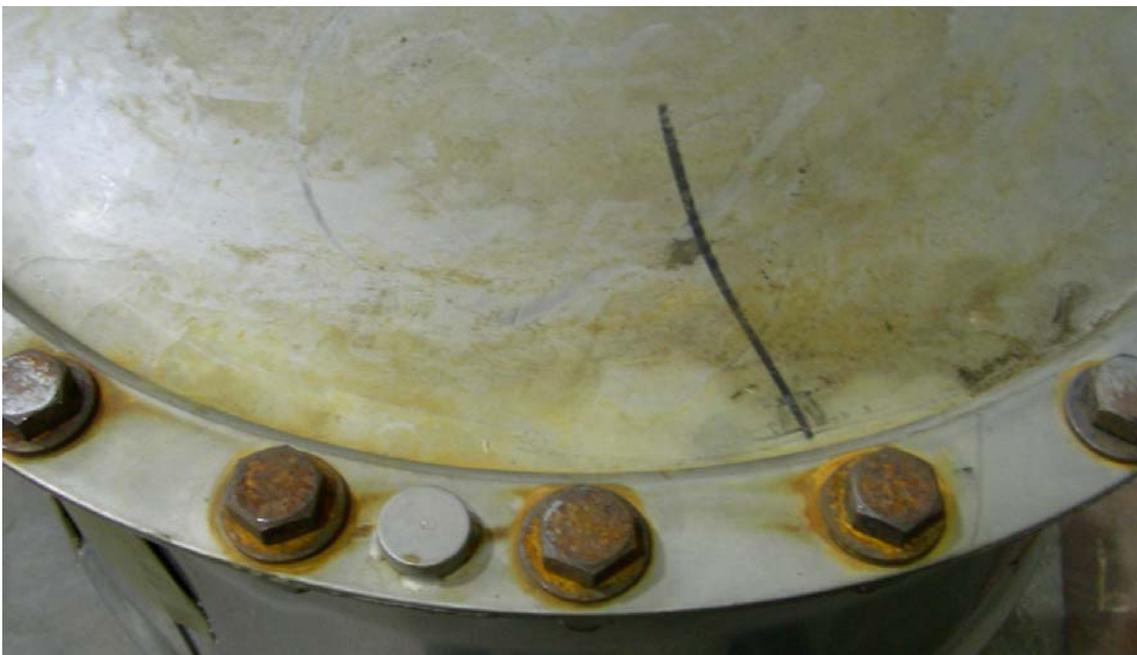
A general visual examination was performed on all metallic components. Aside from the corrosion of the lead shield (discussed above) no significant damage or degradation was observed, although there was light corrosion on some of the drum closure bolts (Figure 12). A similar observation of rust staining of the top drum surface was made during field surveillance. Several components were observed to have fabrication markings. Various markings were stamped or engraved on the containment vessels and lids (Figure 13). These markings appear to be identification numbers used during manufacture, prior to association of the parts with a final package number.

Figure 12. Light corrosion on some of the drum closure bolts.

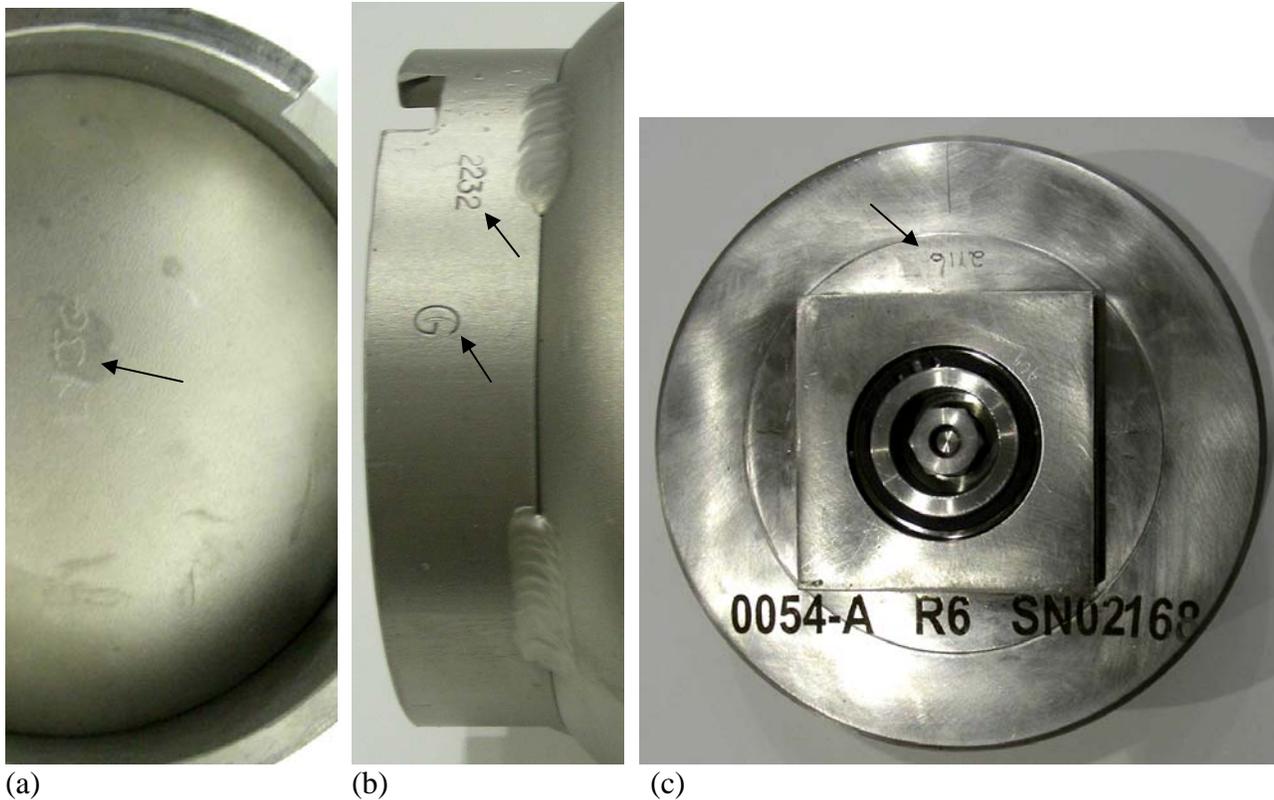
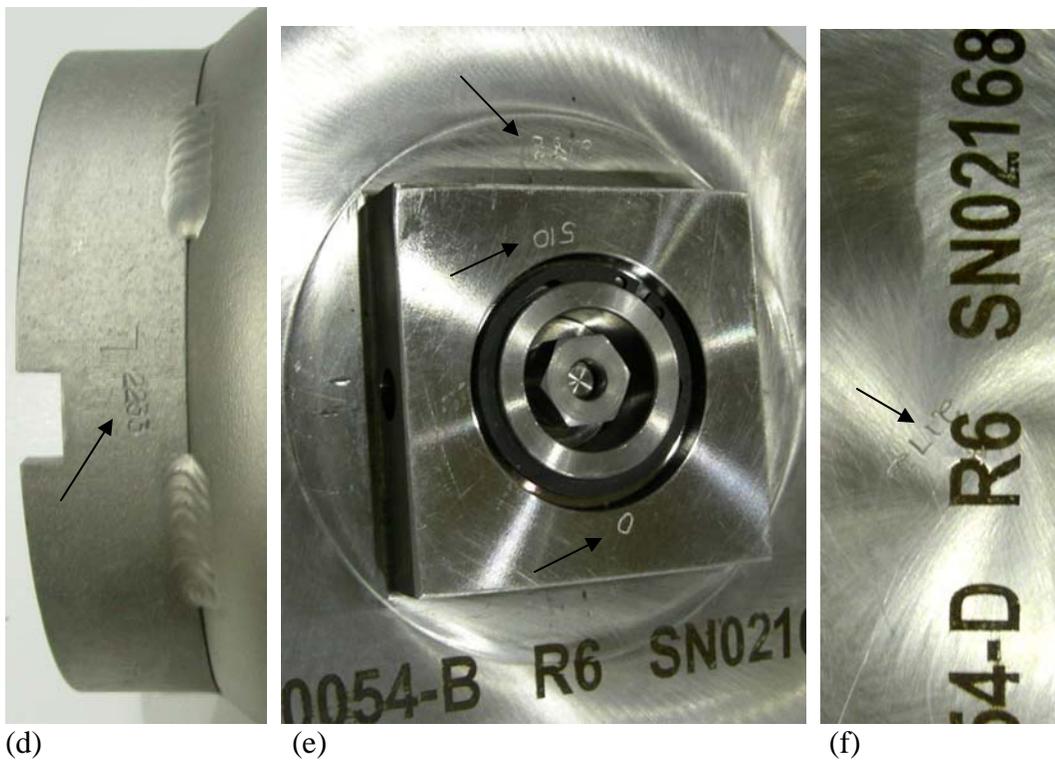
Figure 13. Fabrication markings (at arrows) on PCV (a, b), PCV lid (c) SCV (d) and SCV lid (e, f)
