**MODEL 9975 LIFE EXTENSION PACKAGE 1 – FINAL REPORT**

Savannah River National Laboratory  
Materials Science & Technology

Publication Date: March 2011

**Document No.** SRNL-STI-2011-00113 **Rev. No.** 0

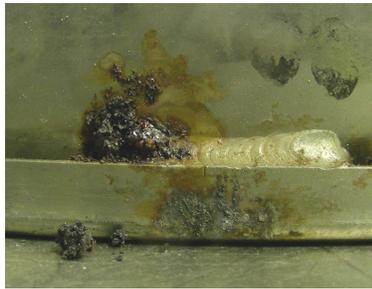
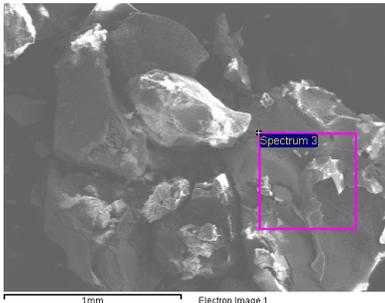
<p>Drum OD surface at bottom stitch weld</p>	<p>8 particles checked</p> <p>7 particles have some or all stainless steel elements (Fe, Cr, Ni, Mo) plus 8 – 24 wt% Cl</p> <p>1 particle is “dirt” (Na, Al, Si, Cl, K, Ca, F, O)</p>	<p>52.6 wt% Fe 10.0 wt% Cr 2.5 wt% Ni <b>12.4 wt% Cl</b> 0.5 wt% Si 0.4 wt% S 21.6 wt% O</p>

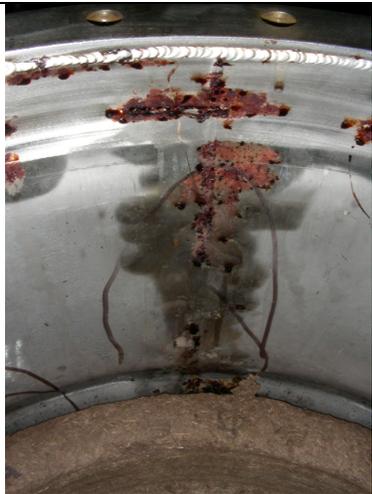
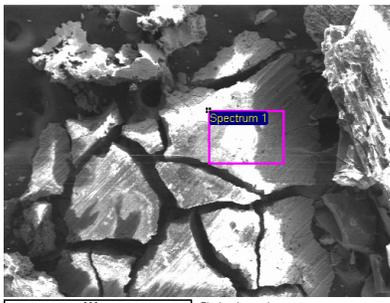
<p>Drum ID surface at top flange stitch welds and vertical seam weld</p>	<p>7 particles checked:</p> <p>All particles have some or all stainless steel elements (Fe, Cr, Ni, Mn) plus O</p> <p>4 particles have 1 - 3 wt% Cl</p> <p>Some have significant amounts of Si and/or Al</p>	<p>43.7 wt% Fe 11.8 wt% Cr <b>3.0 wt% Cl</b> 7.6 wt% Al 4.4 wt% Si 29.6 wt% O</p>

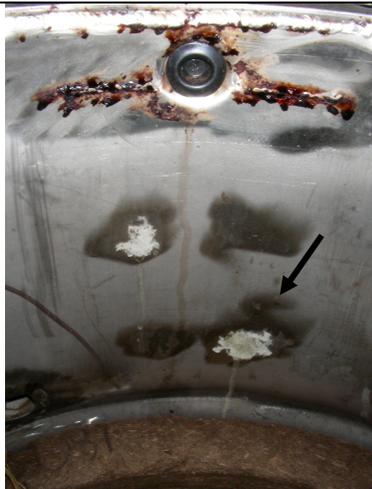
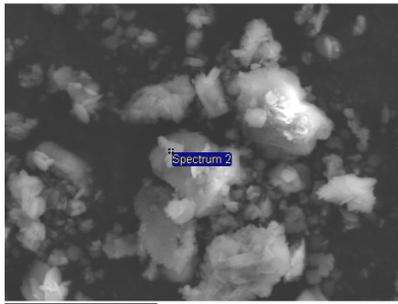
<p>Drum ID surface behind bar code plate attachment weld</p>	<p>8 locations on 5 particles checked:</p> <p>All locations have some or all stainless steel elements (Fe, Cr, Ni, Mn) plus O</p> <p>4 locations on 4 different particles have 0.5 – 0.9 wt% Cl.</p> <p>3 locations on 2 different particles have 1 – 2 wt% Cu.</p>	<p>20.2 wt% Fe 0.6 wt% Cr 19.0 wt% Ni <b>0.9 wt% Cl</b> 16.7 wt% Al 4.5 wt% Si 4.1 wt% Na 1.3 wt% Cu 29.6 wt% O</p>

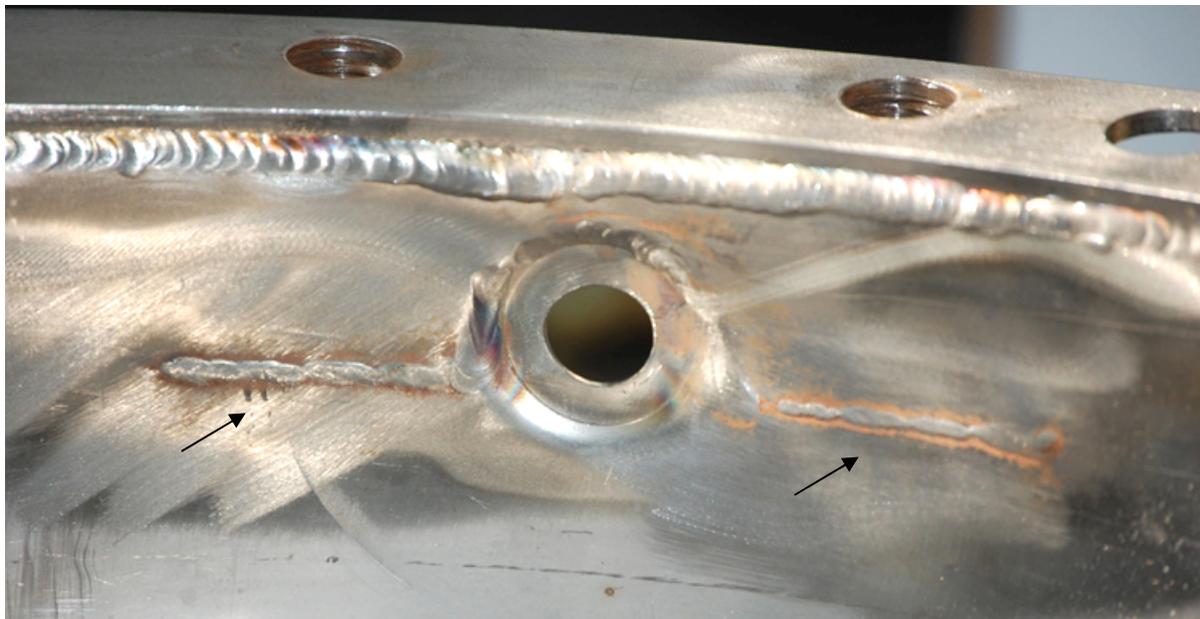
- The appearance of light corrosion was noted on the drum ID surface along the bolting flange stitch welds after 18 weeks at temperature (Figure 4). No significant change in this was noted until the 92 week examination, when the corrosion was much more extensive.

Figure 4. Appearance of light corrosion around the drum flange stitch welds noted after 18 weeks at temperature in phase 2.

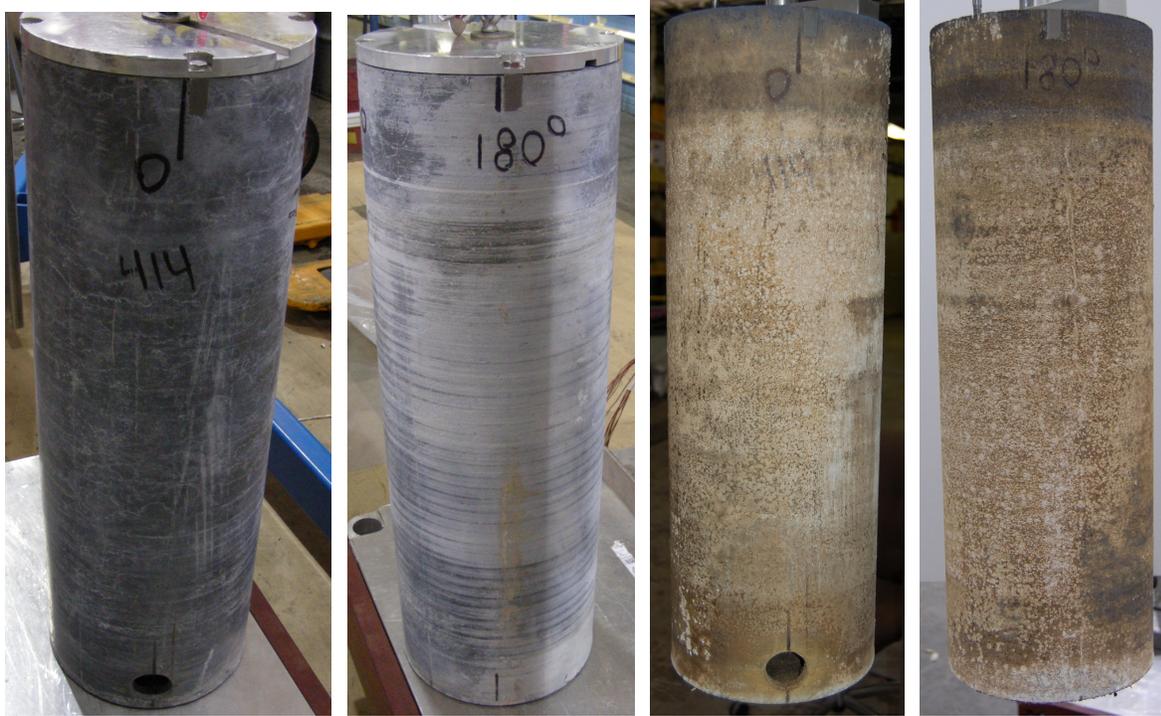
- Corrosion of the shield was heavy after 18 weeks at temperature, and visibly heavier after 39 weeks at temperature. Little change was evident subsequently. (Figures 5, 6)

(a) 0 degrees (b) 180 degrees (c) 0 degrees (d) 180 degrees  
Figure 5. LE1 shield before test (a, b), and after 45 weeks conditioning (c, d).

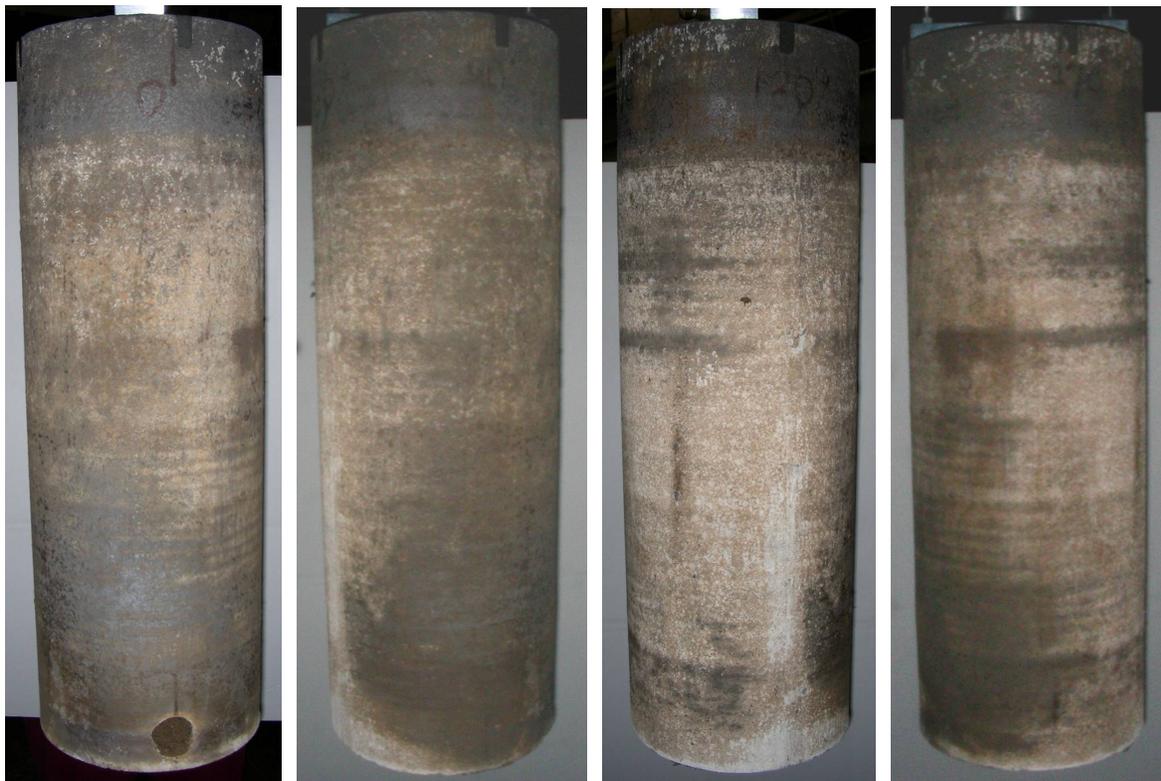
The corrosion of the lead shield is also of interest. In LE1, moderately heavy corrosion was observed during the first inspection, after 18 weeks in test, and included tan and orange regions. This is in sharp contrast to the corrosion typically seen on a 9975 shield (smooth white surface). After 39 weeks conditioning, the corrosion was mostly white and brown, with a dark blue area near the top (Figure 5). Little subsequent change was noted (Figure 6). Chemical analysis of corrosion product collected from the LE2 package showed that it was generally consistent with the lead carbonate seen on other packages, with elevated levels of chlorine present [5]. Given the similarity in appearance of this shield and the LE1 shield, it is assumed that the corrosion product composition is similar.

(a) 0 degrees (b) 90 degrees (c) 180 degrees (d) 270 degrees  
Figure 6. LE1 shield after 92 weeks conditioning.

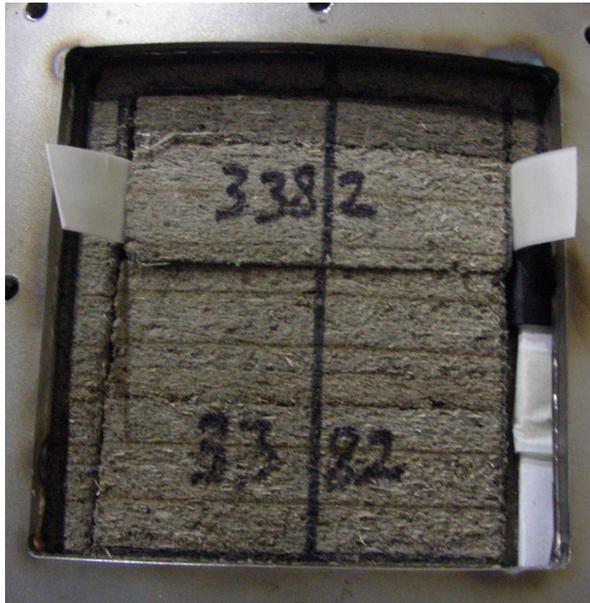
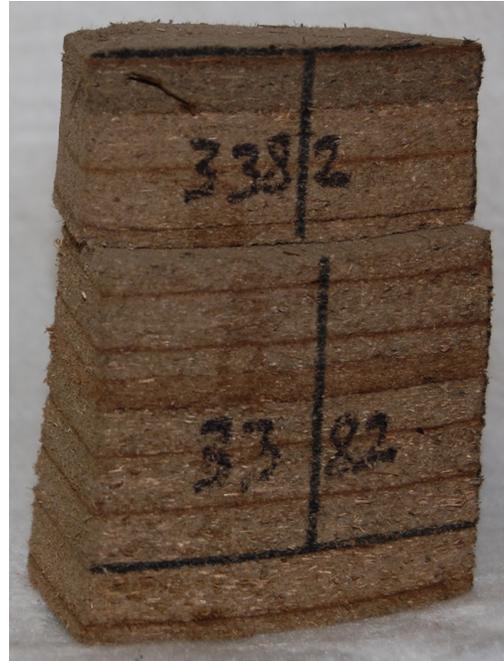
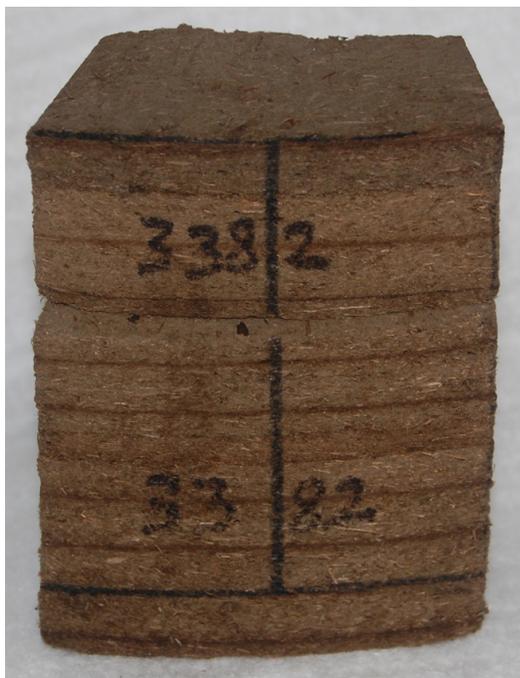
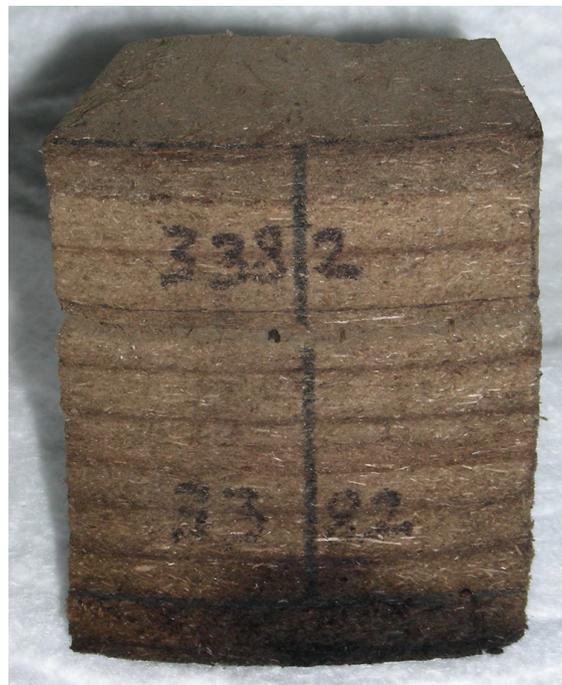
Photographs of the removable sections help to track fiberboard changes over time. A sequence of these photographs is shown in Figure 9. The bottom fiberboard layer tends to accumulate the most moisture, as seen in Table 1 and Figure 3. However, the bottom fiberboard layer did not become saturated until the final inspection after 92 weeks conditioning. It was also significantly darkened at this time. At no time was mold observed on the fiberboard, although a strong odor (e.g. rotting vegetation) had developed after 14 weeks in test. Since the entire package exterior was maintained at 142 °F, this elevated temperature may have precluded the growth of mold, although other mechanisms for breaking down fiberboard were active, as evidenced by the odor.

Figure 9. Sequence of photographs of small removable fiberboard sections from test LE1.

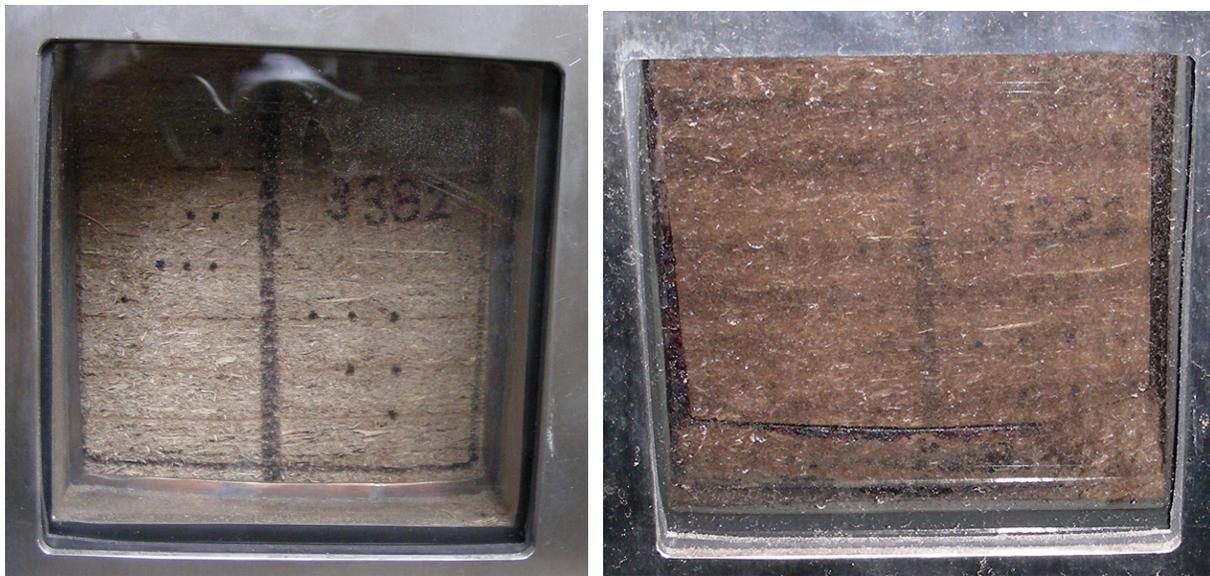
(a) baseline (b) after 77 weeks conditioning

Figure 10. View of the side of test LE1 through the view port

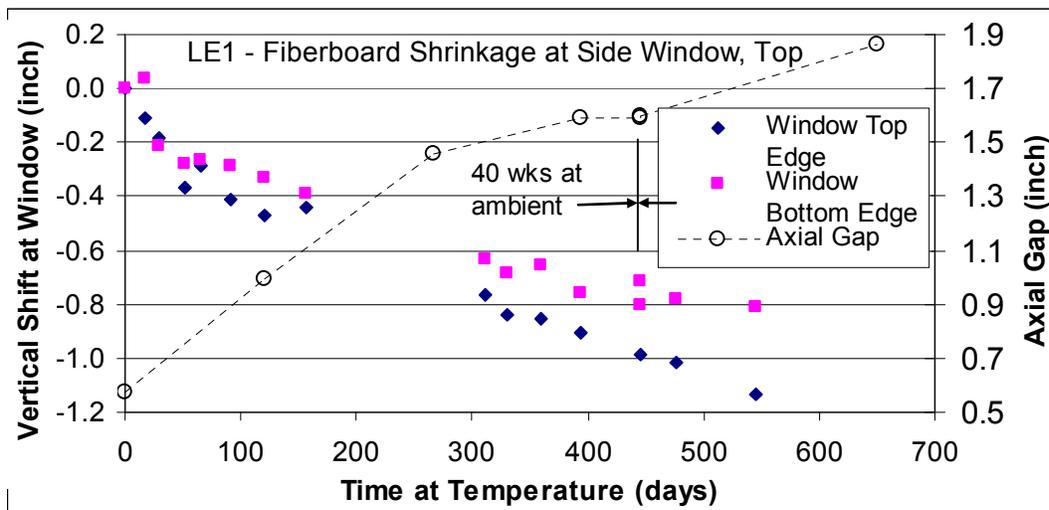
An increase in the axial gap at the top of the package is also related to the migration of moisture within the fiberboard. As moisture redistributes within the package, a majority of the fiberboard loses moisture (on average) and shrinks axially. In addition, an increased moisture content of the bottom fiberboard layers locally reduces its compression strength, leading to compaction of those layers under the weight of the package internal components. In addition to these moisture-driven phenomena, the fiberboard will shrink due to slow pyrolysis in an elevated temperature / humidity environment. Under the collective influence of these effects, the axial gap in the LE1 package increased from an initial value of 0.58 inch and exceeded the 1 inch (maximum) criterion after approximately 18 weeks conditioning. The axial gap eventually reached 1.86 inches.

Figure 11. Vertical shift (downward) of fiberboard in LE1, as viewed through the side view port, compared with increase in the axial gap at the top of the package.

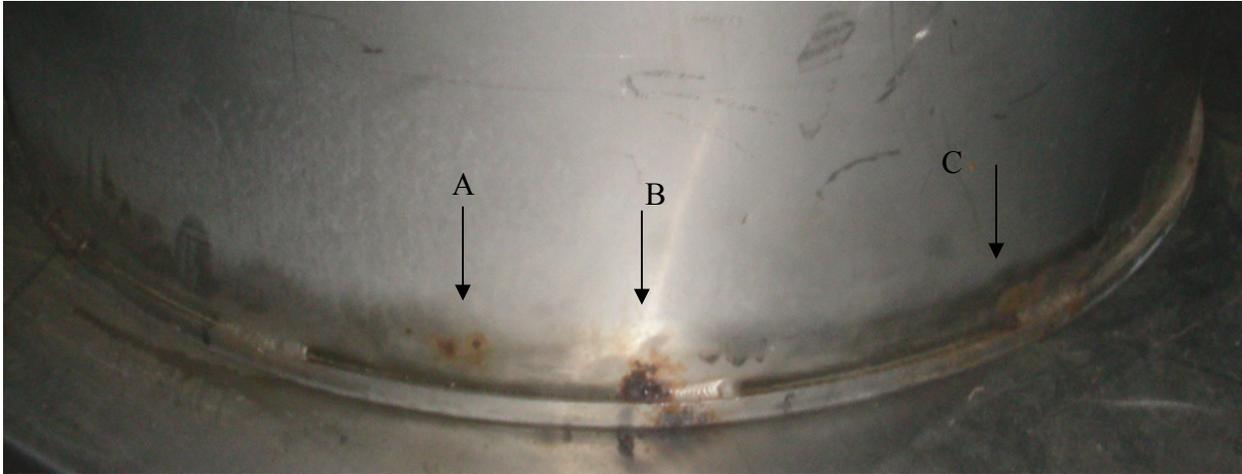
On the drum exterior surface, local spots of corrosion were observed on and near the stitch welds around the bottom of the drum (Figure 13). At least 1 of these locations (labeled “A” in Figure 13) was associated with corrosion at the same location on the inside surface. After a light cleaning, both surfaces at this location showed pitting (Figures 14, 15), and throughwall penetration was confirmed by putting water inside the drum and observing moisture on the outside surface.

Figure 13. LE1 drum outer surface showing corrosion on (B, C) and near (A) the bottom stitch welds after 92 weeks conditioning.

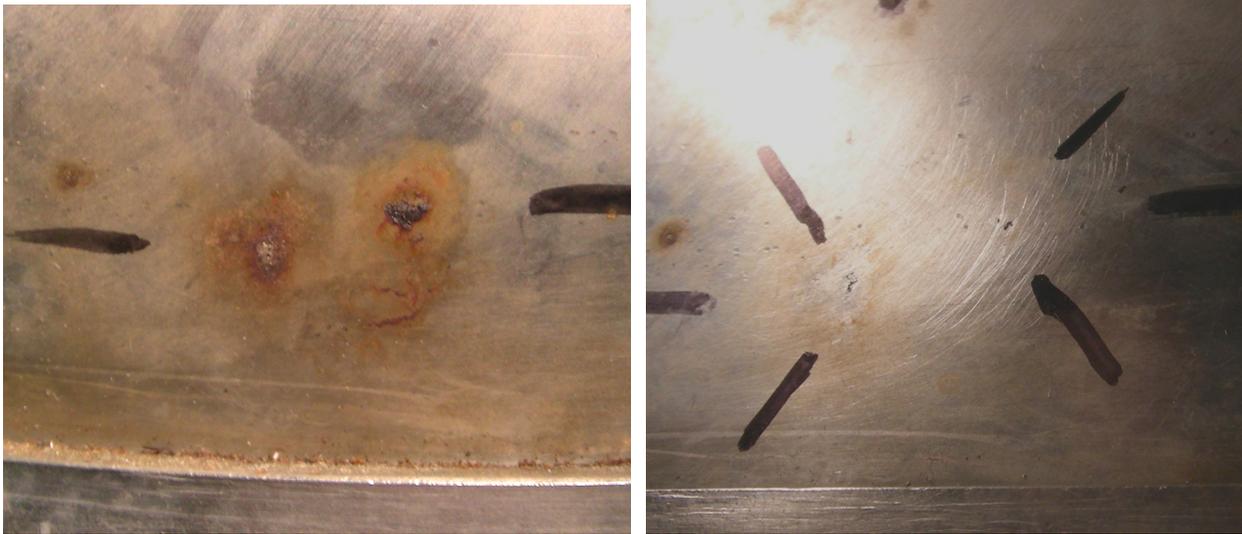
Figure 14. LE1 drum outer surface at location "A" of Figure 13, before and after cleaning. Permanent marker was added to identify corrosion locations after cleaning.

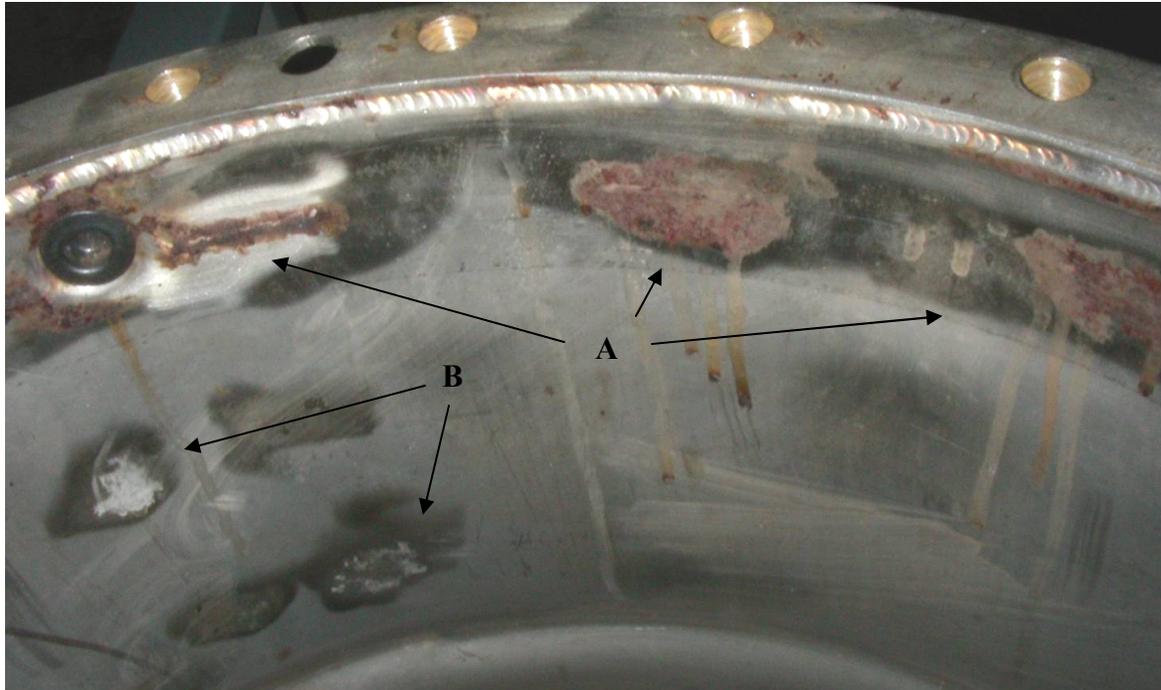
On the interior drum surface, corrosion was observed in conjunction with most of the fabrication welds. These welds were generally made from the outside, but were still associated with corrosion on the inside surface as a result of the weld heat-affected zone. This observation applies both to the original drum fabrication welds and to the welds made during modification. Typical photos of the corroded areas are shown in Figures 16 - 19. In Figure 16, heavy corrosion is seen around a top flange stitch weld. This is a more advanced stage of the very light corrosion noted after 18 weeks (Figure 4). After cleaning (Figure 17), a general corrosion attack of the surface is observed. Most of the corrosion was dark red - brown to black in color. Some staining from adherent fiberboard was also noted in some areas. In contrast, the corrosion behind the bar code plate attachment welds was white (location “B” in Figure 16). After one of these locations was cleaned, a light general corrosion of the surface was also observed.

Samples of the corrosion product were collected from three areas for analysis in the scanning electron microscope using energy dispersive x-ray spectroscopy. These areas included a stitch weld near the bottom of the drum exterior (location B in Figure 13), a stitch weld near the top of the drum interior (similar to location A in Figure 16), and behind a bar code plate attachment weld on the drum interior (location B in Figure 16). Results are summarized in Table 3.

Figure 16. LE1 drum inner surface showing corrosion behind top flange stitch welds (A), and behind bar code plate attachment welds (B).

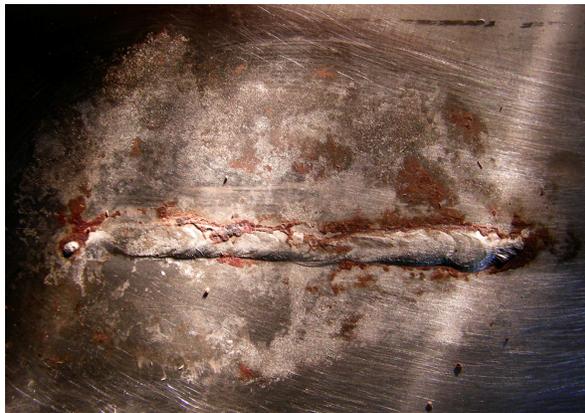
Figure 17. LE1 drum inner surface behind top flange stitch weld after cleaning.

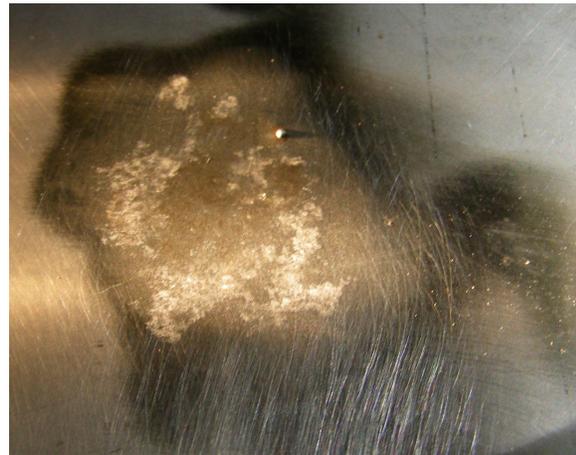
Figure 18. LE1 drum inner surface behind bar code plate attachment weld after cleaning.

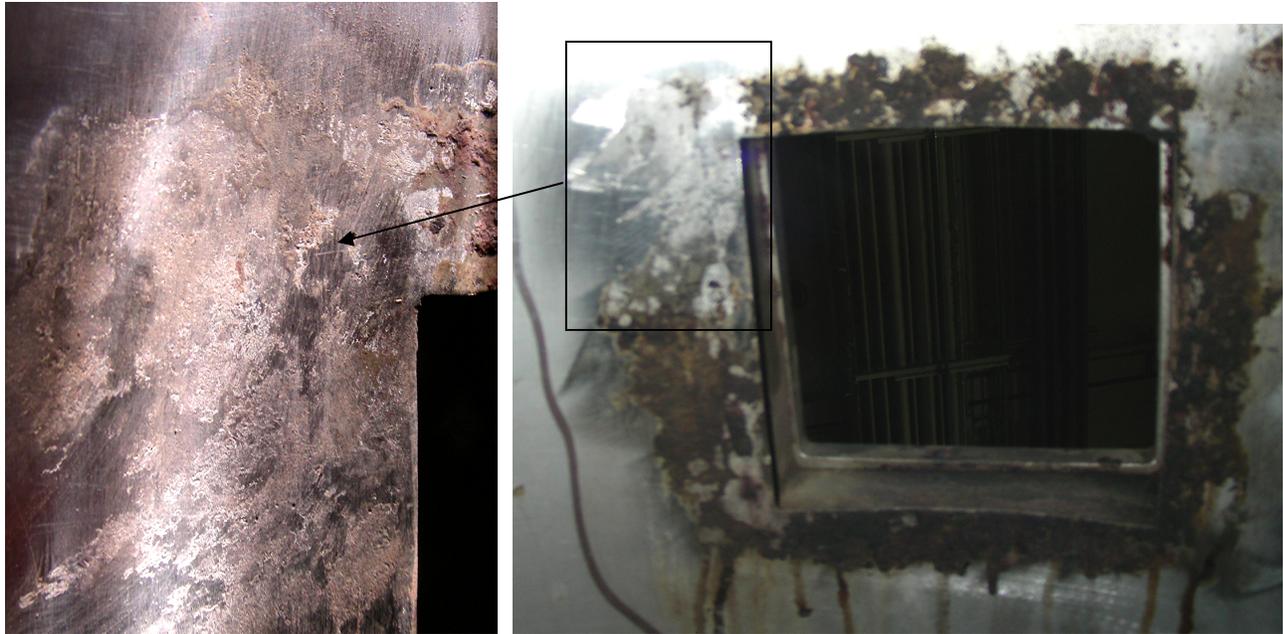
Figure 19. LE1 drum inner surface around window. Corrosion product has been cleaned from one corner revealing general corrosion attack of the drum.
