**Savannah River
National Laboratory™**

3013 DE Inner Container Closure Weld Corrosion Evaluation

September 2013

SRNL-STI-2013-00527, Revision 0

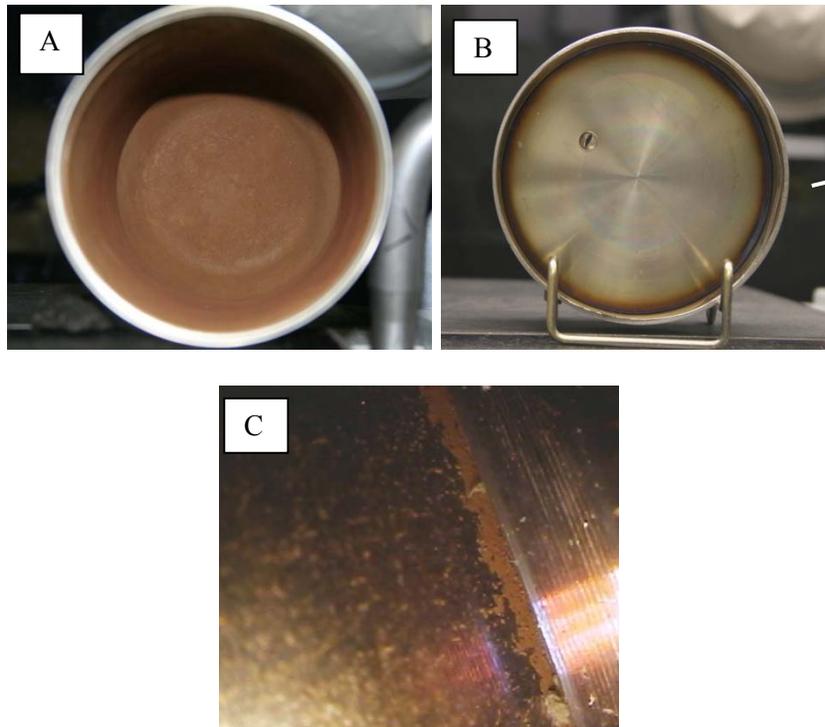
The corrosion observed in the HHMC was far greater than any observed in containers examined during DE. The HHMC was examined during FY11 using the standard DE procedure. The standard DE would include a visual evaluation of the interior and exterior surfaces of both the lid and container body. Figure 2-1 shows the condition of the convenience container and inner container lid. Because of the presence of material observed on the inner container lid near the closure weld region, a decision was made to section the inner container lid so as to examine the surfaces in the gap between the lid and sidewall near the closure weld. This gap region, which is shown schematically in Figure 2-2, cannot be readily examined during the standard visual evaluation performed during DE. Figure 2-3 shows a side view of the inner container closure weld gap of the HHMC as well as the pie sections cut from the inner container lid. After observing corrosion in this gap, the decision was made to examine the inner container closure weld gaps in other DE containers because a through wall crack in this region would provide a path for corrosive gases to contact the interior surfaces of the outer container and potentially jeopardize the primary barrier [2]. Several DE containers that were being processed from FY12 had pieces from the inner container closure weld gap archived for closer examination along with the previously archived inner container pie sections from FY09 DE2.

Figure 2-1 HHMC as observed during DE: A) convenience container, interior surface; B) inner container lid, interior surface; C) a material resembling corrosion product outside the inner container closure weld gap

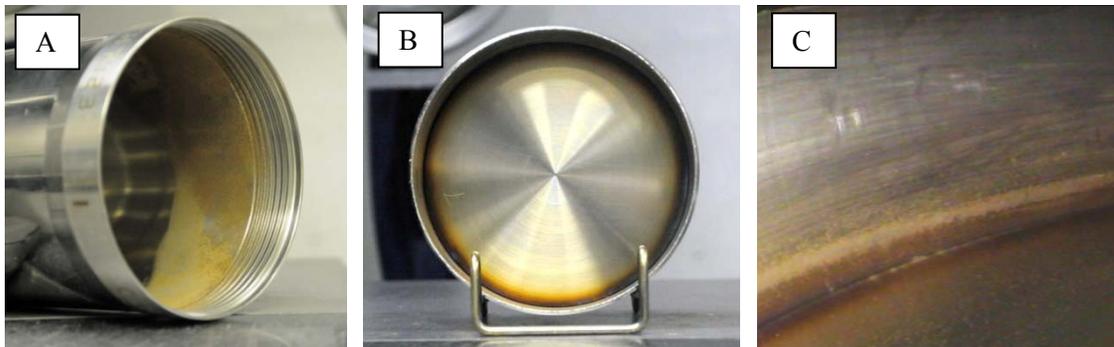
Figure 2-4 FY12 DE4 as observed during DE: A) convenience container, interior surface; B) inner container lid, interior surface; and C) borescope image of a material resembling corrosion product outside the inner container closure weld gap

For FY12 DE4, a band of corrosion, material or mechanical damage was identified outside the inner container lid closure weld gap as shown in Figure 2-4 (C). Pie sections of the inner container lid, identified as A and B, were taken from locations with this material. The initial analysis of the A and B pie sections consisted of SEM/EDS to evaluate the type of degradation and what elemental species were associated with it. The sidewall and lid pieces showed a slightly banded appearance moving away from the weld down towards the gap opening as shown in Figure 4-12 (note white arrow shows direction of gap opening).

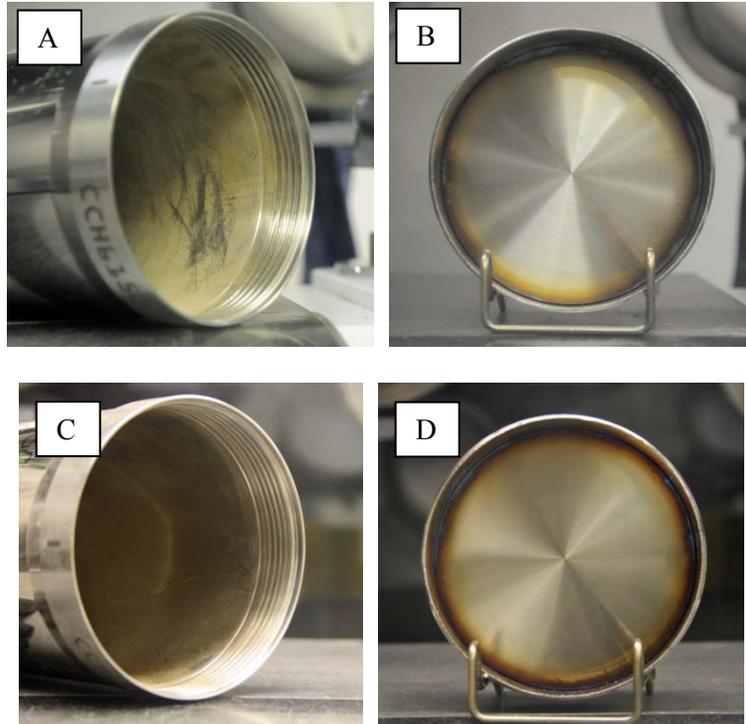
The convenience container of DE6 had a coating that could be wiped; no suspect pits were observed. For DE7, suspect pitting was observed both on the container threads and the interior

surface of the convenience container lid. For both containers, no material was found at the entrance to the gap of the inner container closure weld as was found for the HHMC and FY12 DE4. Four pie sections at orthogonal positions were cut from each inner container lid with the 0° point being at the end point of the weld as observed on the exterior surface.

Figure 2-5 Interior surfaces of container observed during DE: A) FY12 DE6 convenience container; B) FY12 DE6 inner container lid; C) FY12 DE7 convenience container; and D) FY12 DE7 inner container lid

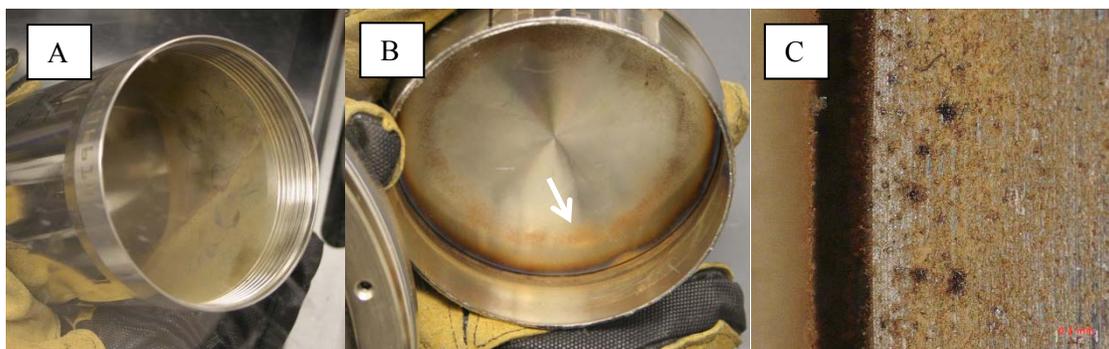
Figure 2-6 FY09 DE2 as observed during DE: A) convenience container, interior surface; B) inner container lid, interior surface; and C) stereo-micrograph of surface outside inner container closure weld, 25x

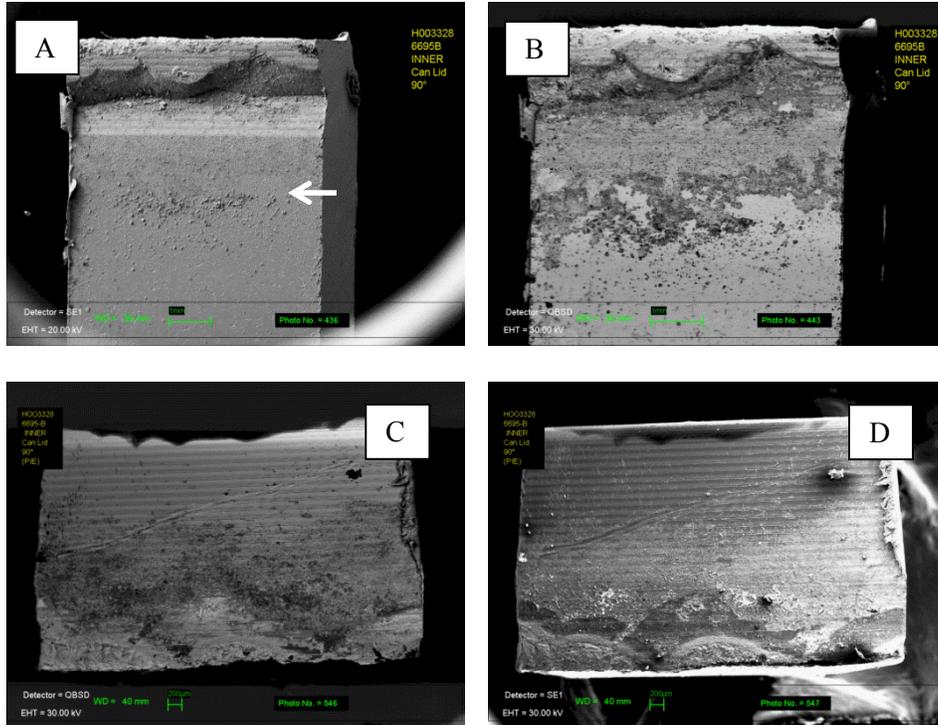
The sidewall and lid surfaces that make up the weld gap were examined on the SEM for all orthogonal samples of the HHMC. Figure 4-3 shows the surface morphology for the sidewall and lid pieces of the 90° pie section. The secondary (SE) images (Figure 4-3 (A) and (C)) show the topography, while the backscatter (QB) images (Figure 4-3 (B) and (D)) show the difference in atomic number for surface components. The three other pie sections had surfaces with similar appearances. A band of particulate can be seen on the sidewall which lies outside of the gap (note white arrow in image). The source of this particulate has not been identified. This particulate band and a band next to the weld are darker in color (Figure 4-3 (B)) indicating that low Z elemental compounds such as oxides and chlorides are present.

Figure 4-3 SEM micrographs of the sidewall and lid pieces of the 90° pie section from HHMC inner container closure weld gap: A) sidewall, SE; B) sidewall, QB; C) lid, SE; and D) lid, QB

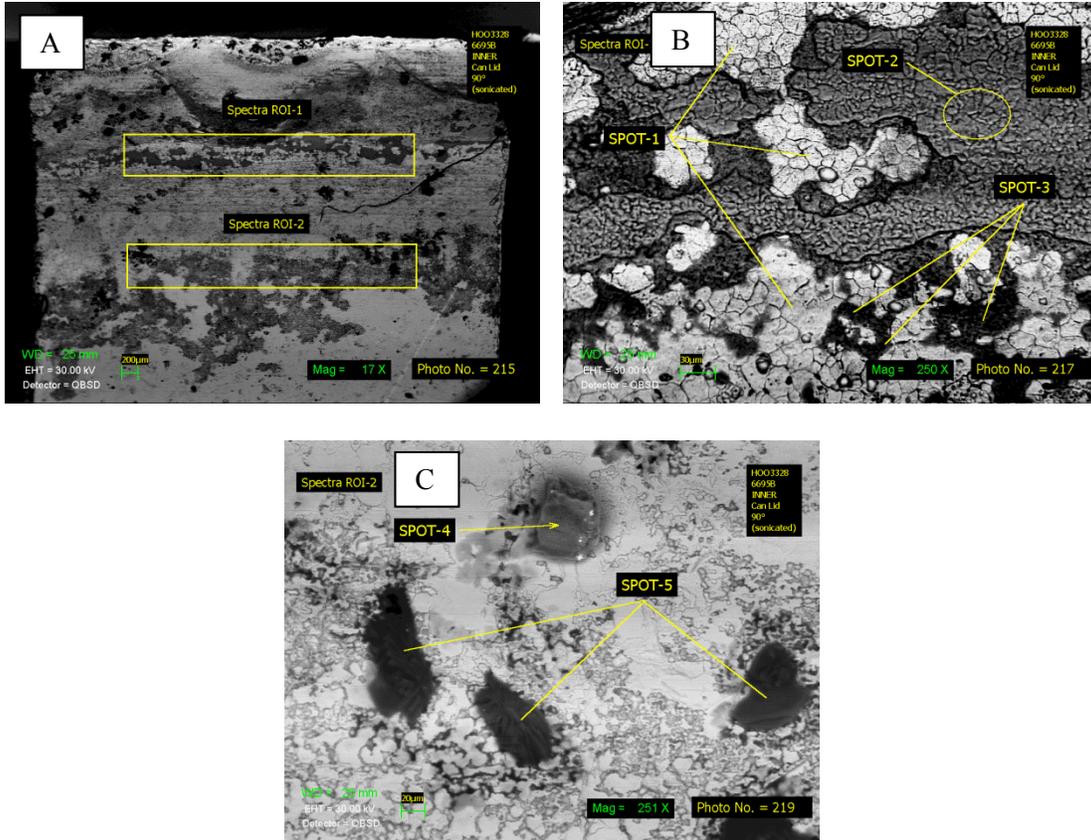
The sidewalls from the 90° and 270° pie sections were cleaned in a commercial sonication cleaner to remove the particulate and any loose oxide so pitting or cracking could be observed if present. In Figure 4-7, an SEM micrograph shows the surface of the sidewall from the 90° pie section after cleaning. Two regions of interest (ROI) are identified. The ROI closer to the weld, ROI1, continued to have a heavily oxidized surface as shown in Figure 4-7 (B). Similar areas were found for the sidewall from the 270° pie section. In ROI2, the surface was not covered by oxide, although the degradation of the surface appears to form continuous circuits. Chloride was still present on the surface (spot 3 in (B) associated with a large oxygen and chromium peaks and spot 4 in (C) associated with a more typical chromium and iron peak distribution).

Figure 4-7 SEM micrographs of the sidewall from the 90° pie section for the HHMC after cleaning: A) micrograph showing overall surface of the sidewall, 17x; B) micrograph from ROI1, 250x; and C) micrograph from ROI2, 251x

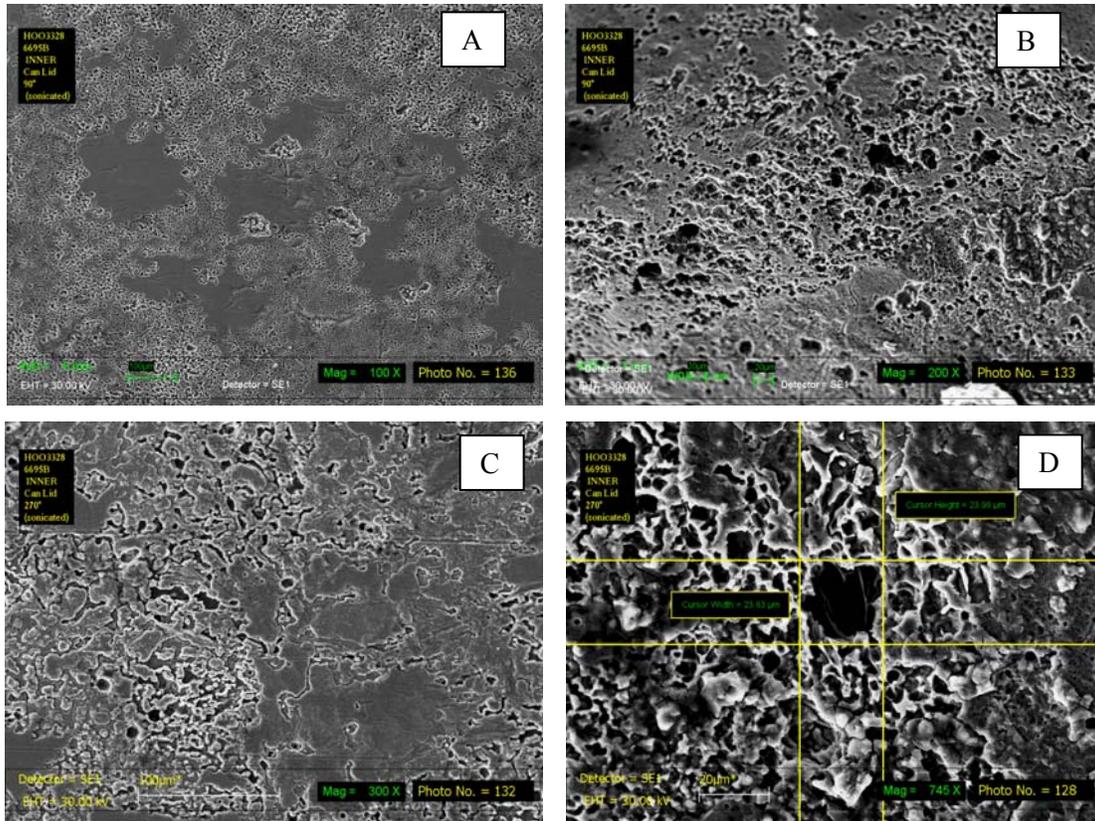
The corrosion morphology differed slightly between the two ROI, but may be a difference in severity and not mechanism. Figure 4-8 shows the morphologies which were found on both the 90° and 270° pie sections. Figure 4-8 (A) and (C) show a circuitous nature to the degradation, while Figure 4-8 (B) and (D) show a more pocked or pitted surface with some connectivity.

Figure 4-8 SEM micrographs of the sidewall gap surface for the HHMC after cleaning: A) 90° pie section, 100x; B) 90° pie section, 200x; C) 270° pie section, 300x; and D) 270° pie section, 745x

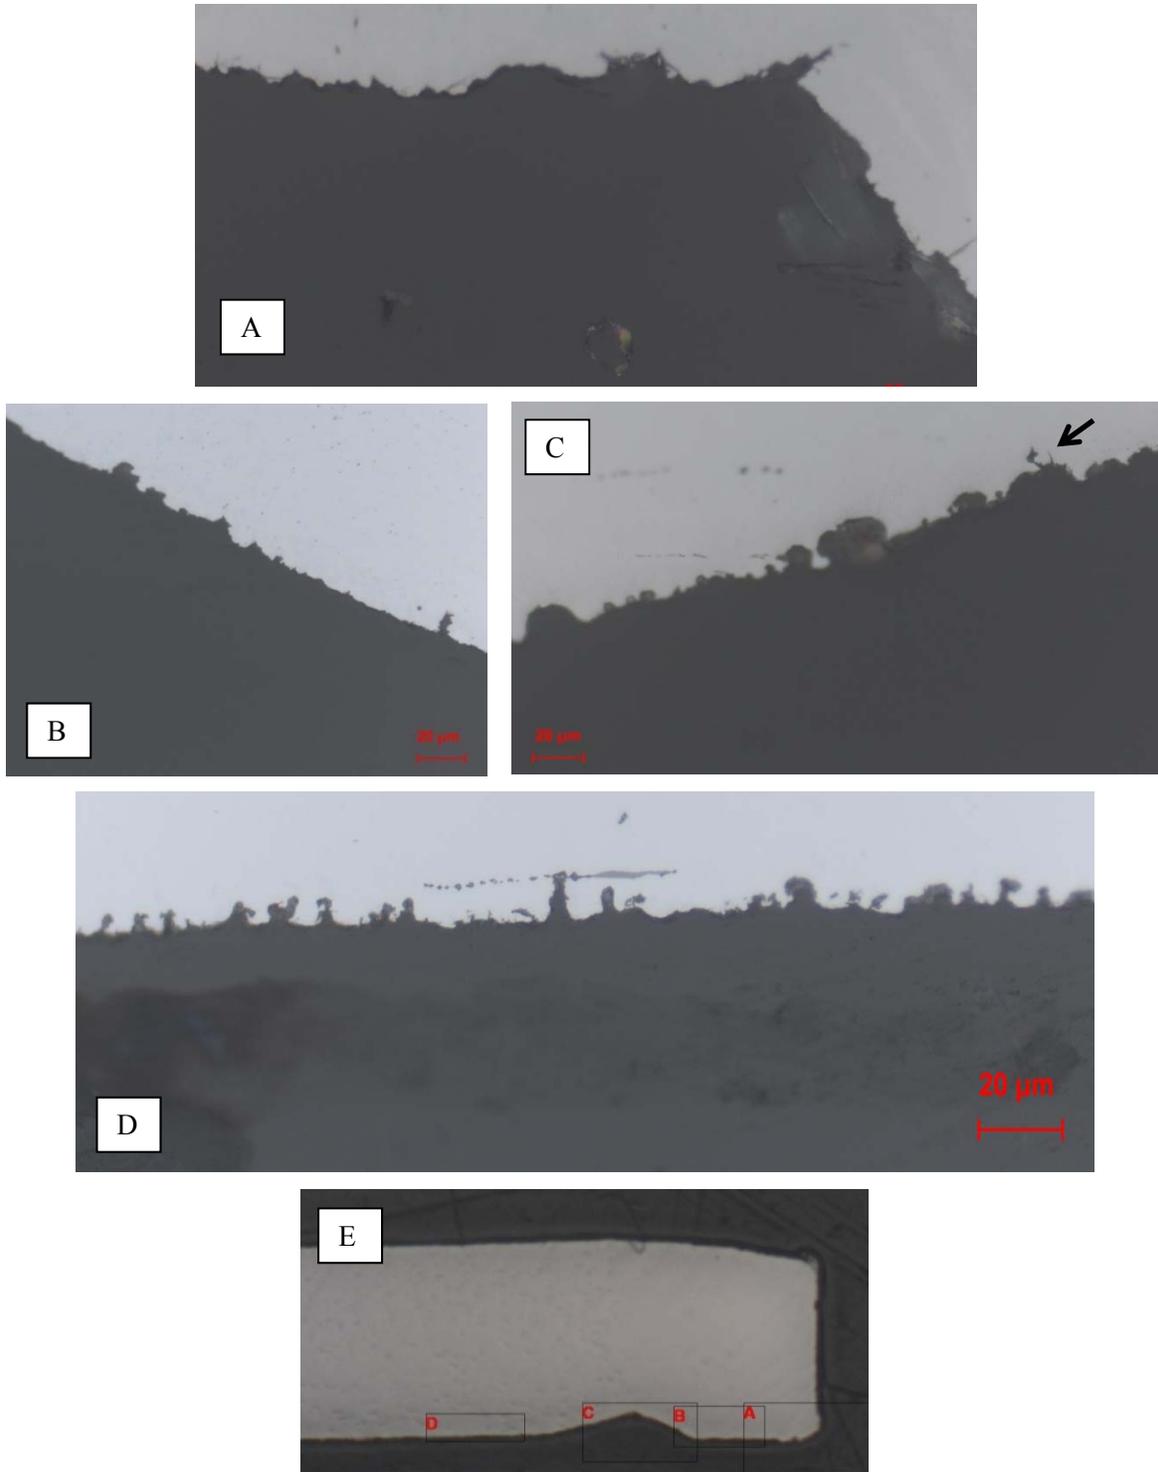
The lid and sidewall pieces were placed into epoxy mounts and examined in cross section to evaluate the presence of pitting and any cracks. Figure 4-9 shows micrographs of the pitting for the sidewall surfaces from each pie section. Figure 4-10 shows micrographs of the pitting along the lid surface for the 90° pie section. Pits were observed on all surfaces and ranged in depth from 5-10 μm. The pits were both hemispherical as well as elongated. Some pits were irregular and jagged. Oxides, presumably a byproduct of corrosion, were found in the bottom of some pits (Figure 4-9 (D)). Some pits also had crack precursors that extended away from the pit (black arrows in Figures 4-9 (C) and 4-10 (C)). The transition from crack precursor to pit is not defined. The pit morphology was similar to those described by Sato for passive (smooth wall) and active (irregular wall) pits [5].

Figure 4-9 Cross sectional micrographs from different location along the sidewall for each pie section from the HHMC: A) 270° pie section, 500x; B) 90° pie section, 500x; C) 0° pie section, 500x; D) 180° pie section, 500x; and E) cross section of sidewall showing location of micrographs, 12.5x (i.e. micrograph in A comes from location A on sidewall)

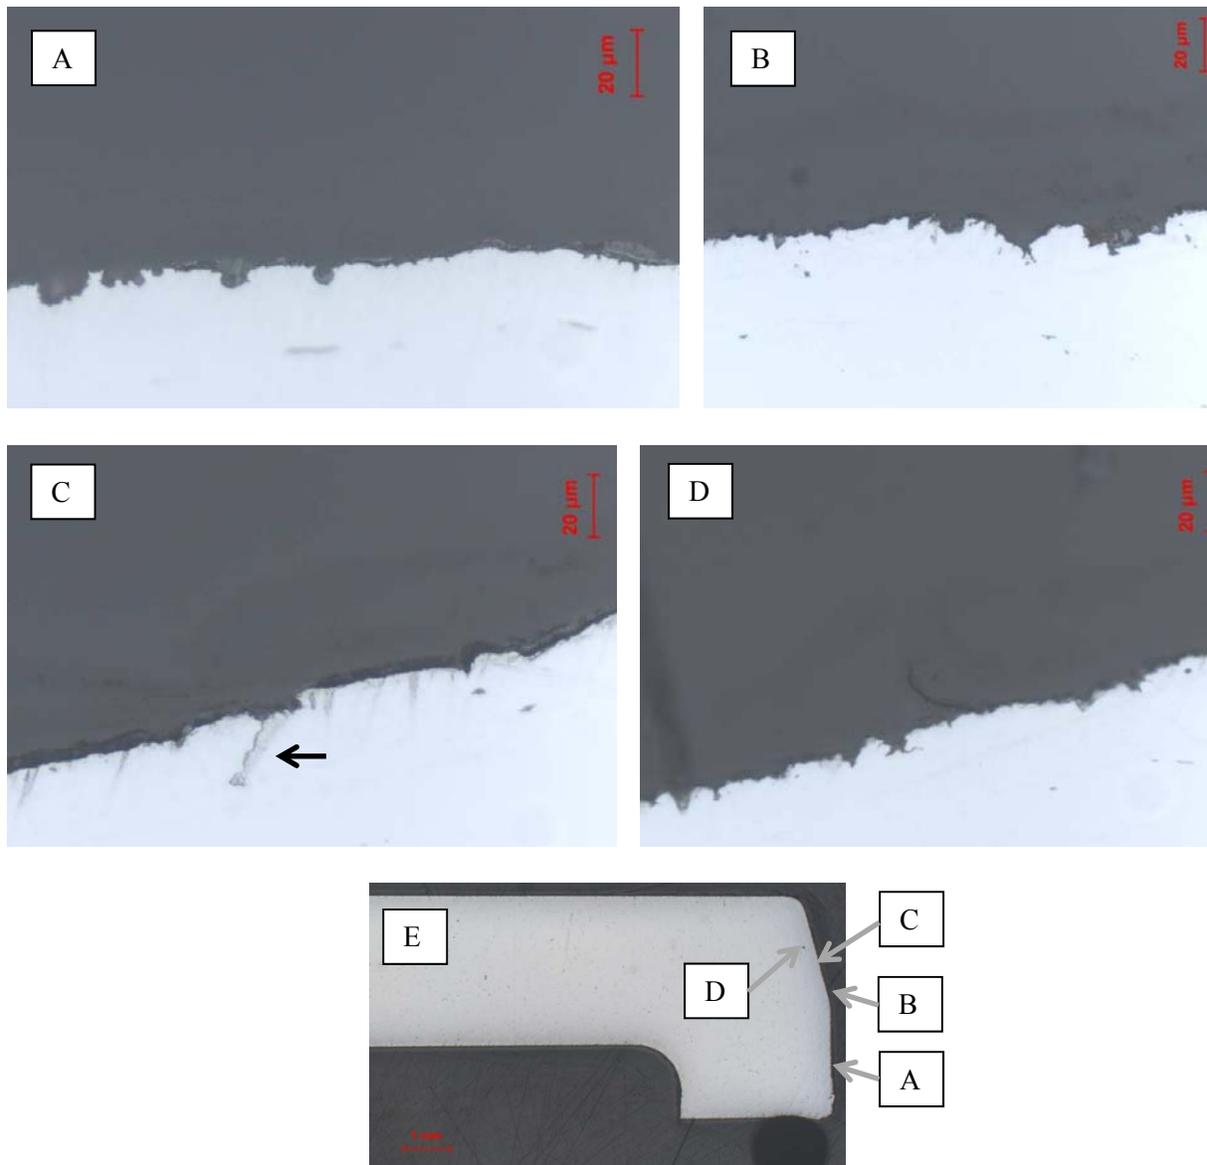
Figure 4-10 Cross sectional micrographs from different location along the lid of the 90° pie section from the HHMC: A-D) pit locations along lid gap surface, 500x; and E) overview of lid showing locations for micrographs in (A) through (D), 12.5x

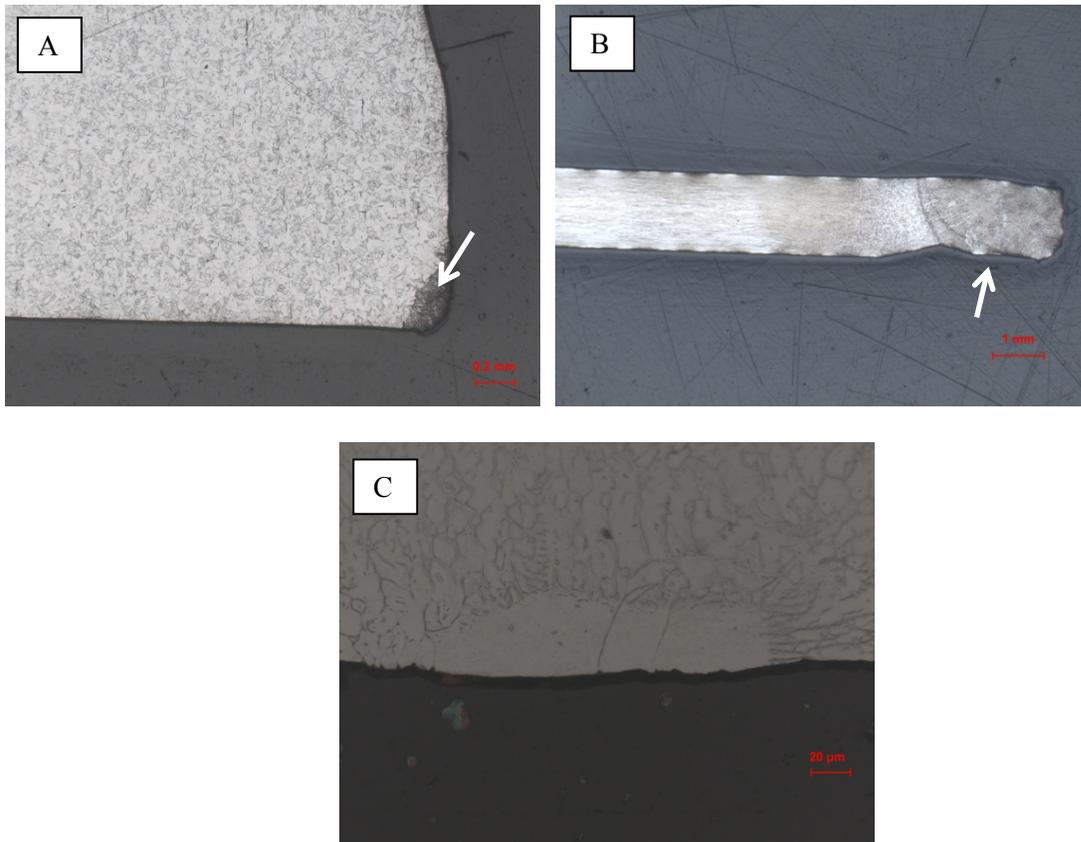
The mounted samples were etched to determine the parts of the sidewall and lid that had a dendritic microstructure resulting from the welding process or maintained their original microstructure. The lid was found to have only a small portion that had a dendritic microstructure, which was located near the top of the weld gap (See Figure 4-11 (A)). On the sidewall, the dendritic microstructure extended to the top of the bevel apex as shown in Figure 4-11 (B). A significant portion of the gap sidewall surface was dendritic. From this analysis there is some indication that the pitting was associated with the interdendritic regions (See Figure 4-11 (C)). Pitting in 304L is known to be associated with manganese sulfide inclusions although there was no specific evidence of this association [6].

Figure 4-11 Cross sectional micrographs showing the location of the dendritic microstructure in the HHMC inner container closure weld region (indicated by arrows): A) lid from 90° pie section, 50x; B) sidewall from 270° pie section, 12.5x; C) sidewall from 270° pie section showing pits forming at interdendritic regions, 500x

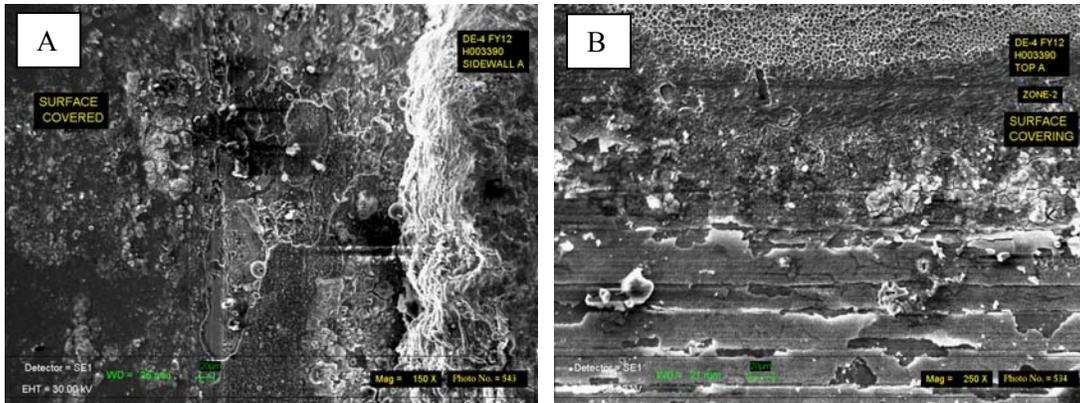
identified as the outermost layer, which has been noted for weld oxides [4]. All pieces showed a layering of the oxides/corrosion products as shown in Figure 4-14 for the sidewall and lid pieces from the A pie section. Opened pits were not observable prior to cleaning.

Figure 4-14 Secondary electron micrographs of the sidewall (A, 150x) and lid (B, 250x) pieces from the A pie section for FY12 DE4 showing the layer of oxides and corrosion products on the sample

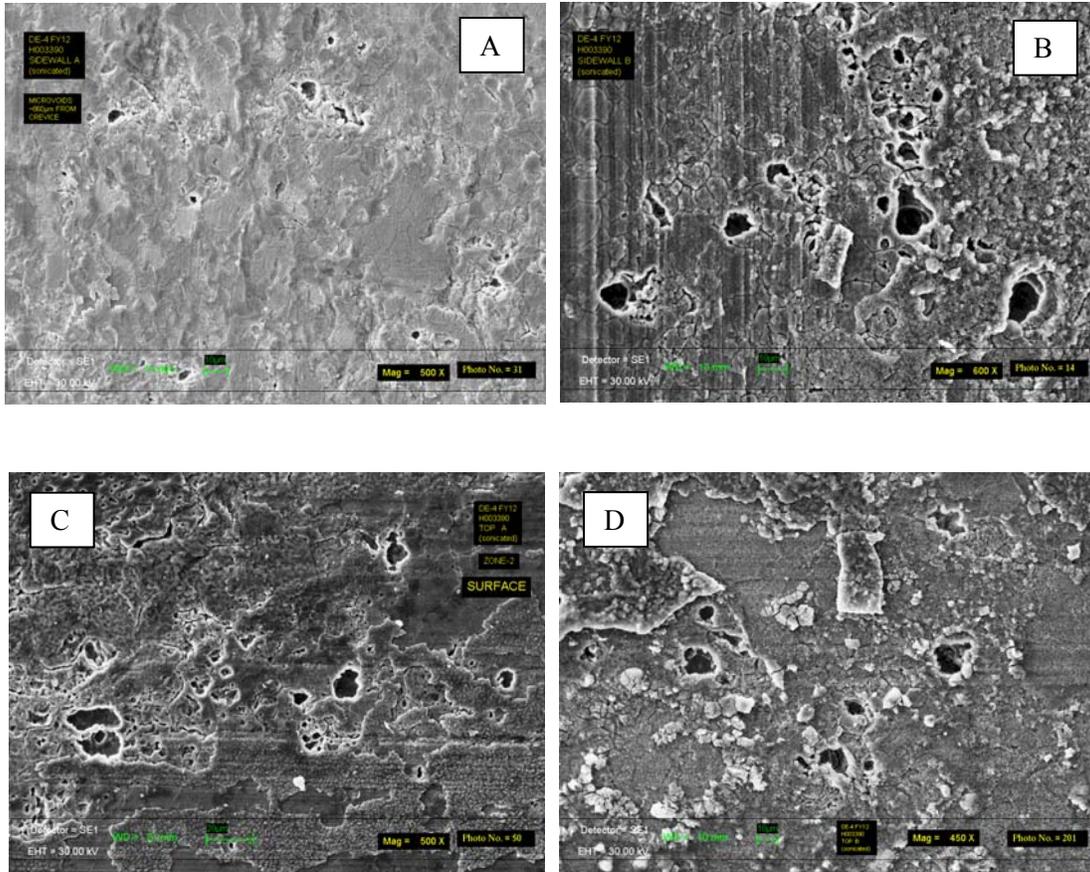
After cleaning, much of the corrosion products were removed, but oxides still remained. This oxide is probably associated with the initial weld oxide formed when the inner container was welded since the cleaning procedure was not sufficiently aggressive to remove this oxide. Pitting was now clearly observable on all pieces as shown in Figure 4-15. The largest pit was measured on the sidewall piece from the A pie section with a length of approximately 60 μm (40 μm at widest point). Pits sizes for both the lid and sidewall varied from less than 10 μm to approximately 30 μm . Pitting was located both near the weld as well as closer to the gap opening as shown in Figure 4-15. Cracking was not observed.

Figure 4-15 Secondary electron micrographs for FY12 DE4 inner container closure weld gap surfaces showing the observed pitting: A) sidewall from A pie section, 500x; B) sidewall from B pie section, 600x; C) lid from A pie section, 500x; and D) lid from B pie section, 450x

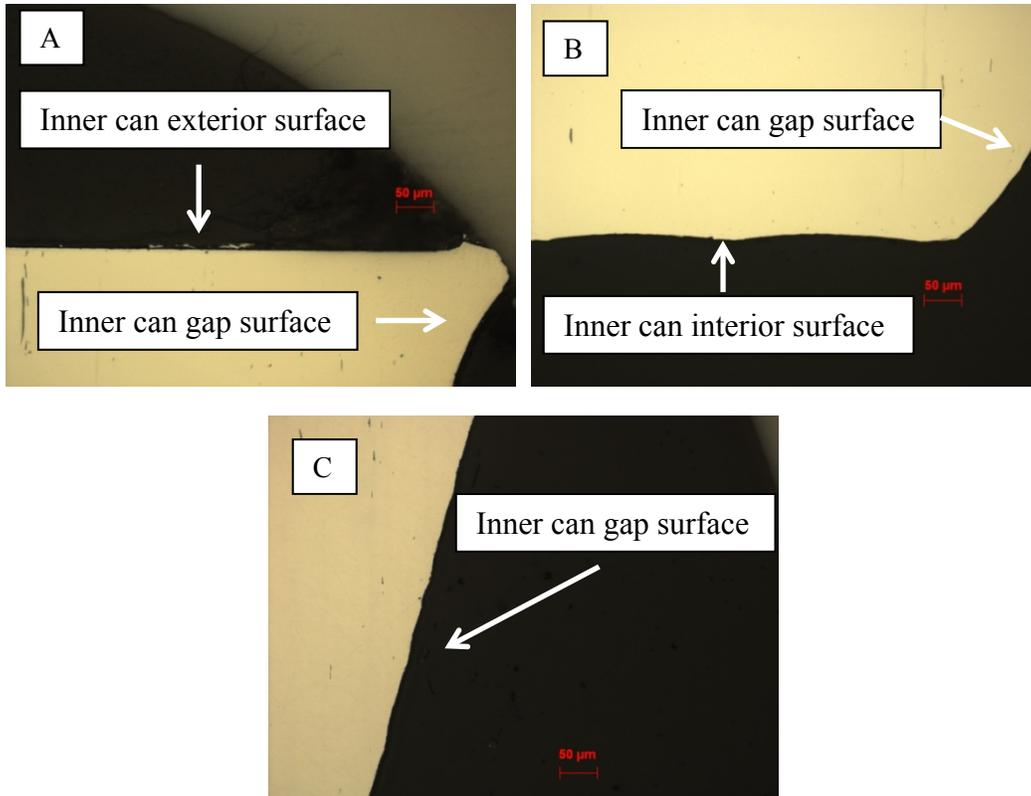
Figure 4-16 Cross sectional micrograph (200x) of the inner container lid for FY12 DE4 showing no degradation along the gap and bottom surfaces for the first (A), second (B), and third (C) planes

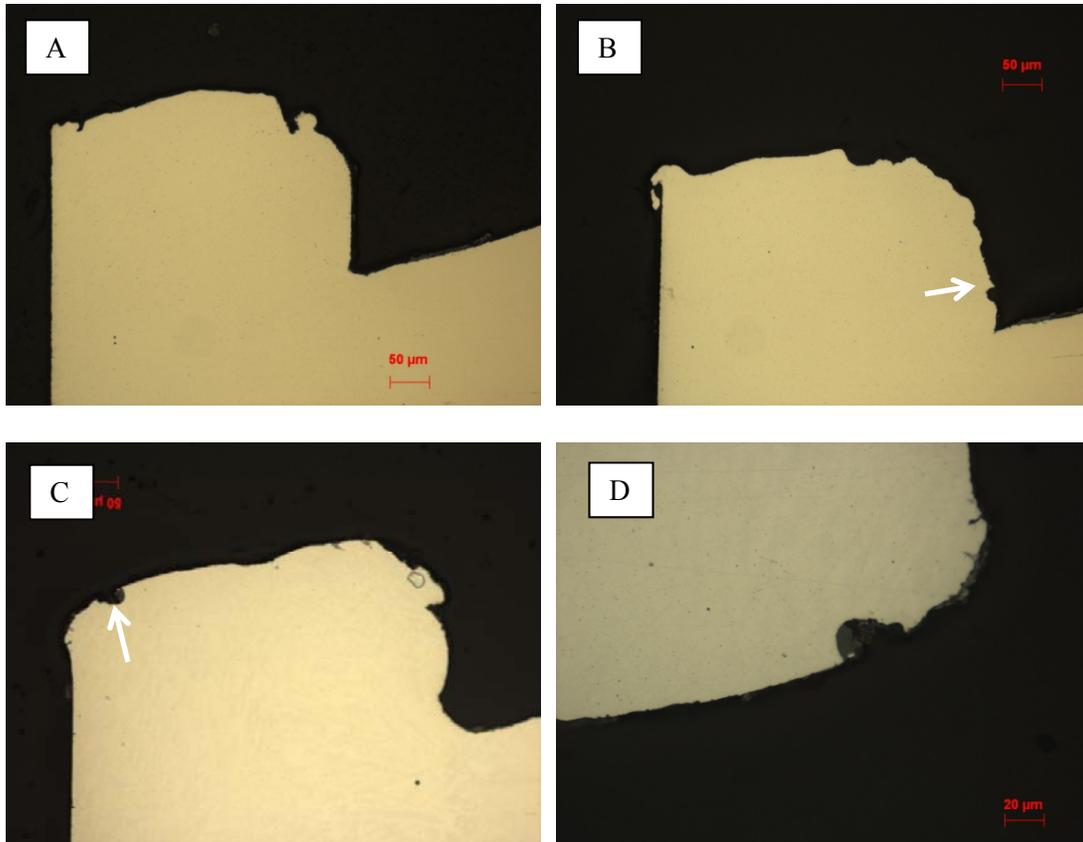
Figure 4-17 Cross sectional micrographs of the sidewall piece for FY12 DE4 for the first (A, 200x), second (B, 200x), and third ((C, 200x) and (D, 500x) planes of observation

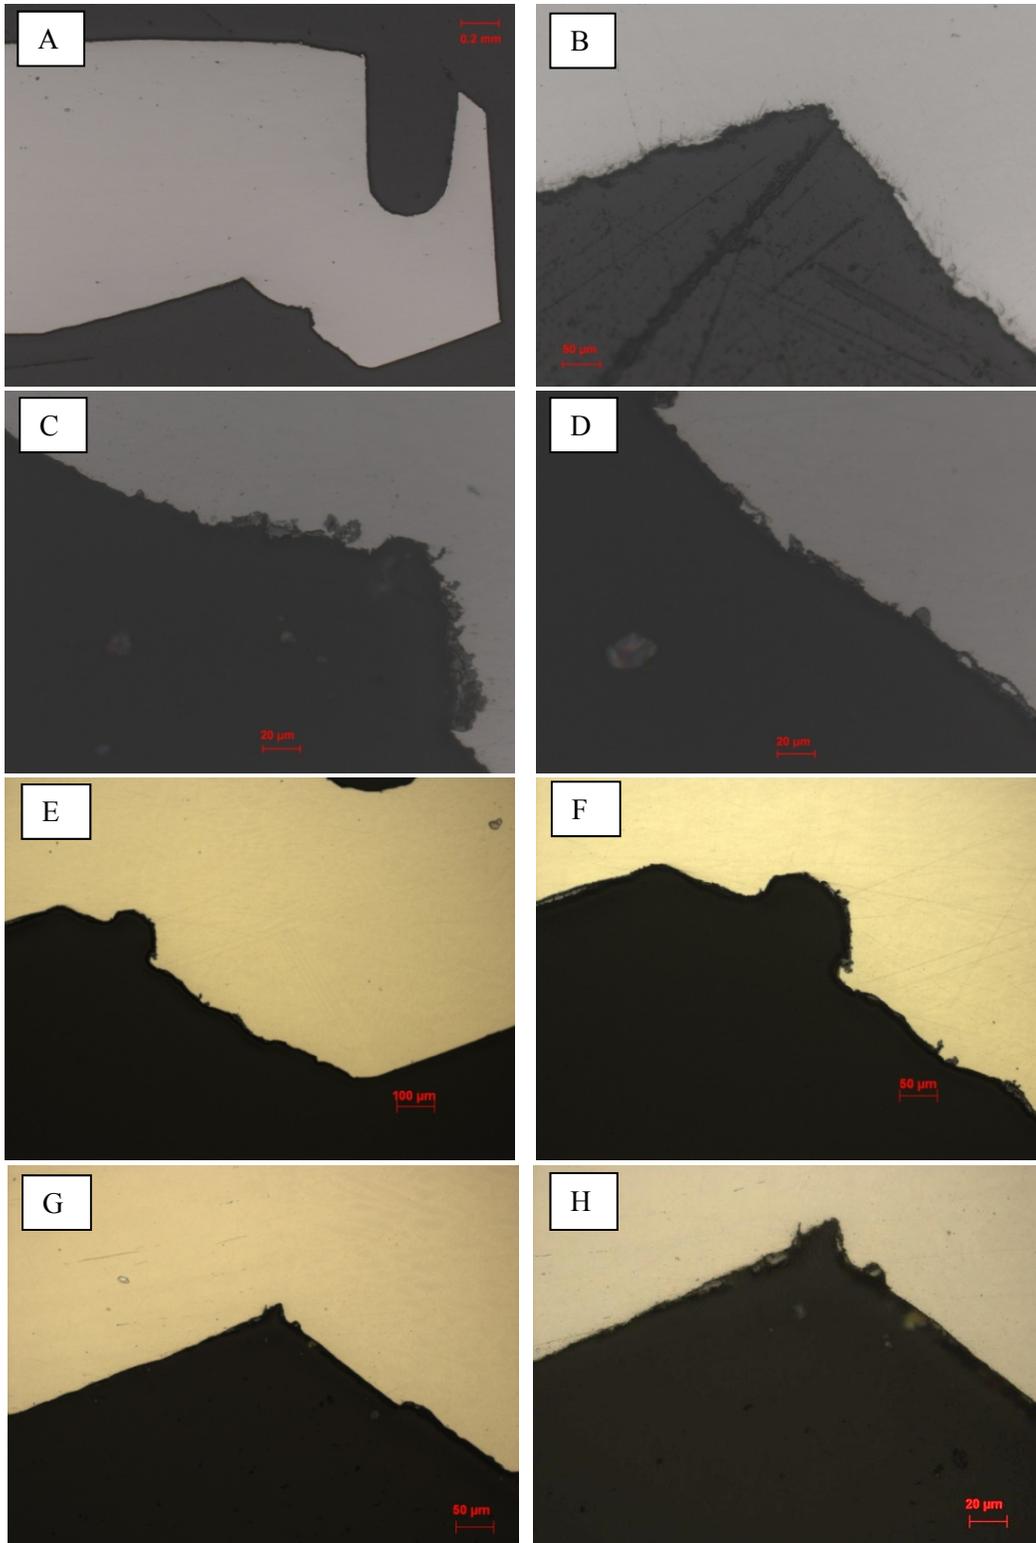
Figure 4-24 Pitting observed in the sidewall surface of the 90° pie section from the inner container closure weld gap for FY12 DE6 (A-D, first plane; E-F, second plane; G-H, third plane): (A) 50x; (B) 200x; (C) 500x; (D) 500x; (E) 100x; (F) 200x, (G) 200x, and (H) 500x

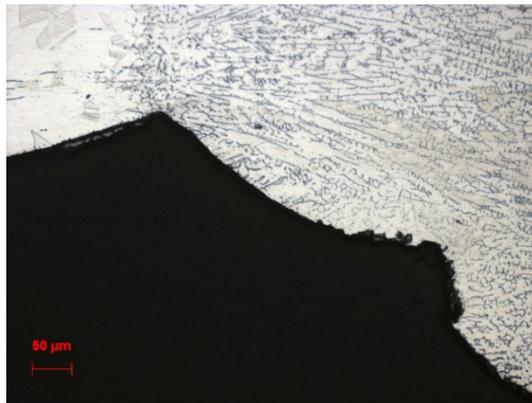
Figure 4-25 Microstructure near the pit observed in the sidewall of the 90° pie section for FY12 DE6 (200x, electrolytically etched 10% oxalic acid)

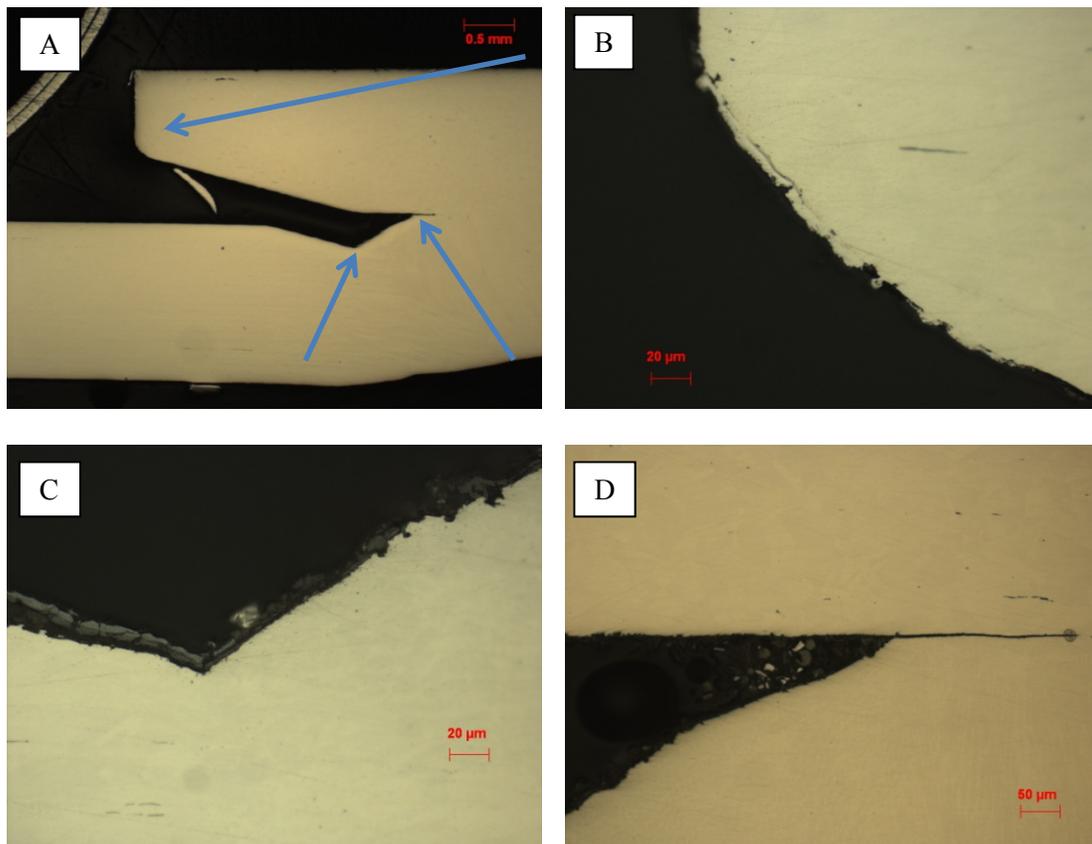
Figure 4-39 Closure weld gap region for the 180° pie section from FY09 DE2: (A) gap region, 12.5x; (B) pitting at the gap opening on the lid, 500x; (C) pitting on the sidewall, 500x; and (D) top of gap showing a crevice, 200x (arrows in A show the location of the other micrographs)

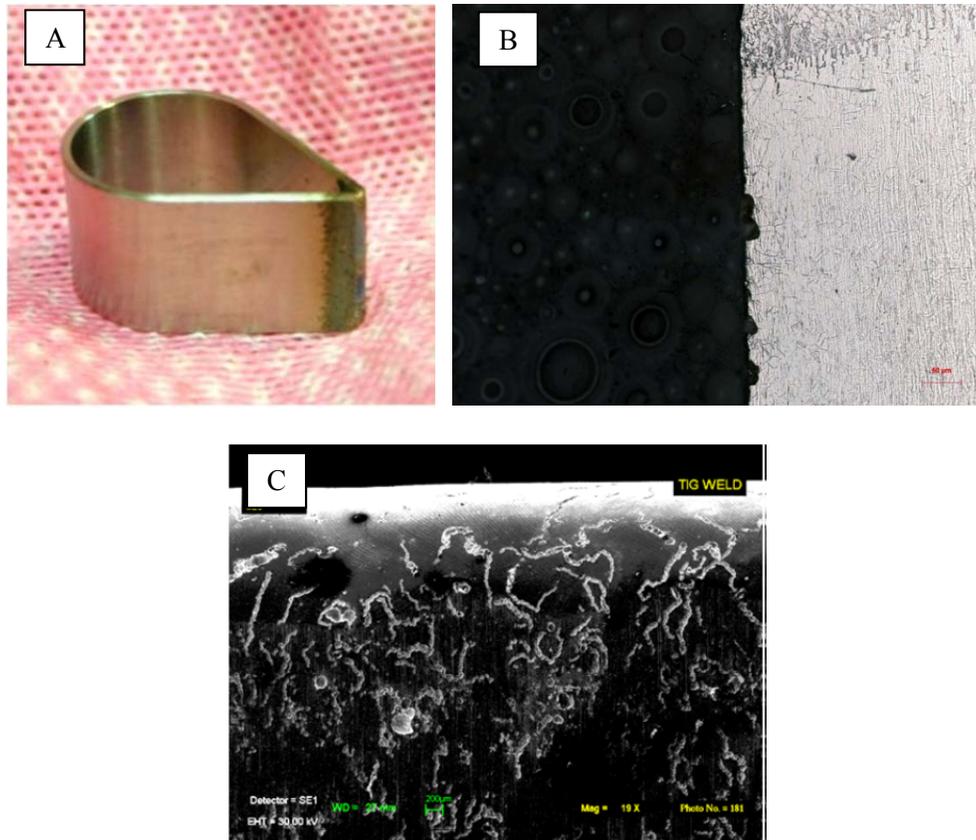
Figure 5-2 Corrosion observed in the closure weld region of teardrop-shaped coupons after exposure to a plutonium oxide/chloride salt mixture with 0.5 wt% water: A) teardrop-shaped coupon exposed to vapor only after 85 days; B) cross-sectional micrograph (200x) of pitting in coupon after 85-days exposure; and C) SEM micrograph (19x) of pitting on TIG weld surface after 340-day exposure, sample was cleaned
