EXAMINATION OF SHIPPING PACKAGE 9975-02403

W. L. Daugherty

March 2016

SRNL-STI-2016-00152, Revision 0

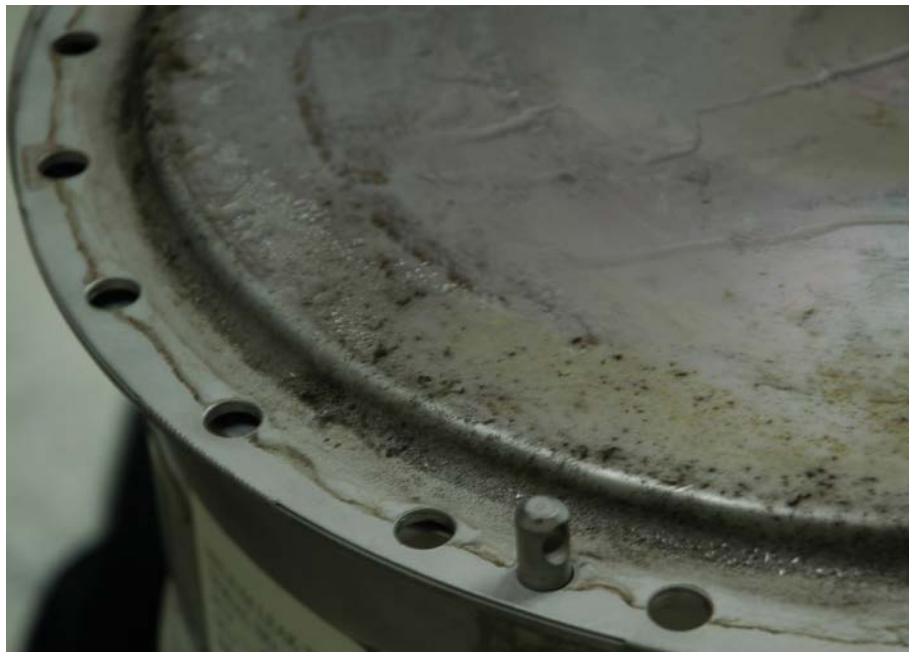
Figure 1. Stains and liquid condensate on underside of lid. Photo taken by NMM personnel.

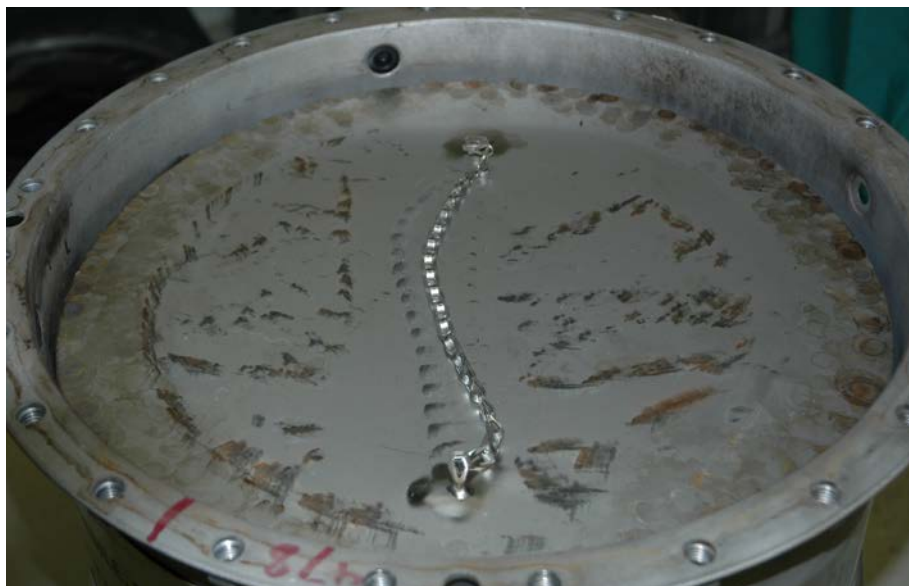
- The axial gap remained approximately the same as measured in KAC (1.722 inch)
- The dark stains on the air shield (other than the obvious water stains) resulted from rubbing against the encapsulated blanket, as evidenced by matching patterns between the two components. The dark stains on the lid and drum do not appear to be mold, but were not identified. They have no discernible height, and do not rub off easily. On the drum, these stains occur at 3 elevations – at the top, near the interface between fiberboard assemblies, and near the bottom.

Figure 2. Water stains and other markings on air shield and upper drum interior. Photo taken by NMM personnel.

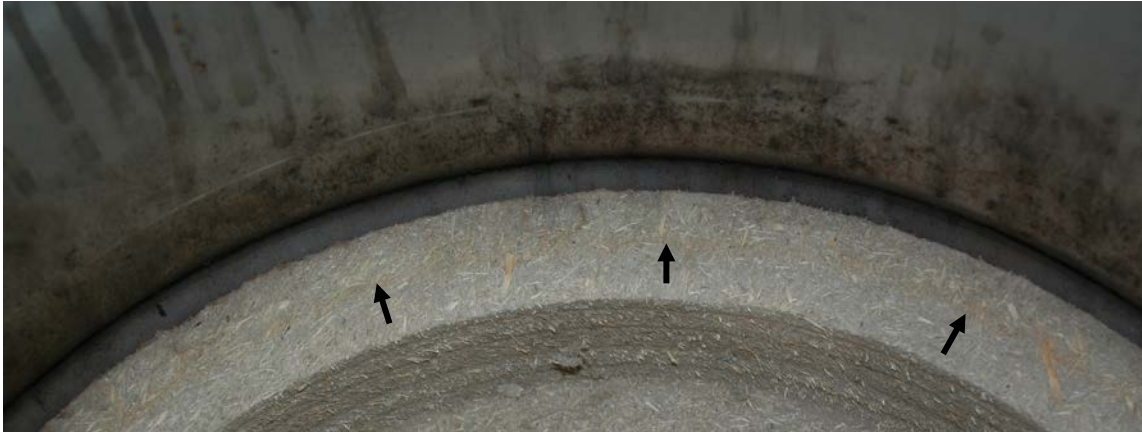
Figure 3. Water stains and other staining on drum interior. Light water staining is also visible on the step of the lower fiberboard assembly. Photo taken by NMM personnel.

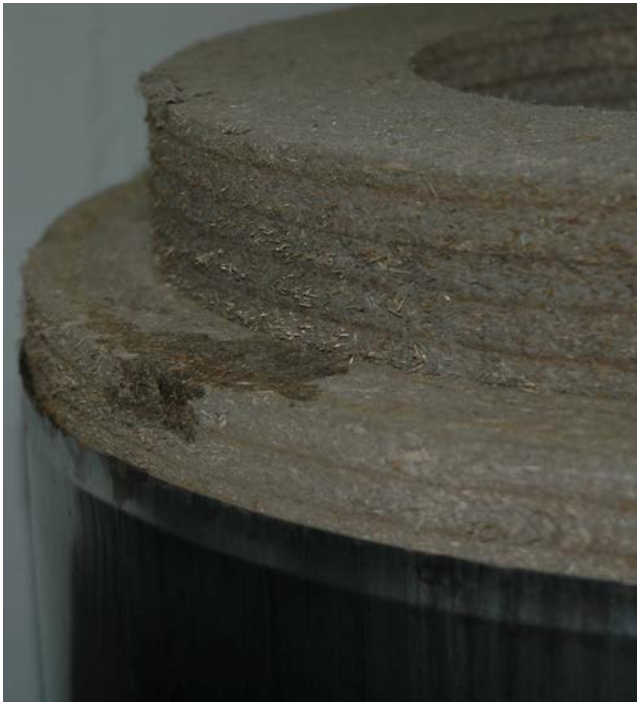
- The dark spot on the upper fiberboard assembly is smeared glue. A fainter water stain forms an irregular ring around the step on both fiberboard assemblies (Figure 8)

Figure 4. Dark stain on upper fiberboard assembly. Photo taken by NMM personnel.

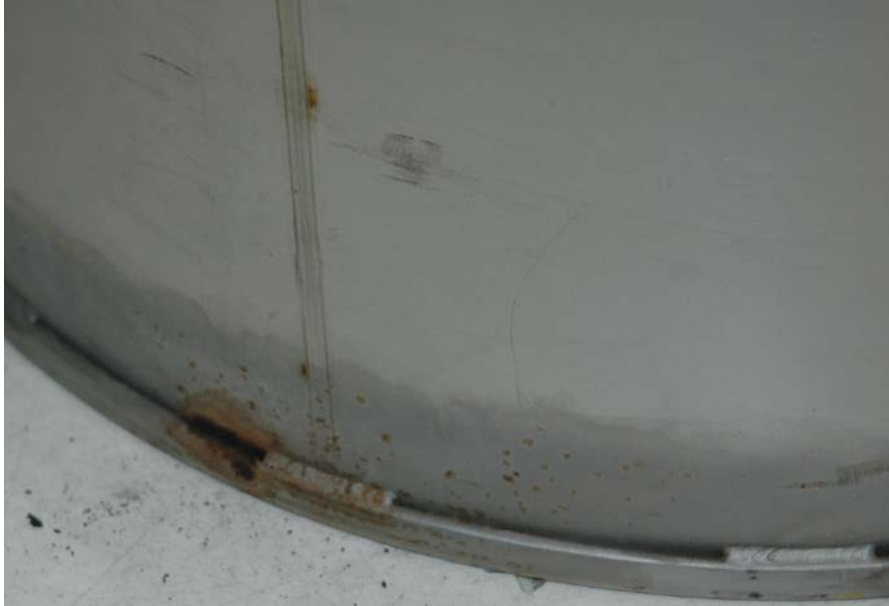
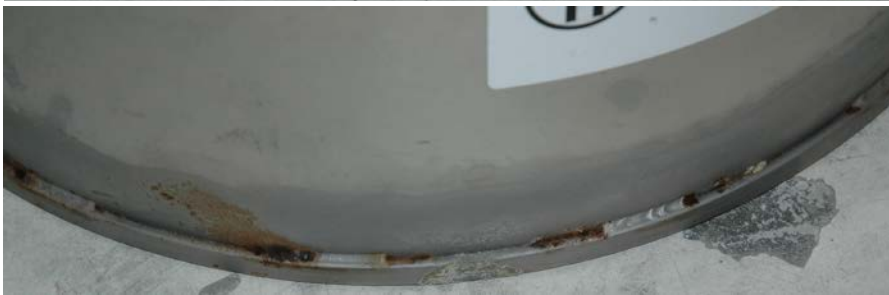
- In addition to several areas of corrosion along the drum lower flange, there are multiple small corrosion spots in one area on the drum bottom, and a few small spots along the vertical seam weld (Figures 6-7).

As moisture migrates through the fiberboard, chlorides can leach out and concentrate at the bottom. This can create favorable conditions for pitting or stress corrosion cracking of the drum. Since the bottom lip of the drum is not fabricated to produce a water-tight seal, some of the moisture and chlorides can seep out. As a result, corrosion may occur in this area of the drum when significant moisture migration has occurred. Regions immediately adjacent to a stitch weld along the bottom lip are especially prone to corrosion since the residual stresses from welding help create easier leak paths at these locations. The presence of chlorides has not been confirmed in these packages, but is the most probable cause of the drum corrosion. Chlorine is added to the cane fiber prior to fiberboard production as a fungus control measure [4].

Figure 5. Corrosion on lower flange of drum. Photos taken by NMM personnel.

It was recently recommended that checking for corrosion along the bottom edge of the drum be implemented for packages that are removed from storage, as well as high wattage packages remaining in storage. The appearance of such corrosion on 9975-02403 further indicates that such corrosion may provide an indication of significant moisture concentration and related degradation within the package. This condition is more likely to develop in packages with higher internal heat loads.

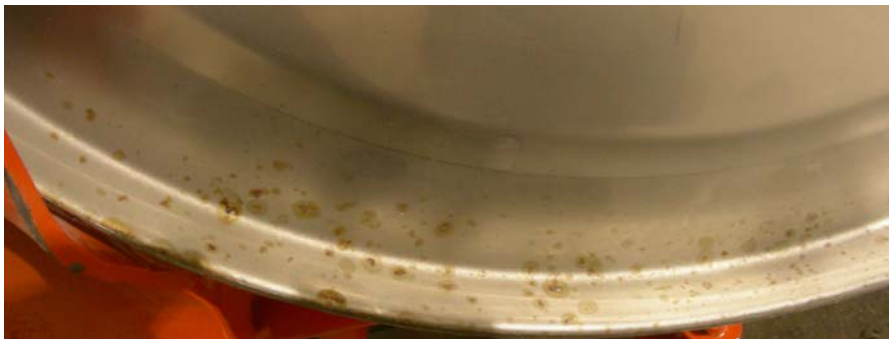
The drum is constructed in a manner that creates a tight crevice along the bottom edge, with the possibility of a very narrow leak path through this crevice. Given the appearance of corrosion on the outer drum surface in this area, a small amount of water was placed along the crevice inside the drum to see if a significant leak path existed. No water was observed along the outer surface after 30 minutes.

Figure 6. Region of localized corrosion on the drum bottom.

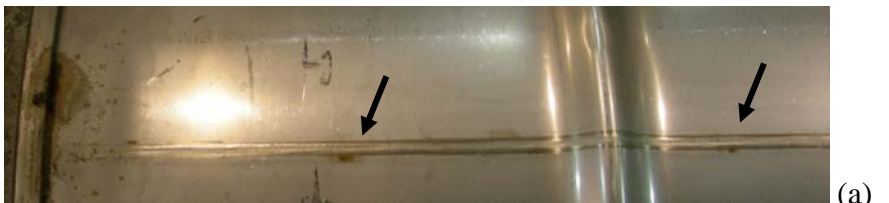
Figure 7. Localized drum corrosion along the vertical seam weld.

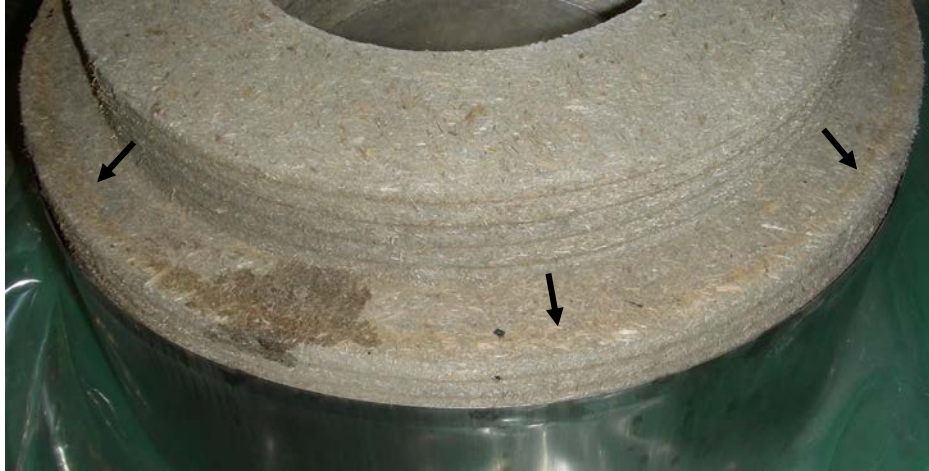
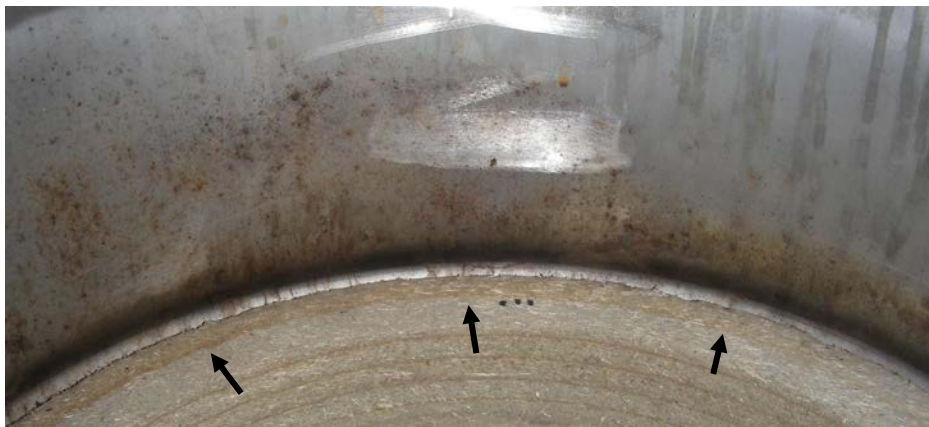
Figure 8. Water stain on the step of each fiberboard assembly.

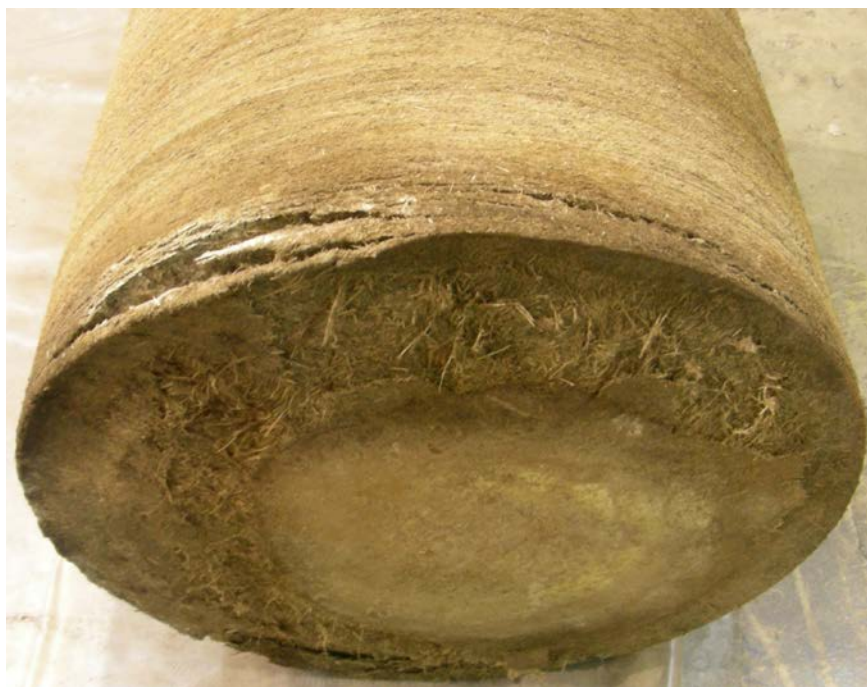
- The bottom layers of the lower fiberboard assembly were saturated, with significant mold present (Figure 9). The bottom layers were very fragile and separated during handling. Portions of the bottom layer remained stuck to the drum (Figure 10). After scraping this material off the drum, its weight was 48 grams. Additional regions of mold were growing on the side of the lower fiberboard assembly (Figure 11).

The axial fiberboard dimensions are generally less than nominal drawing dimensions. While some variation in fiberboard dimensions is normal, the overall height of the lower assembly is significantly reduced (26.7 inches nominal, 25.774 actual). Compared to nominal dimensions, two-thirds of this reduction has occurred in the bottom 3.8 inches (below the bearing plate).

Figure 9. Mold near bottom of lower fiberboard assembly, along with layer separation and material missing from the bottom

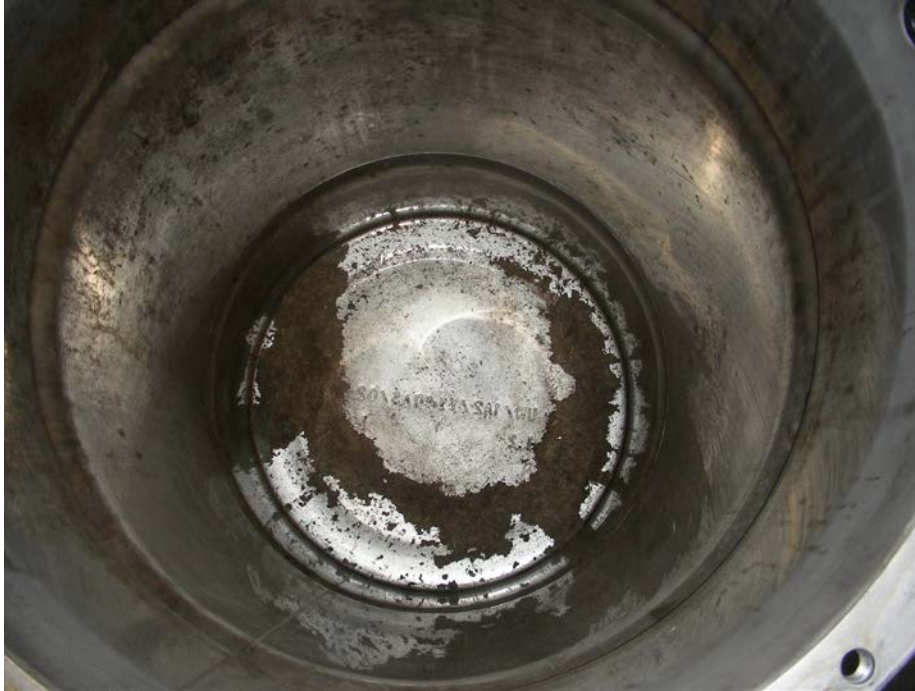
Figure 10.
Fiberboard material
stuck to the drum

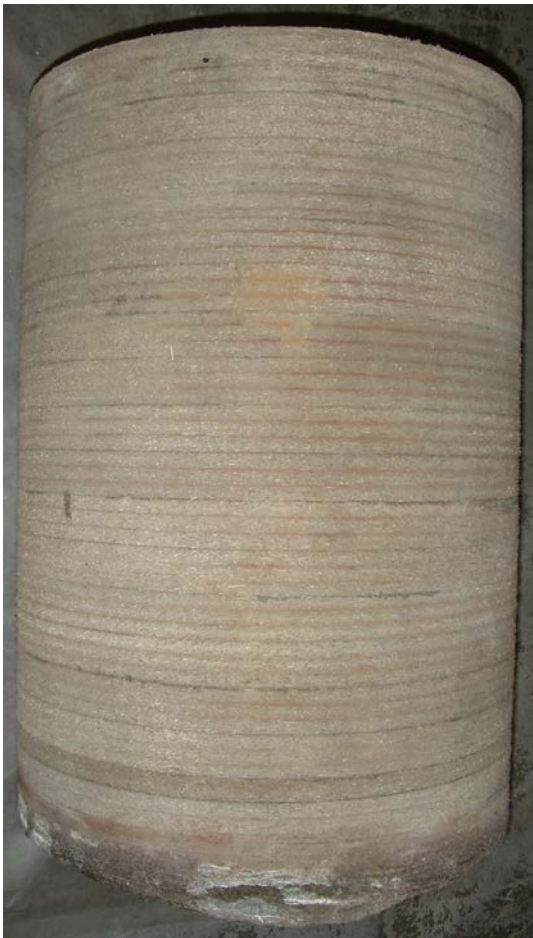
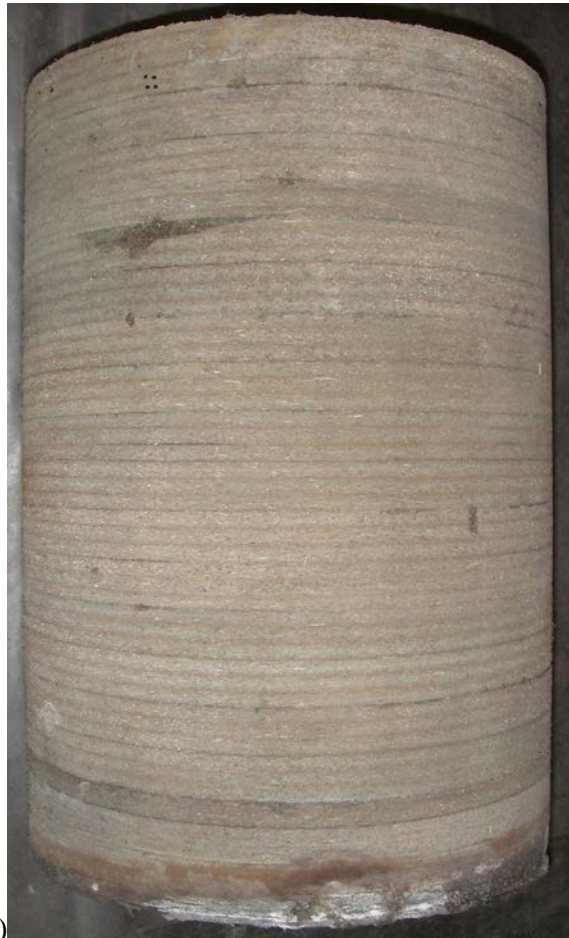
Figure 11. Mold on the side of the lower fiberboard assembly

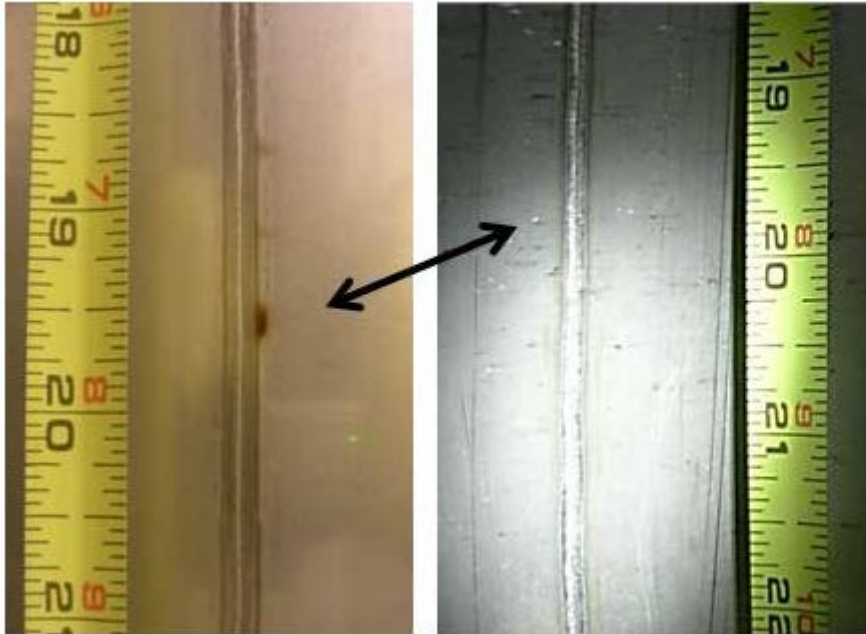
After identifying several corrosion spots along the vertical seam weld of the drum, the drum interior was re-examined for evidence of similar corrosion on the corresponding inner surface (Figures 12-13). Several elongated dark spots were observed adjacent to the seam weld inner surface, but these generally did not match the locations of the corrosion spots on the outside surface. It is therefore concluded that the corrosion spots did not originate from the inside.

Figure 12. Example of corrosion spot on the drum exterior (a) along the vertical seam weld (~19.5 inches from the drum flange), compared to the corresponding location on the interior (b) with no visible corrosion

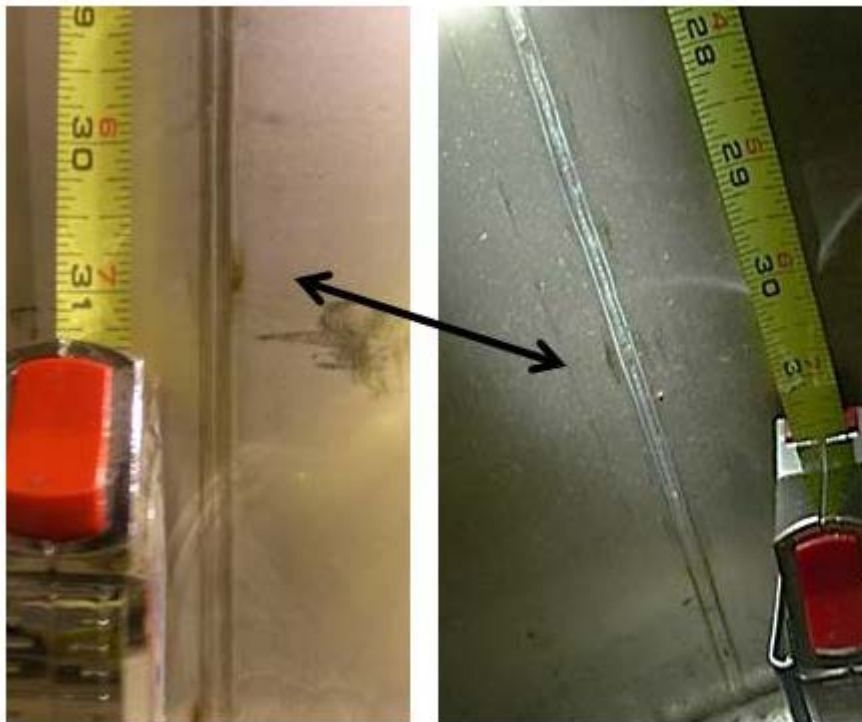
Figure 13. Example of corrosion spot on the drum exterior (a) along the vertical seam weld (~30.8 inches from the drum flange), compared to the corresponding location on the interior (b) with an elongated dark spot.

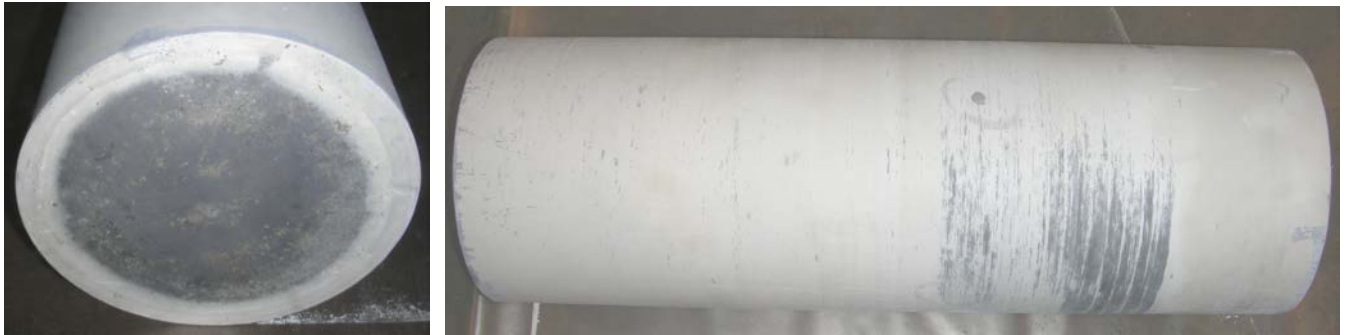
Dimensional measurements were taken for the lead shield to compare to drawing requirements (Table 2). The inside diameter at the top of the shield is specified to be 7.25 – 7.26 inches. The average of 4 measurements for this dimension was 7.266 inches. The other shield dimensions meet drawing requirements. The thickness of the shield (0.538 inch) is the same at the top and at the bottom, indicating that no significant creep of the lead has occurred. Most of the side and part of the bottom surface is covered with a white, lead carbonate corrosion layer (Figure 14).

Figure 14. Bottom and side of lead shield from 9975-02403
