EXAMINATION OF SHIPPING PACKAGES 9975-01658, 9975-02075 AND 9975-02738

W. L. Daugherty

May 2016

SRNL-STI-2016-00294, Revision 0

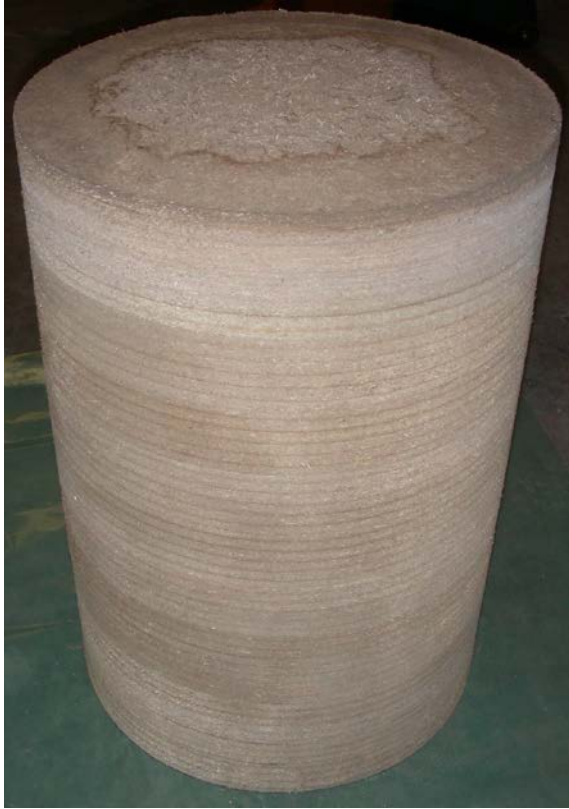
- The bottom 1-3 layers of the lower fiberboard assembly were saturated (darkened). On the bottom surface, this saturated region extended several inches in toward the center. (Figure 1)
- Dried water spots along one side on top of the air shield * (Figure 2).

Each package had some degree of elevated moisture in the bottom fiberboard layers (with light mold observed on 9975-02738), but the remainder of the fiberboard assembly had typical moisture levels, and presented an appearance consistent with non-degraded fiberboard.

Figure 1. Lower fiberboard assembly from 9975-01658 (upside down) showing bottom layers and outer portion of the bottom darkened from moisture. This photograph was taken in SRNL on April 14, 2016, 9 days after the package was unloaded in KAC.

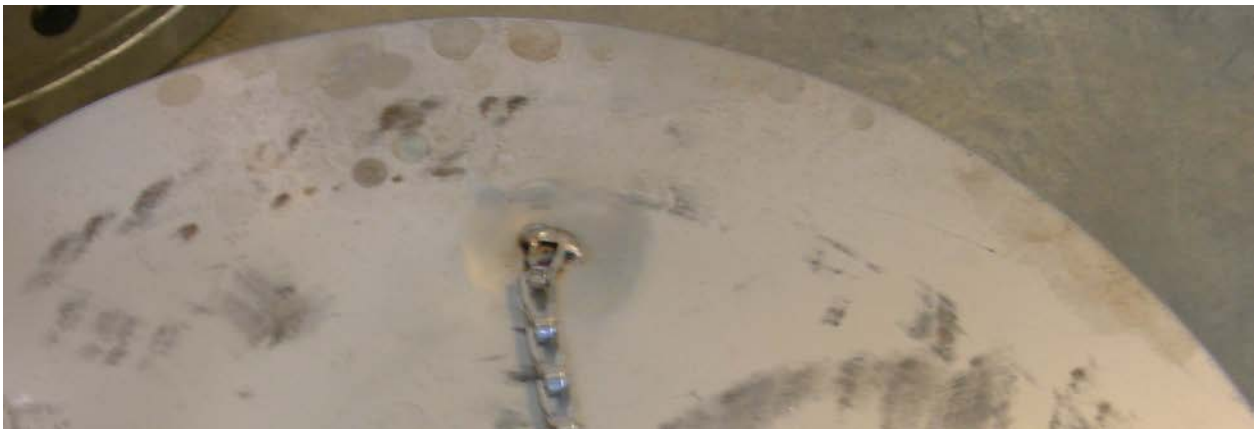
The water stains on the 9975-01658 air shield indicate condensate had formed on the lid at some point. Although there was no stain on the drum side corresponding to water running down to the bottom, such condensation can be an effective mechanism for concentrating water at the bottom of the drum. Condensation on the drum and lid interior surfaces may also have contributed to the corrosion noted in those locations in 9975-01658 and 9975-02738. These incidences of corrosion were only examined visually, and their exact nature has not been identified, although the corrosion on the 9975-01658 ID surface is similar in appearance to the corrosion observed on the drum exterior of other packages. It is judged that the integrity of these drums has not been significantly challenged by this corrosion.

Figure 2. Dried water spots on the 9975-01658 air shield

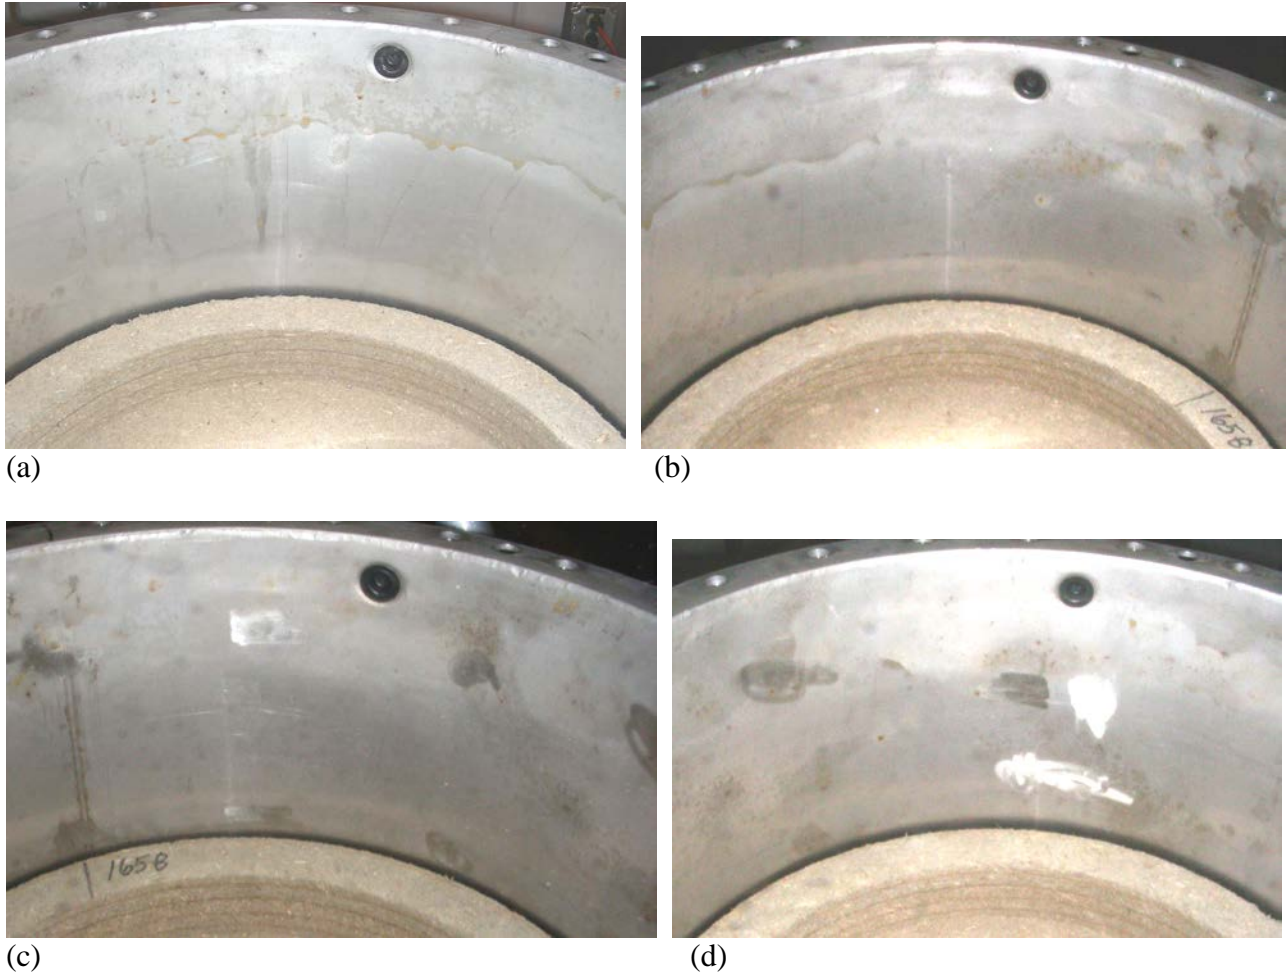
- Stains and light corrosion on the drum ID surface * (Figure 3).
- Light corrosion on the underside (interior surface) of the lid.
- Light corrosion on the bottom of the drum, along the outer corner (Figure 4).

Figure 3. Stains and light corrosion on 9975-01658 drum ID surface.

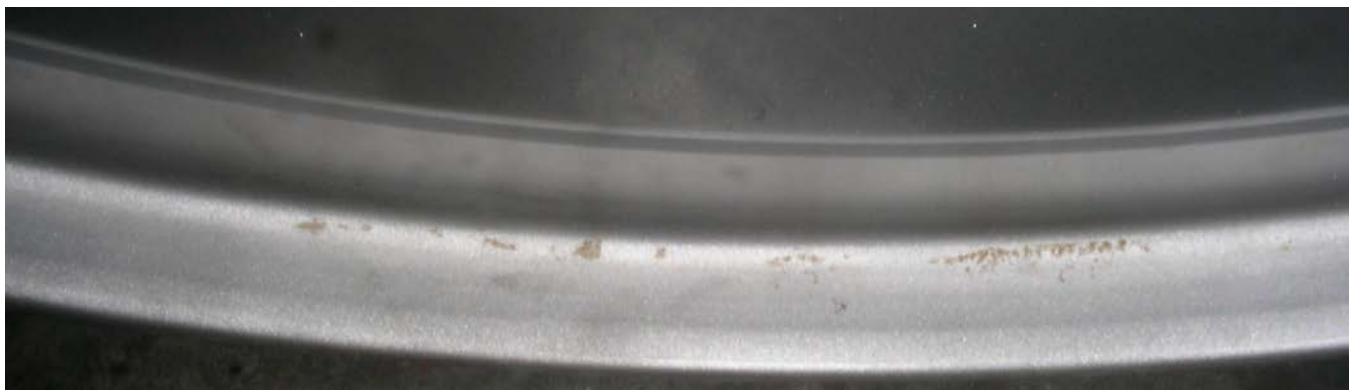
Figure 4. Light corrosion on the bottom of the 9975-01658 drum.

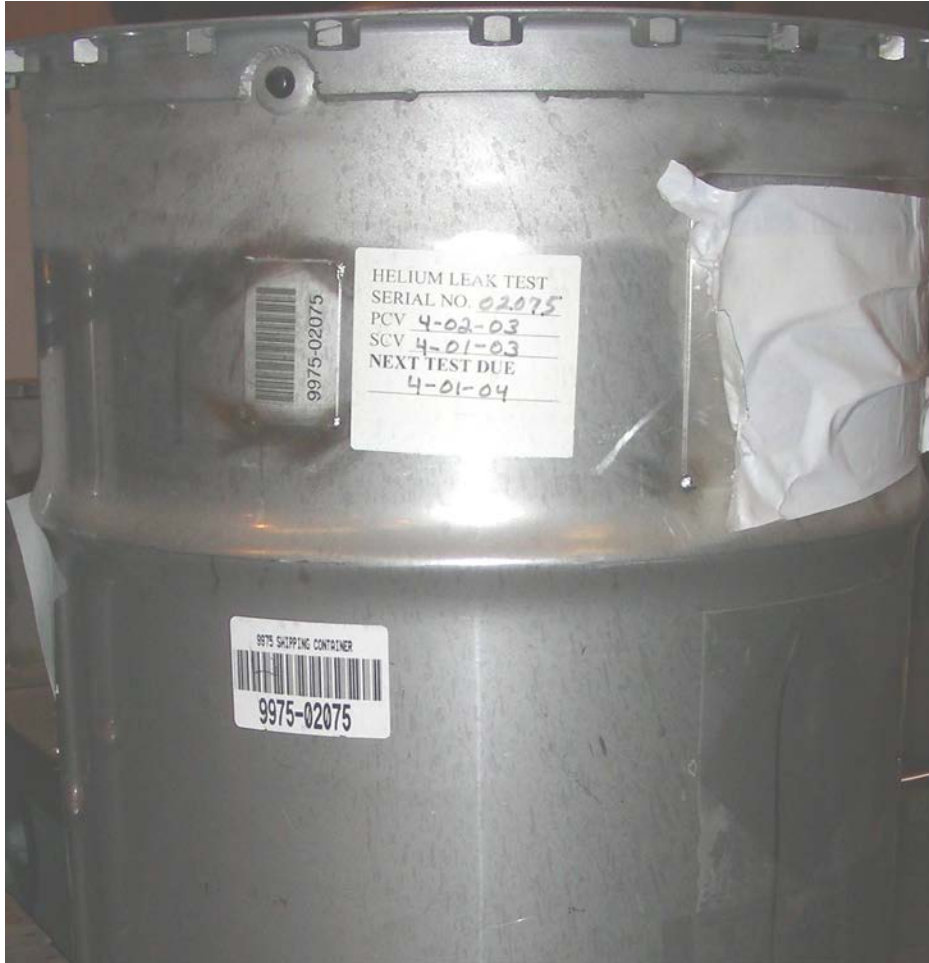
- Water spots on the drum exterior surface * (Figure 5).
- Light corrosion on the bottom of the drum, along the outer corner (Figure 6).

Figure 5. Water spots on the side of 9975-02075 drum.

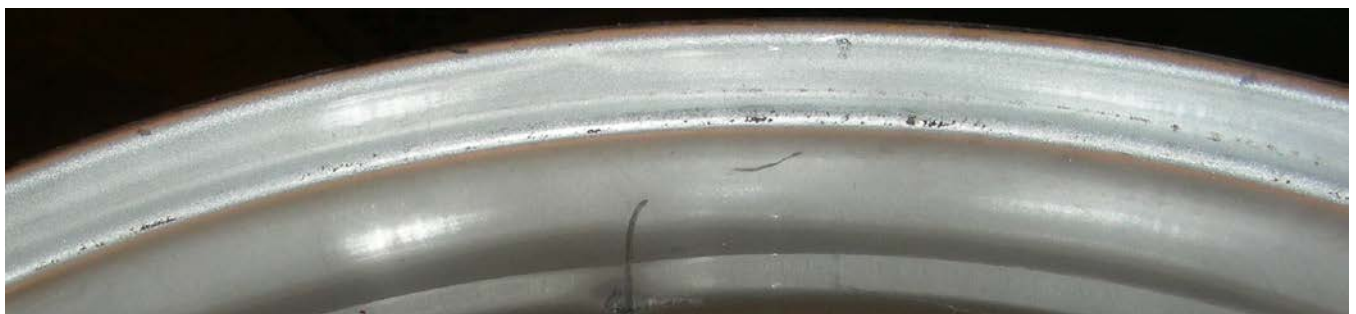
Figure 6. Light corrosion on the bottom of 9975-02075 drum.

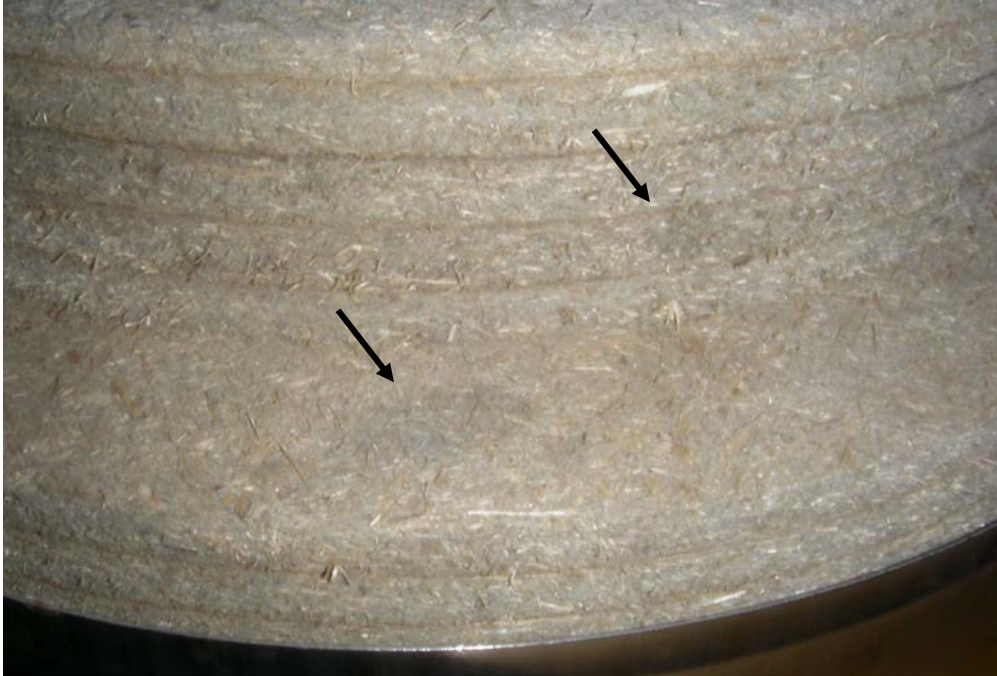
- Light stains on the upper fiberboard assembly (Figure 7).
- Glue residue and light mold on the side of the lower fiberboard assembly (Figure 8).
- Light corrosion on the bottom of the drum, along the outer corner (Figure 9).
- Deposits and/or corrosion product on the underside (interior surface) of the lid * (Figure 10).
- Not noted in the SRNL examination, but the field surveillance identified small corrosion spots on the drum ID surface * (Figure 11).

Figure 7. Slightly darkened areas on the 9975-02738 upper fiberboard assembly. This photograph was taken in SRNL on April 20, 2016, 9 days after the package was unloaded in KAC.

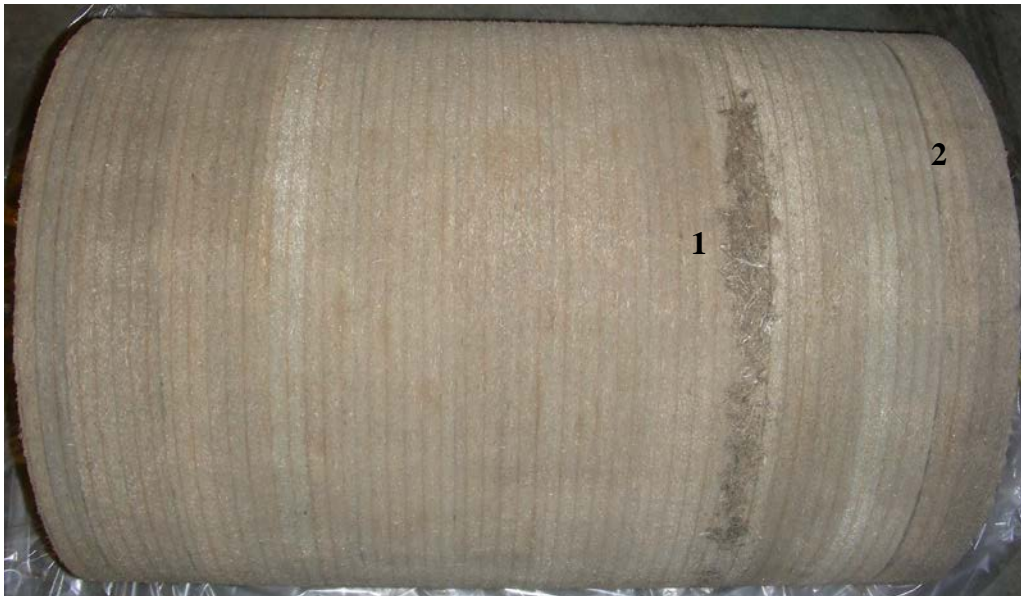
Figure 8. Glue residue (1) and light mold (2) on the 9975-02738 lower fiberboard assembly. This photograph was taken in SRNL on April 20, 2016, 9 days after the package was unloaded in KAC.

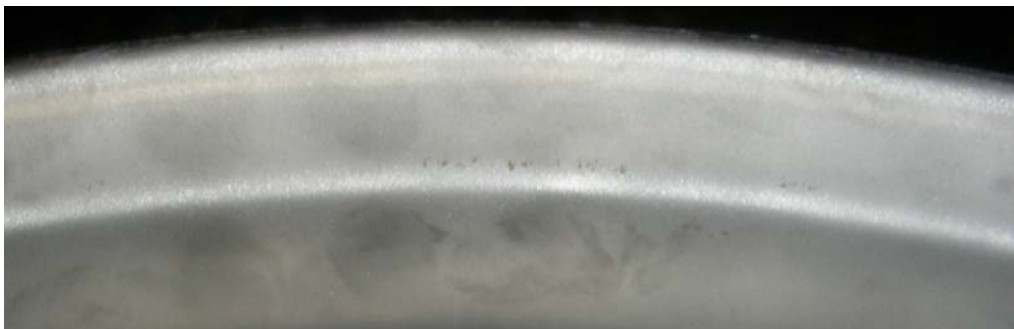
Figure 9. Light corrosion on the bottom of 9975-02738 drum.

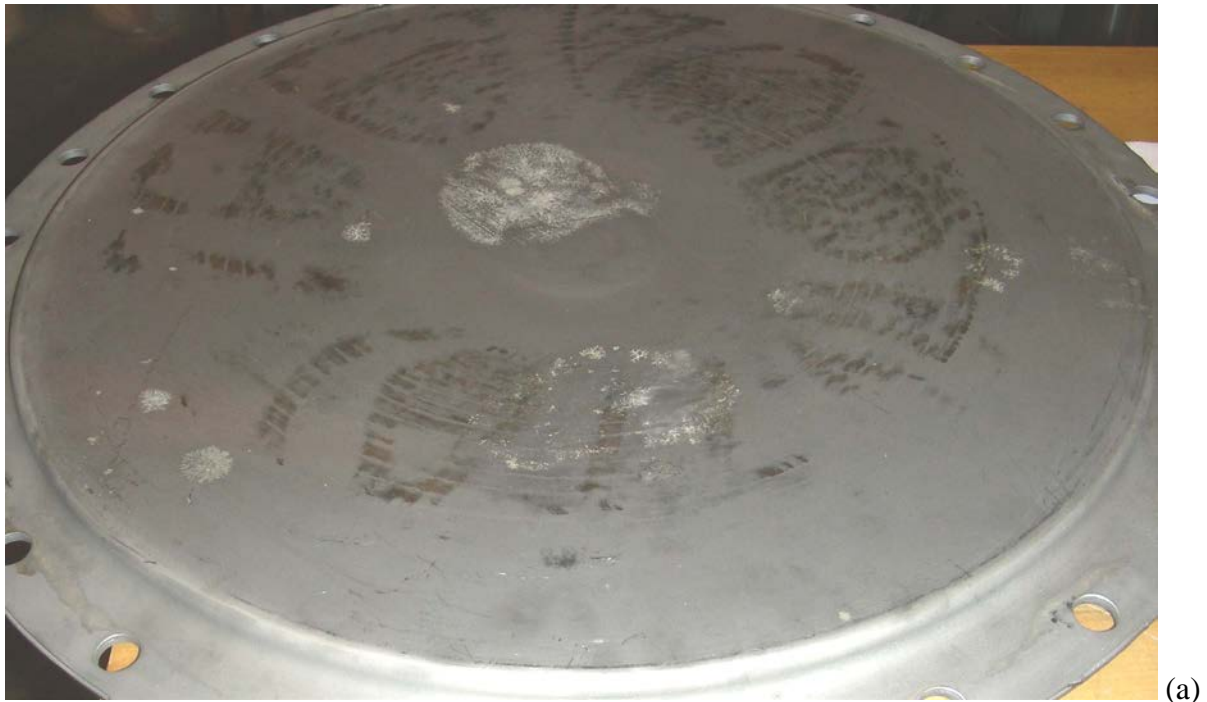
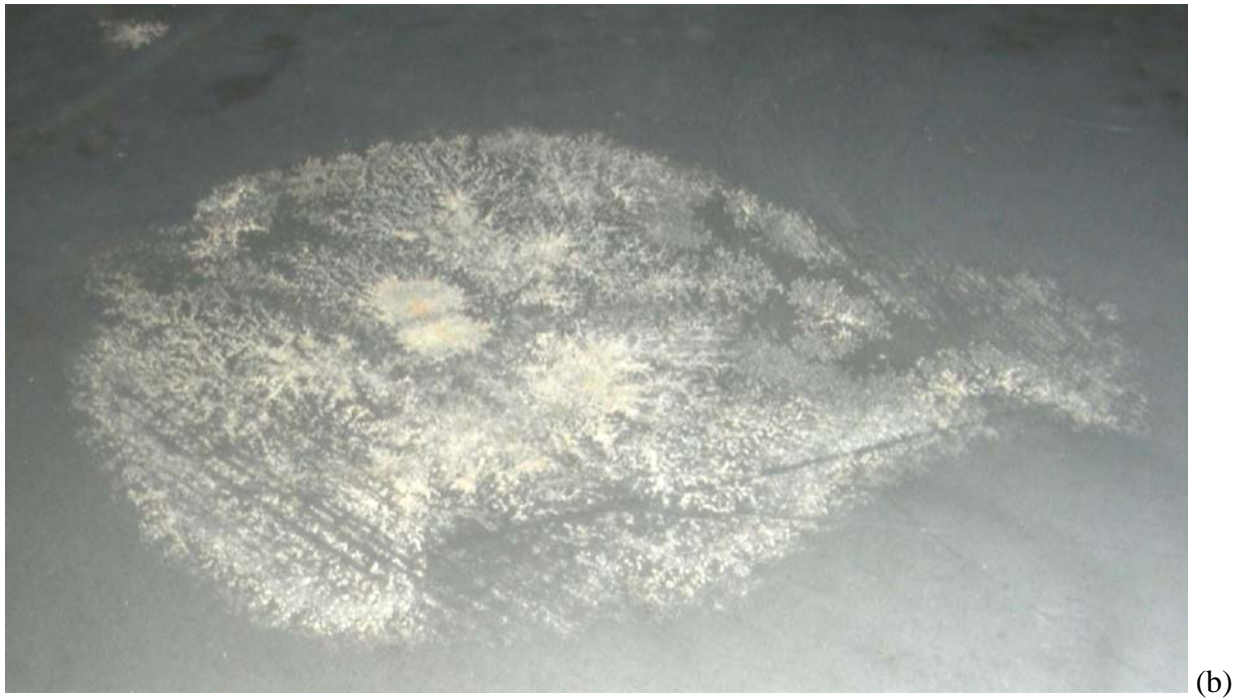
Figure 10. Deposits and/or corrosion product on the underside of the 9975-02738 lid (a), with a detail of the central spot in (b).

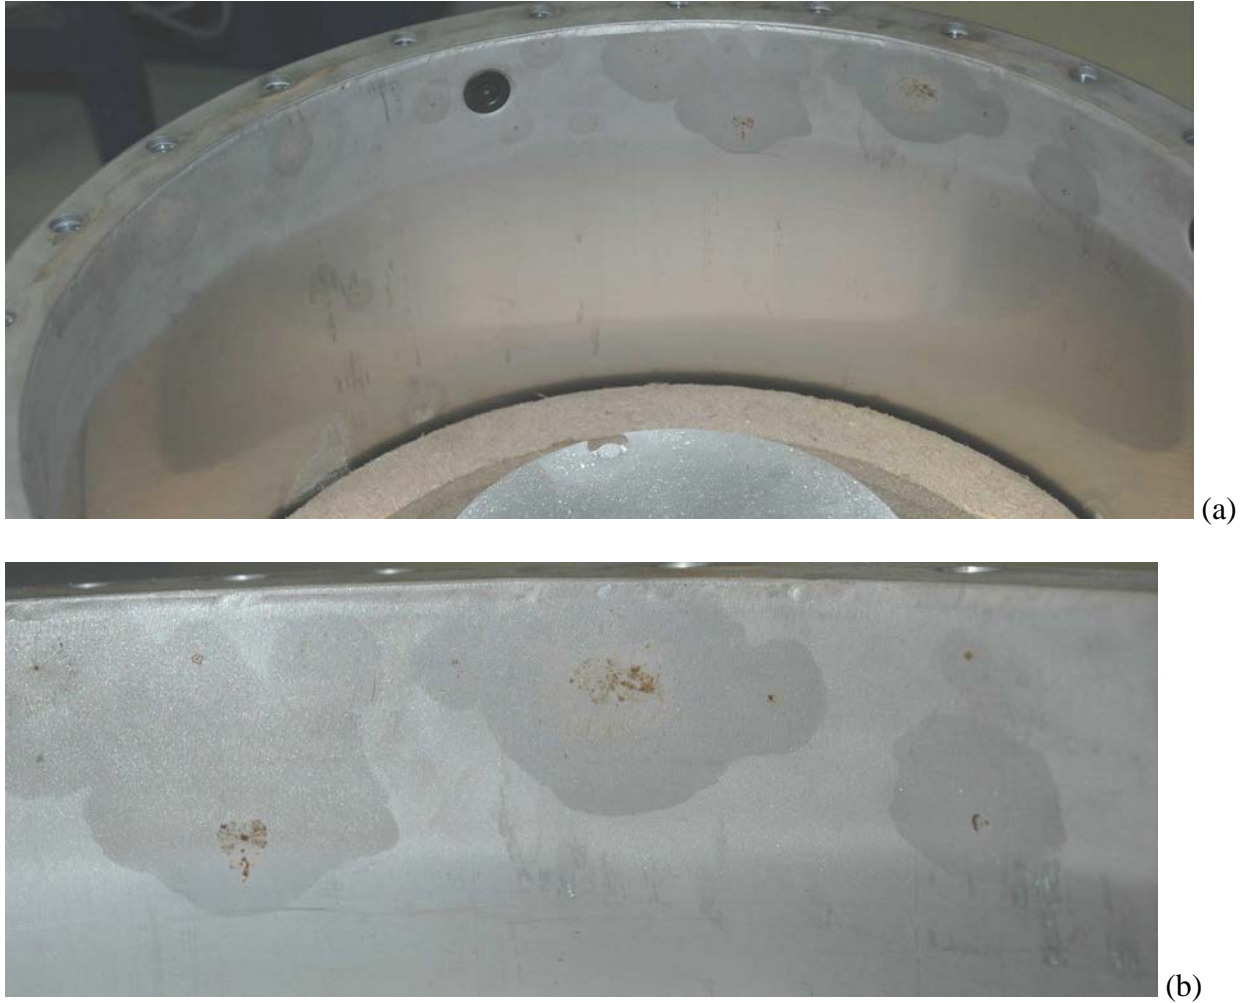
Figure 11. Corrosion on the 9975-03728 drum interior. Photos taken in KAC by NMM personnel.

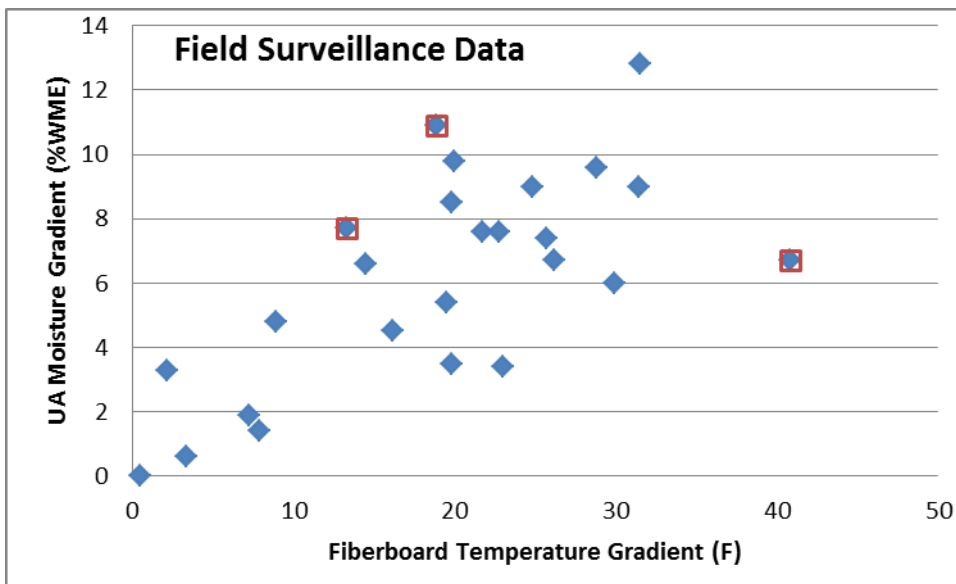
The data in figure 12 show a degree of scatter, but an overall trend is apparent. Reasons for the scatter might include local variation in fiberboard properties, and circumferential variation in the temperature of a package due to varying heat load of adjacent packages. The three symbols in Figure 12 that are highlighted are from the packages documented in this report. These are among the most extreme outliers, although the specific reason(s) for their variation are unknown. Based on the general trend and the heat load of these packages, 9975-01658 has a lower fiberboard moisture gradient than expected for its heat load, while the other two packages have a lower thermal gradient than expected for their heat load.

Figure 12. Comparison of moisture gradient across the upper fiberboard assembly to the temperature gradient based on KAC field surveillance data of packages with cane fiberboard. The highlighted data are from 9975-01658, 9975-02075 and 9975-02738.

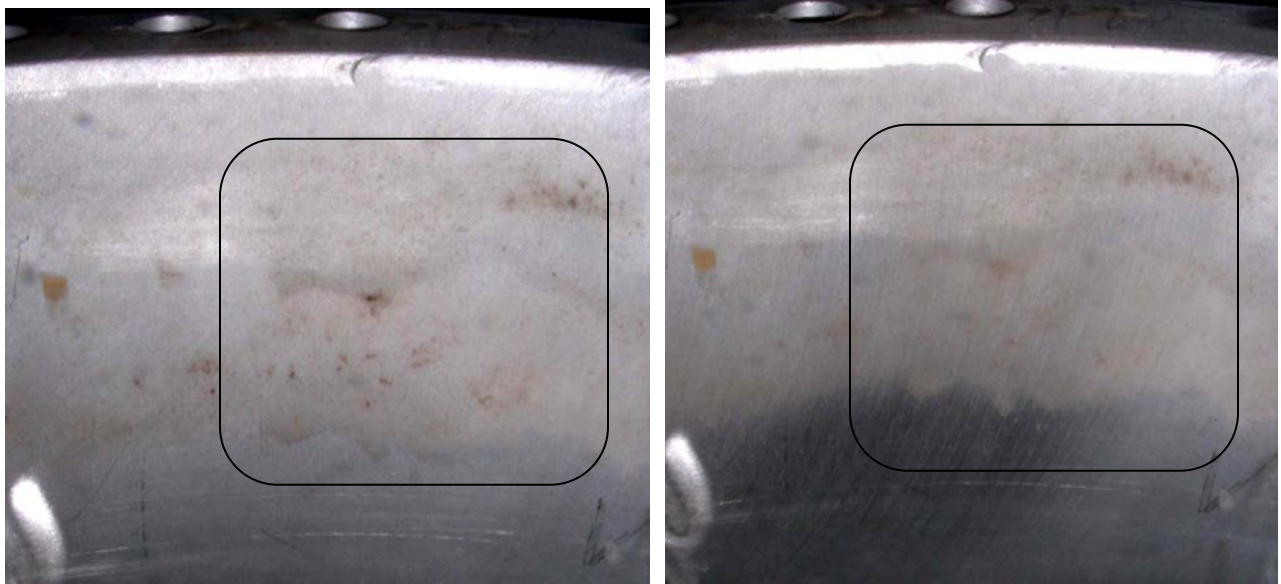
A fine-bristle wire brush was used on local regions of corrosion: on the 9975-01658 drum interior surface, and on the 9975-02738 lid. Photographs of these regions before and after brushing (Figures 13, 14) show much of the corrosion remaining, suggesting there may be some small depth of penetration.

Figure 13. Corrosion on 9975-01658 drum interior before and after light brushing of the indicated area.

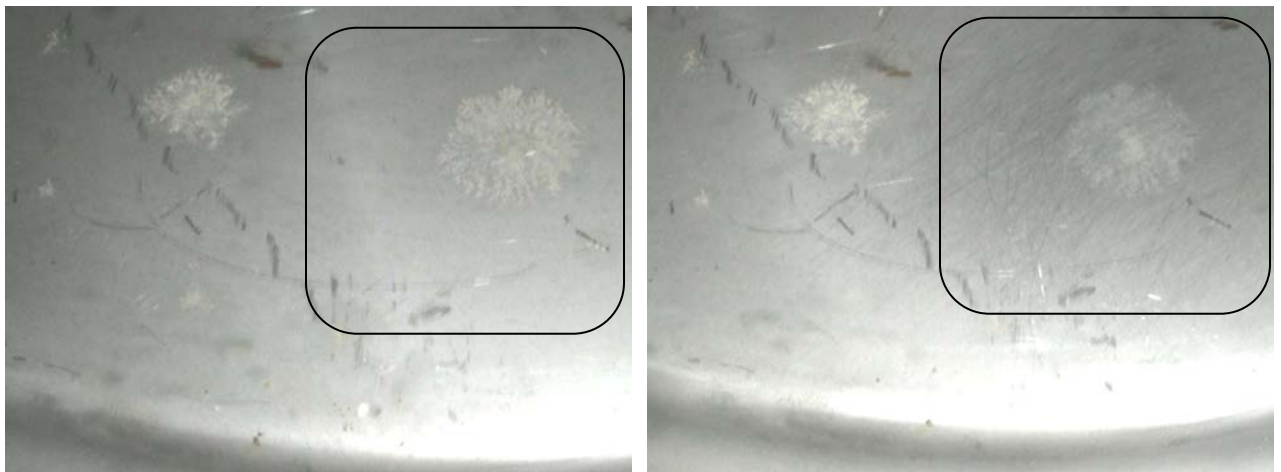
Figure 14. Corrosion on 9975-02738 lid underside before and after light brushing of the indicated area.
