Evaluation of Pad 18 Spent Mercury Gold Trap Stainless Steel Container Failure

August 2016

SRNL-STI-2016-00443, Revision 0

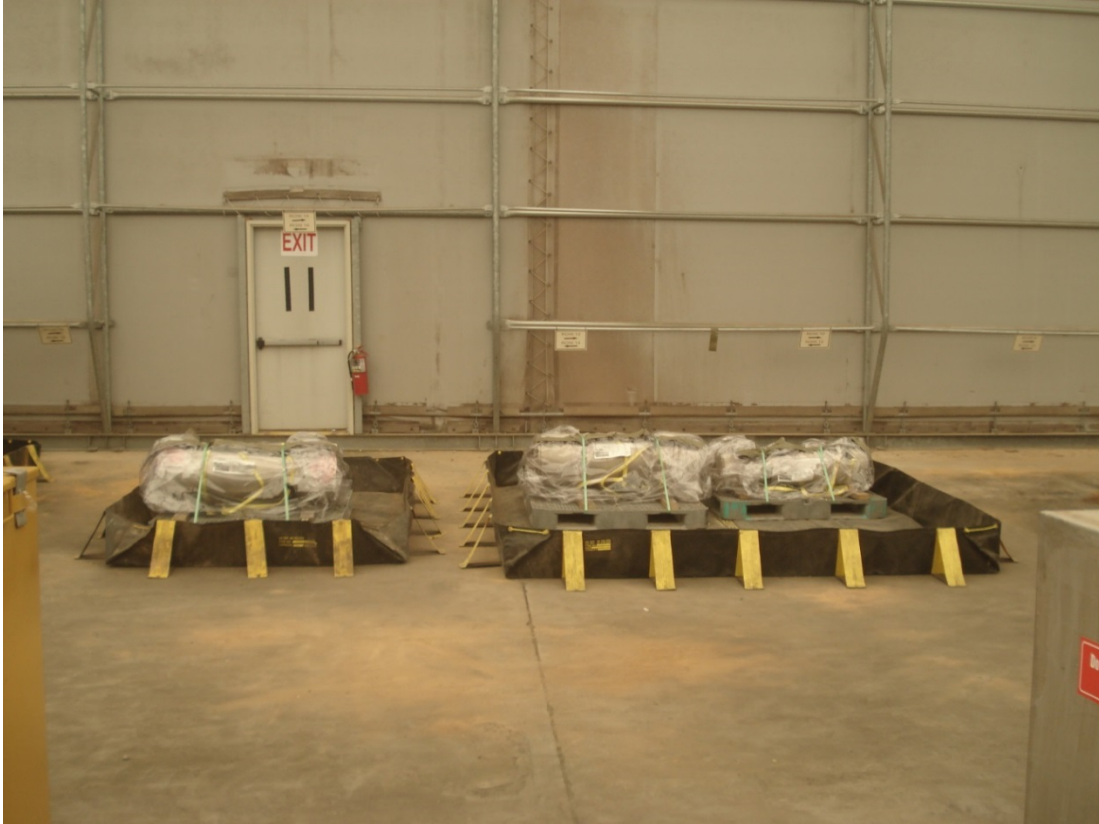
The leaking container (HMSF001220) was received from Tritium on 12/10/1985, initially placed into Culvert T3 in 643-29E, and was later removed from Culvert T3 and placed into Culvert T5. On 9/16/2009, the container was removed from Culvert T5 and stored on a pallet in 643-29E. The container/pallet was relocated from 643-29E to TRU Pad 16 on 4/14/2011. On 5/09/2014, the container/pallet was relocated to TRU Pad 18. The container is currently located inside a spill dike on Pad 18 with other similar containers (HMSF001221, HMSF001222 and HMSF001223), all containing spent mercury gold traps from the Tritium facility (Figure 1).

Figure 1. Spent Mercury Gold Trap Cylinders Stored on Pad 18
(current configuration after spill contained/observed)

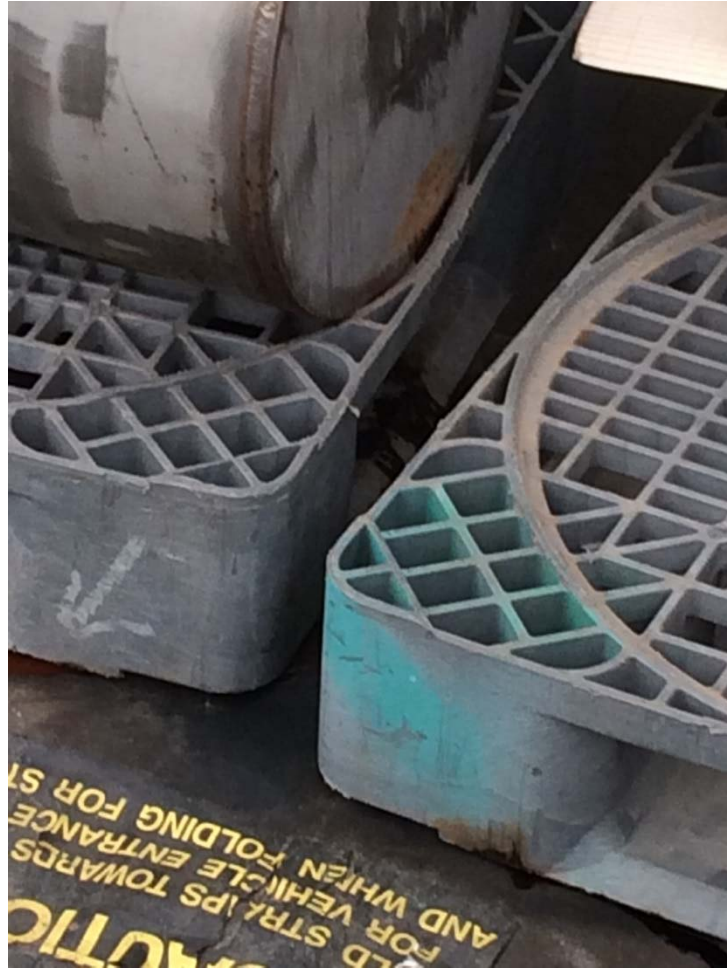
Inspection of the container (HMSF001220) revealed signs of corrosion on the suspected leaking end (opposite of lifting lugs), Figure 2. The container was rotated for examination and photographed. Significant staining was observed on the container consistent with the contact point with the storage pallet. Pitting was also observed on the container end weld (Figure 3). Minor corrosion is also evident on the ends of other containers, but is more consistent with iron contamination during container fabrication, welding and handling.

Figure 2. Leakage initially found from gold trap container HMSF001220

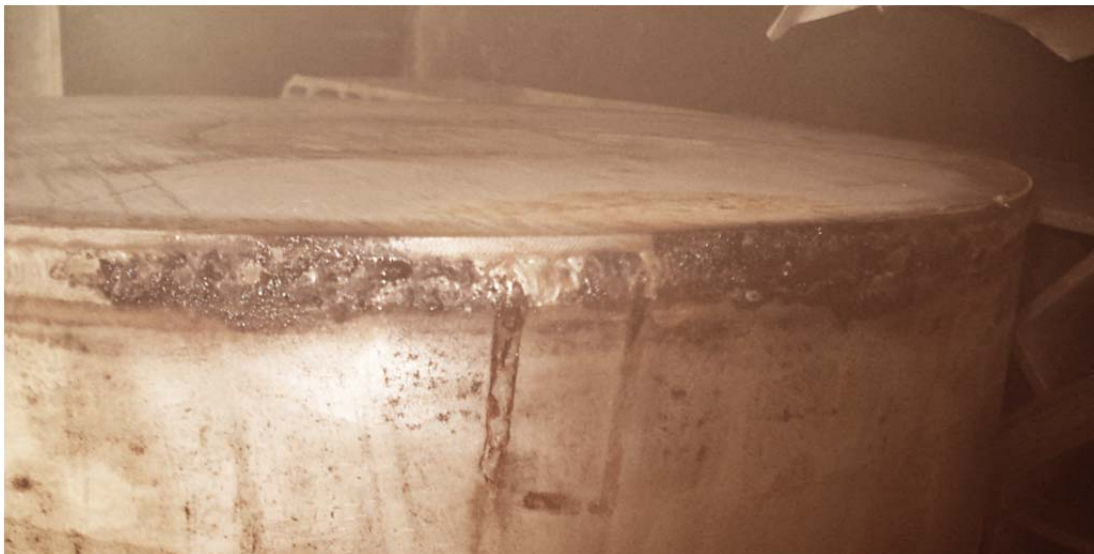
Figure 3. Corrosion at the leaking end of cylinder HMSF001220 (rotated for examination)
(Pitting in weld area and staining consistent with pallet orientation, leak site not identified)

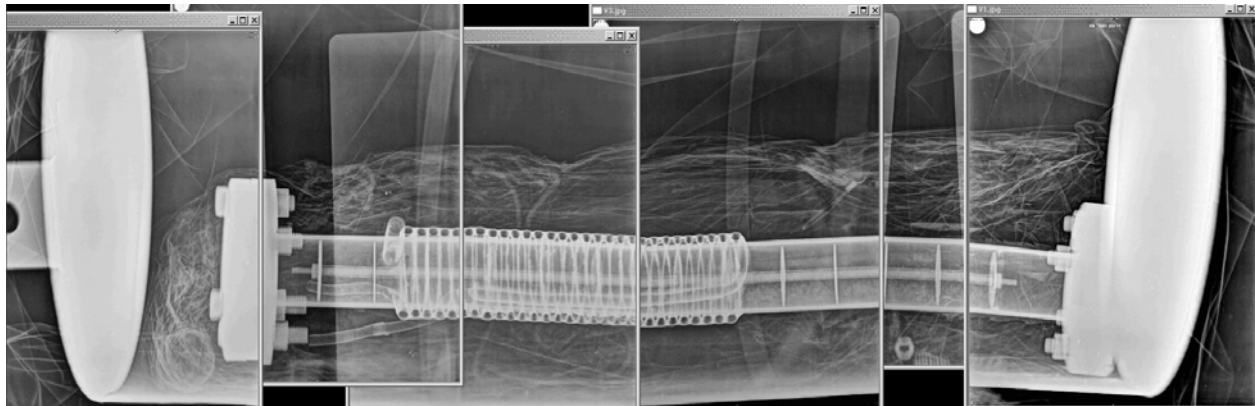
4a.

X-ray examination of the failed waste container (HMFS001220) by AECOM personnel revealed the internal presence of a significant quantity of plastic packaging material as well as the presence of approximately 250 mL of remaining residual liquid. A total of approximately 500 mL of liquid is estimated to have been within the container prior to leakage, based on the leakage volume (~250 mL), the amount of sample obtained for analysis and volumetric estimation of remaining liquid from X-ray images. X-ray images of the failed container are shown in Figure 4a-b. Figure 4b shows the container elevated approximately 7° to confirm liquid shift. Note the distinction between plastic packaging external to the container and the packaging within the container and around the gold trap.

Figure 4a-b. X-ray images of container HMFS001220 with spent mercury gold trap (liquid confirmed after a 7° elevation)
