MODEL 9975 LIFE EXTENSION TEST PACKAGE 3 – INTERIM REPORT

W. L. Daugherty

January 2017

SRNL-STI-2017-00045, Revision 0

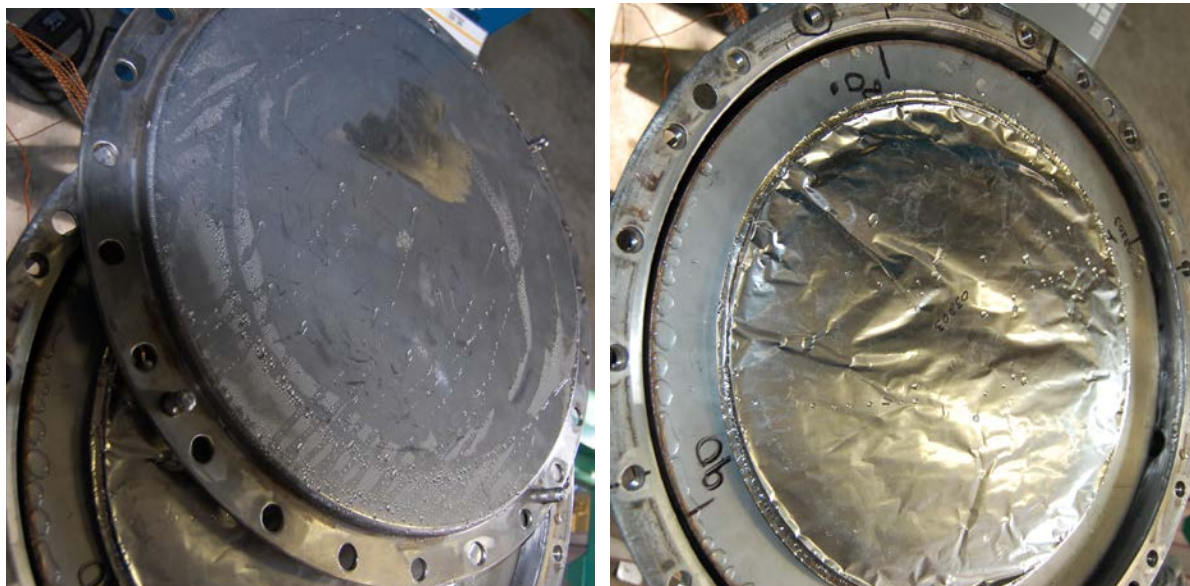
- After 2 weeks in test, liquid condensation was observed on the underside of the drum lid and on the air shield (Figure 3). The moisture level of the bottom fiberboard layers is above saturation (>38 % wood moisture equivalent, or % WME).

Figure 3. Liquid condensate on the underside of the drum lid and on the air shield, observed after 2 weeks in test.

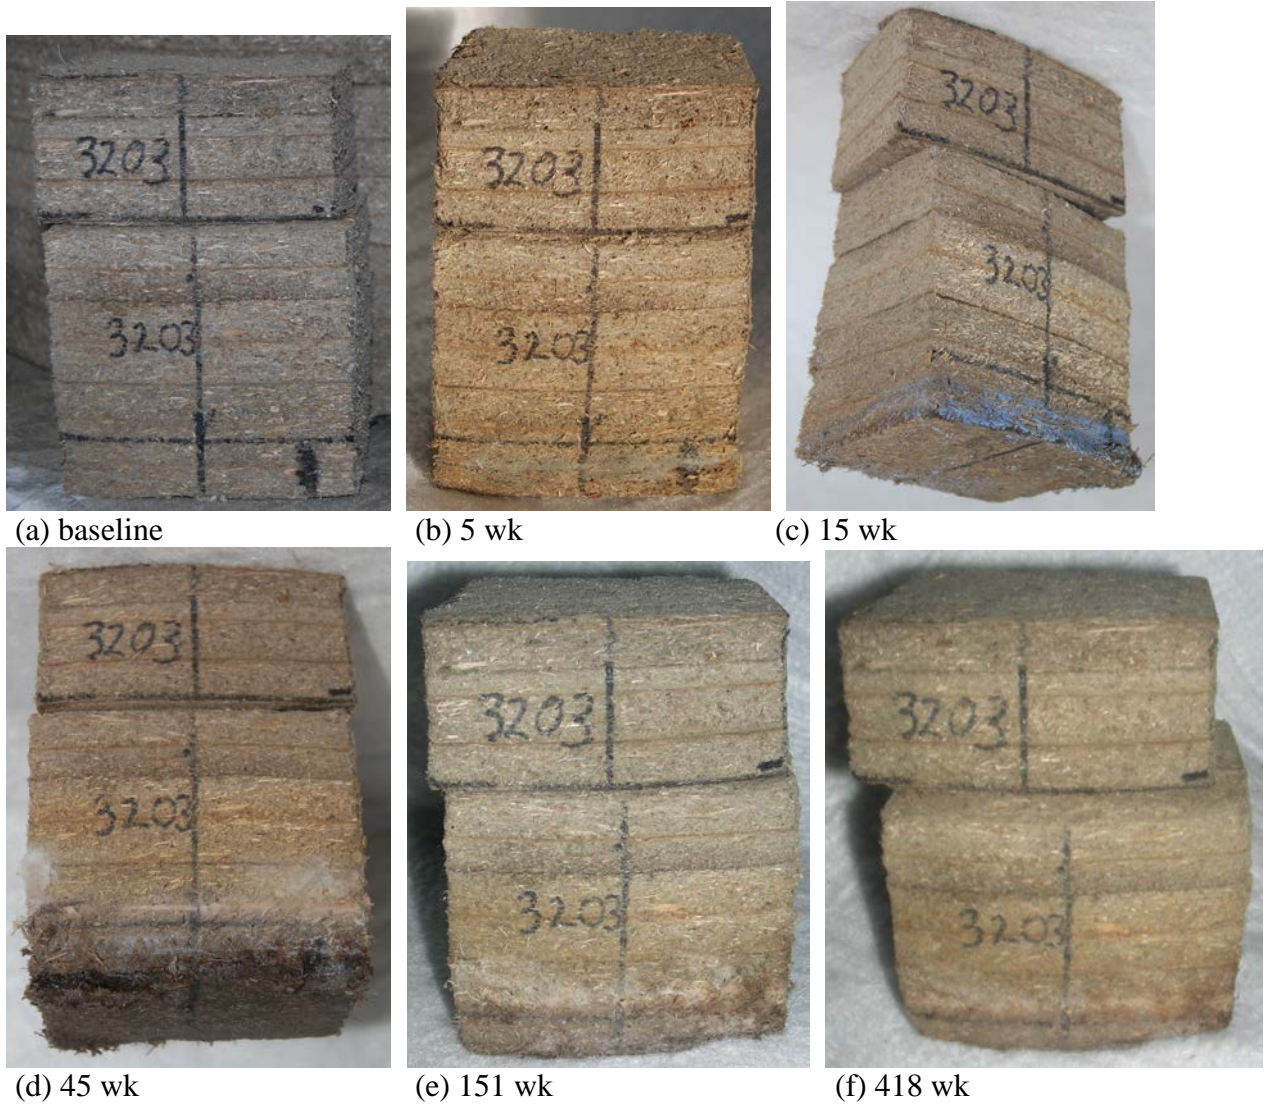
- After 5 weeks in test, mold was observed on the lower layers of the bottom removable fiberboard section. The mold changed color and texture through 45 weeks in test, and gradually became dormant by week 151. Little change has been observed after that. (Figure 4)

Figure 4. Sequence of photographs of small removable fiberboard sections from test LE3.

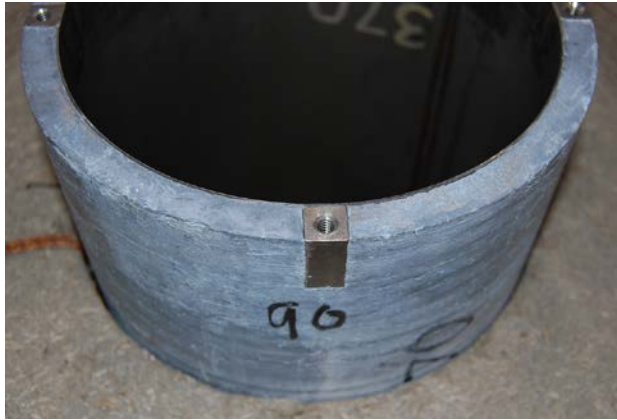
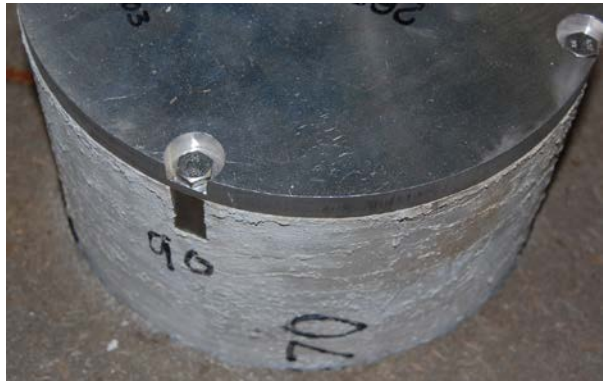
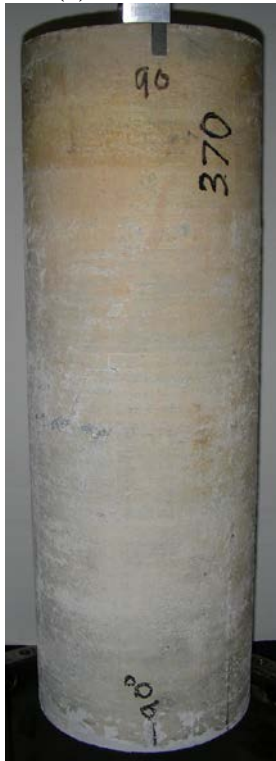
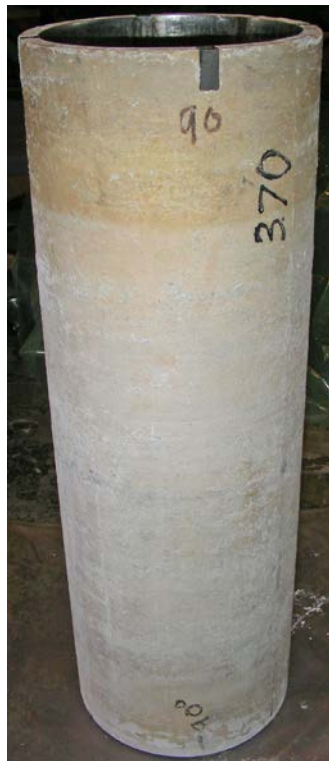
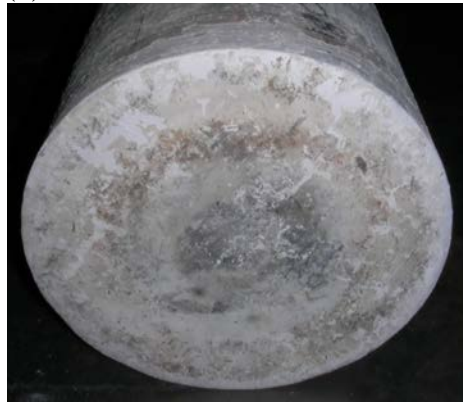
- After 7 weeks in test, increased corrosion on the outer surface of the lead shield was observed, along with some nodular corrosion deposits. Lead shield corrosion approached its heaviest visual appearance by 26 weeks, and the upper portion of the shield darkened slightly after that (Figure 5).

The corrosion of the lead shield is also of interest. Significant corrosion product was observed after 7 weeks in test, and was white and nodular (Figure 5). The corrosion product had become somewhat heavier after 26 weeks in test, but did not appear to increase significantly after that. Instead, the appearance began to change slightly in that the upper portion of the lead shield (adjacent to the upper fiberboard assembly) yellowed slightly (observed after 109 weeks in test) and retained that appearance during subsequent testing. A greater degree of discoloration was observed on the lead shield from the second life extension package. Analysis of the corrosion product from that shield showed it to be consistent with lead carbonate, with up to 10 wt% chlorine (likely from the fiberboard) [3]. The lead carbonate corrosion typically seen on a 9975 lead shield is smooth and white. Once the corrosion product on a typical lead shield is sufficiently thick (a few thousands of an inch), it will begin to loosen and flake off.

A heavy corrosion layer was noted on the lead shield after 26 weeks (21.3 weeks at temperature), and was not observed to change significantly during subsequent inspections. If the baseline weight of all fiberboard is subtracted from the total package baseline weight, the remaining components had a combined baseline weight of 138.9 kg. After 43.7 weeks at temperature (the next time all fiberboard was weighed), the remaining components had a combined weight of 139.1 kg. This residual weight has remained approximately constant since that time. The weight gain of ~200g is attributed to lead corrosion.

It is postulated that the lead shield gained 200g in weight during the initial aging period. If this weight gain came from the production of basic lead carbonate, $Pb_3(CO_3)_2(OH)_2$, then this weight gain resulted from the consumption of 807g lead metal. With a nominal density of 0.41 lb/in³, this corresponds to a loss of 4.34 cubic inches of lead. The side of the lead shield (conservatively ignoring the bottom surface) has a nominal surface area of 641 square inches. The uniform loss of 4.34 cubic inches would remove a 6.8 mil layer of lead metal, corresponding to a corrosion rate of 17 mils/year in the first 21.3 weeks at temperature. Reference 7 describes that the corrosion product is actually a combination of basic lead carbonate, $Pb_3(CO_3)_2(OH)_2$, and lead carbonate, $PbCO_3$. If some of the corrosion product from LE3 is lead carbonate, less metal loss would be needed to account for the observed weight gain. In addition, analysis of the lead shield corrosion product from the second life extension package identified up to 10 wt% chlorine was present. The slight discoloration of the LE3 lead shield corrosion product suggests some impurities are also present. Such impurities would further reduce the amount of metal loss for the observed weight gain. Therefore, a 200g weight gain of the LE3 lead shield is consistent with the short-term high corrosion rates measured in Reference 7. Note, however, that these corrosion

Figure 5. Progression of lead shield corrosion. Corrosion was uniformly heavy by week 26, and the upper portion (adjacent to the upper fiberboard assembly) gradually darkened somewhat by week 109. Very little change has been observed since that time. The corrosion thickness on the bottom decreases toward the center (e).

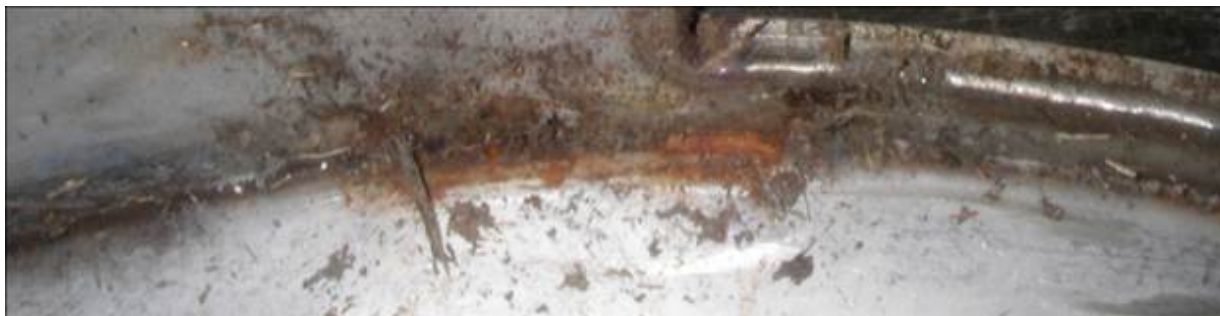
- After 109 weeks in test, corrosion was observed on the drum interior at the bottom crevice (Figure 6). This corrosion is not associated with any fabrication weld, and has not grown through-wall.

While limited corrosion was observed on the LE3 drum, it is noted that corrosion also occurred on the drums of the first two life extension packages. In comparison, the LE3 drum began corroding later, and has corroded less than the other two packages. Some of this corrosion is observed in areas where the drum was modified, and may be related to the modification activities, although some is also associated with non-modified areas. Corrosion of the stainless steel drum might be expected if moisture migration within the fiberboard leads to the concentration of chlorides on the drum surface, or from biological influences. However, the corrosion observed in LE3 is less severe than that observed in the earlier packages, and is judged to not represent a challenge to the drum integrity.

Figure 6. Corrosion of the drum interior along the bottom crevice, observed after 109 weeks in test.

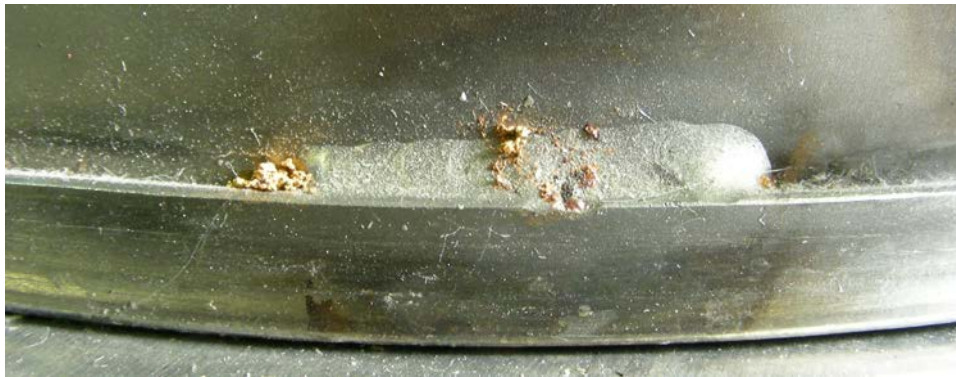
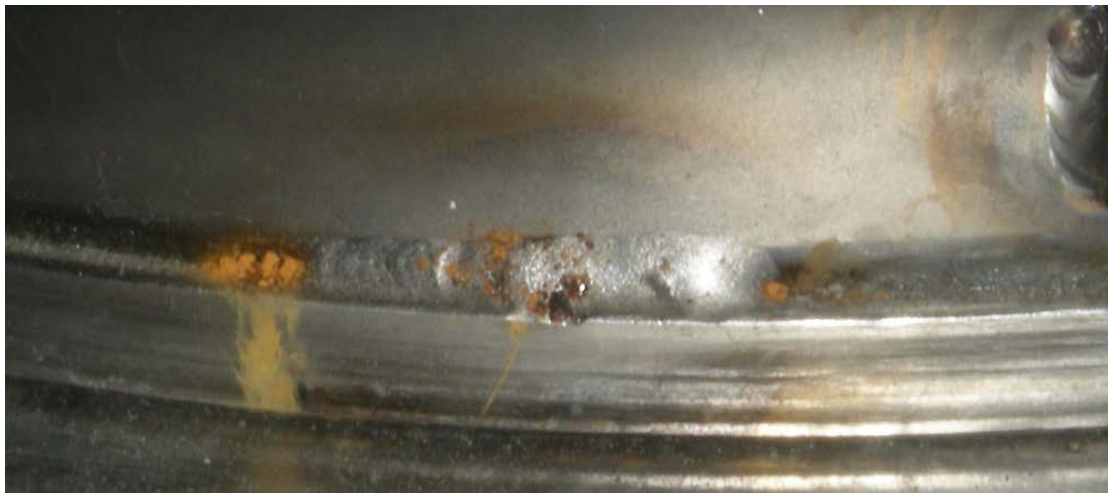
- After 119 weeks in test, possible corrosion was observed on one stitch weld along the bottom edge of the drum exterior (Figure 7). After 151 weeks, additional corrosion was observed on the same stitch weld and on additional stitch welds.

Figure 7. Corrosion of the drum exterior at a stitch weld along the bottom edge, observed after 119 weeks in test (a). After 151 weeks in test, some additional corrosion is observed at this location (b).

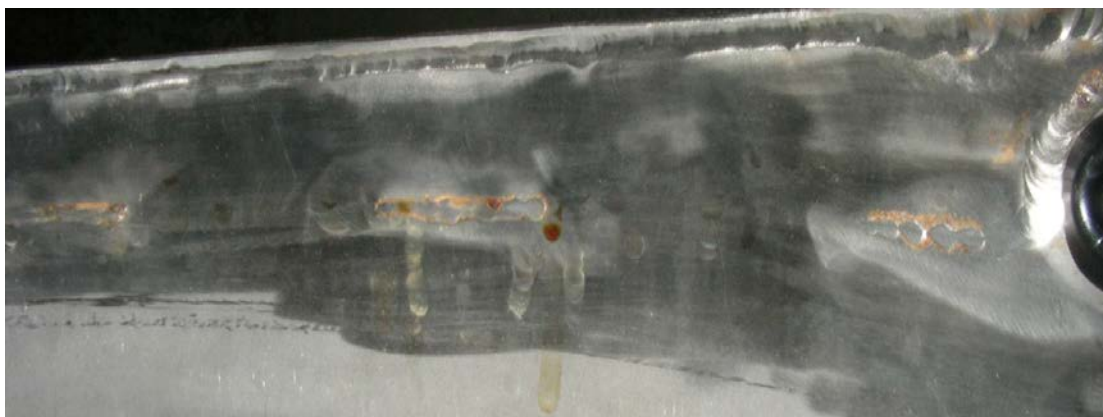
Two conditions have developed that are not consistent with package certification requirements. The axial gap at the top of the package increased to a maximum value of 1.549 inches, exceeding the 1 inch criterion. In addition, staining and/or corrosion have formed in a few spots on the drum. However, the package remains capable of performing its function. Aging of this package continues.

- After 190 weeks in test, staining and/or corrosion was observed on the drum interior at the top flange stitch welds (Figure 8).

Figure 8. Corrosion / staining of the drum interior at the upper flange stitch welds, observed after 190 weeks in test.

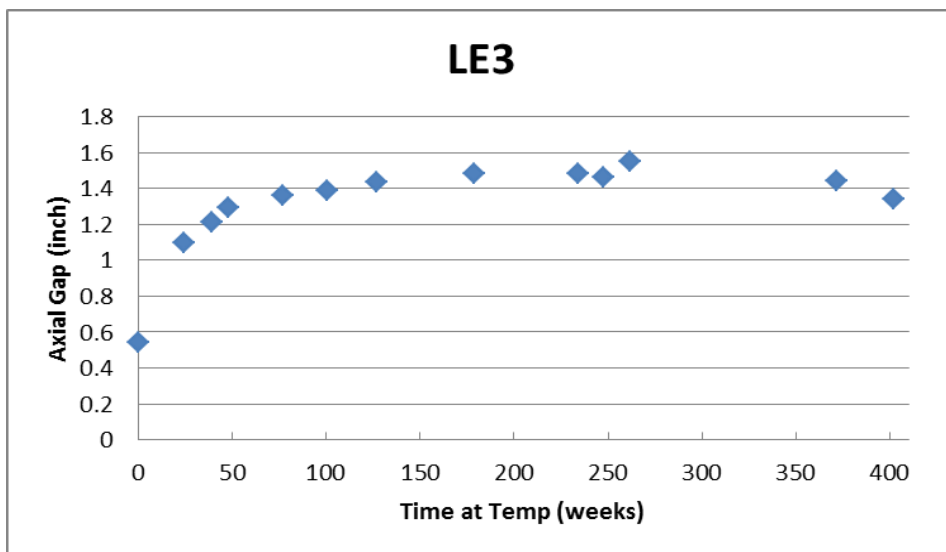
Related to the change in fiberboard height is the change in axial gap at the top of the package. The axial gap is plotted in Figure 19. The baseline axial gap is smaller than nominal (0.545 inch vs 0.8 inch). During initial assembly, the axial gap was smaller on one side (0.459 inch) and interfered with drum closure such that the closure bolts were used to compress the fiberboard somewhat and pull the lid tight. From this extreme axial gap condition, interpolation of the data indicates the axial gap exceeded 1 inch after ~20 weeks at temperature. This 1 inch threshold is taken as an action point for packages in service to investigate whether significant package degradation has occurred. The axial gap in LE3 continued to increase, with a maximum value of 1.549 inches after 262 weeks at temperature.

Figure 19. LE3 axial gap change over time. Interpolation indicates the axial gap exceeded 1 inch at ~20 weeks
