# Examination of Shipping Package 9975-04985

August 2017

SRNL-STI-2017-00514, Revision 0

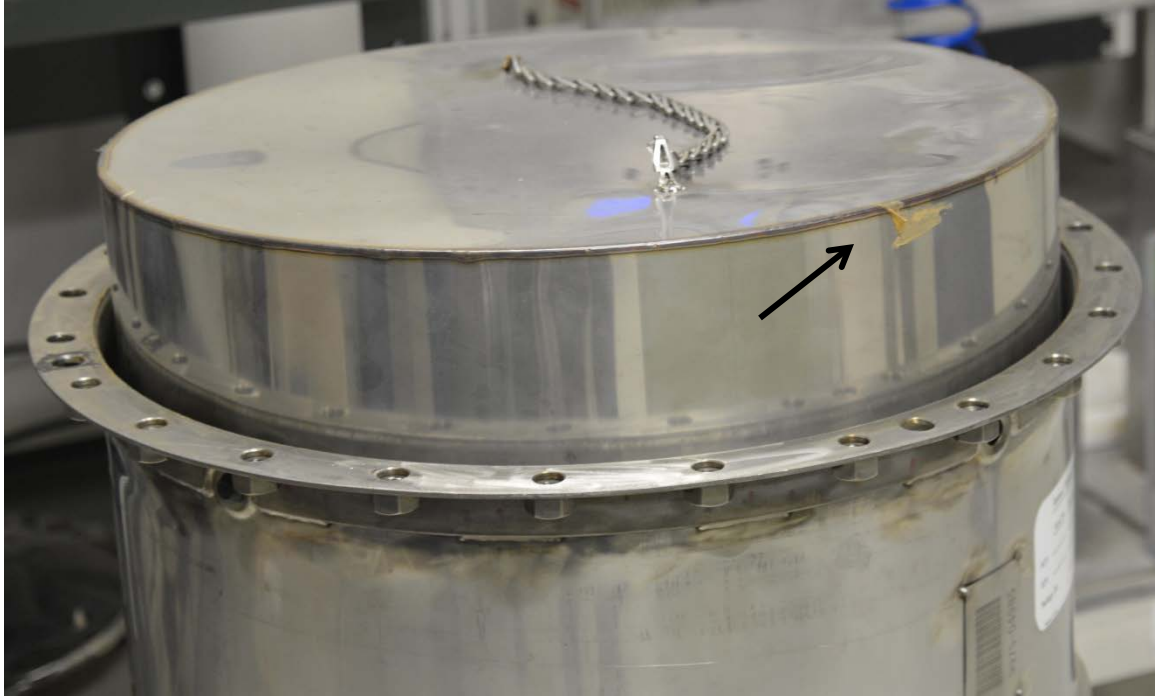
- The upper fiberboard assembly did not come out smoothly - it required two operators to remove. The fit to the shield was very tight. Some effort was also required to re-install the fiberboard (Figure 1).
- There was a heavy layer of corrosion product (lead carbonate) on the shield, and a significant amount fell loose when the fiberboard assembly was removed. It was noted that a cloud of lead carbonate was generated by removing the fiberboard assembly. Additional lead carbonate was observed on the ID surface of the upper fiberboard assembly (Figure 2), on the shield lid and on the lower fiberboard assembly (Figure 3).

Figure 1. 9975-04985 with upper fiberboard assembly partially replaced. Note the tape on the air shield (arrow). Photo taken by KAC personnel during surveillance.

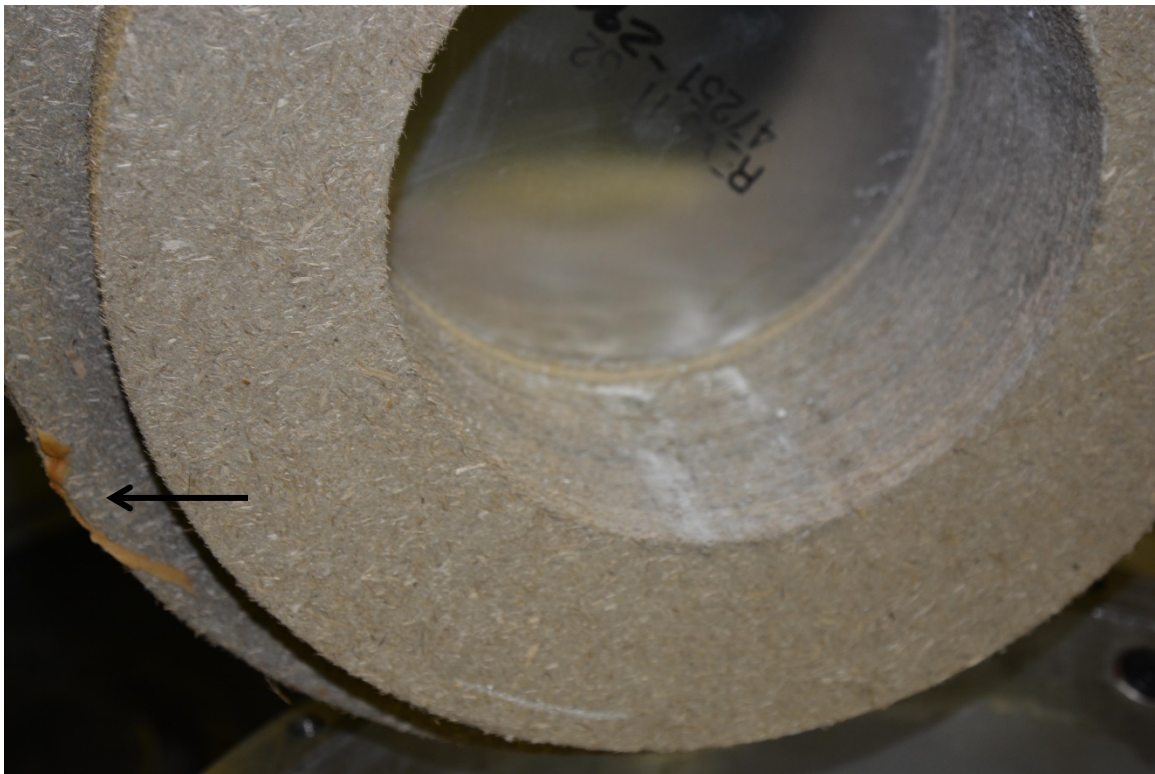
Comparing the dimensions of the shield and upper fiberboard assembly shows clearance existed at all points of measurement, although the second set of upper fiberboard assembly measurements shows a degree of eccentricity. It is unknown which fiberboard dimension would have originally aligned with which shield dimension. The diametral clearance for any combination of measured values is smaller than the minimum value based on drawing dimensions, although it is recognized that fiberboard dimensions may change in service and are not bound to original fabrication tolerances. The linear white streaks shown in Figure 2 indicate that local areas existed where the upper fiberboard assembly was tight to the shield.

Figure 2. Lead carbonate deposits noted on the upper fiberboard assembly ID surface during surveillance. The linear orientation of the white deposits indicates a tight fit to the shield. Fibrous deposits are also shown (arrow). Photo taken by KAC personnel during surveillance.

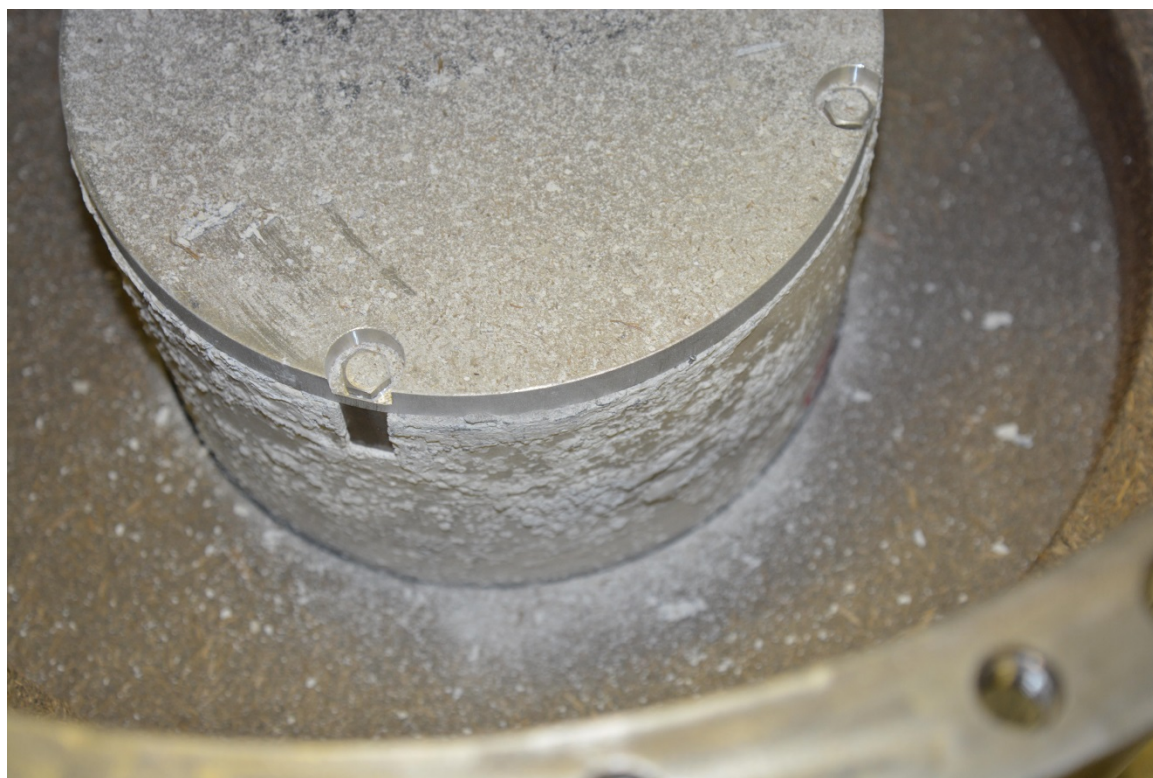
Figure 3. Lead carbonate deposits from the shield which ended up on the lower fiberboard assembly and shield lid. Photo taken by KAC personnel during surveillance.

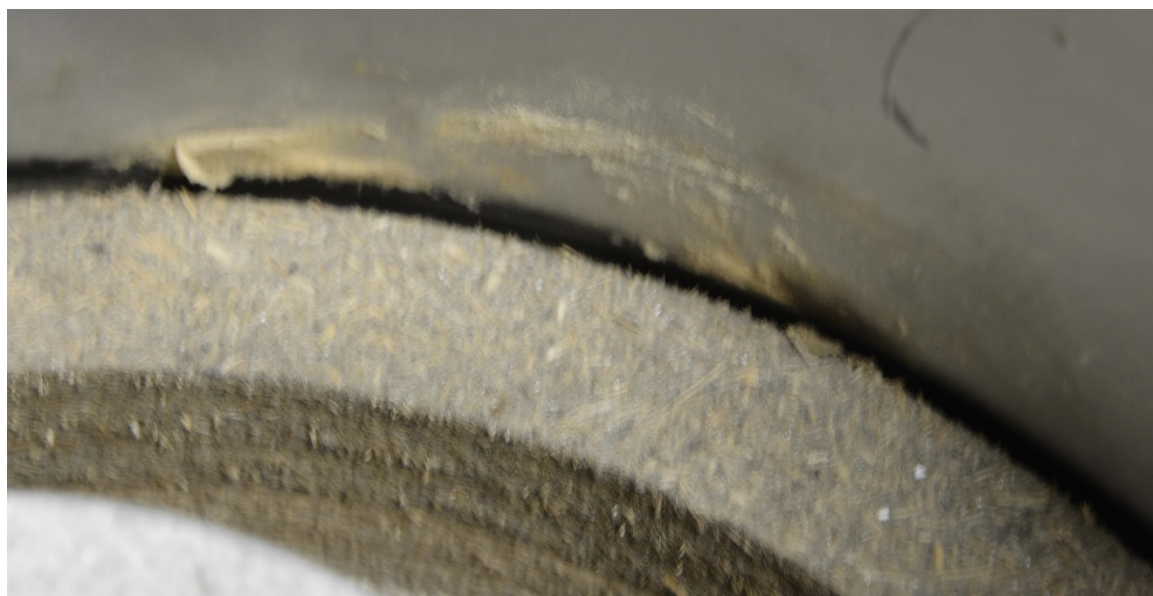
In an additional observation, foreign material was noted on the fiberboard assemblies and drum interior (Figures 1, 2, 4 – 6).

Figure 4. Fibrous deposit on drum interior surface. Photo taken by KAC personnel during surveillance.

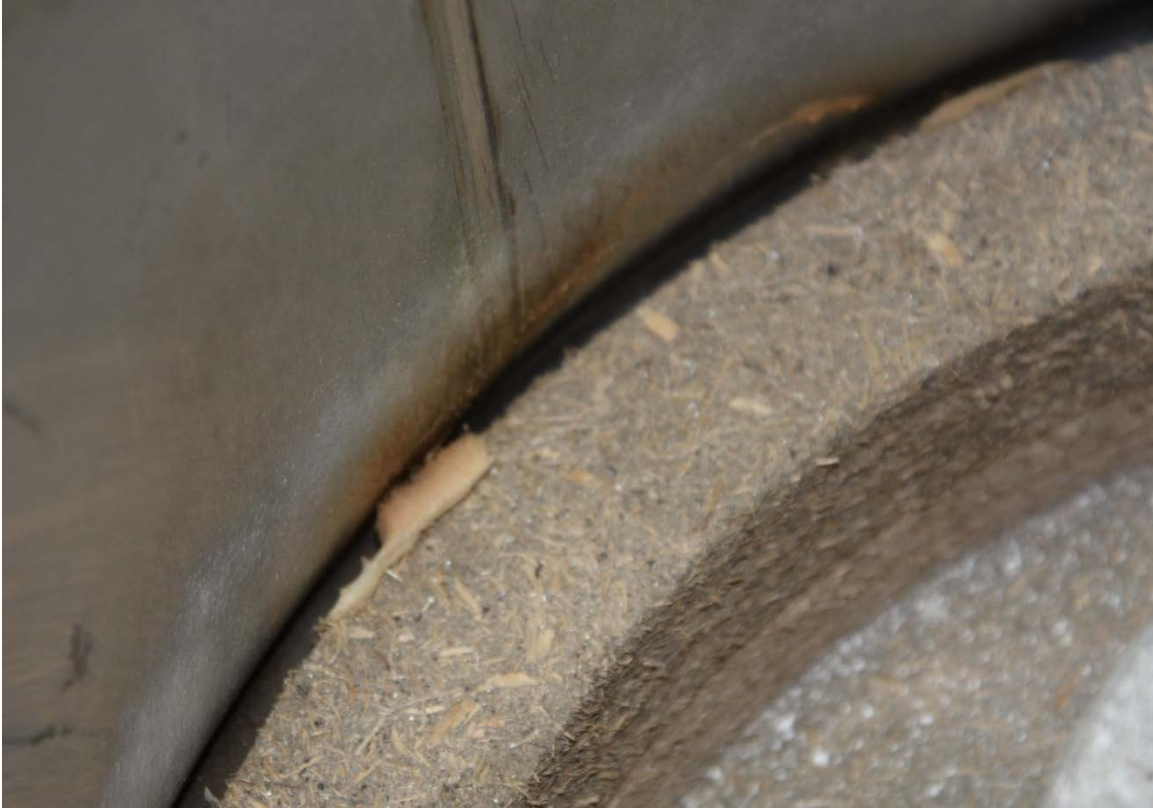
Figure 5. Fibrous deposits on lower fiberboard assembly. Photo taken by KAC personnel during surveillance.

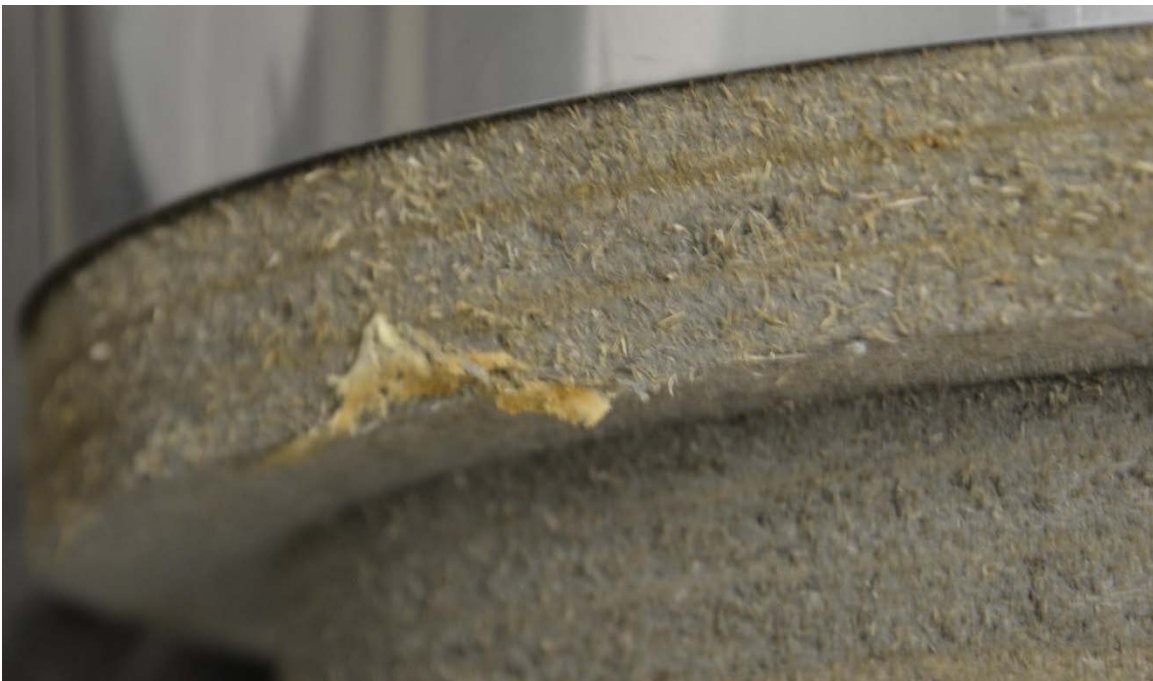
Figure 6. Fibrous deposits on upper fiberboard assembly. Photo taken by KAC personnel during surveillance.

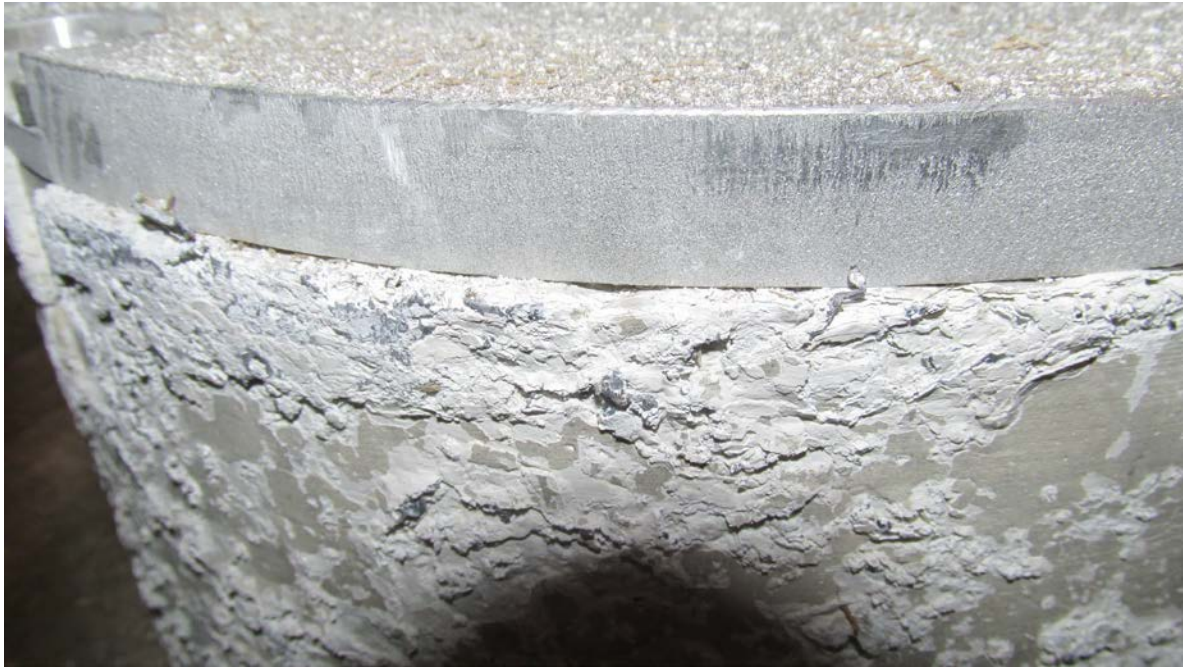
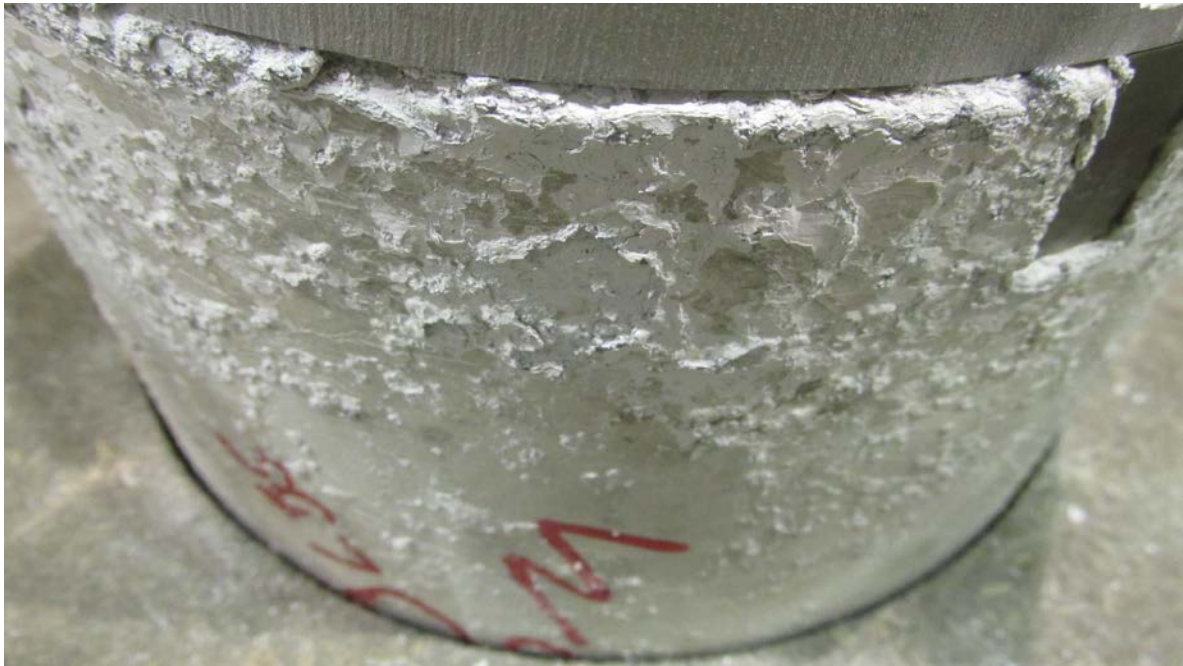
All visible lead surfaces were covered with lead carbonate. Some areas, especially along the top edge had flaked or blistered off, but additional lead carbonate remained. Most of the flaking and blistering had occurred in the upper 2 – 3 inches of the shield, which displayed an overall rougher surface (Figure 7).

Figure 7. Roughness and irregularities of the shield surface, especially in the top ~2 inches.

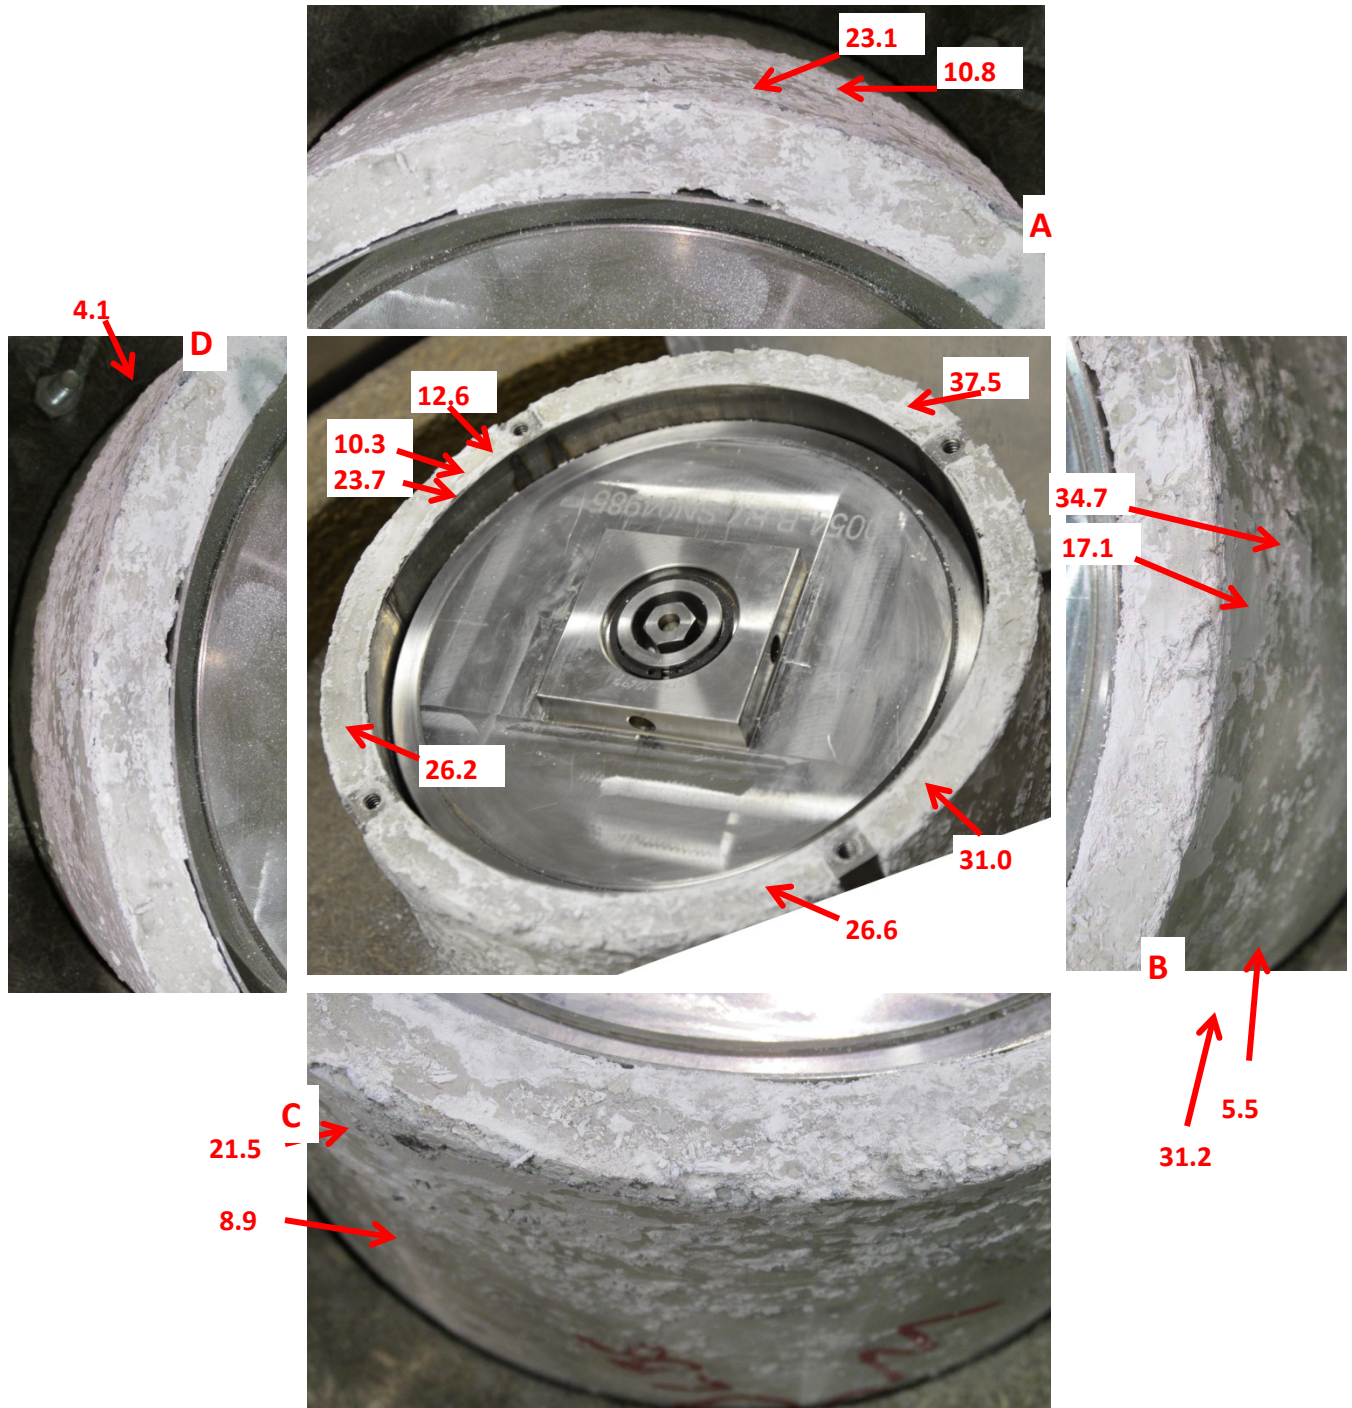
The thickness of the lead carbonate remaining on the shield was measured with an Elcometer 345 FN coating thickness gage, which uses an eddy current technique. The probe was zeroed on a non-ferrous base material, and then verified with a non-metallic shim set. The gage was then used to measure the lead carbonate thickness at multiple locations, as illustrated in Figure 8. These locations included locations of previous flaking. The lead carbonate thickness ranged from 0.010 to 0.038 inch on the top edge of the shield, and from 0.004 to 0.035 inch on the side of the shield. The thinner readings were generally taken at sites of prior flaking, or more than ~2 inches from the top of the shield

The upper region of the shield sidewall had lead carbonate thicknesses up to 0.038 inch. The thickness of lead lost to corrosion is approximately 45% of the corrosion product thickness if lead carbonate ( $\text{PbCO}_3$ ) is formed, and approximately 40% of the corrosion product thickness if basic lead carbonate ( $\text{Pb}_3(\text{CO}_3)_2(\text{OH})_2$ ) is formed [3]. Both of these corrosion products could be formed, although basic lead carbonate has generally been identified on shields where the corrosion product was analyzed [4, for example]. The production of 0.038 inch of corrosion product would therefore consume up to 0.017 inch of lead. Package 9975-04985 was in service (following leak test) for about 9.7 years, which gives an average corrosion rate of 0.0018

inch/year based on the thickest measured corrosion, and about 0.0013 inch/year for the more average thickness of about 0.028 inch measured in the upper region of the shield. Reference 3 recommended a corrosion rate of 0.002 inch/year as a conservative estimate for 9975 packages. The observed behavior falls within this rate.

\* These locations are illustrated in Figure 8. Each location is approximately ½ inch counterclockwise from a threaded insert and approximately ½ inch from the top of the shield.

Figure 8. Lead carbonate thickness measurements taken with the coating thickness gage. All measurements are in mils. The arrows identify the approximate measurement location. The four letters (A, B, C, D) show the approximate location of shield thickness measurements and lead carbonate thickness measurements made after some of the lead carbonate was scraped off. Center photo taken by KAC personnel during surveillance.

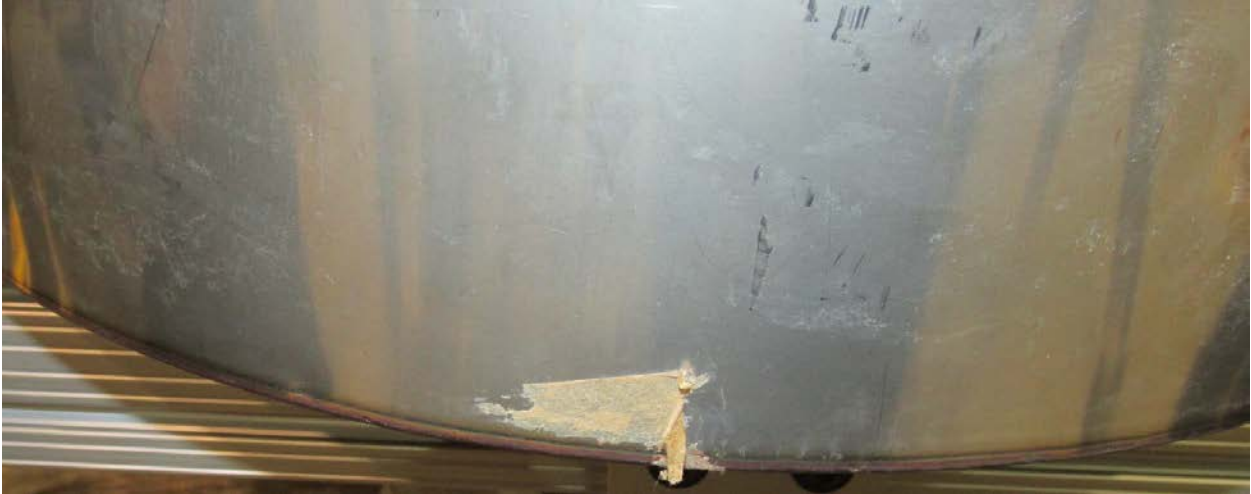
The foreign material on the fiberboard assemblies and drum interior was visually examined. The object adherent to the upper fiberboard assembly air shield (Figure 9) was identified as tape. It lies along the top edge on the side of the air shield and has a straight edge and two irregular torn edges. One of the torn edges follows the top edge of the air shield. Based on its position, it appears a stray piece of tape (probably masking tape) became stuck to the top and side of the upper assembly. Upon removal from the top of the air shield, the portion that was stuck to the side tore off and remained in place.

Figure 9. Foreign material on the upper fiberboard assembly air shield, which was identified visually as tape. The upper assembly is upside down in this photo.

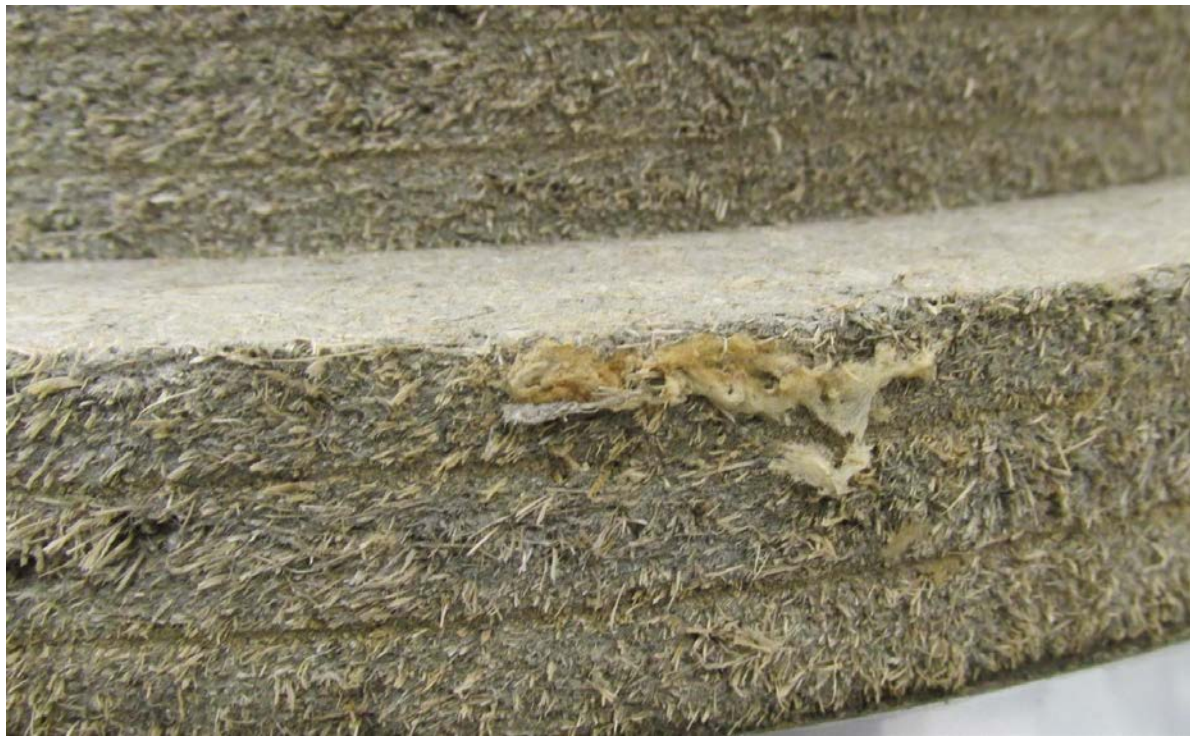
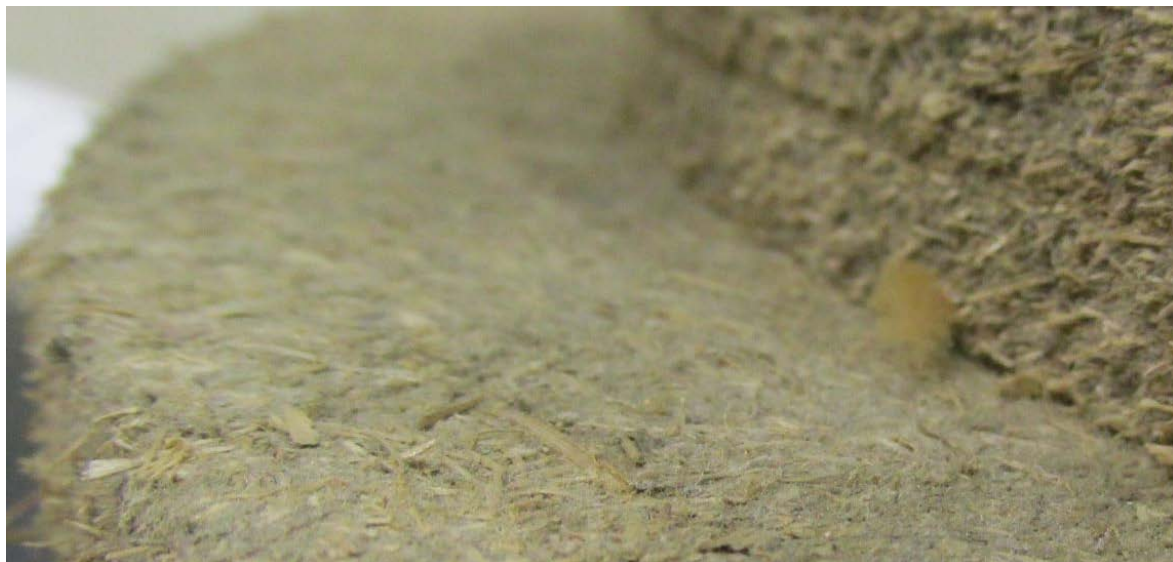
Additional foreign material was observed in two locations on the outer step of the upper fiberboard assembly (Figure 10). The material in both these locations had a “fluffy” appearance. A portion of the larger object was taken for further examination. Similar “fluffy” material was observed in three locations on the outer step of the lower fiberboard assembly and adjacent drum surface (Figure 11). In addition, one additional foreign object with more of a “wispy” appearance was observed on the outer step of the lower fiberboard assembly (Figure 12). This “wispy” object was also taken for further examination.

Figure 10. “Fluffy” foreign material observed in two locations (a, b) on the upper fiberboard assembly

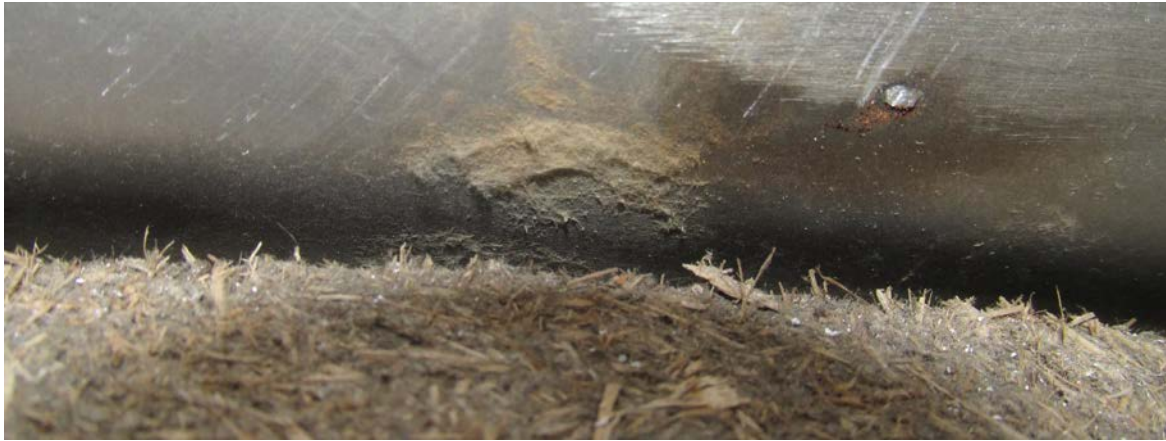
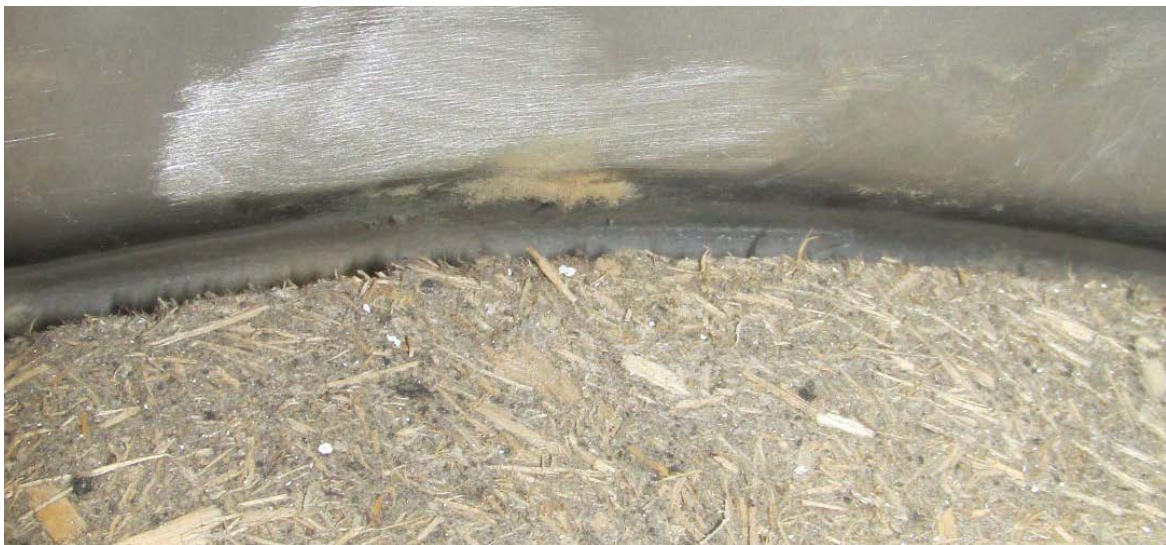
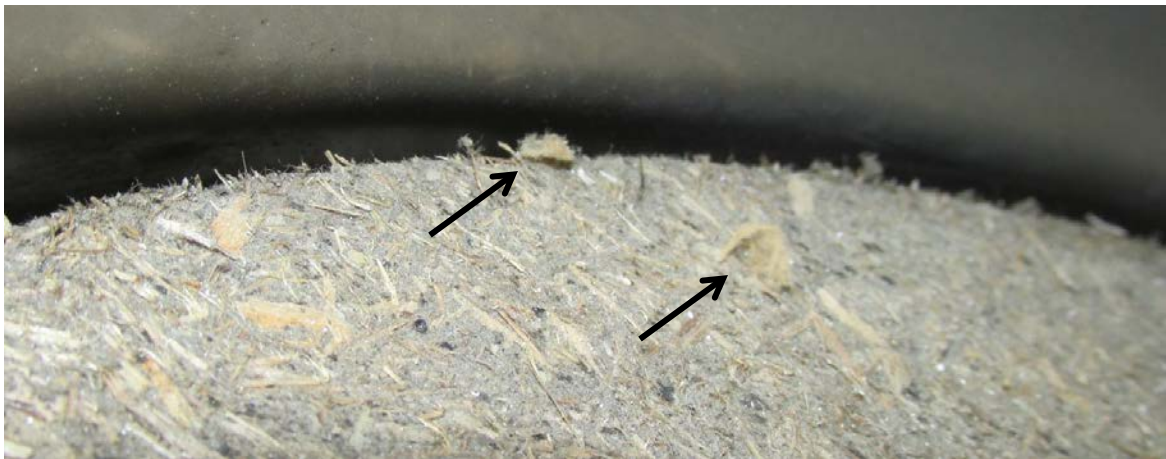
Figure 11. “Fluffy” foreign material observed on the drum (a, b) and lower fiberboard assembly (c).

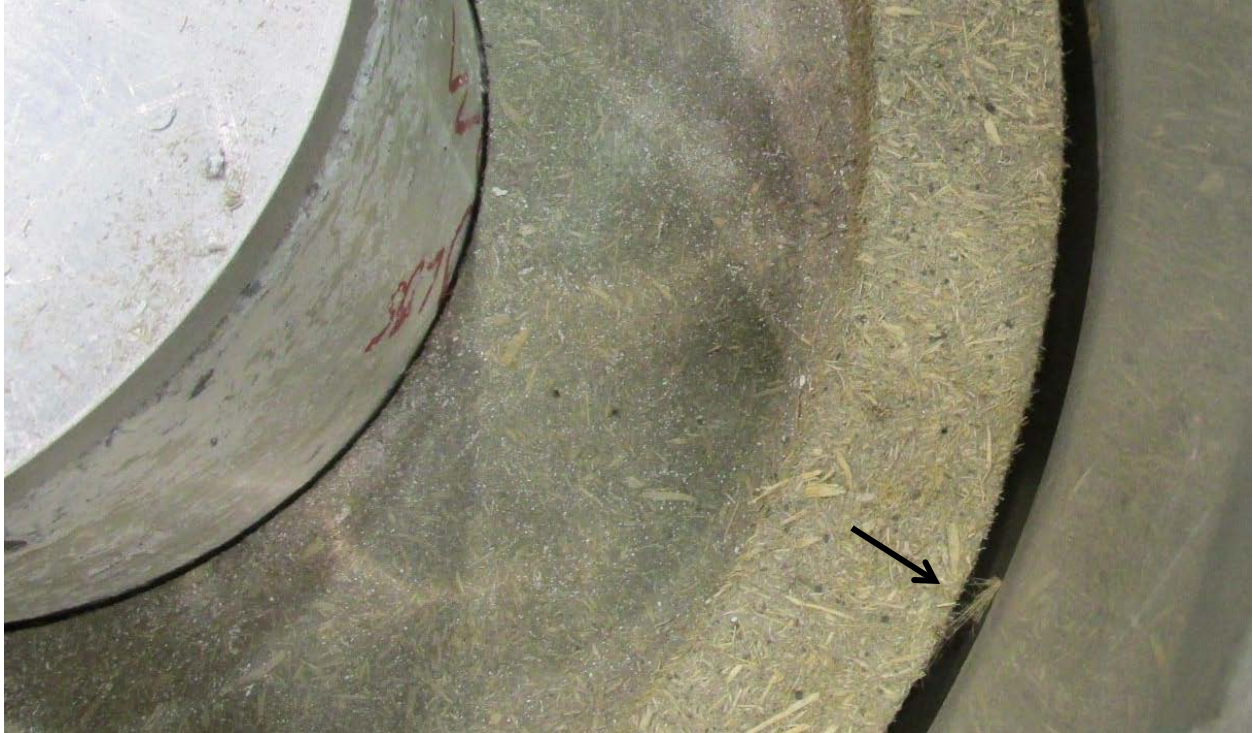
Figure 12. “Wispy” foreign material observed on the lower fiberboard assembly.

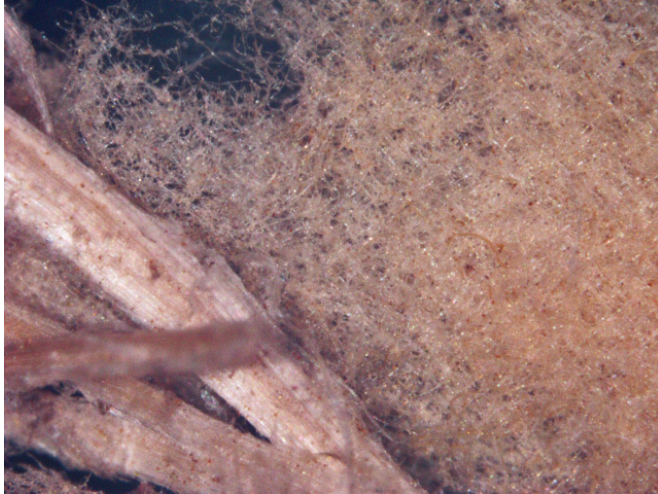
The two foreign object samples were examined at low magnification (up to 100X). The “fluffy” material consists of a few chips of cane fiber enmeshed in a larger quantity of much finer fibers (Figure 13). In comparison, a sample of known cane fiberboard viewed at the same

The apparent foreign material that was observed on the drum and fiberboard assemblies appears to originate from the cane fiberboard. Both incorporate a combination of larger chips and finer fibers, although the foreign material has a much higher concentration of finer fibers. The larger chips are relatively intact sections of cane, which in turn appear to be made up of numerous fine fibers. The cane fiberboard sample also had a number of small particles throughout, presumably from the binders used in its manufacture. Similar particles were observed in the collected sample, but were less concentrated among the more numerous finer fibers. The collected sample is consistent with cane fiberboard material in which the finer fibers have been selectively concentrated, or most of the coarser cane pieces have been "teased" or separated into their finer constituent fibers.

Figure 13. “Fluffy” material removed from the upper fiberboard assembly, photographed at 50X.

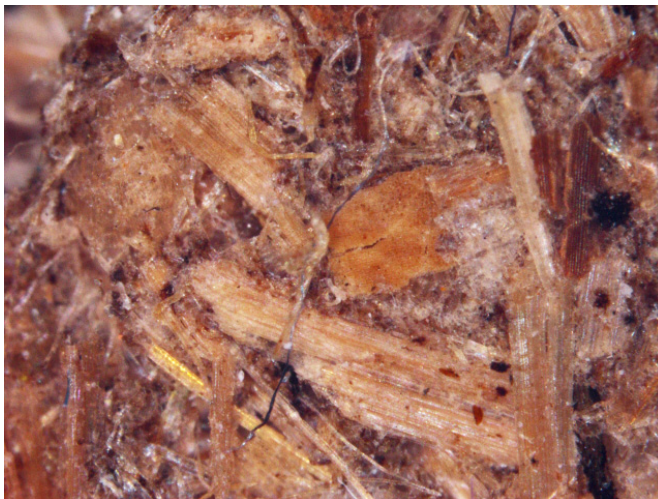
magnification has a similar appearance, although it contains a much higher ratio of larger chips compared to finer fibers (Figure 14). The larger cane fiber chips are composed of a large number of fine parallel fibers, which can separate under some circumstances. The “fluffy” material appears to be cane fiber which has been mostly broken down physically to its finest constituent fibers. The wispy sample contains a number of straight fibers that are intermediate in size to the cane fiber chips and the finer fibers. This sample also has some finer fibers attached to each straight section (Figure 15). It appears to be a cane fiber chip that has begun to break down physically, but has not yet been reduced to fine fibers.

Figure 14. Sample of cane fiberboard photographed at 50X.

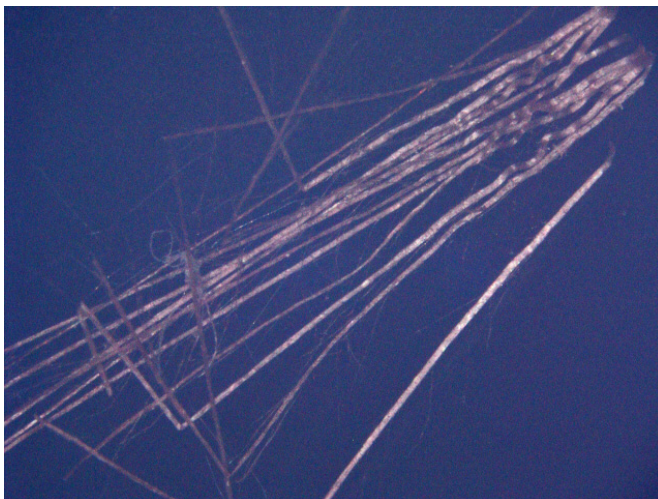
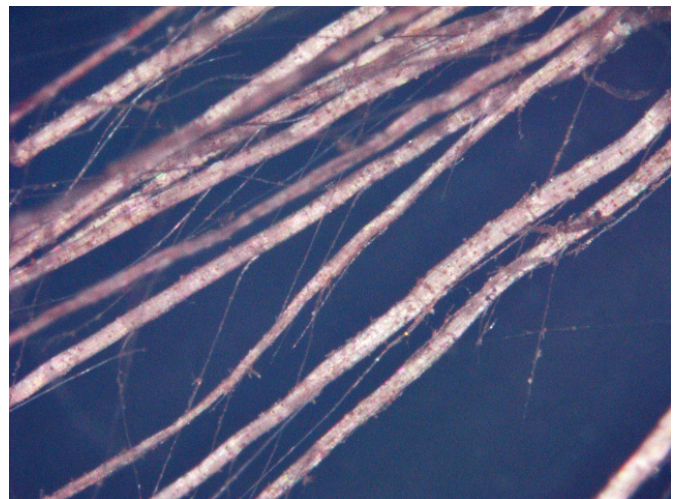
Figure 15. “Wispy” material removed from the lower fiberboard assembly, photographed at 15X (a) and 50X (b).
