**OCTOBER 1, 1989 TORNADO AT  
THE SAVANNAH RIVER SITE (U)**

**JANUARY 1990**

**Westinghouse Savannah River Company  
Savannah River Site  
Aiken, SC 29808**

WSRC-RP-89-1288

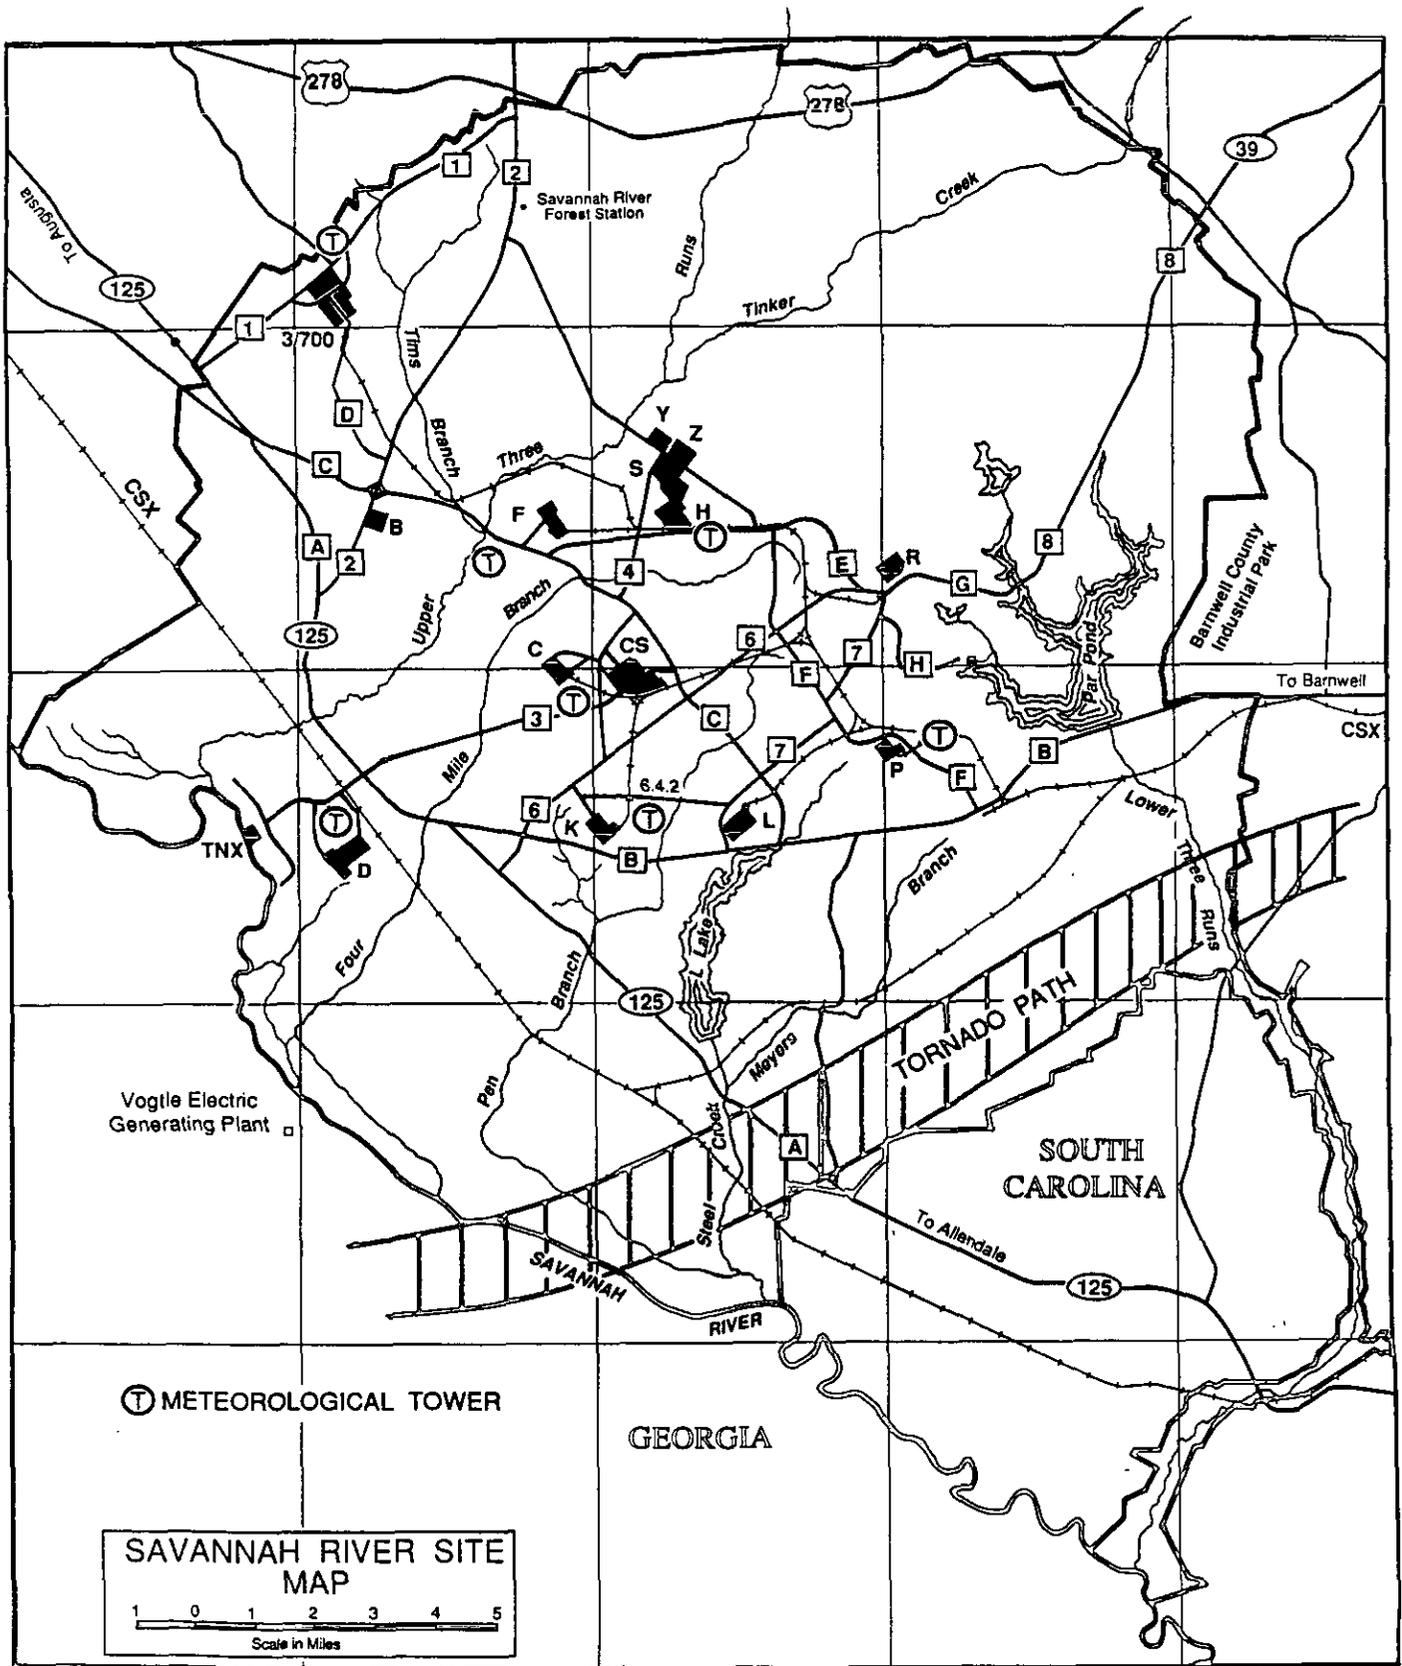
The tornado path extended across the south of the SRS from the WSW to the ENE and generally followed Road A-18 (Tennessee Road) (see Figure 1). Tree damage occurred in the Savannah River swamp near Stave Island and reports of damage were received from areas in Georgia west of the Savannah River. The furthest east of any reported property damage was offsite near Snelling, SC on the east side of the SRS. It is possible that the tornado touched down in rural areas outside the SRS, but this was not reported.

Figure 1. Swath of damage (hashed area) of the October 1, 1989 tornado at the SRS.

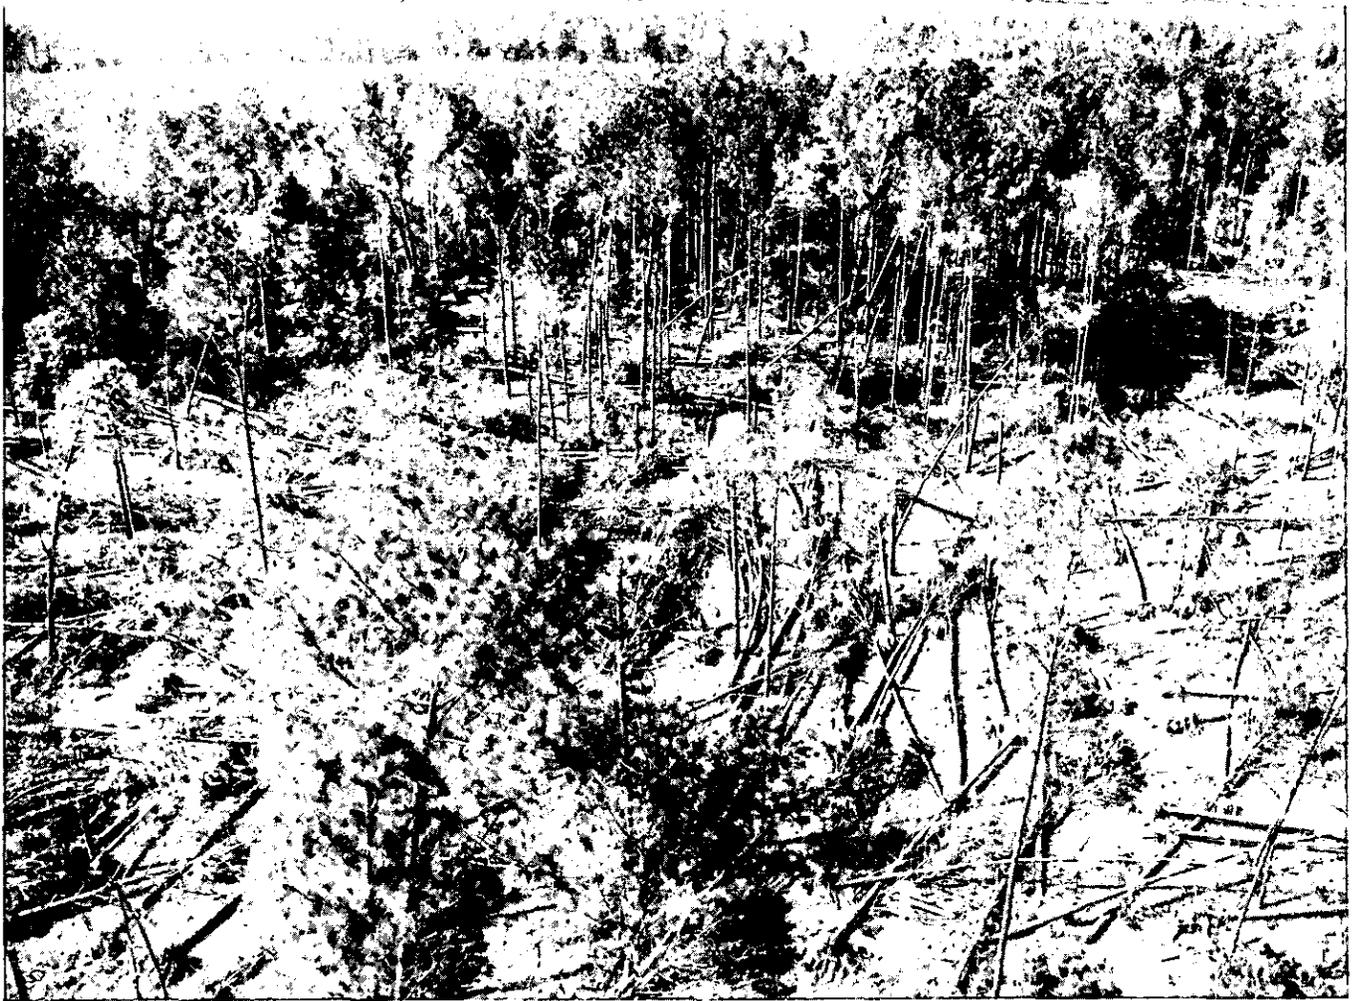
Aerial photos of several tree damaged areas are shown in Figures 2, 3, 4, 5, and 6. Figure 2 shows pine trees scattered in several directions. Closer inspection reveals a preferential orientation of trunks in two directions approximately 90 degrees apart. Figures 3 and 4 show areas of uprooted and broken off pine trees with trunks lying about 70 degrees apart. Figure 5 shows a stand of mainly hardwoods mowed over by the storm. Figure 6 shows an extensive area of downed pine trees. As in Figures 3 and 4, the trees have fallen mainly in two directions separated by about 70 degrees.

directions strongly suggest that the small scale and highly cyclonic wind circulation of a tornado passed over the area. On a slightly smaller scale, Figure 2 shows many directions of felled trees indicative of tornado damage.

**Figure 2. Aerial view showing multiple tree-fall directions.**

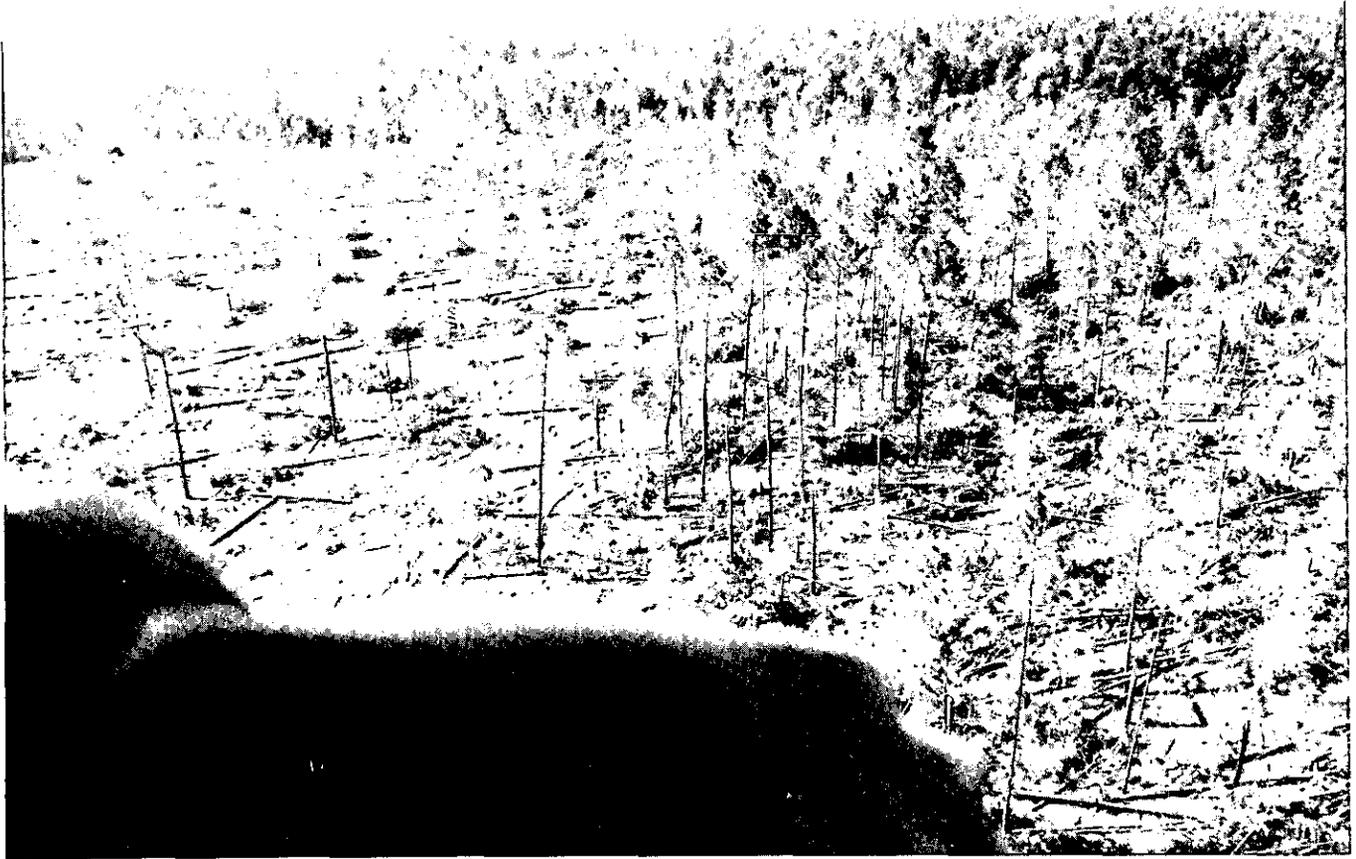
**Figure 4. Tree-falls approximately 70 degrees apart.**

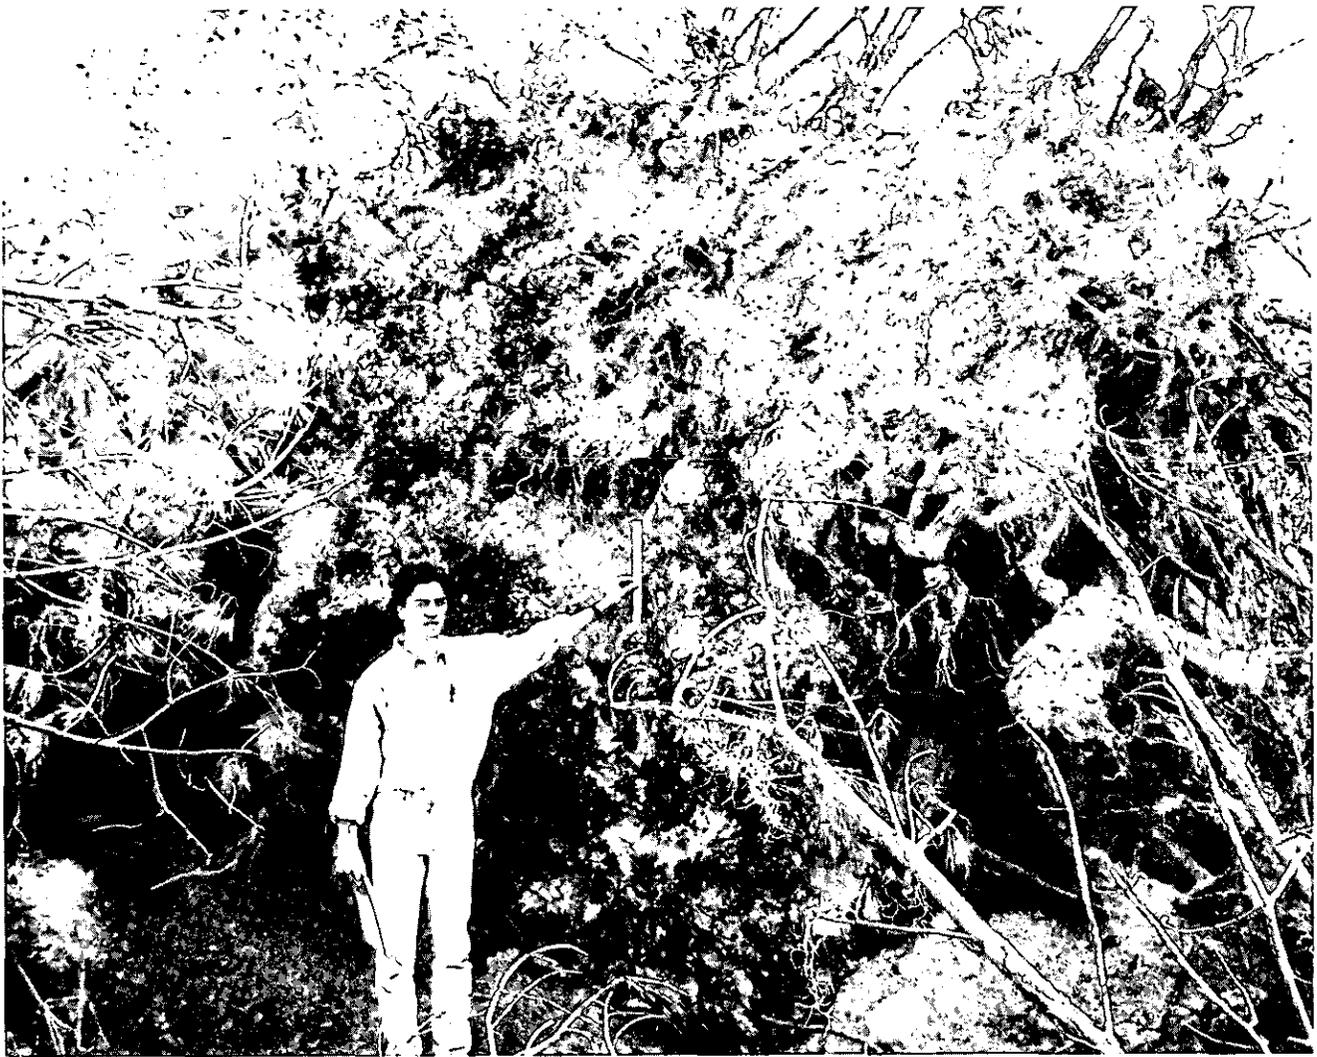
Figures 8, 9, 10, 11, 12 and 13 were taken in the mature forest 1/4 mile south of Gate 23 on Road 9. This area is significant because no evidence of surface high winds was found. Rather, only the taller, mature trees were felled or broken. This pattern implies that the tornado was above the ground in this area. Figure 9 shows the large number of trees broken off 15 to 25 ft above the ground in this area. The branches on the ground in the picture's foreground are from upper sections of tree trunks.

**Figure 8.** An approximately 15-ft-high root ball resultant from the fall of four pine trees just south of Gate 23 on Road 9. The tree diameters were (1) 24 in., (2) 18 in., and (1) 8 in.. (The height of the ruler and person are 15 in. and 6 ft, respectively.)

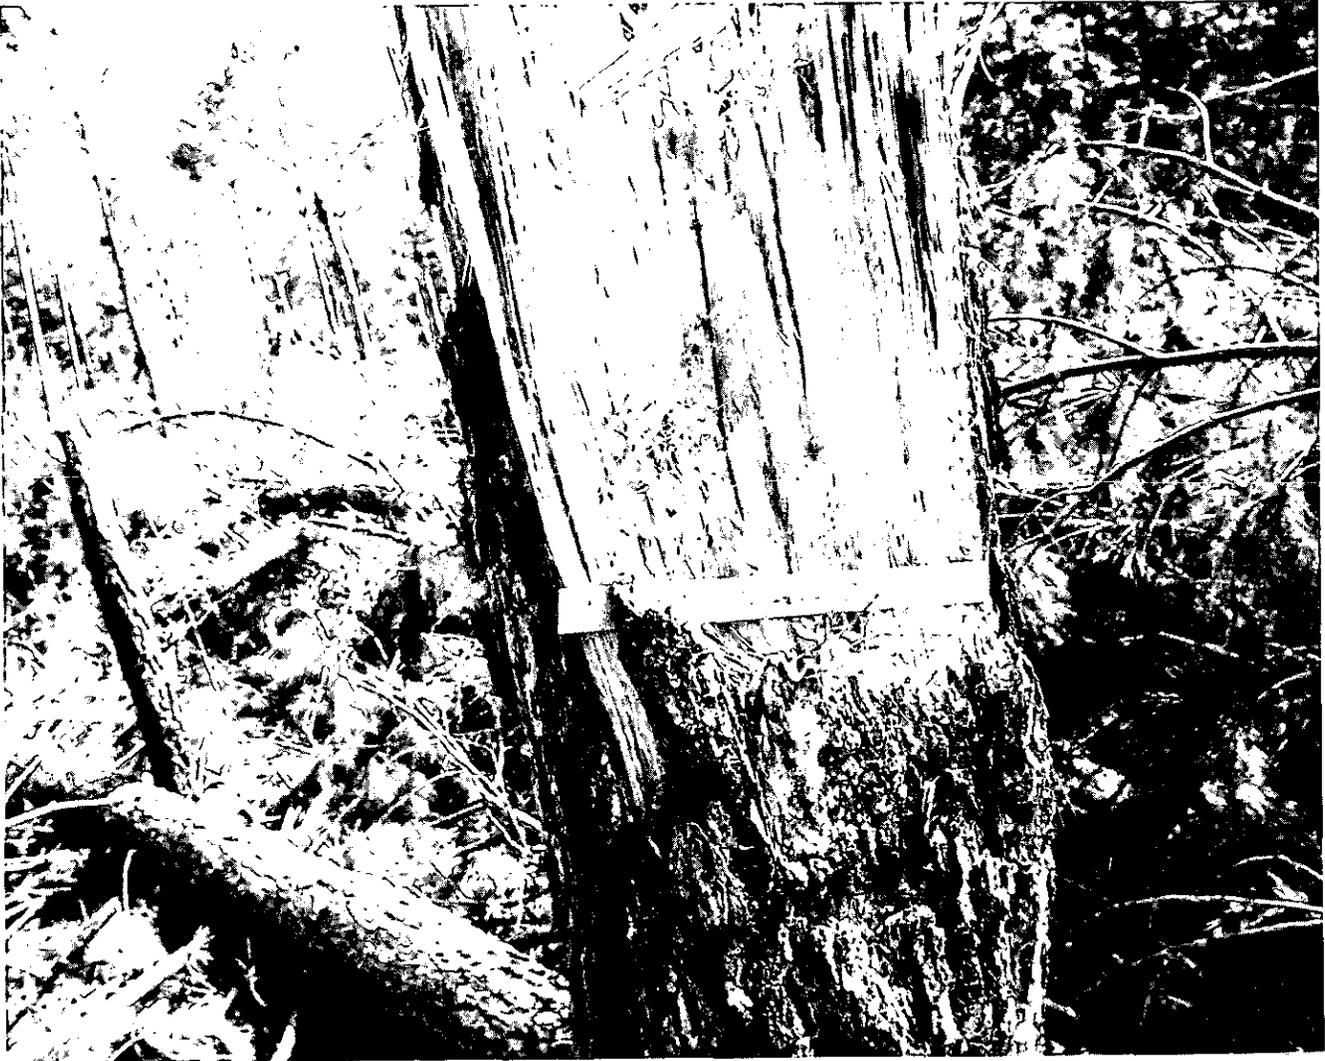
Figures 10, 12 and 13 show some of the largest pine trees destroyed by the tornado. Figures 10 and 12 show 18-inch-diameter pines broken off 6 ft and 18 ft above ground, respectively. Figure 13 is a 13-inch pine tree felled by the tornado.

**Figure 10. Closeup of broken pine over 15 in. (ruler length) in diameter just south of Gate 23 on Road 9.**

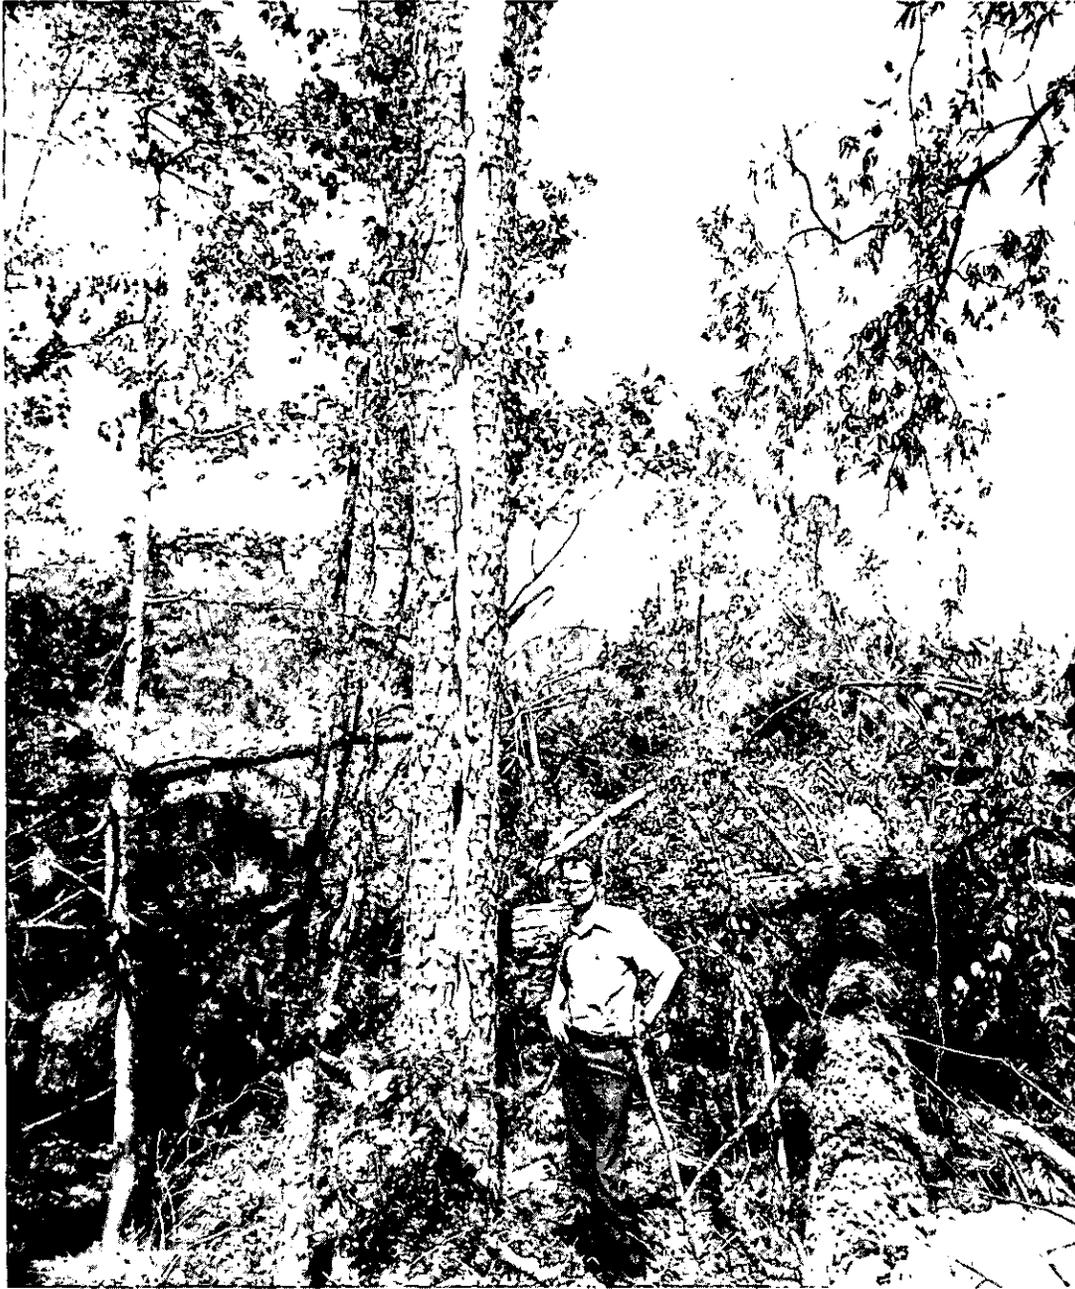
**Figure 12. Large snapped and split pine tree with a 6-ft person near Gate 23.**

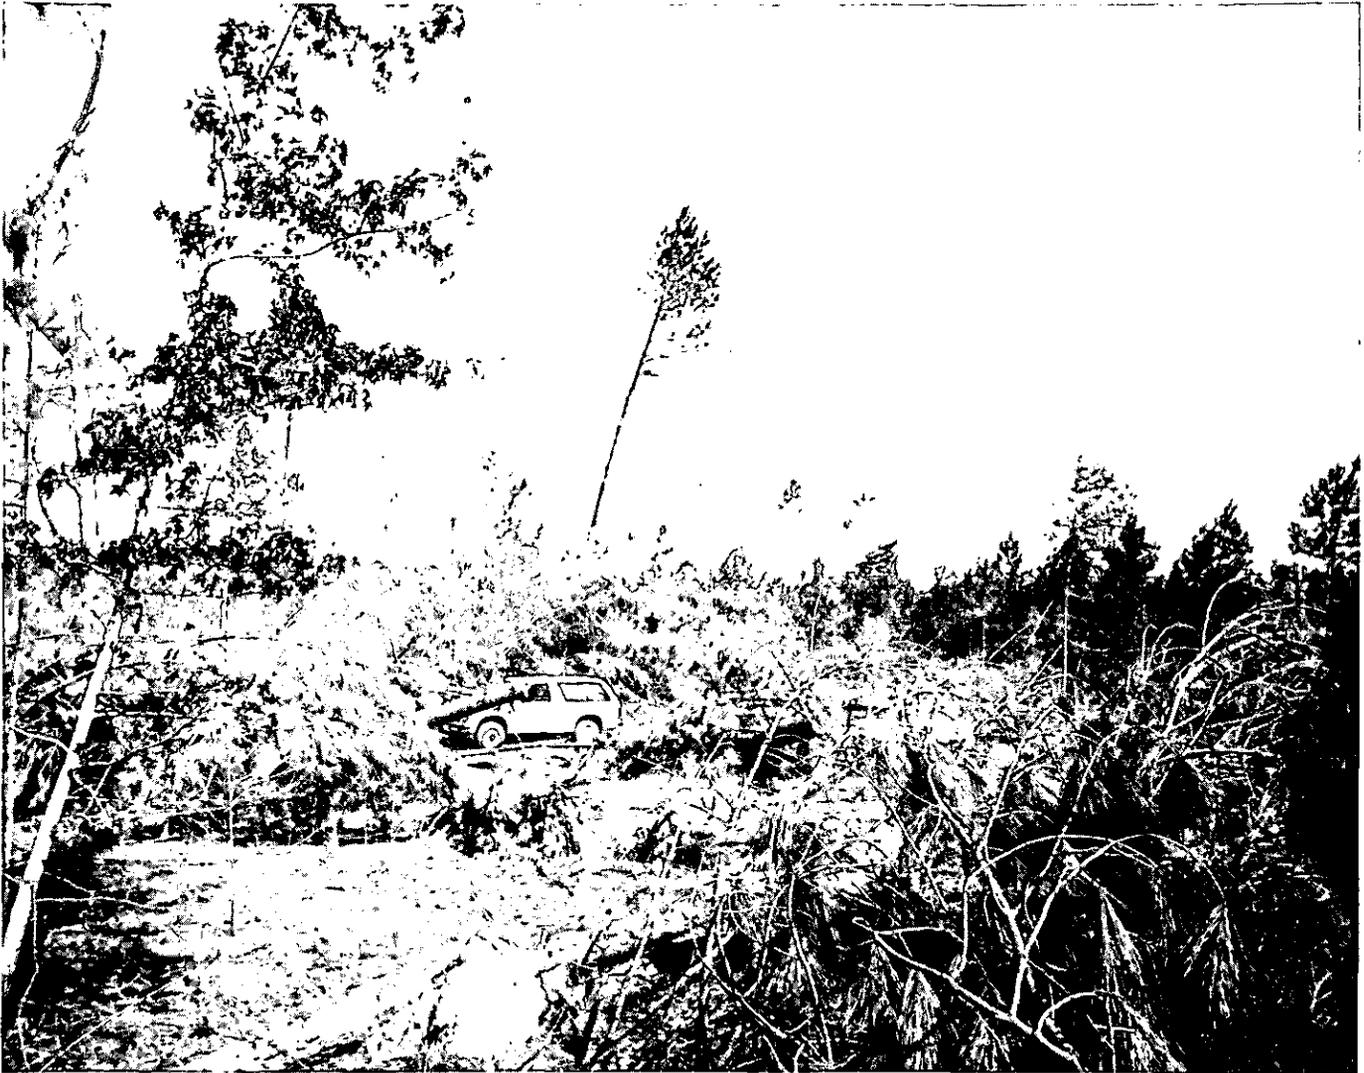
The photographs in Figures 14 and 15 were taken about 1 mile southeast of Gate 23 off of Road A-18. Few trees were left standing in this area, and even small trees showed the effects of high winds.

**Figure 14.** Uprooted and broken pine forest about 1 mile southeast of Gate 23 off Road A-18 (Tennessee Road). Note how few trees are standing in the distance. This damage path width was estimated to be 0.5 mile.

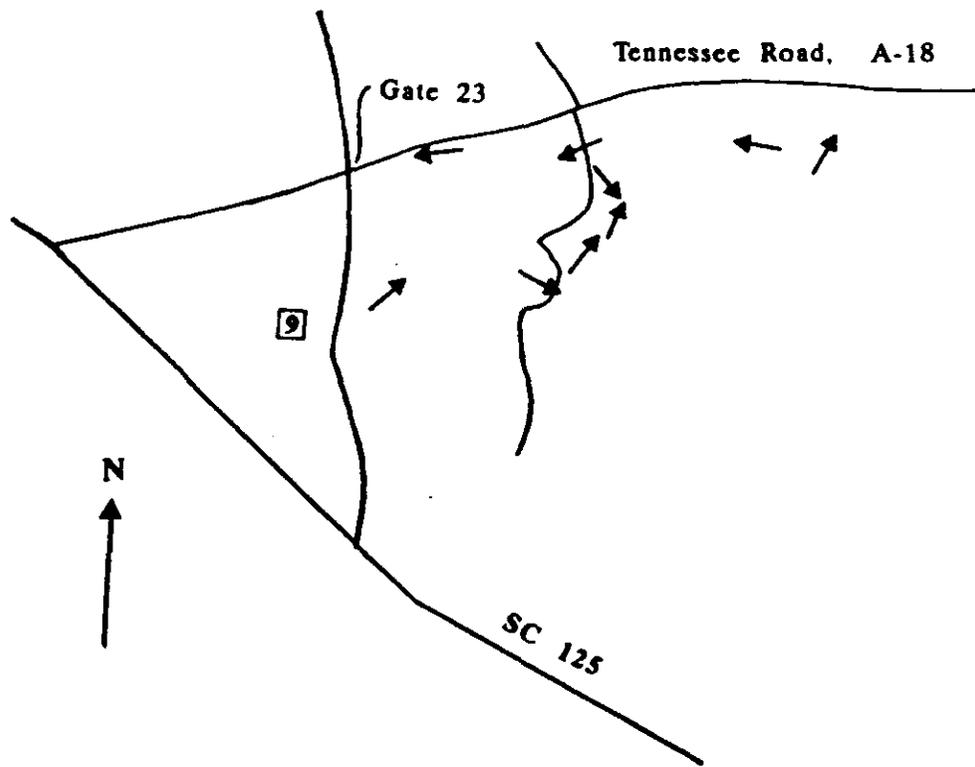
According to Fujita, tornado damage is distinguishable from downbursts by circular tree-fall patterns when viewed from above. Figure 24 shows tree fall directions in the damage swath to the east of Road 9. Arrows indicate the direction of felled trees in this area. These

Figure 24. Tree-fall directions for the area south of Tennessee Road.
