WSRC-RP-89-1311

**FINAL SUMMARY REPORT  
FOR  
1989 INSERVICE INSPECTION (ISI)  
OF  
SRS 100-P REACTOR TANK**

Issued: December 15, 1989

**SRL SAVANNAH RIVER LABORATORY, AIKEN, SC 29808**  
Westinghouse Savannah River Company  
Prepared for the U. S. Department of Energy Contract DE-AC09-88SR18035

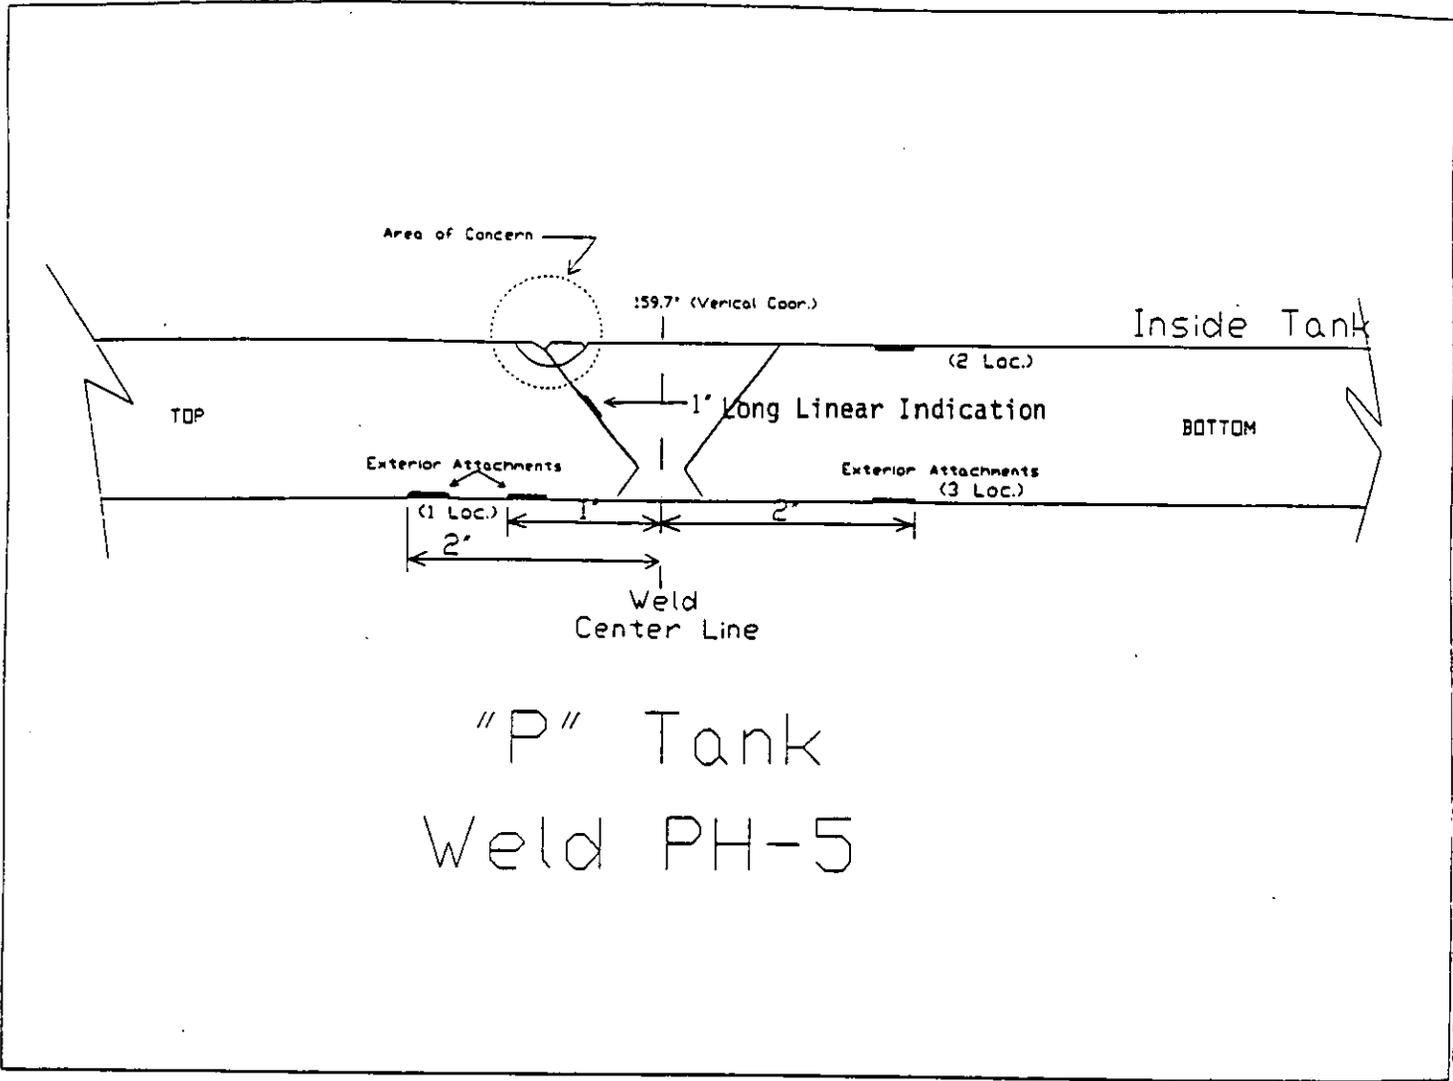
"P" Tank  
Weld PH-5

- 3.1.4. In addition to the series of reflectors noted above, a singular, linear indication approximately one inch in length was noted which was located within the weld at the fusion line between the weld and the base material. This indication was believed to be the remains of a weld flaw which may have been the cause for a weld repair to have been performed in this area.

3.3.2. Visual inspections which utilized the in-tank, high resolution Rees cameras were performed of the area in question in order to examine the surface condition of the weld in an attempt to determine the cause of the ET lift-off signals. The video scans covered the entire length of the questioned area and video tapes were made which will be archived as records. The visual scans revealed evidence of a weld deposit which is located at the upper edge of the weld P-H5. This weld deposit appears to have been ground flat but was not blended into the surrounding metal. As a result, distinct edges can be seen which will typically result in UT reflectors.

3.4.4. This review identified four areas of weld PH5 which showed evidence that a weld repair had been performed during the original fabrication. One of the repaired areas coincided with the area under investigation.

4.1. The origin of the UT reflectors was attributed to geometric anomalies associated with a weld repair which was performed during the original fabrication of the tank. It is believed that the repair was performed to remove welding defects prior to the tank being placed into service. This conclusion is based on the following:

4.1.3. The visual inspections show a surface configuration which is indicative of a weld repair area. A reworked area of weld is apparent which has an obviously rough surface. This is consistent with the ET data and accounts for the lift-off signals.

4.1.4. The review of the original radiographs showed that the RT's still retain a radiographic quality that allows more than adequate interpretability. Review of interval 22-23 and 23-24 of weld TBNA-EX3 indicates the presence of a weld repair area which is coincident with the area in question.

5.1. The area of concern, which starts at S=411.2 and ends at S=427.5, is not indicative of the presence of IGSCC indications. It results from a weld repair which is outside the scope of the Reactor Tank Inspection Program and is, therefore, a nonrelevant indication due to its association with a weld repair.

5.2. The indications have been classified as nonreportable but have been noted as "remarks" in the data packages as baseline information for use in future inspections.
