September 30, 2003

**CORROSION OF EXHAUST AND FILTRATION EQUIPMENT  
IN A RADIOACTIVE WASTE INCINERATOR**

Charles F. Jenkins  
Westinghouse Savannah River Company

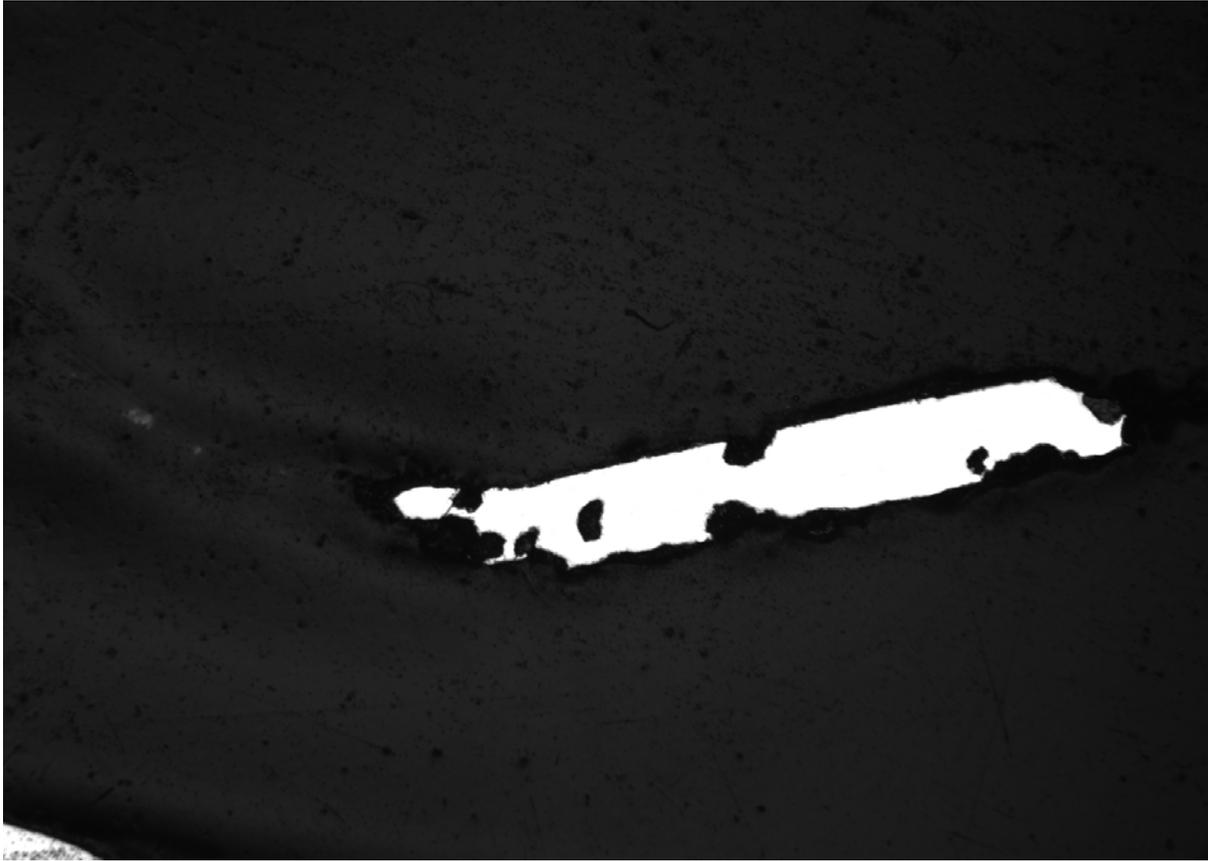
Pieces of metal wire from the prefilter were studied optically and in the scanning electron microscope (SEM). Only small remnants of the wire trapped within the woven fiberglass support structure were obtained. The pieces were short, < 0.3 to 5 cm., and the ends were corroded and broken. Chloride salts, silicates and rust were adhered to all surfaces (Figure 4). The deposits were easily dislodged, exposing clean metal. Some wire ends appeared to be cut, thus pre-existing the corrosion. However, the short lengths generally resulted from break-up of corroded, initially longer wire. Transverse chatter marks and long axial scratches associated

Pitting was the principal reason for failure of the prefilter. Pitting and possibly stress cracking of the wire would be expected based on the wet gas and high chloride content. Scattered large round bottom pits were seen. Wire break up resulted from pits growing across the wire or from fracturing through the reduced cross section due to the pits.

Figure 2. Piece of HEPA prefilter wire (0.1 mm). The stainless steel in the wire wool filter pitted and broke up as a result of the exposure. Magnification, ~160x.

It was also recommended that the prefilter material be changed to an alloy having more resistance to chloride attack. Even if misting is eliminated, there will be a tendency to condense during maintenance shutdowns and standby periods, leading to exposure of the fine wire in the pads to corrosive solutions.

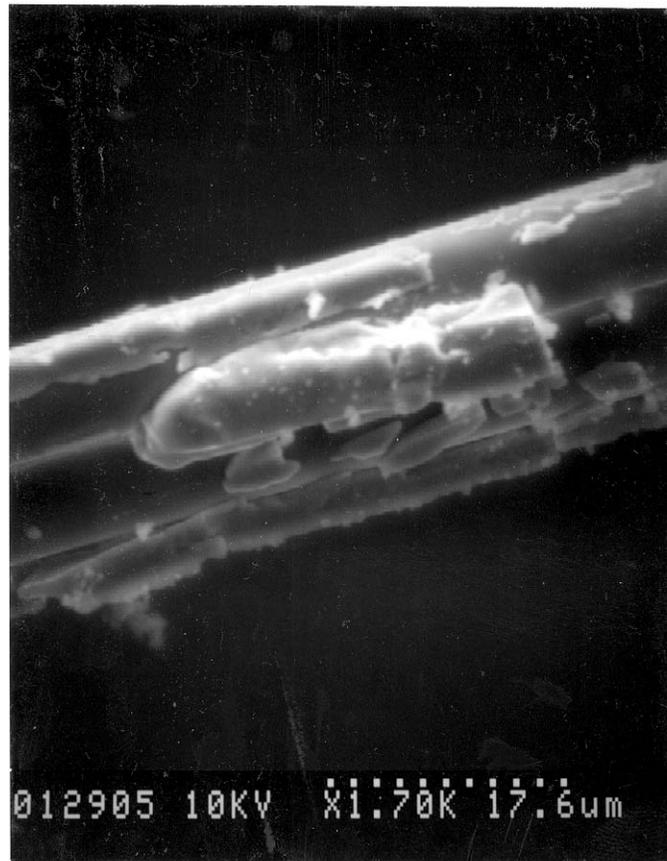
Figure 4. Deposits on pieces of three prefilter wires.  
Analysis of the deposits showed KCl, NaCl,  
Fe-O, and Na-Al-silicates.

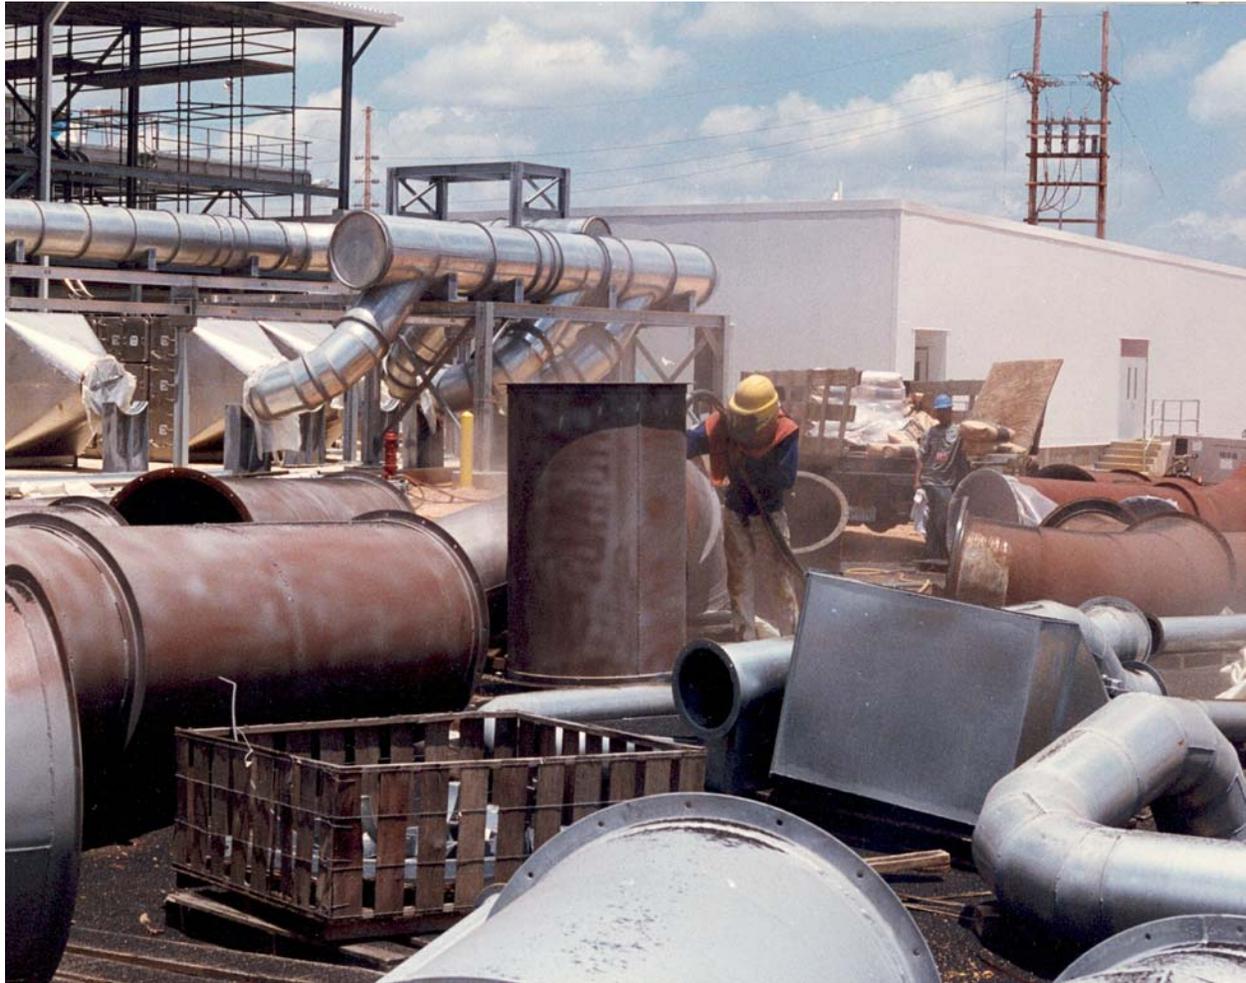
Ultrasonic thickness measurements of the 30 in. (76 cm) carbon steel duct indicated that metal loss was uniform and not excessive. Thickness was 0.126 in. (3.2 mm) for the 10-gage (standard steel gage) material, nominally 3.4 mm thick. Mild flaky rust could be easily delaminated or separated at the inside wall, a result of exposure to the hot moist air environment.

The interior was studied with a video camera. Uniform surface rust, some loose scale, and scattered traces of a greenish/yellow residue were observed, the latter along the invert and at "high water marks" near the filter end. The water levels reached 7.5 cm above bottom. There was no evidence of non-uniform or localized attack or deterioration. The particulate oxides trapped at the filters had originated on these steel surfaces. Though only mild attack had occurred, the steel corrosion rate for the environment could exceed 25 mm/y. As a result, a protective coating (PLASITE<sup>®</sup> 4310<sup>(1)</sup> vinyl ester) was recommended to isolate the steel from the acid conditions. Abrasive blasting to white metal was specified for the interior and the duct was disassembled for this purpose (Figure 5). Several coats of the vinyl ester material were applied to develop a specified 40-mil (1 mm) final protective coating.

Figure 5. Sections of steel exhaust duct being prepared for interior lining with a vinyl ester resin. HEPA filter housings in the background were replaced with similarly coated housings.

To further improve exhaust system operation, it was necessary to retain the higher gas temperature longer and to avoid water drop out ahead of the filters. For this purpose, the large duct was wrapped with fiberglass insulation for its entire length. The filter housings have 8-pound density mineral wool thermal insulation applied.

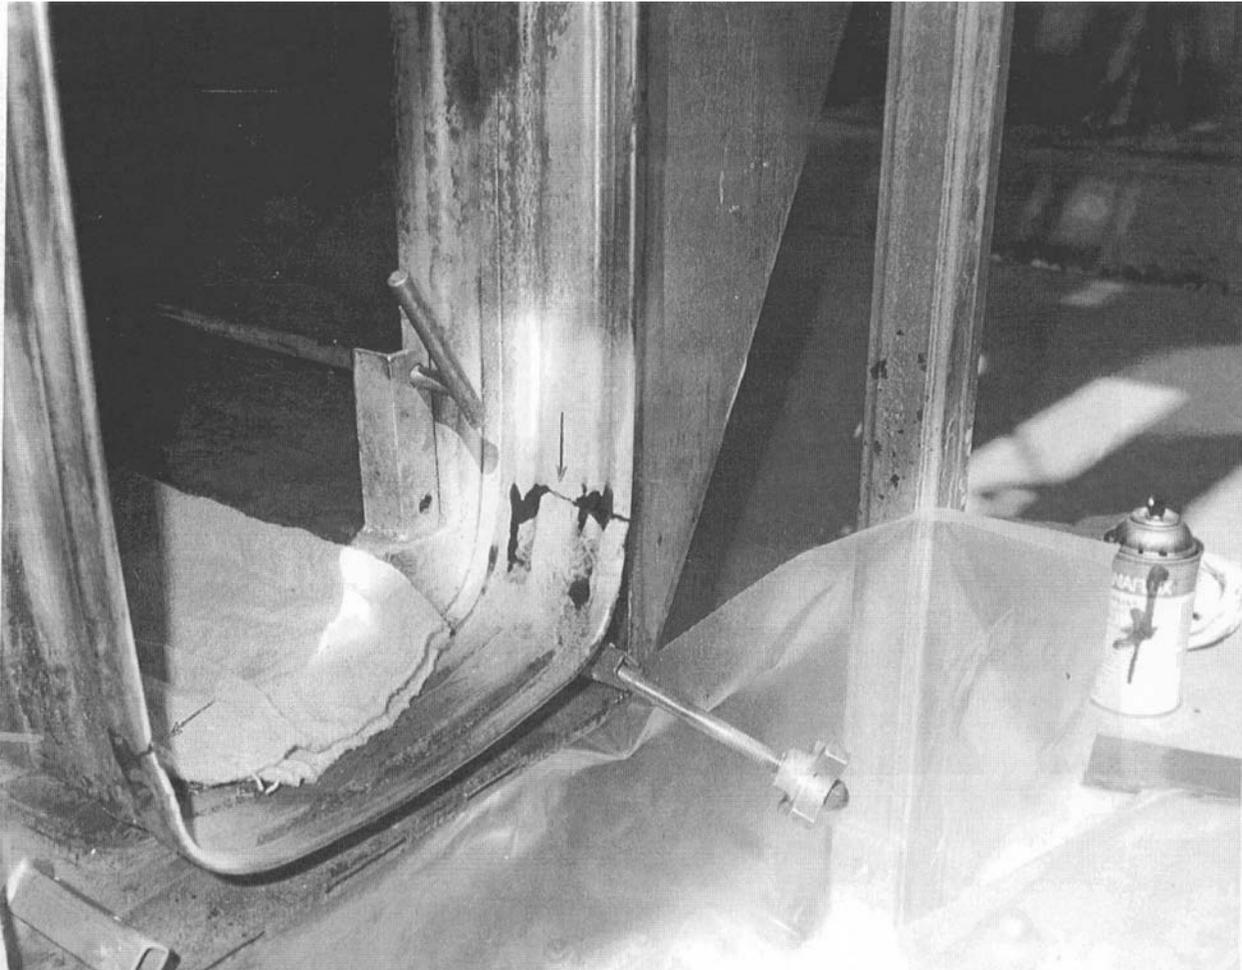
Dye penetrant examination of the interiors of the HEPA filter housings revealed large cracks on the prefilter access door seal area (Figure 6), and in heat affected zones of tack welds joining

interior walls to the floor (Figure 7). The cracks had the appearance expected for chloride stress corrosion. Metallurgical confirmation was not performed. All the cracks were at high residual stress locations, due to severe cold working or welding. The cracks were also at locations that effectively had been at times immersed in off-gas condensate.

Figure 6. HEPA filter access port on housing, with major cracks on seal surfaces.<sup>1</sup>

The new stainless steel HEPA filter housings have the interior lined with the same PLASITE<sup>®</sup> vinyl ester coating used on the ductwork. The coating provides the needed isolation from the chlorides. Alternate alloys that were considered for housing included AL6XN, 20Cb-3, C 276, and G 30. All are more resistant to chloride effects than Type 304L austenitic stainless steel, but fabrication costs are much higher, which precluded their use.

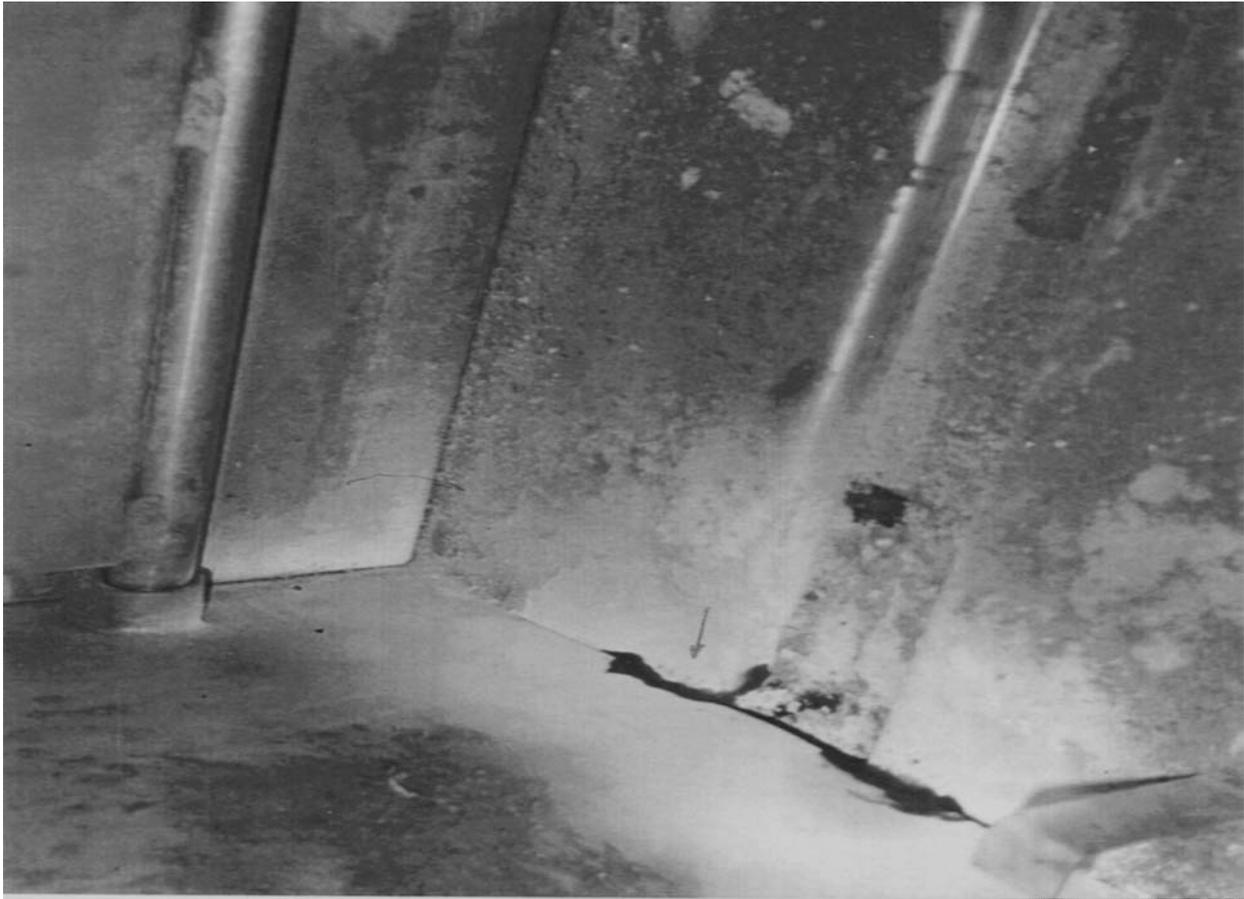
Figure 7. Crack (arrow) on floor, inlet side of filter housing. Location is at a tack weld.<sup>1</sup>

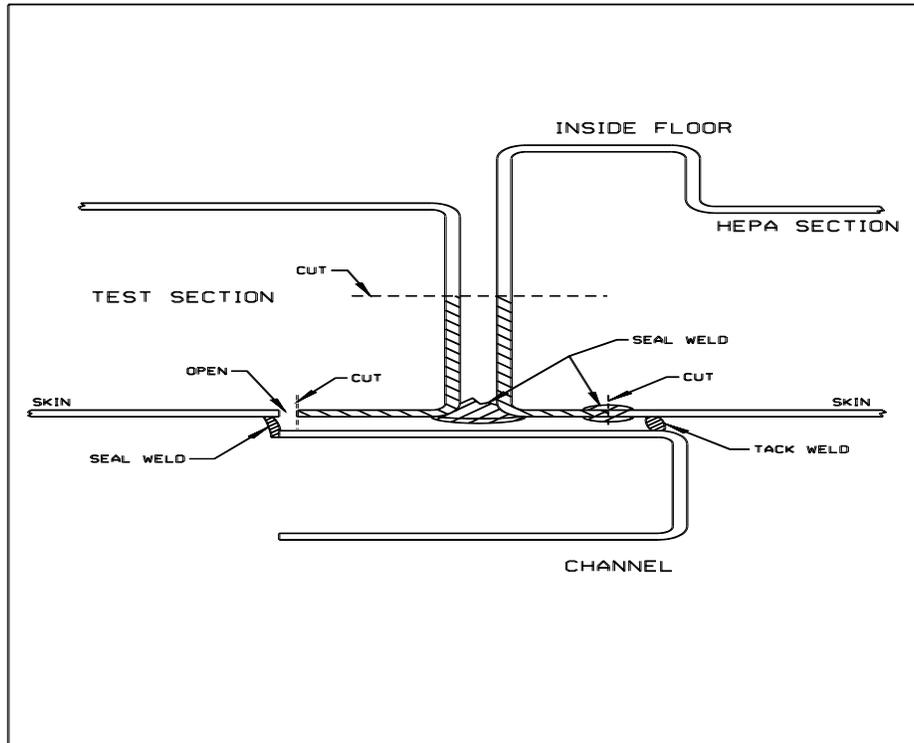
Figure 8. Sketch illustrating a junction between adjacent box sections in an assembled HEPA filter housing. The sample T-section removed for metallographic study is indicated. The open leak path shown is normally included closed by the “seal weld” to the outer supporting channel.

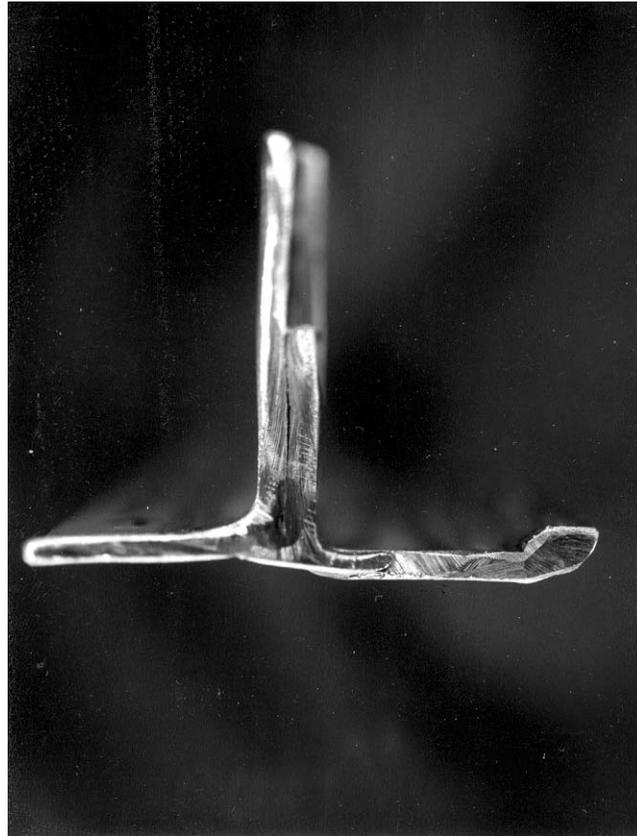
The T-section from the bottom of the filter housing was examined metallographically. A photograph of the section is shown in Figure 9 (compare Figure 8). When in place, the two opposing legs of the T may be seal welded to the exterior skin. In this particular sample, one of the legs was only tack welded to the skin. One edge of the exterior channel at the location was seal welded to the skin but not to the leg of the T. In addition, the channel was only tacked to the

opposite leg, so an open path existed around the channel within the annular insulation space. Chloride stress cracking existed on the interior floor at the same general location, explaining the inability to hold pressure in the HEPA filter housing.

The crevice formed by the sides making the vertical leg of the T-section was opened by bending apart the contacting sides. Staining existed within the crevice, but no loss of material was evident.

Figure 9. T-section removed from HEPA filter housing at a leak site. Absence of a seal weld between the outer skin and the angle on the left provided one part of the leak path. Magnification is ~ 2 X. The crack on the interior floor (Figure 7) penetrated the floor plate and was the other part of the leak path.
