CHARACTERIZATION OF CORROSION DAMAGE ON ALUMINUM FUEL ASSEMBLIES IN BASIN STORAGE

T.C. Andes, W.S. Large, R.B. Castle, M.R. Louthan, Jr., V.S. Valdes, and R.L. Sindelar
Westinghouse Savannah River Company
Aiken S. C. 29808

ABSTRACT

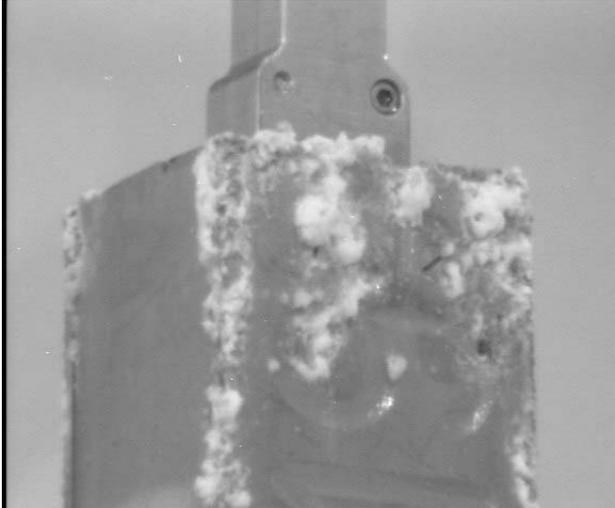
and is characteristic of localized attack on aluminum alloys exposed to aggressive water environments [4-6]. The majority of the corrosion was at or near the end of the stored assemblies as illustrated by the photograph of assembly #219 (Figure 1A). The examinations also showed that most of the corrosion was on the structural plates although some corrosion was apparent on the outer fuel plates. The increased tendency for corrosion on the structural plates may be attributed to two factors:

- 1) along the crevice formed by the junction between the outer fuel plate and the structural plate,
- 2) near the screws that connect the structural plate to the lifting rod, and
- 3) at the cut ends of the structural plate.

Figure 1A. RA-3 Assembly #219 Examined at the Ezeiza CSF Shows Increased Corrosion Attack on the Structural Plate (center) Compared to the Fuel Plate (left) and Increased Attack at the Location of the Stainless Steel Screws

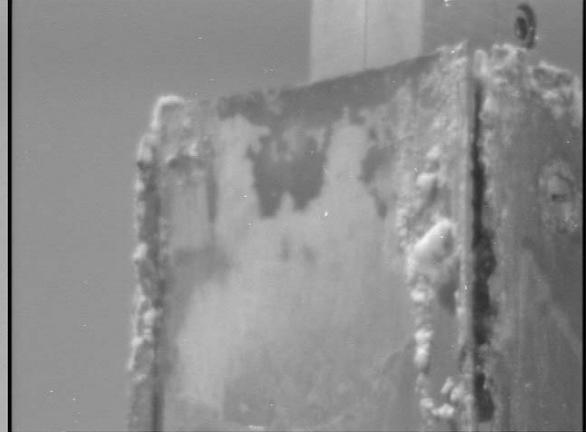
In the extreme, the crevice corrosion at the fuel plate/structural plate junction was sufficient to cause separation between the two plates (Figure 2A). Nevertheless the assembly was successfully lifted and transported by

the lifting rod attached to the corroded end of the assembly. Most of the assemblies that showed corrosion showed limited attack that was generally confined to the outer fuel plate/structural plate crevices and the corners and edges of the structural plates.

Figure 2A. RA-3 Assembly #243 Examined at the Ezeiza CSF Shows Crevice Corrosion Attack at the Side Plate (right) Connection to the Fuel Plate (center)

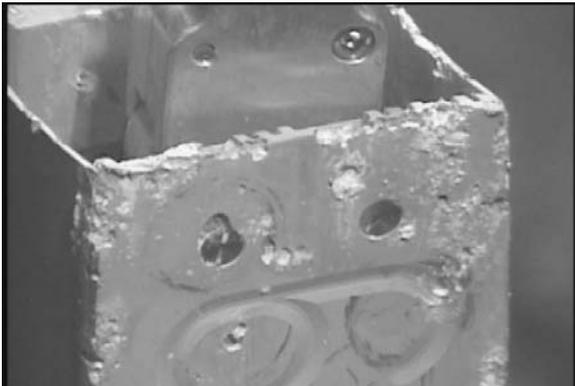
The second detailed examination showed little or no change in the condition of the Ezeiza assemblies as shown in Figures 1-3. This examination was made after the assemblies had experienced

The operations outlined above removed some of the corrosion product from the assembly surfaces and allowed the actual extent of corrosion to be more readily observed. The presence of

Figure 1B. RA-3 Assembly #219 Examined Underwater in SRS L-Basin Shows Loss of Corrosion Nodules and No Evidence of Additional Corrosion Attack. The Stainless Steel Screws Have Been Removed.

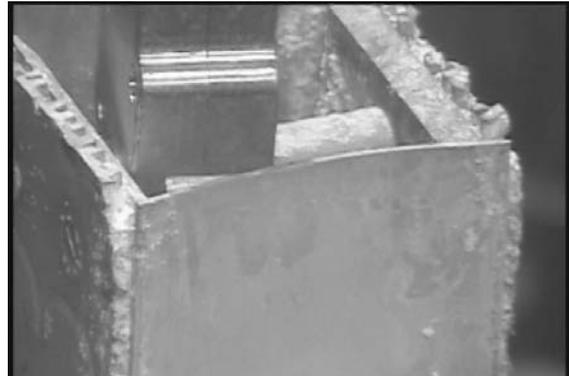
Numerous assemblies showed some corrosion in the regions adjacent to the stainless steel screws that connected the lifting rod to the structural plate while other assemblies showed no evidence of accelerated corrosion in that area. The lack of attack at this rather obvious site for potential galvanic corrosion is consistent with the importance of anode to cathode ratio in galvanic corrosion processes. The lack of corrosion also suggests that galvanic corrosion was generally avoided because of the large amount of aluminum surface exposed. Although the use of stainless steel screws (cathodic to aluminum) to connect aluminum components was successful for these components, prudent engineering design would avoid such coupling whenever practical. Reasons to avoid such coupling were apparent in assembly 219 (Figure 1A) where the preferential attack of the aluminum at the aluminum to stainless steel interface was apparent in the 2001 inspection (Figure 1B). However, as is also apparent in comparing Figure 2A with 2B, corrosion product buildup over the galvanic couple tended to exaggerate the extent of corrosion.

Figure 2B. RA-3 Assembly #243 Examined at SRS L-Basin Show No Significant Change Except for Loss of Corrosion Product Nodules

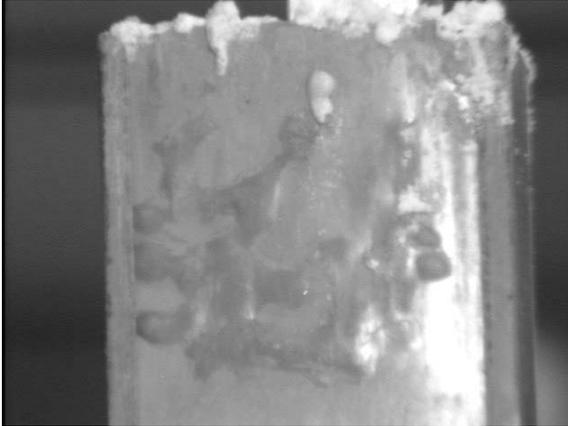
- 5) galvanic attack from the stainless steel screws in aluminum structural plates occurred in many of the assemblies, and
- 6) filiform corrosion was observed near the end regions of the fuel plates in several assemblies. The corrosion appeared to initiate at the structural plate/fuel plate junction.

Figure 3A. RA-3 Assembly #112 Examined at the Ezeiza CSF Shows Apparent Filiform Corrosion
