Application of Material Characterization Techniques to Electrical Forensic Analysis

T. David Mills, P.E.
Senior Member, IEEE
Bechtel Savannah River, Inc.
Savannah River Site
Aiken, SC 29808
U.S.A.
803-952-9011
803-952-9220
d.mills@ieee.org

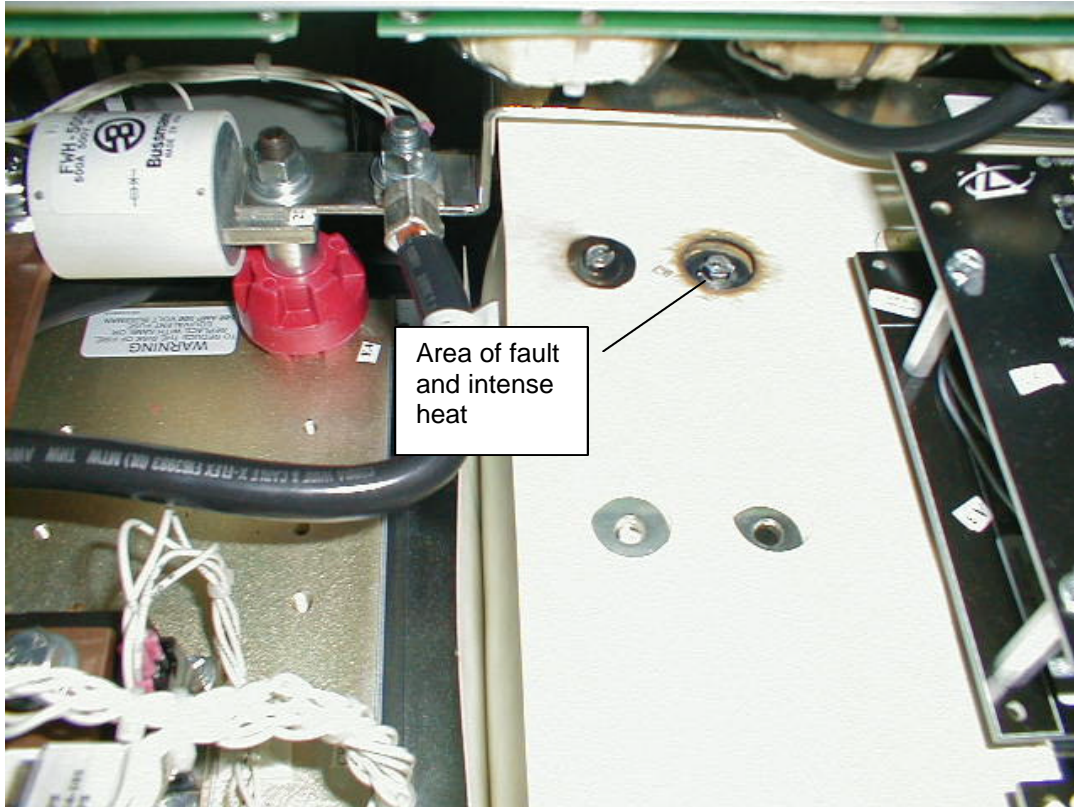
found. The terminal screw and the bus bar assembly at the location shown in Fig. 1 were burnt with metal melting where the capacitor had discharged. There were no other obvious indications of damage at any other location. Due to the narrow confines of the damage, it was proposed that some small piece of debris fell into the terminal area of the capacitor causing it to discharge. Due to the intense heat, no loose remains of the item of debris could be found. No loose or missing fasteners were observed upon inspection of them.

Fig. 1 Initial view of arc flash area

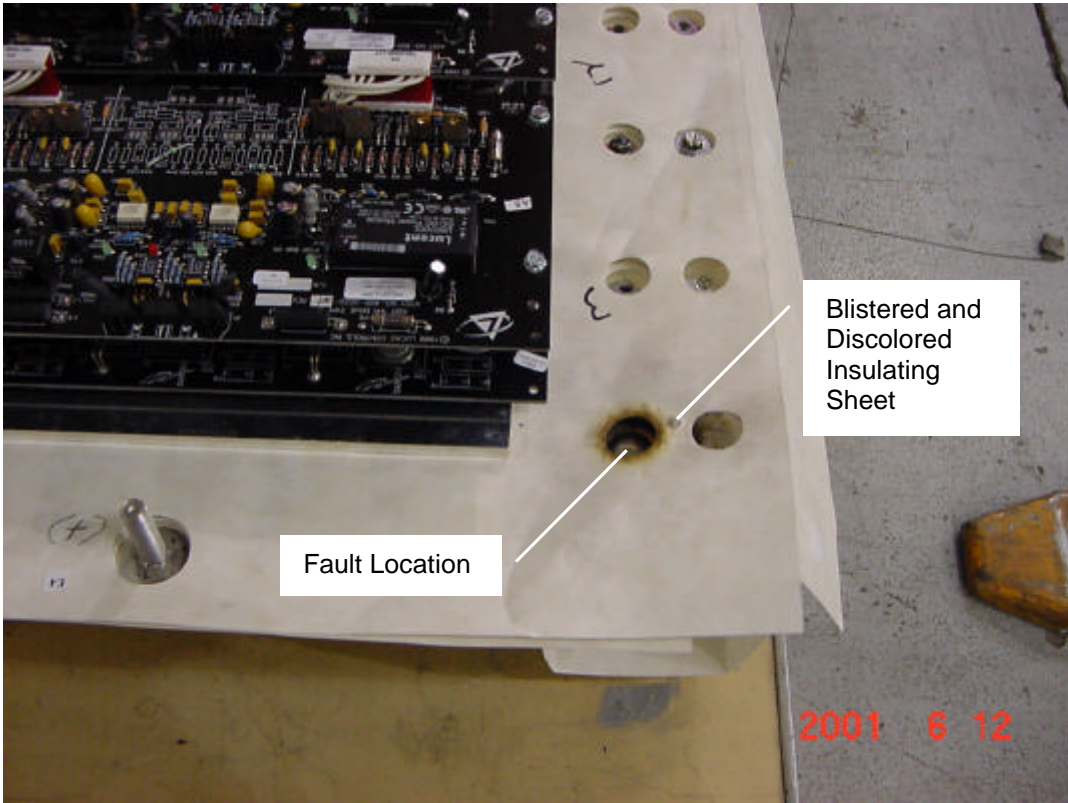
Fig. 2, Unit removed from cabinet

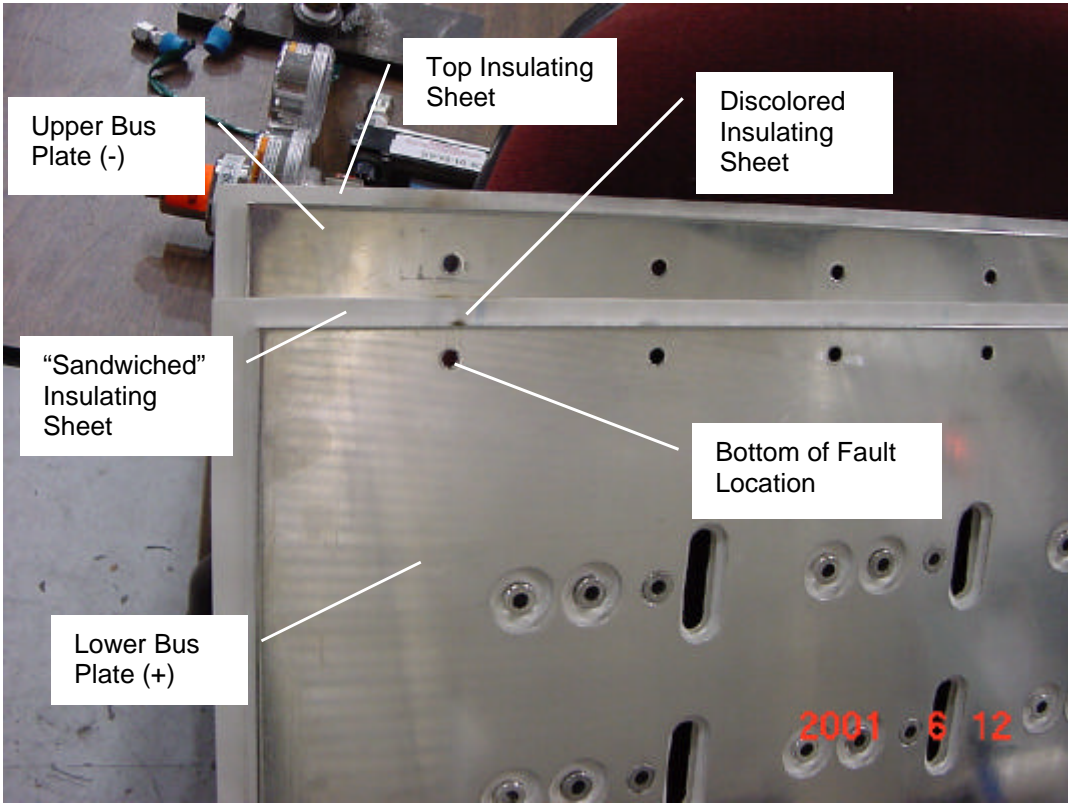
Fig. 3, Disassembled capacitor plate

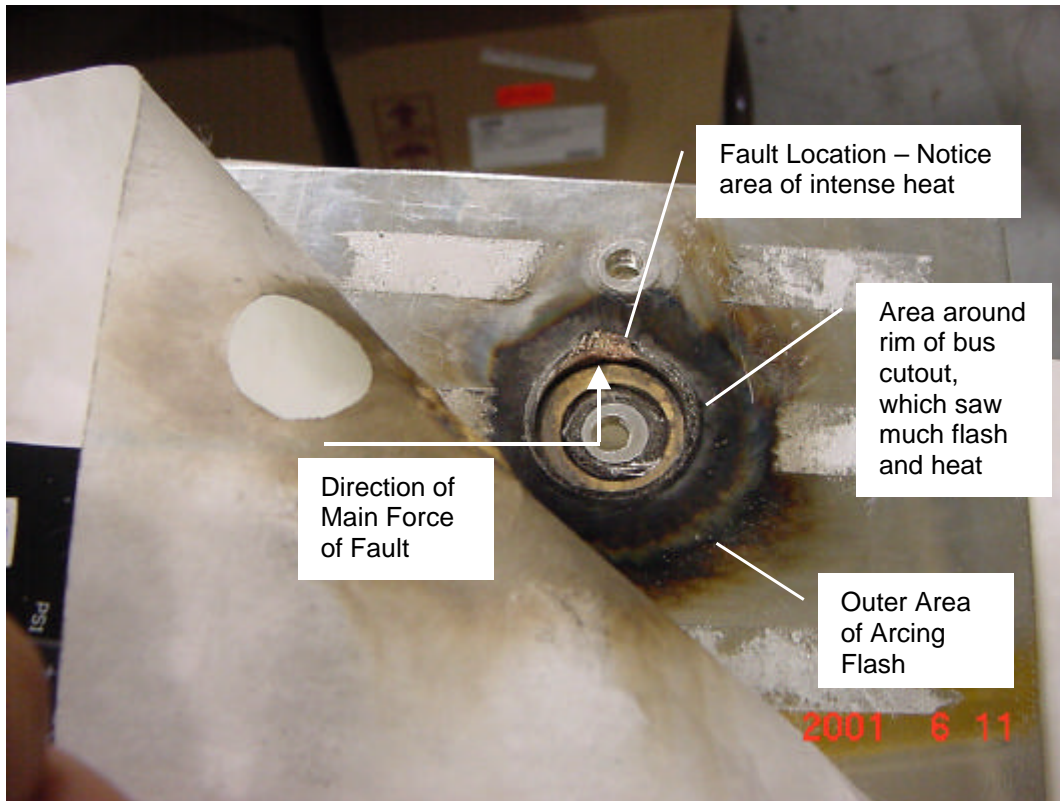
Fig. 4, Fault area uncovered

As an interim measure, we determined that a remote possibility existed that some other “foreign” material could make its way into the capacitor/plate connection area and fashioned a insulating cover from the same material used in the fabrication of the plate assembly. This “fix” worked well as there were no additional mishaps or setbacks to the testing program.

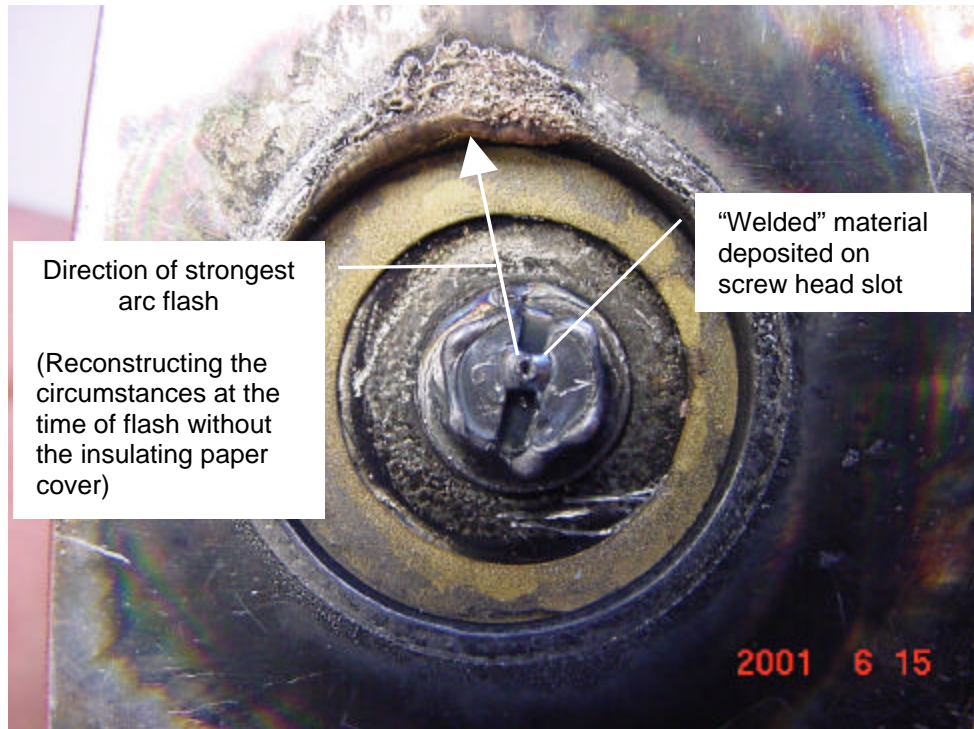
The University of Cincinnati laboratory technician ran several tests on samples of bus, insulation paper, and screws to determine if any foreign material residues were present. We were looking for anything that might indicate that the fault was caused by a piece of debris, which was shaken down into the terminal location. It was found that material deposited on the screw head involved in the flash was something other than the screw material and different than any bus material present. The material had been “welded” by the DC arc and a puddle was left attached to the screw head in the slot area. Fig. 6 shows a simulated reconstruction of the screw and bus assembly, as it would have been at the time of the arc.

Fig. 6, Reconstructed view of screw head and plate assembly

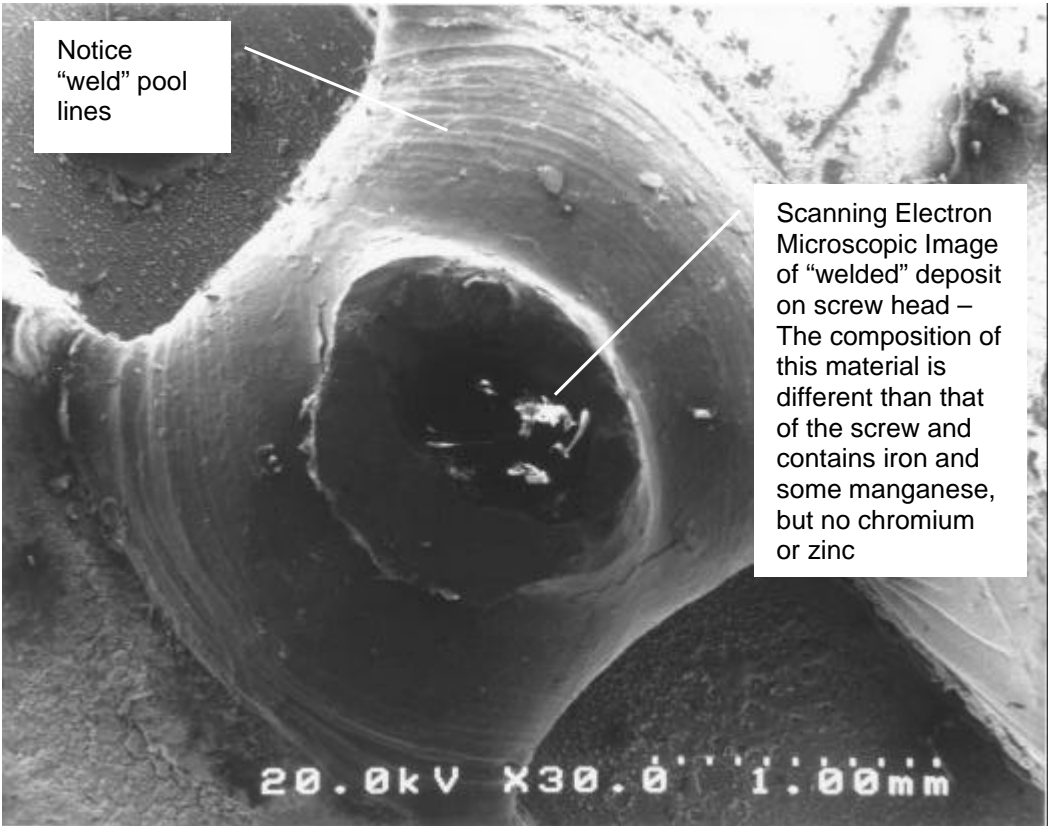
Fig. 7 shows the scanning electron microscopy photo of the screw head involved in the flash. The material in the “pool” was characterized as an iron with some trace of manganese, but differed from the chromium/zinc/steel of the screw itself. Fig. 8 and Fig. 9 indicate the differences of the two materials.

Fig. 7, Scanning Electron Microscope photo of screw head

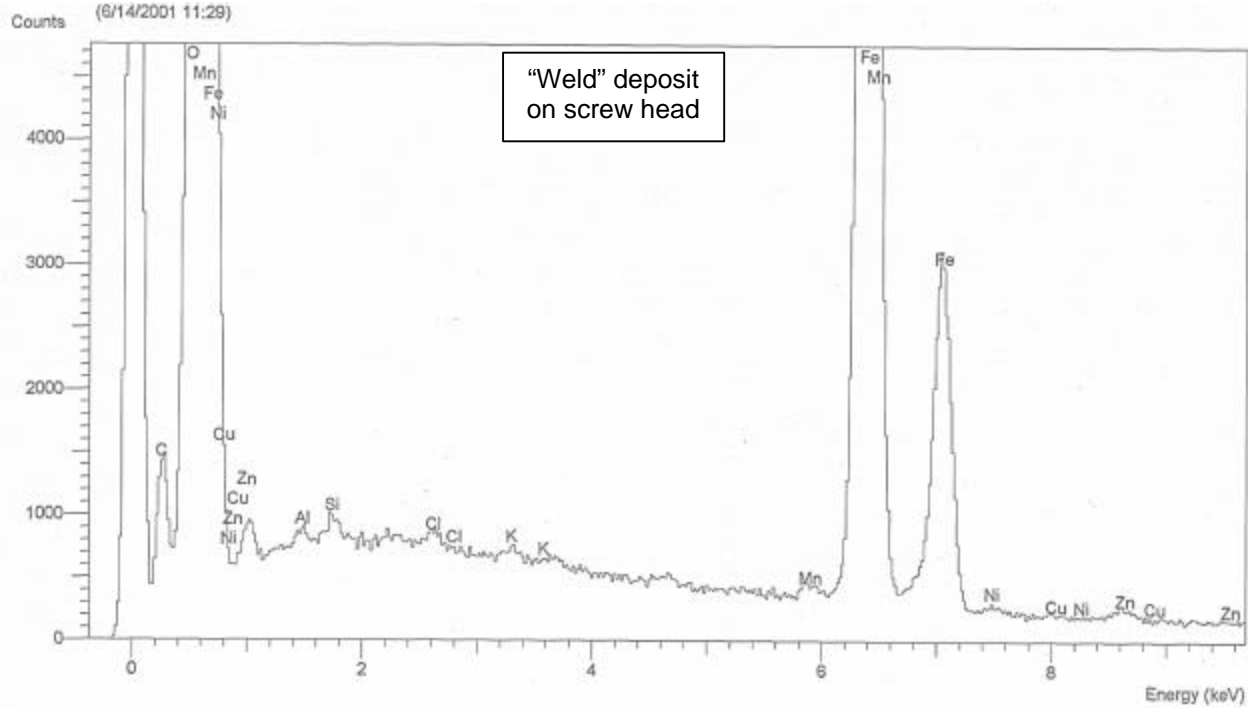
Fig. 8, SEM printout of screw head with "foreign" material

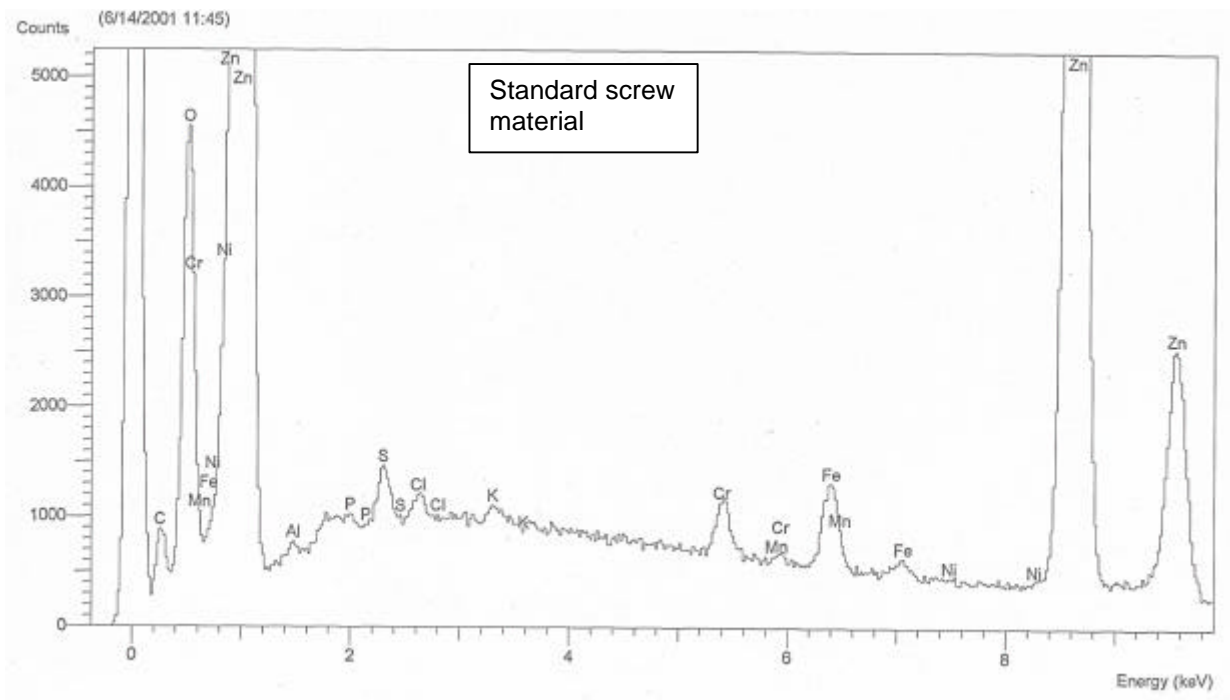
Fig. 9, SEM printout of standard screw head
