EXAMINATION OF DWPF MELTER MATERIALS AFTER 8 YEARS OF SERVICE

Daniel C. Iverson, Kenneth J. Imrich, Dennis F. Bickford, James T. Gee, Charles F. Jenkins and Frank M. Heckendorn
Westinghouse Savannah River Company
Aiken, SC 29808

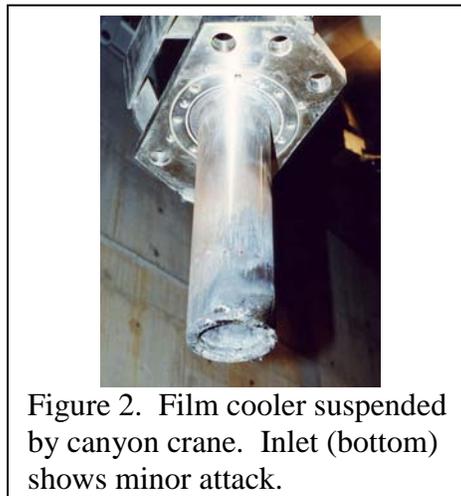
Following completion of cold chemical runs in 1996, an extensive visual inspection of melter top head and off gas components was performed. The inspection focused on vapor space and molten glass attack. No significant degradation was observed, except for the chloride salt attack and oxidation of the borescope (Ref. 1) and minor oxidation

Figure 2. Film cooler suspended by canyon crane. Inlet (bottom) shows minor attack.

of the tip of the off gas film cooler (Figure 2).

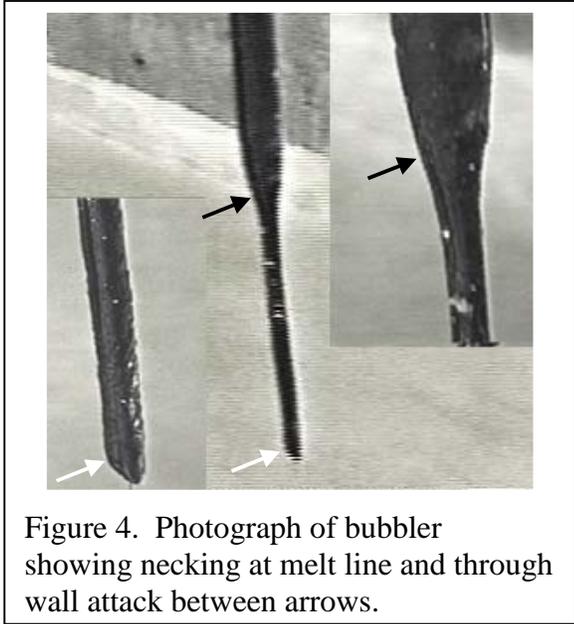
The melter center thermowell was removed in May 2000 and visually inspected. It experienced slight melt line attack, but otherwise appeared to be in good condition. The Inconel 690 dip tube bubbler melt level detection device was removed in April 2002 after approximately seven years of service. It originally had a 7.62 cm (3 in) outer diameter with a 1.27 cm (0.5 in) diameter center bored hole through which argon was bubbled at 0.014 to 0.028 m³/hr (0.5 to 1 scfh). Remote video inspection revealed that through wall attack had occurred on one side over approximately 76.2 cm (30 in) of the submerged length ending just below the melt line (Figure 4). This relatively high rate of material loss can be attributed to the “scrubbing” effect of continuous bubbling. A portion of the tip, approximately 15 cm (6 in), was completely lost.

Figure 4. Photograph of bubbler showing necking at melt line and through wall attack between arrows.

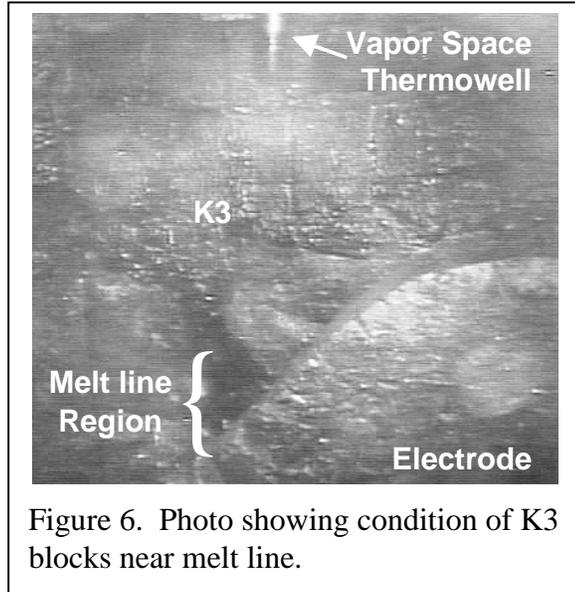
The glass contact refractory, Monofrax™ K-3, was in excellent condition. Minimal spalling was observed in several localized regions around the melt line. It was significantly less than that observed in pilot scale melters. Refractory attack was expected to be greatest in the vicinity of the melt line, but only minimal corrosive attack was observed (Figure 6 and 7). Corners of the refractory blocks exhibited some rounding; however, the joints were still square indicating that no significant shifting of the refractory blocks had occurred.

Figure 6. Photo showing condition of K3 blocks near melt line.

Gross material loss was low. This qualitative observation was based on relative distance between the back face of the upper electrodes and the refractory wall. This represents a refractory corrosion rate significantly lower than that predicted by the initial pilot scale work. Melter design life was 2 years based on the pilot scale work and a corrosion allowance of 4 inches of refractory. The present results are better than those seen in the Large Slurry Fed Melter and Scale Glass Melter at SRS (Ref. 3).

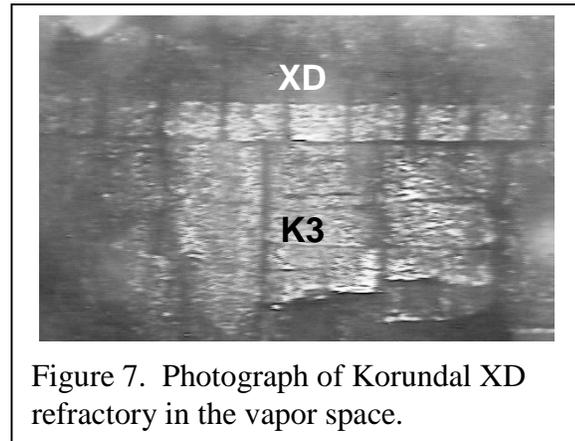
The vapor space refractory, Korundal™ XD, was in excellent condition (Figure 7). No missing pieces or shifted blocks were seen. No signs of chipping or spalling were observed around the top head penetrations or dome heaters. The entire refractory surface was glazed.

Figure 7. Photograph of Korundal XD refractory in the vapor space.

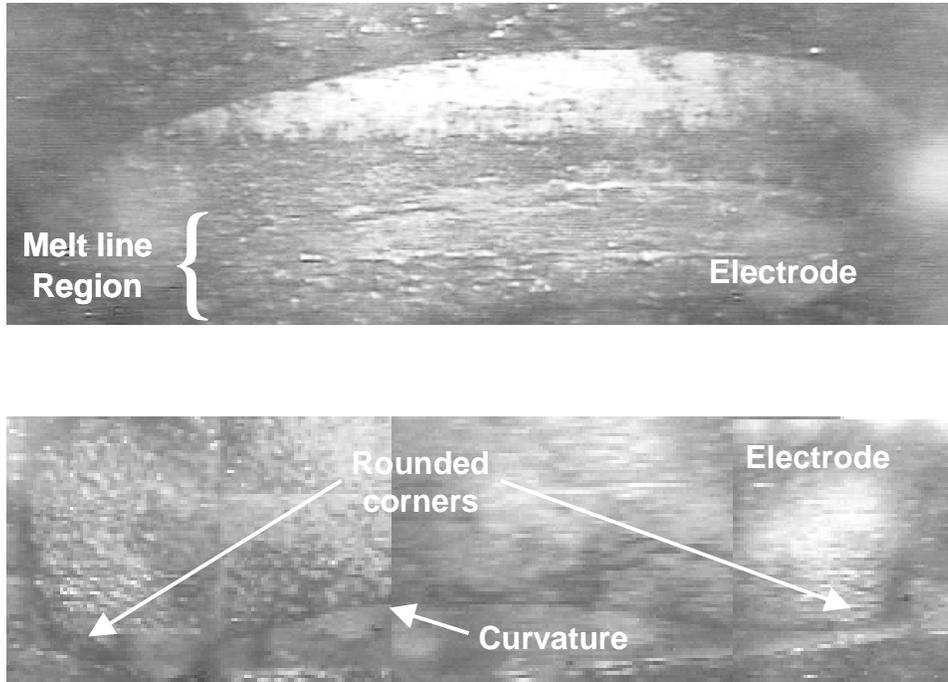
The lower electrodes were not visible due to residual glass in the melter. Upper electrodes were completely visible and exhibited rounding of corners and edges below the melt line and an obvious downward deflection (Figure 8). The

Figure 8. Upper electrode, Top photo: Upper portion showing downward deflection. Bottom photo: Composite showing curvature and rounding of corners on the bottom portion.

deflection was probably a result of creep. The faces of the electrodes exhibited an irregular surface morphology; however, it was not clear whether it was due to localized material loss or build-up of deposits.

The upper electrodes were originally 101.6 cm (40 in) wide by 38.1 cm (15 in) high by 7.62 cm (3 in) thick. The 215.5 kg (475 lb) electrode was supported by a centrally located 10.2 cm (4 in) diameter bus and was mounted flush against the refractory wall. Downward deflection of the ends was significant and was symmetric around the bus (Figure 9). Initially it was thought that the observed shape was due to material loss resulting from corrosion. A more detailed examination revealed that the shape was due to deflection rather than corrosion. This is based on the following:

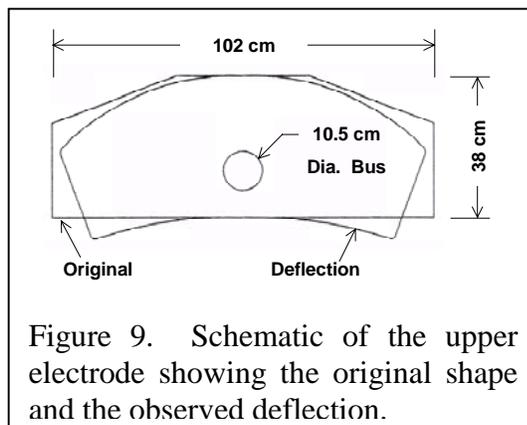
Figure 9. Schematic of the upper electrode showing the original shape and the observed deflection.

- 1) Normal corrosion mechanisms cannot explain the concave shape of the bottom of the electrode.

- 2) The upper portion shows curvature, yet the edges appear sharp suggesting they were not significantly corroded.
- 3) The overall appearance suggests uniform symmetric slumping about the axis of the electrode bus. The appearance is similar to that expected under high creep rate conditions.

Existing high temperature creep data (Ref. 4, 5) show that at DWPF operating temperatures significant slumping is not expected. However, these data were generated using materials that had not been exposed to melter environments or at extended times (years). A change in mechanical properties due to long term elevated temperature exposure may explain the observed deflection. This supposition is based on an earlier metallurgical examination of the Inconel 690 drain valve exposed to 1150 °C glass for 7 years in the Integrated DWPF Melter System (IDMS). An extensive change in morphology was noted, including internal void formation, extremely large grains, and precipitates on grain boundaries through the entire microstructure (Figure 10). Electrode temperature may also have been a factor. This is based on modeling, which shows that higher

temperatures can be expected at the electrode face than in the bulk glass. Another factor is that the DWPF melter was at times operated up to 50 °C higher than the 1150 °C design temperature. (The melting point of Inconel 690 is 1345 °C.)

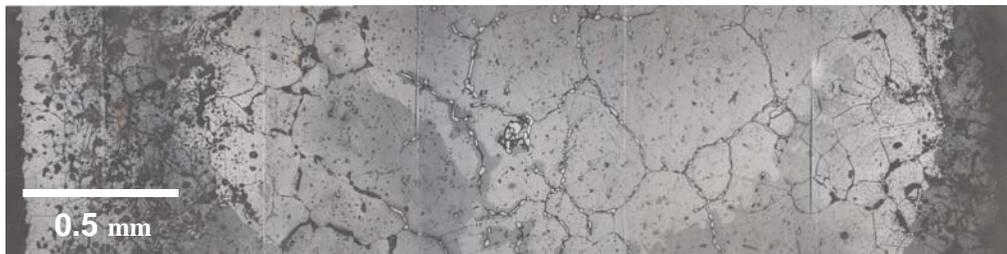
Figure 10. Photomicrograph showing the microstructure of an Inconel 690 through-wall section of the IDMS drain valve.

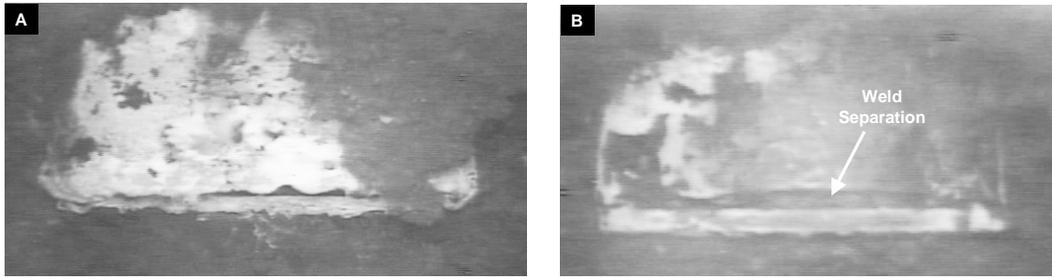
Both the primary and backup off gas film coolers were in good condition (Figure 11). Heavy deposits were observed on the tips that penetrated into the plenum but the contour of the lower lip was still visible. A small separation in a weld along the lower edge of the backup film cooler was observed. In the IDMS, a one tenth scale pilot melter, the film cooler was replaced after approximately 6 years of operation because several inches of material from the lower portion were lost.

Figure 11. Primary (A) and backup film coolers (B). Weld separation on the lower lip of backup film cooler is evident.
