Going Where No Man Can Go

Abstract – This paper discusses the successful remote visual inspection of a contaminated air exhaust tunnel running beneath the Savannah River Site’s H-Canyon nuclear material separations facility. The air exhaust tunnel has been in operation since the 1950’s, and the portion of the tunnel inspected has not been seen or accessed since startup. Numerous challenges were overcome in the deployment of the vehicle, including an initial 10-ft drop, travelling a long distance through harsh environmental conditions, surviving and recovering from a second vertical drop, turning 90 degrees, and subsequently travelling further. Video of the entire inspection was transmitted back to a control station, and the vehicle was abandoned in place for possible future use.

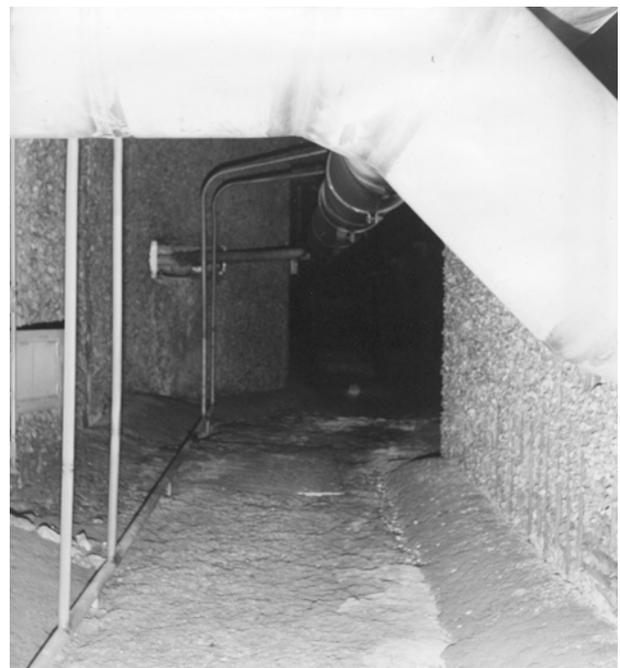
Figure 2. Photo of Air Tunnel

exceeding 250 Rem are common in the canyon remote areas, from which air is pulled into the air tunnels. Figure 2 shows the condition of a previously inspected portion of the Warm Canyon air exhaust tunnel.

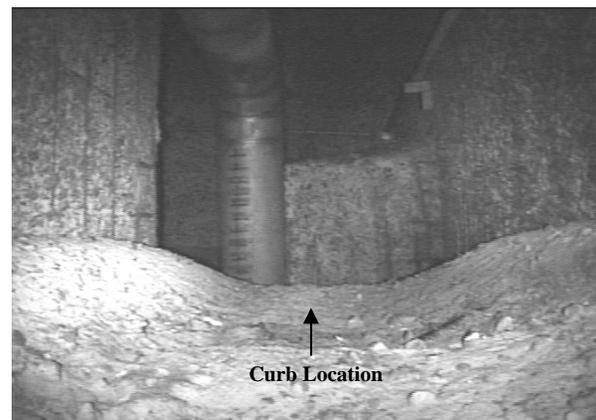
Figure 4: Tunnel Condition Approaching Curb

The vehicle traveled through the tunnel with no difficulty and reached the curb location within fifteen minutes. The video from the vehicle revealed erosion of the walls and ceiling, which subsequently resulted in the buildup of aggregate on the floor. The erosion was caused by years of air, sand, and chemicals flowing through the tunnel. Because of the buildup on the floor, the curb was no longer an obstacle. Figure 4 shows the condition of the walls and the area where the curb was expected to be.

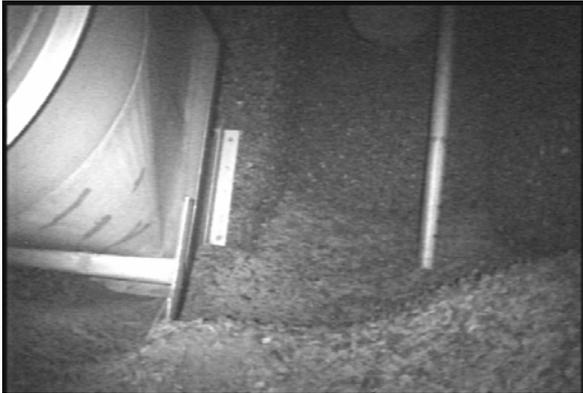
Figure 5: Portion of OHBL Duct and Transition Tie-in Point

the handlers kept a tight hold on the cable to prevent freefall of the vehicle. As it was lowered, the vehicle tracks were driven in an effort to grip the floor and right the vehicle. In less than ten minutes, the vehicle had landed safely on the floor and was able to view the transition tie-in point. Figure 5 shows a portion of the OHBL duct and transition tie-in point. Figure 6 shows two photos of the eroded condition of this transition point.

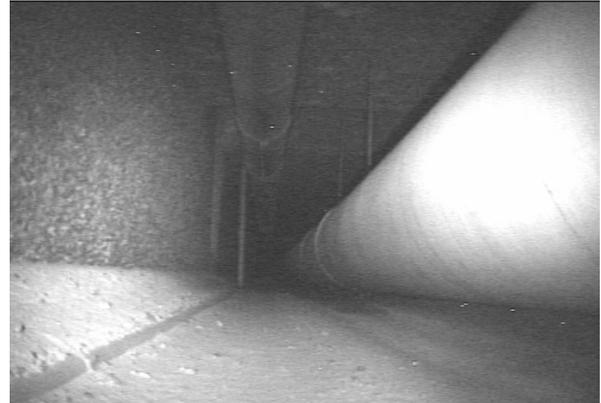
Figure 7: Photo of Crossover Tunnel

Successful visual inspection of the OHBL exhaust duct and the transition tie-in point facilitated the structural evaluation of the ducts, support hangers, and tunnel condition. Inspection of the duct transition point also confirmed that the concrete degradation at the duct transition point tie-in is the most likely source of the canyon air in leakage to the OHBL duct. This also addressed concerns from DOE regarding fission product buildup on the OHBL HEPA filters. Additionally, the vehicle was able to inspect the canyon air tunnel sump, the canyon vessel vent header, and additional piping, which had not been previously viewed.
