WSRC-MS-2004-00762

**EVALUATION OF LEAK SEAL ADDITIVES –
COOLING WATER PIPE IN NUCLEAR WASTES**

C. F. Jenkins, J. I. Mickalonis, D. A. Wilson and G. T. Chandler
Westinghouse Savannah River Company
Savannah River National Laboratory
Aiken, South Carolina

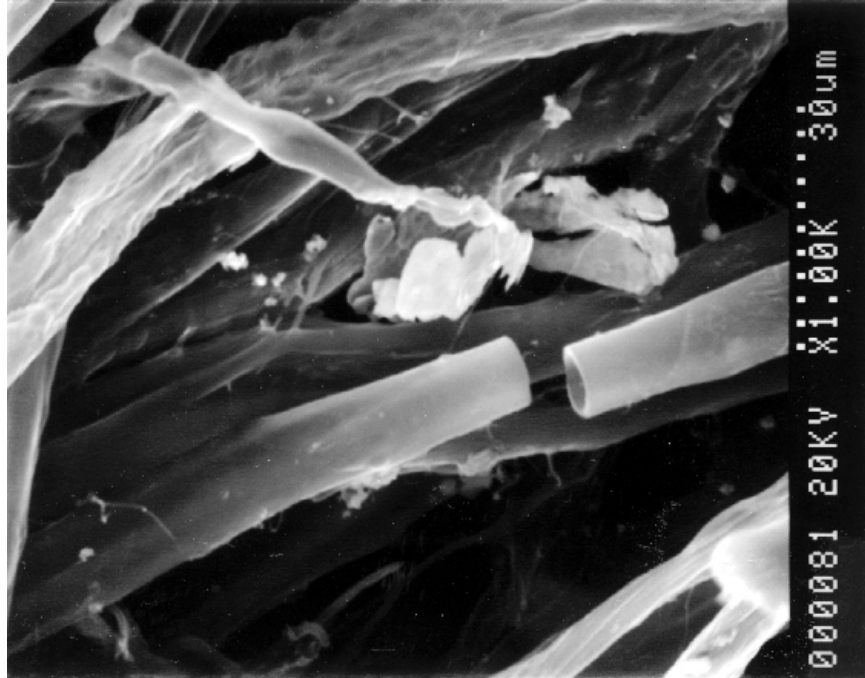
The fibers, shown in Figure 1, are thin wall tubes, transparent or translucent, and predominantly beige or light tan in color. The diameters ranged from 6-20 microns (0.00024-0.00080 inches), with most at 11-17 microns. Lengths were less than one inch. As indicated above, the cellulose fibers develop as the compound is applied. The fibers appeared to grow larger with time. The sodium and copper contents in the seals varied.

FIGURE 1. SEM photomicrograph of filtered fibers from sealant

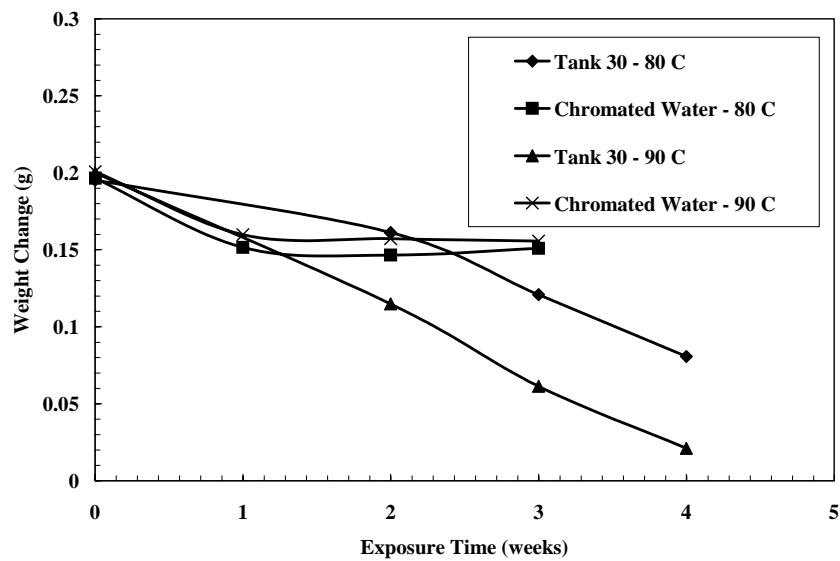
Weight change results from these tests are shown in Figure 3. Weight losses occurred in all the test solutions. A seal degrades to a greater extent with waste exposure (no salt layer) than with exposure to chromated water. The water and simulated waste exposures resulted in dissolution and removal of some of the water glass/sodium silicate component in the seal, Figure 4. Attack of the seal by waste appeared to be more rapid than attack in plain water. In both cases, haystacked fibers remained after the exposure, though they were matted or pressed together. Individual tubular fibers were collapsed and the loose piles were compressed and closed down.

FIGURE 3. Weight Change of Fibers in chemical degradation tests

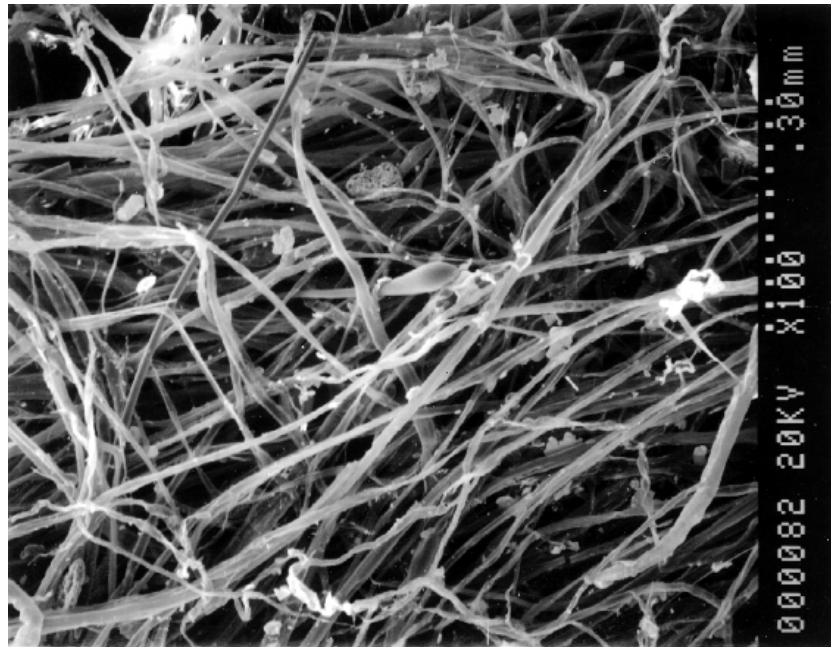
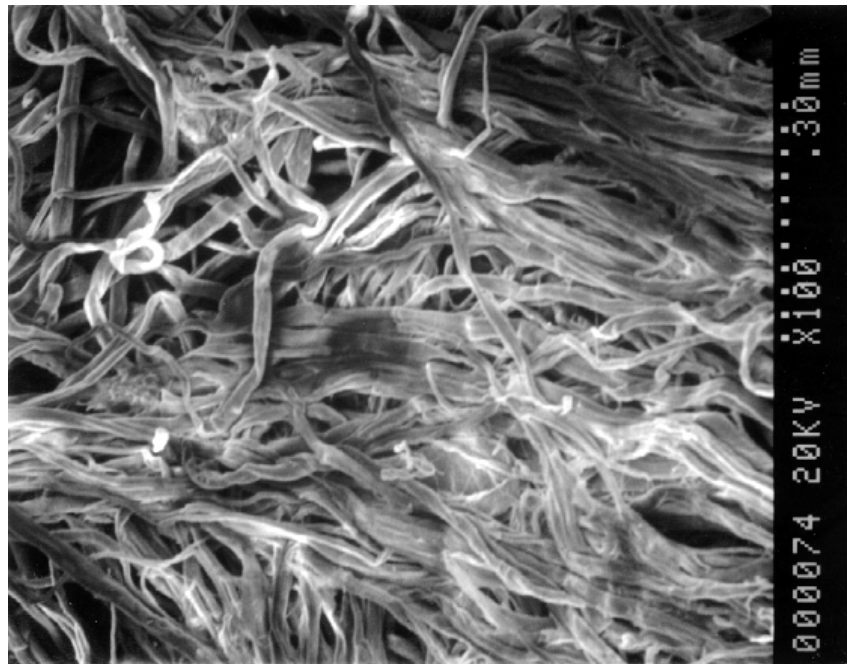
FIGURE 4. SEM photomicrographs of sealant fibers exposed to (A) water and (B) sodium hydroxide solution

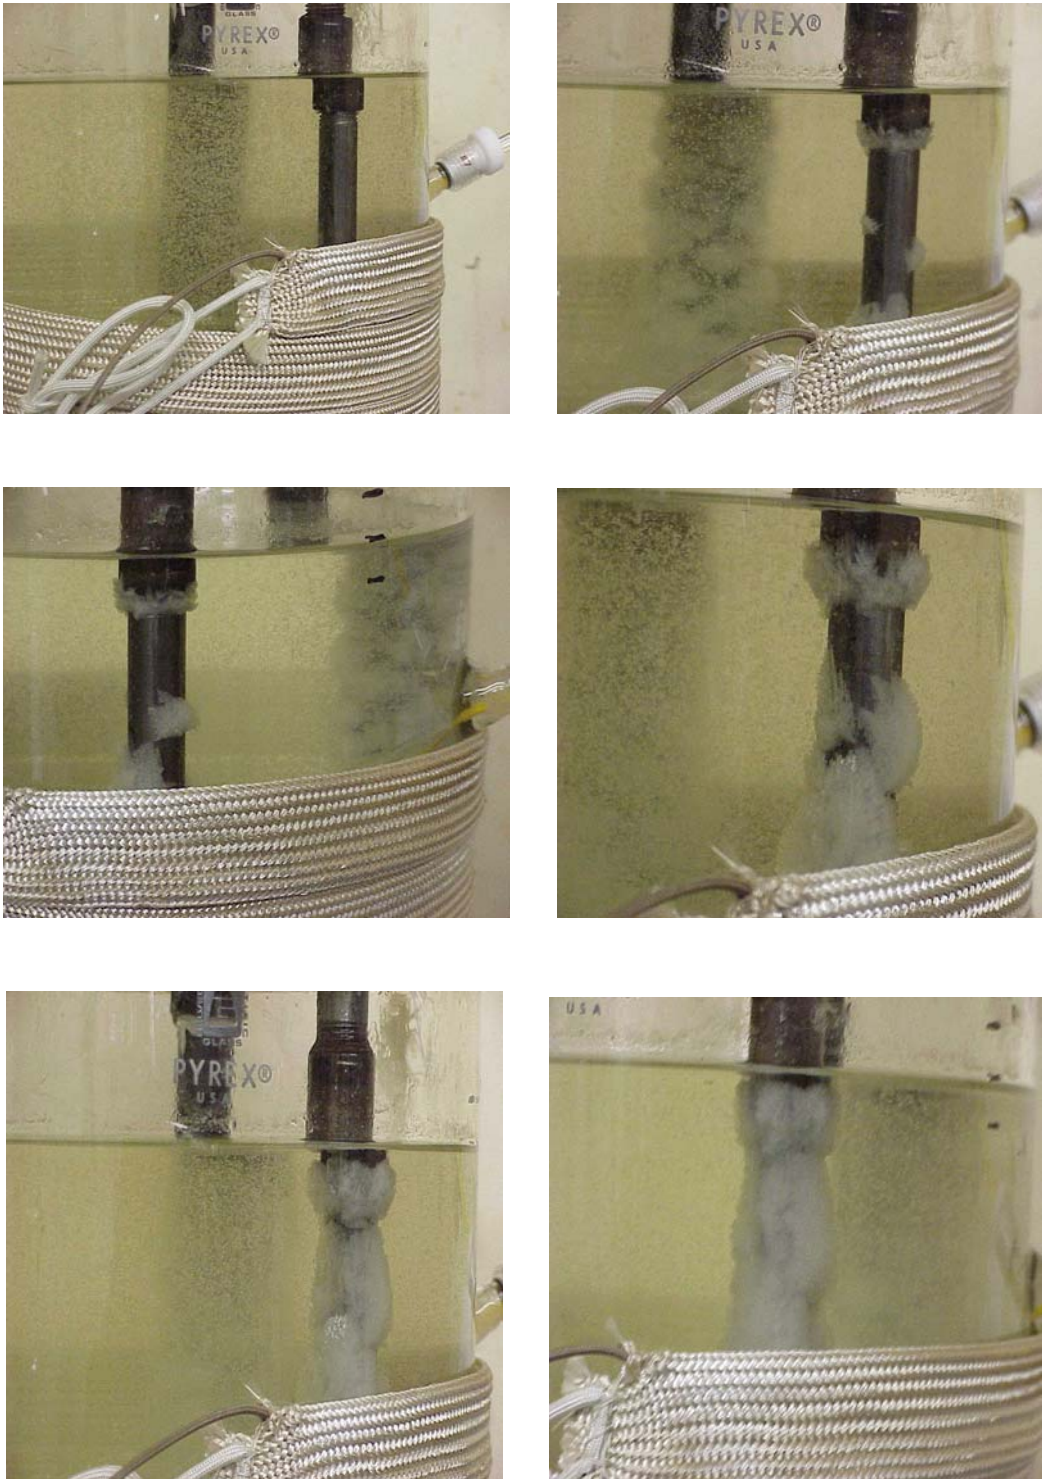
The first test was conducted in several phases. During the first eight-day phase, sodium nitrate was added until a salt layer began to form on the pipe. The second phase was conducted for four days to allow formation of a complete salt layer. Figure 6 shows sequential photographs taken during salt deposition. In the third phase, desalting was performed by shutting off coolant flow. In absence of cooling, the bath temperature spiked to 100°C and the sample pipe leaked. The circulating coolant with sealant was turned back on, but the leak sites did not reseal.

FIGURE 6. Salt layer formation on cooling pipe in Environmental Flow Loop

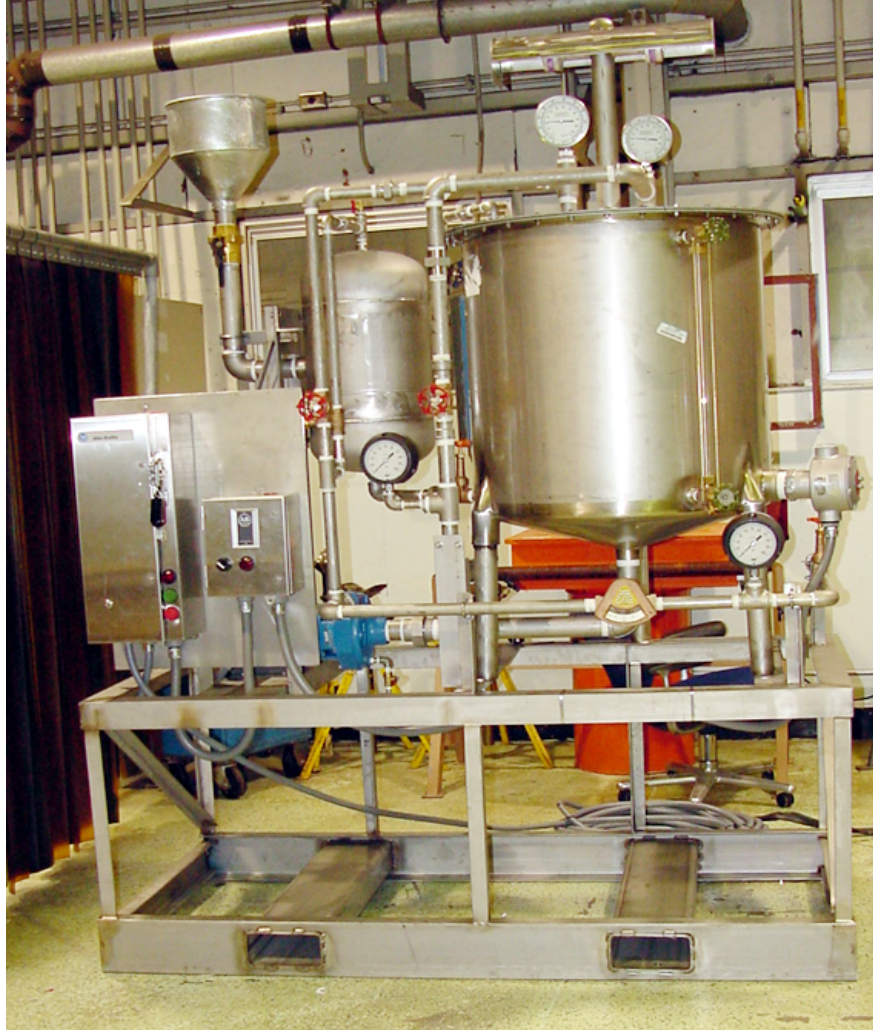
FIGURE 7. Sealant Deployment System

A sealant deployment system (SDS) was designed to tie into spare branch connections of the CCW supply and return headers located on the tank top. The deployment system, Figure 7, consists of a charge funnel for loading the sealant into a small holding tank prior to mixing, an interim mixing tank with internal heater for blending coolant water and sealant, and a circulation pump for introducing the blend into the pipe loop. A diagram of the SDS configuration is shown in Figure 8.

The deployment strategy for sealant application involved: 1) Close all cooling coil inlet and outlet valves to isolate the coils from the CCW supply and return headers, 2) Isolate the waste tank CCW supply and return headers from the distribution system, 3) Connect the SDS to spare branch connections on the tank top supply and return headers. With these actions implemented, the sealant blend can be introduced and recirculated in the tank top distribution piping. Sealant would flow from the SDS skid to the CCW supply header, through a cross-tie line connecting the supply header to the return header, and then back to the skid. This strategy permitted treatment of the individual coils by isolating the cross-tie line circulation and then opening the coiling coil inlet and outlet valves to establish flow in the coil.
