**Degradation and Failure Characteristics of
NPP Containment Protective Coating Systems**

Preliminary Evaluation of Plant Coating Specimens

Publication Date: March 2001

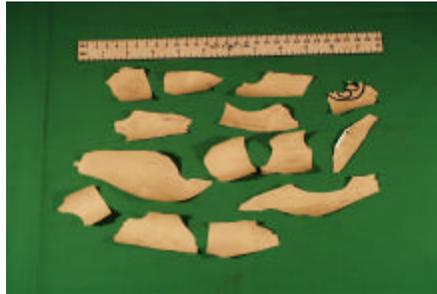
The topcoat is off-white and the IOZ primer is gray in color. A close-up view of the largest coating chip is shown in Figures 2-2 and 2-3, with the topcoat side up. Although the primer was observed to be well adhered to the topcoat, powder residue was readily removed during routine handling. In addition, the topcoat thickness appeared to be greater than that of the primer adhered to the topcoat. The amount of primer remaining on the substrate is currently unknown. It is assumed that the majority of primer thickness was left on the carbon steel substrate.

Figure 2-1. As-received chips

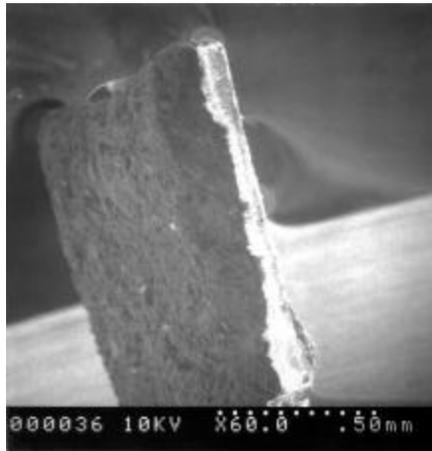
The chip samples were examined using an SEM to reveal surface morphology and characteristics of the IOZ primer. Samples were examined using a Hitachi scanning electron microscope at low voltage (10-20KV). A low magnification view of a chip sample is shown in Figure 2-4, with the topcoat (white) charging slightly due to its non-conducting nature. Samples were grounded in the microscope using conductive carbon tape to minimize such effects. Non-conducting samples can be sputter-coated with gold or carbon, but surface defects and other important features can often be masked or covered at microscopic levels. From Figure 2-4, the overall chip thickness was estimated to be approximately 180 microns or approximately 7 mils. Although only a rough estimate from an angular view, this is consistent with a 4-6 mil thick topcoat and a 2-3 mil primer which has cohesively split (2-3 mils for the primer would be acceptable, with all other application factors ideal).

Figure 2-4. SEM photomicrograph of a representative paint chip (60X)

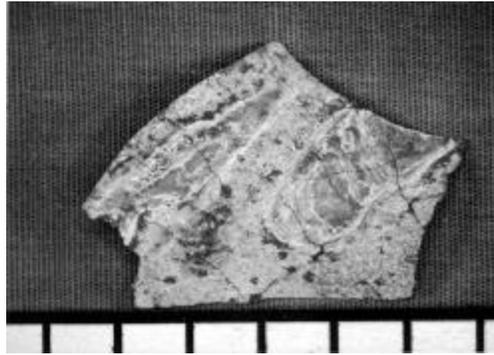
The pre-irradiated specimens did not curl to the extent of the non-irradiated specimens. The irradiation embrittled the chips, as qualitatively noted by the reduction in ability to bend the specimens before breaking for the irradiated chips, compared to the non-irradiated chips. The steam exposure softened the chips and allowed plastic flow, since bending in excess of that at room temperature was observed. The IOZ layer of the irradiated chips was also observed to contain numerous small cracks following the steam exposure, as shown in Figure 2-16. This was in contrast to the non-irradiated exposed chips, which did not show formation of cracks.

Figure 2-16. IOZ side up of chip specimen exposed to 300 °F steam following additional radiation to 0.2×10^9 R.

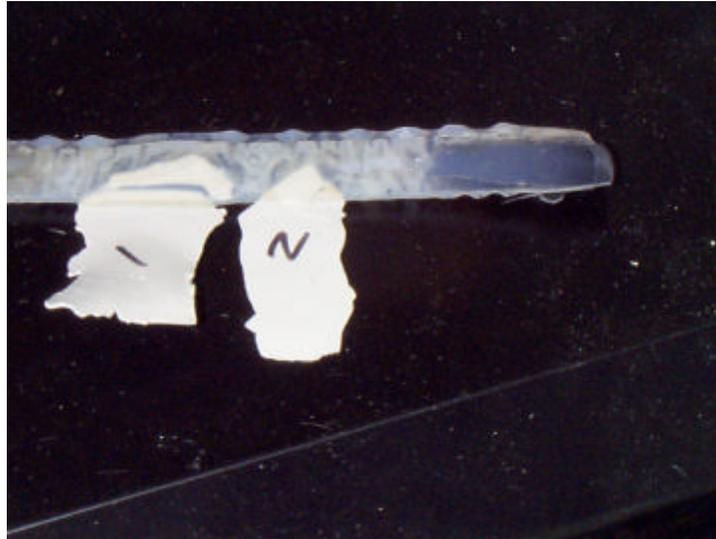
To test the hypothesis that a single-layer system should not be subject to the high degree of curling because differential expansion/contraction could not occur (unless the single-layer was not uniform), tests were run with single-layer coats. First, specimens of “artificial” debris chips, prepared by LANL for transport tests, were exposed to 300°F steam for 1 hour. The artificial chips exhibited only minor deformation compared to the plant-provided chips (Figure 2-18). Next, single-layer specimens were prepared by carefully grinding off the 0.005” IOZ layer on the chips using 1200 grit paper. Some residual IOZ remained at the edges of the chips, since it was difficult to remove this layer without breaking the chips.

Figure 2-18. Photograph of the artificial chips following steam exposure

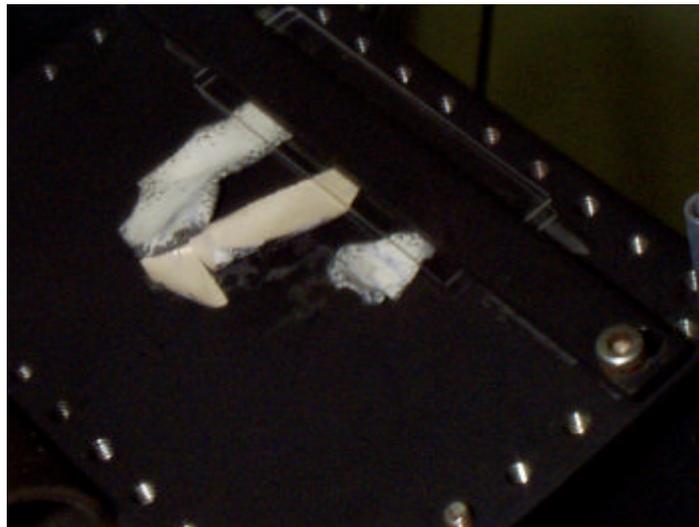
The single-layer chips were exposed to 300°F steam for 1 hour and the results (Figure 2-19) showed only minor curling of the chips compared to the results from the two-layer chips.

Figure 2-19. Photograph of the single-layer chips following steam exposure

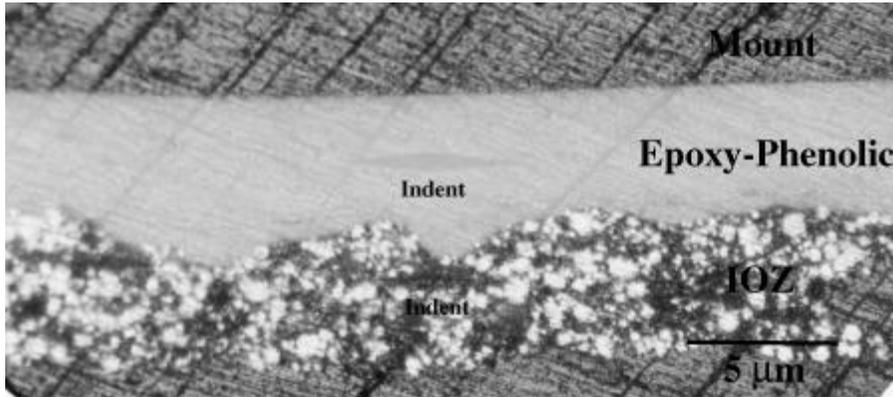
Additional characterization of the failed chips was performed. The as-received chips were mounted in cross-section and polished to show the two-layer system (see Figure 2-20). The Knoop hardness (HK) was determined using a 10 gram load. Measurements were made in the epoxy-phenolic layer with an average hardness number of 15.9 HK of five data (17.3, 15.5, 15.9, 15.8, 14.8). Measurements in the IOZ layer were more difficult to make because the contrast of the structure obscured the indentation. The average hardness number is 33.4 HK of three data (44.9, 28.2, 27.2).

Figure 2-20. Photomicrograph of the failed chip in cross section showing the two-layer system with the Knoop hardness indents in the epoxy-phenolic and IOZ layers

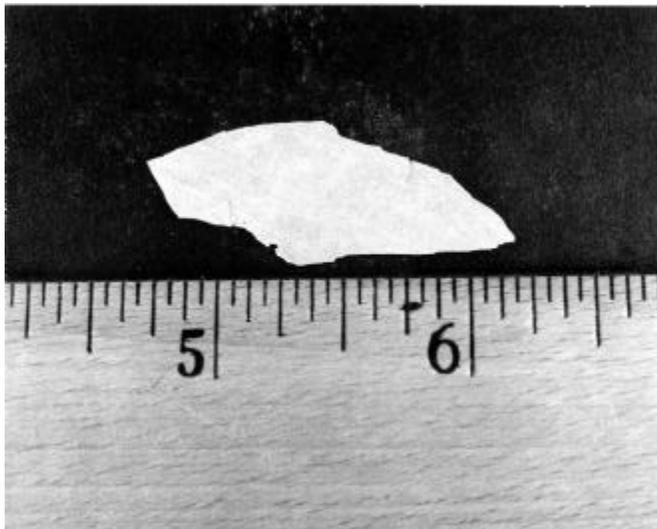
Figure 3-3. As-received debris, ceilings/wall location, 3rd Floor ceilings– topcoat with surfacer attached (note 1/4" cracks)

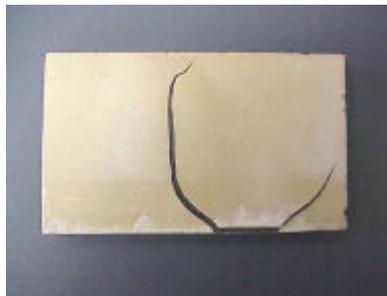
Figure 4-1. Overall view of snubber support base plate specimen as it appeared after DBA testing.

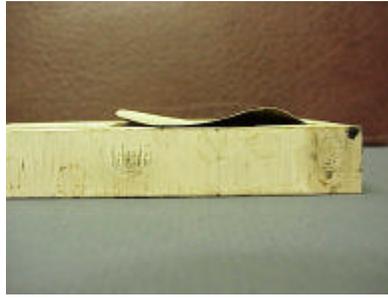
Figure 4-2. Side-view of the test specimen illustrating the extent of coating delamination.

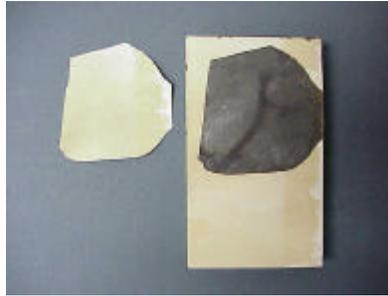
Figure 4-3. Overall view of the test specimen after removal of the failed chip. Note: The chip was removed approximately along the bond/non-bond interface.

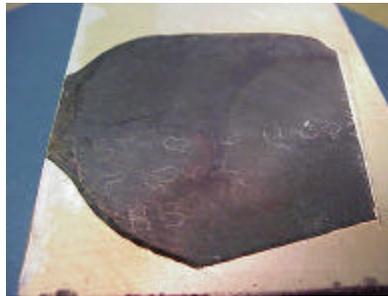
Figure 4-4. Close-up view of the test specimen revealing identification markings in the steel plate surface beneath the failed chip. Note: The surface in this area appeared smooth, with minor surface scratches similar to what might be expected from wire brushing.

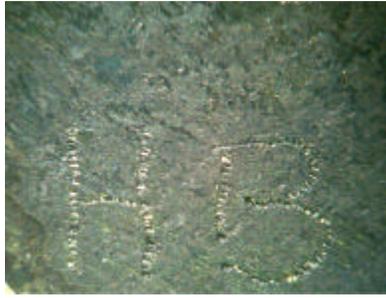
Figure 4-5. Close-up view of the surface of the steel plate beneath the failed chip illustrating the smooth, lightly brushed appearance. Note the presence of coating remnants in the marking indentations. (Magnification about 10X)

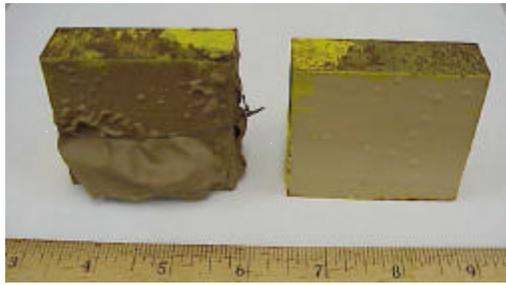
Figure 4-8. Overall view of the snubber support plate specimens following DBA/LOCA testing. The irradiated specimen (left) exhibited delamination and blistering of all of the coated surfaces. The non-aged specimen exhibited minor blistering. The dotted lines indicate the approximate immersion level. Note: The yellow paint present on the cut surfaces of the specimens was applied by SRTC to help control the formation of rust during the DBA/LOCA testing.

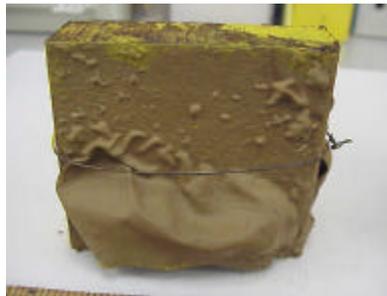
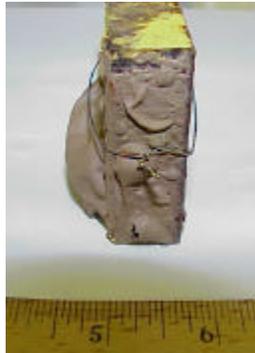
Figure 4-9. Front and side views of the irradiation-aged specimen illustrating the extensive blistering present following DBA/LOCA testing. Note: The wire was used to secure a thermocouple to the specimen front surface during testing.

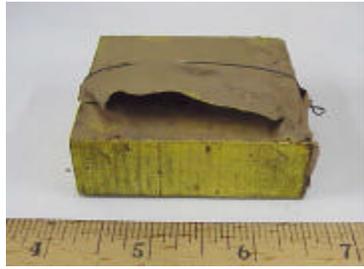
difference in depth of damage can, perhaps, be explained as a difference in the depth of oxidation of the coating, which occurred prior to irradiation.

Figure 4-10. Bottom view of the irradiation-aged specimen illustrating the delamination that occurred in the immersed portion of the specimen during DBA/LOCA testing. The coating was split intra-coating (i.e., a portion of the coating remained on the steel substrate).

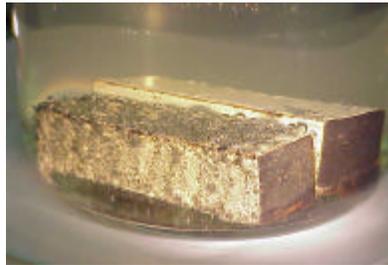
Portions of the aged and non-aged coating specimens were immersed in room temperature water, which was then heated to 200° F (Figure 4-11). As the water was heated, gas bubbles appeared on the coated surfaces of the irradiated specimen, accompanied by the formation of blisters in the coating as the temperature approached 200° F (Figure 4-12).

Figure 4-12. Overall view of the aged and non-aged specimens after immersion for approximately 2 hours in 200° F water. Note the formation of gas bubbles and blisters on the coated surfaces of the irradiation-aged specimen.

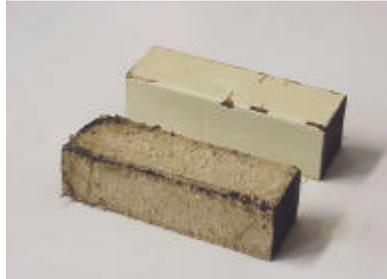
Figure 4-13. Immersion test specimens following removal from the test vessel. No evidence of coating degradation was observed on the non-aged specimen.

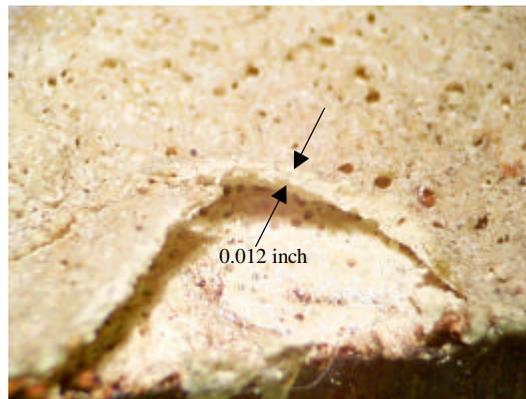
Microscopic examination of the irradiated specimen revealed an extensive network of pores and blisters throughout the coating. Measurements of the coating thickness made in broken blisters revealed a delamination depth similar to that seen in the DBA/LOCA testing. As before, a remnant of coating remained on the substrate beneath the blisters (Figure 4-14).

Figure 4-14 Photomicrograph of the surface of the irradiation-aged specimen following immersion testing. The thickness of the broken blister is approximately 0.012 inch – which is consistent with the delamination observed in the DBA/LOCA test. Note, also, the presence of minor blisters and pores in the surface of the coating. Magnification approximately 10x.

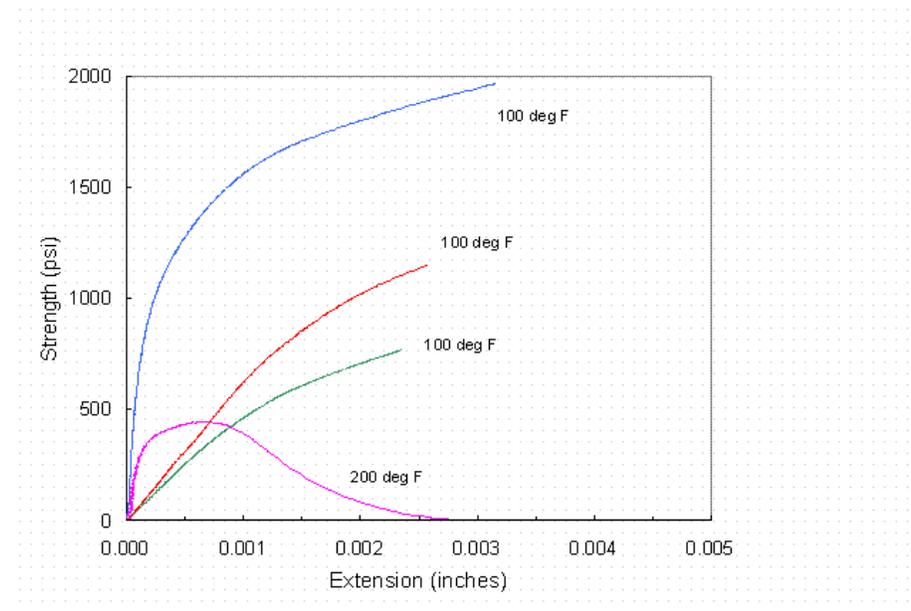
Figure 4-15 shows the load-extension results from an as-received plate in the dry condition. The highest strength was 1970 psi at 100 °F, in which test failure, or separation of the puller from the substrate, occurred at what appeared to be the topcoat/primer coat interface. In the lower strength failures at 100°F, failure occurred at the topcoat/primer interface as well as at the primer coat/substrate interface. In the instances of separation at the substrate, there appeared to be spots of rust on the steel substrate, which probably accounts for the lower strengths. The relatively lower strength and more ductile failure observed in the 200°F test compared with the 100°F tests are consistent with observations in the epoxy phenolic/inorganic zinc coating on steel (the SRTC System 1 coating).

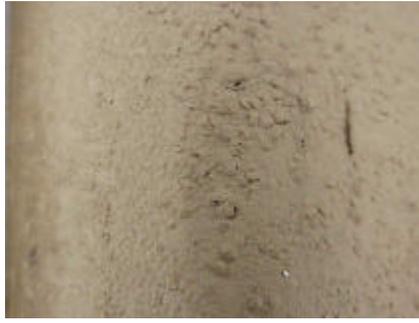
The coating did not fail, according to the acceptance criteria of the ASTM specification (Figures 4-17 and 4-18). However, under microscopic examination, there was evidence of failure of the coating in the irradiated specimen, similar to what has been observed in other irradiated specimens - by release of fine particles (Figure 4-19).

Figure 4-18. Macroscopic view of the surface of the irradiation-aged specimen, revealing the presence of intact blisters.

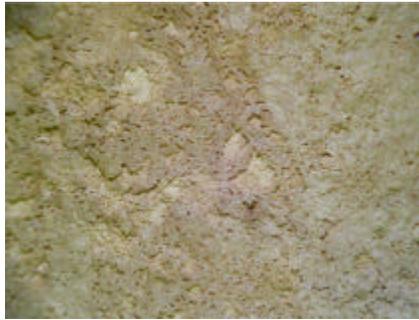
Figure 4-19. Microscopic view of the surface of the irradiation-aged handrail specimen, following DBA-LOCA testing. Magnification is approximately 7x.

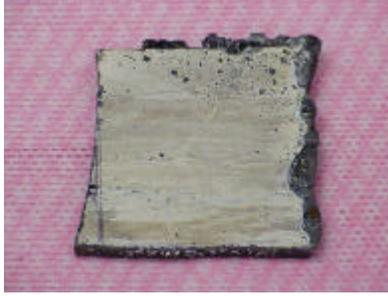
Figure 5-3 Overall view of the coated plate specimen as it appeared after immersion in 200° F water for approximately 24 hours. Only minor corrosion of the saw-cut edges of the specimen was observed.
