B-25 Corrosion Evaluation Summary Report (U)

**Savannah River Technology Center
Strategic Materials Technology Department
Materials Technology Section**

Publication Date: January 2002

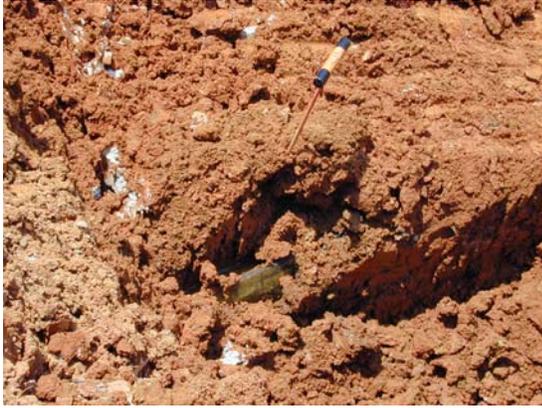
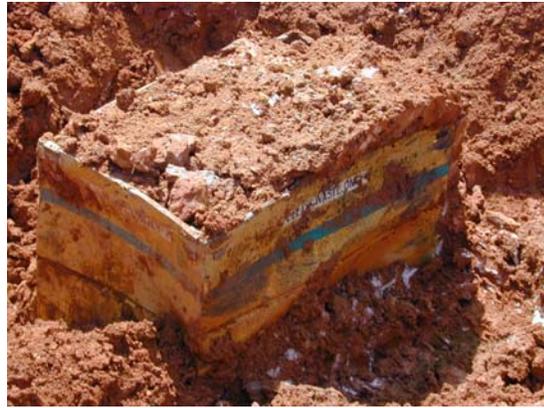
Excavation of the B-25 by Construction personnel began in the morning of May 2, 2001. The B-25 was uncovered by late afternoon and it was apparent that the lid cover was distorted and slumped into the container, Figure 1. The soil around the B-25 was very moist and both soil and water had accumulated inside the container. The void spaces between the original contents of

Figure 1 B-25 at dig site (a) B-25 just uncovered (b) exterior of B-25 exposed.

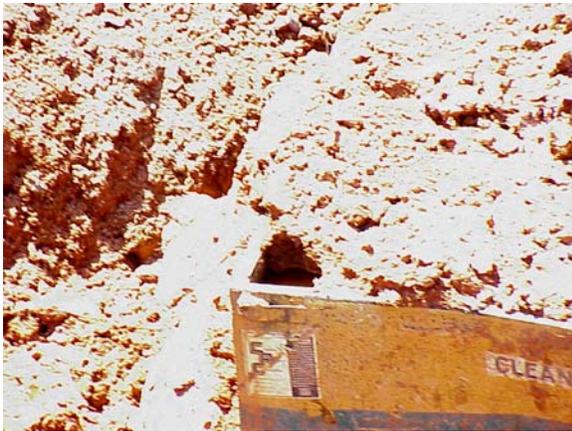
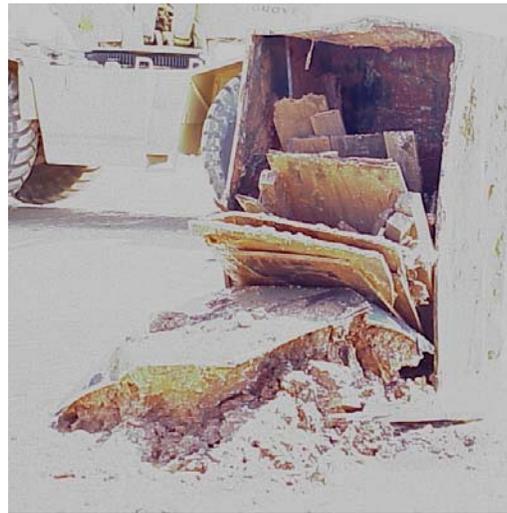
the B-25 had filled with a combination of soil and water, Figure 2. Water flowed from the container when its contents were dumped while some of the moist soil adhered to the container contents and walls. Samples of the adhering soil and from regions near the B-25 burial site were bagged for shipment to an offsite vendor for analyses of soil pH, moisture content, electrical resistivity, and chloride and sulfate concentrations, Table I. Field measurements of the soil adjacent to the B-25 showed a pH of approximately 5.4 and a temperature of about 64.4°F, Table II. Under these conditions non-painted, low carbon steel would be expected to experience at least 0.010 inches per year of corrosion loss. However, the majority of the B-25 was protected from corrosion by the “painted” film, thus little to no corrosion was visually noted in the painted areas. Localized corrosion and pitting was observed in regions where the protective coating was breached.

Figure 2 B-25 at dig site showing presence of water and soil inside box (a) Opening into B-25 container (b) Water and soil dumped out of B-25 container.

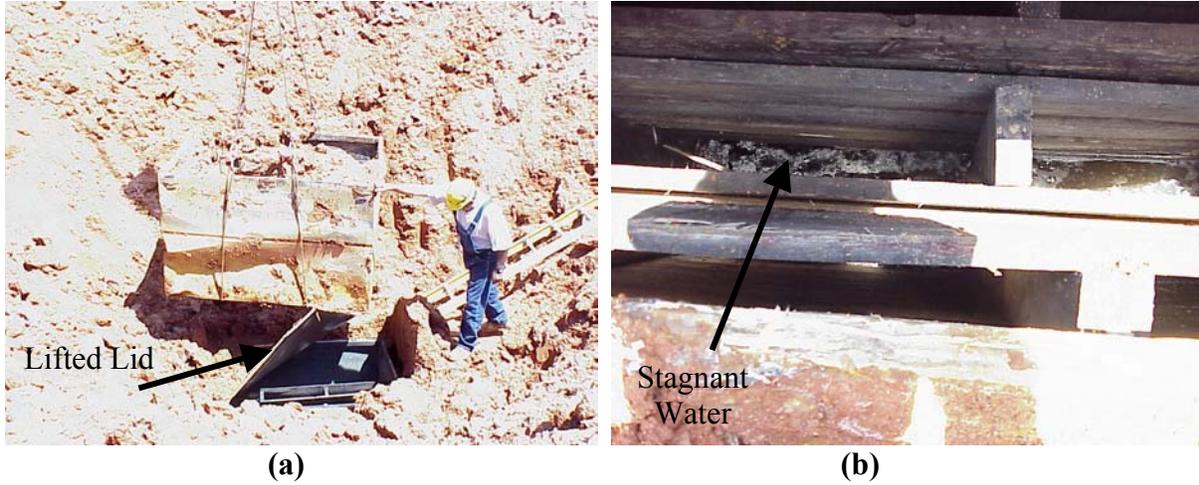
Figure 3 Buried B-25 below the excavated B-25. Lid was intact yet water was present inside the container (a) Lower lid lifted off B-25 container (b) Stagnant water in bottom of B-25 container.

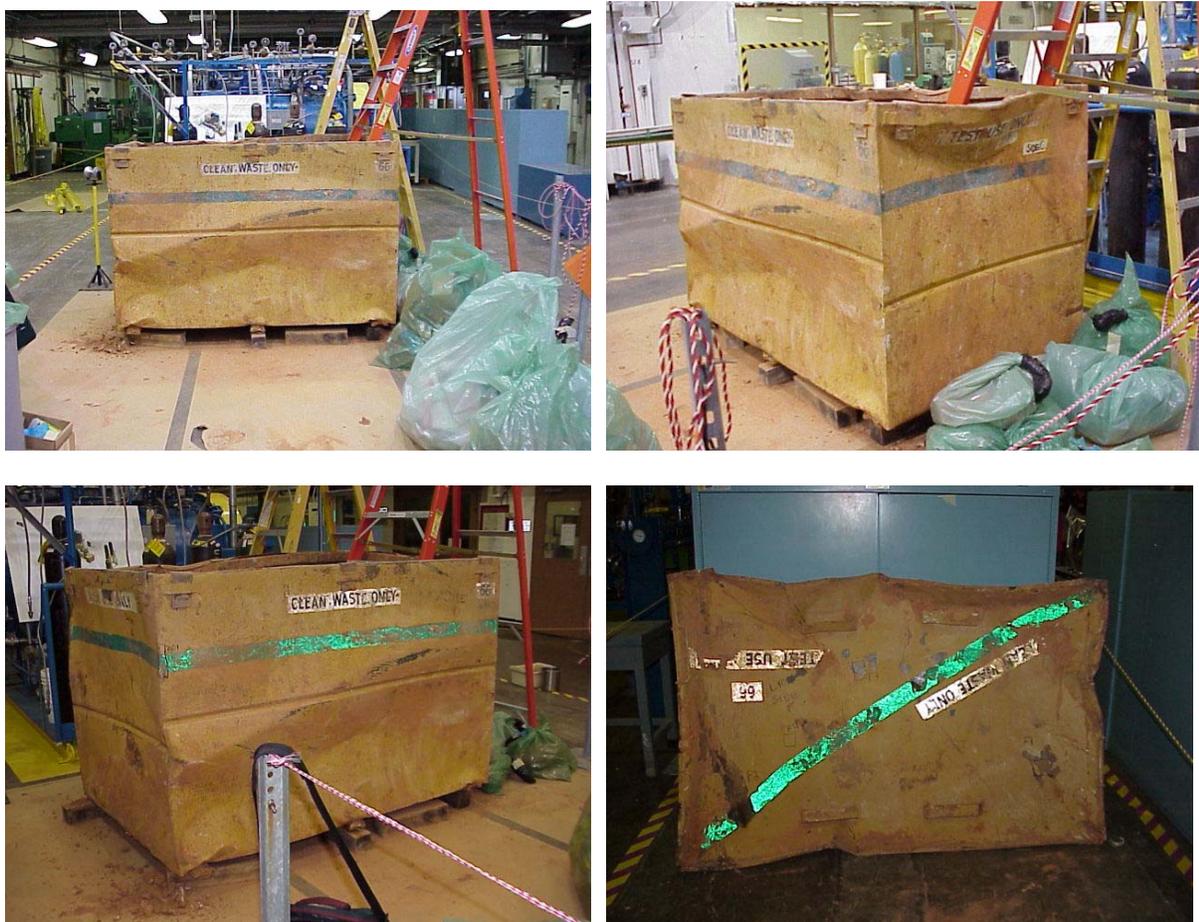
The B-25 container was structurally sound even though the corners and edges had been slightly crushed due to previous compacting, Figure 4. One corner in the bottom of the box had a through wall leak path that allowed a small amount of water to leak from the container while it was stored in the laboratory.

Figure 4 Outside of excavated B-25. No visible corrosion (rust) seen.

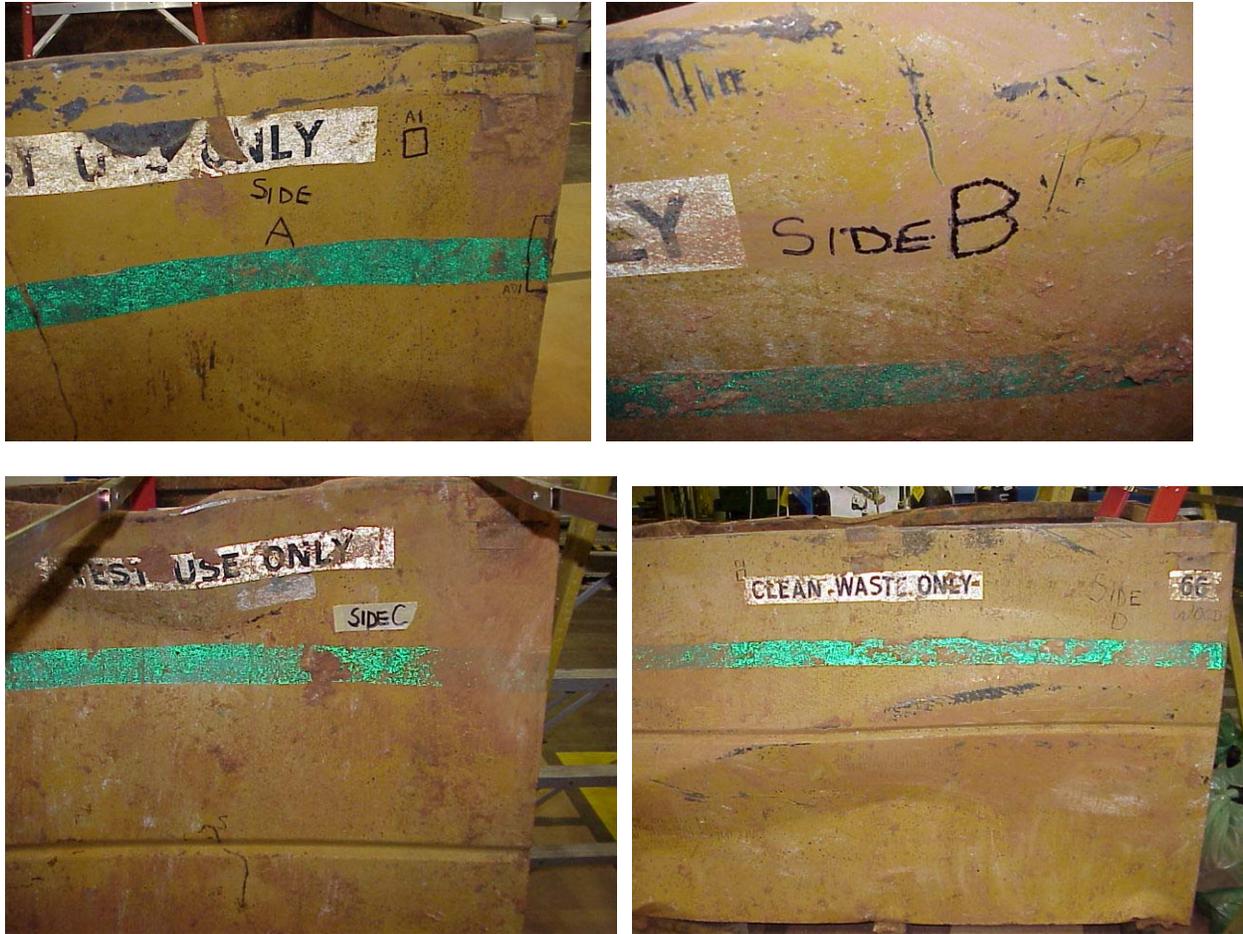
Figure 5 Excavated B-25 showing primer and alkyd enamel intact over much of the container. Lack of enamel on several areas due to handling (forklift, etc.).

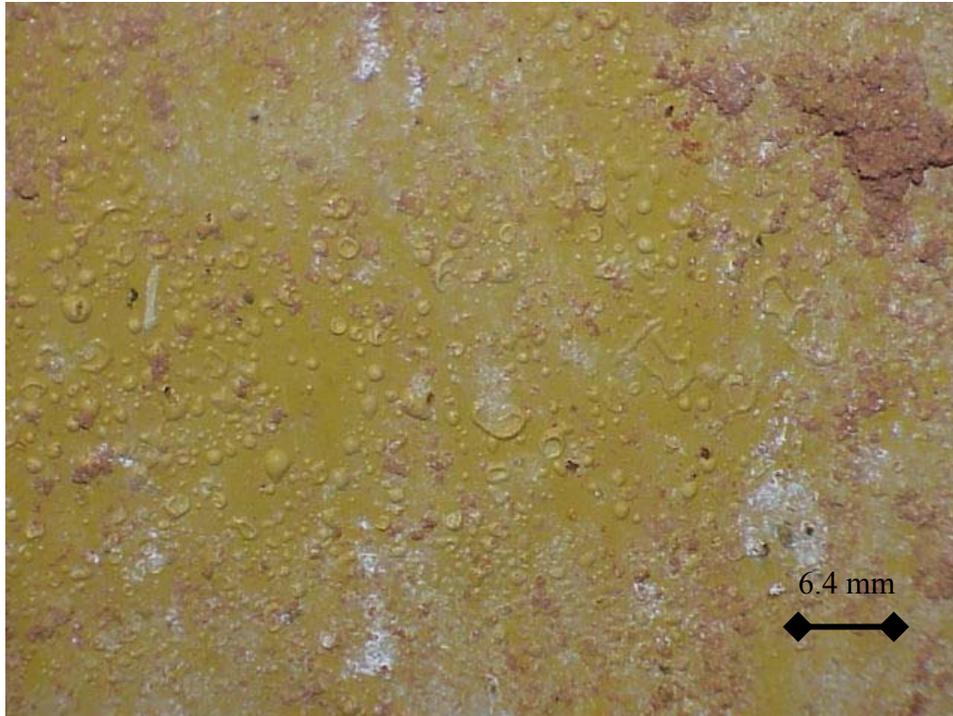
Figure 6 Alkyd enamel blistering over much of the B-25 container surface.

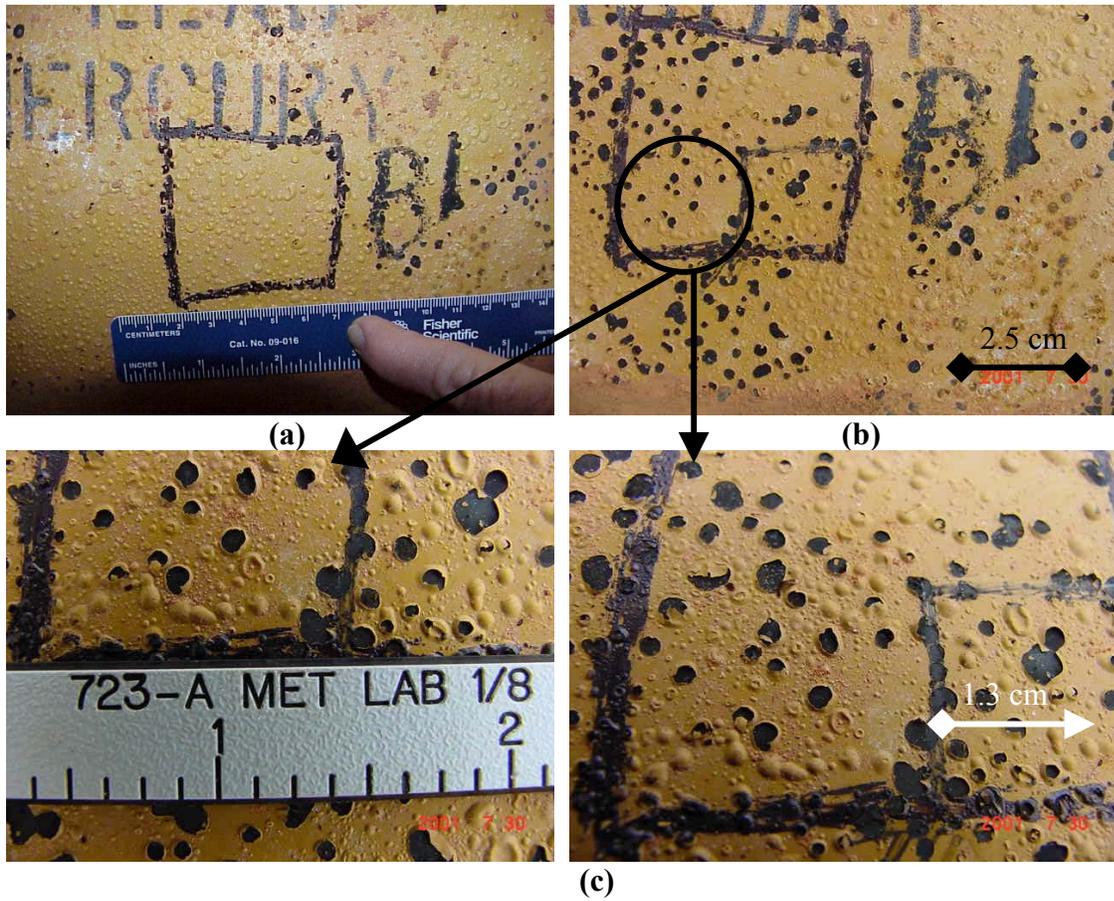
The majority of blisters on the vertical walls of the B-25 were approximately 1/8" in diameter, although some larger blisters were evident, Figure 7. Growth of the blisters is due to cathodic delamination around the edges of the blister. In most cases when an intact blister was scraped away, the primer appeared to be securely adhered to the metal surface. The lack of blistering in the primer, Figure 7 (c), suggests that the primer is permeable to both moisture and hydrogen. However, there were areas where both the enamel and the primer degraded. In those areas an oxide buildup was observed, Figure 8. This oxide was black, which is indicative of Fe_3O_4 rather than Fe_2O_3 , which is the typical rust color. Generally, Fe_3O_4 will form as a corrosion product when the oxygen content is restricted. Any oxygen involved in the corrosion reaction that was not from the water itself had to permeate both the alkyd film and the primer and was therefore permeation limited.

Figure 7 Paint blisters on the surface of B-25 container (a) Intact blisters, (b) broken blisters, (c) broken blisters showing intact primer.

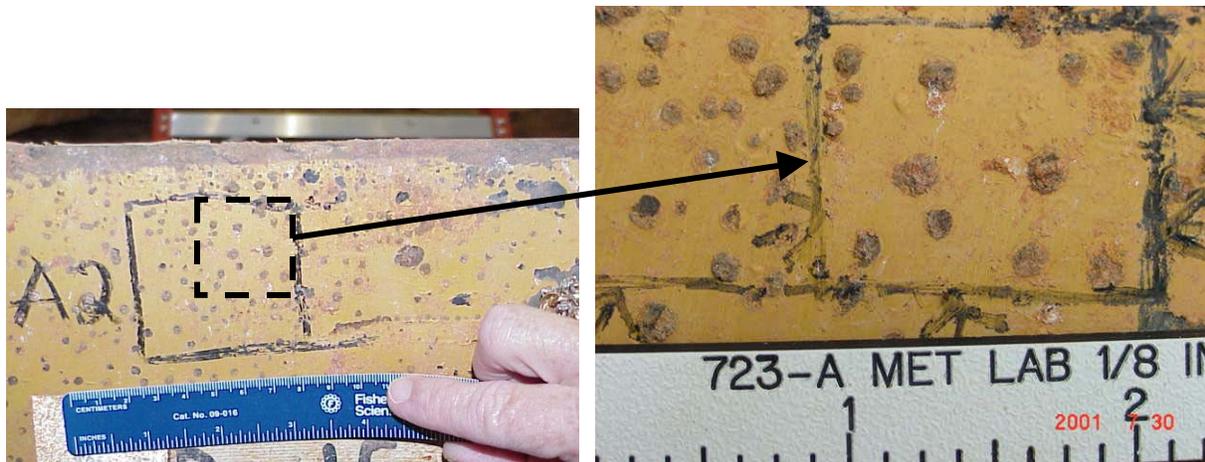
Figure 8 Pitted area with corrosion build-up on surface.

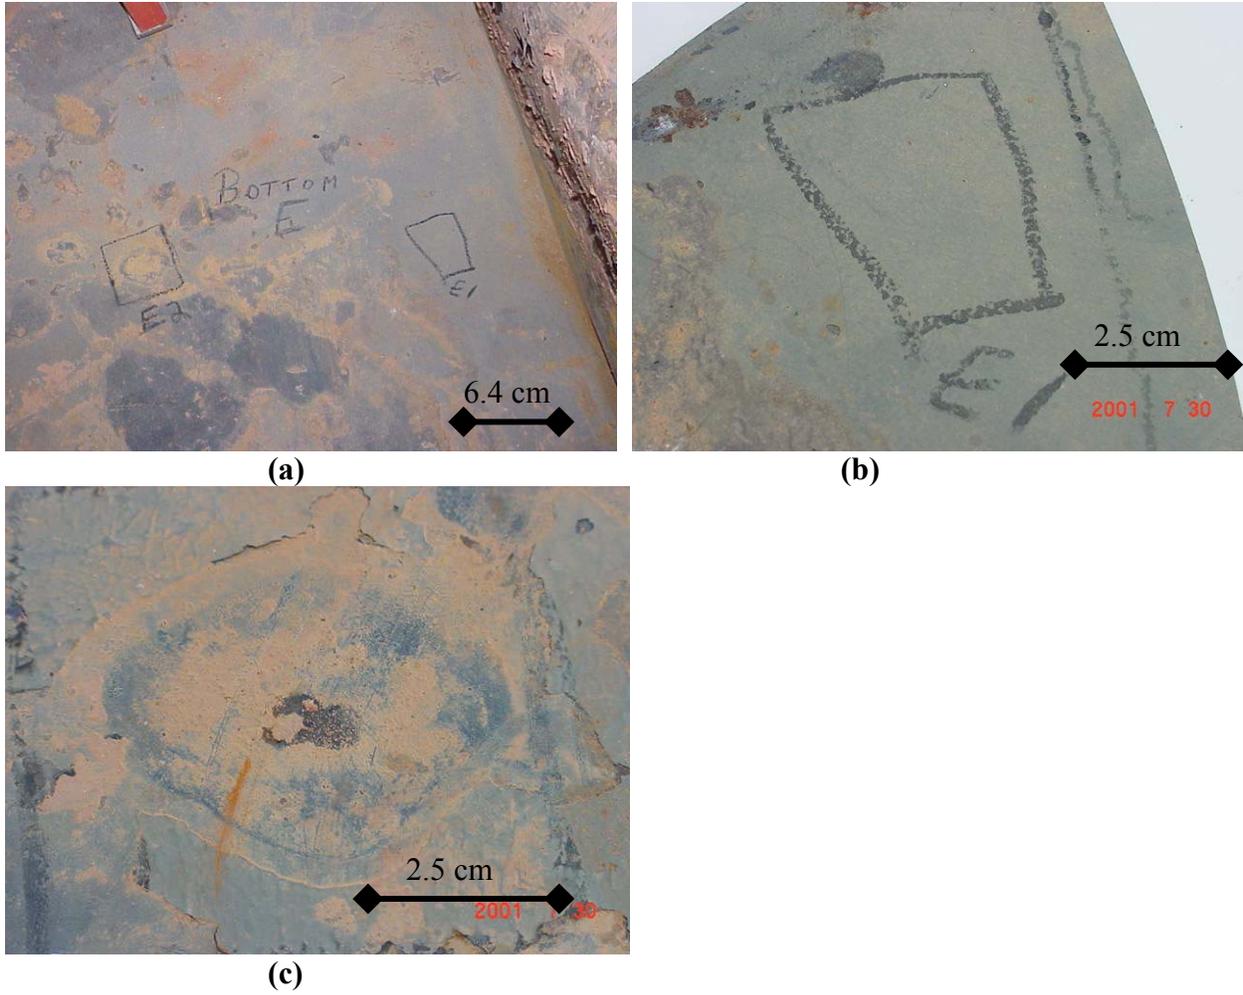
Minor pitting on the exterior of the container was observed. The interior of the container sides did not show any evidence of corrosion product accumulation, Figure 9, although flakes of the black primer were easy to peel from large areas, approximately 20 in², Figure 9 (c). Examination of the outside of the container bottom showed large areas of general corrosion, apparently associated with areas where a forklift truck damaged the protective alkyd film during container handling, Figure 10.

Figure 9 Inside bottom of B-25 container (a) No corrosion (rust) is visible, (b) Primer appears to be adhered to some of the surfaces, (c) Primer has flaked off surface and degradation is visible.

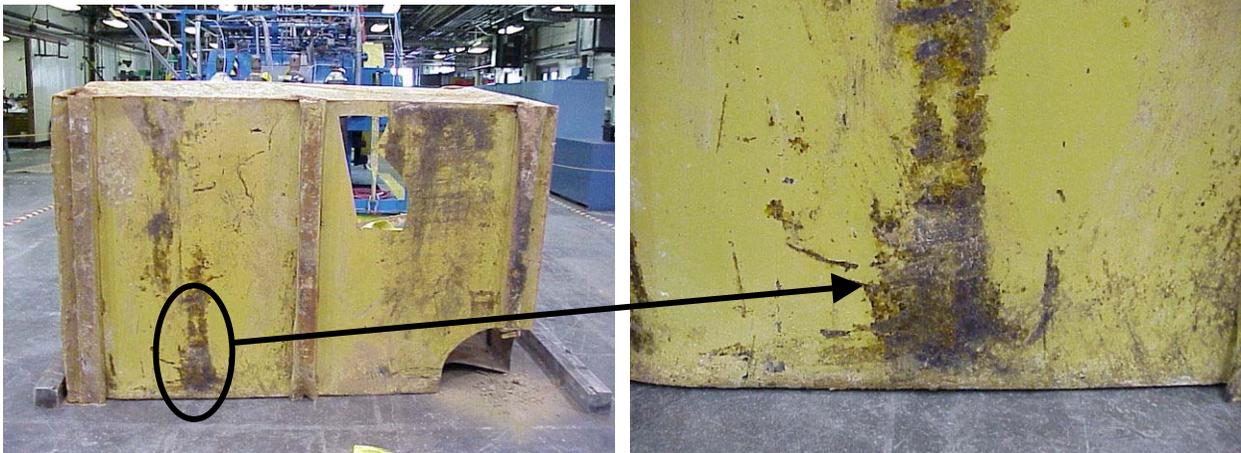
The increased amount of corrosion on the exterior of the B-25 floor where a forklift had scraped the B-25 surface is not unusual because the protective coat was removed and the metal surface was exposed. This corrosion in this area is termed general or uniform corrosion. Uniform corrosion generally occurs at a constant rate if, as is the case for iron in slightly acidic water, the corrosion process does not produce a protective film. Therefore, the rate of general corrosion calculated for the bottom of the B-25 floor may accurately reflect the corrosion rate for a B-25 container buried under similar conditions.

Figure 10 Outside bottom of excavated B-25. Presence of corrosion (rust) as a result of abrasions from a forklift prior to burial.

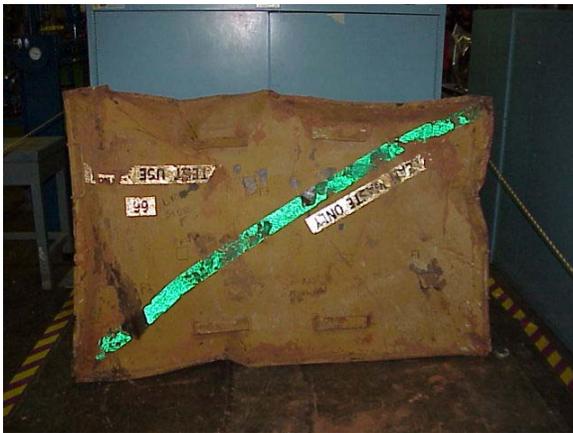
The lid of the B-25 was caved into the box and a large amount of soil closely adhered to the external surface, Figure 11. The lid was transported to the laboratory in 773-A with the soil intact so that the regions of contact between the lid and the soil could be examined during the soil removal process, Figure 12. The contained contact surfaces of soil samples removed from the lid had replica imprint of the pits that had developed in the lid, Figure 13. These replica imprints demonstrated the degree of contact between the soil and the lid. Macroscopic pits associated with the replica imprints and from regions where the soil had detached prior to the examination were observed on the exterior surface of the lid. The pits varied in size from approximately 1/8" in diameter to approximately 1/4" in diameter, Figure 14. In several areas a group of pits had coalesced to form a large area of degradation (approximately 9 in.²), Figure 15. On the underside of the lid, some areas of primer delamination and material degradation were observed, Figure 16.

The lid deformation was most likely caused by the weight of the soil upon burial of the B-25 container eight years ago [9]. There was no evidence that this deformation, by itself, caused a breach in the coating to exacerbate corrosion. Additionally, one of the upper B-25 lid handles was torn from the container, Figure 23, during the burial process. Corrosion on both the interior (underside) of the lid and the exterior of the lid was present, Figure 24. On the underside of the lid, some areas of primer delamination and material degradation associated with general corrosion, were observed. The exterior of the lid had large areas of pitting and in several areas the pits coalesced in a central location to form a large area of degradation (approximately 9 in²), Figure 15. Metallographic cross sections of the lid show the presence of general corrosion, individual pits and coalesced pits, Figure 25-26. The soil, being in such close contact with the lid, showed the replica imprint of the pitting corrosion on the lid exterior, Figure 13. Where there was close contact with the soil on the lid, there was no evidence of the alkyd enamel remaining on the lid. The alkyd enamel appeared to have “dissolved” into the soil as a result of the moist environment.

Figure 11 B-25 container lid deformation due to weight of soil during burial process.

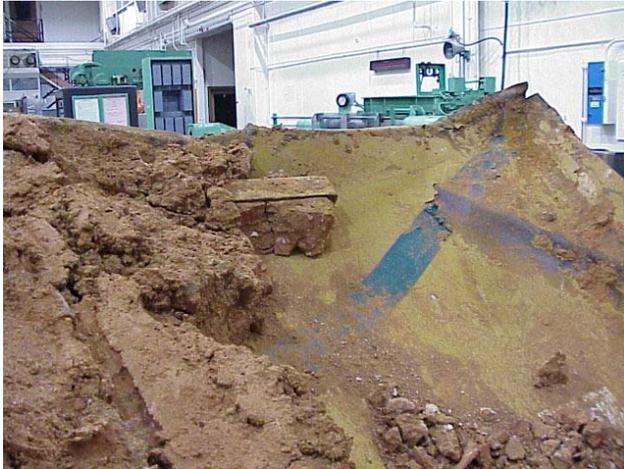
Figure 12 Soil in close contact with B-25 container lid.

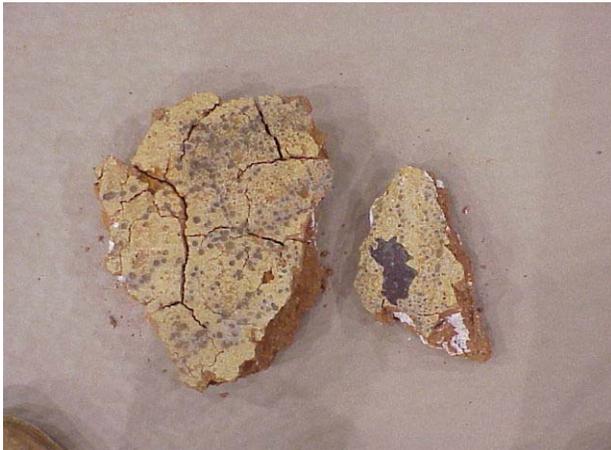
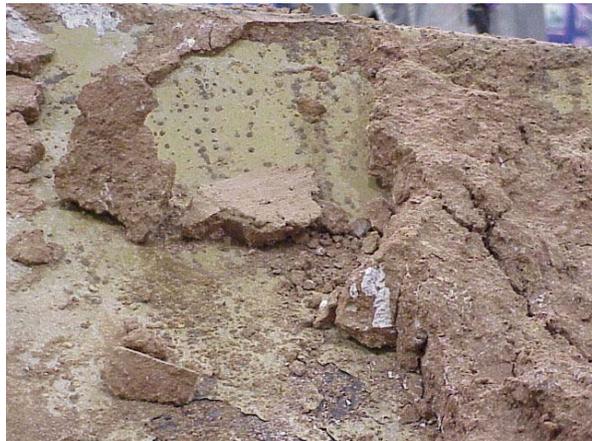
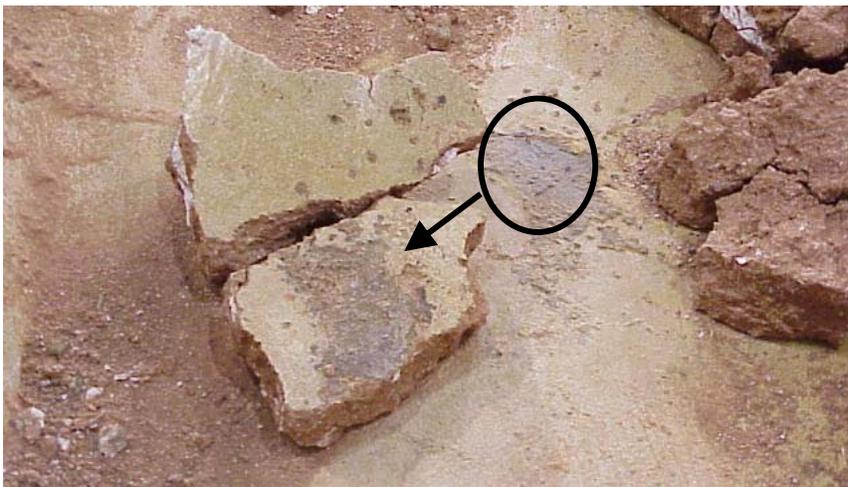
Figure 13 Chunks of soil showing the imprints of pitting on lid surface.

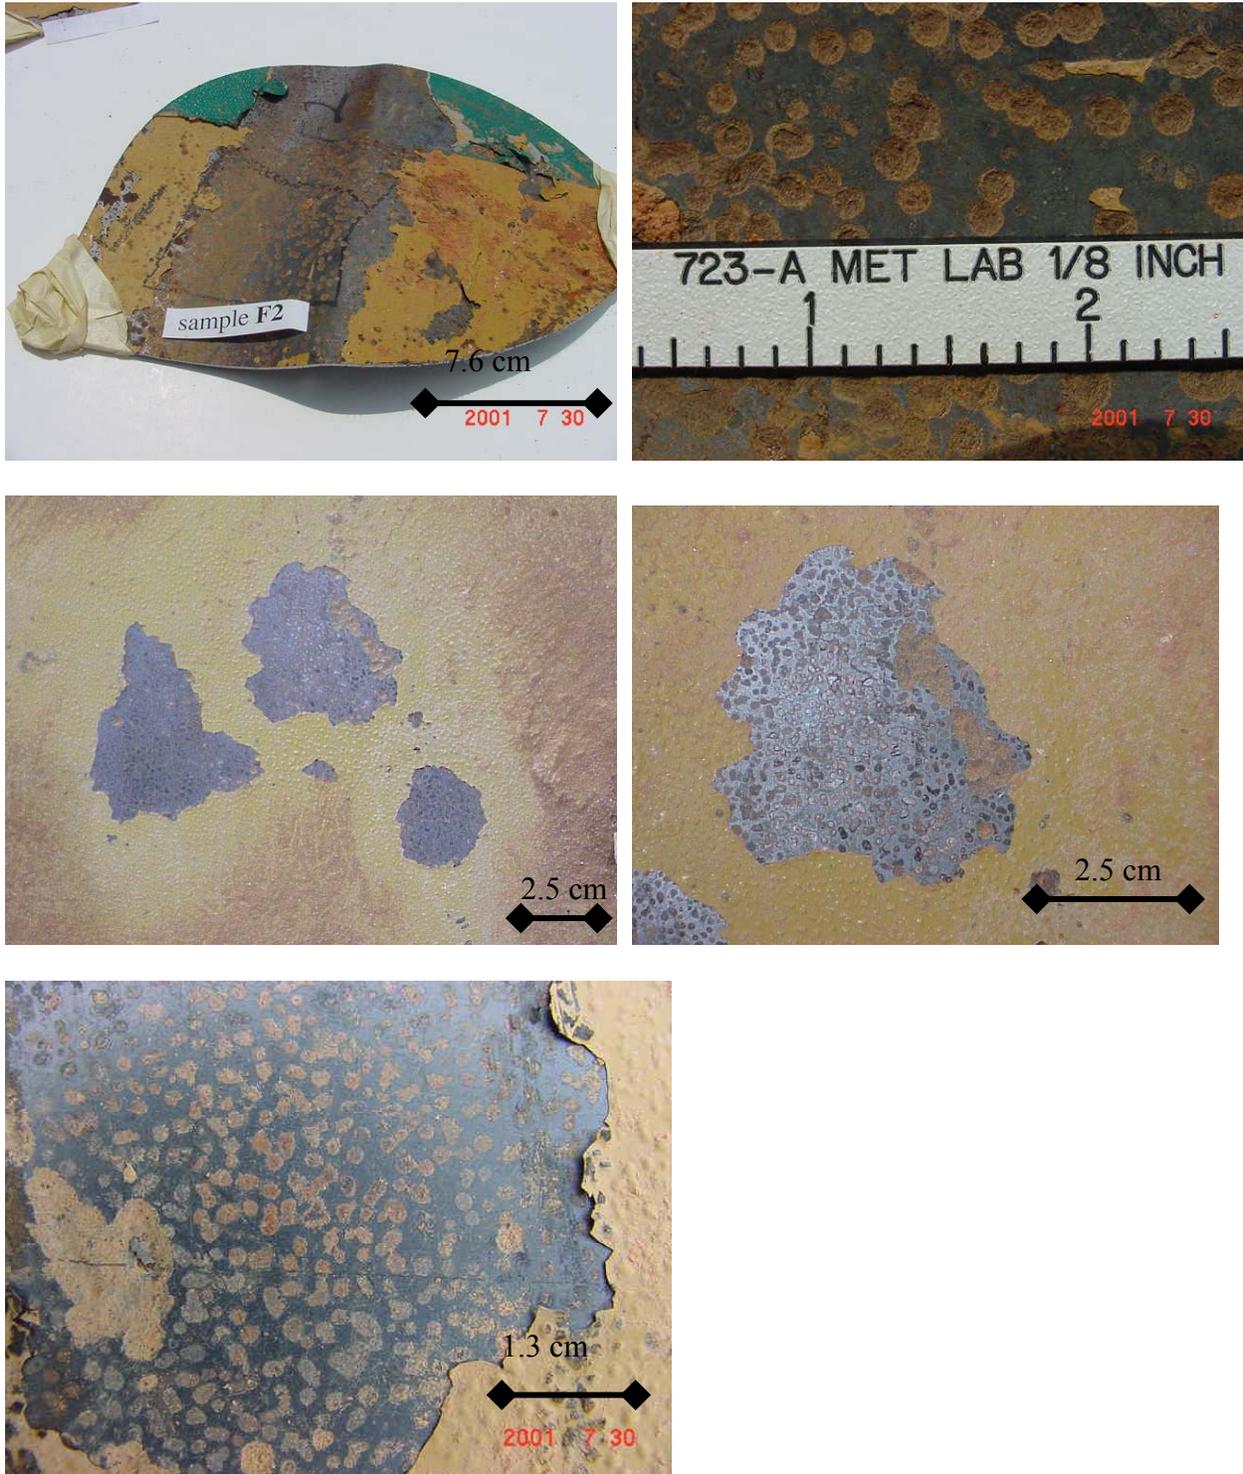
Figure 14 Large areas of macroscopic pitting on lid surface.

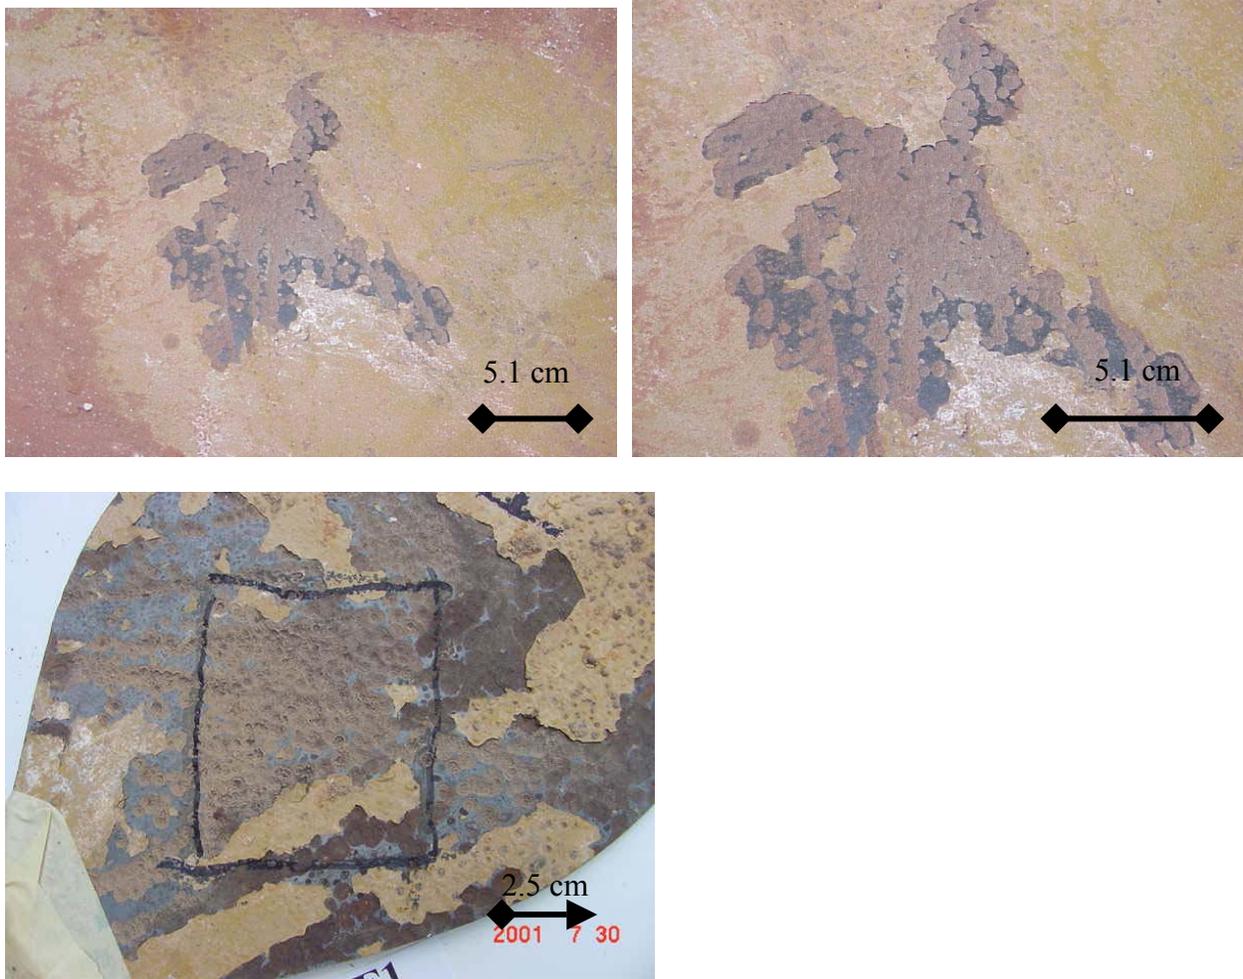
Figure 15 Coalesced pitting on lid surface.

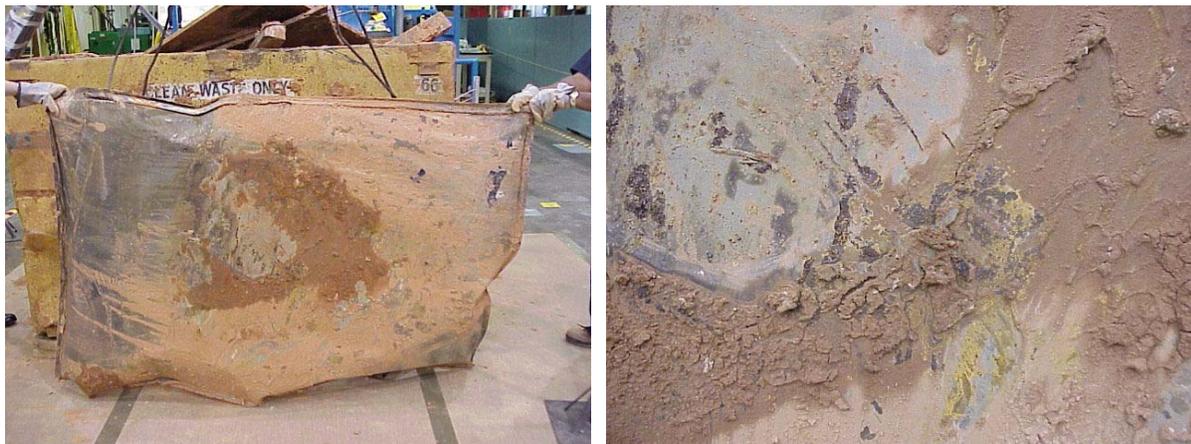
Figure 16 Underside of B-25 container lid showing primer delamination.

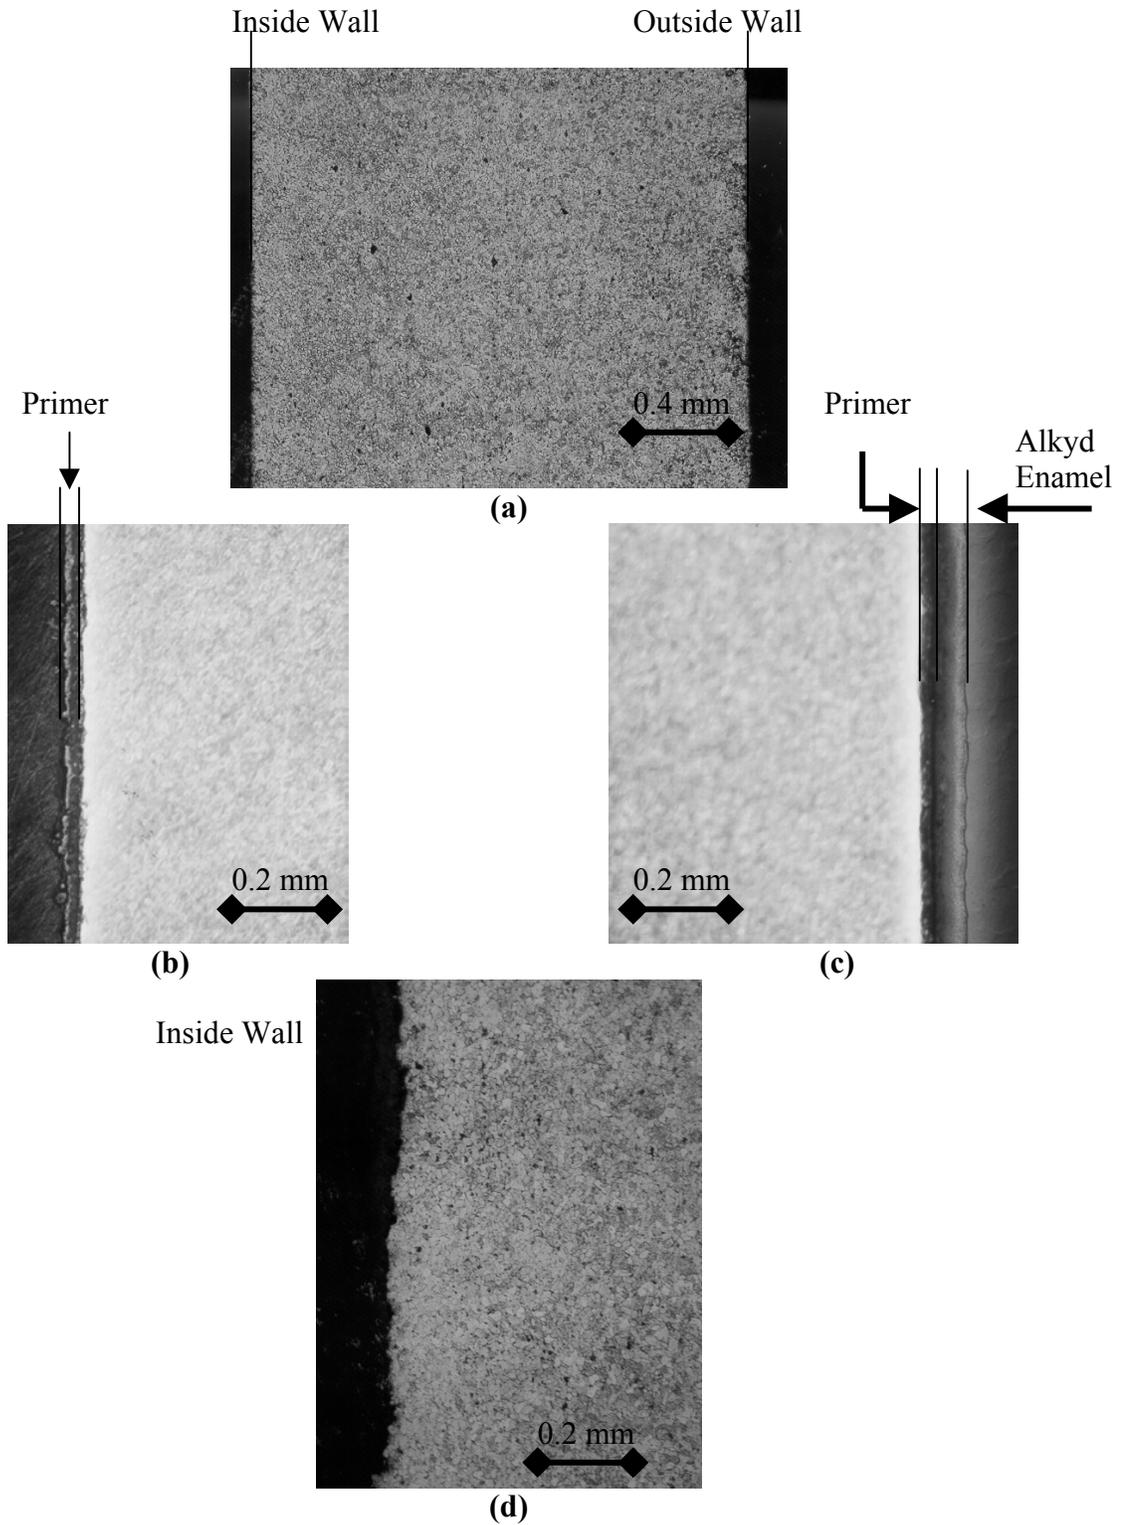
Results from the metallography of the B-25 sections being examined indicate that the nominal wall thickness is close to 0.0775" which is 20% less than the minimum required wall thickness in the current specification [2]. This is, however, consistent with a previous procurement specification [1], which required 14-gauge carbon steel (nominal thickness of 0.0747"). The current procurement specification requires a 12-gauge carbon steel (nominal thickness of 0.1094"), a primer thickness of 0.002" inside and outside the box, and an alkyd enamel thickness of 0.00125" on the exterior of the box [2].

Additionally, the primer thickness on the excavated B-25 container is approximately half of the primer thickness specified in the current procurement specification and the alkyd enamel thickness is approximately twice the thickness quoted in the current purchase specification,

Figure 17. If the primer thickness on in-service B-25 containers is only half of the specified thickness then the corrosion protection in these containers is significantly below the implied levels. These findings indicate that differences between B-25 containers may exist and that a complete analysis of the various types of B-25 container is required to ensure the applicability of any assessment of the in-service behavior.

Various levels of degradation were observed from the samples sectioned from the walls of the B-25 container. Certain areas sectioned exhibited little to no degradation, Figure 17. In these areas, the primer was in tact on the interior and the primer and alkyd enamel were in tact on the exterior. Regions where blistering of the alkyd enamel paint were observed had very shallow pits, Figure 18 while regions where the blister had cracked and flaked off showed deeper pits, Figure 19. Regions where the blister flaked off and an oxide layer had formed showed the deepest pits, Figure 20. These observations are consistent with the various stages of pitting corrosion previously described.

Figure 17 Metallographic cross section of B-25 wall in an area with good primer and enamel adhesion (a) Nominal wall thickness, (b) Primer thickness, (c) Alkyd enamel thickness, (d) Little to no degradation in B-25 wall.

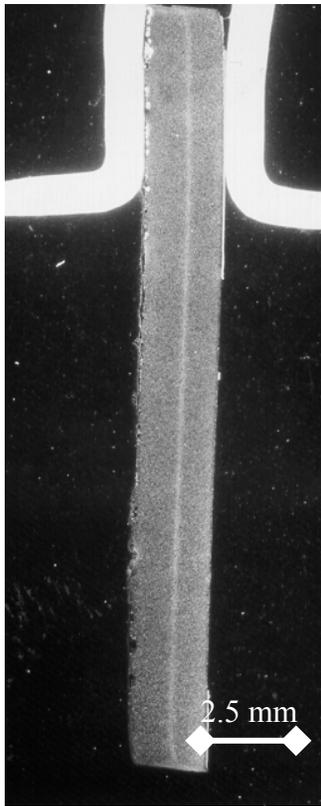
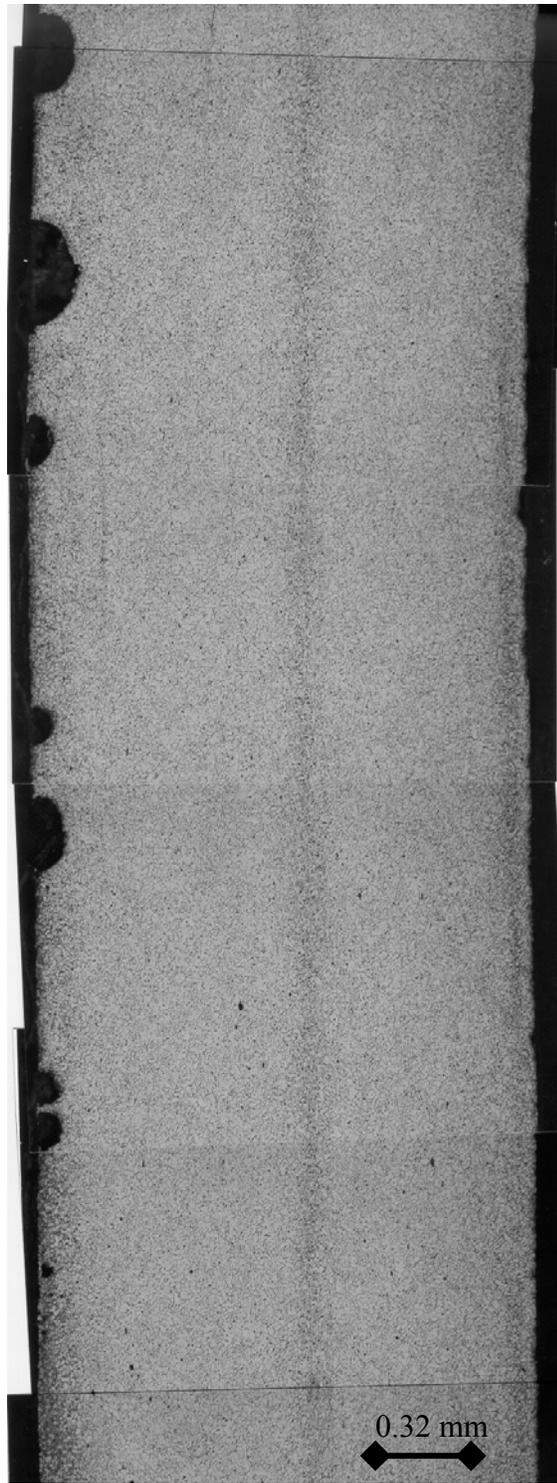
Figure 18 Metallographic cross section at B1 (Reference Figure 7) from a blistered enamel area on exterior of B-25 container. Note the inside pitting rather than the outside (a) Low magnification of overall sample, (b) Montage of region.

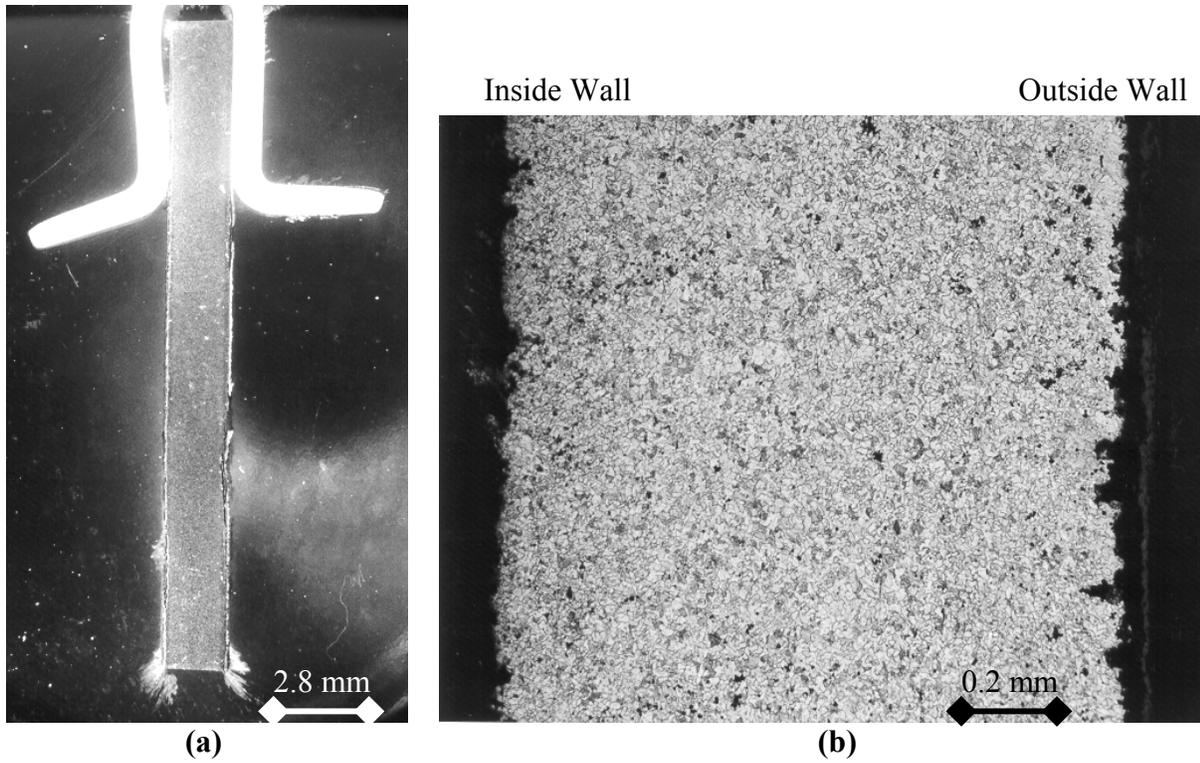
Figure 19 Metallographic cross-section of area where blisters had flaked off of exterior of container (a) Low magnification of overall sample, (b) Higher magnification of pitting on both inside and outside of wall.

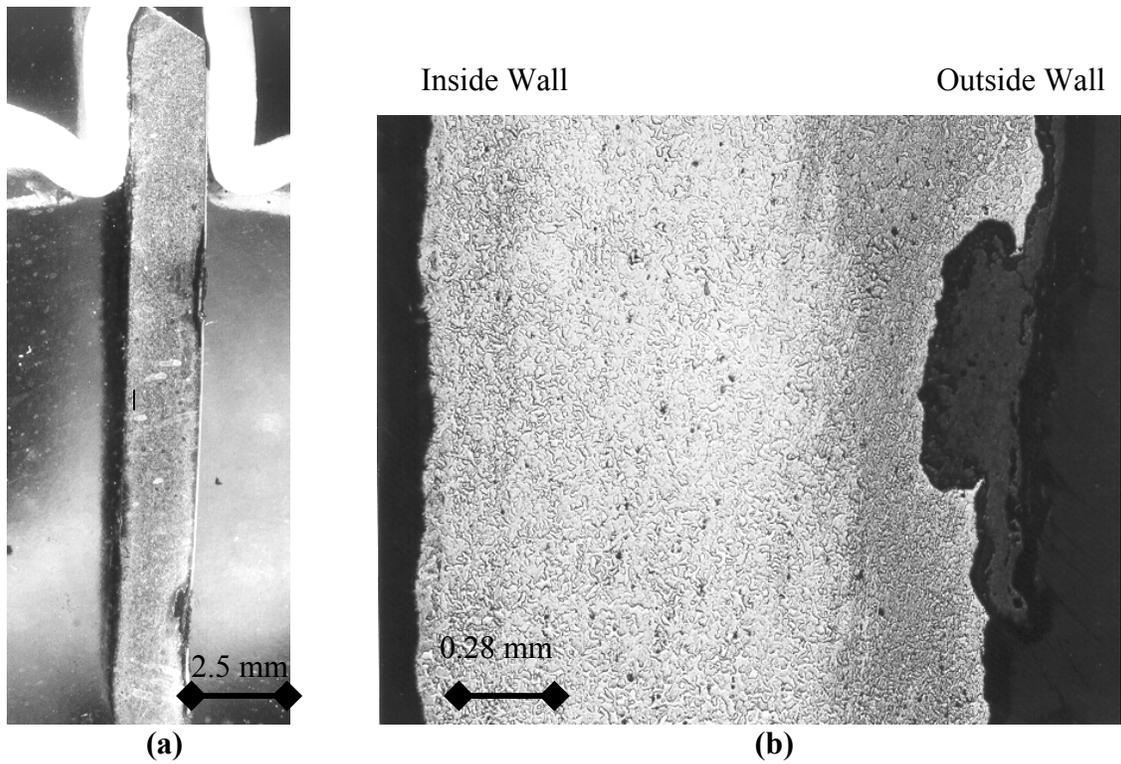
Figure 20 Metallographic cross section showing pits where oxide layer formed on exterior wall of B-25 (Reference Figure 8) (a) Low magnification of overall sample, (b) Higher magnification of deep pits from outside to inside. Some general corrosion seen from inside to outside.

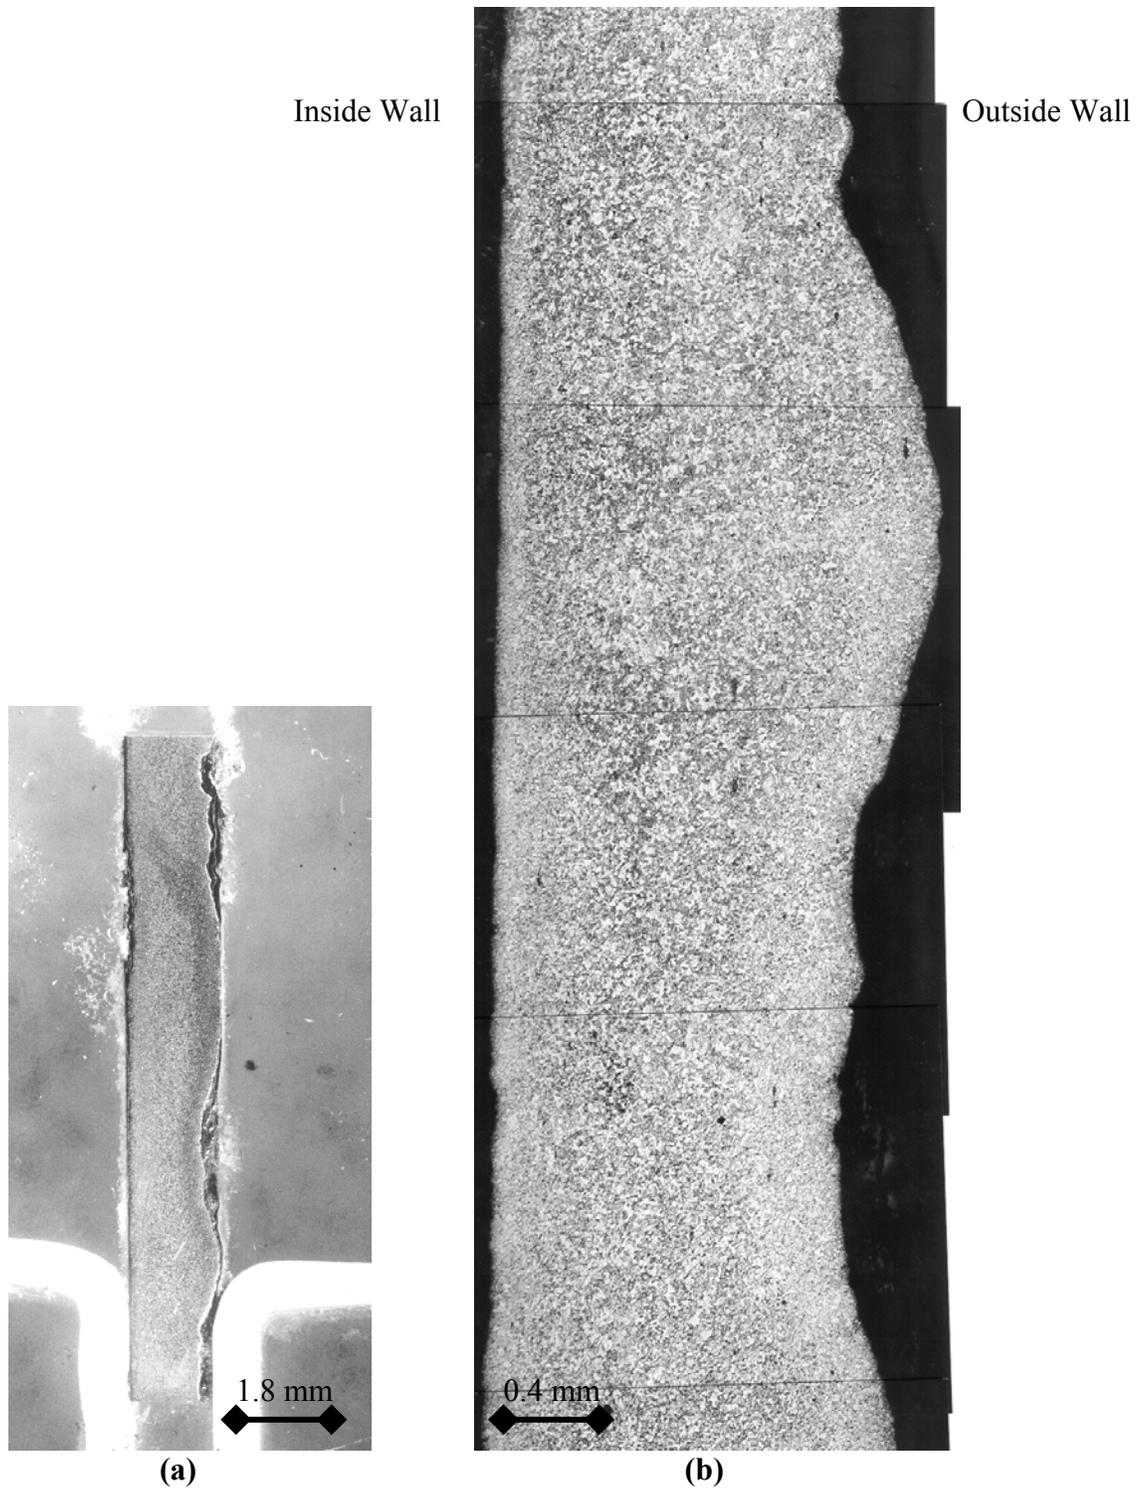
Figure 22 Metallographic cross section of B-25 container floor showing the presence of general corrosion on the outside section due to abrasions from a forklift prior to burial (Figure 10) (a) Low magnification of overall sample, (b) Higher magnification montage showing level of corrosion degradation to the floor.

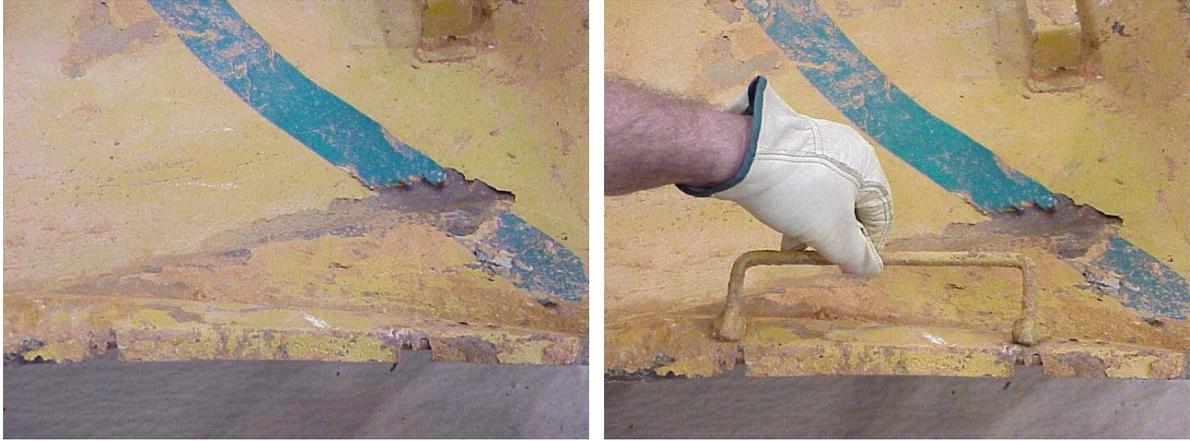
Figure 23 Lid handle found dismantled from B-25 container.
