B-25 Corrosion Evaluation Summary Report (U)

**Savannah River Technology Center
Strategic Materials Technology Department
Materials Technology Section**

Publication Date: January 2002

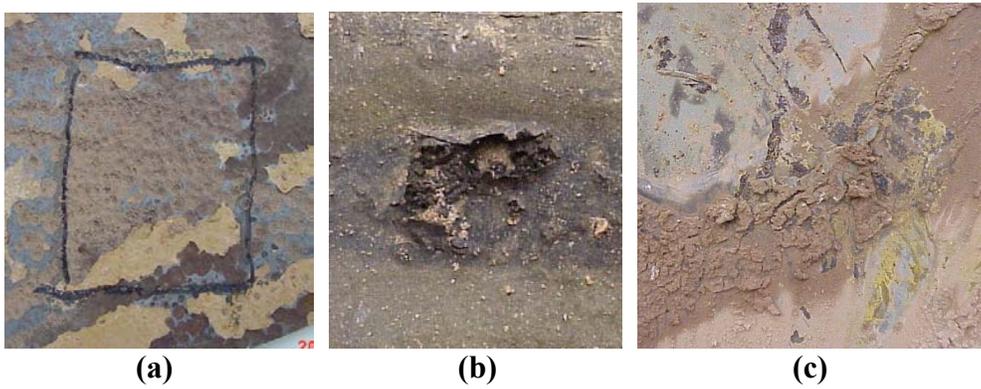
Figure 24 Corrosion on inside and outside of lid. Paint and/or primer has delaminated from the surface where soil was in close contact with metal. (a) Outside of lid, (b) Inside of lid, (c) Inside of lid.

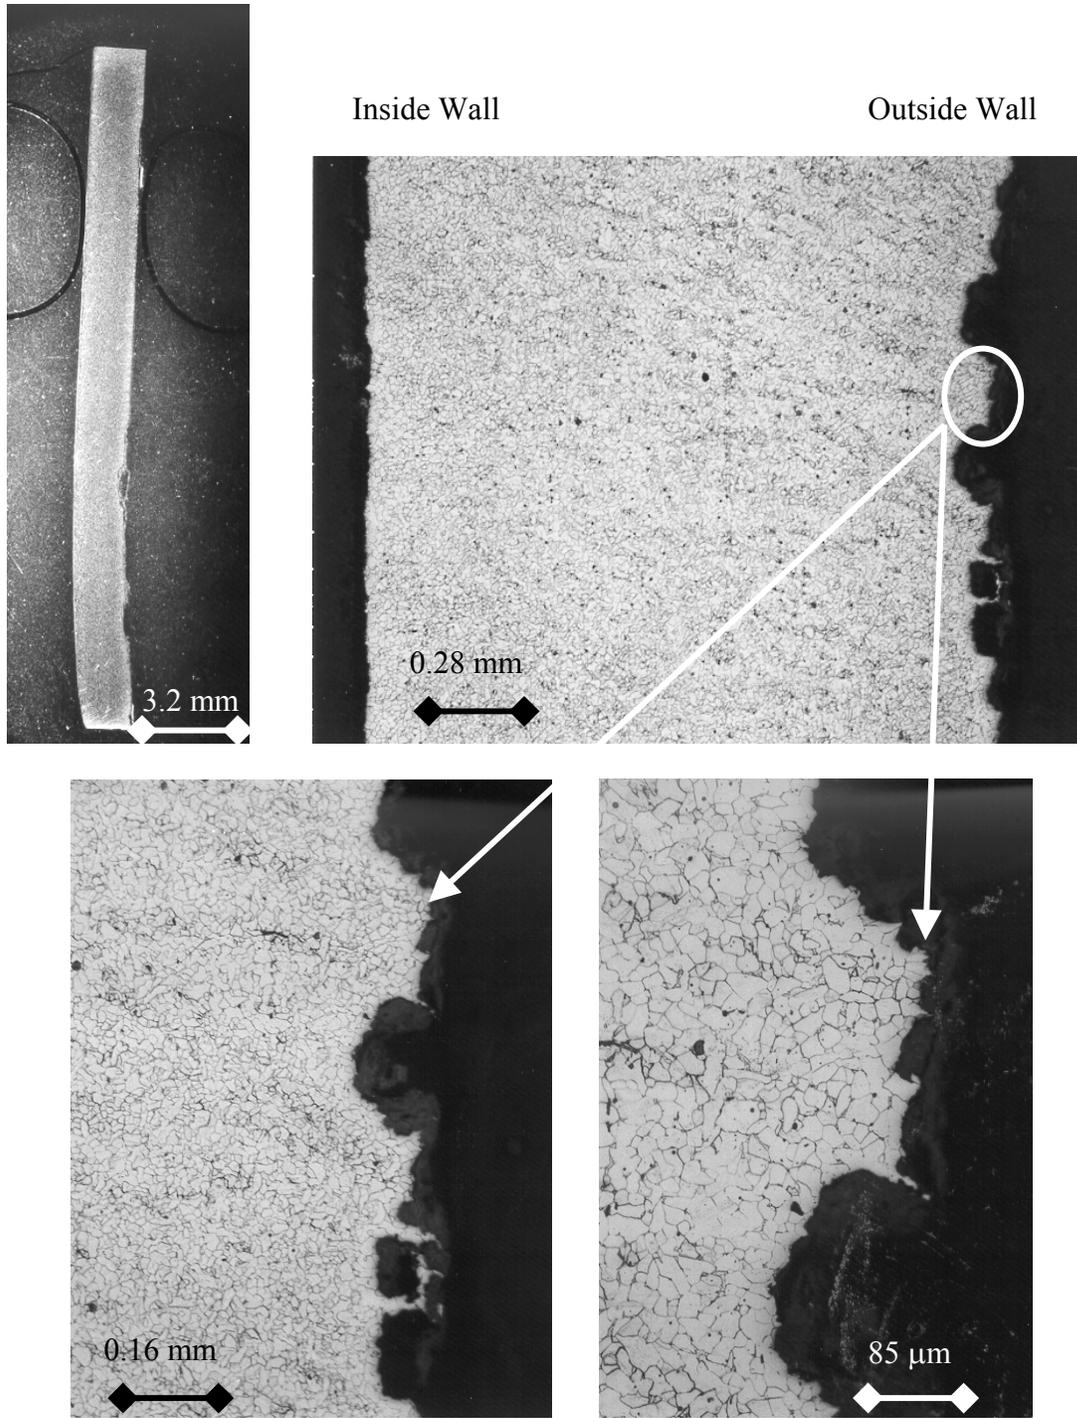
Figure 25 Metallographic cross section of lid showing wide shallow pits (Reference Figure 14).

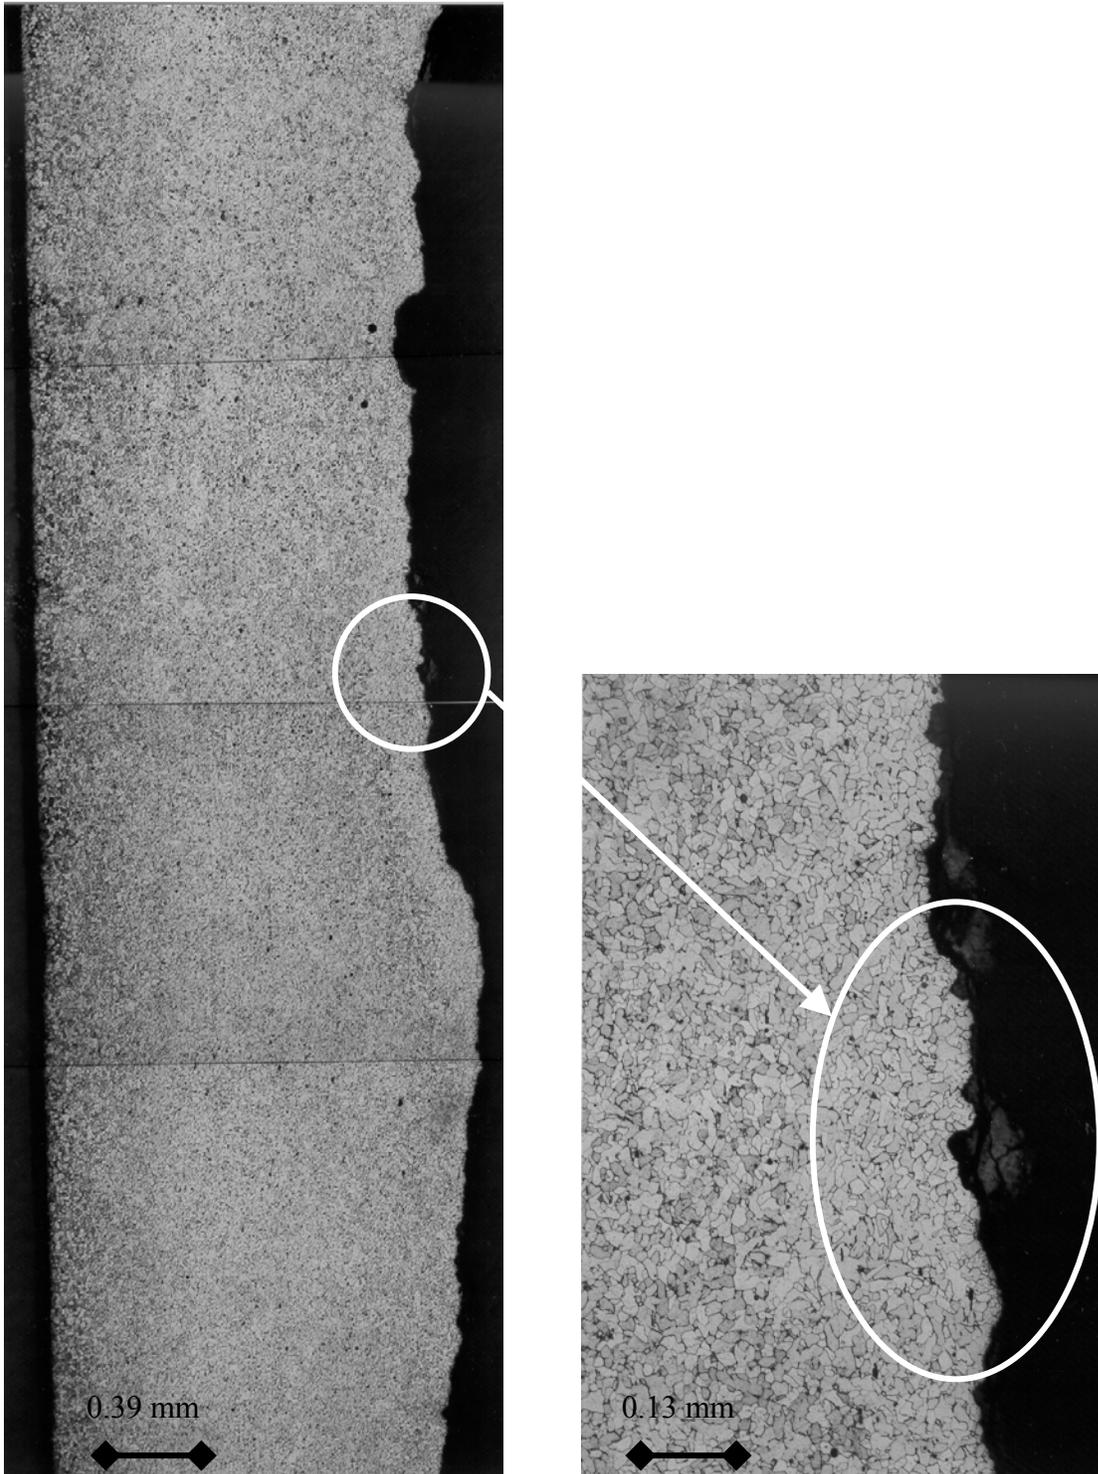
Figure 26 Metallographic cross section showing region on lid of B-25 container with coalesced pits (Reference Figure 15).
