SRS Type II HLW Tank 15 NDE Inspection Results

Savannah River Technology Center
NDE and Materials Reliability
Materials Technology Section

February 24, 2003

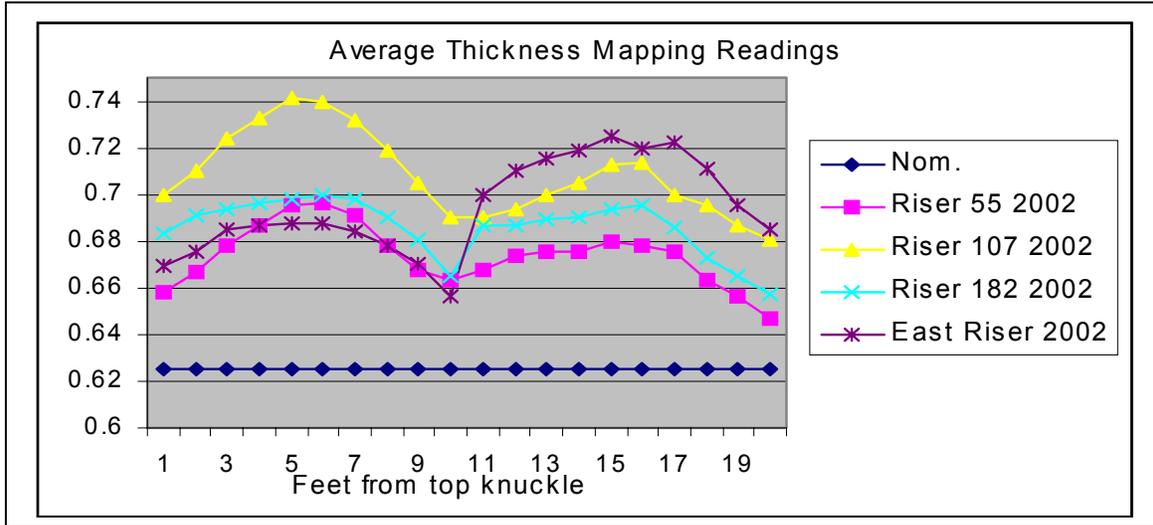
Figure 9: Average Thickness Summary Plot

Thickness mapping was performed on 1% of the circumference of the tank for the entire accessible height of the tank (see Figure 9 and Table 2). These thickness mapping examinations were performed to detect and measure any general wall loss, pitting or interface attack in all regions of the tank including the vapor space. No reportable wall loss or pitting was detected.

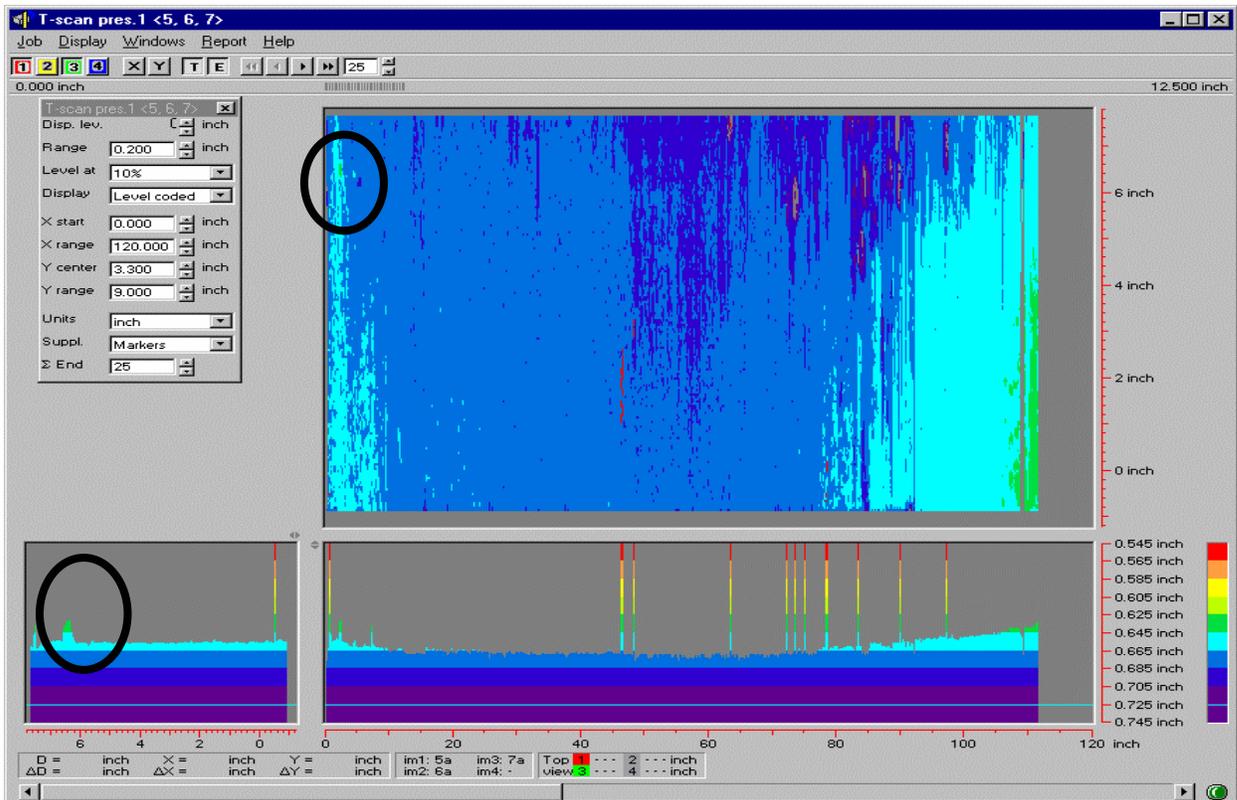
Figure 13: Thickness Mapping Image of Lower Plate, Riser 55

Inspections of Tank 15 through riser IP 55 included one vertical strip for the entire accessible height of the tank. No reportable areas were detected in the vertical strip. The minimum thickness detected in the upper and lower plates are above nominal thickness. The minimum thickness detected in the upper plate was 0.639 inch and is near the edge of the plate toward the middle weld. The minimum thickness detected in the lower plate was 0.632 inch. This minimum thickness area is a 0.25 x 0.40 x 0.030 inch deep indication approximately 2.5 inches from the middle weld. The minimum thickness at the bottom of the same plate is 0.634 inch. The indication is in the black circle (see Figure 13). The image shows the plate to be thinner at the edges. There are several noise spikes shown in the side and end views. These noise indications were evaluated and determined to be non-relevant. No Crack-like indications were detected in this strip.

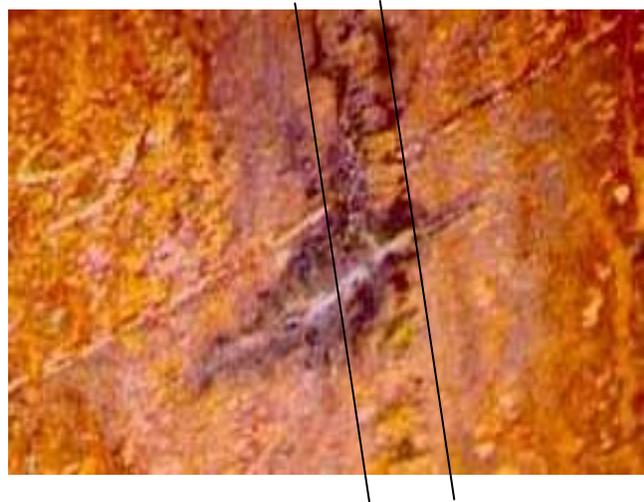
Figure 14: Visual Image of Crack in Upper Plate Vertical Weld, Riser 55

One previously identified indication in the upper plate vertical weld at approximately 53 feet was also examined under riser IP55. The indication was observed at 200 inches above the tank bottom. Due to the high weld profile and limited time and the fact that the examination of this leaksite was not a requirement of the Tank 15 ISI scope, the indication was only examined from one side of the vertical weld. The examinations were performed on the side of the weld opposite the riser. The crack was confirmed to be through wall, but also had a partial through wall segment. Measuring the indication on the right side only, the through wall portion was 1.4 inches. The total length was 3.7 inches on that side of the weld. Figure 15 shows some of the UT data from this indication.

A picture of the indication at 200 inches above the tank bottom, rotated to the same orientation as the P-scan data is shown in Figure 13. The image is rotated 180 degrees (up-side down). The vertical weld edges are marked on the image. Only the part of the indication on the left side of the picture was scanned (Right side of weld looking at tank). The through wall portion of that crack which is visible in the picture is represented by the blue portion of the P-scan data in Figure 14. The yellow and green portions of the P-scan image indicate the part of the crack that is only partially through wall.

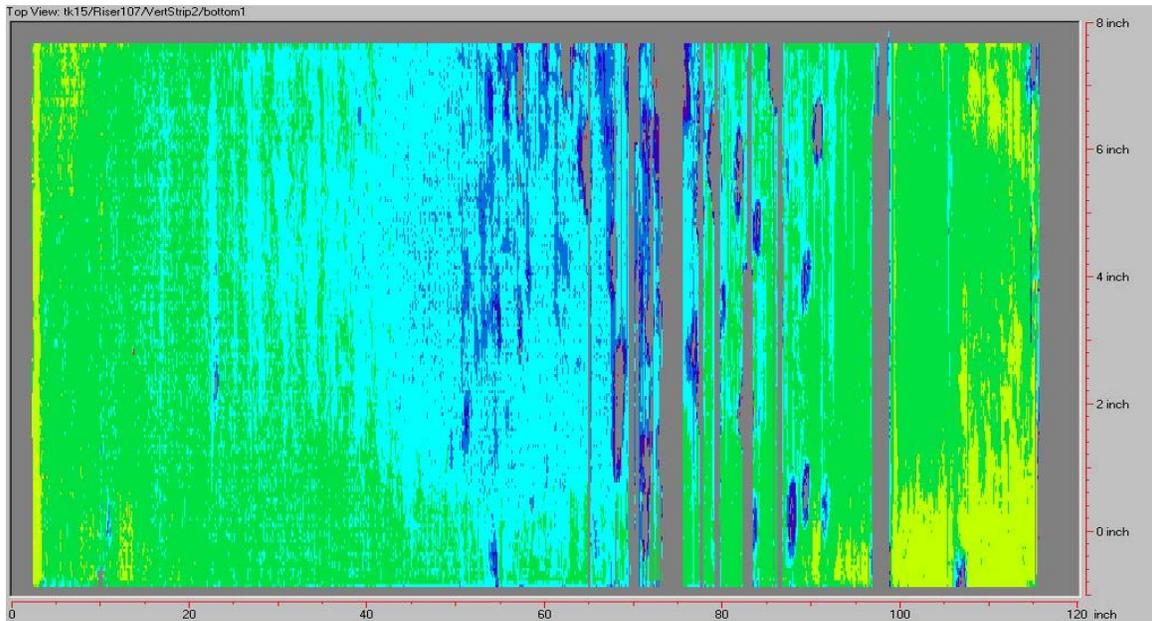
Figure 16: Thickness Mapping Image of Lower Plate, Riser 107

Inspections of Tank 15 through riser IP 107 included one vertical strip for the entire accessible height of the tank. No reportable areas were detected in the vertical strip. The minimum thickness detected in the upper and lower plates are above nominal thickness. The minimum thickness detected in the upper plate was 0.657 in. and is near the edge of the plate at the middle horizontal weld. An area was recorded with a minimum thickness of 0.665 in. and is a 0.23 x 0.538 x 0.035 inch deep indication near the top weld. The minimum thickness detected in the lower plate was 0.654 in. and is near the middle horizontal weld. Figure 16 shows the vertical strip scan of the lower shell plate. The image shows the plate to be thinner at the edges. There were rough surface areas causing loss of data and several noise spikes. These noise indications were evaluated and determined to be non-relevant. No crack-like indications were detected.

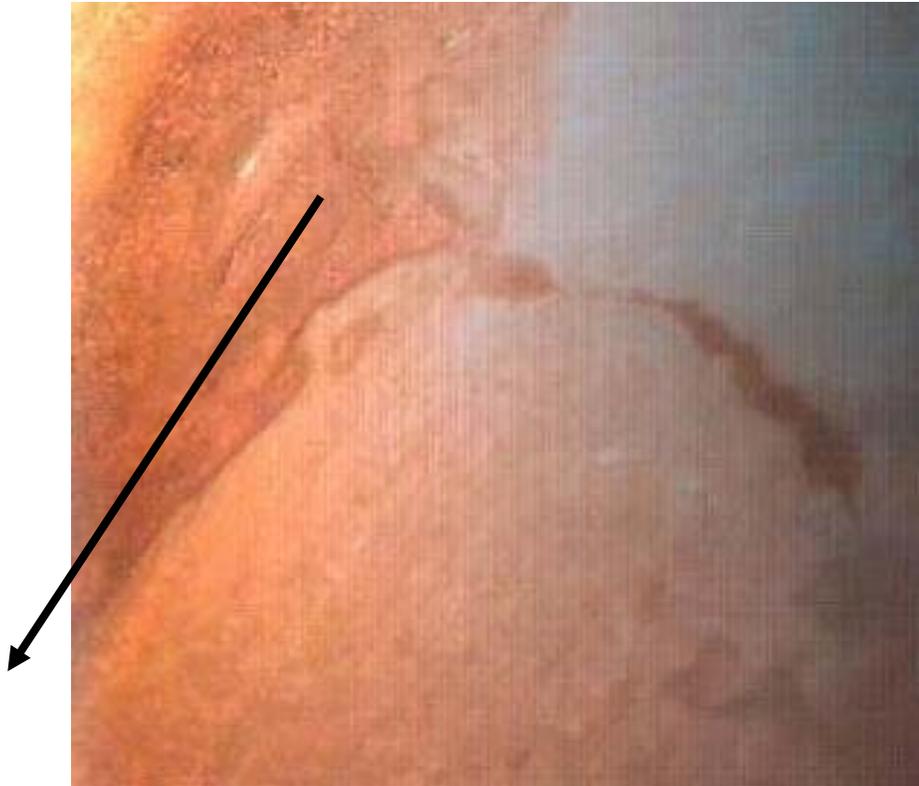
Figure 17: Picture of Mid Plate Indication at Attachment, Riser 107

This indication was scanned several times. The indication is in the shape of an arch. Due to the attachment weld on the exterior of the tank, one end of the indication could not be scanned. The length of the accessible area was measured to be 3.7 inches (3.7 inches vertically, 2.3 inches horizontally).

Figure 17 shows part of the arch shaped indication. The image is actually rotated about 15 degrees. The arrow is in the area where it appears that the lifting lug was knocked off. (arrow points toward bottom of tank). Based on the UT and bleed-out, the indication appears to continue into the attachment removal area.

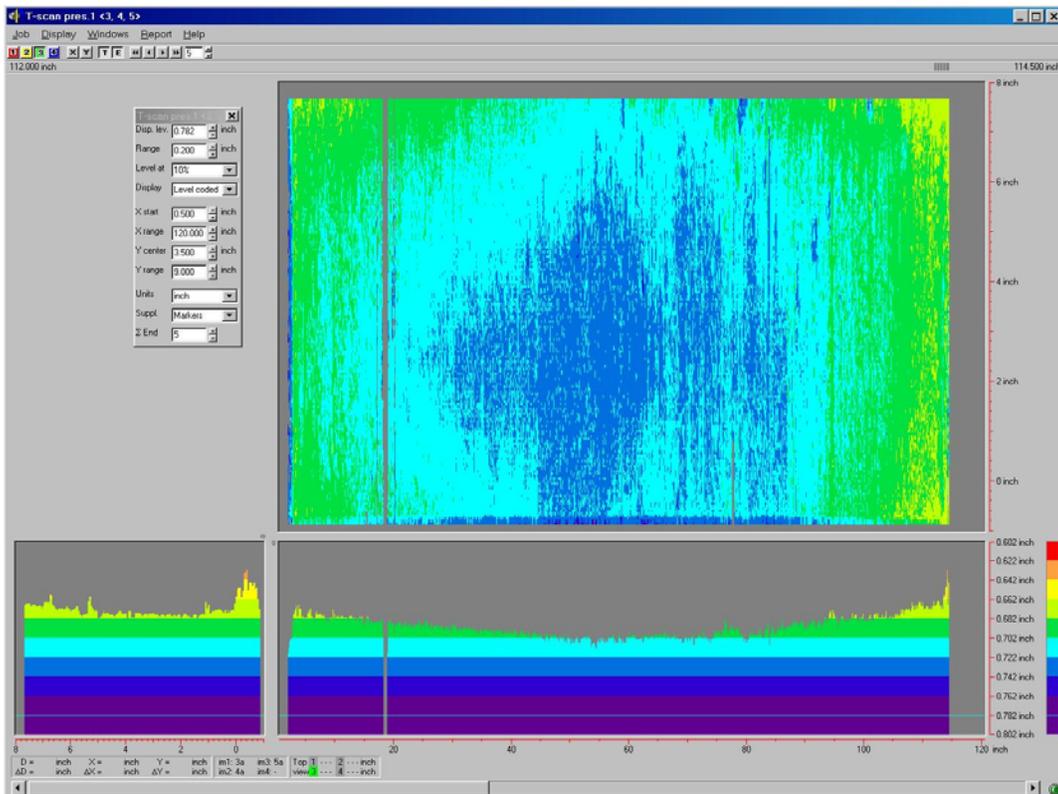
Figure 18: Thickness Map of the Lower Plate Vertical Strip, East Riser

Inspections of Tank 15 under the East riser were performed through riser IP182 and consisted of one vertical strip for the entire accessible height of the tank. One of these two strips is summarized under the East riser inspections. In the vertical strip performed under the East riser there were no reportable thickness areas detected. The minimum thickness detected in the upper plate was 0.622 in. (only 0.003 in. less than nominal thickness) and was located near the middle weld. One area near the top knuckle weld was noted as a 0.34 x 0.97 x 0.040 inch deep indication. The minimum thickness detected in the lower plate was 0.632 in. and is in the weld preparation area, near the bottom knuckle weld. No crack-like indications were detected in the vertical strip.

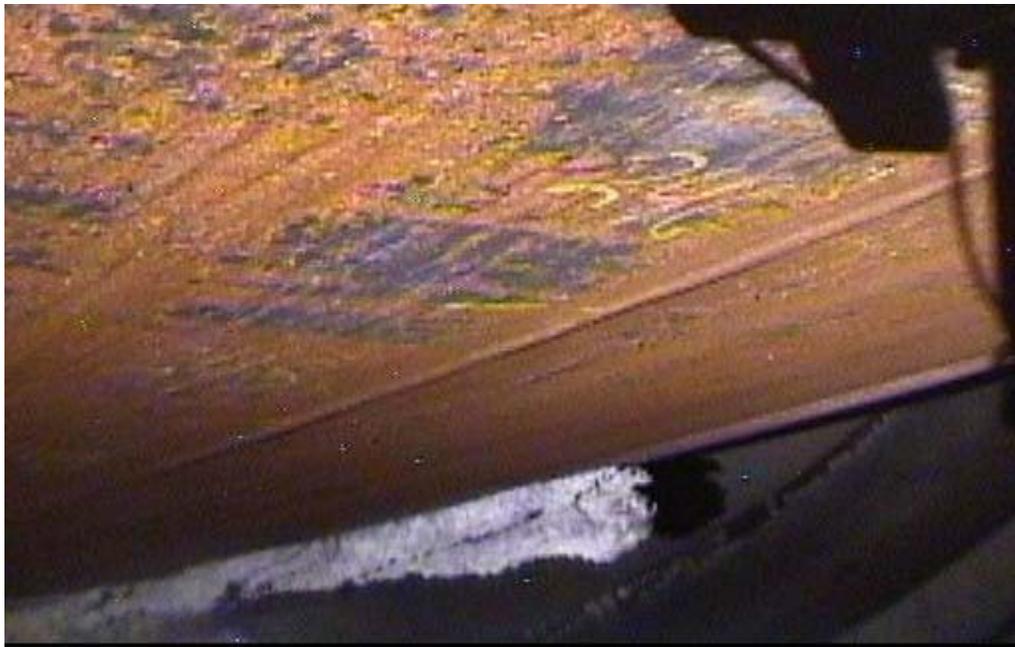
Figure 19: Picture of Lower Plate Vertical Weld at 175 feet, Riser 182

The vertical weld in the lower plate located at 175 feet was examined for vertical and horizontal cracking. Due to the high weld crown geometry which prevented scanning in some areas, the entire length of weld could not be examined. Although the weld crown and multiple attachment welds prevented inspection of the majority of the weld, several sections of the weld were successfully examined. Four new crack indications were recorded on this weld. Figure 19 shows the weld at 175 feet and a large salt nodule covering a leak site on the vertical weld at 172 feet.

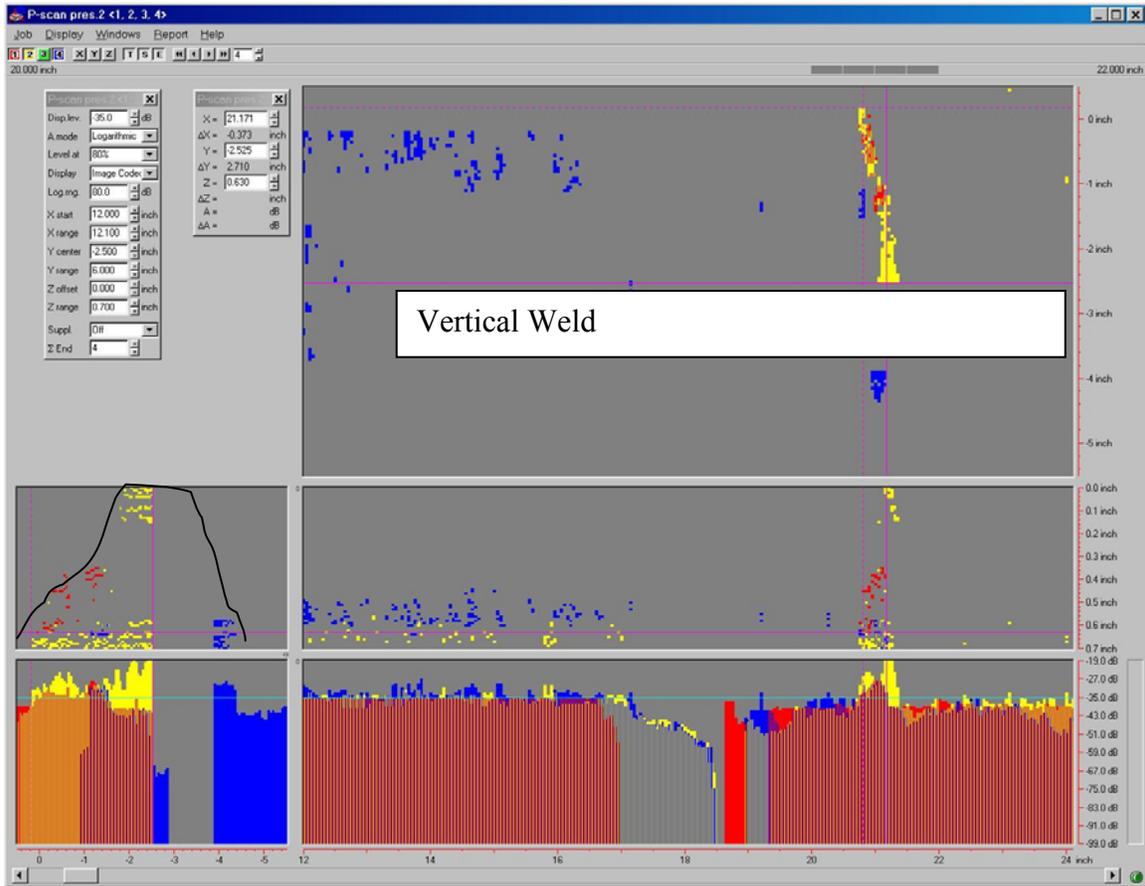
Figure 20: P-scan Image of Horizontal Crack Across Vertical Weld at 175 feet

The following is a summary of the indications detected in the lower plate vertical weld at 175 feet. Four horizontal (perpendicular to the weld) indications were detected in the portions of the weld that were examined (see Table 1). The shortest indication was 1.2 inches and less than 25% through wall. The longest indication had a combined length (on both sides of weld) of 5.8 inches and was 60% through wall. The through wall indication (see Figure 20) measured 4.5 inches total length.

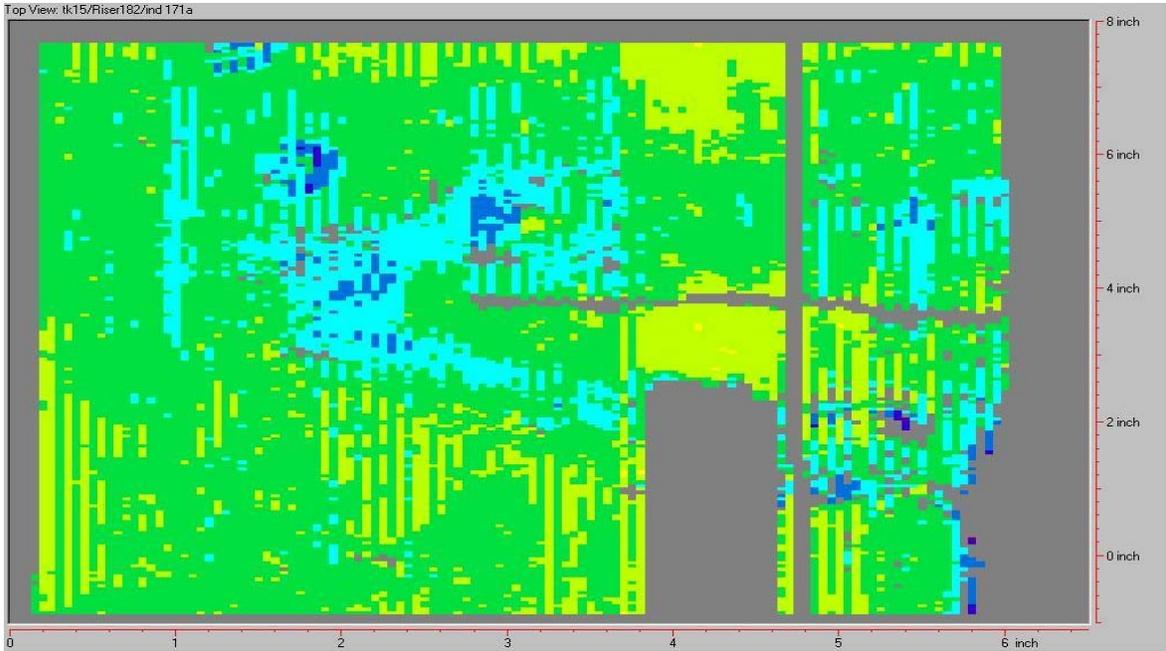
Figure 21: Thickness Map of Crack at 172 feet Middle Horizontal Weld

The leak site at 172 feet is a vertical crack perpendicular to the horizontal weld near a lower plate vertical weld. Figure 21 shows the thickness mapping scan in the area of the indication (upper plate only). Both of the P-scan images are rotated 90 degrees. Left to right on the image equates to starting above the horizontal weld and scanning down to the weld. The crack location in the upper plate is evident in the thickness mapping image due to loss of back-wall from the crack (gray horizontal line). The middle horizontal weld is at the right edge of the thickness mapping data.

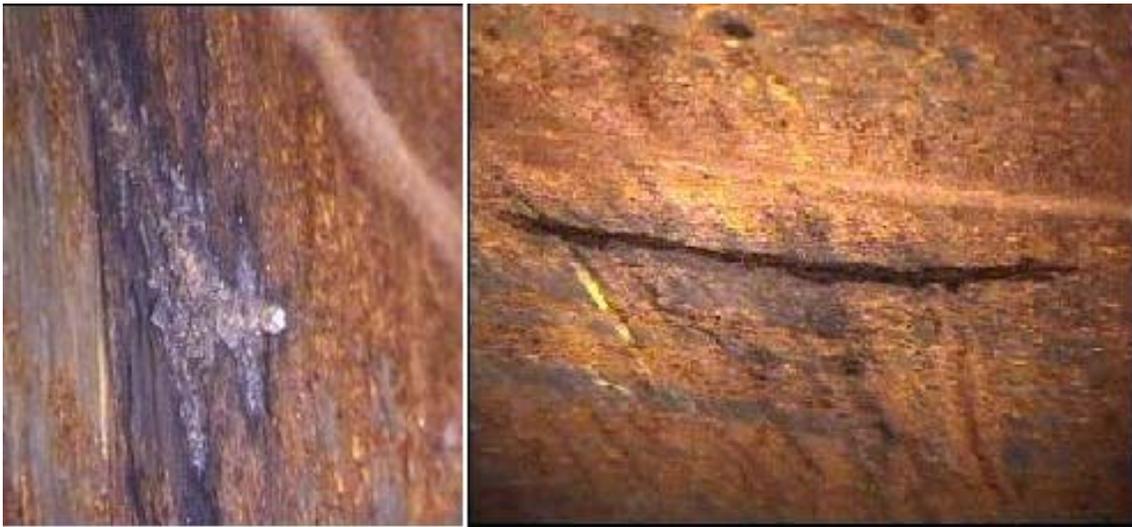
Figure 23: As-Found and Bleed-out Image of Crack at 192 feet, Middle Horizontal Weld

The leak site at 192 feet is a horizontal/arched crack in lower plate at a weld repair location. The through-wall portion (verified visually with bleed-out technique) of this crack was measured ultrasonically to be 10.2 inches. The indication is arch shaped around a significant weld repair in the horizontal weld. The weld repair area appears to be approximately 8 inches long and centered on the through-wall portion of the crack. The total length of the indication was measured at 18.1 inches. As shown in Figure 24, this indication is longer at the inside surface than on the outside. Figure 24 shows the end of the indication to be made up of multiple, shallow (partial through-wall) branches. This condition was also noted on the indication at 207 feet (Figure 28).

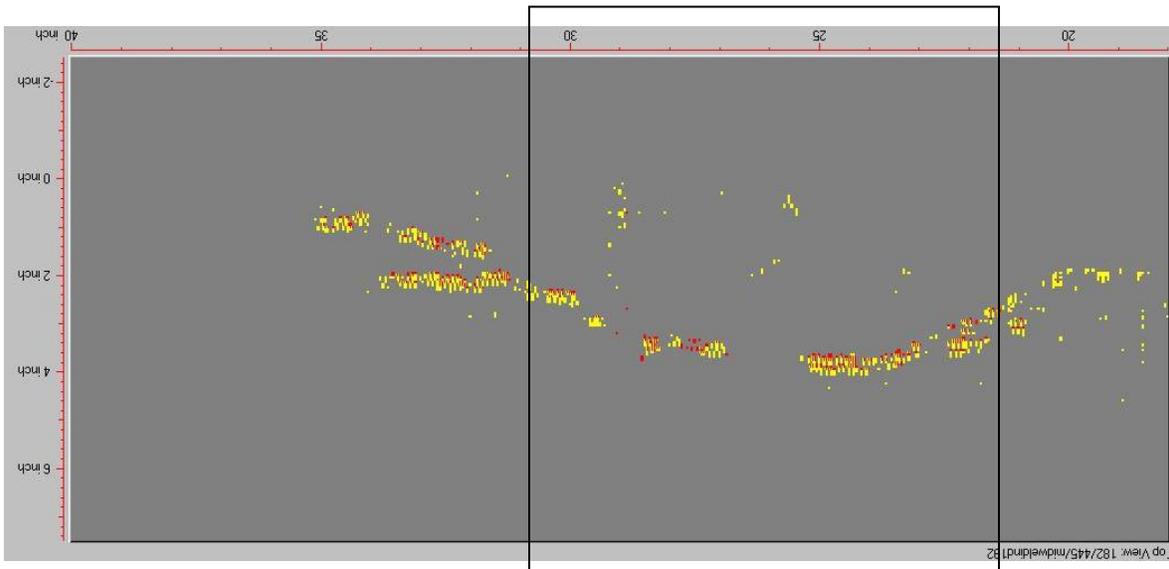
Figure 24: P-scan Image of Crack at 192 feet, Middle Horizontal Weld

Through wall part of crack (shown in Figure 23) inside boxed area. P-scan image rotated to same orientation as visual image.

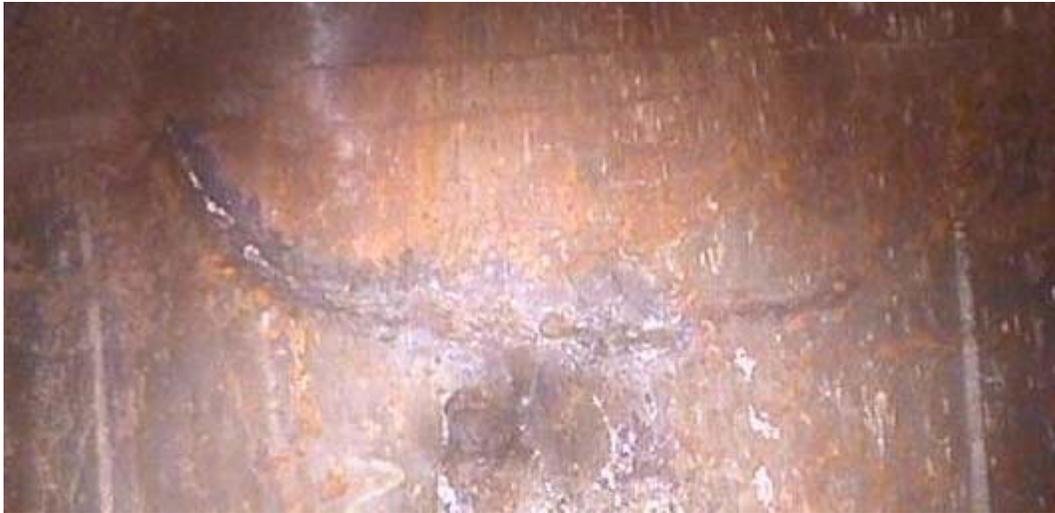
Figure 25: As-Found Image of Indication at 207 feet, Middle Horizontal Weld

Leak site at 207 feet is a horizontal/arched crack in lower plate at a weld repair location. The through-wall portion of this crack (verified visually with bleed-out technique, see Figure 27) was measured ultrasonically to be 12.7 inches. The indication is arch shaped around a significant weld repair in the horizontal weld. The total length of the indication was measured at 17.5 inches. Figure 25 show the indication in the “as-found” condition. As shown in Figure 28, this indication is longer at the inside surface than on the outside. Figure 28 also shows the end of the indication to be made up of multiple, shallow (partial through-wall) branches.

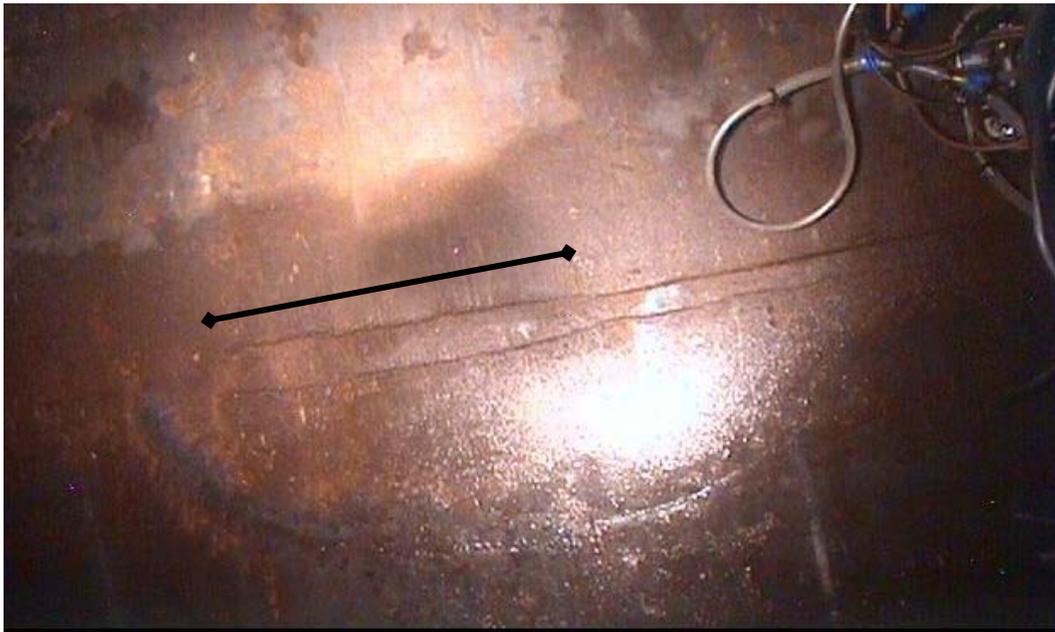
Figure 26: Image of Weld Repair at 207 feet Middle Weld

In the above image, the combination of the wet surface (water for UT couplant) and lighting provide a good view of the weld repair area. The repair area appears to be approximately 7 inches long.

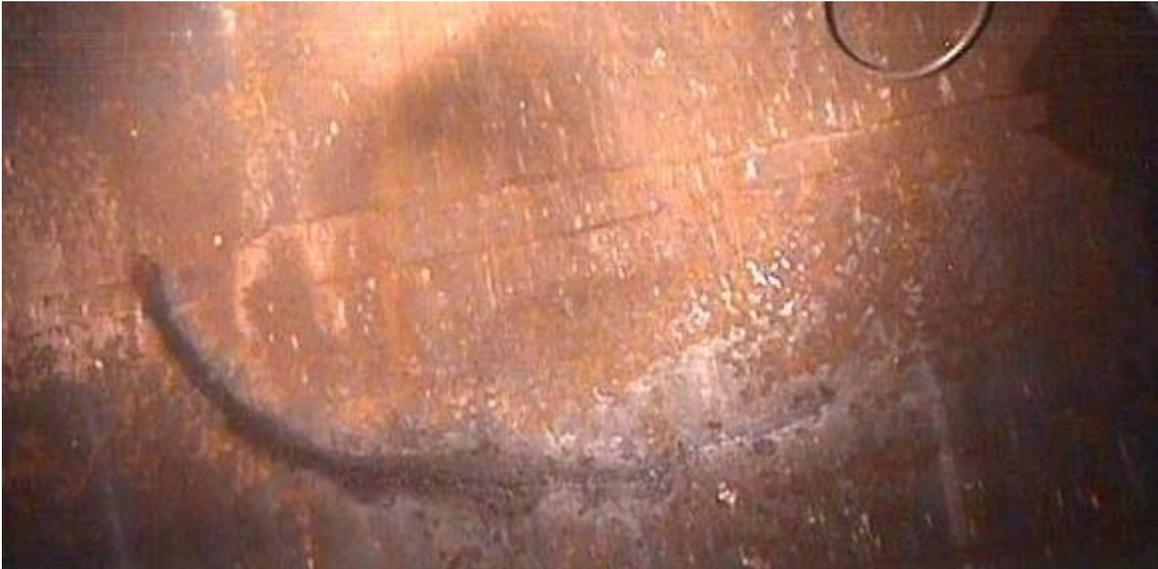
Figure 27: Image with Bleed-Out from Indication at 207 feet, Middle Horizontal Weld

The figure above shows the bleed-out from the portion of the crack that is open to the outside (100% through wall). There appears to be distortion at the OD beyond the bleed-out area from a portion of the crack that is through-wall, but the opening is sealed to water bleed-out.

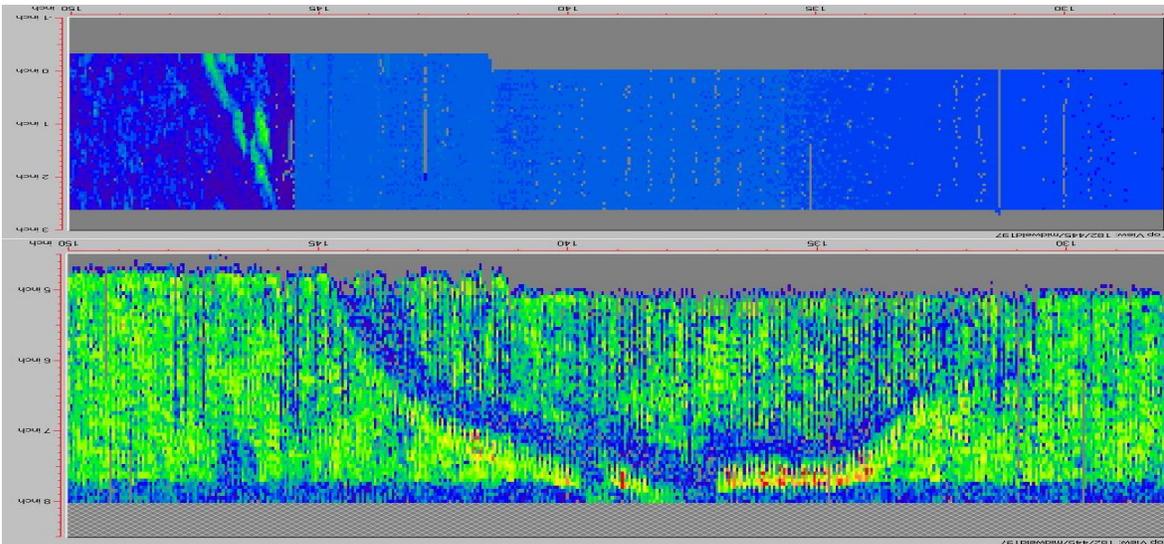
Figure 28: Composite of P-scan Images Indication at 207 feet, Middle Horizontal Weld

Figure 27 is a composite image including data from both sides with the weld running horizontally through the center (same orientation as pictures). The break in the indication at the center of the arch coincides with a visible break on the surface. The top portion of the image, from the transducer pointing parallel to the weld, shows the branched nature of the crack at the end which consists of multiple short, shallow, parallel cracks. In the bottom portion of the image, from the transducer pointing perpendicular to the weld, the shadow created by the arched crack provides evidence of its length and depth despite the poor orientation to the transducer sound beam. P-scan images were rotated to same orientation as visual image.
