**9W-12W, 8H and 10H Cell, Rack Pan, and**  
**Air Tunnel Inspections**  
**For the Safe Deactivation NCSE**

**WSRC-TR-2004-00510**

**September 2004**

Westinghouse Savannah River Company  
Closure Business Unit  
Aiken, SC 29808

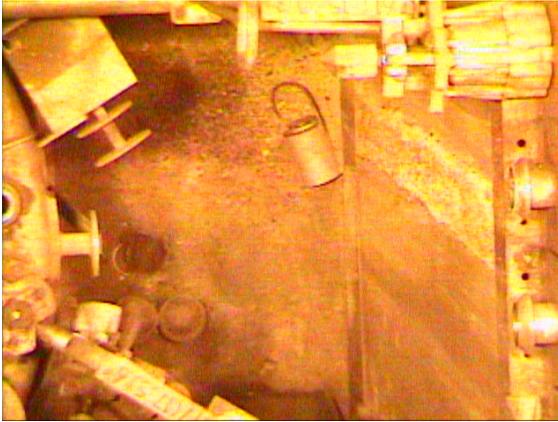
Overall, 9W was the cleanest and least damaged cell and rack pan. Some corrosion of the west wall, along with some sand and aggregate, was located under nozzles 100-60(9W), the 9.7 discharge jet, and roughly under nozzles 46-48(9W) [picture 9W-1]. Both corrosion paths seemed to have originated from the rack pan drain. Some deposits were observed in the NW corner next to the wall between the curb and the trunion guide and some stains from leaks were noted on the west wall appearing to originate near nozzles 43-44(9W). Some indications of leaks were observed on the wall below nozzle 40(9W) [picture 9W-3], a transfer route to FB-line; no deposit was noted on the floor. The top of tank 9.8 looked to have a smattering of a light colored crystalline deposit.

9W-1) Noz 60-100(9W) 9.7 jet

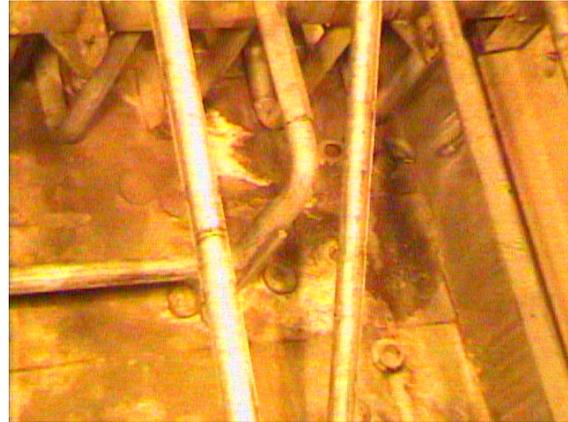
The rack pan was clean except for roughly a 2'x2' area north of the expansion loop table under lanes H-J [picture 9W-2]. This area has some black staining and some light-colored deposits. Generally solutions transferred in the far lanes like H and J are waste solutions such as spent solvent washes, 1DW and sump solutions.

9W-2) 9W rack pan north of H-J lanes on rack table

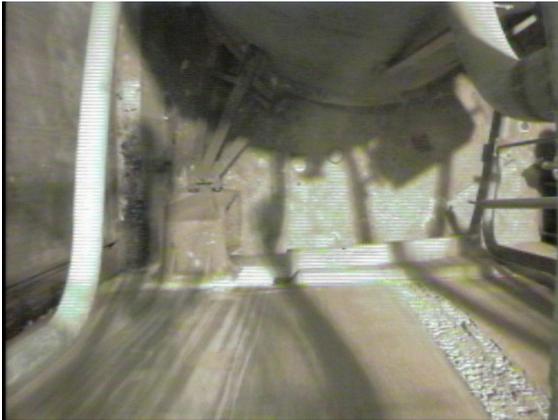
9W-3) 9W cell: South of north trunion guide under Noz 46-48 near tank 9.8

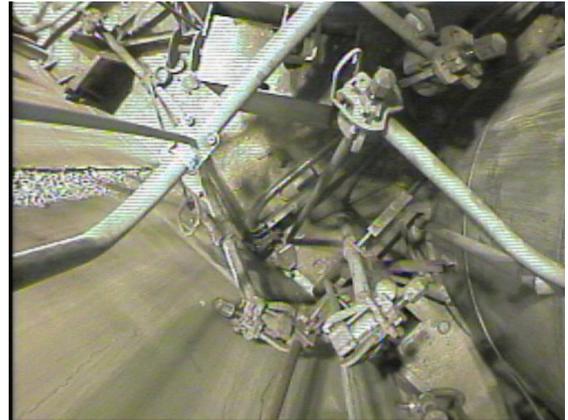
9W-4) 9W wall and floor next to 9.7, 9.6, and sump

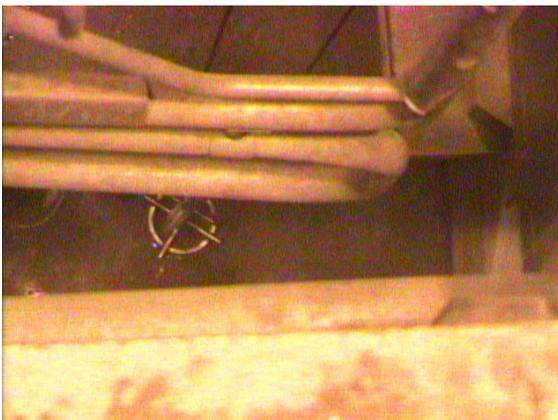
9W-5) Measuring tool sitting in puddle in northwest corner from north

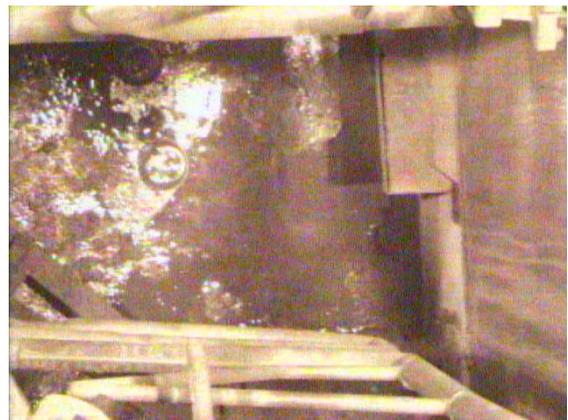
9W-6) puddle northwest corner, W of 9.8, under air exhaust

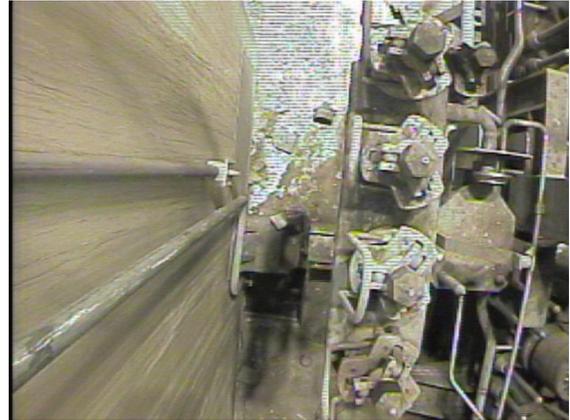
Most of the 10W cell floor was relatively deposit-free with the exception of two large, distinctive deposits of sand/concrete [pictures 10W-1, -2, and -3] and, possibly, plutonium on the floor in the northwest quadrant of the cell [picture 10W-4]. The deposits were located under nozzles 59(10W) and 48(10W) where solution drained down the walls from the rack pan drains. The

10W-2) 10W sump and 10.6M feed nozzles

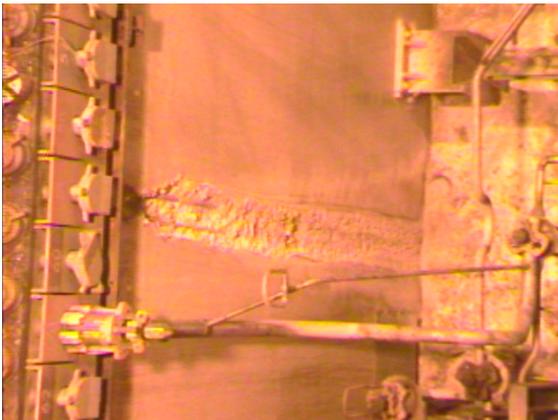
10W-3) West wall corrosion under nozzle 60(10W) near 10.6M

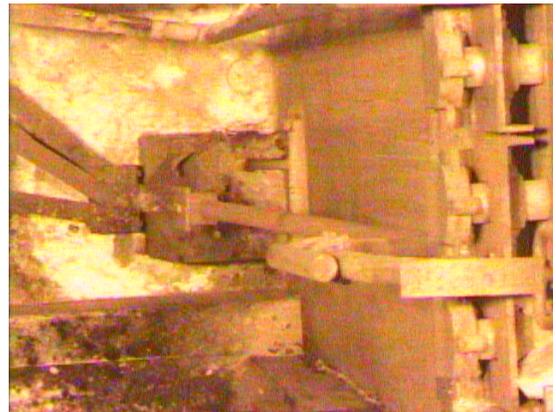
10W-4) Nozzle 43-44(10W) trunion guide northwest corner of cell

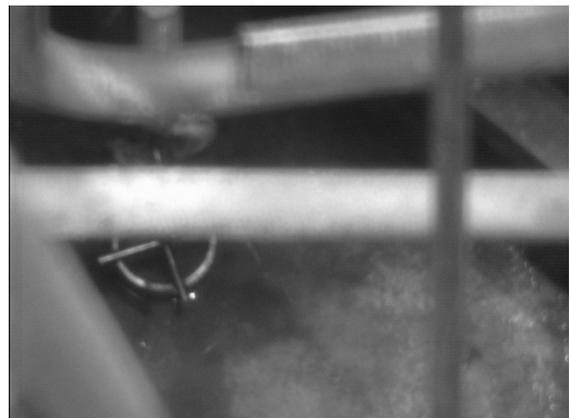
10W-6) Measuring tool in puddle on northwest corner

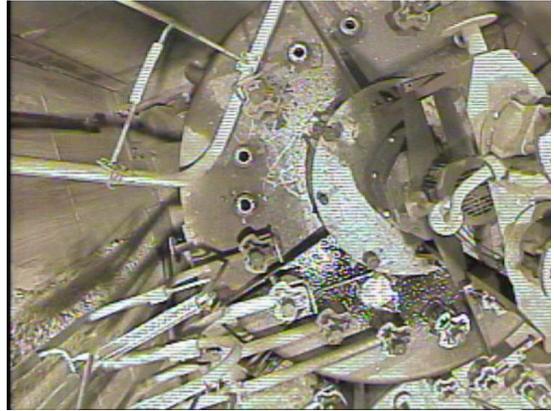
The cell floor had more debris scattered across it in the form of concrete chunks and sand than the previous cells [pictures 11W-1, -3, and -4], probably because the solutions in this cell consisted of 4M nitric acid versus the less than 1M acid processed in 9W and 10W. It also had its share of gaskets, dust covers, and dummies. There were two (2) areas on the west wall under the rack pan drains that were corroded and eroded, each resulting in a concrete/sand deposit west of 11.7 and 11.8 [pictures 11W-2, -3, and -5]. Neither of these areas was as severe as that seen in 10W, e. g. no re-bar was exposed, the channeling was not as deep, and the deposits did not appear to be as extensive. Tank 11.7 looked to be dusty on top. Tank 11.8 was covered with grease and oil from the agitator lube line [pictures 11W-2].

11W-2) Wall corrosion and lube oil on Tank 11.8

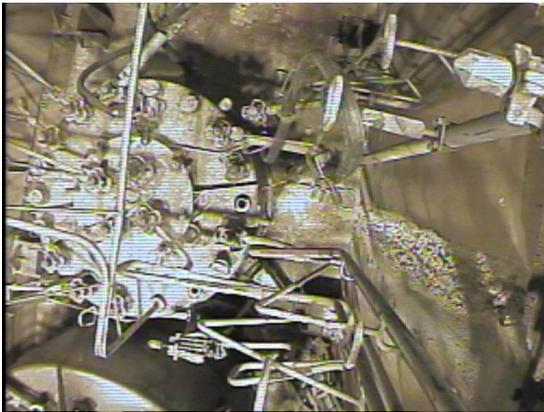
11W-3) 11.7 wall corrosion under nozzle 59(11W)

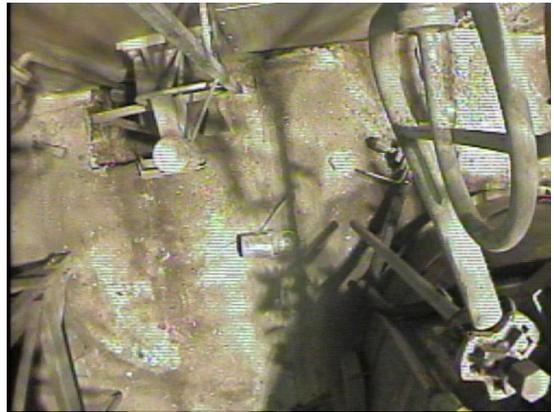
11W-4) 11W sump between Tank 11.7 overflow and 11.5M support frame

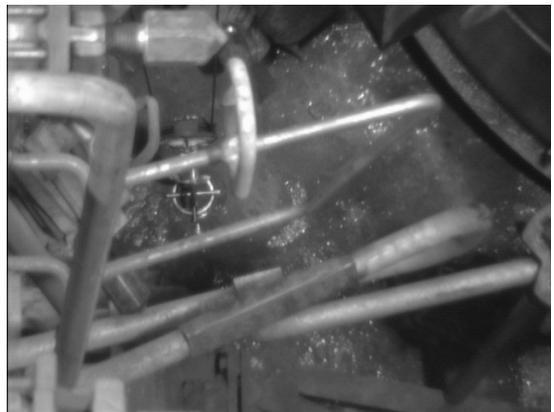
After the sump flush water was allowed to drain and was jetted from the sump, a small puddle remained north of the 11.7 trunion guide and west of tank 11.8. Its depth was less than 2" as measured by the depth gage [pictures 11W-6].

11W-6) Puddle west of Tank 11.7

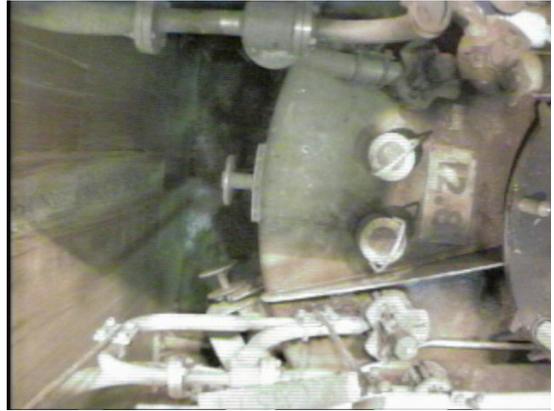
The cell floor in 12W had the most trash and debris of the four Warm Canyon cells and several areas of the walls were corroded [pictures 12W-1, -2, and -3]. This cell was the only one with the concrete defaced on the cold wall. It looked as though acid had been sprayed on the cold wall east of vessel 12.5, as the erosion started mid-wall and appeared wider at the top than the bottom. The walls under each of the rack pan drains exhibited corrosion and erosion, though no exposed re-bar was noted. The floor contained a scattered assortment of gaskets, dust covers, dummies, a hook, nuts, concrete chunks, etc. The added equipment litter is most likely due to equipment handling and storage in the pump storage rack in module 12.7. The floor also seemed dustier and grimmer than the previous cells, possibly due to a combination of corrosion caused by the higher acidities of the solutions and chemical reactions during valence adjustment, and the organic washed in washer 12.8. Over the life of the cell, tank 12.5 has erupted and overflowed several times because of uncontrolled nitrite reactions.

12W-2) Deposit and wall next to Tank 12.8

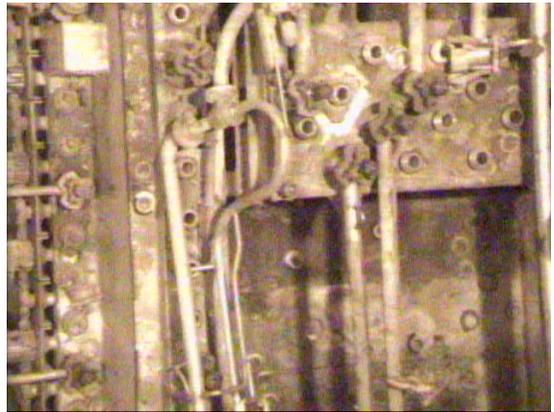
In the rack pan near the expansion loop table, on the table, and several of the nozzles, evidence of white, crystalline deposits were noted. The material was most likely sodium carbonate, considering the location and the solutions processed on that side of the cell. No other build-ups were noted in the rack pan [pictures 12W-4 and -5]. The usual assortment of gaskets was observed.

12W-4) 12W expansion loop table and rack pan

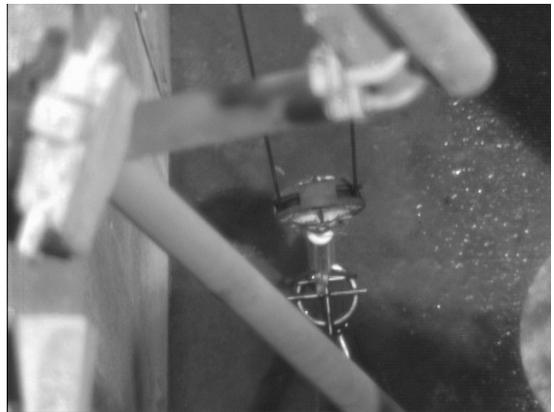
12W-6) Gauge resting in puddle

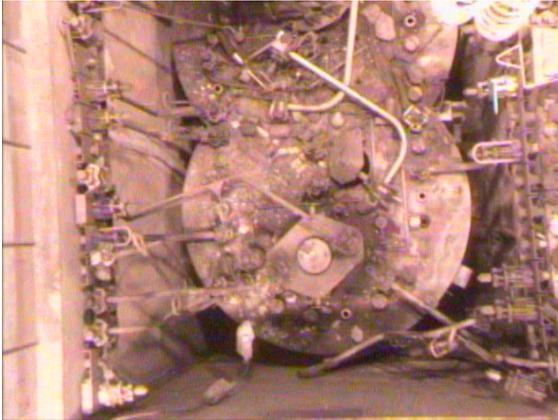
The tanks occupy so much of the cell; it was difficult to see the floor. Large chunks of concrete were observed all over the floor, on top of the tanks, and intermingled within the nozzles [pictures 8H-1, -2, -4, -5, and -6]. Sand, aggregate, and smaller, broken pieces of concrete also covered the floor [pictures 8H-8 and -12]. Dummy connectors, dust cover, gaskets, fallen rebar, and miscellaneous tools were observed [pictures 8H-8, -11, and -12]. The cell covers and some of the cell pedestals were damaged. The cold wall exhibited some signs of corrosion under nozzles 10 and 11 [picture 8H-6]. The hot wall was scored in four areas with deep furrows as it had been corroded and eroded as the concrete washed out from under the rack pan drains; deposits were observed on the cell floor due to the sand and aggregate [pictures 8H-7 through -12].

8H-1) Tank 8.1, south end

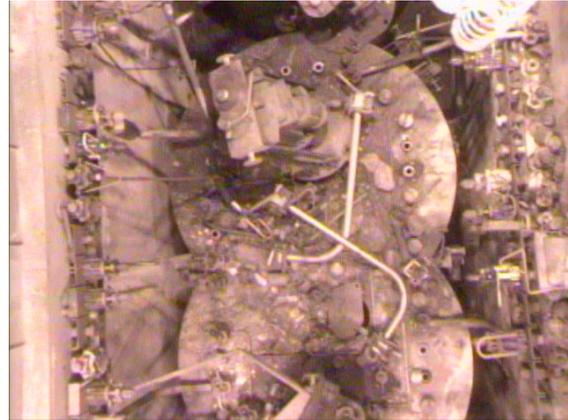
8H-2) Tank 8.1

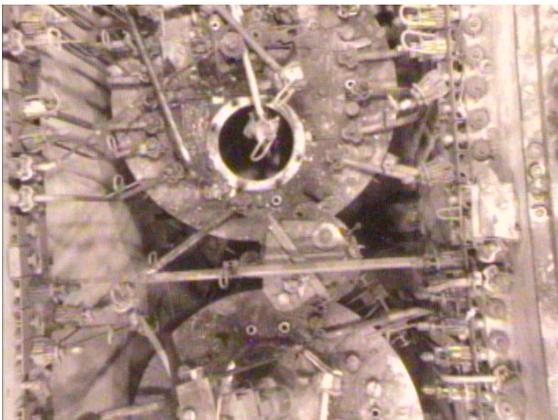
8H-3) Tanks 8.1 and 8.3 and stored agitator mid-cell

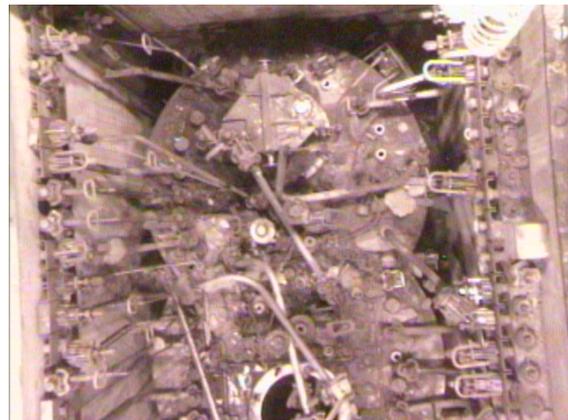
8H-4) Tank 8.3, north end

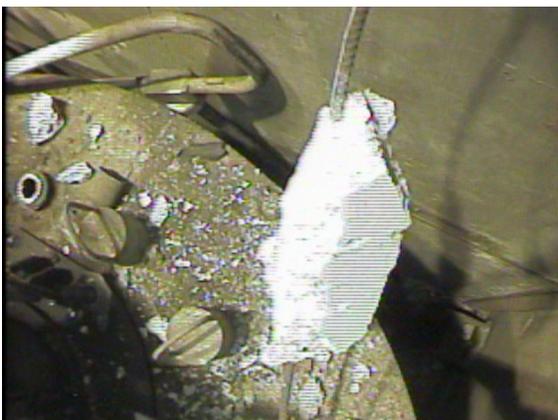
8H-5) Chunk of concrete on rebar over Tank 8.1

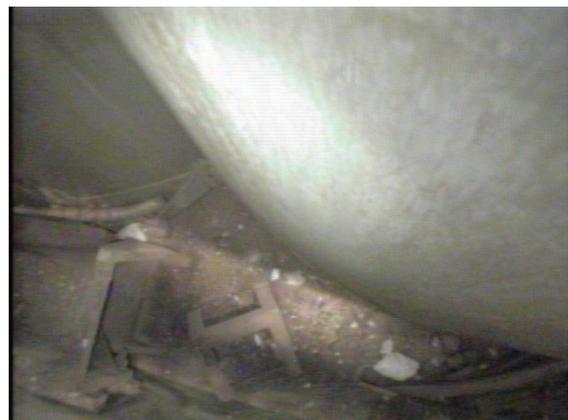
8H-6) Floor West of Tank 8.1 (cold wall) and module 8.2 trunion guide

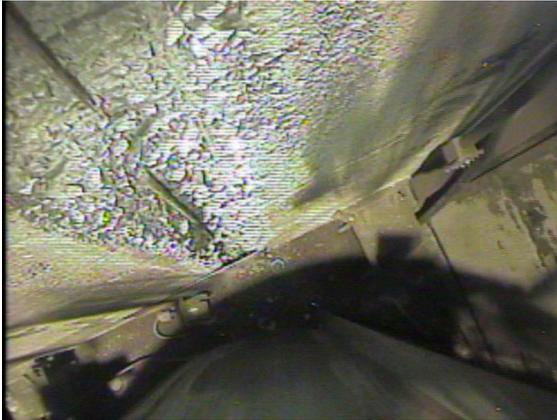
Damage to the wall underneath the rack pan drains was severe enough there were gaps in the concrete behind the plate covering the air tunnel exhaust register. As the concrete degradation progressed, the sand, cement, and aggregate, as well as liquid, would wash into the canyon air tunnel.

8H-7) Corroded concrete under nozzle 80(8H) rack pan drain

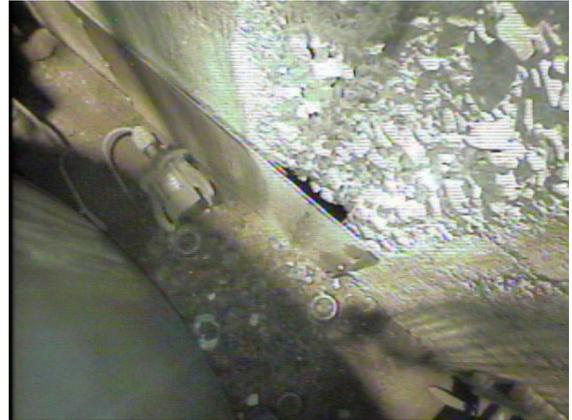
8H-8) Corroded concrete under nozzle 80(8H) at air tunnel duct

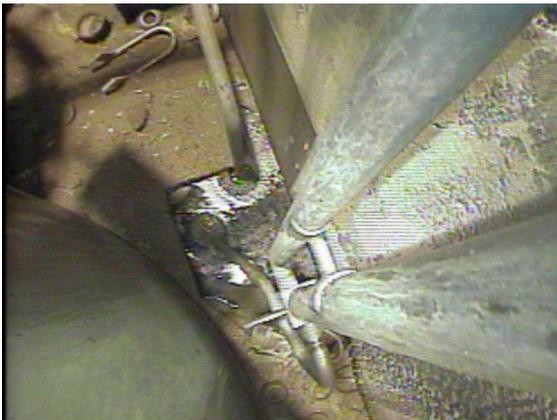
8H-9) 8H sump

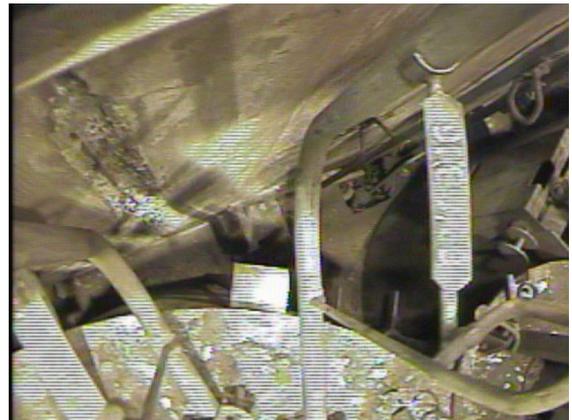
8H-10) Between 8.3 and wall under nozzle 59(8H) exposed rebar

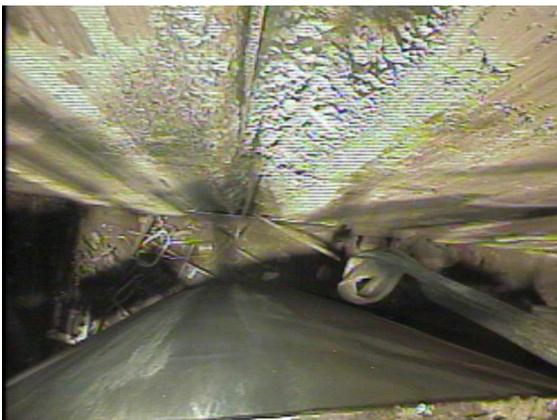
8H-11) East wall in 8.4 module under nozzle 48-49(8H)

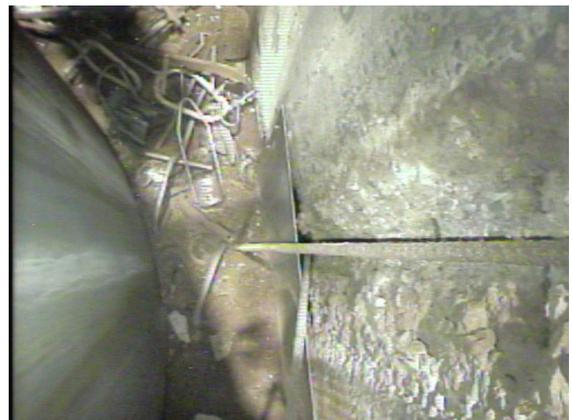
8H-12) Floor, dislodged re-bar, and air tunnel duct

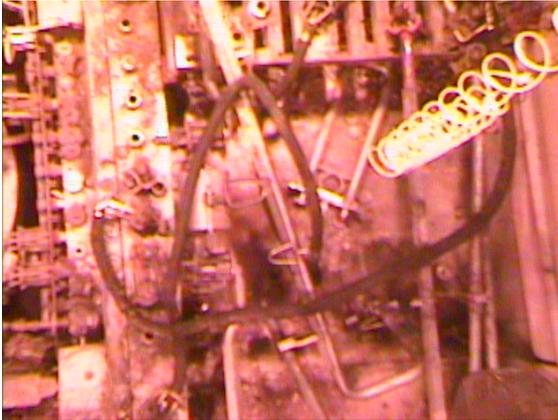
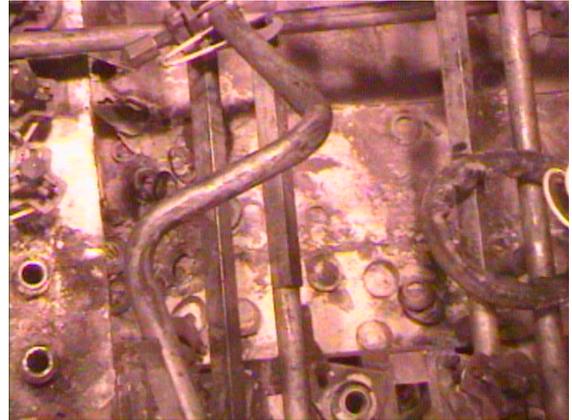
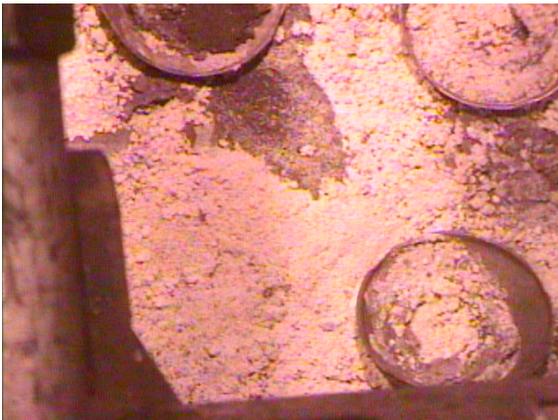
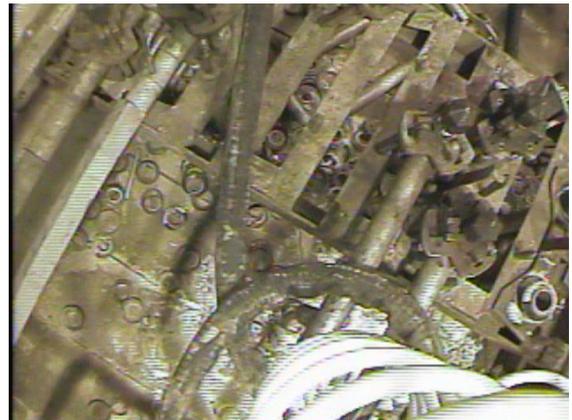
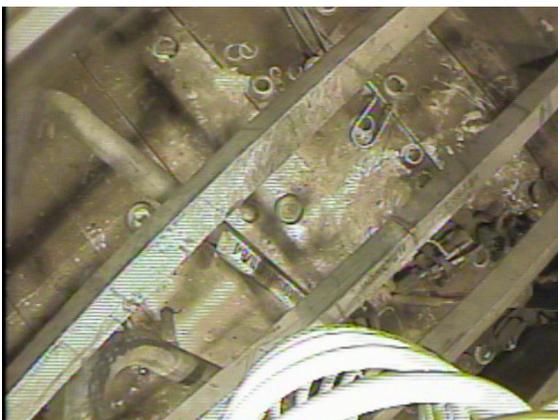
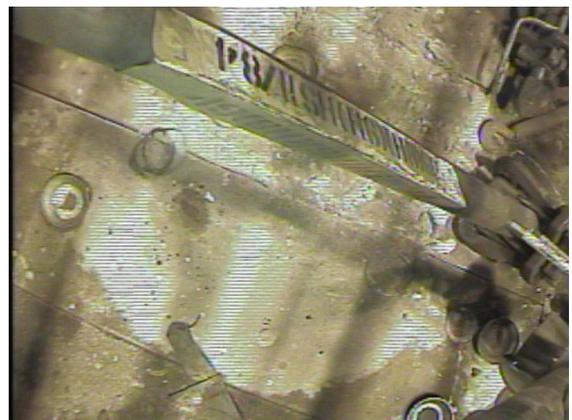
The rack pan was dirty with deposits and abandoned equipment (gaskets, piping, flex jumpers, dummy connectors, dust covers, etc) particularly near the expansion loop table [pictures 8H-13 through -18]. The deposits either looked like some kind of fine grained sand [pictures 8H-17 and -18] or crystallized, yellow uranium [pictures 8H-14 and -15]. Most of the rack pan was covered with a dark, dusty or maybe oily, stain [picture 8H-17]. Based on engineering judgment, it was concluded that the deposits did not exceed 200 kg of plutonium nitrate.

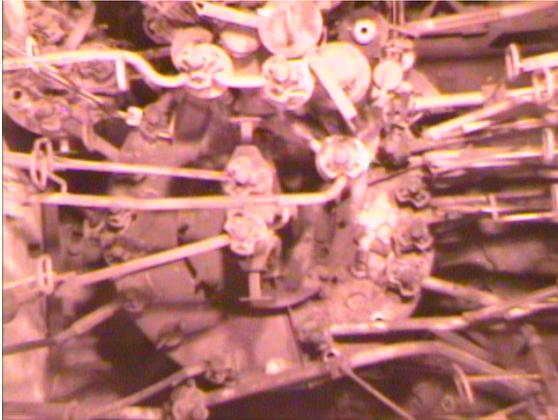
The south end of the 10H cell is filled with tanks (10.1, 10.1-2, 10.2, 10.2-1, and the PRC) so that the floor was difficult to see [picture 10H-1]. The west side of the floor (cold wall) was littered with broken pieces of concrete, as well as pieces of equipment (dummies, gaskets, dust covers, etc.) [pictures 10H-2 and -3]. The east side of the cell floor (hot wall) was filled with chunks of concrete, aggregate, and sand along with pieces of equipment [pictures 10H-5 through -10]. The west wall (hot wall) showed severe signs of corrosion at the site of the rack pan drains, eating away enough concrete that the re-bar was exposed or had dislodged and dropped to the floor [pictures 10H-6 and -7]. Some concrete pieces were observed on the tops of the tanks as well as accumulations of sand from the concrete cell covers and dried process solutions of fissile material (darker components), uranium, and concentrated waste salts [pictures 10H-1 and -4]. Shallow deposits, mostly likely waste solution salts and sludge with trace fissile material, were caked and peeling on the top of HAW concentrate tank 10.1 like dried mud [picture 10H-4]. Tanks 10.2, 10.3, and 10.4 appeared to be covered with a gritty, sandy looking layer of material (most likely concrete dust from the cell covers) and a darker, oily looking area (lube oil and dust) was on top of tank 10.4 [picture 10H-2 and -3]. Based on engineering judgment, the accumulations of fissile material did not exceed 200 kg of plutonium nitrate nor exceed 20" in depth by 35" in diameter.

10H-1) Top of Tanks 10.1, 10.1-2 and PRC

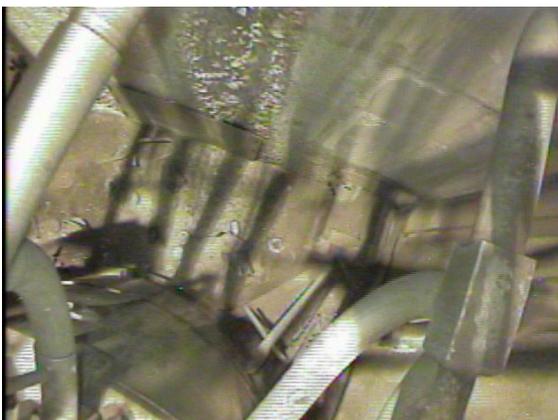
10H-5) Corrosion under nozzle 80(10H), east of Tank 10.1

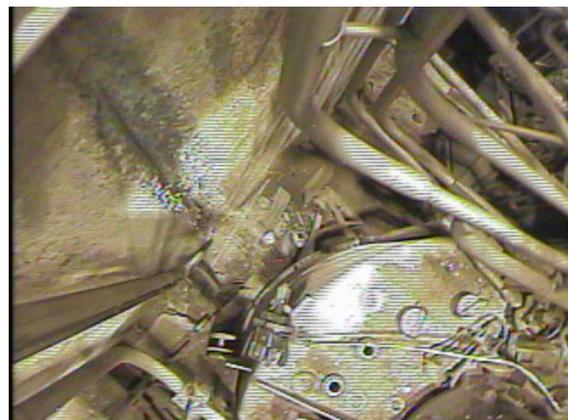
10H-6) Furrow under nozzle 70(10H), floor and top of Tank 10.2

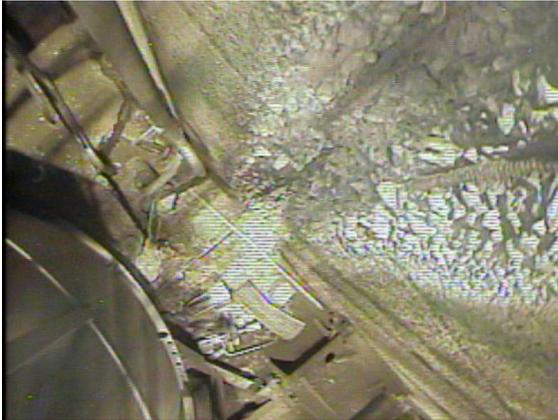
10H-7) Furrow under nozzle 70(10H), exposed and missing

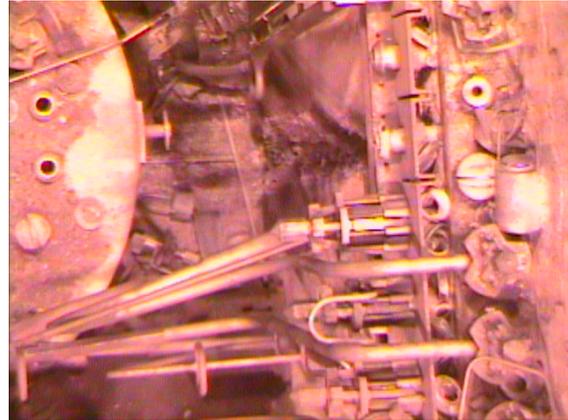
10H-8) Floor and wall east of Tank 10.2 under nozzle 71(10H)

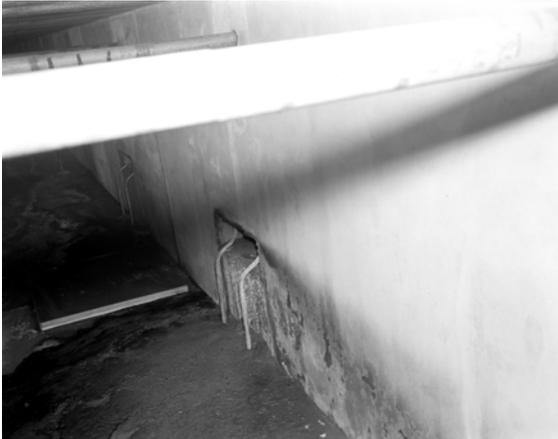
In 1965, a chronic leak on one of the 2BP routes resulted in 7-8 kg of plutonium deposited in the WCAT; it was subsequently removed [Plutonium in Section 9W WCAT Incident- 1965 picture 10079-001]. The photographs showed the plutonium as a dark deposit; the Plutonium Handbook (ref. 2) reported plutonium nitrate crystals coloration as black. Dark deposits, a mixture of sand and aggregate and, possibly, some plutonium oxide or plutonium nitrate crystals were observed in WCAT. Pictures from 2001 and 2003 WCAT inspections were compared to those from the 1965 inspections before and after the plutonium incident. Based on the 1965 pictures with the known quantity of plutonium in the WCAT, it was determined that a large amount of plutonium nitrate (>70 kg) that could be dissolved in water and cause a criticality was not left in the WCAT. Refer to the Warm Canyon Air Tunnel Pictures- 2001 Inspection pictures.

10079-001 Section 9W looking North toward module 9.8 at the plutonium deposit

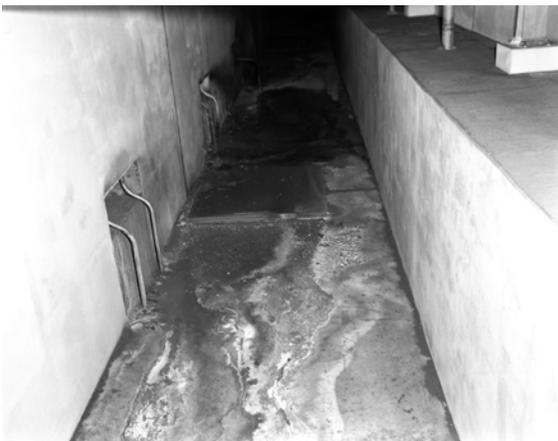
10079-005 Section 10W looking South toward modules 10.5 and 9.8 (Pu deposit)
