Review of Type I High Level Waste Tanks Ultrasonic Inspection Data (U)

Savannah River National Laboratory
Materials Science and Technology Directorate

Publication Date: March 2006

DOCUMENT: WSRC-TR-2003-00560, Rev. 1

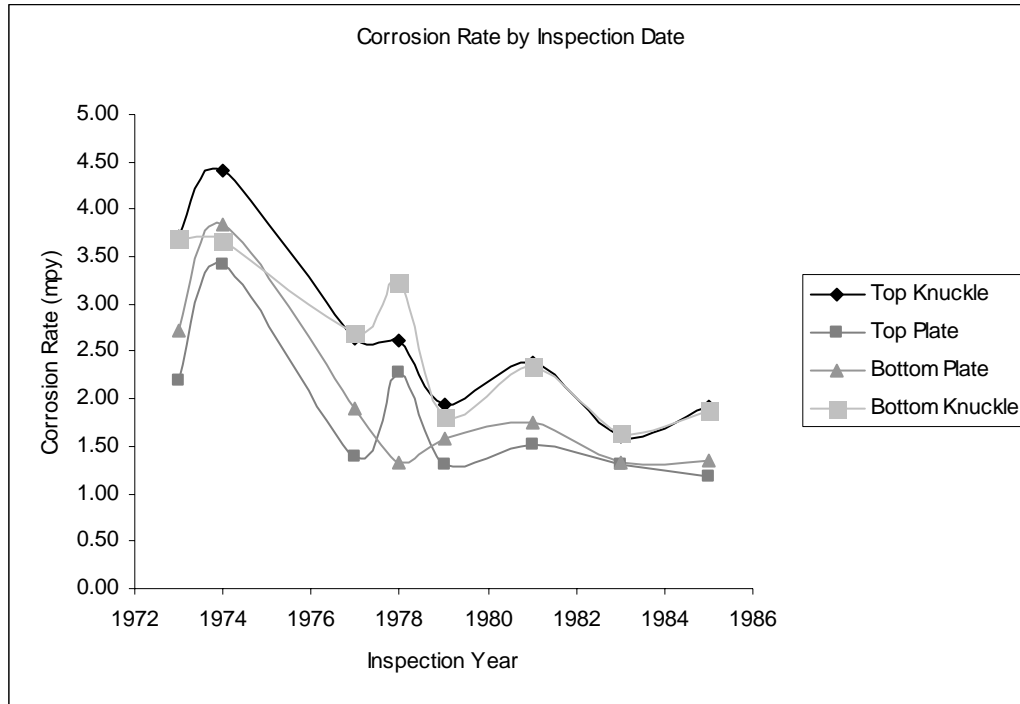
Figure 3: Corrosion Rate Data Sorted by Inspection Date for Type I Tanks

The corrosion rates are seen to decrease with each inspection from 1973 to 1981, and then become constant. The corrosion rates are between 1 and 2 mils/year as calculated from the most recent inspection (1985). The top knuckle and the bottom knuckle exhibit the higher corrosion rates which may be due to several reasons. The UT inspection technique was limited in data collection ability on the top knuckle and the bottom knuckle, and therefore collected data very near edges of the plate sections and near the welds. The edges of the plates are typically thinner due to the rolling process therefore the thickness indications are lower than expected. The corrosion rates calculated near the knuckles may be artificially lower than the plate general corrosion rates due to the fabrication process and the limited number of measurements. Alternatively, it may indicate that the general corrosion rate in the vapor space is higher than when exposed to bulk inhibited solution. The similarity between the corrosion rates at the top knuckle and the bottom knuckle indicate that the combination of the UT measurement technique and the inherent thinning at the edges is the controlling factor, rather than an active vapor space corrosion mechanism. Additionally, the general corrosion rates are well within expected corrosion rate.³

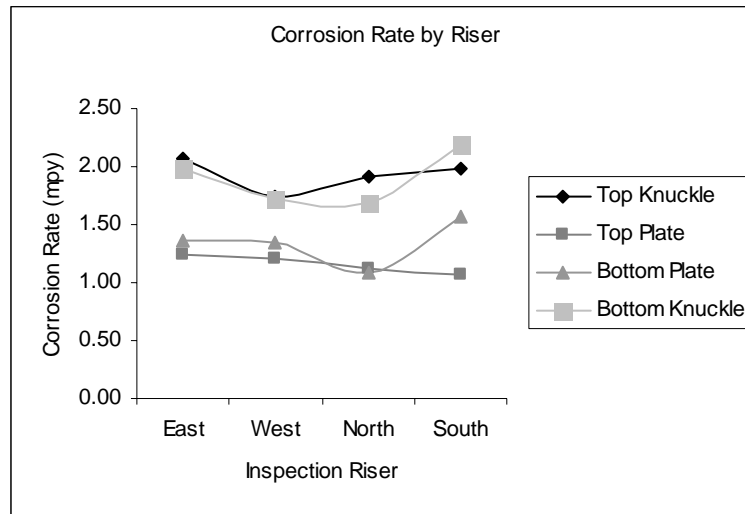
Figure 4: Corrosion Rates of Type I Tanks Sorted by Riser

The data is plotted in Figure 4. The corrosion rate for the top knuckle and bottom knuckle appears higher in the East and South Riser. The data for the top plate seems constant under each riser, with the corrosion rate on the bottom plate higher under the South Riser.

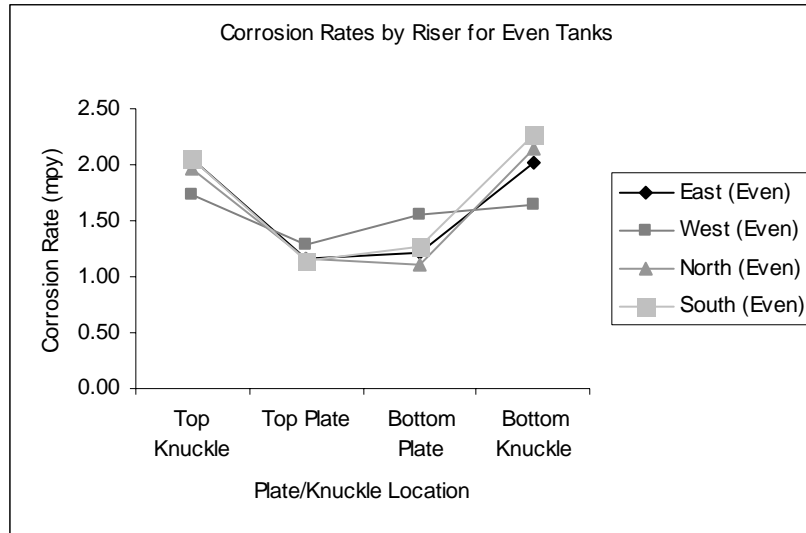
Figure 5: Corrosion Rates by Riser for Even Tanks

The corrosion rate data for the even tanks with the ventilation duct in the southwest quadrant is shown in Figure 5. The south quadrant has a slightly higher corrosion rate than the other quadrants at the top and bottom knuckle. The west quadrant indicates higher corrosion rates at the bottom plate and bottom knuckle.

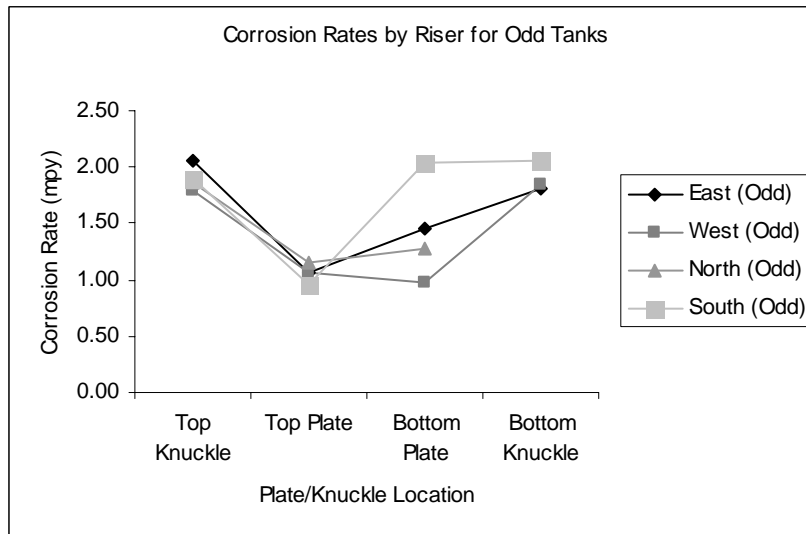
Figure 6: Corrosion Rates by Riser for Odd Tanks

The corrosion rate data for the odd tanks with the ventilation duct in the southeast quadrant is shown in Figure 6. The south and east quadrants indicate higher corrosion rates at the bottom plate and bottom knuckle.
