FY2004 Corrosion Surveillance Results For L-Basin (U)

Savannah River National Laboratory
Materials Science and Technology

Publication Date: September 2005

DOCUMENT: WSRC-TR-2005-00067

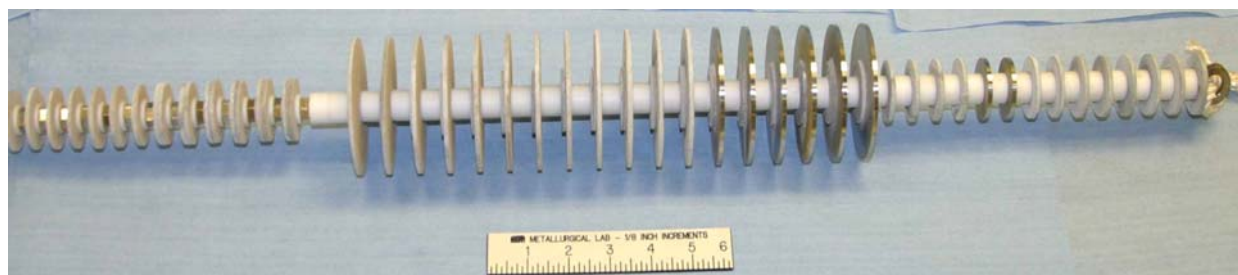
Figure 1. Disk coupons were removed on February 14, 2004 after 97 months immersion and are shown as-received from L-Basin on original hanging stainless steel rod.

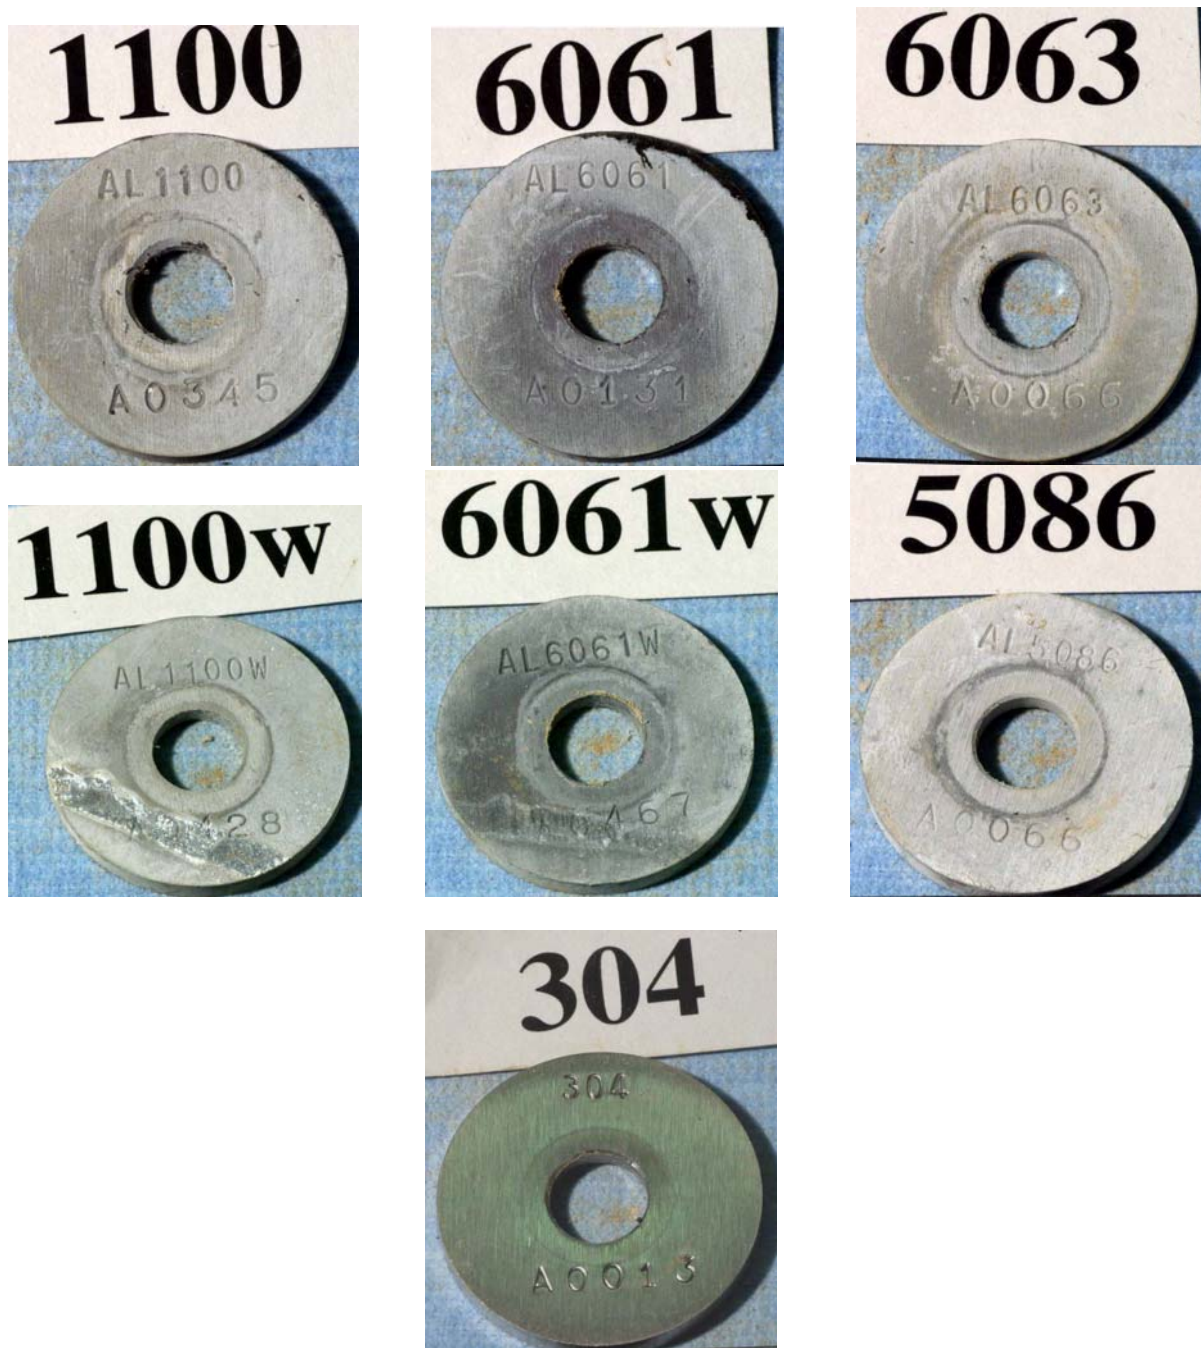
Selected images of individual 2004 surveillance coupons are shown in Figure 7. Percentage weight gains of approximately 0.85-1.05 % for the 2004 aluminum samples versus weight gains of 0.4 to 1.15% for 2003 are graphed in Figure 8. The welded coupons gained slightly more than the non-welded coupons in 2003 but this was not repeated in the 2004 coupons. One welded 6061 coupon from 2004 revealed percentage weight gains equal to or slightly less than the gains of the non-welded 6061 coupons. This is unusual since the autogeneous weld is expected to show more corrosion based on the 2003 data. One of the 1100 coupons (2003) did show a lower percentage weight gain due to slightly higher initial weight and slightly lower weight gain (± 0.5 gram) which was not repeated by the 2004 coupon results. Overall, these coupons appear visually comparable to coupons withdrawn in 2001, 2002, and 2003. The individual coupons from all four years of evaluation appear to be undergoing uniform oxidation.

Figure 7. Examples of the individual coupons removed in 2004. Oxide scale in the PTFE washer area is visible in all, except for the 304. The amount of oxide growth appears to be minimal since sample identification is visible on all coupons shown above.

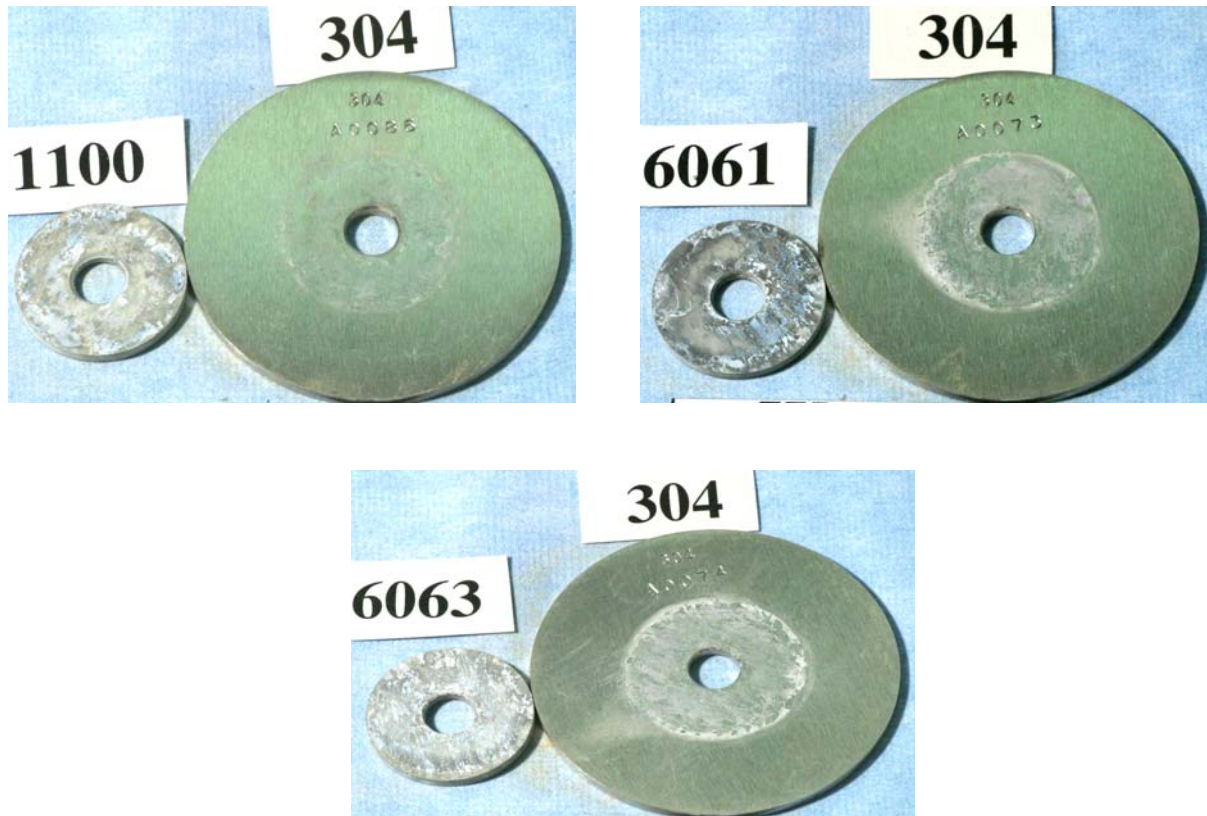
The most appreciable oxide buildup observed is in galvanic couples, which is marked by heavy oxidation between the samples of dissimilar metals (see Figure 9 to Figure 11). Howell [5] and Vormelker [6] noted similar behavior in 2001 and 2003, respectively. The coupons from the years 2001 to 2003 appear similar. Selected galvanic coupons from 2004, representing the different aluminum alloys in contact with 304, were photographed and then cleaned with a 16M nitric acid solution (approximately 1.5 hours) for oxide removal.[7] Multiple (stirred) immersions were performed with weights measured before and after each cleaning step to ensure oxide removal and not the removal of metal. Small amounts of oxide remained on a few coupons. The effect on pit depth measurements is estimated to be less than 0.0005 inch. Aluminum (1100 and 6061) galvanic coupons are shown in Figure 10 with no visible pitting in the cleaned coupons. However, Figure 11 does reveal pitting in the cleaned 6063 coupon within the surface area mated to the stainless coupon and at the edges of the PTFE washer. Multiple pit sites were also observed on the 6063 coupon in the 2003 corrosion surveillance report.[6] Galvanic corrosion (pitting) is expected on aluminum/stainless steel combinations since aluminum is anodic to stainless steel. Pitting beneath the edge of the PTFE washer is due to crevices that exist between the surfaces of the two materials. Pitting on the 6063 coupon could also be due to end grain attack since the coupons were cut from an extruded bar. Thus, the face of the 6063 coupon represents the end of the bar and is subject to end grain attack.

Figure 9. Aluminum 1100, 6061, and 6063 coupons galvanically coupled with 304 stainless steel are shown with mating surfaces in view. The surface characteristics of these mating surfaces after 8 years immersion remain similar to previously removed coupons.

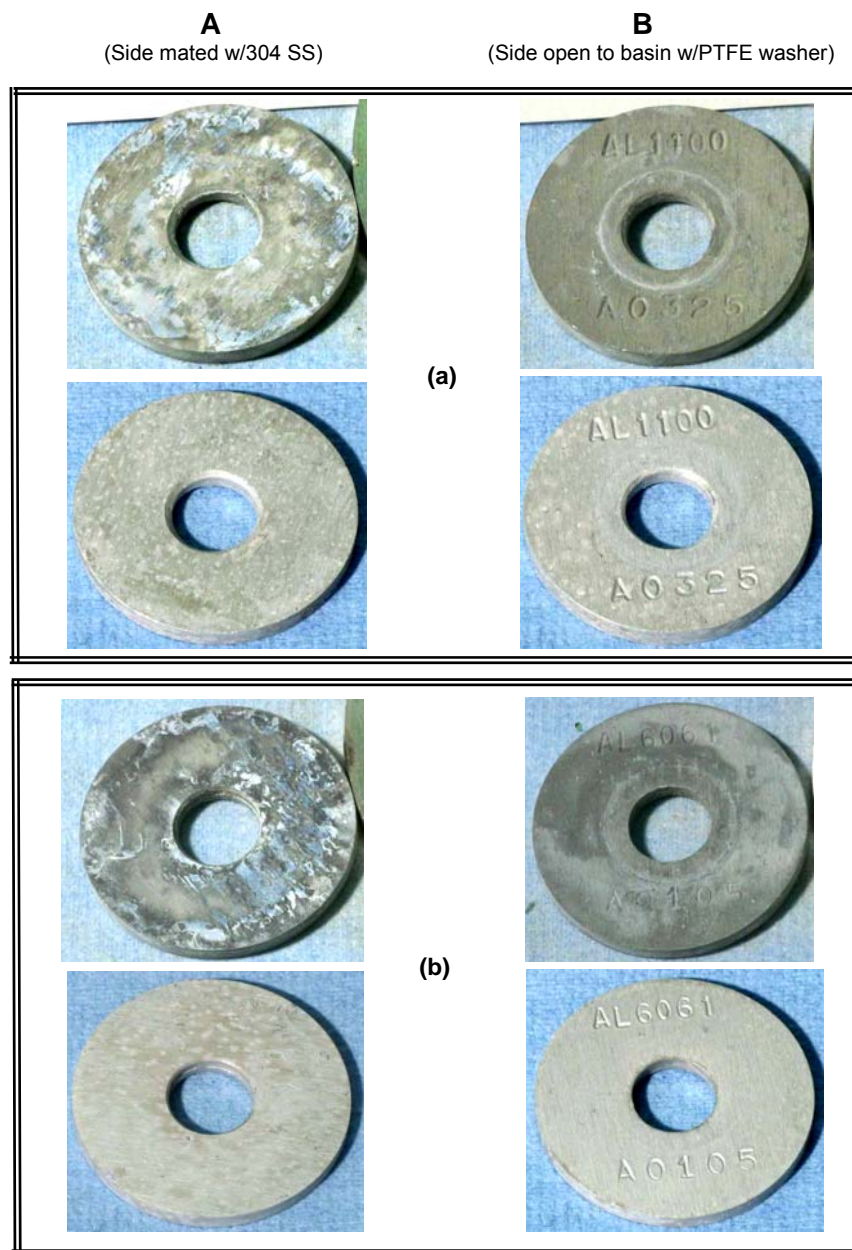
Figure 10. Before cleaning (upper photos in (a) box) and after cleaning (lower photos in (b) box) photos of selected aluminum galvanic coupons (32 mm OD) mated with larger (70 mm OD) 304 stainless steel coupons. Upper coupon group (a) is 1100 aluminum. Lower group is 6061 aluminum. Pitting is not visible in these images.

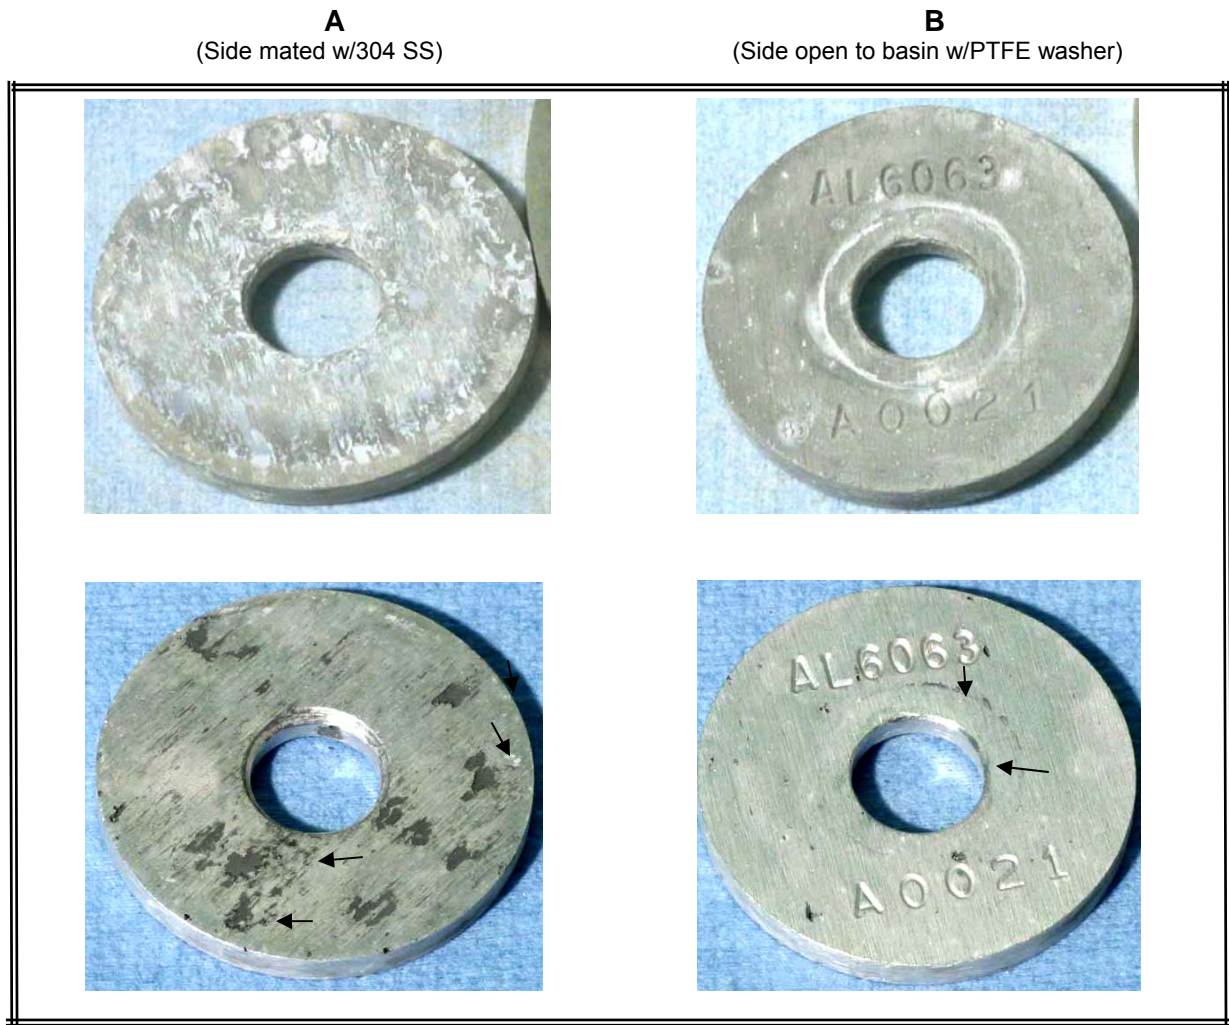
Figure 11. Aluminum 6063 coupon is shown before (upper) and after (lower) cleaning. Dark areas show remaining oxide that was not removed. Remaining oxide thickness on coupons is approximately 0.0005 inch which should not affect depth measurements. Pitting (noted by arrows) is visible in area that was beneath PTFE washer (lower right photo) and on coupon face (lower left photo) where crevice existed while in contact with 304 stainless steel. Original coupon diameter is 32 mm.

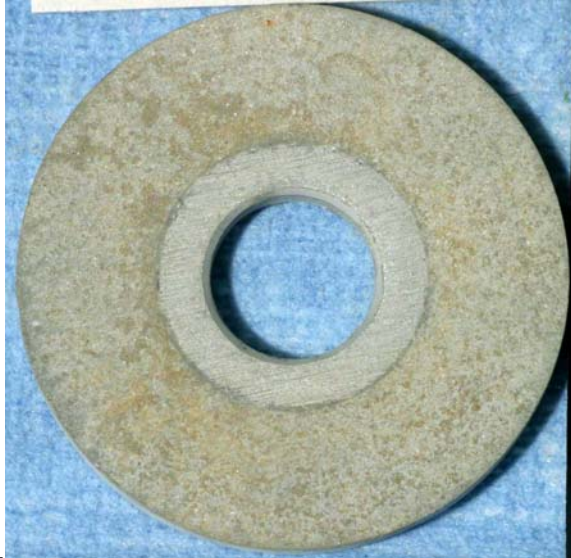
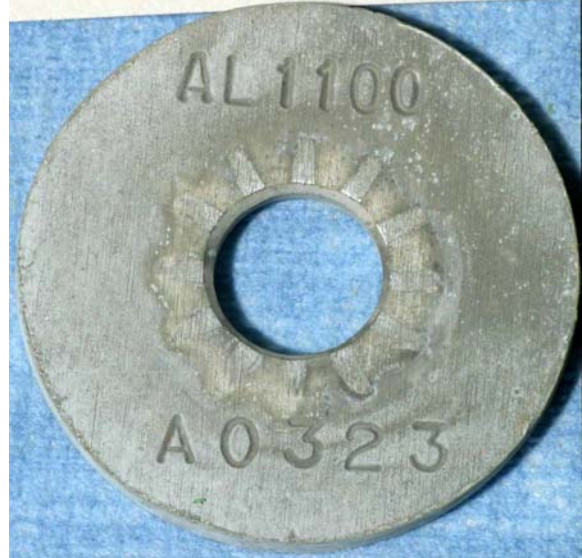
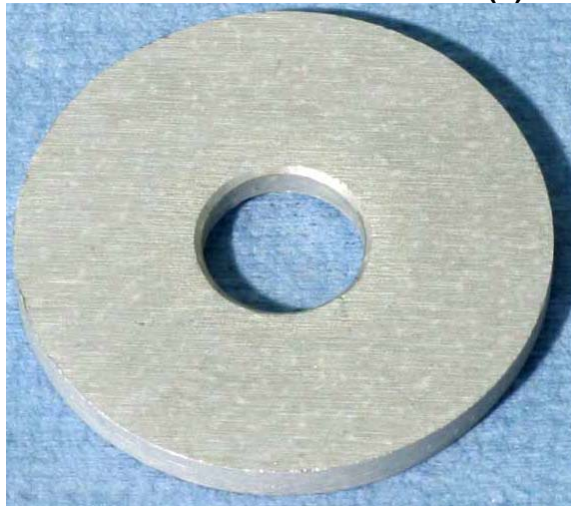
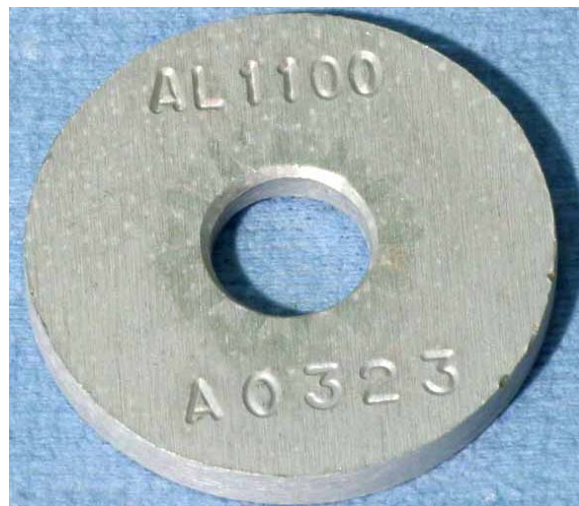
Figure 16. Before and after cleaning imprint of a serrated PTFE washer and its crevice effect on an Al 1100. No pitting was observed within the PTFE washer area.

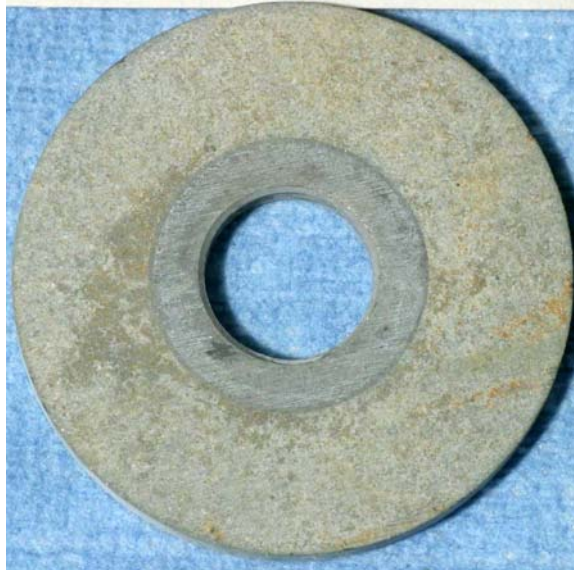
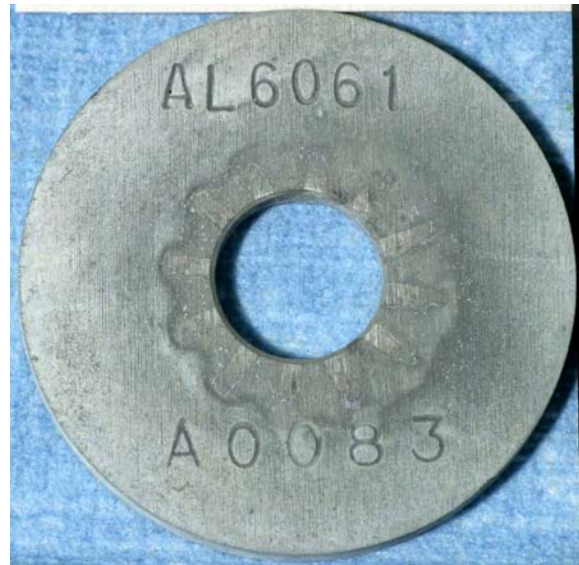
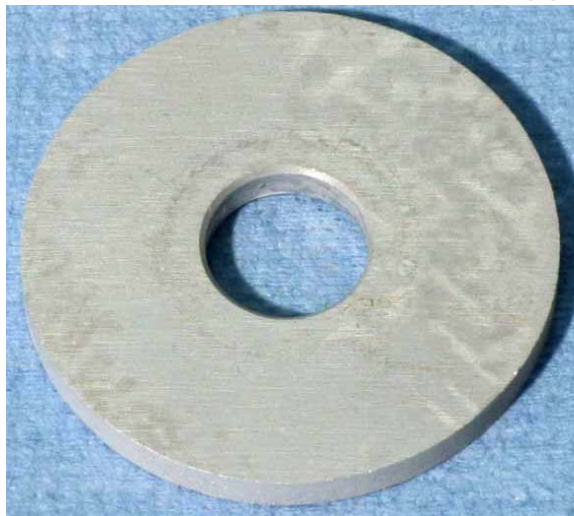
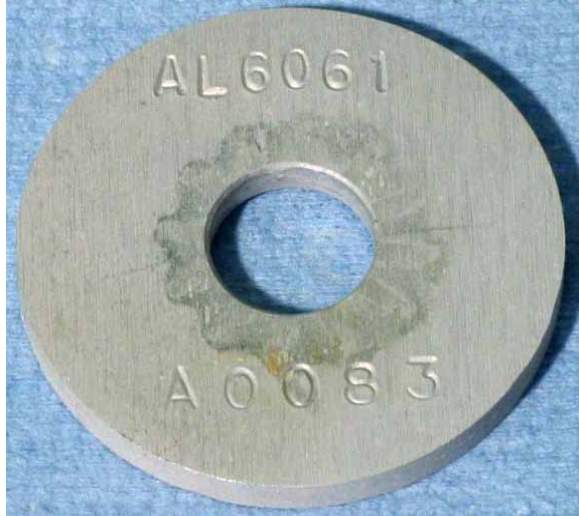
Figure 17. Before and after cleaning imprint of a serrated PTFE washer and its crevice effect on an Al 6061 coupon.

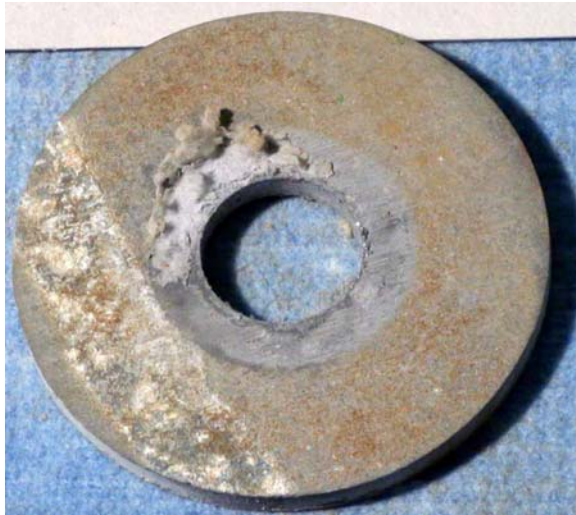
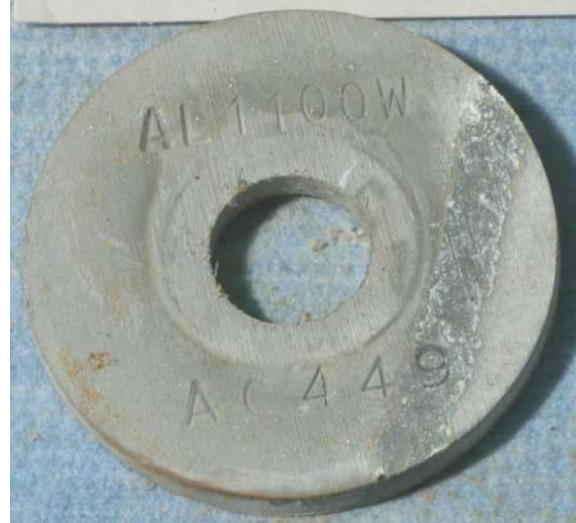
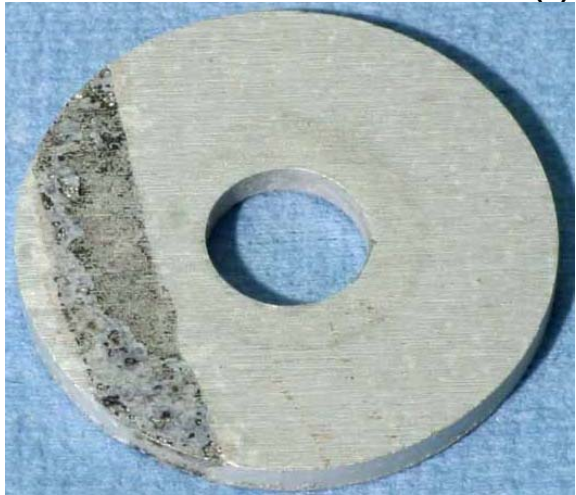
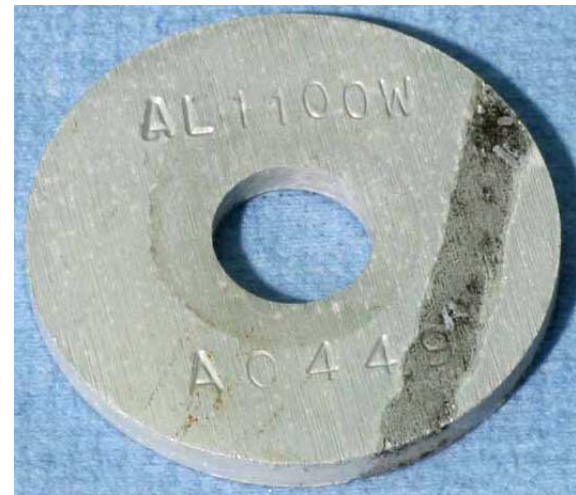
Figure 18. Visual appearance of as-received and as-cleaned autogeneous welded 1100 coupon displaying some retention of black oxide after nitric acid cleaning. Upper left image reveals oxide peeling off when PTFE washer was removed.

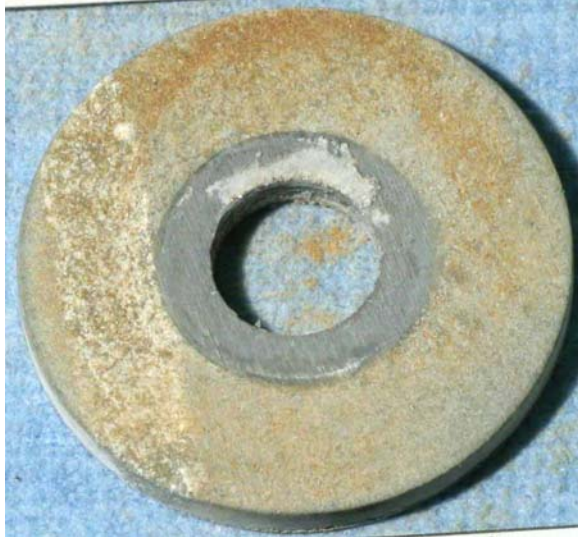
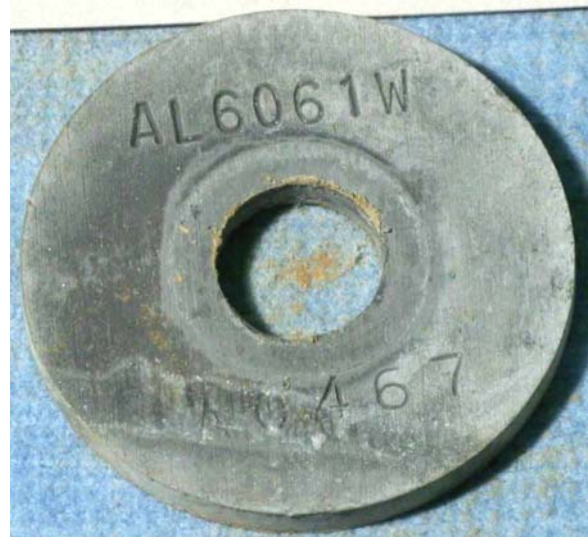
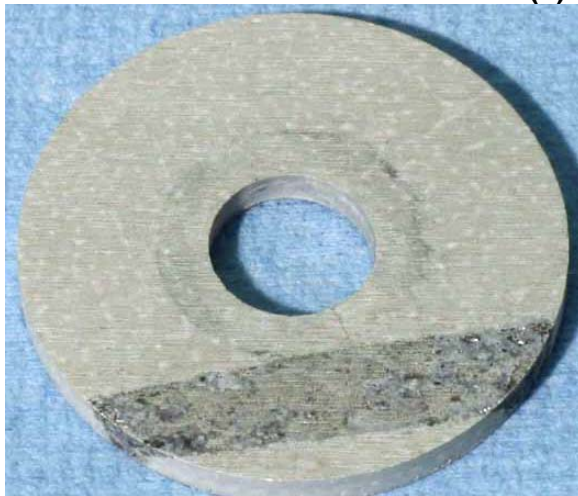
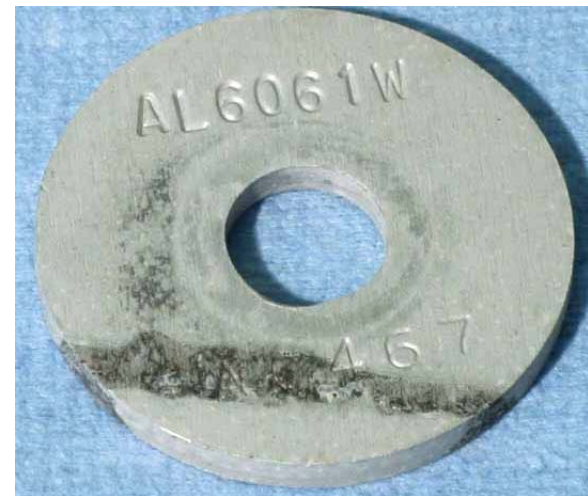
Figure 19. Visual appearance of as-received and as-cleaned autogeneous welded 6061 coupon displaying some retention of oxide (black) after nitric acid cleaning. Black spots in the weld and in the crevice area left by the PTFE washer indicate possible pit locations.

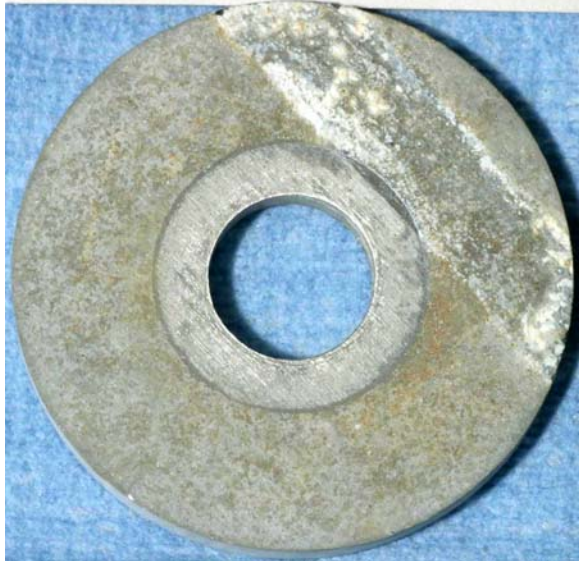
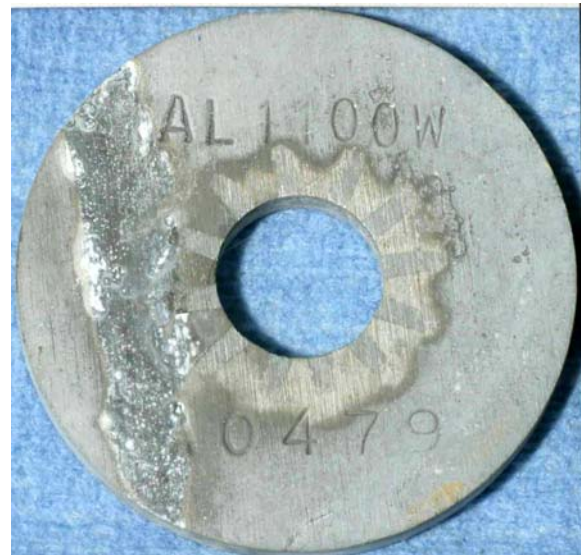
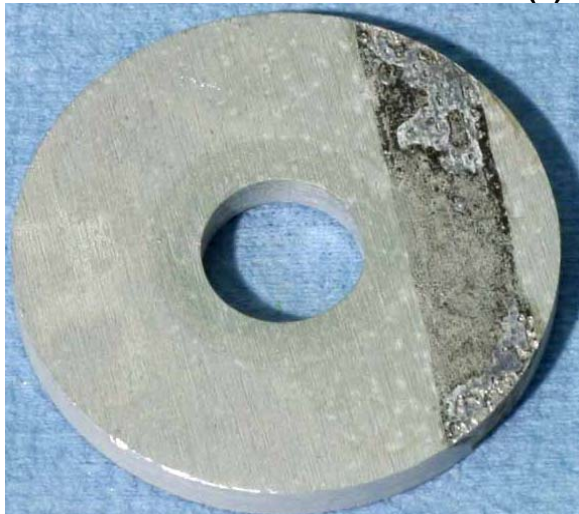
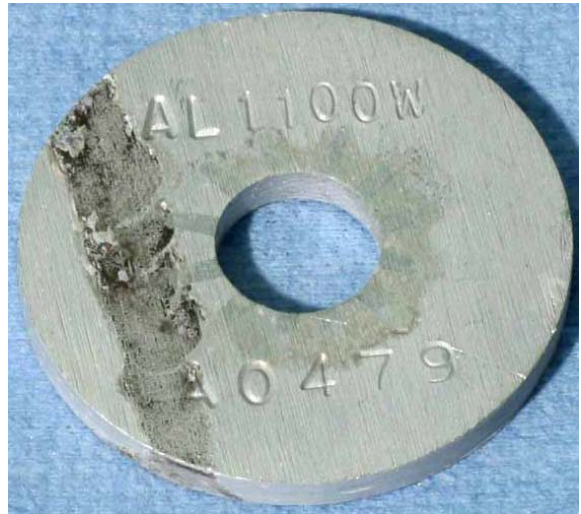
Figure 20. Visual effects of a serrated (crevice) PTFE washer on autogeneous welded 1100W coupon in the as-received and as-cleaned condition. Notice that oxide is still remaining on the lower left image. Limited attempts were made to remove the oxides but extensive pitting was still found in the weld area on both sides (~60 pits in weld on lower left photo and ~40 pits in weld on lower right photo).

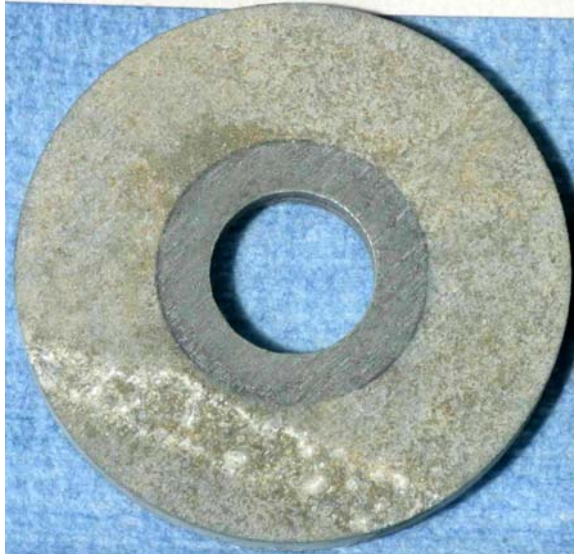
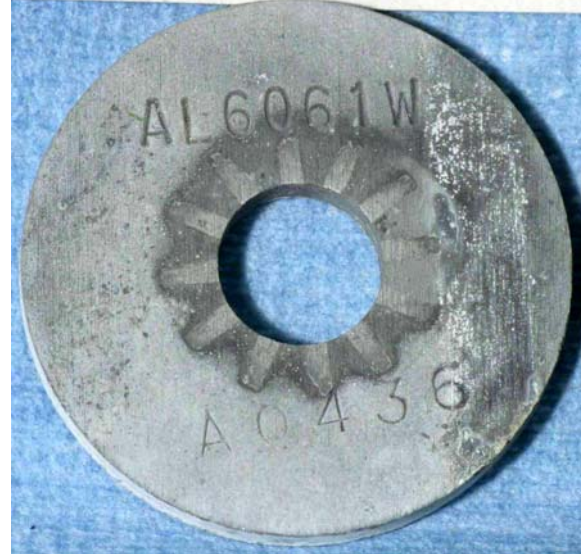
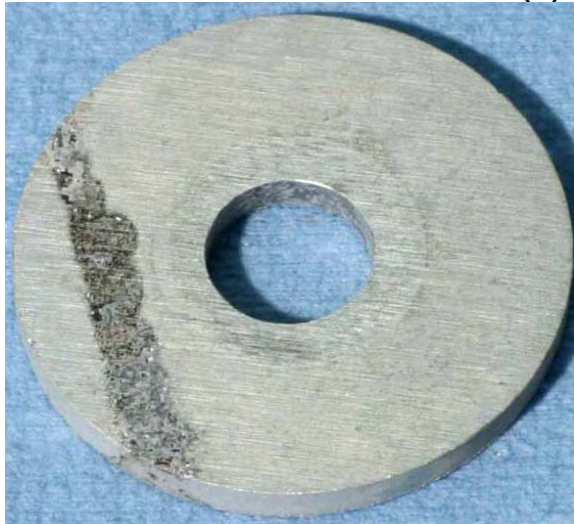
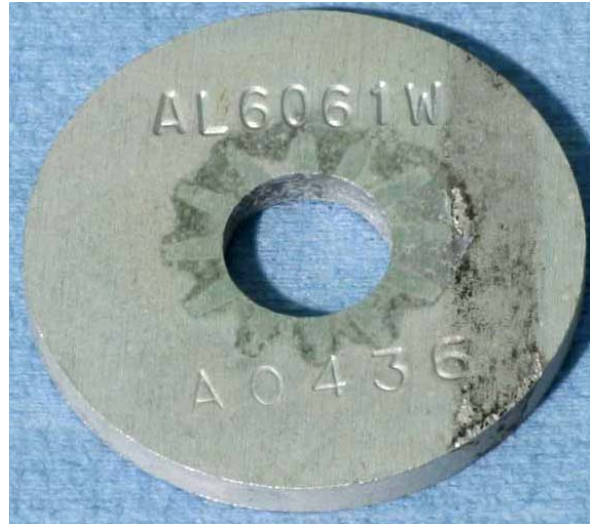
Figure 21. Effect of serrated (crevice) PTFE washer on the visual appearance of as-received and as-cleaned autogeneous welded 6061 coupon.

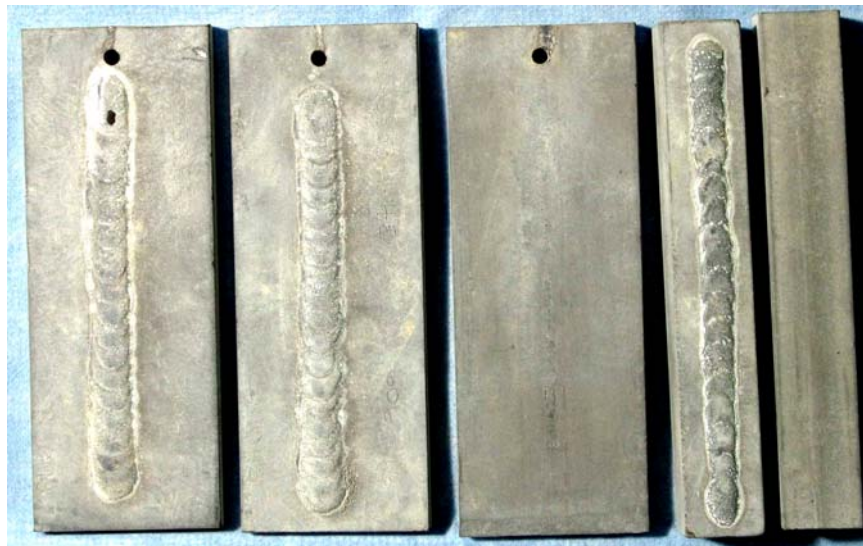
The as-received condition of the aluminum support rack coupons after L-Basin exposure, both welded and non-welded, is shown in Figure 24. These aluminum rack furniture samples, with and without welds, were immersed in L-Basin for approximately 97 months. Corrosion is visible as the white oxide formation in the heat affected zone (HAZ) of the welds with no apparent visual differences between the 2004 rack coupons and those from previous years. The visual appearance does not indicate a substantial increase in degradation. Examination of the weld HAZ in a scanning electron microscope revealed rod-type morphology versus round particles

Figure 24. Aluminum rack furniture samples, with and without welds, after 97 months immersion. Corrosion is visible as the white oxide formation in the heat affected zone of the welds which is similar to that shown in previous years. Plate coupons are 6061-T6 and “U” channel coupons are 6063-T5. Welding was performed with a R4043 filler metal.

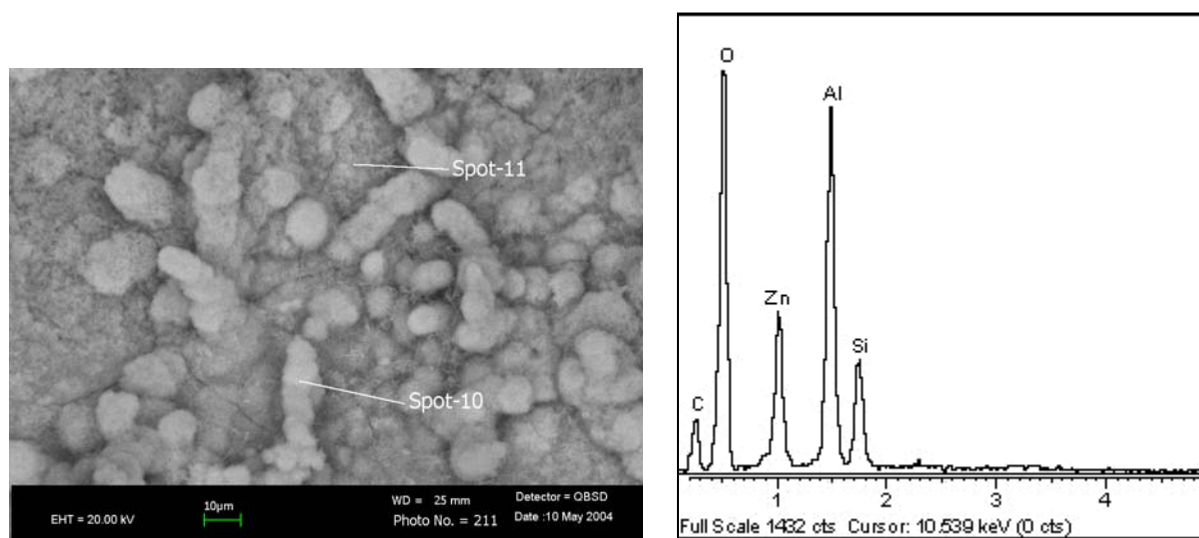
found on the base metal (6063 T5) as shown in Figure 25. Analysis of the HAZ (spot 10) by electron dispersive spectroscopy (EDS) revealed the presence of zinc. Specific Zn levels were not measured since this particular contaminated EDS system is not equipped for quantitative analysis. The chemical composition of the 6063 base metal and the R4043 in Table 1 shows that zinc levels are at or below 0.10%. Zinc levels in 6061 are more than double that of 6063 and the oxides may show this same behavior. Even though the 0.10% level in 6063 is below the detectable limit of EDS analysis ($\geq 0.20\%$), zinc was detected in the surface oxides in the weld HAZ in 6063. A recent chemical analysis of L-Basin water revealed a zinc level of 0.17 ppm. These levels are extremely low and thus conclude that Zn absorption from L-Basin water is probably not causing the presence of Zn in the surface oxides. Another source of Zn may also be from preferential oxidation of zinc from the sample. Zinc is normally anodic to aluminum. This has to be further explored in future work.

Figure 25. Left photo reveals rod-like morphology in aluminum oxide in HAZ of weld on 6063 T5 U-channel versus particle morphology in base metal oxide. Energy Dispersive Spectroscopy (EDS) of Spot-10 in right graph reveals Zn in rod-like particle along with Al, O, and Si.

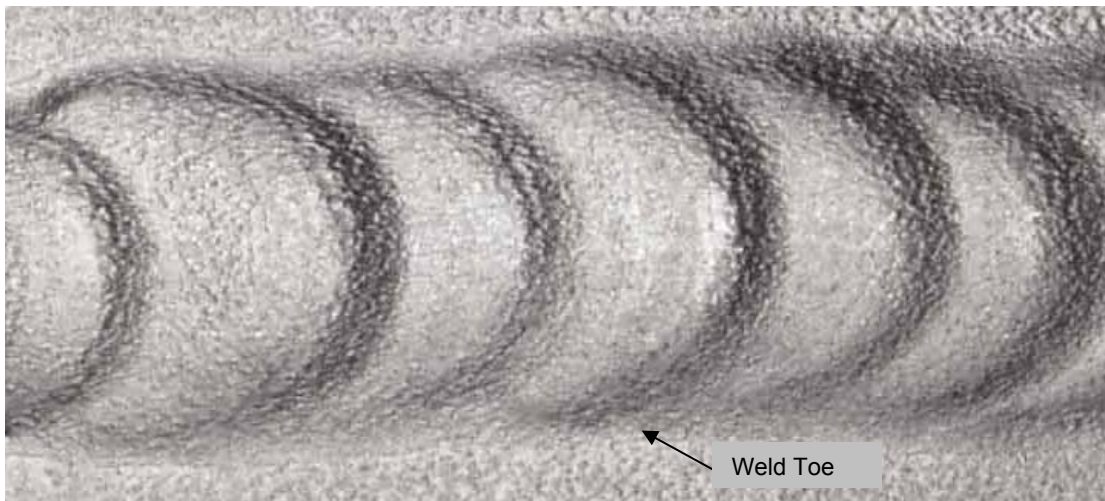
An original 6063 furniture rack U-channel weld is shown in Figure 26. This original welded coupon, provided by the manufacturer of the fuel rack installed in L-Basin, shows evidence of being etched or bead blasted (Figure 26.) which probably matches the condition of the furniture rack coupons installed in L-Basin. After nitric acid cleaning of the welded coupons was performed per Reference 7, numerous pitting sites were exposed in the weld metal (Figure 27 to Figure 28) on both the 6061 plate and the 6063 U-channel. Pit depths ranged from a less than 0.5 mils in the base metal to a maximum of 6 mils in the toe of a welded plate (Figure 29) with average pit densities ranging from 2 to 16 pits/mm² (Figure 29). The maximum pit density, 16 pits/mm², was in the weld of a 6061 T6 plate from 2003. This value is much higher than the other welded plate coupon in which the maximum pit density was approximately 5 pits/mm². The maximum pit density in the two U-channel coupons is less than 10 pits/mm². Although initially thought to be the result of a galvanic reaction between the base and weld metal, referenced electrode potentials of 6061, 6063, and R4043 in a NaCl-H₂O₂ solution are -0.80 to -0.83 volts.[11] These potentials are virtually the same and thus a galvanic reaction should not occur between the weld and the base metals in this unique solution. Although the application of R4043 is normal industry practice as a corrosion resistant filler metal for both 6061 and 6063, the electrode potentials of the three alloys need to be measured in solutions similar to L-Basin.

Figure 26. R4043 weld bead on as-received 6063 U-Channel coupon. The welded face of the coupon was either chemically etched or bead blasted to clean the surface after welding. Although the surface of the weld reveals an “orange peel” type surface, no pitting is visible in the weld toe or in the weld face.

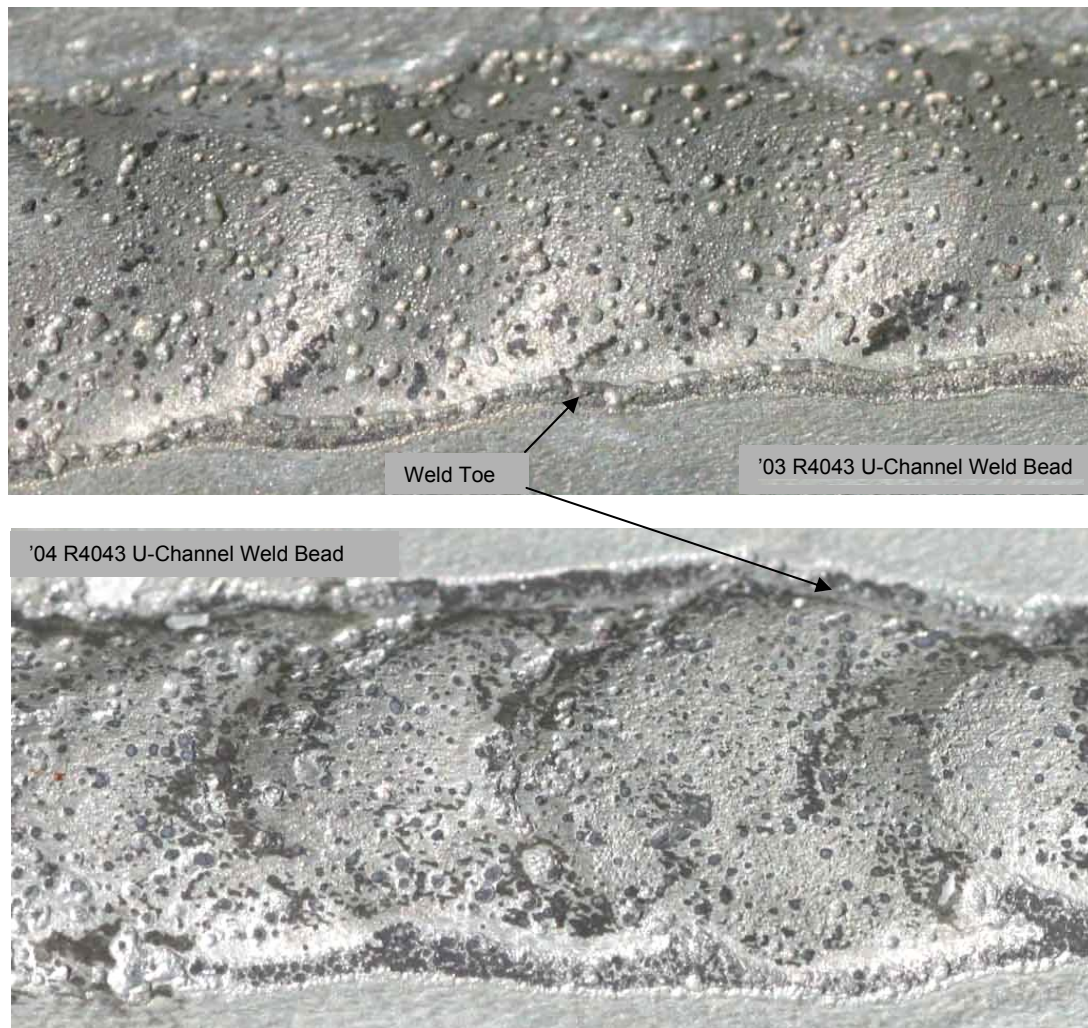
Figure 27. Cleaned R4043 weld beads on 2003 (a) and 2004 (b) 6063 T5 U-Channel samples after immersion in L-Basin for 85 and 97 months, respectively. Vertical width of each weld bead is approximately 6.4 mm. Numerous pits are visible in the weld bead and in the weld toe on each side of the weld bead. Only a few pits were found in the base metal.

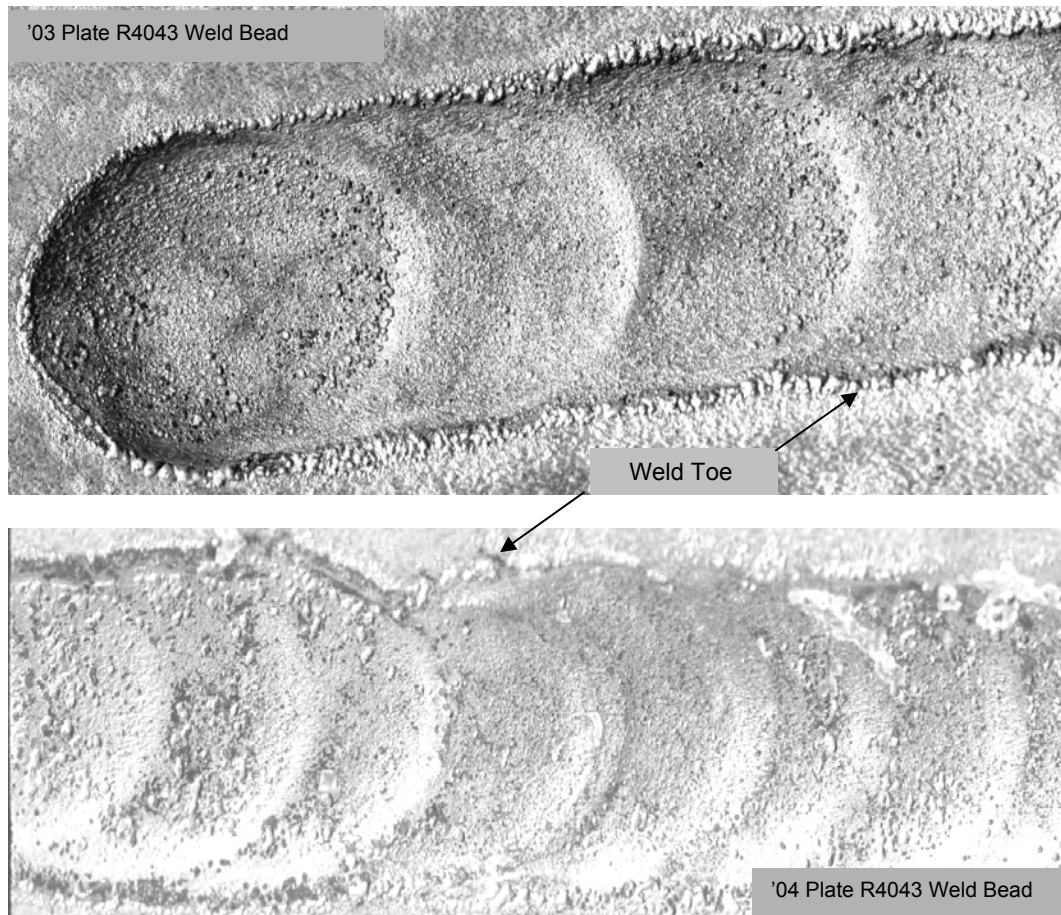
Figure 28. Cleaned R4043 weld beads from '03 and '04 6061 T6 furniture plate samples. Vertical width of weld beads ranges from 6.4 to 9.5 mm. While the number of pits appears to be less than that of the U-channel samples, numerous pits were counted in the weld toe.
