DP - 1077

FAILURE ANALYSES AND PROPERTIES OF SAFETY ROD GUIDE TUBES FROM THE HWCTR

R. P. MARSHALL
C. L. SELBY

April 1967

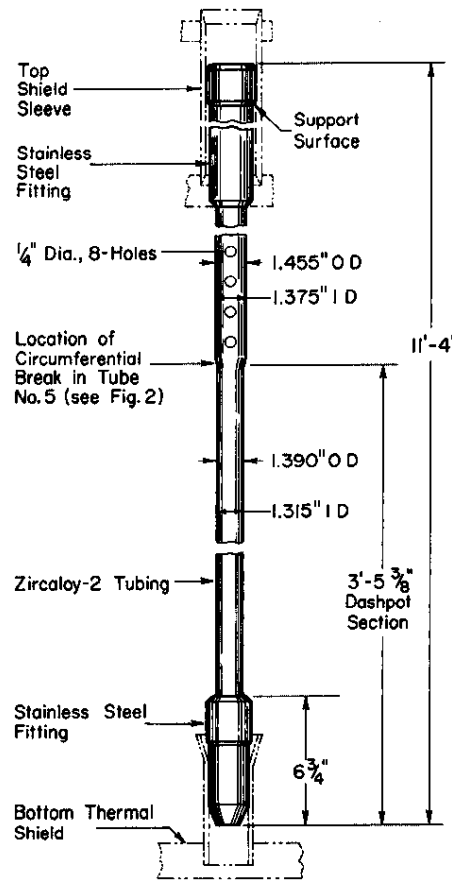
FIG. 1 HWCTR SAFETY ROD GUIDE TUBE

There is no record of how the bottom 42 inches of the tubes were reduced in diameter to produce the hydraulic dashpot section, and it is not known whether the tubes were annealed afterward.

Diameter Reduction from
1.375" ID to 1.315" ID
at top of dashpot section.

- Increase the diameter transition zone from $1/4$ - $3/8$ inch to about 2 inches in length, to reduce the magnitude and concentration of the induced stress pulse.
- Use Zircaloy-4 or low-nickel Zircaloy-2, to reduce hydrogen pickup in the high-pD water used in the HWCTR.
- Anneal tubes after the final fabrication process, to eliminate residual stresses.

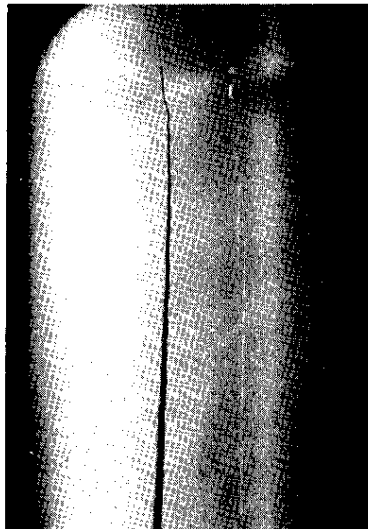
Guide Tube 6

The crack surfaces in Guide Tubes 2, 4, and 6 (Figure 3) had the same appearance and coloration as in Guide Tube 5. No cracks were found in Guide Tubes 1 and 3. The inner and outer surfaces of these five tubes appeared similar to Guide Tube 5.

FIG. 3 CRACKS IN GUIDE TUBES 6 AND 2 (Note that these cracks are similar in nature, but at an earlier stage of development than the cracks shown in Figure 2.)

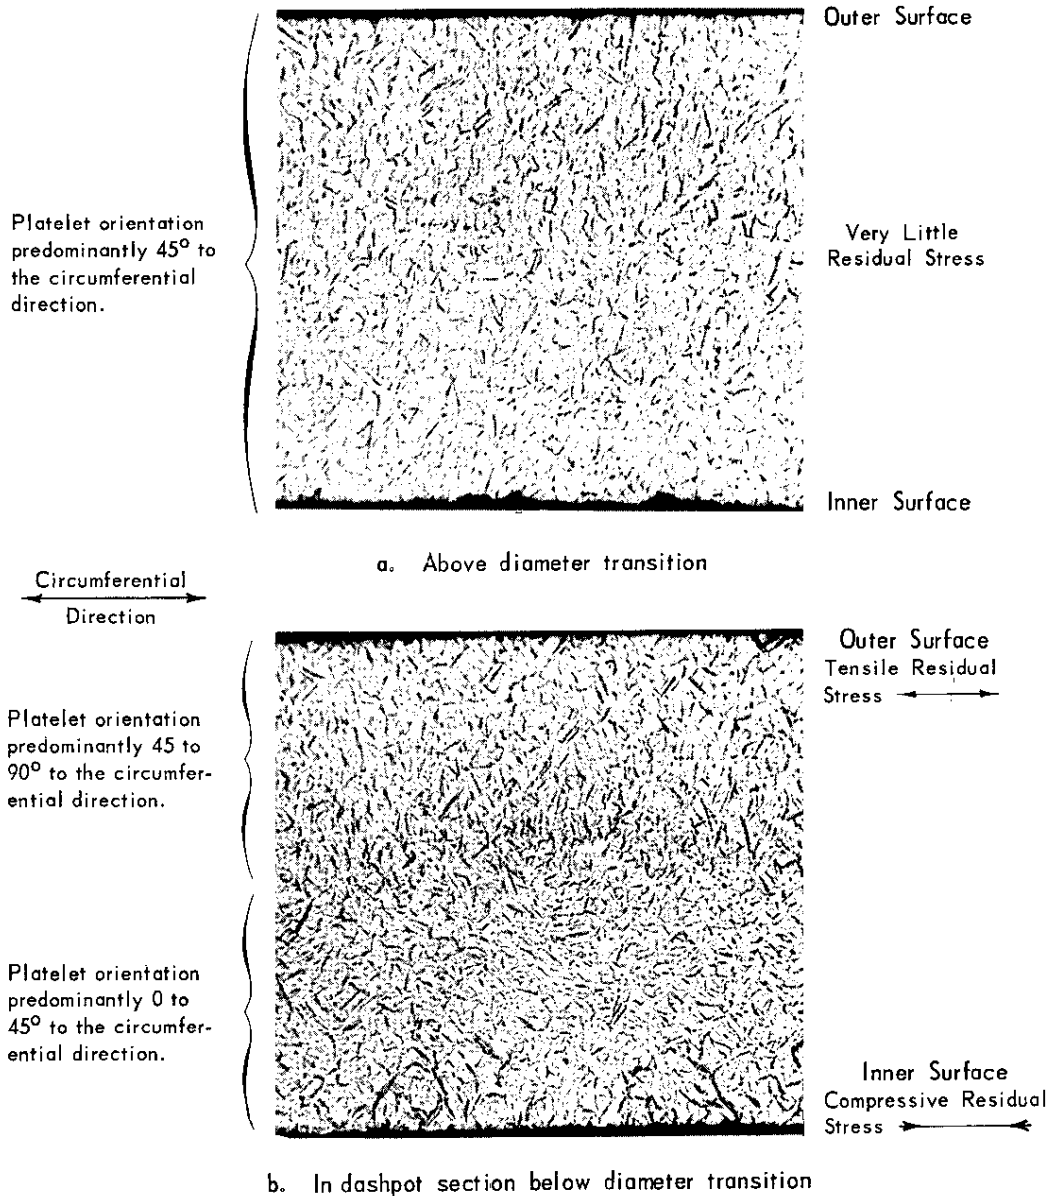
FIG. 4 HYDRIDE ORIENTATION IN GUIDE TUBE 5
(Transverse sections as-polished 60X)

In all tubes, the hydride platelets were oriented predominantly 45° to the circumferential direction above the diameter transition with little variation across the wall (Figure 4a). Below the diameter reduction, however, the platelets were preferentially oriented 45 to 90° to the circumferential direction at the outer surface and 0 to 45° to the circumferential direction at the inner surface (Figure 4b). These orientations resulted mainly from stress orientation of the hydrides⁽²⁾ because of the 13 to 28 kpsi residual stresses in the bottom of the tubes.

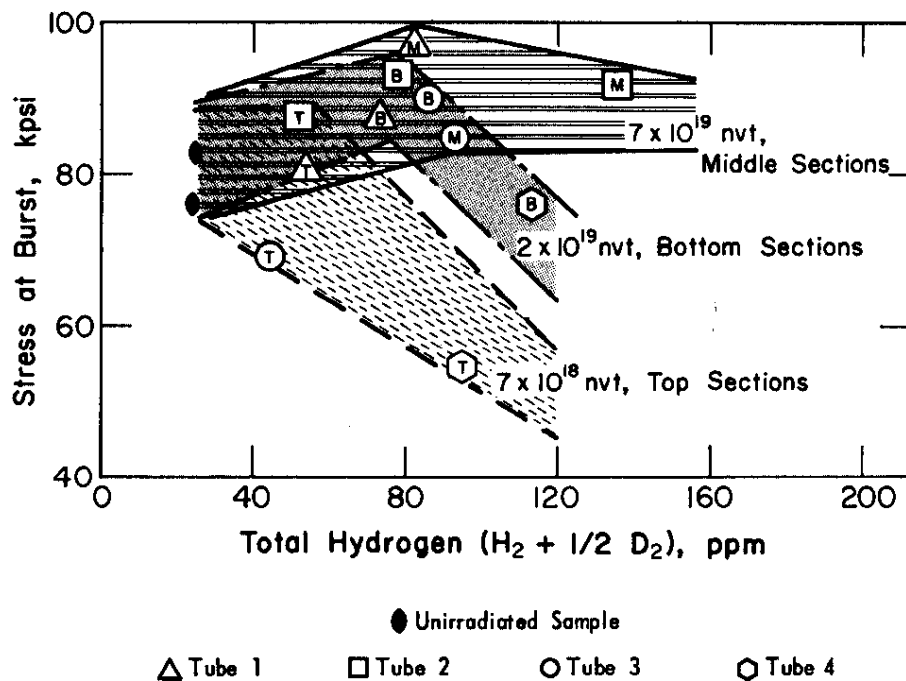
FIG. 5 BURST STRENGTH OF IRRADIATED SECTIONS

The combined effects of irradiation, hydrogen content, and hydride orientation on burst strength are shown in Figure 5. At a fast neutron exposure of 7×10^{18} nvt (top tube sections), irradiation hardening had caused little increase in strength before higher hydrogen contents apparently began to limit strength. With increased neutron exposure, 2×10^{19} nvt (bottom tube sections), some irradiation-induced increase in strength occurred before higher hydrogen contents again limited the strength. At

the highest neutron exposure, 7×10^{19} nvt (middle tube sections), an increase in strength due to irradiation was observed, but hydrogen up to 136 ppm had no effect. These data indicate that hydride orientation had no significant effect on burst strength because the top and bottom sections had much different hydride orientations but exhibited about the same effects of irradiation and total hydrogen.

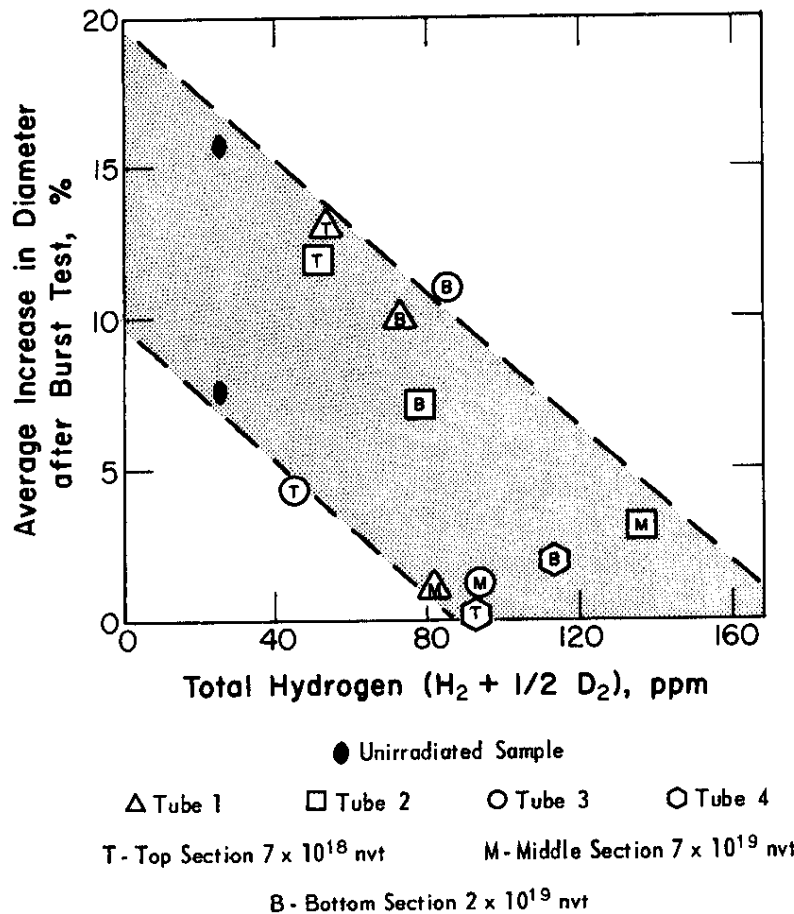
FIG. 6 DUCTILITY OF IRRADIATED SECTIONS DURING BURST TEST

As shown in Figure 6, ductility was lowered by the combination of increased neutron exposure and higher hydrogen contents, and it was not possible to separate the two effects. Hydride orientation had no significant effect on ductility possibly because the radially oriented hydrides were contained in only the outer layer of the tubing.

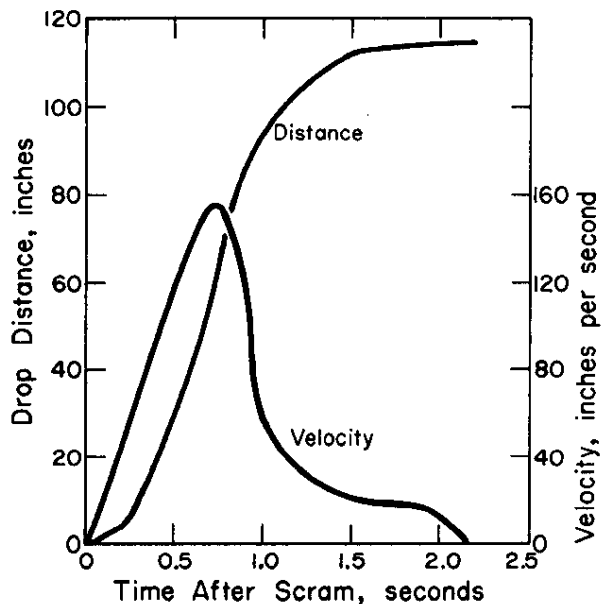
FIG 7 DISTANCE - VELOCITY
CHARACTERISTICS OF
A SAFETY ROD SCRAM
(30°C moderator temp.)

The precise value of stress pulse in the guide tubes during the safety rod drop tests is unknown; calculations indicate a range of 10,000 to 75,000 psi, depending on the deceleration rate, compressibility of coolant, etc. The maximum stress pulse must contain a large circumferential tensile component from the transient increase in pressure of the coolant, but also must include a large amount of stress concentration and some biaxiality because of the sharpness of the diameter transition at the top of the dashpot section. The distance-time-velocity graphs (Figure 7) show that the stress pulse was very rapid. True mechanical impact
