AEC RESEARCH AND DEVELOPMENT REPORT

# **CORROSION OF EQUIPMENT IN THE HEAVY WATER COMPONENTS TEST REACTOR**

June 1965

E. I. DU PONT DE NEMOURS & COMPANY  
SAVANNAH RIVER LABORATORY  
AIKEN, SOUTH CAROLINA

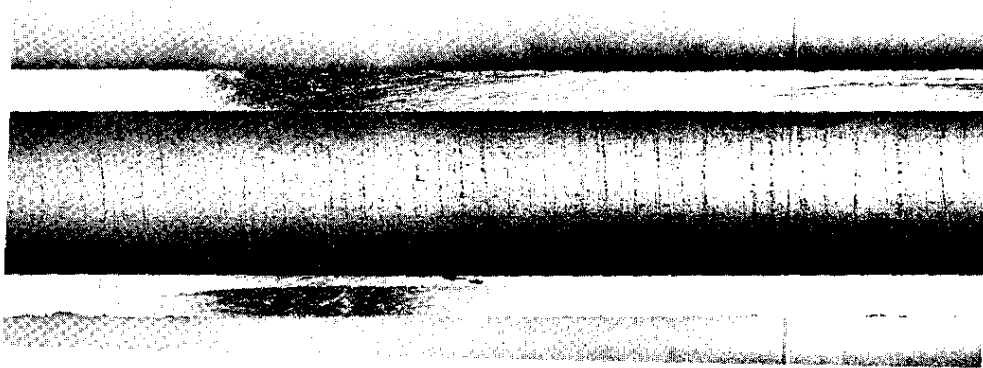
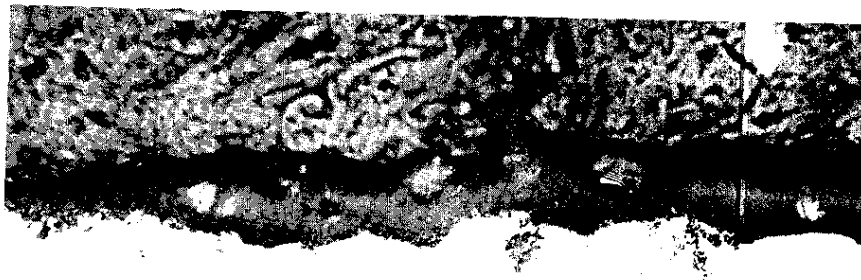
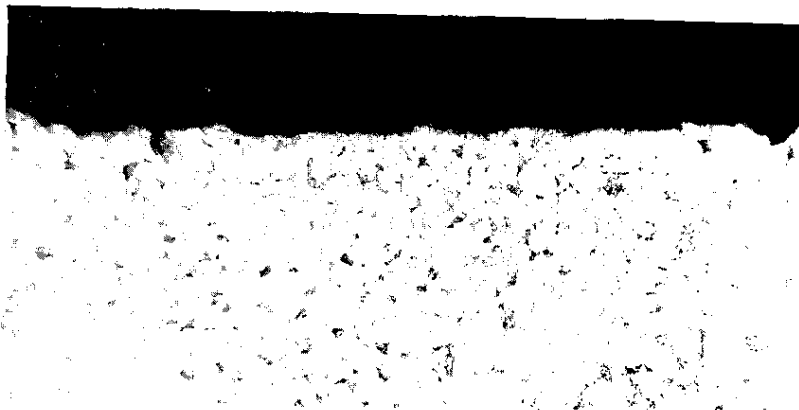
Numerous inspections were made of mild steel equipment and pipe, including the purge cooler heads, steam generator heads, pipe in several locations, and two sections of tube that were removed from the steam generators. Without exception, the conditions were excellent even after extended shutdowns for as long as three months, during which time considerable dissolved oxygen was in the water. All of the surfaces were covered uniformly with adherent black (magnetite) film, and showed no rusting, general corrosion, nor pitting. Figure 6 shows three views of a steam generator tube section that was removed in August 1964. The middle view shows the magnetite film, which is approximately 0.001-inch thick. The maximum corrosion penetration was also approximately 0.001-inch. Some surface roughness was present on these tubes at the time they were installed. They were rusty when received from the vendor, and were chemically cleaned before installation.<sup>(1)</sup>

General View of Descaled Tube

Magnetite  
Film

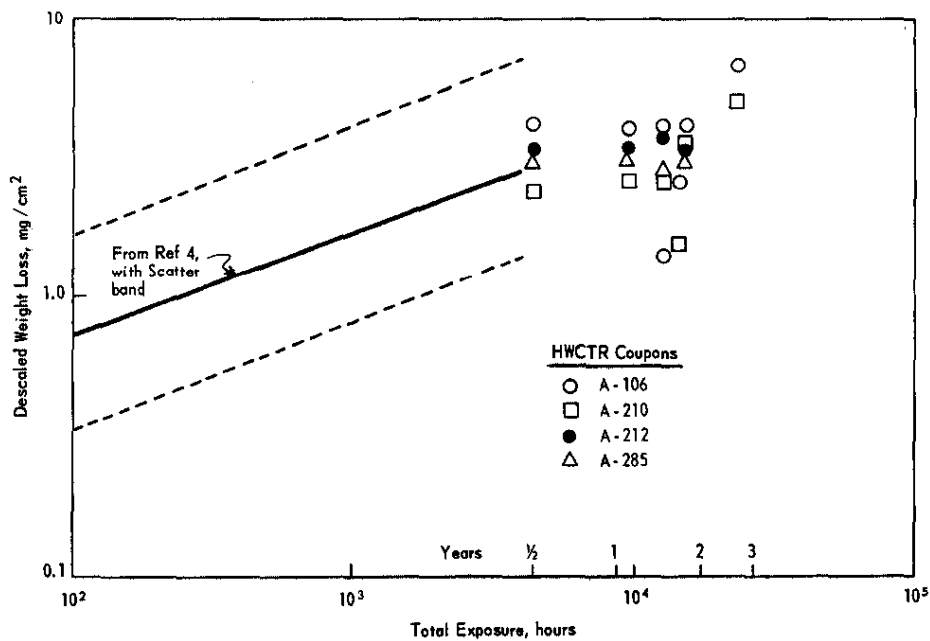
FIG. 7 WEIGHT LOSS OF DESCALED MILD STEEL COUPONS FROM MODERATOR-COOLANT

Coupons were removed periodically and examined for weight loss, pitting, iron release to moderator-coolant, and cracking (of stressed samples). All weight losses were measured on descaled coupons. A total of 61 coupons were examined. The data on weight loss and pitting are presented in Table IV, and the weight loss data for coupons exposed to D<sub>2</sub>O in the reactor vessel are shown in Figure 7. The period of high corrosion rates and oxide film growth apparently ended prior to 4400 hours (six months) of exposure. After 4400 hours, the corrosion rates were very low. For example, the average weight loss between 4400 and 15,240 hours of exposure was only 0.27 mg/cm<sup>2</sup>, or 0.018 mg/cm<sup>2</sup> per month.

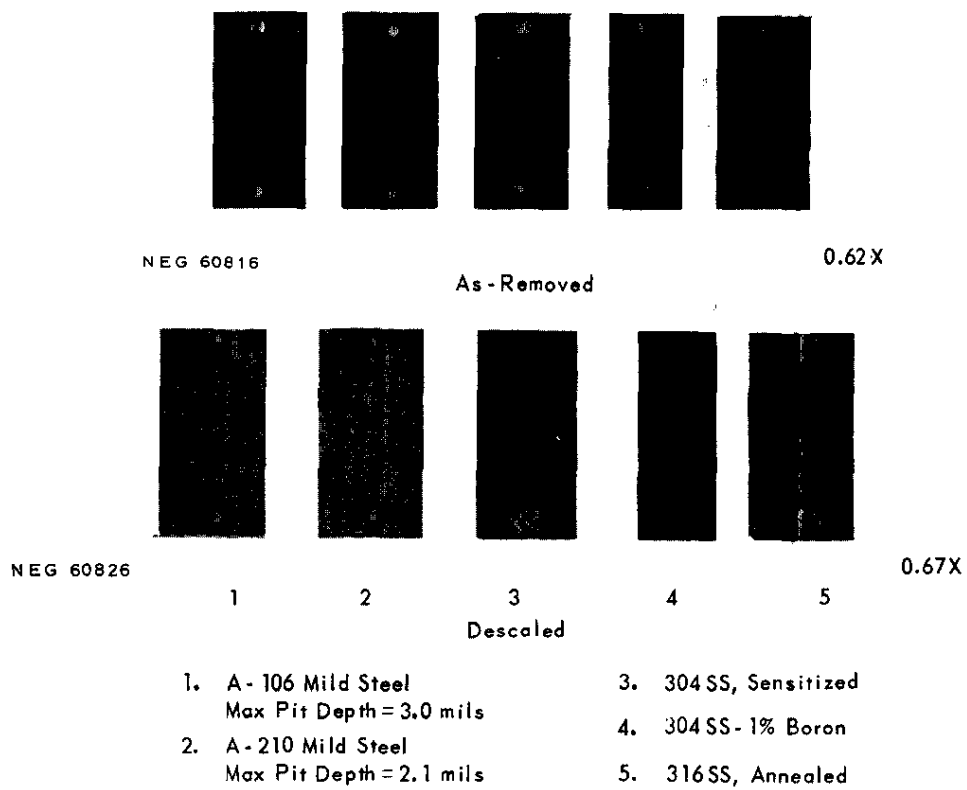
FIG. 8 CORROSION COUPONS FROM D<sub>2</sub>O ABOVE CORE IN REACTOR  
Exposure: 995 Days (23,880 hours)

Although no pitting was found on mild steel pipe, tubes, or equipment, minor pitting did occur on the corrosion coupons, as shown in Table IV. The maximum pit depths of the last coupons examined were lower than those of three previously removed sets of coupons. Two of the mild steel coupons from the last set are shown in Figure 8, along with some stainless steel specimens.

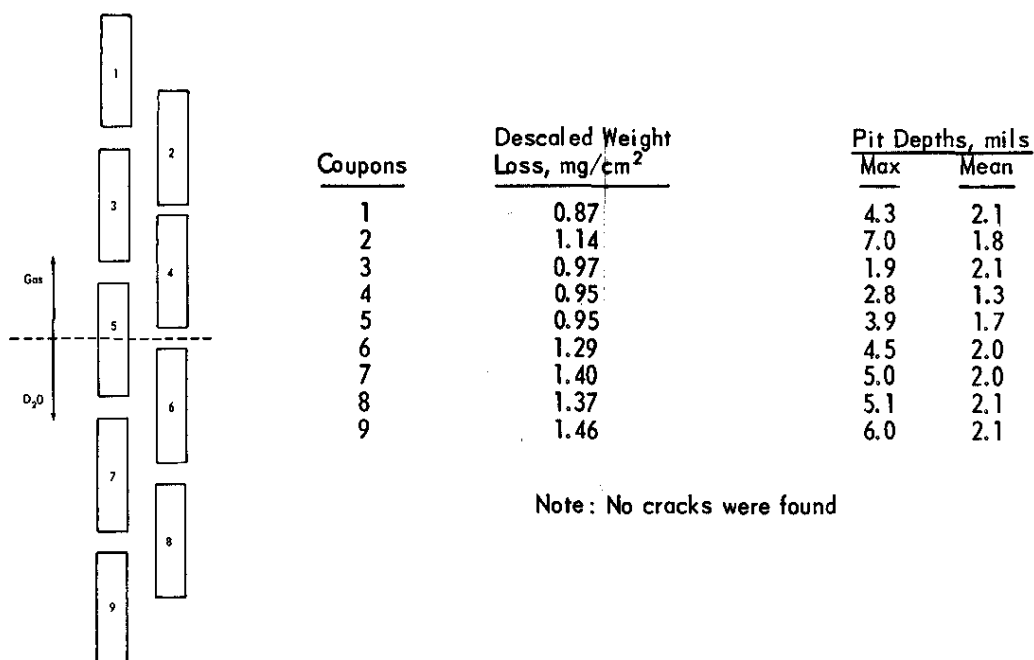
FIG. 9 STRESSED MILD STEEL (A-106) COUPONS FROM D<sub>2</sub>O - GAS INTERFACE  
Exposure: 12,840 hours

One holder, containing nine stressed, mild steel (A-106) coupons, was exposed at the D<sub>2</sub>O-gas interface in the reactor. The arrangement of the coupons and the results of the examination are shown in Figure 9. The primary purpose of this set of coupons was to determine if caustic cracking would occur on stressed mild steel surfaces where lithium hydroxide salt deposits might accumulate. No salt deposits could be seen on the coupons when they were removed, and no coupons cracked. The corrosion (descaled weight loss) of these coupons, in the D<sub>2</sub>O, was lower than that of the other mild steel coupons, including A-106, that were exposed deeper in the D<sub>2</sub>O for the same time period (see Table IV).

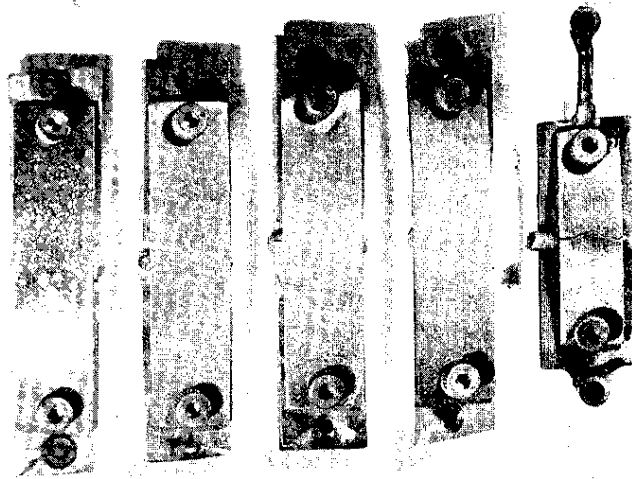
FIG. 11 STRESSED 17-4 PH STAINLESS STEEL COUPONS FROM REACTOR GAS SPACE  
Exposure: 23,880 hours

All of the 17-4 PH stainless steel used in the HWCTR was heat treated at 1100°F, which is believed to be the best treatment for prevention of stress-corrosion cracking. No failures occurred on equipment or corrosion coupons that were heat treated in this manner. Results of corrosion coupon examinations are in Table XII. Three coupons cracked, all of which had been heat treated at 900°F, and two of which were exposed during the preoperational light water test period and then returned to the reactor. Two of the cracked coupons were located in the reactor gas space (see Figure 11), and one was in the D<sub>2</sub>O above the core.

| Condition | In D <sub>2</sub> O Above Core | | In Reactor Gas Space | |
|---|---|---|---|---|
| 48% cold worked, 1 hr at 900°F | No cracks | No cracks | No cracks | Cracked |

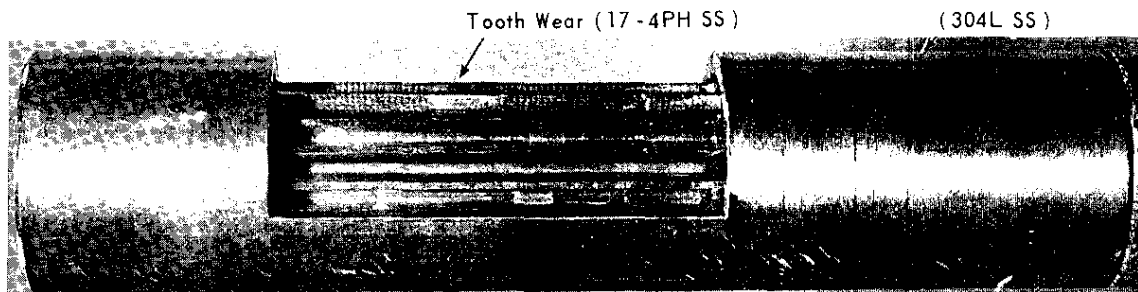
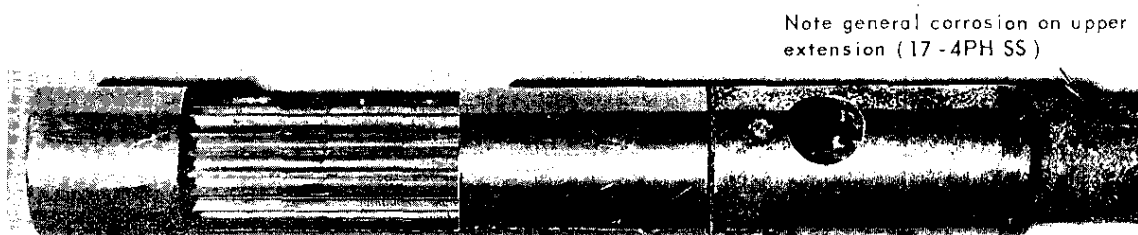
FIG. 12 CONTROL ROD DELATCH PINION GEAR

- 1) Wear on teeth of delatch pinion gear.
- 2) Minor corrosion under O-ring on seal bushing.
- 3) General corrosion of upper extension.

Figure 12 also shows the general corrosion on the upper extension. The appearance of the O-ring groove in the seal bushing is better in December 1964, than in April 1963, because this surface was polished after the first inspection (Figure 13).

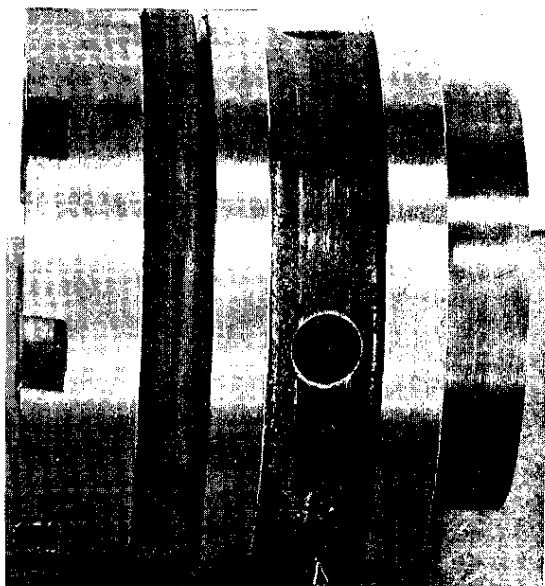
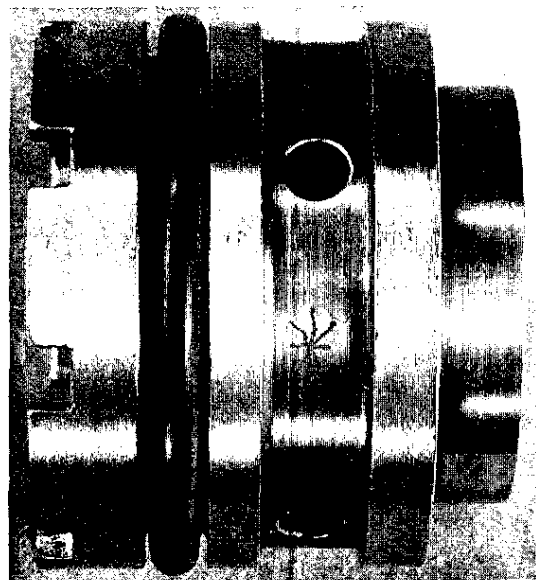
FIG. 13 CONTROL ROD SEAL BUSHINGS, 17-4 PH SS

April 1963 (Note corrosion)
