DPSP-75-1219

MARK 60B BLANKET TUBE FAILURE (U)

August 1, 1975

MARK 60B BLANKET TUBE FAILURE

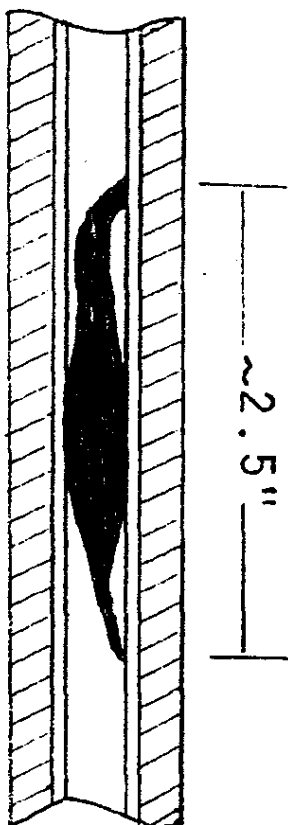
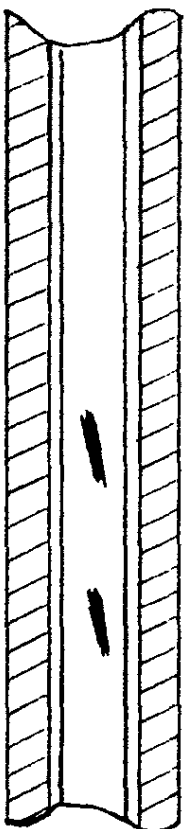
1 5% - 10% LI DROSS POURED WITH CASTING

2 CLADDING PENETRATED OR GREATLY THINNED BY DROSS
OR GRAPHITE INCLUSION

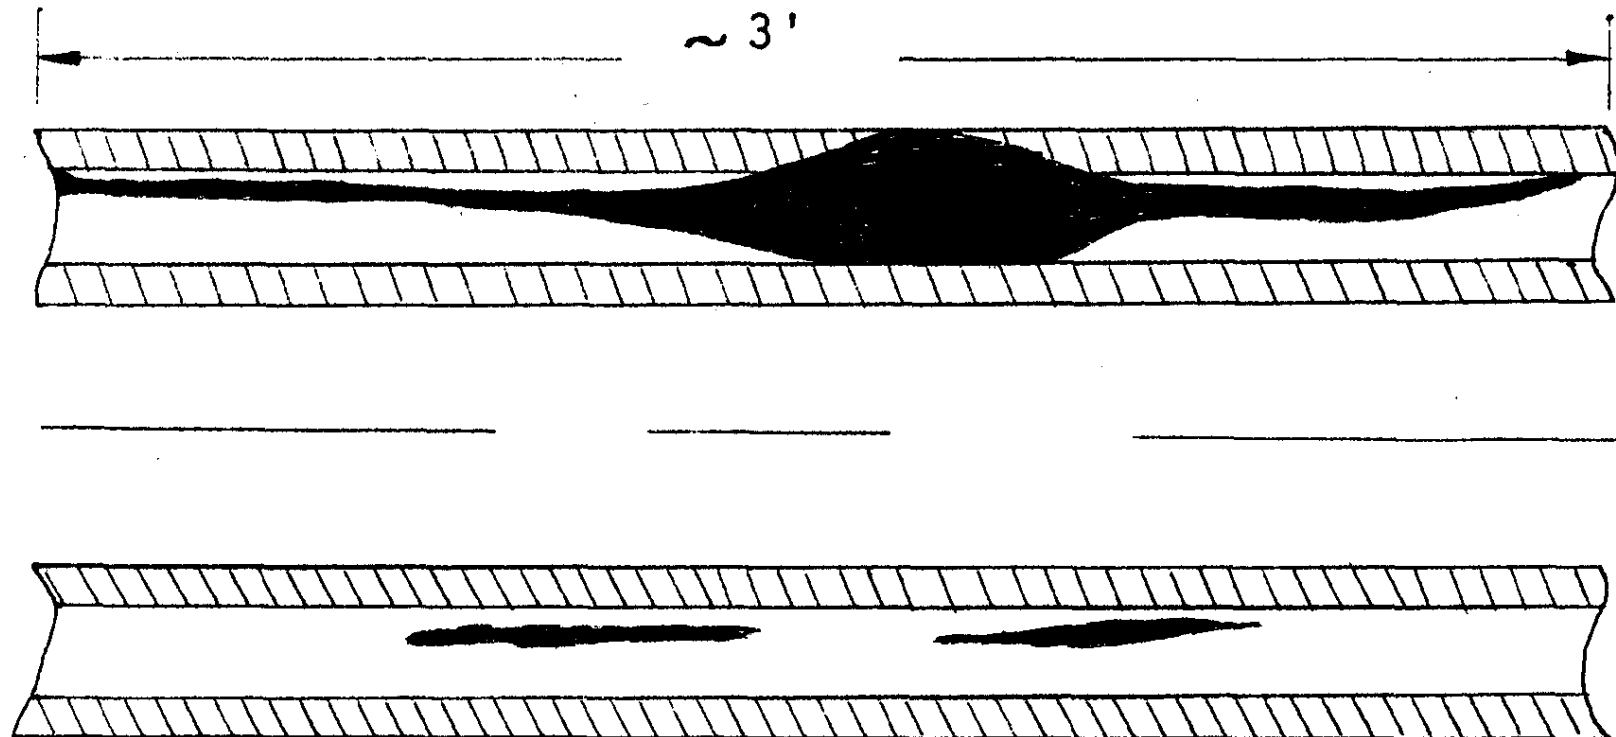
- 3 DROSS, CONTACTED BY MODERATOR, DISSOLVED AND FORMED CAUSTIC SOLUTION, WHICH ATTACKED CORE AND CLADDING
- 4 SWELLING CAUSED BY CORROSION PRODUCT AND GAS EVOLUTION
