# **SRNL EPC Installation Report**

**E-RPT-A-00005**, Revision 0

During the week of August 25<sup>th</sup>, 2021, three Electric Phenomenon Cluster (EPC) sensors were installed at the Savannah River Site (SRS) owned, Dominion Energy (DE) operated 504-2G substation, shown in the figure below.

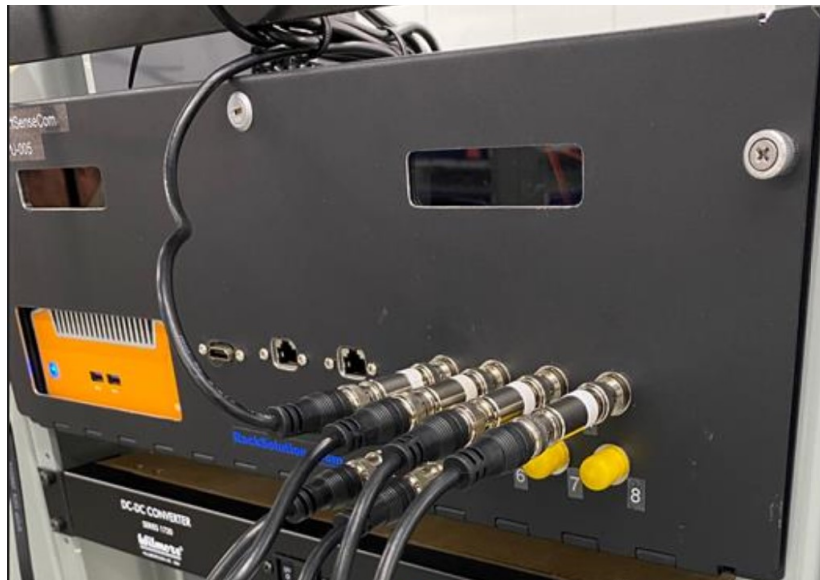
**Figure 2-3. Front Panel of OPU**

To test this theory, the cathode of the coaxial connectors going into the front face of the OPU were tested with a continuity meter to test if there is any form of appreciable electrical connection between each cathode. This test showed that there was in fact an electrical connection between the cathodes of the coaxial terminals on the front face of the OPU. This implies that each of the signal pairs on the internal circuit board have a common leg in each of the signal wire pairs. This demonstration was done in conjunction with SSC personnel, and they are currently working on a fix for the next generation of the OPU hardware.

Another minor hardware issue that was discovered in these tests was the chassis grounding of the coaxial connectors. As shown in the figure above, the coaxial ports that are used to interface with the differential output signal do not have electrical insulation between the chassis and the cathode. This essentially chassis grounded one of the signal wires in the differential pair and caused small signals to be induced on other connected coaxial connectors. This issue has been explained to SSC, and they are currently working on a fix for the next generation of the OPU hardware.

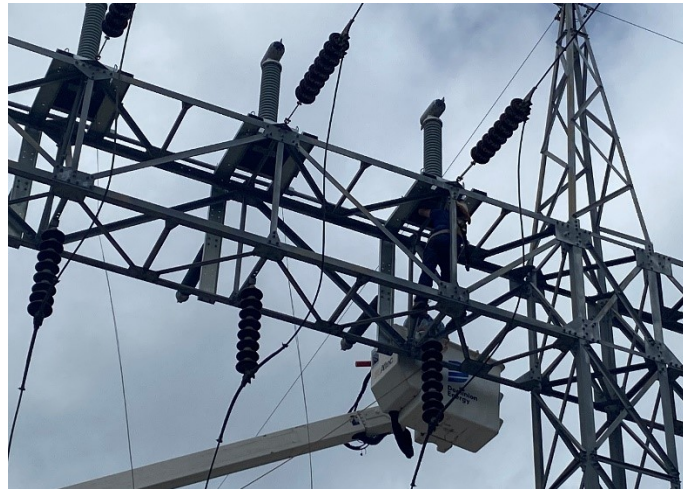
**Figure 3-1. DE Personnel Accessing EPC Interior via Bottom Face**

- It should be noted that the EPC sensors are normally meant to be installed on some form of flat pedestal, with a bottom plate covering the bottom face of the mounting box. For this installation, the EPC was mounted on a truss-based structure, which does not have a solid bottom mounting

base. This in turn left the interior of the EPC base box unsealed and exposed the interior of the EPC base box from the bottom. This is not an issue in this case due to all cables and interior components being weather rated, however in future truss-based installations, a bottom plate would be advised to ensure complete protection of the interior components of the EPC. A figure depicting DE personnel accessing the inside of the EPC base box using the unprotected bottom face is shown below.
