July 30, 2018

To: B. L. García-Díaz

From: M. J. Martínez-Rodríguez

## **Status of the Full Circumference Examination of the Inner Container Closure Weld Region for Selected 3013 DE Containers**

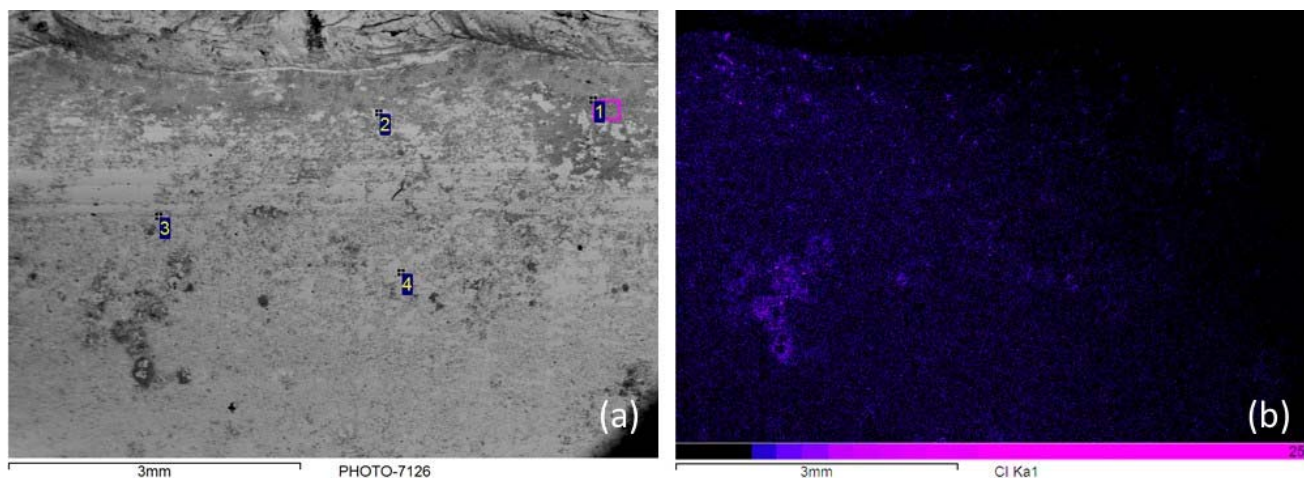
Figure 2. Surface image of Zones 1, 2 and 3 within Section C for FY15 DE07 by (a) SEM and (b) EDS map of Cl.

SEM images of a portion of the sidewall sections of these FCE container show what is most likely corrosion products on the surface. An EDS map of the chloride on the surface for each FCE container show that the amount of chlorides varies with location and that the chlorides are randomly dispersed over the surface. This is reflected on the EDS point scans at several locations which show different intensities for the chloride peak.

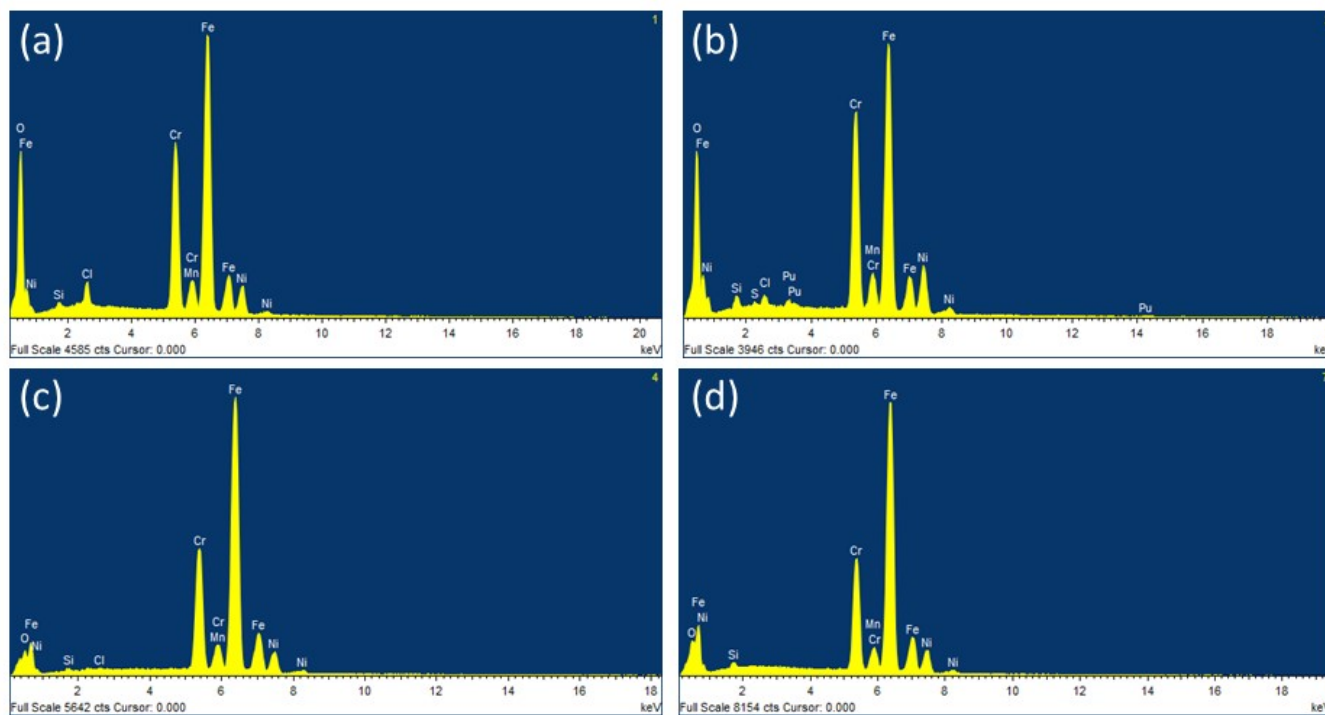
Figure 5. Selected EDS point scans for FY16 DE05 for the image shown in Figure 4(a). Points 1, 2, 4 and 7 correspond to (a), (b), (c) and (d) respectively.

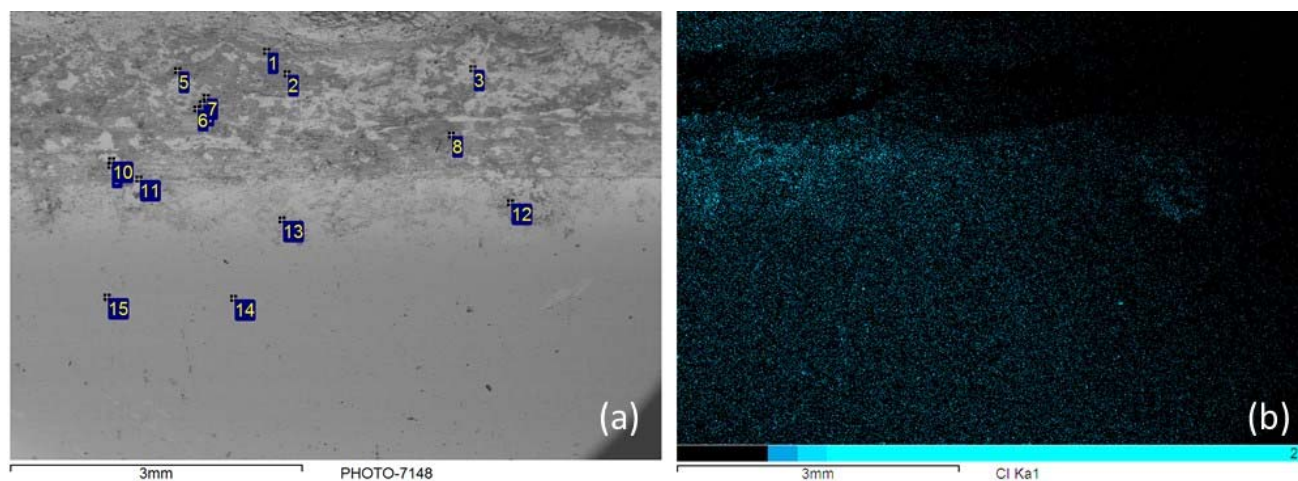
Figure 6. Surface image of Zones 1, 2 and 3 within Section A for FY15 DE08 by (a) SEM and (b) EDS map of Cl.

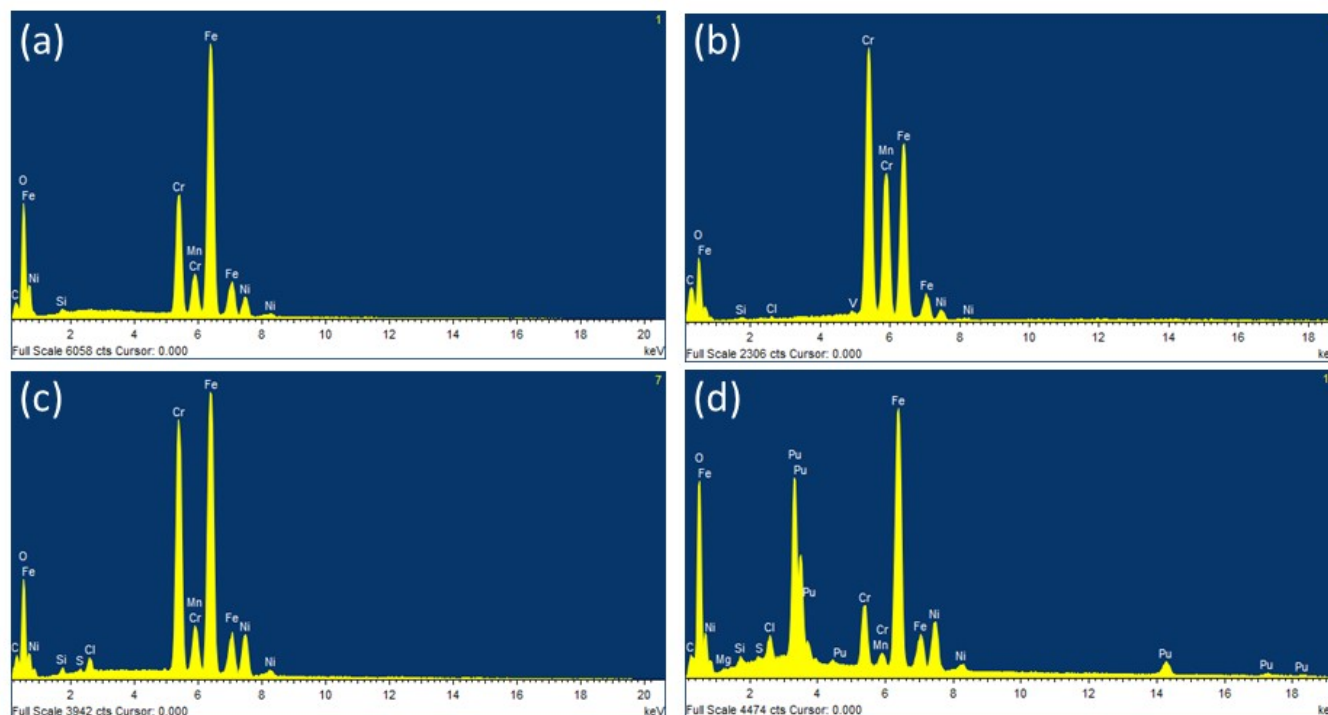
Figure 7. Selected EDS point scans for FY15 DE08 for the image shown in Figure 6(a). Points 1, 4, 7 and 11 correspond to (a), (b), (c) and (d) respectively.

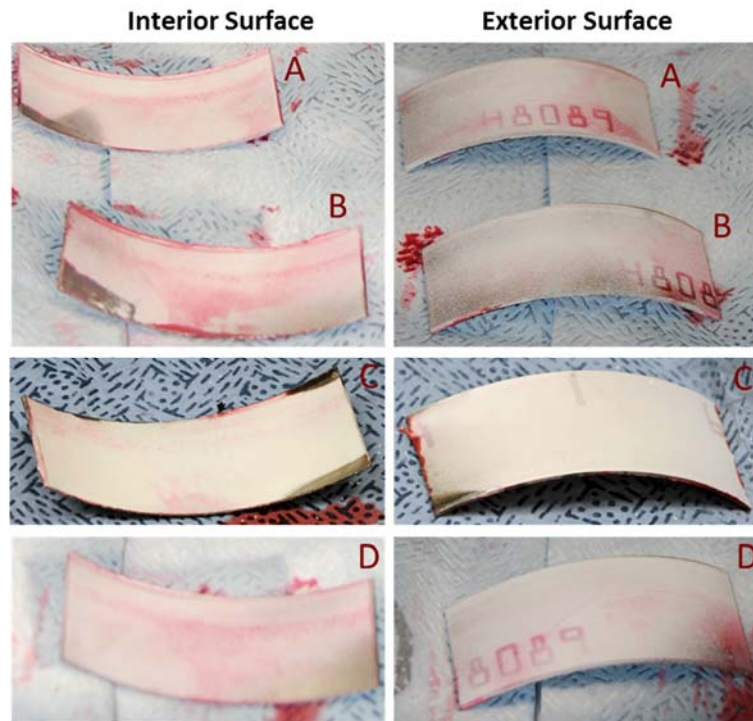
Dye penetrant examination was performed on the interior and exterior surfaces of the sidewall sections of the FCE containers. The method utilized for the dye penetrant test is described in details in reference [4]. The test was performed by a Penetrant Inspector – Level III. Figure 9 through Figure 11 show the dye penetrant test results. These examinations revealed no relevant indication of surface-breaking defects. The stain in the developer, as shown in Figure 11 for FY15 DE08 Section A, that seems to match on the interior and exterior surface, was determined to be a mark on both sides due to handling during sectioning of the inner container lid.

Figure 9. Dye penetrant test for the inside and outside surfaces of the sidewall sections of FY15 DE07.

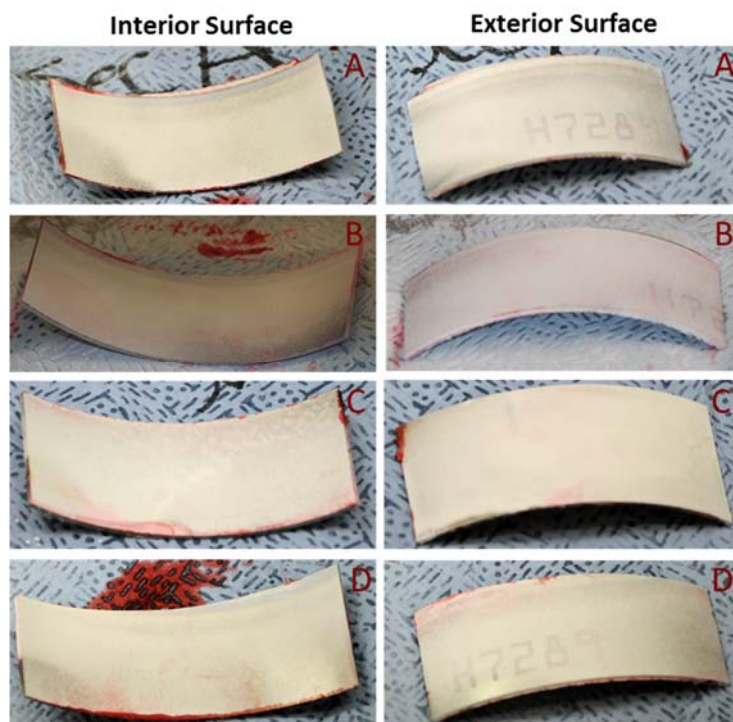
Figure 10. Dye penetrant test for the inside and outside surfaces of the sidewall sections of FY16 DE05.

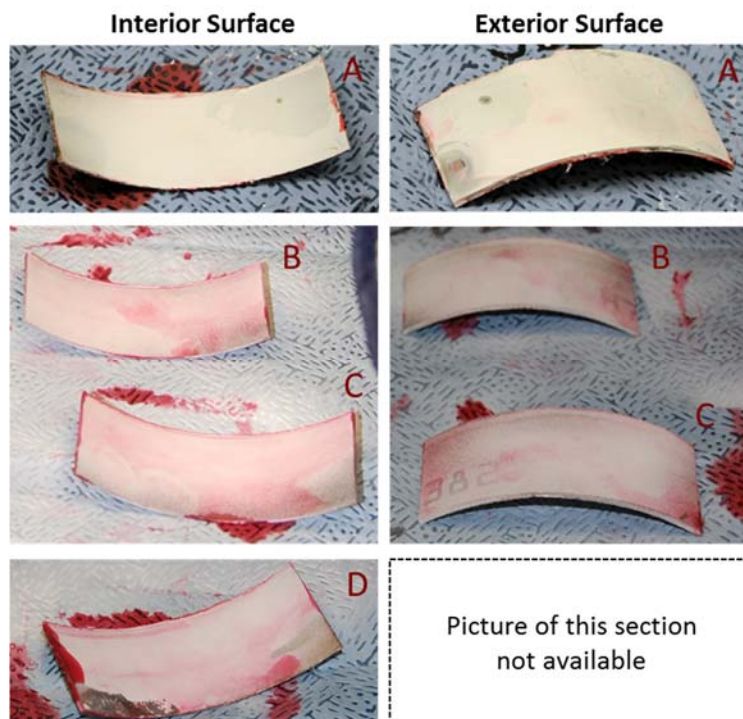
Figure 11. Dye penetrant test for the inside and outside surfaces of the sidewall sections of FY15 DE08.

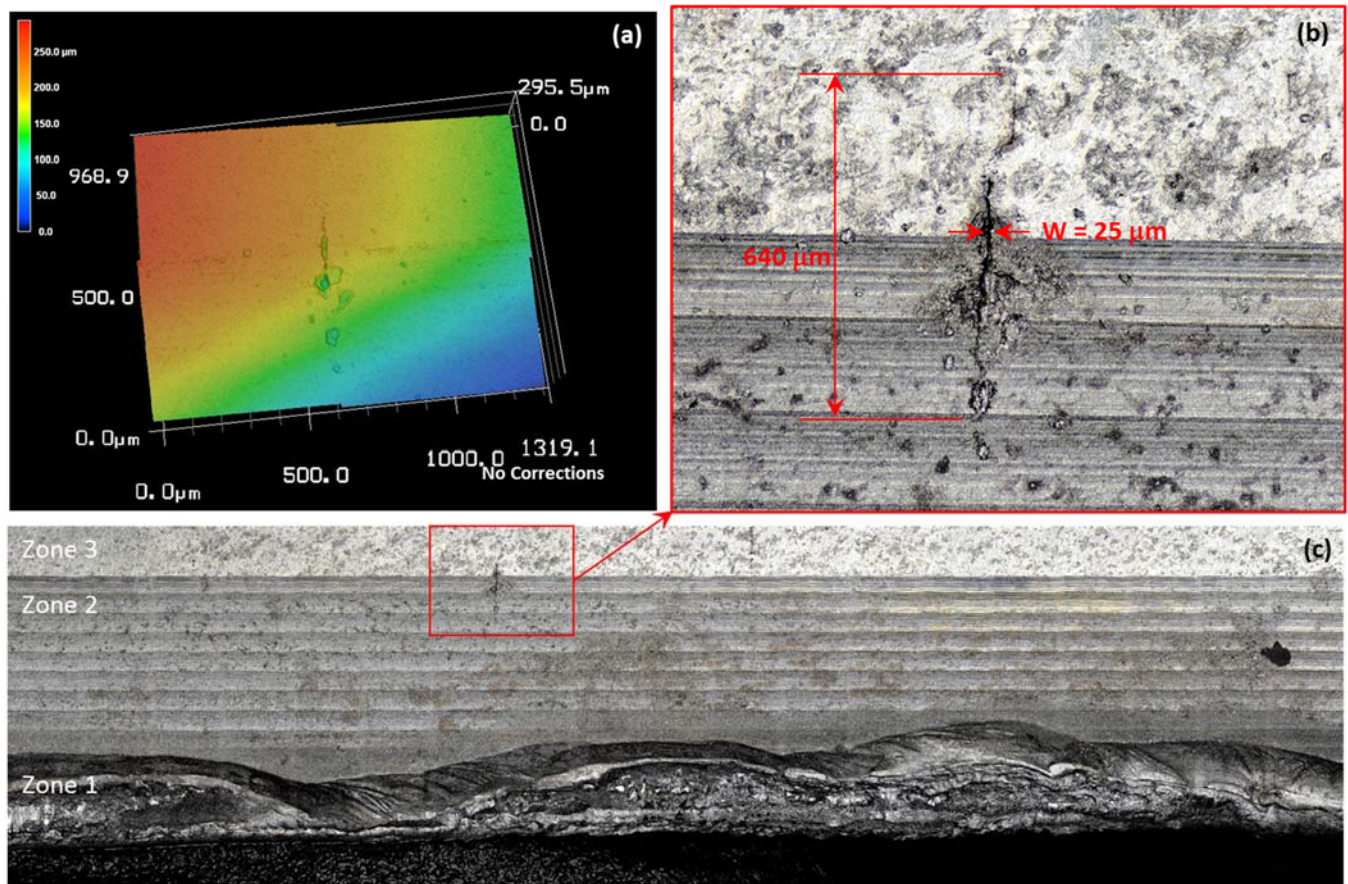
The data collected for FY15 DE07 shows general and localized corrosion on the surface. This includes noticeable surface loss from areas where the tint of the heat affected zone disappeared, rougher surface compared to the baseline container, as well as pits scattered throughout the surface or clustered in small regions. Also, two major suspect corrosion events were observed. This corresponds to one crack found in Section C1 and another found in Section C2. The crack found in Section C1 is shown in Figure 15. This crack was found at the boundary of Zone 2 and Zone 3 extending upward and downward from a large and deep pit. The vertical length of the crack that can be observed from the optical image is approximately 640  $\mu\text{m}$  with its widest opening of about 25  $\mu\text{m}$ . Height scan data shown in Figure 16 indicates that the area around the crack contains pits scattered throughout the surface. Also, the horizontal linear profile (A-B) in Figure 16(b) shows that the maximum depth of the pit that can be measured with the LCM is 66  $\mu\text{m}$ . A vertical linear profile (C-D) along the crack is shown in Figure 16(c). Various depths were measured between 20  $\mu\text{m}$  and 42  $\mu\text{m}$ . Additional LCM data will be collected at higher magnifications on the location of the crack and at the outer surface of the sample and opposite side of the crack. However, in order to determine a more accurate depth for the crack and extent of it, serial metallography and SEM/EDS analysis of sample cross-sections around the crack will be performed.

Figure 15. LCM analysis for the area of the sidewall of FY15 DE07 Section C1 where a crack was found showing (a) the top view of the 3D representation of the surface, (b) the optical image zoom of the crack shown in (c) the optical image of Zones 1 – 3.

Additional characterization will be performed on the locations where the cracks were found. LCM data will be collected at higher magnifications on the location of the cracks and at the outer surface of the sample and opposite side of the cracks. Also, in order to determine a more accurate depth and extent of the cracks, serial metallography and SEM/EDS analysis of sample cross-sections around the crack will be performed. For the analysis of the individual LCM images, a Machine Learning approach is in development and it will be utilized in the future to perform a detailed analysis of the data collected.

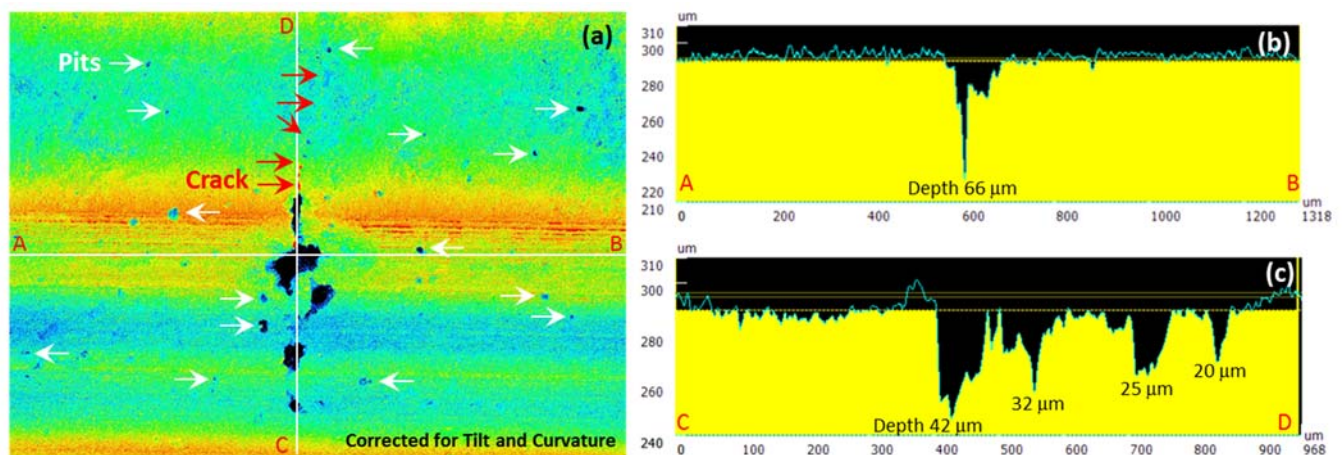
Figure 16. LCM analysis for the area of the sidewall of FY15 DE07 Section C1 where a crack was found showing (a) the height scan for the image in Figure 15(b). Increasing height is represented by transition in color from blue (lowest) to red (highest). White arrows in height scan correspond to pit locations. White lines (A-B and C-D) in height scan show positions of (b) horizontal line profile and (c) vertical line profile.

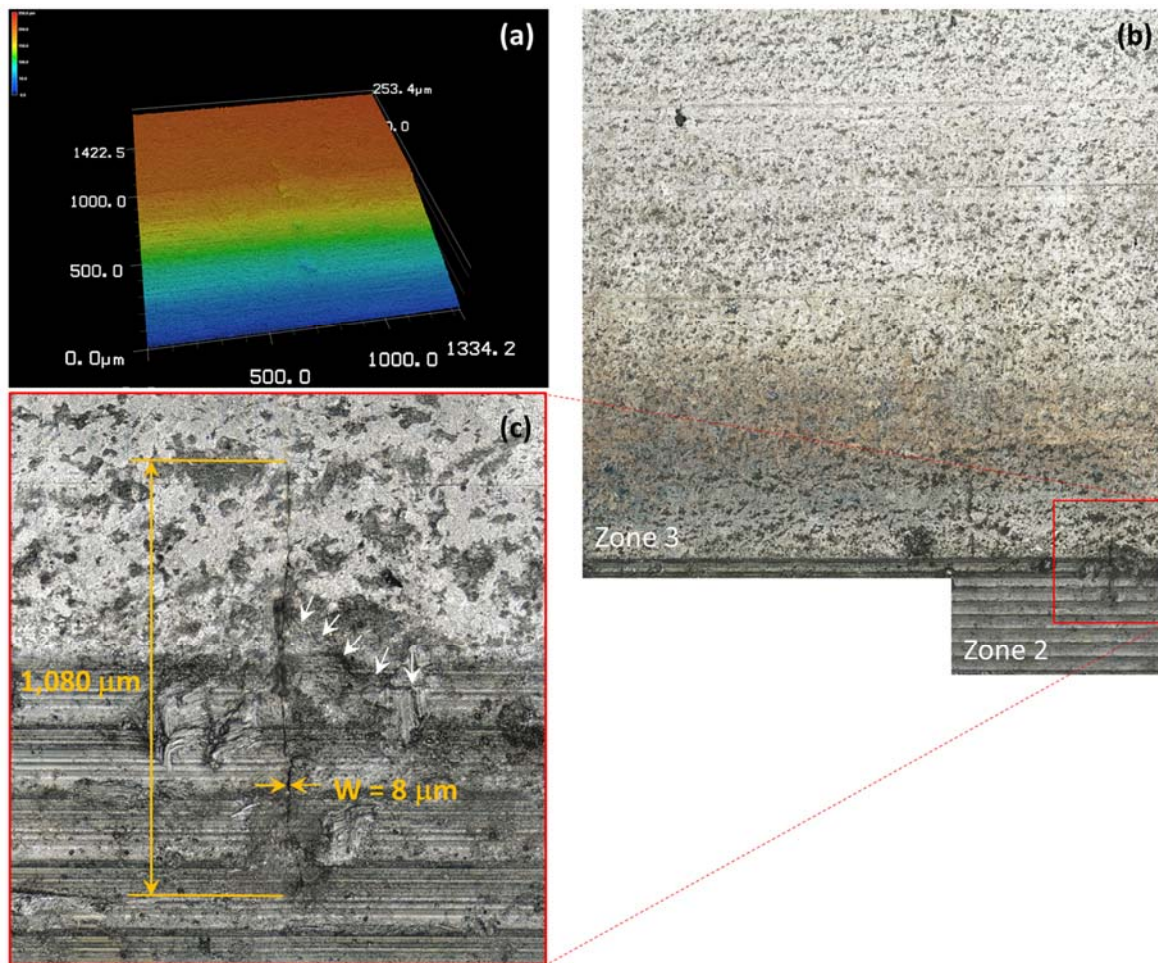
The second crack found was observed on Section C2. This crack was also found at the boundary of Zone2 and Zone 3 extending upward and downward from a large and deep pit as shown in Figure 17. The vertical length of the crack that can be observed from the optical image is approximately 1080  $\mu\text{m}$ . In addition, this crack shows indication of crack branching as pointed by the white arrows in Figure 17(c). Height scan data and linear profiles are shown in Figure 18. The horizontal linear profile (A-B) in Figure 18(b) shows that the maximum depth of the pit that can be measured with the LCM is 68  $\mu\text{m}$ . A vertical linear profile (C-D) along the crack show various depths between 18  $\mu\text{m}$  and 29  $\mu\text{m}$  as shown in Figure 18(c). Additional characterization will be performed for this crack as well.

Figure 17. LCM analysis for the area of the sidewall of FY15 DE07 Section C2 where a crack was found showing (a) the top view of the 3D representation of the surface, (b) the optical image of Zones 2 – 3 where the crack was found and (c) the optical image zoom of the crack.

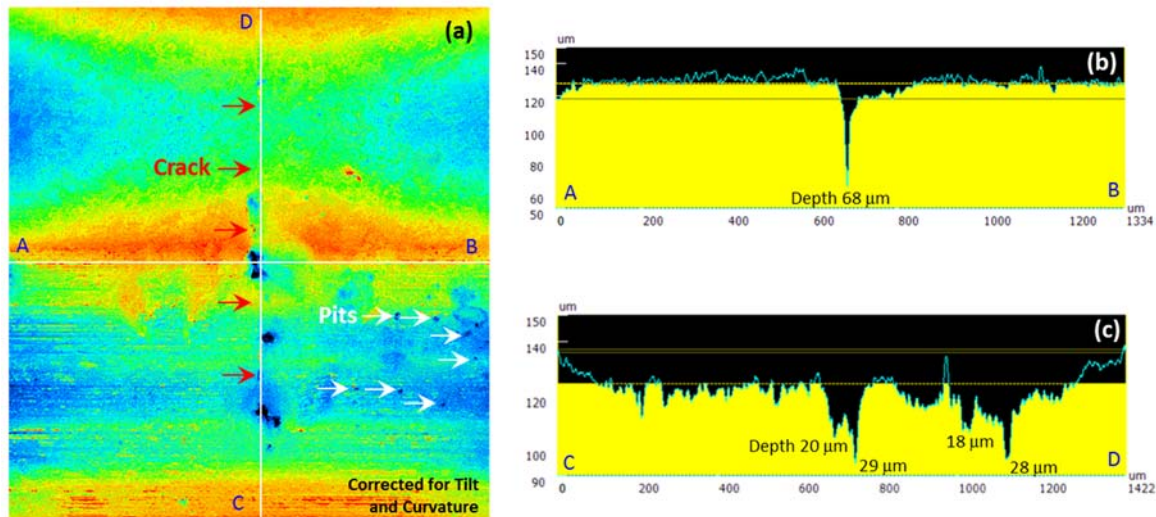
Figure 18. LCM analysis for the area of the sidewall of FY15 DE07 Section C2 where a crack was found showing (a) the height scan for the image in Figure 15(b). Increasing height is represented by transition in color from blue (lowest) to red (highest). White arrows in height scan correspond to pit locations. White lines (A-B and C-D) in height scan show positions of (b) horizontal line profile and (c) vertical line profile.

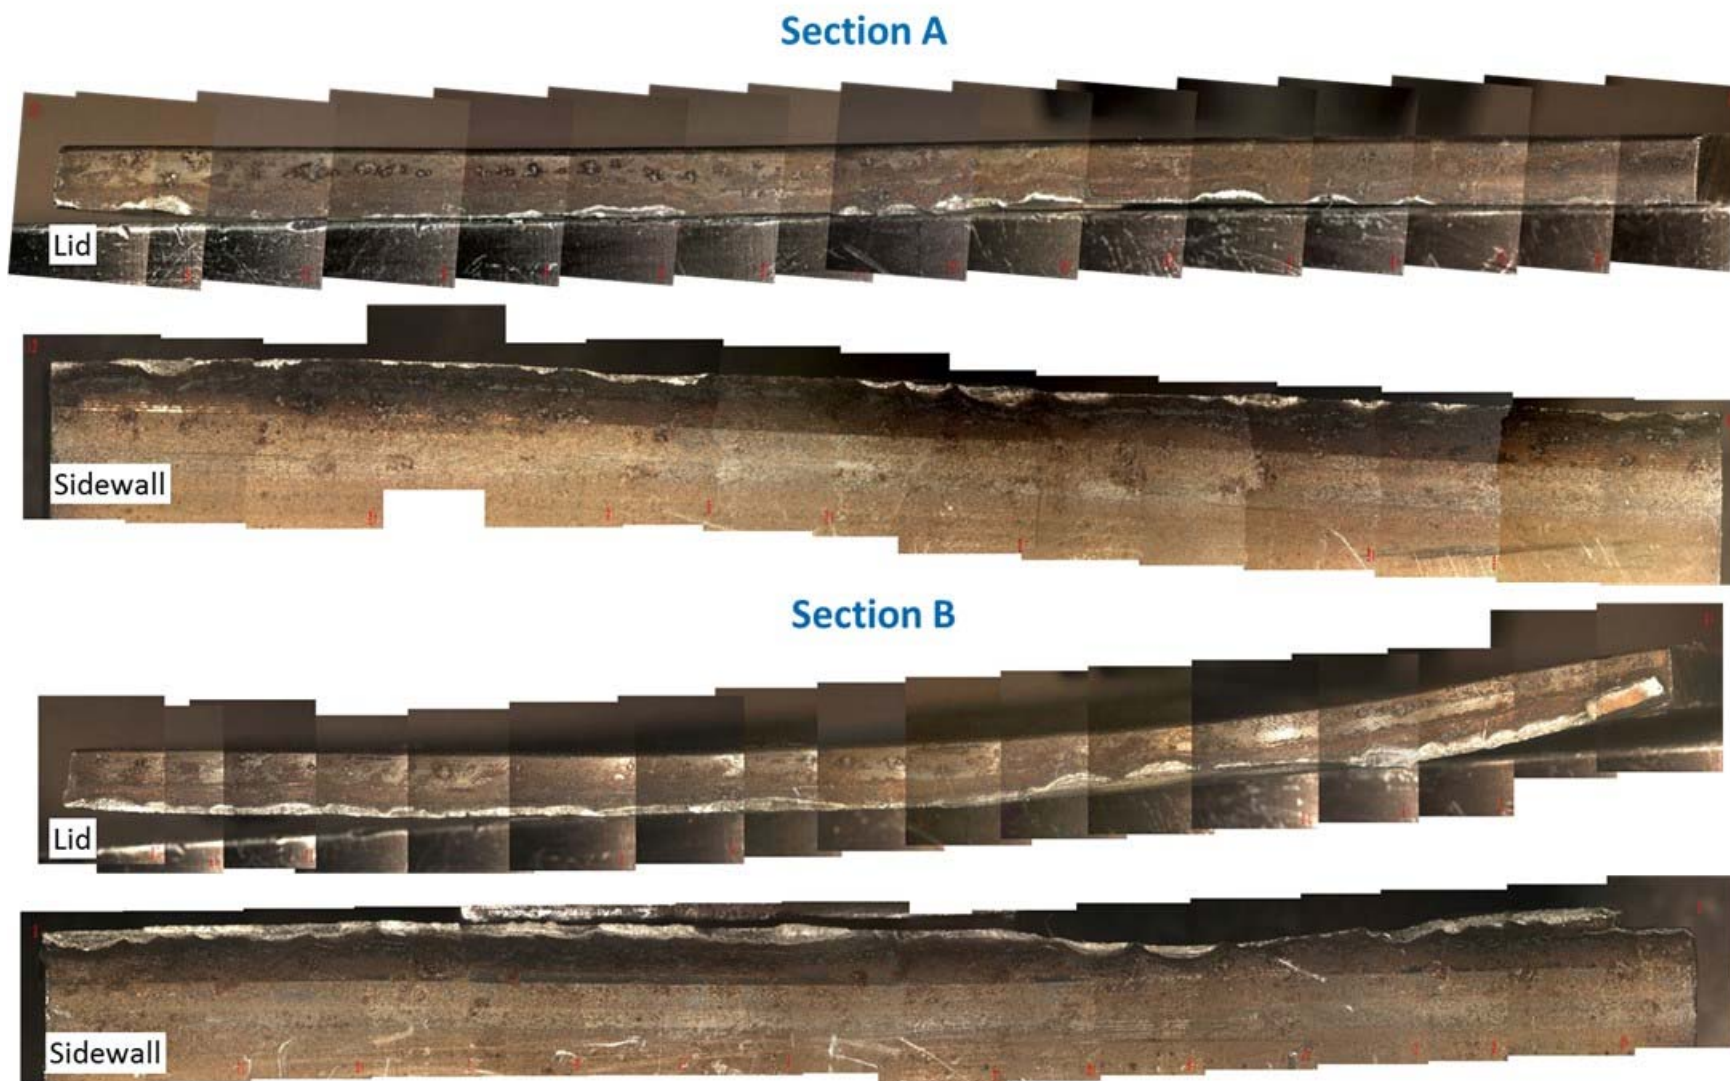
Once the weld was removed and the lid and sidewall separated, a series of images of the now accessible ICCWR were taken using the stereo microscope. These images were assembled into a panoramic view for each section lid and sidewall. These panoramic views of the ICCWR are shown in Figure A.1 through Figure A.6 for the FCE containers. Technical issues during the weld removal of FY16 DE05 Section D caused the loss of part of the ICCWR as shown in Figure A.4. It was estimated that about 6% of the ICCWR area was lost based on the 6 mm analysis in Zone 3 [6]. It was determined by the MIS Working Group that this container will still be analyzed as scheduled. All the sections show corrosion in the ICCWR.

Figure A.1. Panoramic assembly of stereomicroscope images of ICCWR for FY15 DE07 Sections A and B.

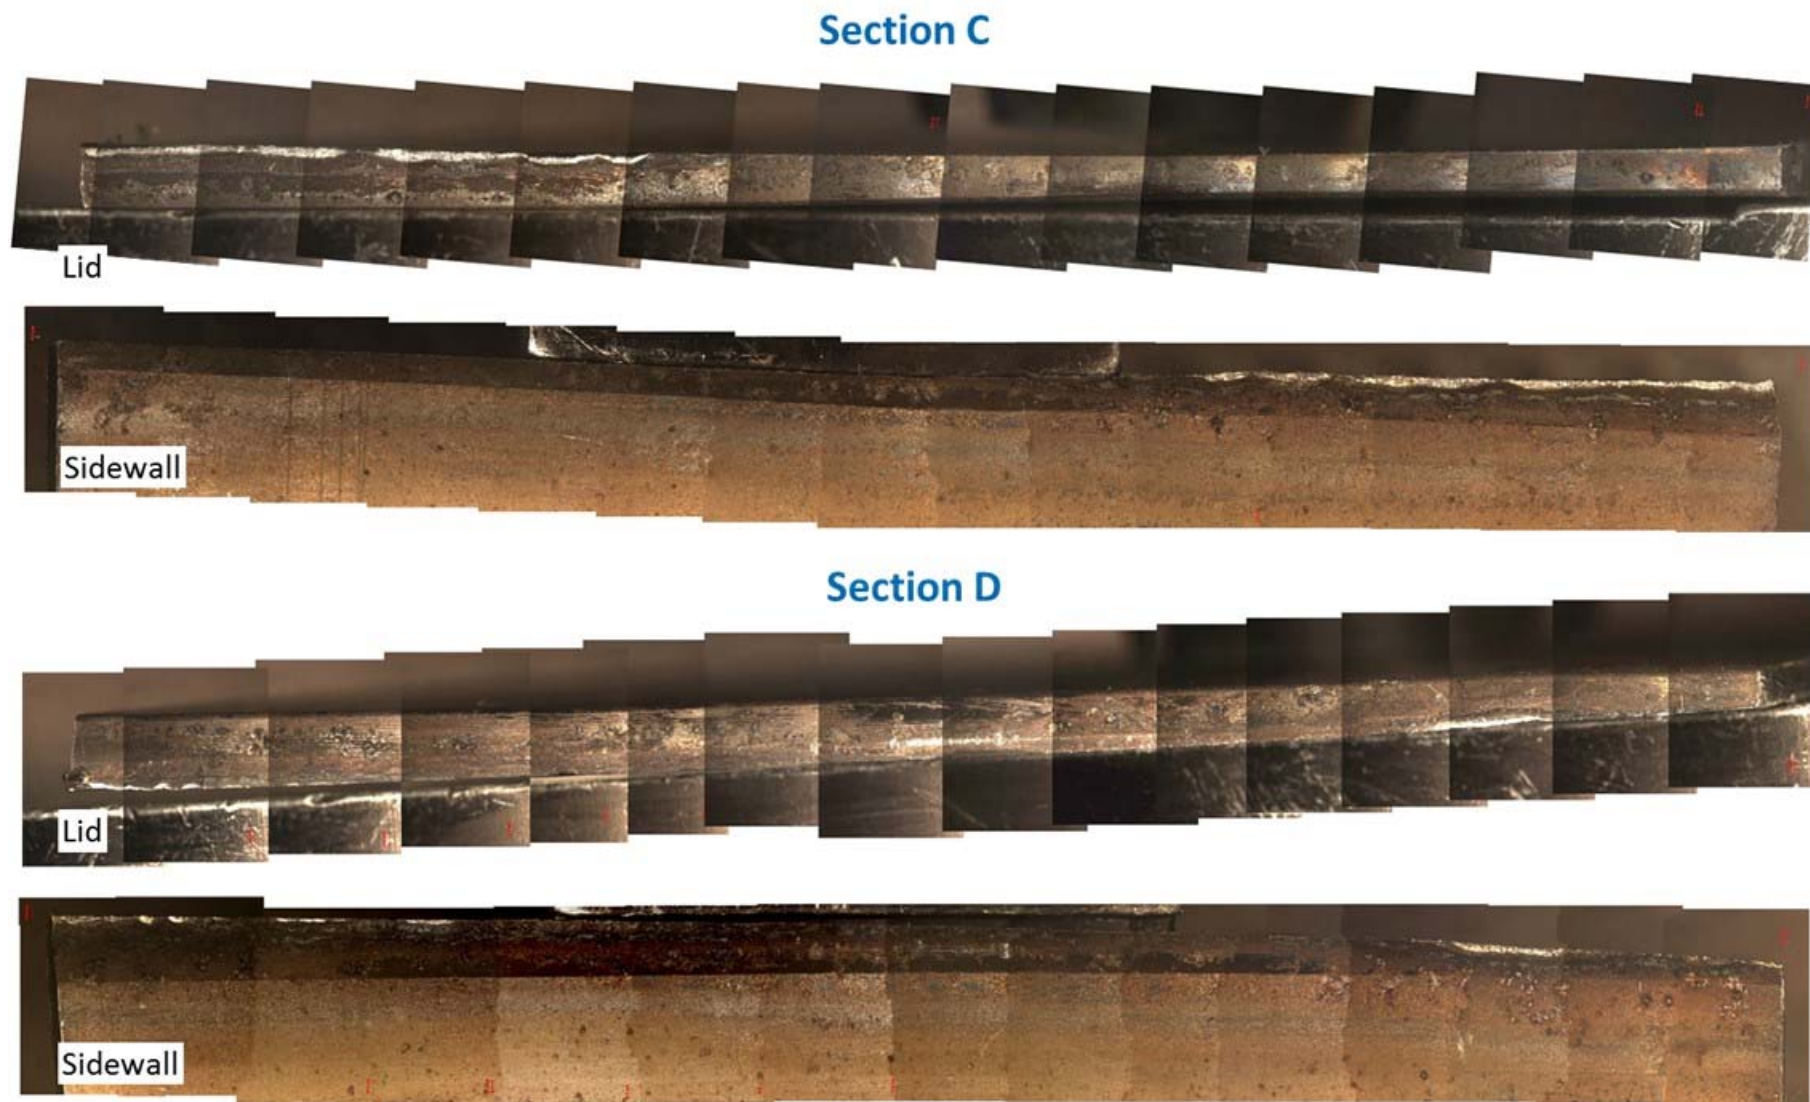
Figure A.2. Panoramic assembly of stereomicroscope images of ICCWR for FY15 DE07 Sections C and D.

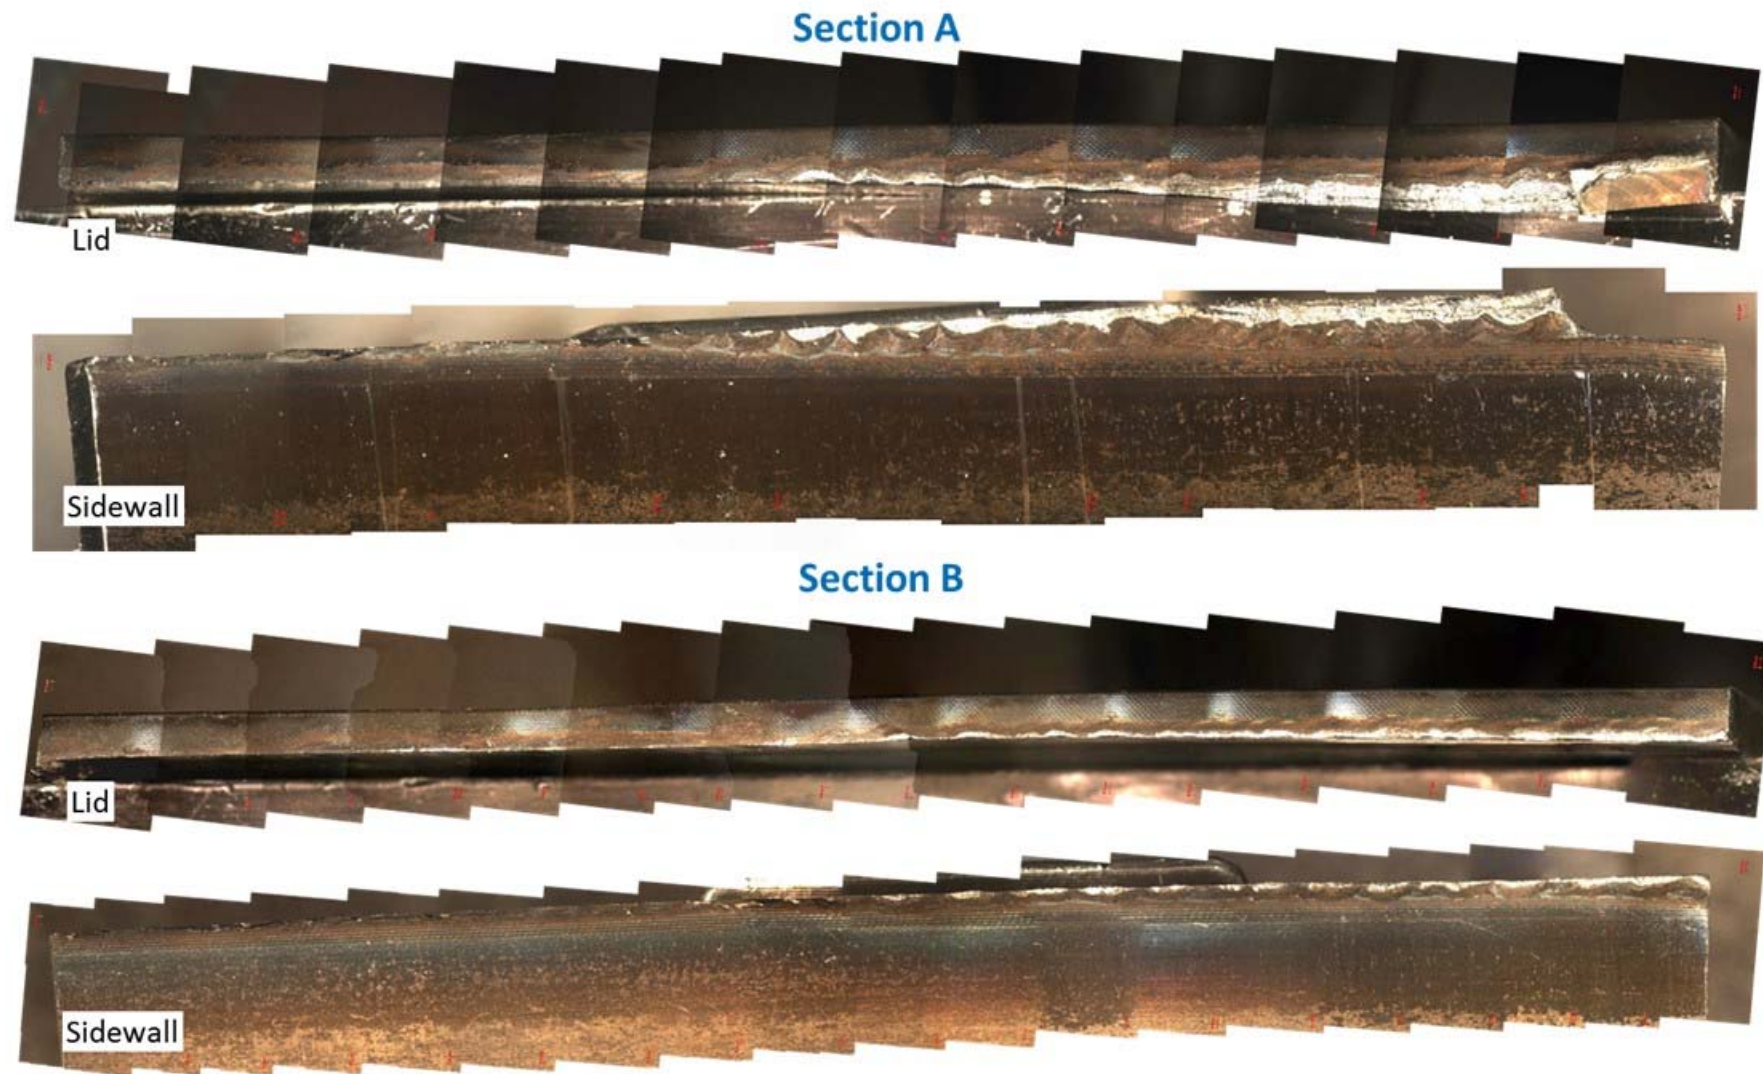
Figure A.3. Panoramic assembly of stereomicroscope images of ICCWR for FY16 DE05 Sections A and B.

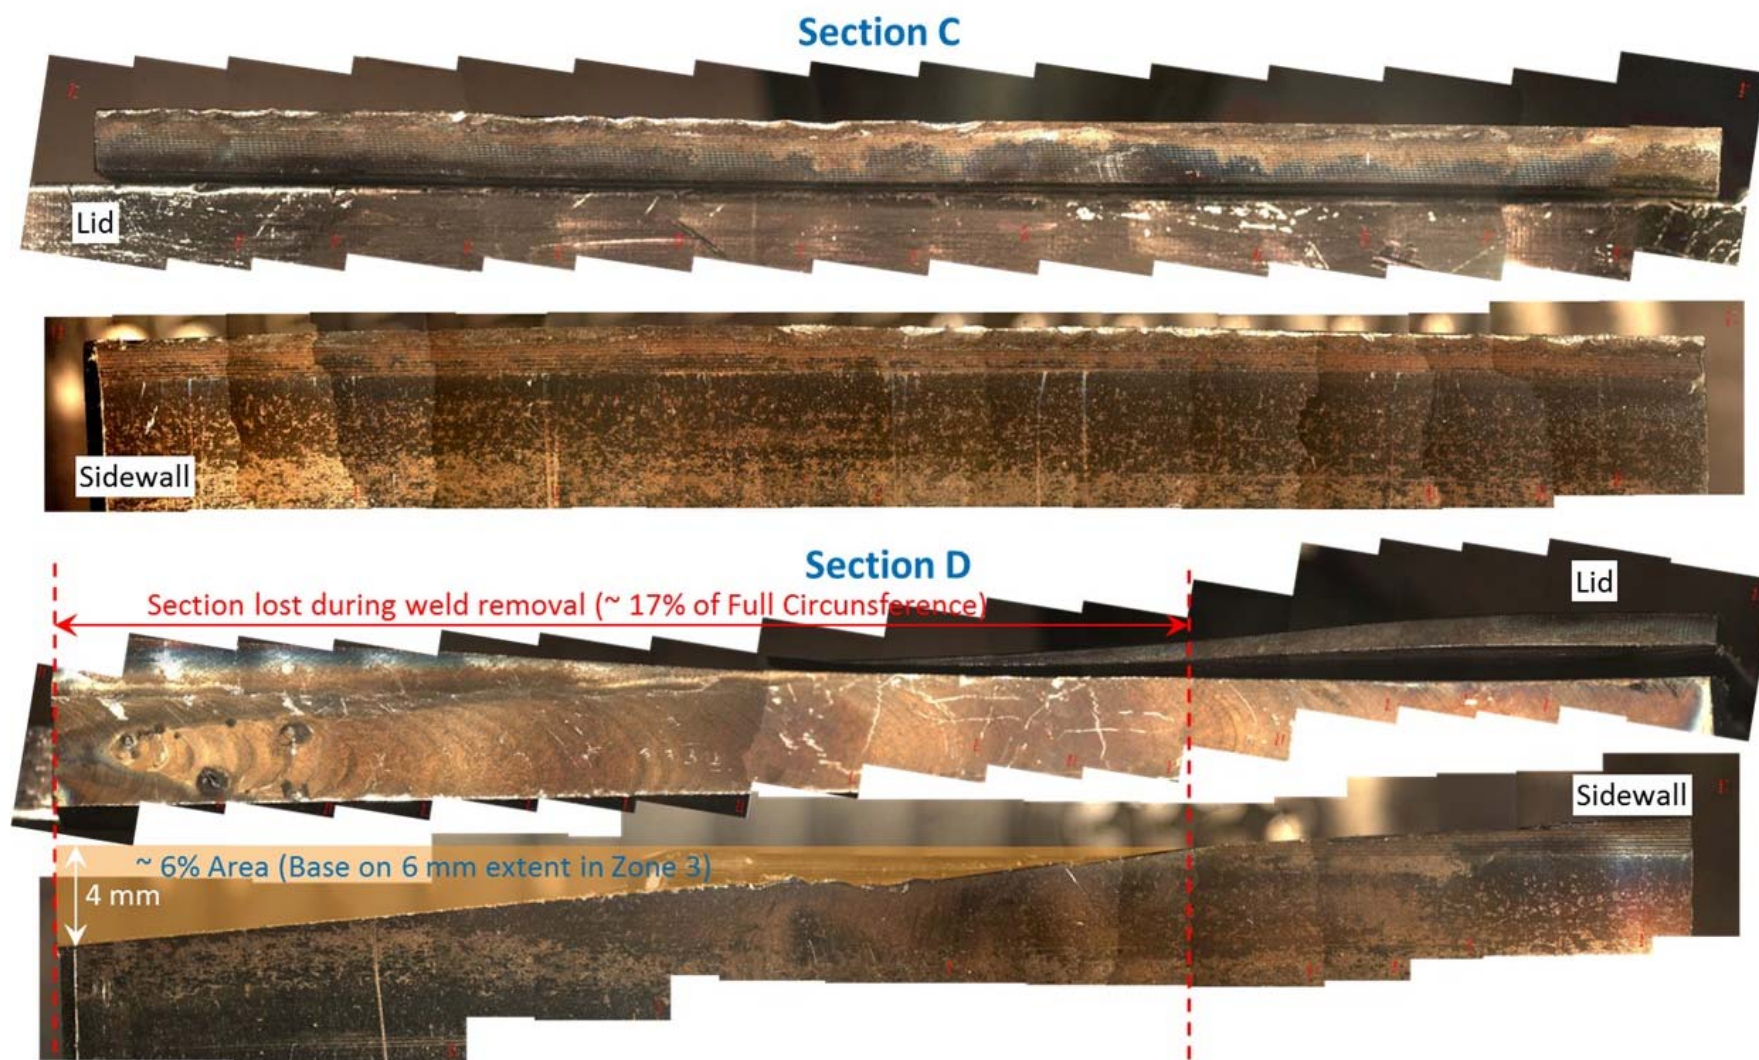
Figure A.4. Panoramic assembly of stereomicroscope images of ICCWR for FY16 DE05 Sections C and D.

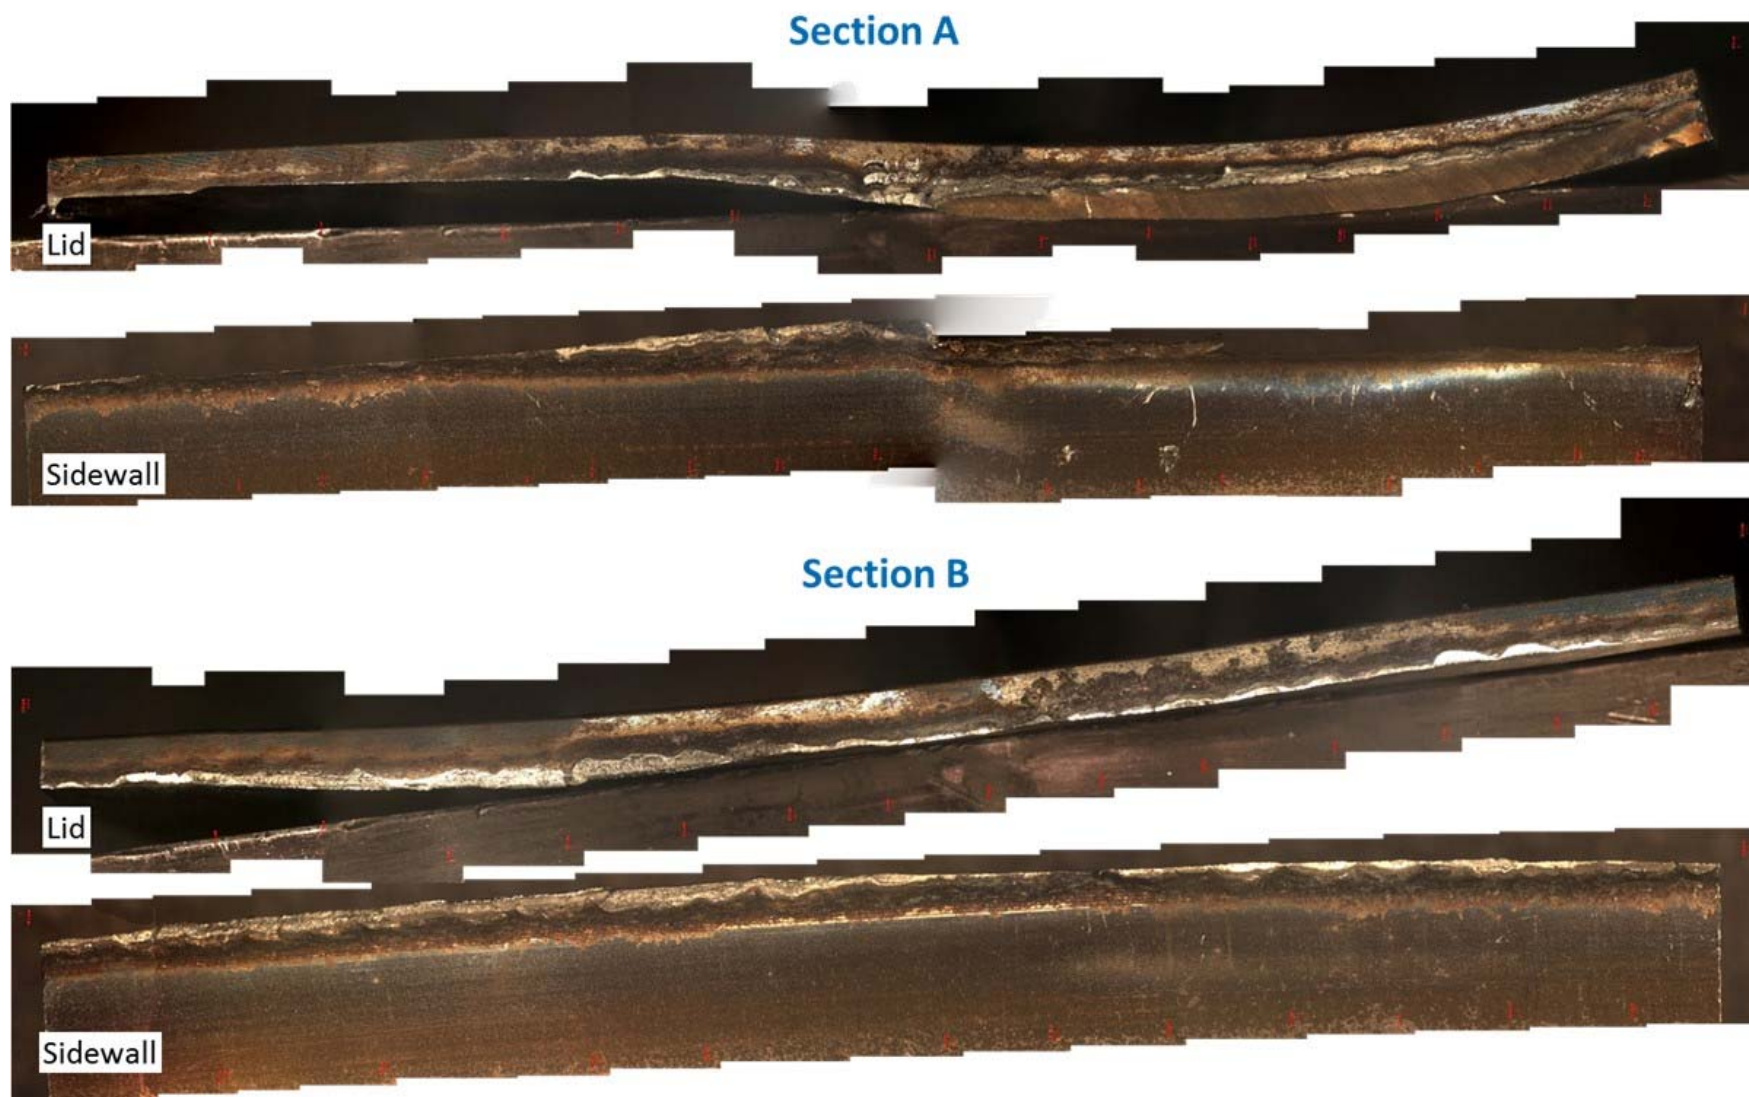
Figure A.5. Panoramic assembly of stereomicroscope images of ICCWR for FY15 DE08 Sections A and B.

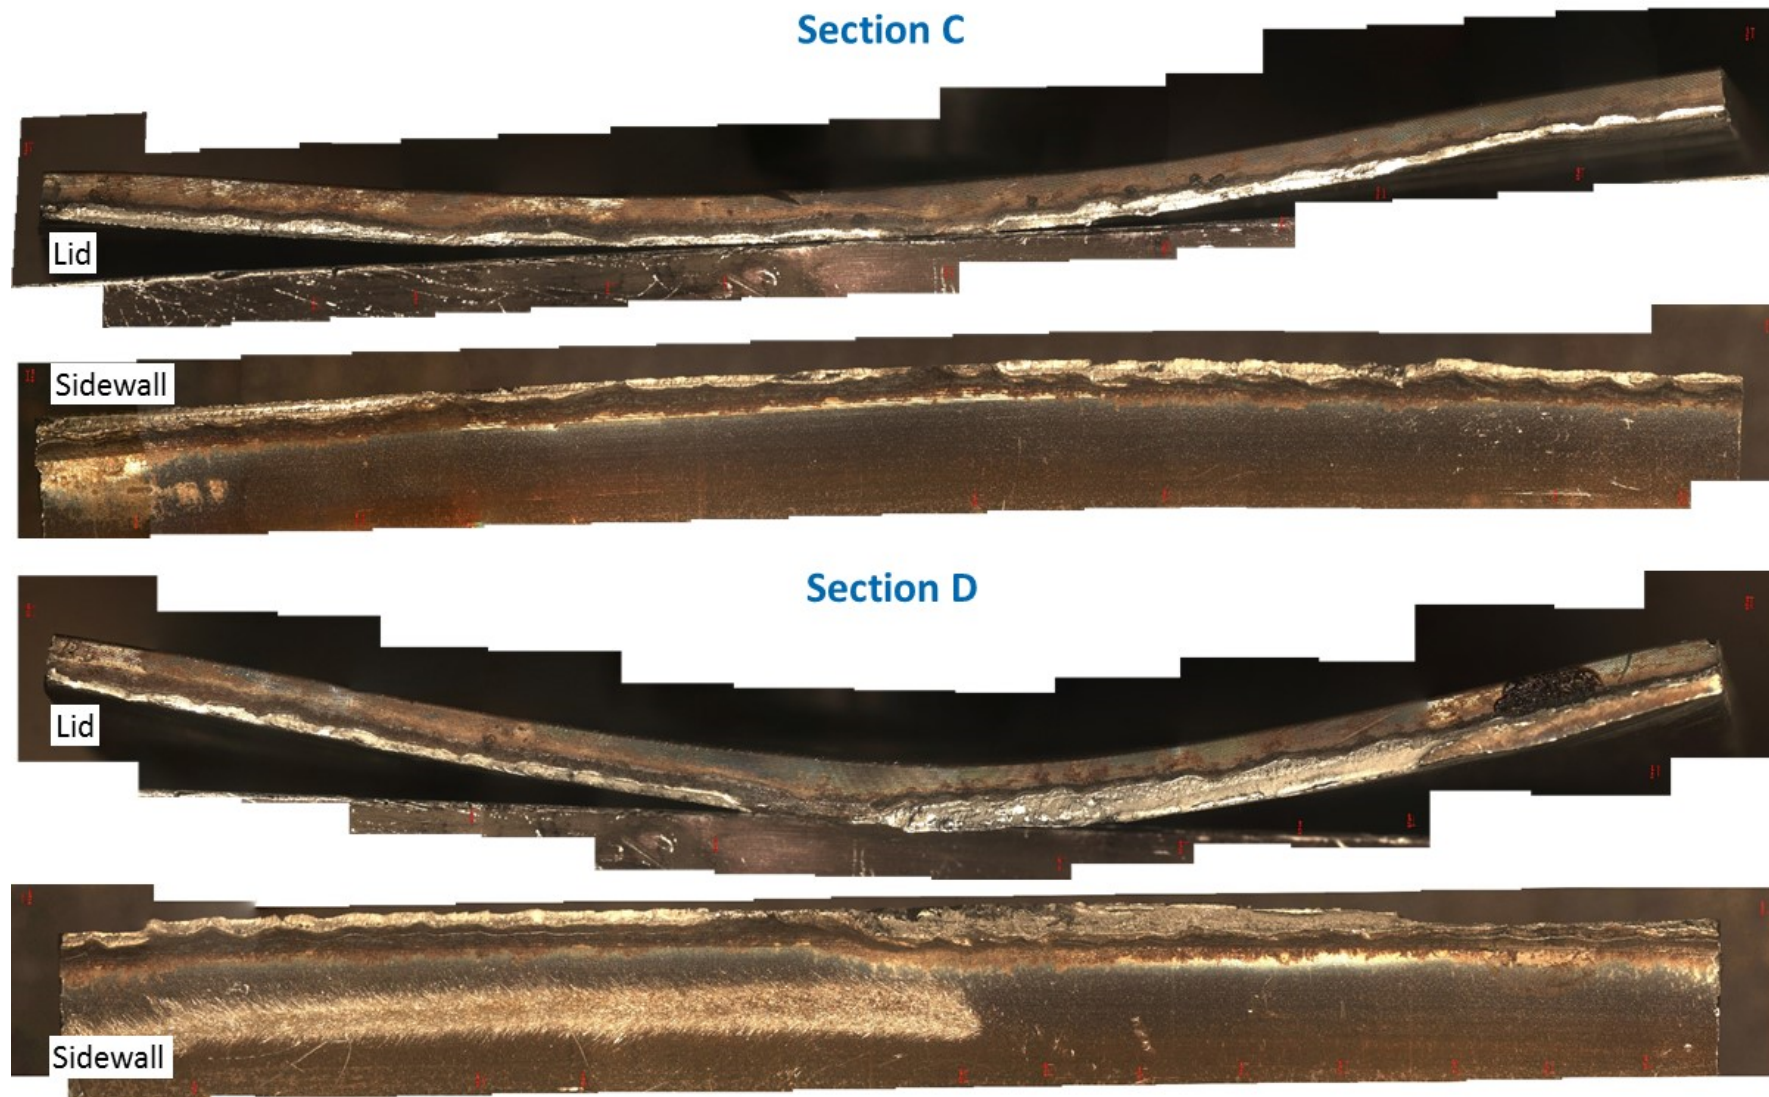
Figure A.6. Panoramic assembly of stereomicroscope images of ICCWR for FY15 DE08 Sections C and D.
