July 25, 2019

From: M. J. Martínez-Rodríguez, 773

FY19 Status of the Full Circumference Examination of the Inner Container Closure Weld Region for Selected 3013 DE Containers

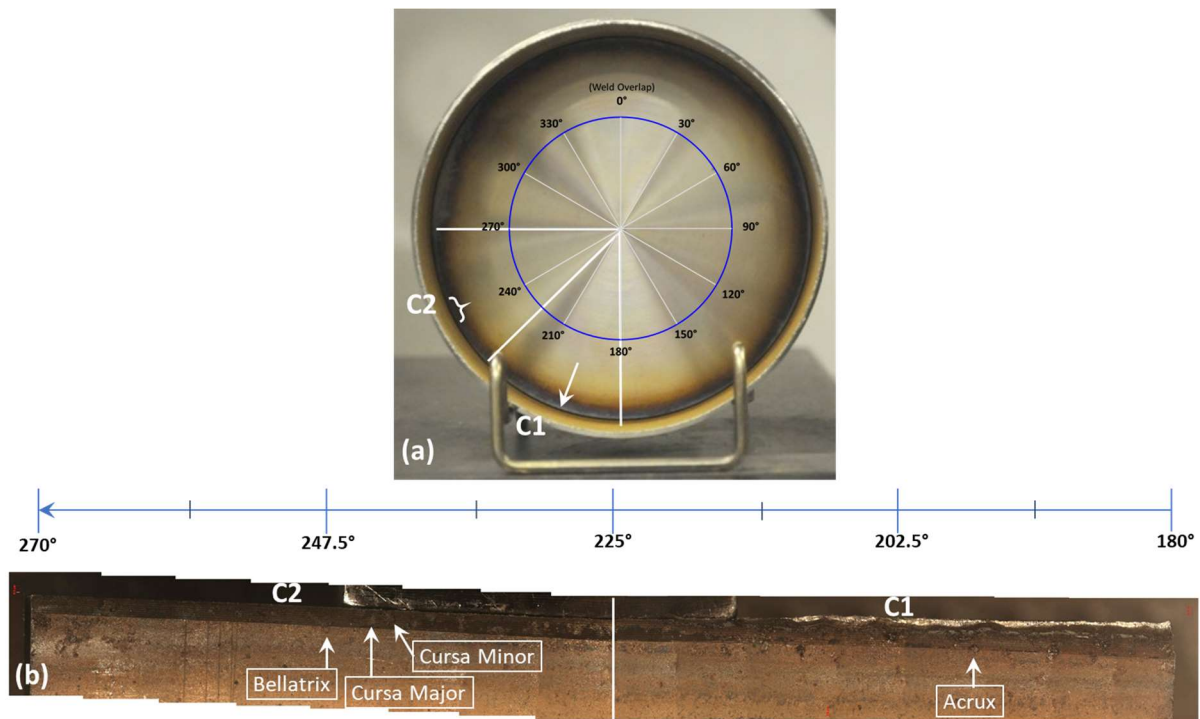
The three ICCWRs show general and localized corrosion on the surface. However, FY15 DE08 show more areas with agglomerated pits in Zones 2 and 3 than the other two DEs. The major suspect corrosion events were observed for FY15 DE07 on Sections C1 and C2 and for FY15 DE08 on Section C2. These events correspond to suspect cracks or crack-like features identified with a unique name to easily refer to each feature. FY15 DE07 shows a crack-like feature, identified as Acrux, in Section C1 and three features

in Section C2 identified as Bellatrix, Cursa Minor and Cursa Major. Acrux and Bellatrix are located at the boundary of Zone 2 and Zone 3. Cursa Minor and Cursa Major are in Zone 2. FY15 DE08 shows two crack-like features, identified as Denebola and Draco, in Section C2. Both features are located at the boundary of Zone 2 and Zone 3. However, gas analysis and statistical evaluation of the gas compositions and pressures via GEST analyses suggest that leakage between the OI and IC volumes was unlikely. Additional characterization and analysis will be performed on the locations where the cracks were found.

The data collected for FY15 DE07 shows general and localized corrosion on the surface. The major suspect corrosion events were observed on Sections C1 and C2. These events correspond to suspect cracks or crack-like features. In order to distinguish the different major features found on the ICCWR of DEs a unique name was used to easily refer to each feature. Figure 2 shows a summary of the potential crack features found on the ICCWR of FY15 DE07. The major features named Acrux in Section C1 and Bellatrix in Section C2 were described in FY18 [7]. Two additional features, Cursa Minor and Cursa Major, were found in Section C2 are shown in Figure 3. Unlike Acrux and Bellatrix, which are located at the boundary of Zone 2 and Zone 3, Cursa Minor and Cursa Major are located in Zone 2. The vertical length that can be observed from the optical image for Cursa Minor and Cursa Major is approximately 195 μm and 350 μm , respectively, as shown in Figure 3(a). Height scan data shown in Figure 3(b) indicates the presence of pits scattered throughout the surface. The horizontal linear profile (A-B) in Figure 3 (c) shows the depth of Cursa Major at the center as 17 μm and the profile (C-D) in Figure 3(d) shows the depth of Cursa Minor at the center as 34 μm . Also, a pit close to Cursa Minor shows a depth of 29 μm . However, gas analysis and statistical evaluation of the gas compositions and pressures via GEST analyses suggest that leakage between the OI and IC volumes was unlikely [8]. Sections C1 and C2 of FY15 DE07 were sent to Los Alamos National Laboratory (LANL) for characterization by X-Ray Tomography (XRT).

Figure 2. Summary of potential crack features found on the ICCWR of FY15 DE07 showing (a) the picture of the inner container lid indicating the approximate location of features and (b) the corresponding panoramic assemblies of stereomicroscope images indicating the location of the features. Note that the panoramic assemblies are oriented such that the weld is above Zone 2

Additional characterization will be performed on the locations where the crack-like features were found. Sections C1 and C2 of FY15 DE07 were sent to LANL for characterization by XRT. Section C2 of FY16 DE05 will be examined by serial metallography at SRNL for characterization of the cross-sections by SEM. LANL and the University of South Carolina (USC) are working on methods for the analysis of the individual LCM images.

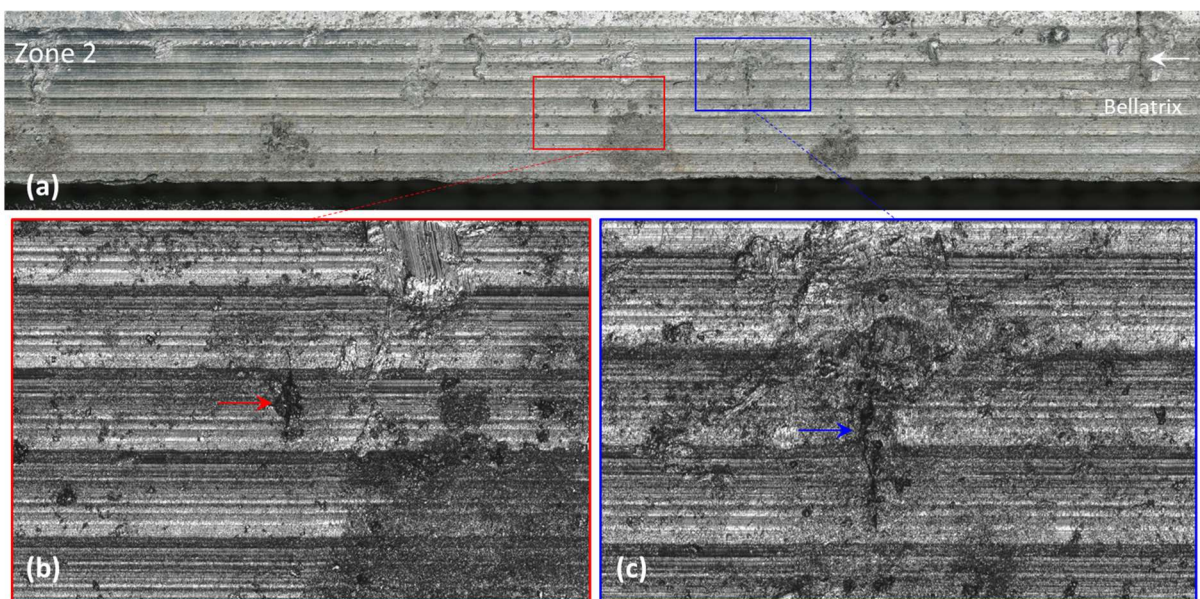
Figure 3. LCM optical images of the ICCWR of FY15 DE07 Section C2 showing (a) a portion of Zone 2 where the potential crack features are located, (b) a zoom of the region where Cursa Minor is located and (c) a zoom of the region where Cursa Major is located. Note that the picture is oriented such that the weld is below Zone 2.

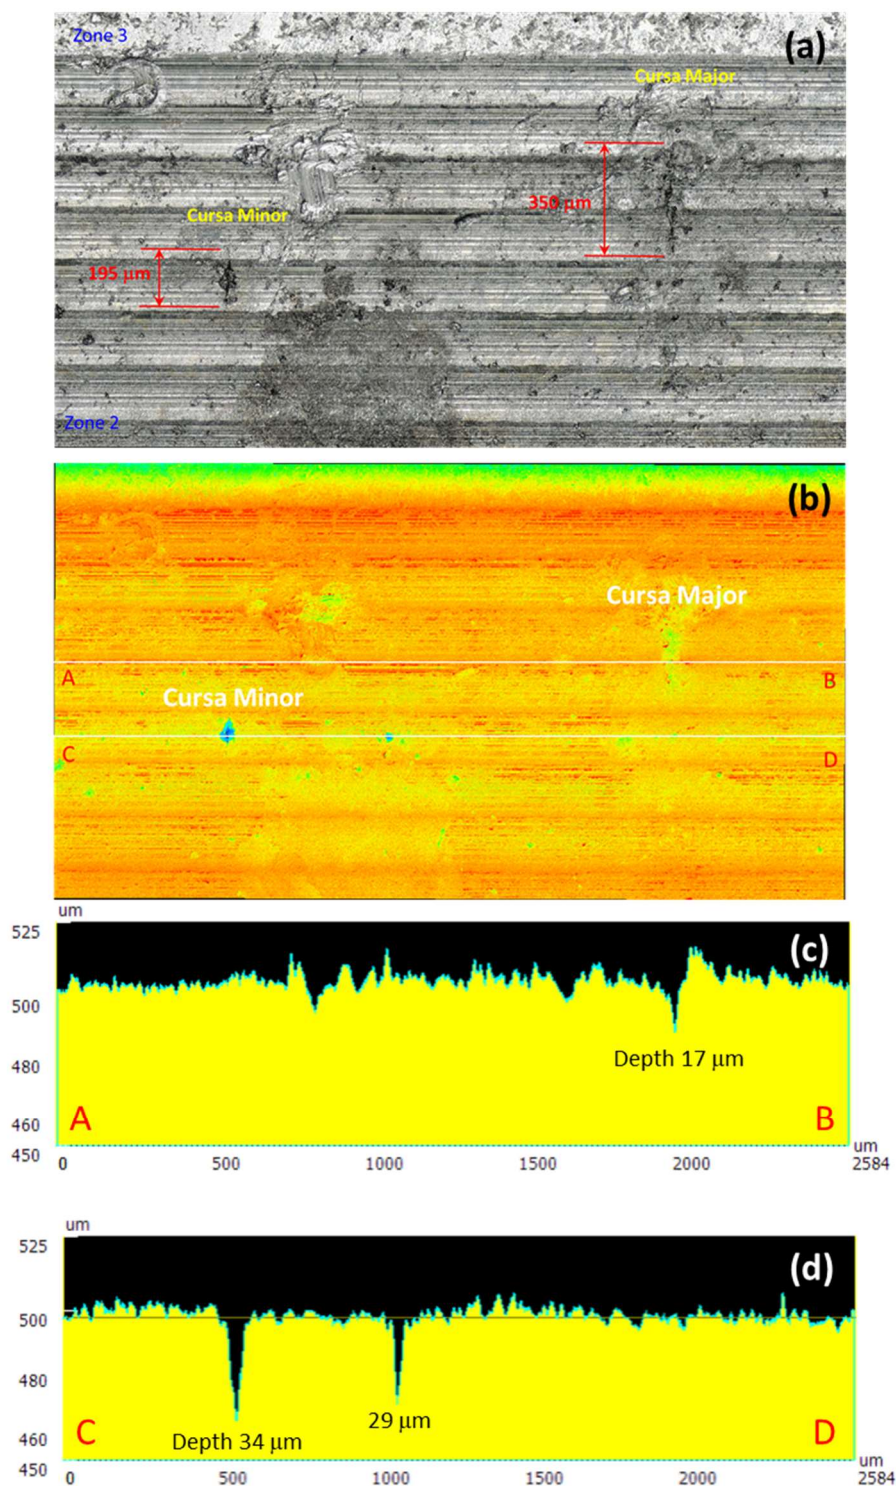
Figure 4. LCM analysis for the area of the sidewall of FY15 DE07 Section C2 where Cursa Minor and Cursa Major are located showing (a) the optical image and (b) the height scan. Increasing height is represented by transition in color from blue (lowest) to red (highest). White lines (A-B and C-D) in the height scan show positions of (c) horizontal line profile across Cursa Major and (d) horizontal line profile across Cursa Minor.

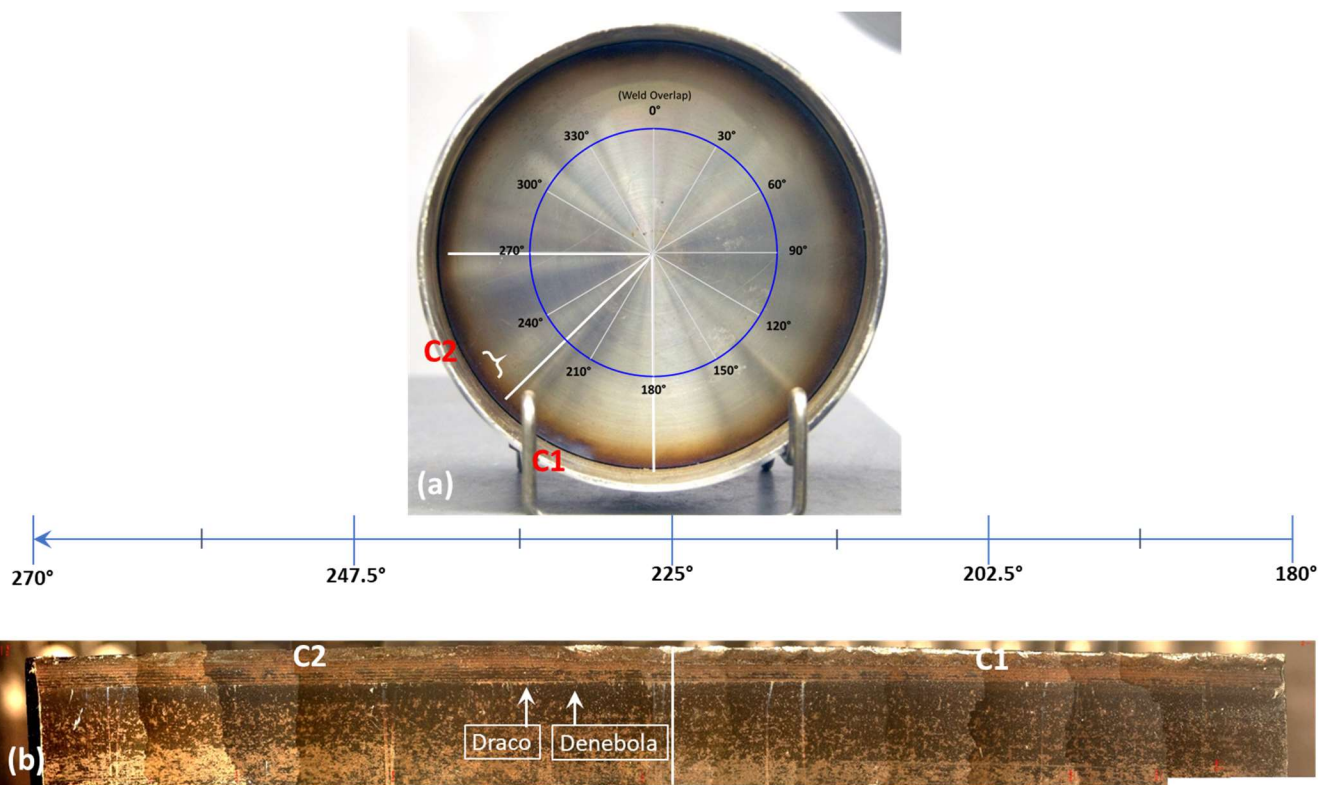
The data collected for FY16 DE05 shows general and localized corrosion on the surface. The major suspect corrosion events were observed on Section C2, which show two crack-like features. These two major features, Draco and Denebola, are indicated in Figure 5. Both features are located at the boundary of Zone 2 and Zone 3 as shown in Figure 6, While Denebola appears to be a large crack-like feature, Draco is a small feature that seems to be composed of several interconnected pits. Further examination will be required to determine if a crack has been developed. The length that can be observed from the optical image for Denebola is approximately 130 μm with its widest opening of about 10 μm , as shown in Figure 7(a). The height scan data is shown in Figure 7(b) with the horizontal linear profile (A-B) in Figure 7(c) and the vertical profile (C-D) in Figure 7(d) crossing Denebola around the region where it is deepest. Both profiles show the depth of Denebola at the center as 20 μm . However, gas analysis and statistical evaluation of the gas compositions and pressures via GEST analyses suggest that leakage between the OI and IC volumes was unlikely [8]. Section C2 of FY16 DE05 will be examined by serial metallography at SRNL for characterization of the cross-sections by SEM.

Figure 5. Summary of potential crack features found on the ICCWR of FY16 DE05 showing (a) the picture of the inner container lid indicating the approximate location of features and (b) the corresponding panoramic assemblies of stereomicroscope images indicating the location of the features. Note that the panoramic assemblies are oriented such that the weld is above Zone 2

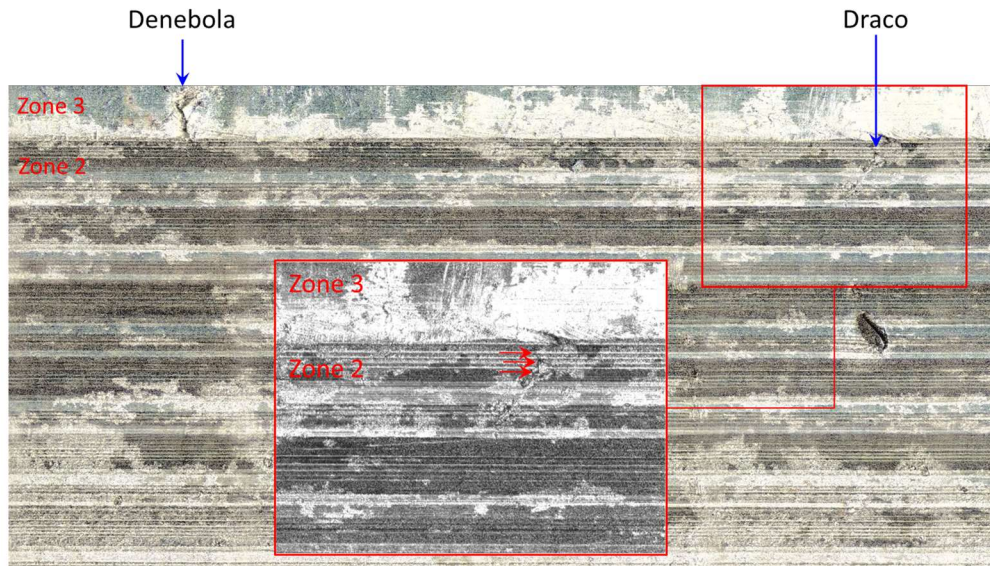
Figure 6. LCM optical images of the ICCWR of FY16 DE05 Section C2 showing a portion of Zones 2 and 3 where the potential crack features are located. The insert window shows a zoom of the region where Draco is located. Note that the picture is oriented such that the weld is below Zone 2.

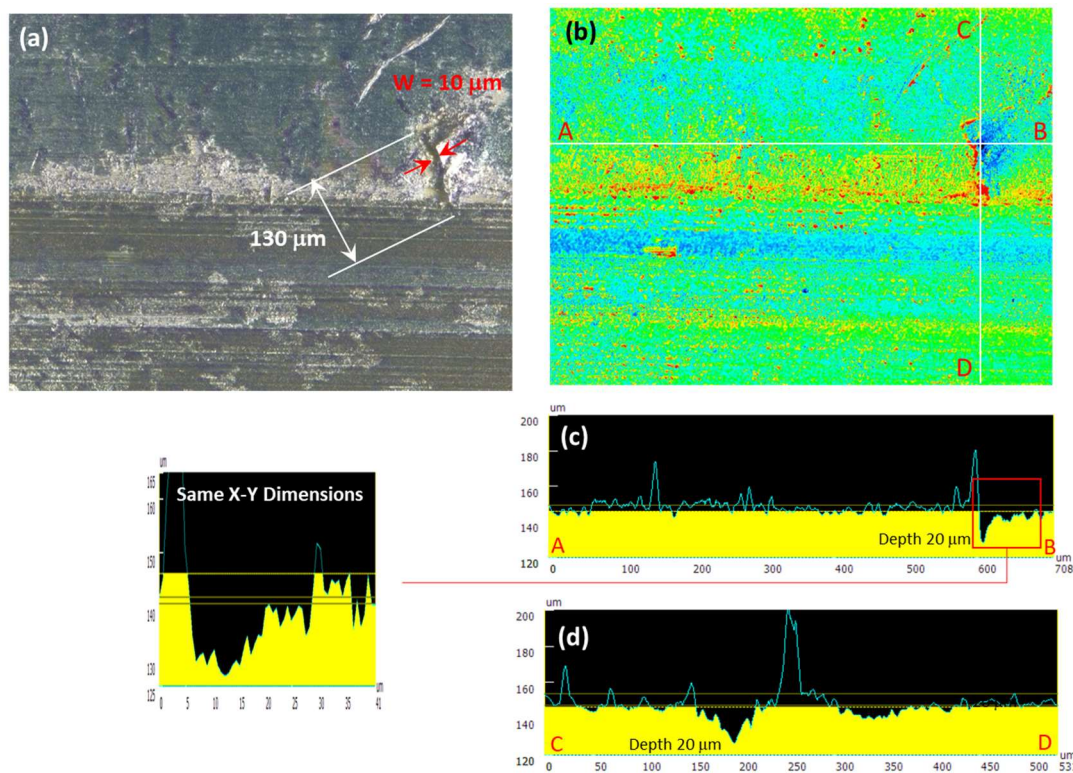
Figure 7. LCM analysis for the area of the sidewall of FY16 DE05 Section C2 where Denebola is located showing (a) the optical image and (b) the height scan. Increasing height is represented by transition in color from blue (lowest) to red (highest). White lines (A-B and C-D) in the height scan show positions of (c) horizontal line profile and (d) vertical line profile.

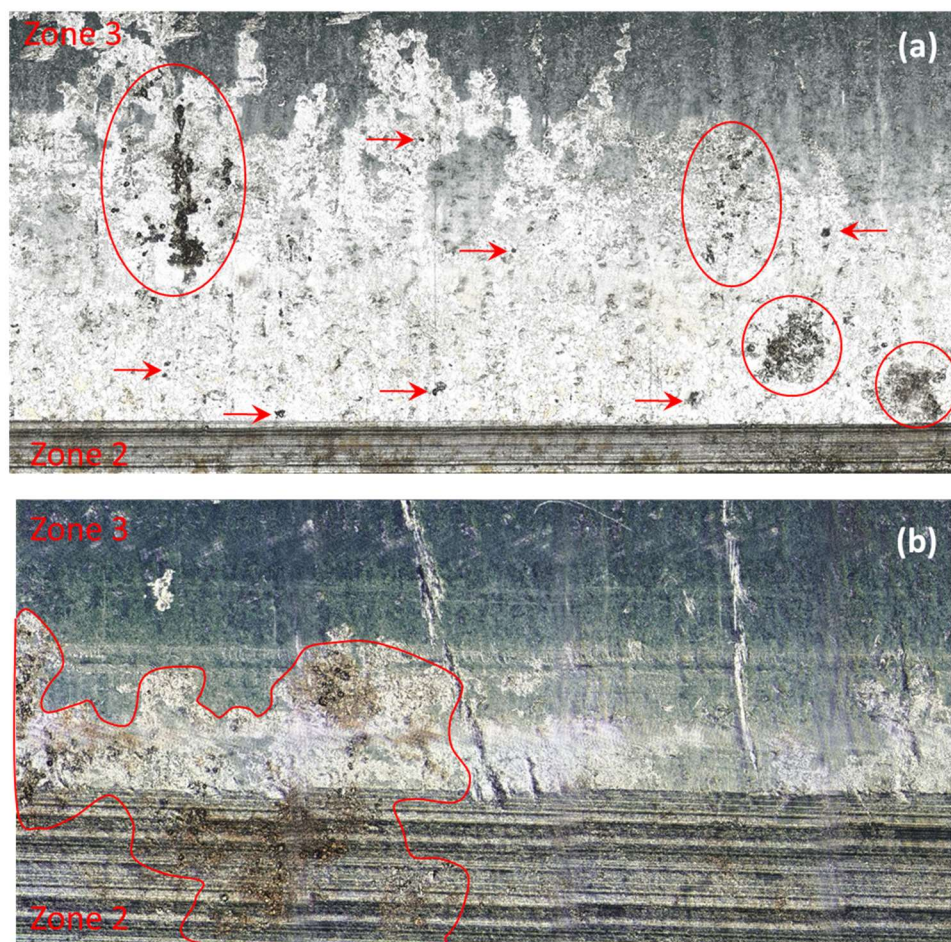
The data collected for FY15 DE08 shows general and localized corrosion on the surface. Although no major suspect corrosion events were observed by LCM on this DE, the ICCWR is characterized by significant number of agglomerated pits as shown in Figure 8. Unlike, FY15 DE07 and FY16 DE05, agglomerated pits were found at a larger extent on Zones 2 and 3. Figure 9 shows the panoramic assembly of Section B1 before cleaning where it can be observe corrosion products along the weld. After the sample was cleaned for LCM analysis it can be observe the pitting agglomeration close to the weld on Zone 2. Although not a corrosion event, FY15 DE08 is also characterized, at a larger extent than the other two ICCWRs, by dent and scratches on the surface as it can be seen in Figure 8(b).

Figure 8. LCM optical images of the ICCWR of FY15 DE08 showing portions of Zones 2 and 3 with pits agglomeration as indicated by the red enclosures on (a) Section A2 and (b) Section B1.

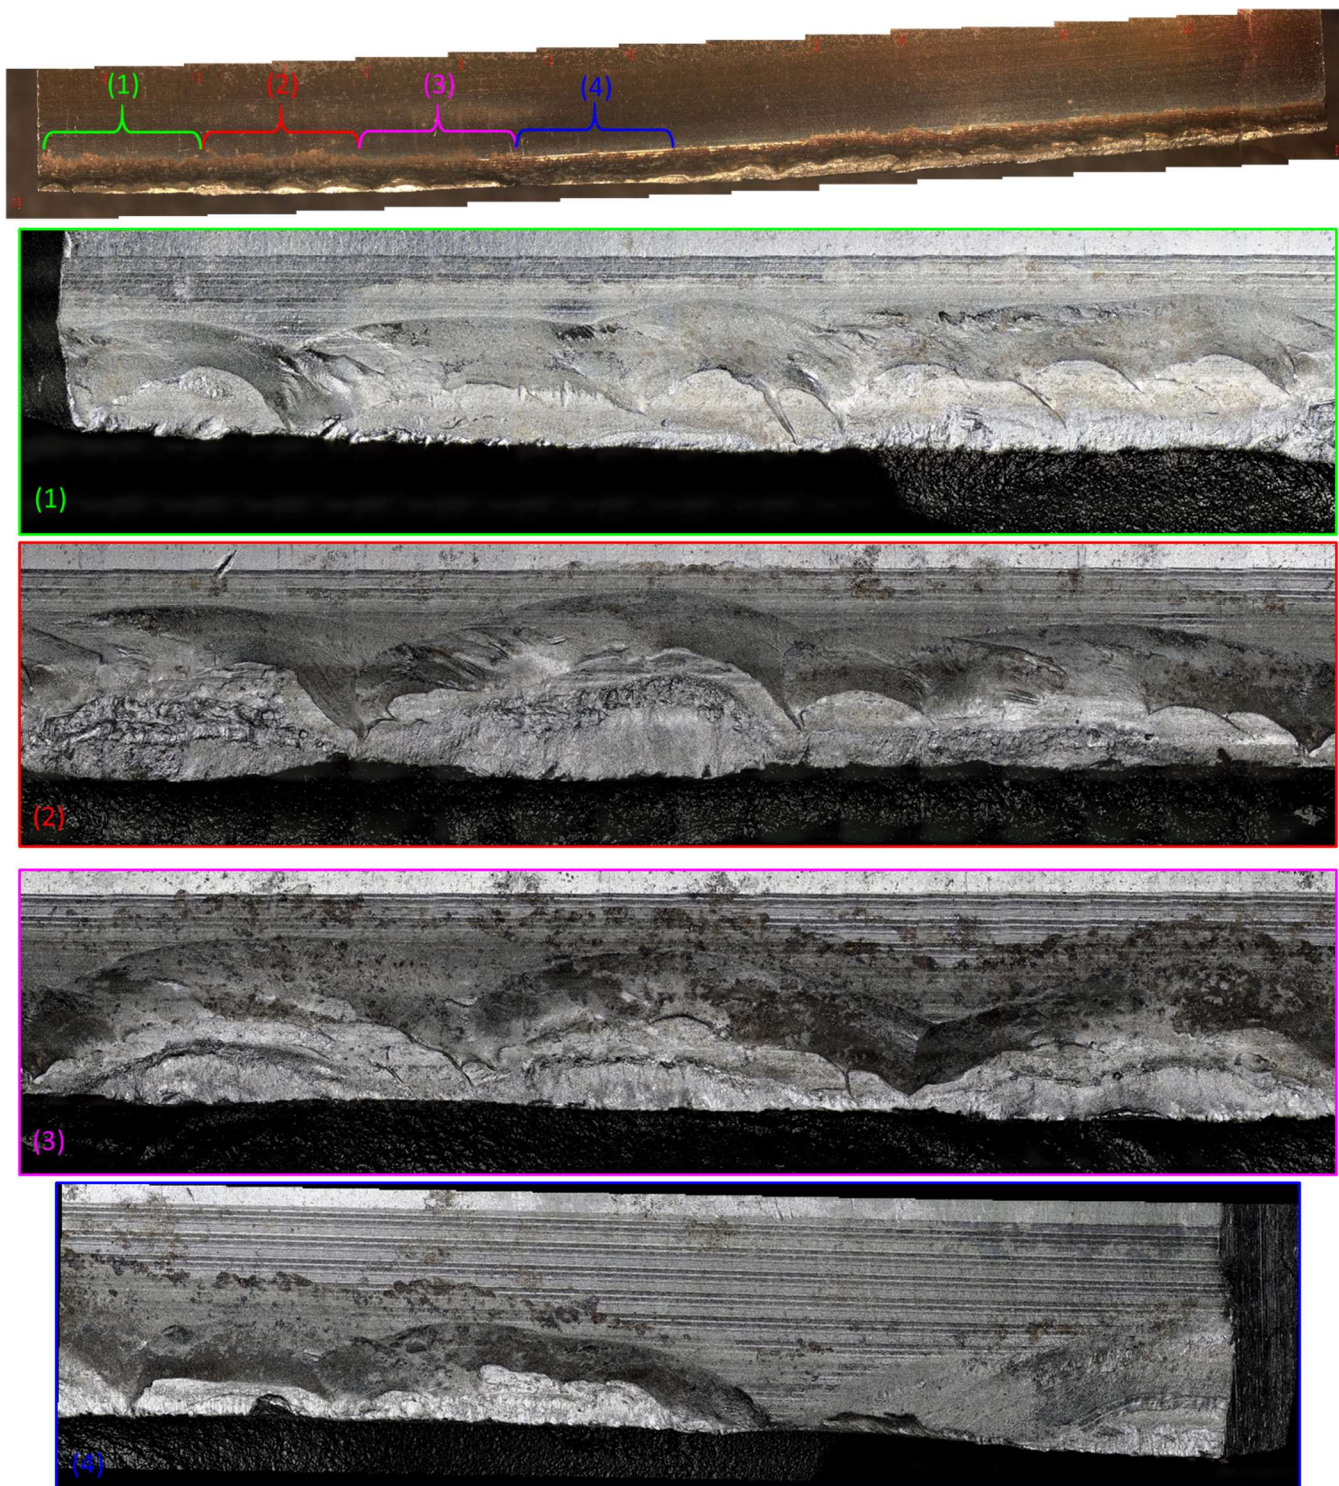
Figure 9. Panoramic assembly of stereomicroscope images of the ICCWR of FY15 DE08 Section B1 (top) showing corrosion products (before cleaning) along the weld. Portions of the LCM optical images (after cleaning), numbered 1-4, shows pitting just above the weld on Zone 2. Both stereomicroscope and LCM images are oriented such that the weld is below Zone 2.
