September 29, 2020

FY20 Status of the Characterization of DEs from the Full Circumference Examination of the Inner Container Closure Weld Region

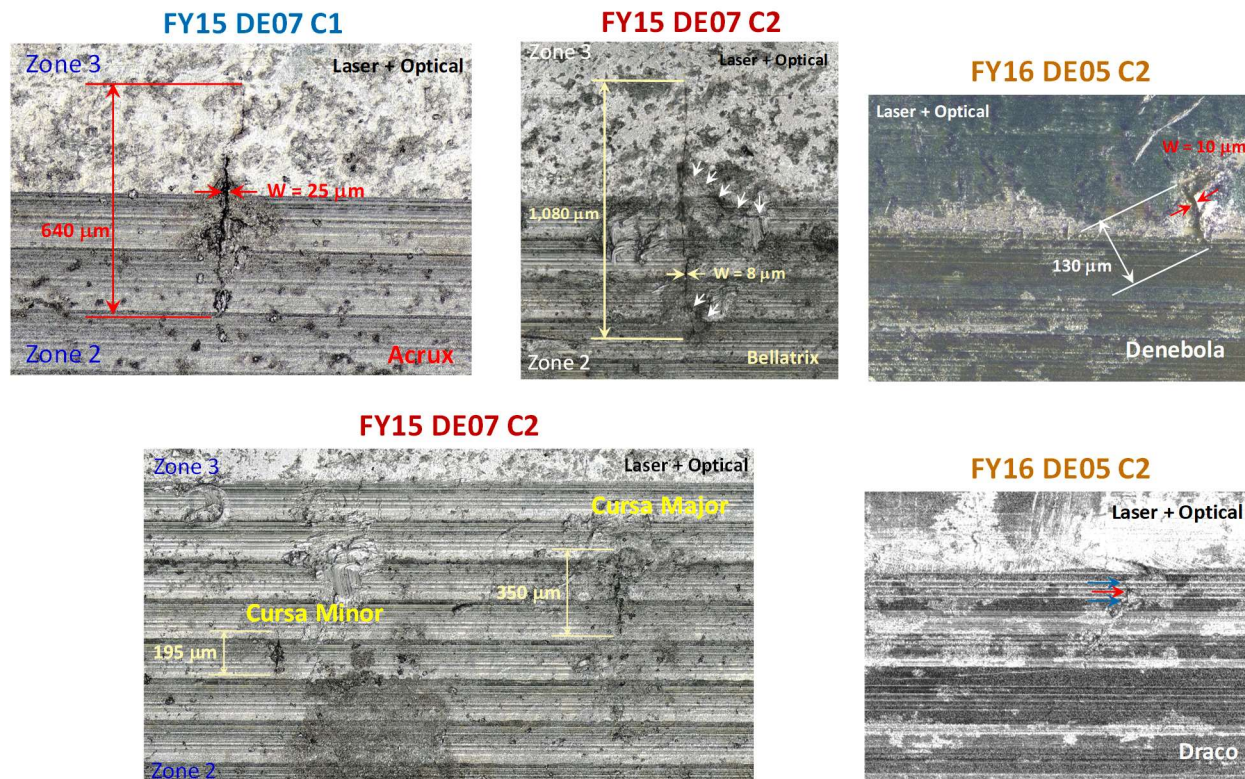
The three ICCWRs show general and localized corrosion on the surface. However, FY15 DE08 show more areas with agglomerated pits in Zones 2 and 3 than the other two DEs. The major suspect corrosion events were observed for FY15 DE07 on Sections C1 and C2 and for FY16 DE05 on Section C2 as shown in Figure 2. These events correspond to suspect cracks or crack-like features identified with a unique name to easily refer to each feature [2, 3]. FY15 DE07 shows a crack-like feature, identified as Acrux, in Section C1 and three features in Section C2 identified as Bellatrix, Cursa Minor and Cursa Major. Acrux and Bellatrix are located at the boundary of Zone 2 and Zone 3. Cursa Minor and Cursa Major are in Zone 2. FY15 DE08 shows two crack-like features, identified as Denebola and Draco, in Section C2. Additional characterization on the locations where the crack-like features were found started in FY20. Sections C1 and C2 of FY15 DE07 were sent to LANL for characterization by XRT. Section C2 of FY16 DE05 was kept at SRNL to perform serial metallography for characterization of the cross-sections by SEM.

Figure 2. Major suspect corrosion events observed for FY15 DE07 on Sections C1 and C2 and for FY16 DE05 on Section C2.

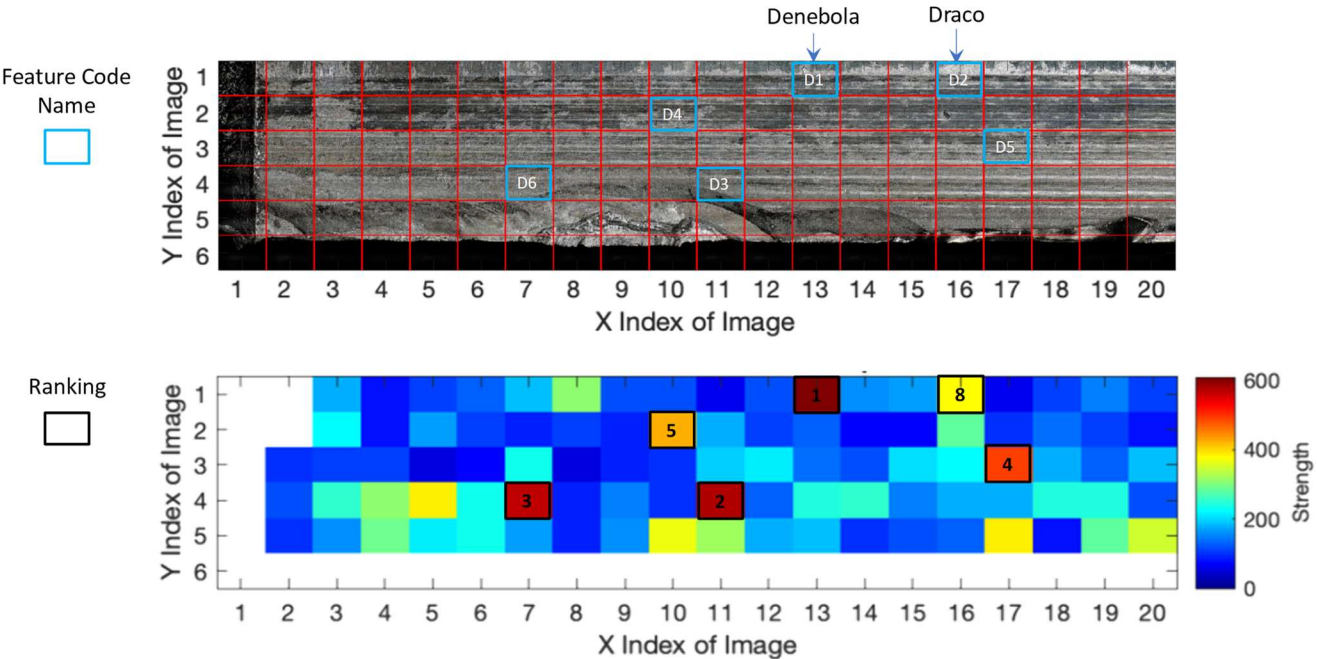
Before preparing the sample for the metallographic analysis, the LCM images of FY16 DE05 Section C2 were analyzed using the IAS developed by LANL [4]. Figure 3 shows a grid over the LCM image of a portion of FY16 DE05 Section C2 with the suspect corrosion features locations labeled as D1 through D6, where D1 corresponds to Denebola and D2 corresponds to Draco. These locations correspond to the cells ranked using the crack strength determined by the IAS. In the IAS, a template matching method is used to match corrosion features to several crack templates. The crack templates consist of predefined crack shapes, sizes and patterns. The crack strength represents the value, determined for each cell, based on the number of matches of the corrosion features to crack templates. The higher the crack strength number indicates that more crack templates match the corrosion features for that cell. Consequently, this will indicate a higher probability of finding a corrosion event in that cell. The cells were ranked based on the crack strength. For example, the cell with the most cracks matching (highest crack strength) correspond to a rank of 1 and so on.

Figure 3. LCM optical image of Zones 1 and 2 for a portion of the ICCWR of FY16 DE05 Section C2 (top). The grid over the image show the suspect corrosion feature locations labeled as D1 through D6, where D1 corresponds to Denebola and D2 corresponds to Draco. The crack strength ranking for each cell was determined by the LANL Image Analysis Software (bottom).

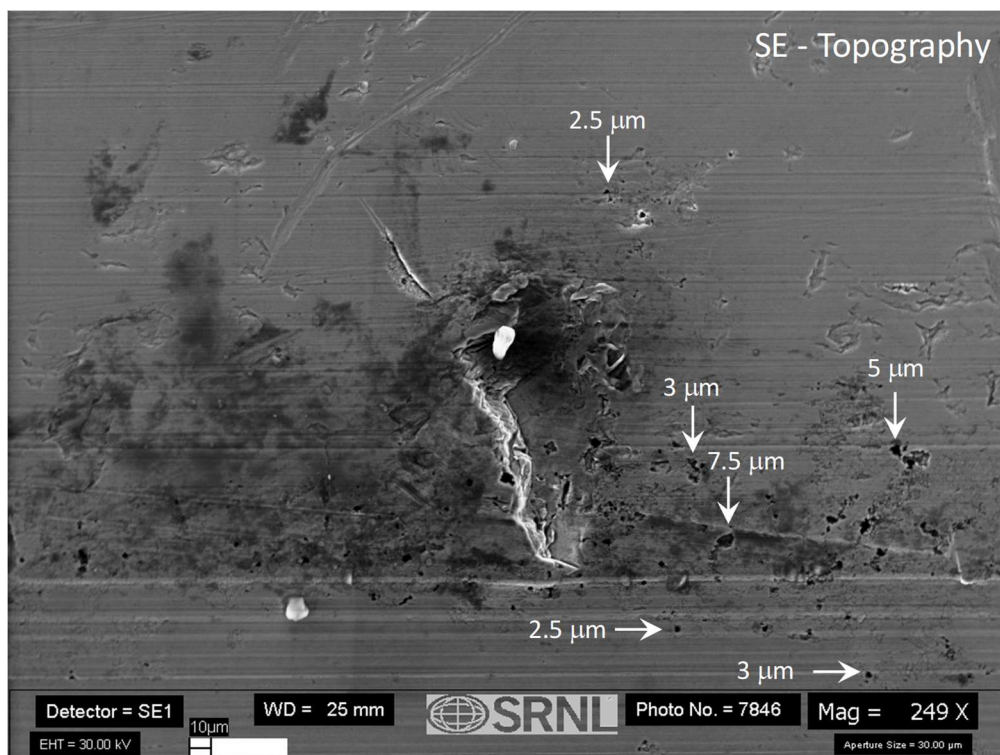
Corrosion features D1 through D6 were characterized by SEM as shown in Figure 4 through Figure 12. A secondary electron detector (SED) was used to produce a topographic SEM image while, in some cases, a back-scatter detector (BSD) was used to obtain an image with contrasts due to composition. The SEM image of Denebola (D1) is shown in Figure 4. Denebola is an apparent chipped section on the surface, but more information will be obtained in the future from the cross-section examination. However, pitting corrosion is observed around Denebola. Draco (D2) is shown in Figure 5, which show a crack with pits along the crack. Pitting corrosion is also observed around Draco. Corrosion feature D3, shown in Figure 6, is a large pit within the grain growth zone close to the weld. A higher magnification SEM image of the area of interest is shown in Figure 7. The large pit has a size of 27 μm . Pitting corrosion is observed around the large pit, with many found between the grains (intergranular corrosion) or within a pit cluster. Figure 8 shows a higher magnification of the large pit. Part of the grain boundary can be observed inside the pit, but no apparent crack was identified. Corrosion feature D4, shown in Figure 9, does not present visible or signs of cracks. However pitting corrosion can be observed on the image. Corrosion feature D5, shown in Figure 10, is a large pit of 38 μm with an apparent crack inside. Intergranular corrosion and coalesced pits were also observed in the image. Corrosion feature D6, shown in Figure 11, is a large pit within the grain growth zone close to the weld. A higher magnification SEM image of the area of interest is shown in Figure 12. The large pit has a size of 52 μm . A large separation of the grains can be observed inside the pit which may indicate intergranular corrosion or a crack formation. Pitting corrosion is observed around the large pit as well.

Figure 4. SEM image of Denebola (corrosion feature D1).

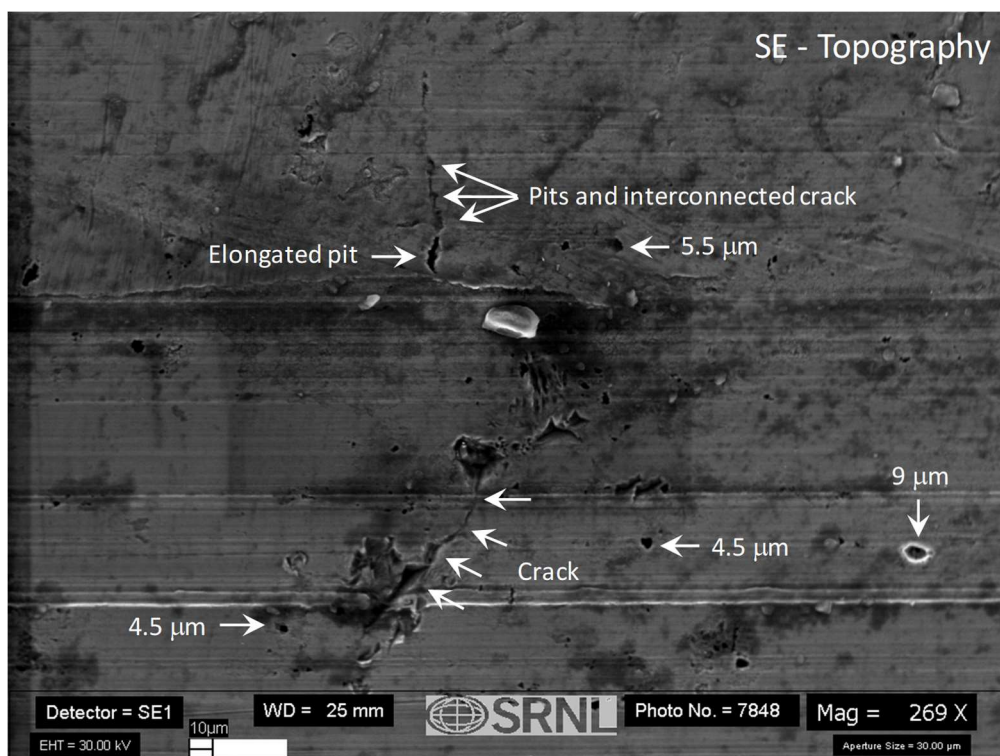
Figure 5. SEM image of Draco (corrosion feature D2).

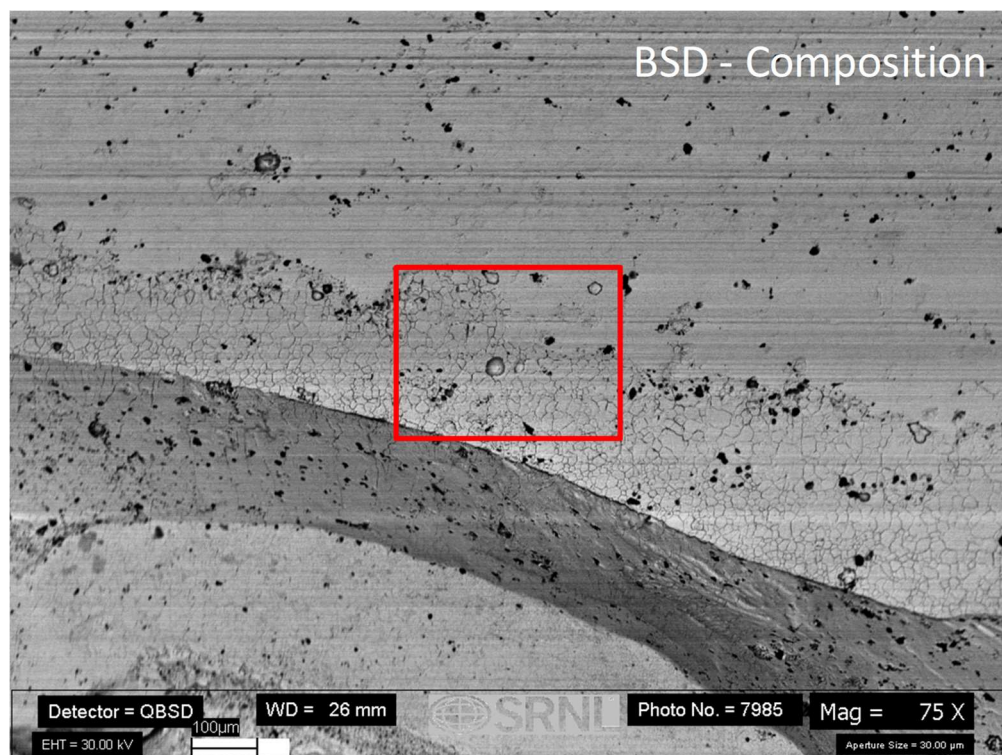
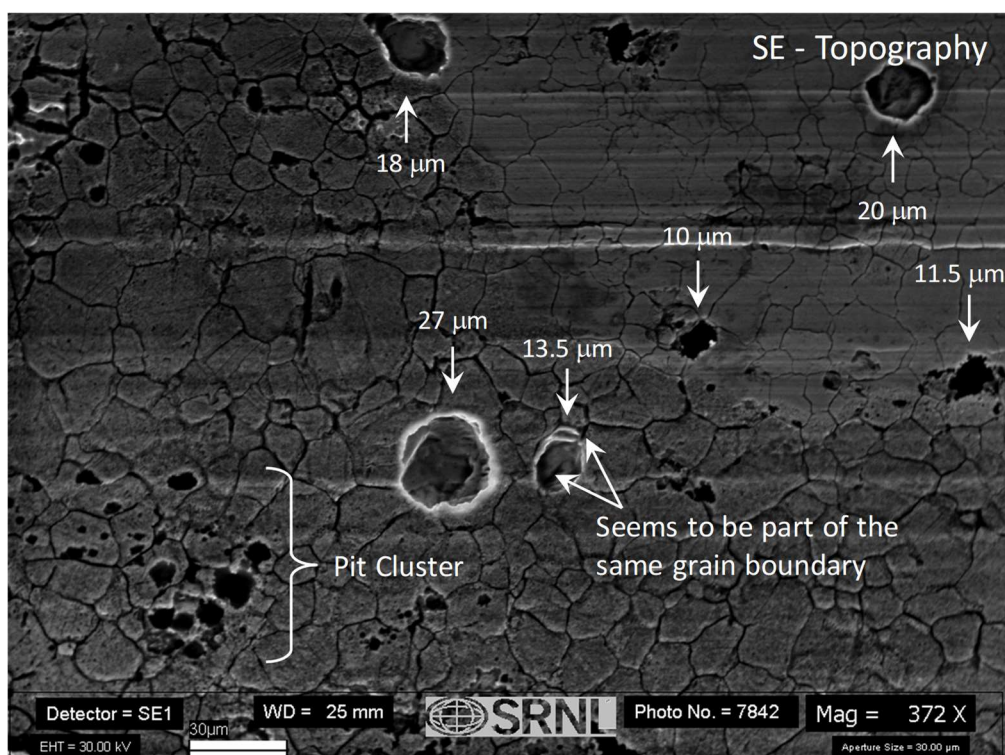
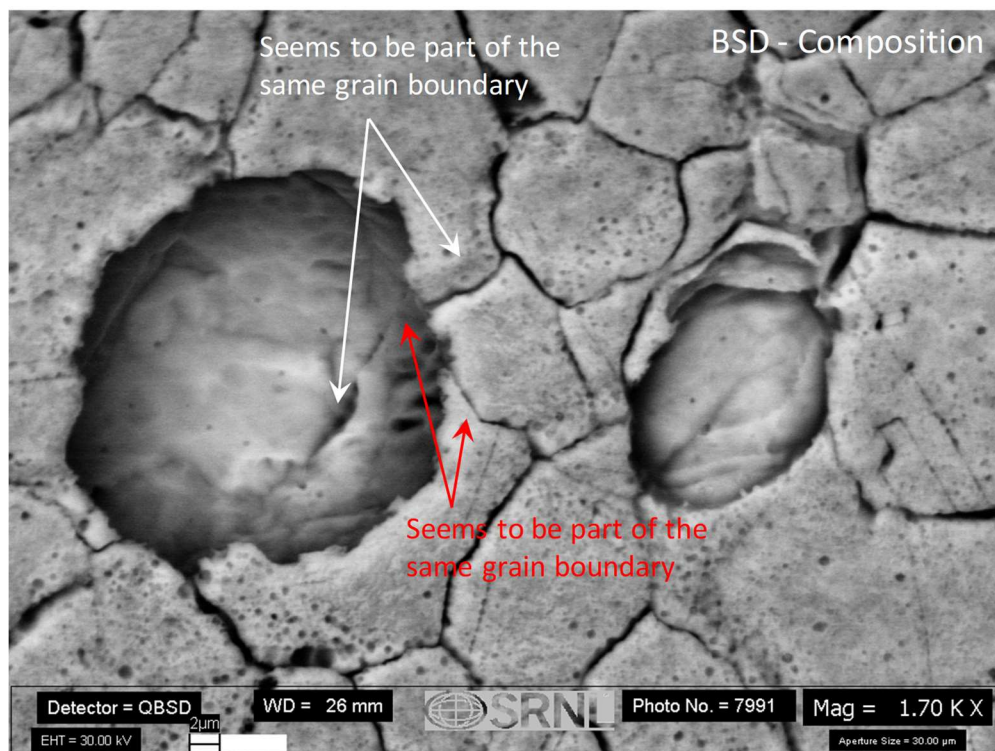
Before preparing the sample for the metallographic analysis, the LCM images of FY16 DE05 Section C2 were analyzed using the Image Analysis Software (IAS) developed by LANL [4]. Several suspect corrosion features were identified, labeled as D1 through D6, where D1 corresponds to Denebola and D2 corresponds to Draco. Corrosion features D1 through D6 were characterized by SEM. The SEM image of Denebola (D1) show it is an apparent chipped section on the surface, but more information will be obtained in the future from the cross-section examination. Draco (D2) seems to be a crack with pits along the crack. Corrosion features D3 and D6 are large pits within the grain growth zone close to the weld. For D3, part

of the grain boundary can be observed inside the pit, but no apparent crack was identified. For D6, a large separation of the grains can be observed inside the pit which may indicate intergranular corrosion or a crack formation. Corrosion feature D4 does not show visible signs of cracks. Corrosion feature D5 is a large pit with an apparent crack inside. Intergranular and pitting corrosion was observed in most of the images. FY16 DE05 Section C2 was cut into a smaller sample, labeled as Subsection C2a, and mounted for cross-section examination. The specimen was successively ground with finer and finer abrasive media to the first position (885 μm from weld edge). SEM images from the 1st round analysis show pits of different sizes (up to 16 μm) and depths (up to 10 μm).

Figure 6. SEM image of corrosion feature D3. Red box corresponds to location of SEM image shown in Figure 7.

Figure 7. SEM image of corrosion feature D3 at a magnification of 372X (center pit of 27 μm).

Figure 8. SEM image of corrosion feature D3 at a magnification of 1,700 X.

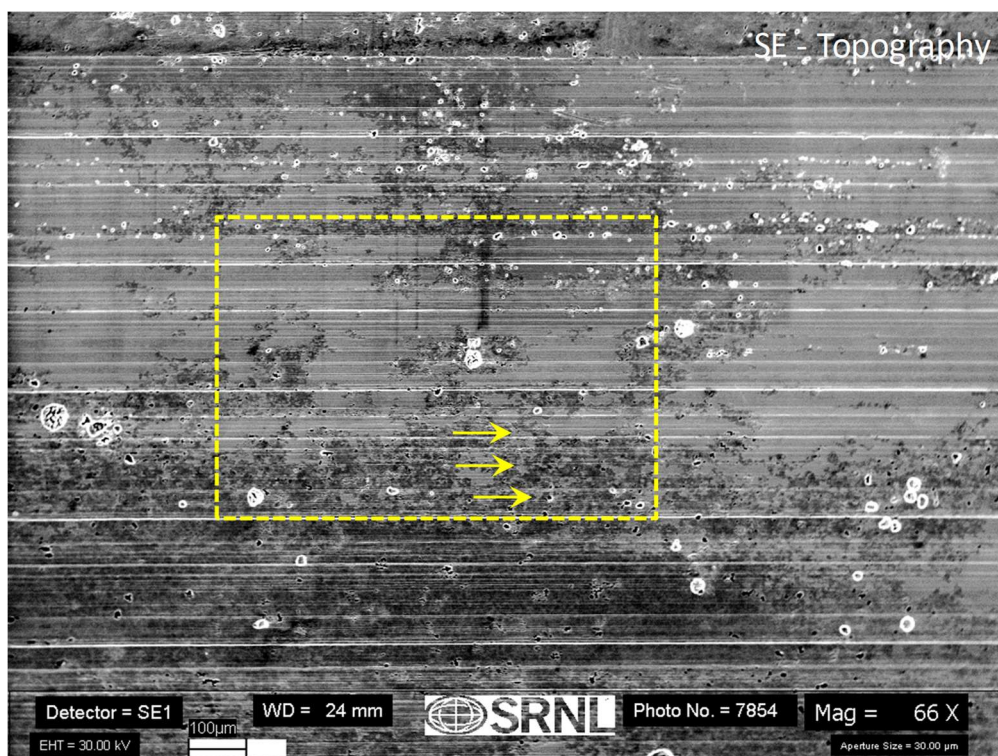
Figure 9. SEM image of corrosion feature D4 (yellow arrows).

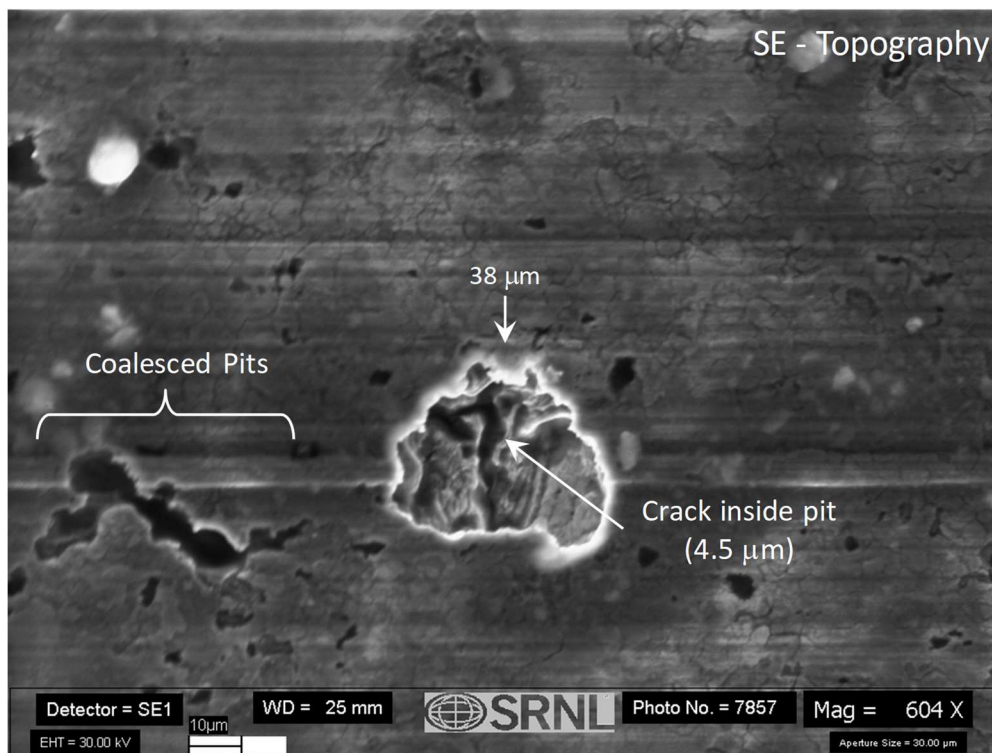
Figure 10. SEM image of corrosion feature D5 (center pit of 38 μm).

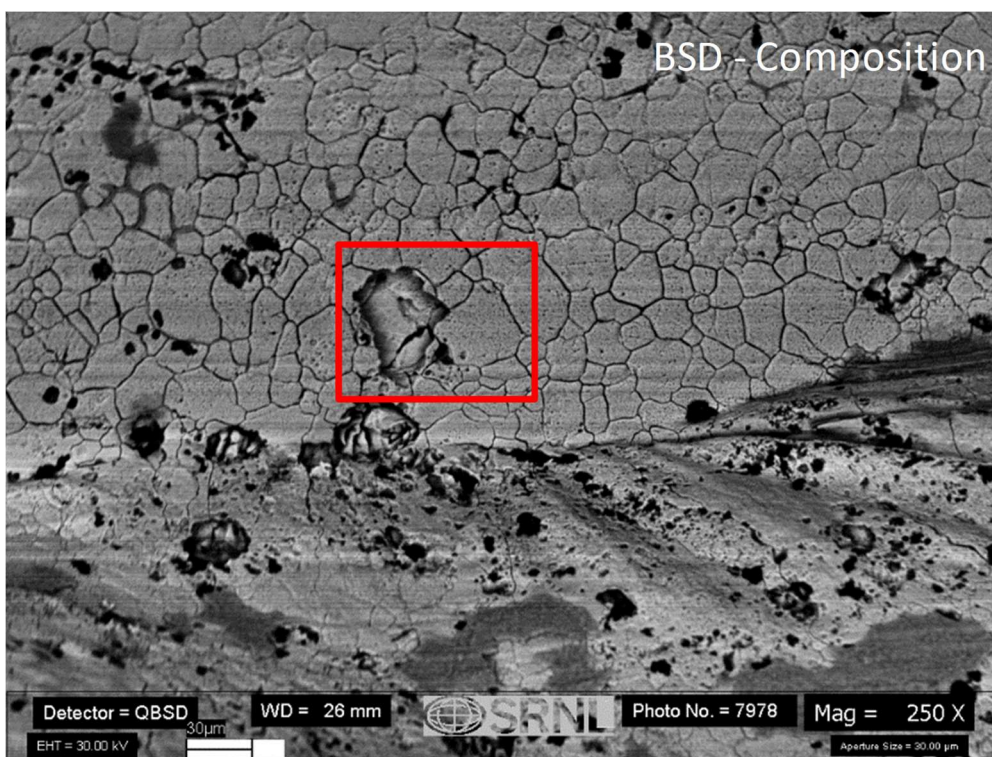
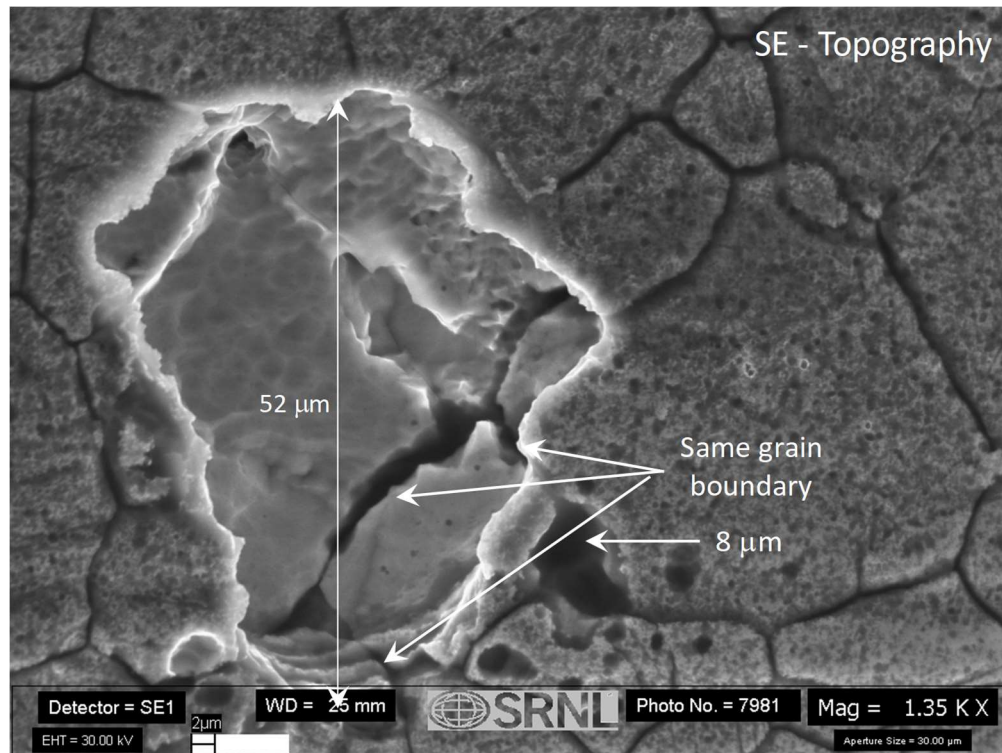
Figure 11. SEM image of corrosion feature D6. Red box corresponds to location of SEM image shown in Figure 12.

Figure 12. SEM image of corrosion feature D6 at a magnification of 1,350X.

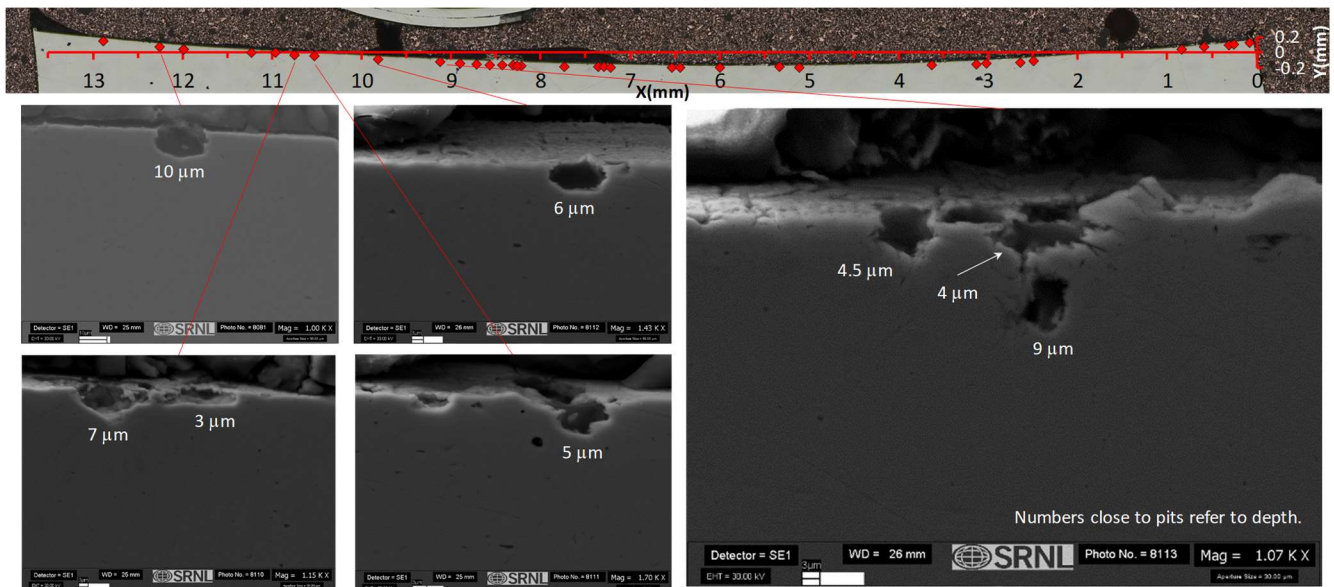
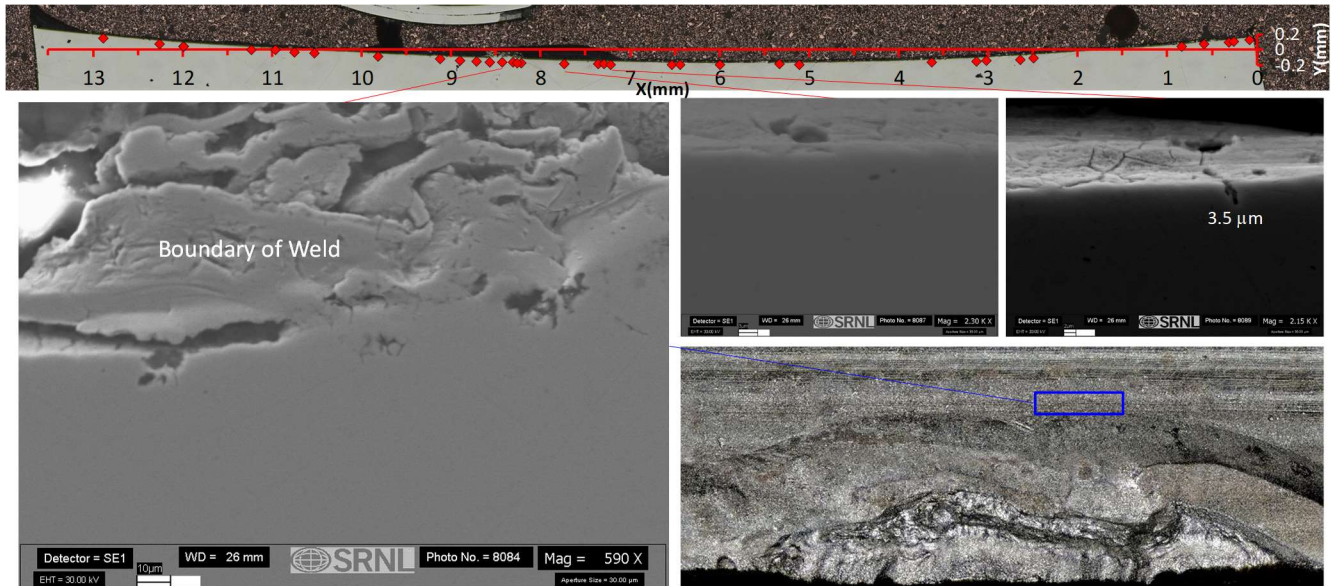
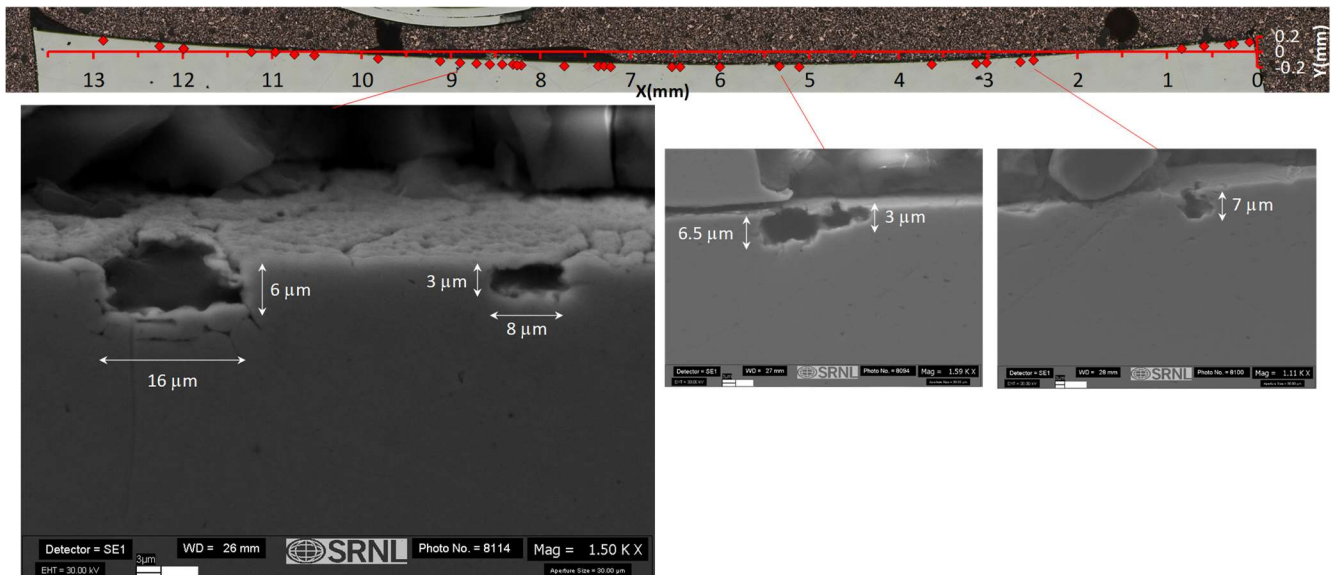
methyl methacrylate, which contain dendritic copper particles. After mounting and curing, the specimen was successively ground with finer and finer abrasive media to the first position (885 μm from weld edge), as shown in Figure 14. SEM images were obtained from this 1st round along the cross-section at several locations, as shown in Figure 15 through Figure 17. Although the best effort was made to stop at corrosion features D3 and D6, the corrosion feature D6 was missed due to the difficulty to stop at a very precise location. However, the main purpose of the cross-section examination is to be able to verify the larger corrosion features D1 and D2 (Denebola and Draco, respectively). Corrosion features D3 through D6 are being analyzed as best as possible while the sample is ground to the target position (D1 and D2). SEM images from the 1st round analysis show pits of different sizes (up to 16 μm) and depths (up to 10 μm). The sample has been ground to the next position and the 2nd round analysis is in progress.

Figure 15. SEM images from the 1st round of the cross-section of FY16 DE05 Section C2a for some positions between 9 – 11 mm from the right edge of the sample.

Figure 16. SEM images from the 1st round of the cross-section of FY16 DE05 Section C2a for some positions between 7 – 9 mm from the right edge of the sample.

Figure 17. SEM images from the 1st round of the cross-section of FY16 DE05 Section C2a for some positions between 2 – 9 mm from the right edge of the sample.

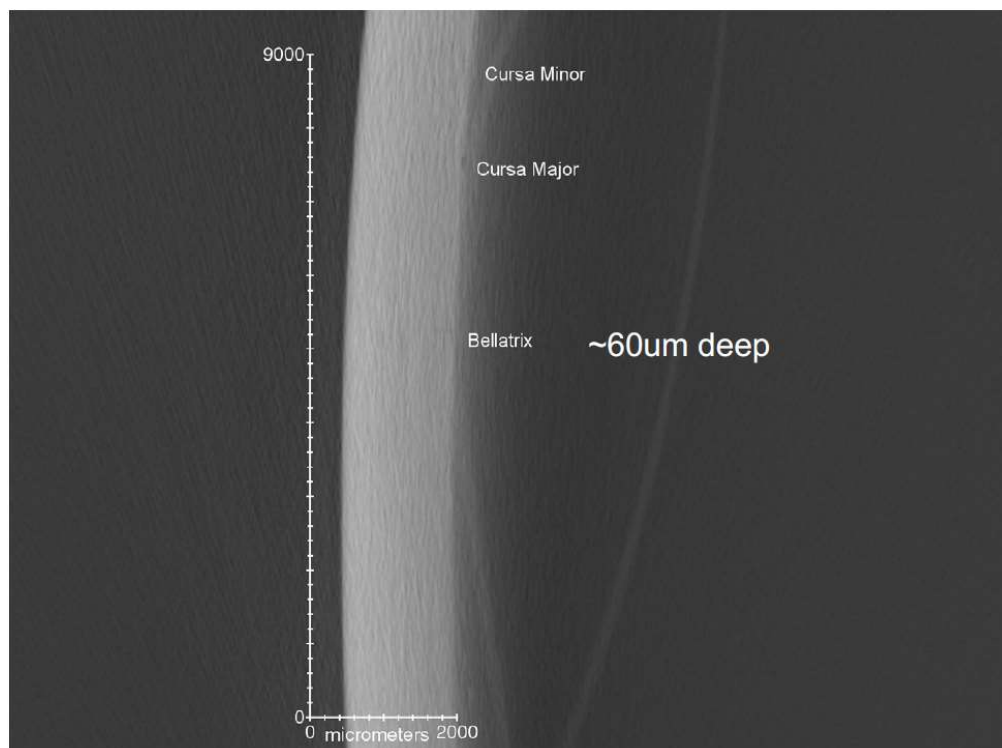
Initial imaging of FY15 DE07 Section C2 was obtained using X-ray Computed Tomography, a nondestructive technique for visualizing the interior features of the sample and obtaining digital information on their 3-D geometries. A cross-section view image of Section C2 is shown in Figure 18 [6]. The image at maximum resolution took 2 days due to sample geometry. Sample geometry also affected the image by showing noise and ghosting. Similar issues would be expected for Section C1. consequently, in order to obtain a better image, LANL sent the samples back to SRNL for sectioning around the areas where the corrosion features are located. The samples were sent back because SRNL has the capabilities for performing cuts on contaminated samples and the SRNL personnel working on these samples is familiarized with the samples and corrosion features location.

Figure 18. XRT image (cross-section view) of FY15 DE07 Section C2 obtained at LANL [6].
