PVP2009-78053

FITNESS-FOR-SERVICE ASSESSMENT FOR A RADIOACTIVE WASTE TANK THAT CONTAINS STRESS CORROSION CRACKS

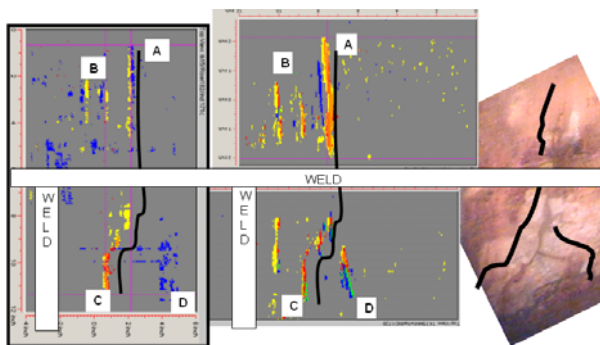
Figure 3. UT scan of stress corrosion crack.

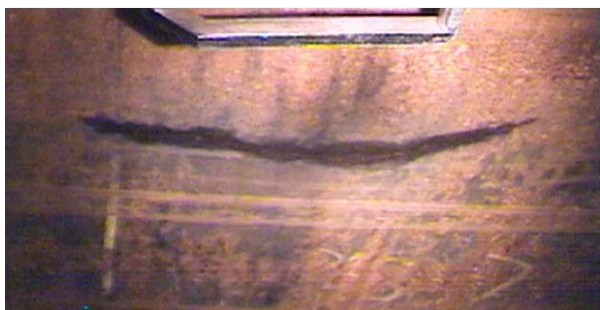
Figure 4. Example of through-wall bleedout.

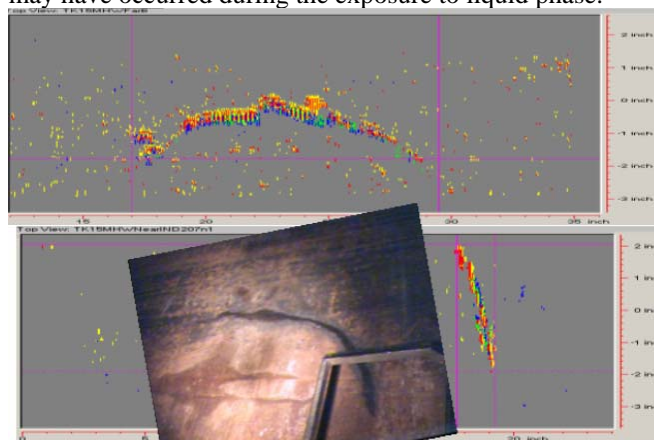
An example of a crack that grew is shown in Figure 5. The crack was first observed in 1994 and had only a limited amount of leakage. During the first 21 years of service the crack was exposed to nitrate-rich liquid, while for the past 25 years it has been in the vapor space. Though the exact date is unknown, visual inspection results and the limited amount of leakage indicate that through-wall penetration occurred during the past 25 years of vapor exposure. However, initiation of the crack may have occurred during the exposure to liquid phase.

Figure 5. Stress corrosion crack near repair weld in tank.

The crack is located near a repair weld in the middle horizontal weld. In 2007, it was determined that the length of the crack was approximately 19 inches. The visible portion of the crack begins at the left edge of the repair weld and then arcs so that it becomes parallel to the horizontal weld. According to the residual stress modeling, the maximum transverse tensile stress occurs at this location [3-5]. The distance of the parallel portion of the arc is approximately 6 inches from the center of the weld. This distance is further than that observed for other cracks in the tank, however, the effect of a nearby vertical weld may influence the residual stress pattern as well. The through wall portion of the crack is approximately 14.4 inches. At each end of the through-wall section of the crack are part through-wall sections (see Figure 5 for UT scan of crack). In the plate above the weld, a primarily vertical branched crack extends tangentially from the repair weld approximately 3.7 inches above the middle horizontal weld. Approximately 1 inch of this segment is through-wall, whereas in 2002, all of this segment was part through-wall. There has been approximately

1.7 inches of crack extension into the base plate since 2002. The segment that has extended is part through-wall. The part through-wall crack in the plate beneath the weld arcs back toward the middle horizontal weld. The arc-like pattern of the crack adjacent to the weld repair is consistent with laboratory results [6]. The behavior also agrees with the residual stress model for a narrow weld repair in that the crack is located a short distance from the weld repair fusion line [5].

Due to a lack of significant driving forces, either hydrostatic or residual stresses, the crack currently does not impact either the structural stability or the leak tightness of the tank. This statement is confirmed by the finite element fracture analysis previously performed on the crack (assuming that it was 15 inches) [7]. The analysis showed that the hydrostatic stresses were not sufficient to drive the crack to instability. The horizontal orientation of the crack means that hydrostatic stresses in the hoop direction will not have a significant impact on further crack growth. Therefore, from a structural stability perspective the crack is not anticipated to be significant to facility operations.
