**ASSESSMENT OF RESIDUAL STRESSES IN SRS AND HANFORD
3013 INNER AND CONVENIENCE CANS**

J. I. Mickalonis

MARCH 2009

Savannah River National Laboratory
Savannah River Nuclear Solutions
Aiken, SC 29808

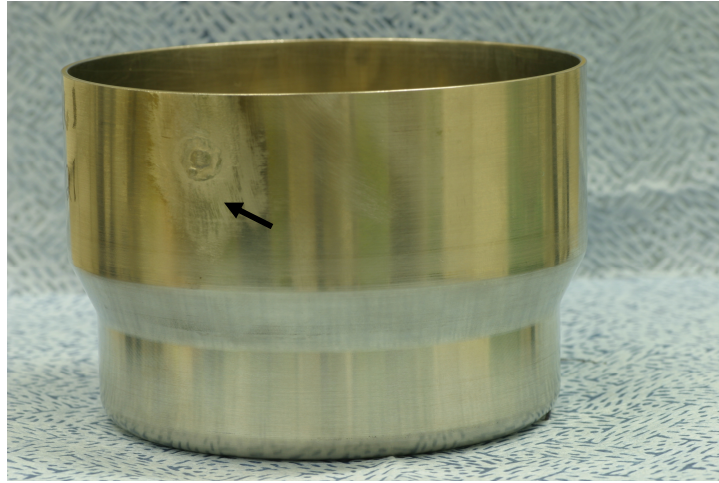
Figure 1. 3013 inner can prior to testing in boiling magnesium chloride; arrow indicates the weld-filled hole in can sidewall.

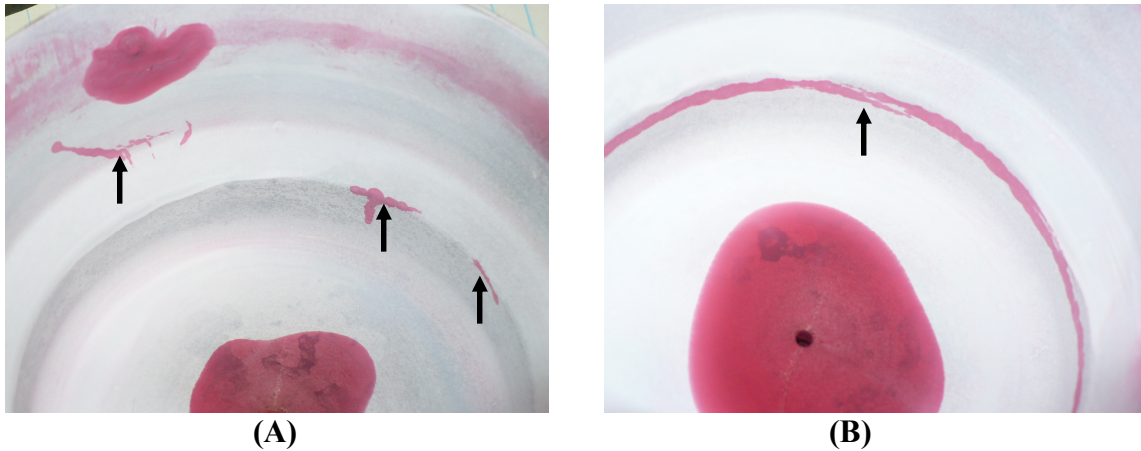
Initially, the inner can bottoms were not thought to have cracked at other locations, such as the areas where the diameter size changes. During the post-test water leakage checks, leaks were only noted from the bottom and the sidewall drilled hole. Dye penetrant testing was used on the can interiors and cracking was located in two cans (can #4 and #2) as shown in

Figure 3. Inner can #4 (Figure 3B) had a circumferential crack which was through wall along a short length. Inner can #2 (Figure 3A) had both circumferential and axial cracks but all cracks were not through wall. The variability in cracking for the inner can bottom may be associated with differences in can fabrication as well as testing variability. It is important to note that one inner can bottom section did not have any other cracks than those associated with the drilled holes.

Figure 3. Dye penetrant testing of 3013 inner can bottoms: (A) Inner can #2, (B) Inner can #4. Pink lines indicate crack locations and pink spots are the drilled hole locations. Arrows indicate cracks not associated with drilled holes.

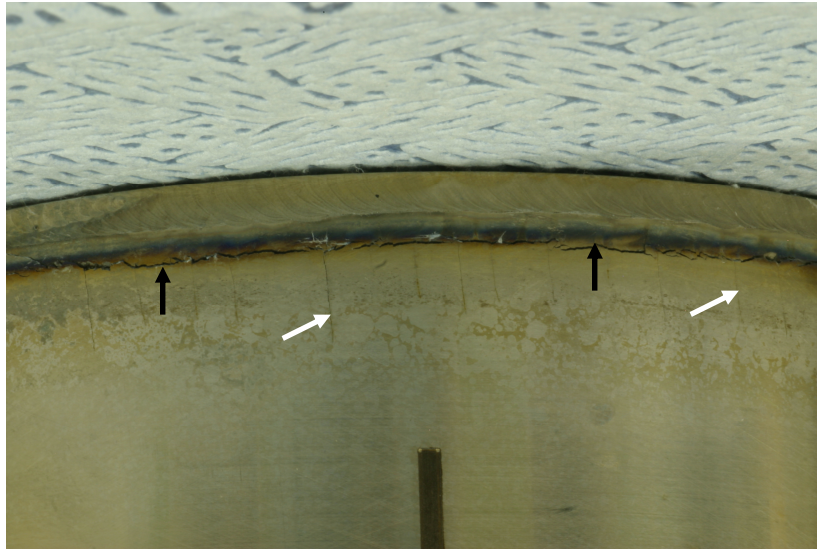
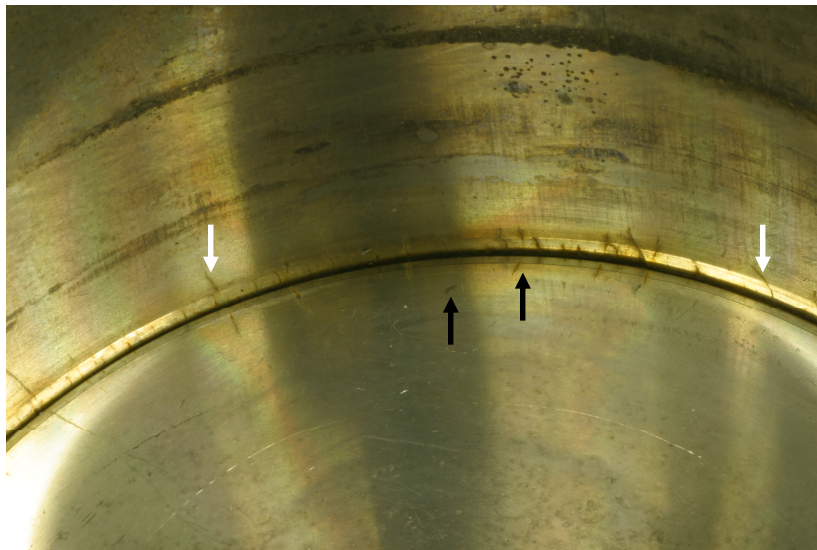
The inner can welded-tops cracked quickly in the boiling magnesium chloride with times of 2 and 3.5 hours. Testing was stopped because of a large amount of leaking from the cracks. The cracks were both along the weld, perpendicular to the weld along the can axis, and radially from the plug perimeter (Figure 4). The crack along the weld occurred in the can which was exposed for the longer time and covered approximately 60% of the perimeter. The cracks in the sidewall were greater in number than those in the plug. Additionally, the cracks were longer (5-9 mm in length) and more apparently through wall. The radial and perpendicular cracks were straight unlike the cracks generated at the drilled holes.

Figure 4. 3013 inner can top after exposure to boiling magnesium chloride: (A) can exterior showing crack parallel to the weld and numerous cracks perpendicular to the weld (white arrows - perpendicular cracks, black arrows - parallel crack), (B) can interior with sidewall and plug cracks (white arrows – perpendicular cracks, black arrows - radial cracks).

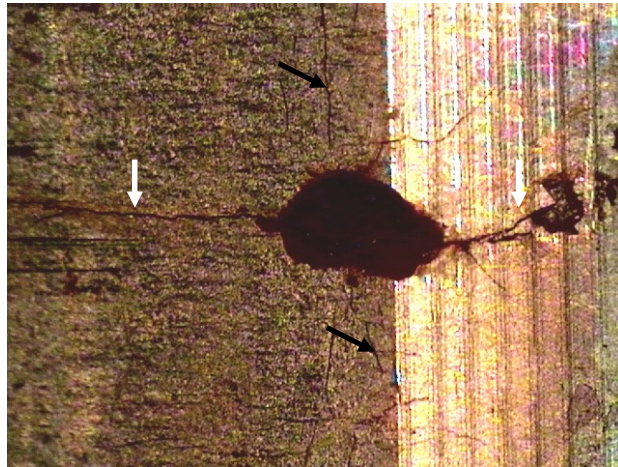
The welded top of inner can #1 was sectioned to look within the crevice formed by the top plug and sidewall. Large pits were found in the plug and sidewall. In many cases these pits were associated with the observed cracks as shown in Figure 5. The small cracks had multiple orientations relative to the pits. The growth of these cracks indicated the complex stress state near the weld.

Figure 5. 3013 inner can top after exposure to boiling magnesium chloride solution showing pit associated with cracking in sidewall. Arrows indicate axial (white) and circumferential (black) cracks.

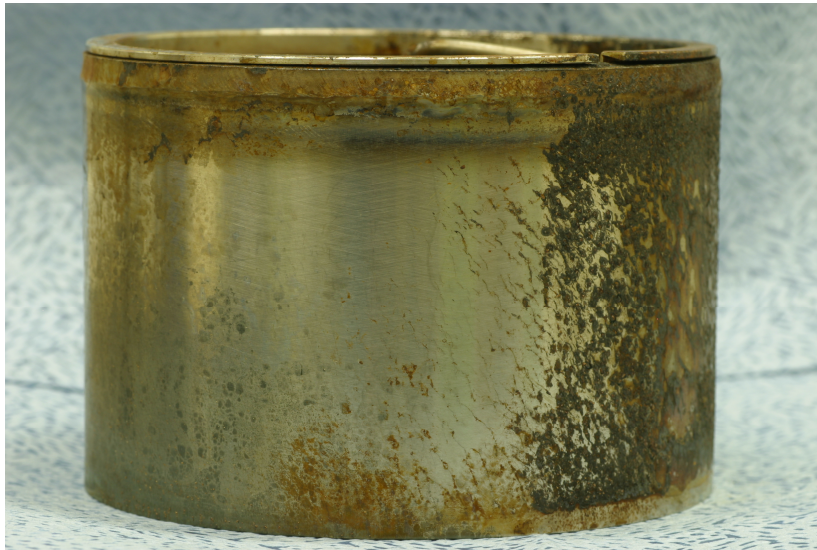
(A)

The inner can top exposed to the vapors of the boiling magnesium chloride solution had small cracks in both the sidewall and top after five days of exposure. The cracks were not through wall. On the exterior, the can suffered principally from general and pitting corrosion (Figure 6A).

Figure 6A. 3013 inner can exposed to vapors of boiling magnesium chloride solution: can exterior showing small surface cracks and heavy pitting.

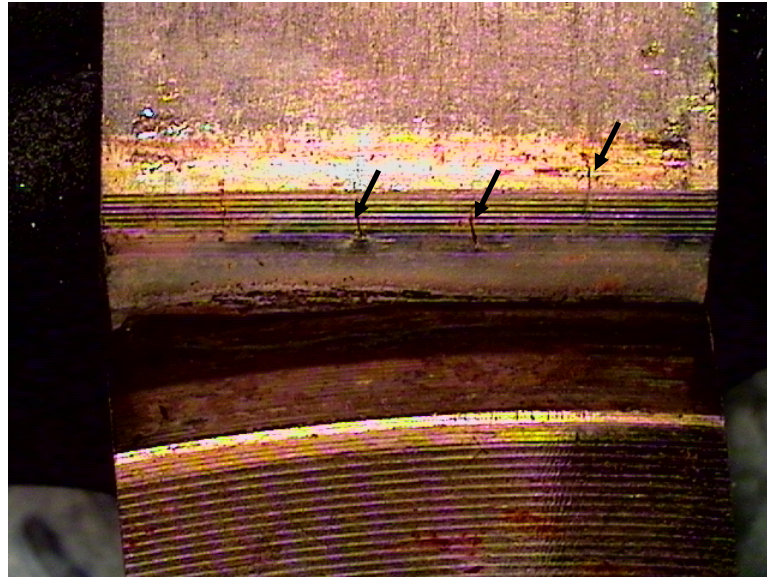
(B)

Figure 6B. 3013 inner can exposed to vapors of boiling magnesium chloride solution: interior can crevice spread open showing small cracks (arrows indicate cracks).

The can was sectioned by EDM so that the interior surface of the crevice could be inspected for pitting and cracking since the use of dye penetrant testing was unsuccessful. Several pie-shaped sections were cut from the can. The crevice was revealed by spreading it open. Inside the crevice large pits and small axial cracks were located. When the crevice was split open the cracks opened up as shown in Figure 6B. Cracks were also found on the side of plug.

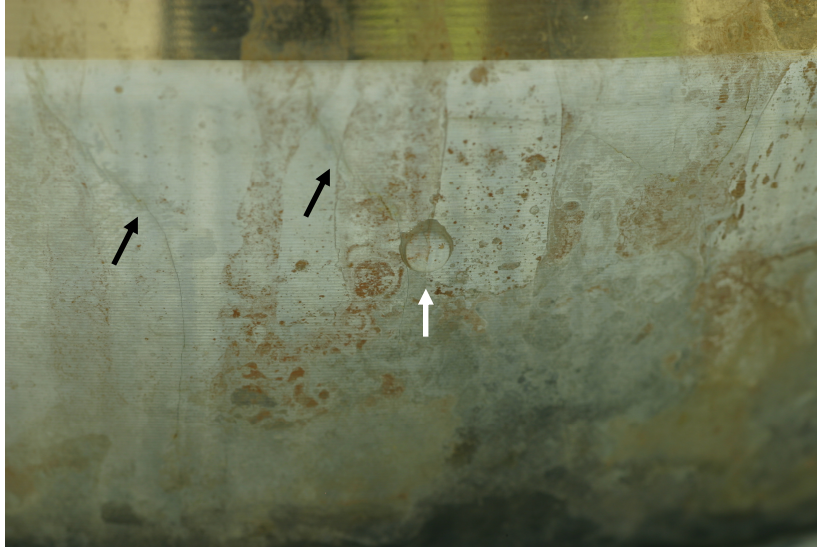
Both the SRS and Hanford convenience cans cracked during testing. The SRS can leaked during testing so the test was stopped. The Hanford can did not leak so it was exposed to the boiling magnesium chloride solution for the entire 48-hour test period. More cracks were found in the Hanford can, which was probably associated with this longer test period. The cracks in the Hanford can were all located in the bottom portion with the angled sidewall (Figure 7). Most of the cracks appeared to curve as they approached the parallel sidewall region of the can. No cracks were found on the bottom of the can. When the Hanford can was leaked checked with water after the test, only two small drops formed on the sidewall (Figure 7). After tapping the can on the counter, which loosened the cracks, water was found to leak from most of the cracks.

Figure 7. Hanford convenience can showing leaking water drop at crack which occurred from testing in a boiling magnesium chloride solution. White arrow indicates water drop and black arrows point to cracks.

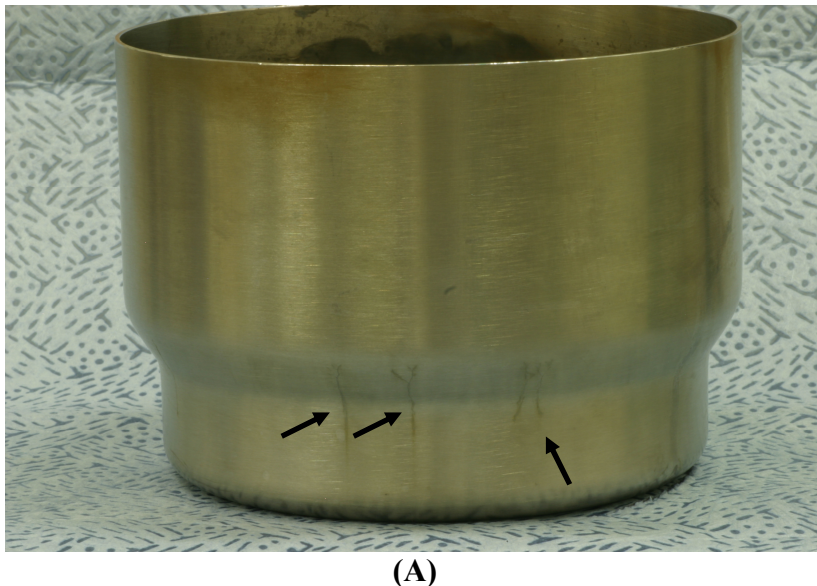
Six cracks were found on the SRS can in the region of diameter size change. These cracks all appeared to have bifurcated and stopped growing at the top of this diameter transition section (Figure 8A). This result was similar to the Hanford convenience can. The SRS can also had radial cracks in the bottom which were through wall (Figure 8B) similar to the sidewall cracks.

Figure 8A. SRS Convenience can after exposure to boiling magnesium chloride solution: can exterior with axial cracks in sidewall. Arrows indicate the cracks.

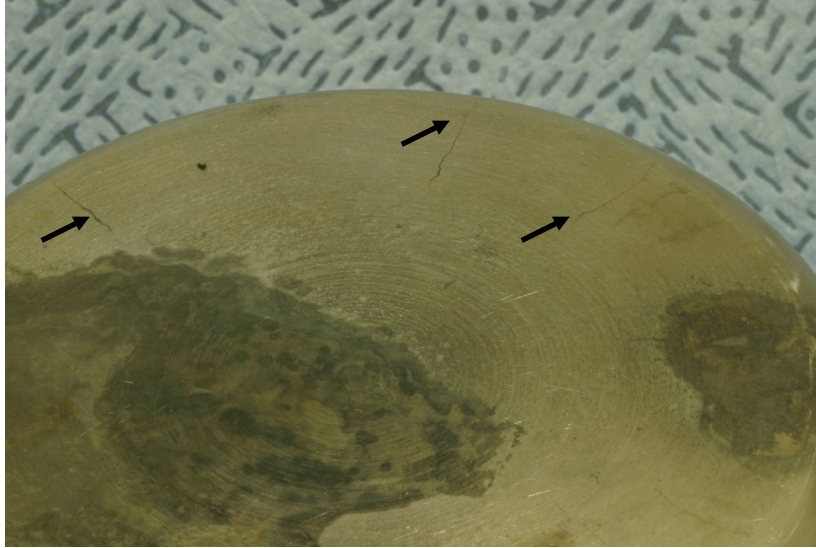
(B)

Figure 8B. SRS Convenience can after exposure to boiling magnesium chloride solution: can exterior bottom with radial cracks. Arrows indicate the cracks.

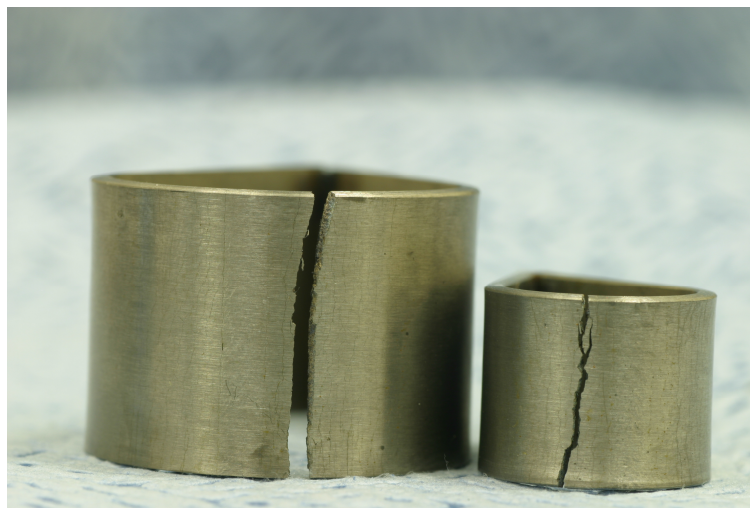
Figure 9. 304L teardrops after exposure to a boiling magnesium chloride solution.

Numerous surface cracks, which were oriented across the width of the teardrop, were found along the entire length except near the weld that held the ends of the teardrop. Teardrops without the autogenous weld were also found to fail in a similar manner but after slightly longer times, approximately 1.6 hours. A small-sized teardrop (0.5' width, 2.5" length, 0.0625" thick) was also tested since this type sample was under consideration for use during the next phase of small scale testing. The teardrop failed after approximately 2 hours with a through wall crack at a similar location to the cracks in the large teardrops (Figure 9).

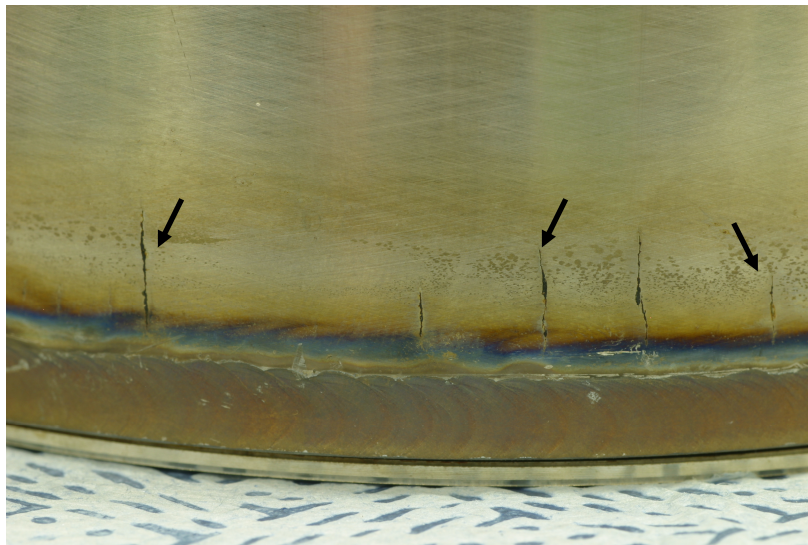
The test with the inner can welded top was performed for approximately 84 hours. The can had not cracked after 24 hours in test, but was cracked in a similar manner to the boiling magnesium chloride at 84 hours. The inner can top cracked quickly (2-4 hours) in the boiling magnesium chloride solution. Multiple cracks grew perpendicular to the weld in the sidewall (Figure 10). The cracks were approximately 5-7 mm in length as measured macroscopically on the exterior sidewall. Many of these cracks were through wall. Cracks were also found in the top plug but only two were suspected to be through wall. These cracks appeared shorter in length. No further evaluation of the cracks was performed on this can.

Figure 10. 3013 inner cap welded top tested a with 40% calcium chloride solution at 100 °C. Arrows indicate cracks.

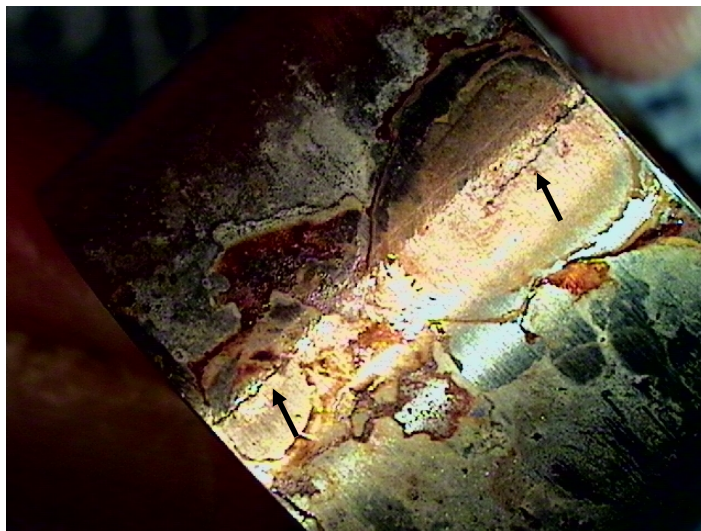
A series of both the standard and small-sized teardrops were exposed to the calcium chloride solution with periodic removals during the course of the test. The initial plan was to obtain an average crack growth rate. The test was run for 220 hours. The first samples, both a standard and small-sized, were removed at 118 hours and found to have multiple cracks which were located primarily along the bottom of the teardrop near the autogenous weld. The amount of cracking increased with time as cracks appeared to generate farther from the weld along the length of the teardrop (Figure 11, page 15). The cracks were also highly branched. Determination of a crack growth rate was not possible because of the multiple cracks that formed. The teardrops in the vapor space region showed minimal degradation with a few spots of discoloration. Cracking was found on both a standard and small-sized teardrop exposed to the vapors only (Figure 12).

Figure 12. 304L Teardrop with cracks after exposure to the vapors from a 40 % calcium chloride solution at 100 °C. Arrows indicate cracks.

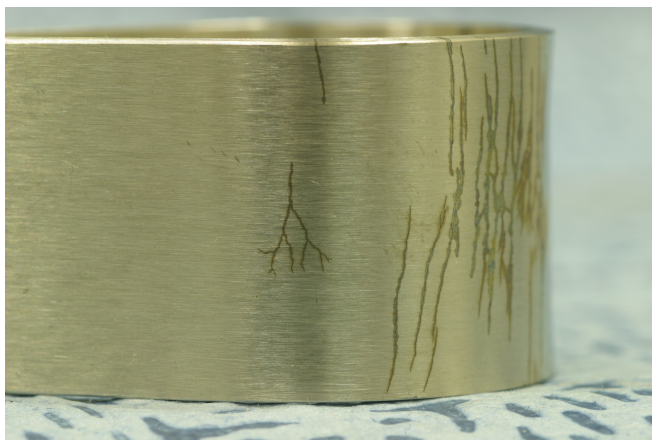
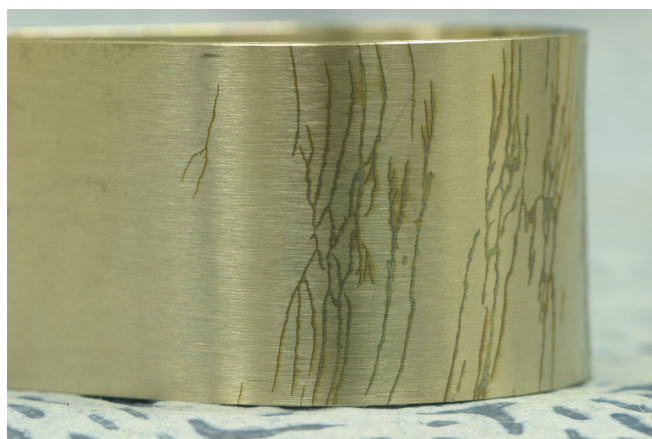
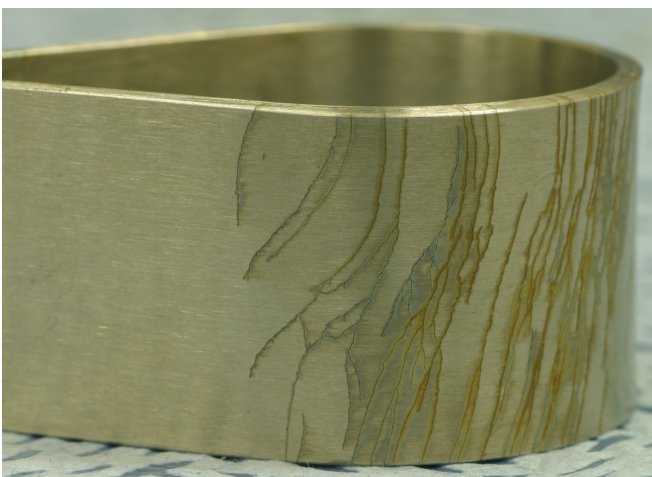
Figure 11. 304L Teadrops tested in 40 % calcium chloride solution at 100 °C for: (A) 188 hours; (B) 194 hours; and (C) 220 hours.
