EXAMINATION OF FIBERBOARD FROM SHIPPING PACKAGE 9975-01819

W. L. Daugherty

Savannah River National Laboratory
Materials Science & Technology

Document No. SRNL-STI-2009-00240 **Rev. No.** 0

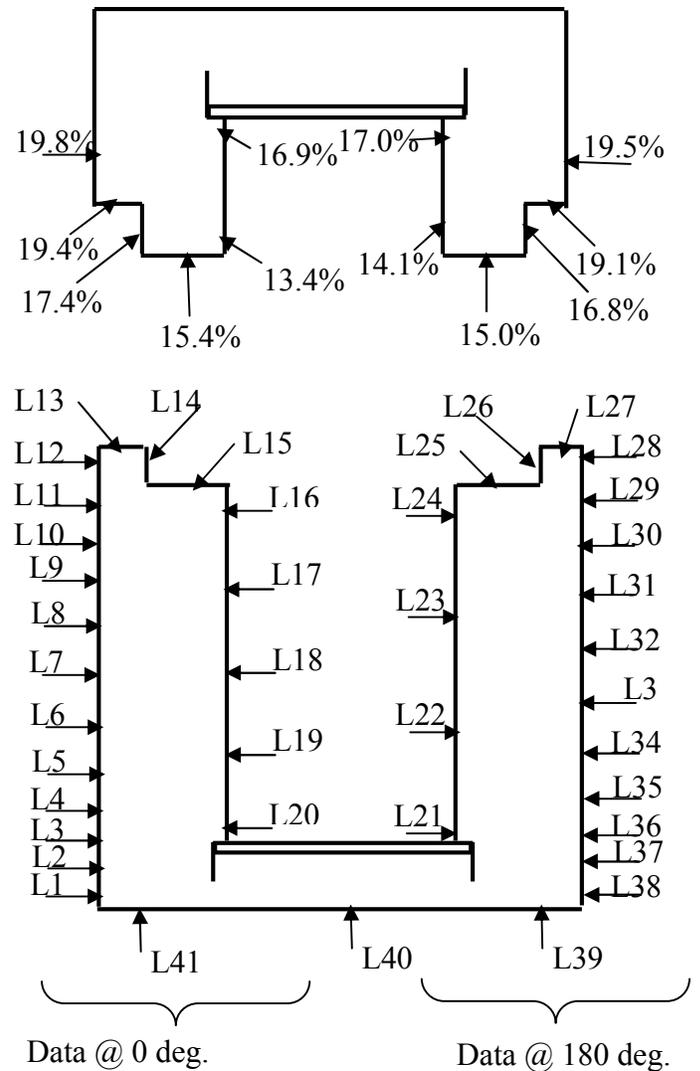
Table 2. Summary of fiberboard moisture content on 3/10/09. Data for the upper assembly are on the sketch. Data for the lower assembly are in the table.

%WME	Location
OD, 0 deg. orientation		
L1	100	1 " from bottom
L2	53	1 1/2 " from bottom
L3	44.0	23 7/8 " from top
L4	32.2	22 7/8 " from top
L5	30.0	21 3/4 " from top
L6	22.2	20 " from top
L7	22.2	17 5/8 " from top
L8	21.2	15 " from top
L9	21.7	12 1/4 " from top
L10	21.0	9 1/4 " from top
L11	22.6	6 1/4 " from top
L12	21.3	2 1/8 " from top
Top surfaces		
L13	19.5	Upper shelf, 0 deg
L14	19.6	Vert. rise, 0 deg
L15	17.5	Lower shelf, 0 deg
L25	17.7	Upper shelf, 180 deg
L26	19.1	Vert. rise, 180 deg
L27	19.8	Lower shelf, 180 deg
ID, 0 deg. orientation		
L16	13.8	1 " from top / 19 1/4 " from bottom
L17	15.2	14 1/2 " from bottom
L18	15.7	10 " from bottom
L19	18.9	5 " from bottom
L20	18.2	1 " from bottom
ID, 180 deg. orientation		
L21	19.2	1 " from bottom
L22	16.5	9 3/4 " from bottom
L23	15.1	14 1/2 " from bottom
L24	16.3	1 " from top
OD, 180 deg. orientation		
L28	20.1	1 " from top
L29	21.4	4 3/4 " from top
L30	19.9	11 " from top
L31	20.3	14 3/4 " from top

L32	22.6	17 3/4 " from top
L33	26.1	20 1/2 " from top
L34	29.3	22 " from top / 4 " from bottom
L35	40.8	2 7/8 " from bottom
L36	36.0	2 " from bottom
L37	47	1 1/2 " from bottom
L38	75	1 1/8 " from bottom
Bottom surface		
L39	100	Near 180 deg side
L40	100	Center
L41	100	Near 0 deg side

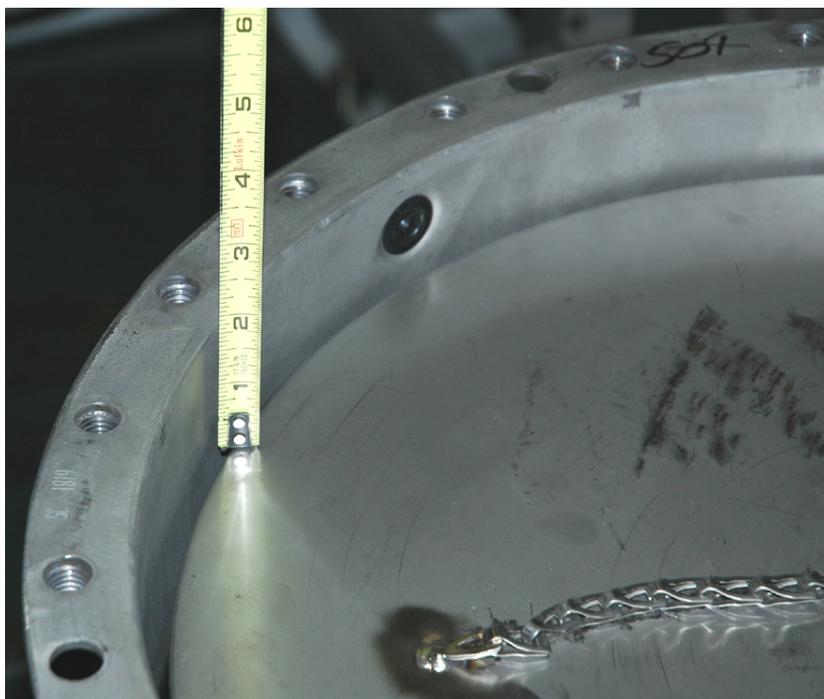
- Upper fiberboard assembly has a thin coat of mold on the exterior surface.
- Accessible fiberboard (upper assembly and exposed top of lower assembly) was firm, resilient and intact.
- Moisture content of accessible fiberboard ranged from 12 to 22 %WME (wood moisture equivalent), compared with a more typical range of 8 to 16 %WME.
- Accessible dimensions are per design. The lower fiberboard assembly sits approximately 1 inch low in the drum. Suspect that this results from the bottom being too short or compressed.

Figure 1. Low fiberboard height condition as first noted when the drum was opened. Photograph provided by NMM.

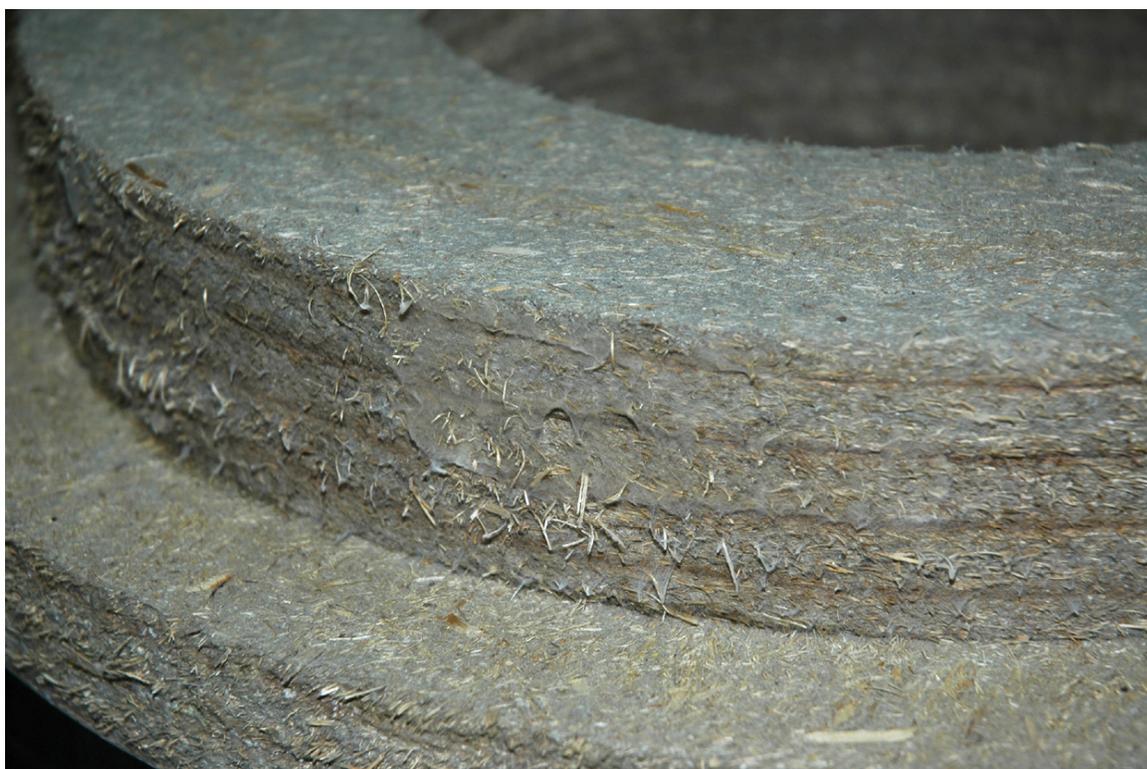
Figure 2. Mold on upper fiberboard assembly when first removed (January 26, 2009). Photograph provided by NMM.

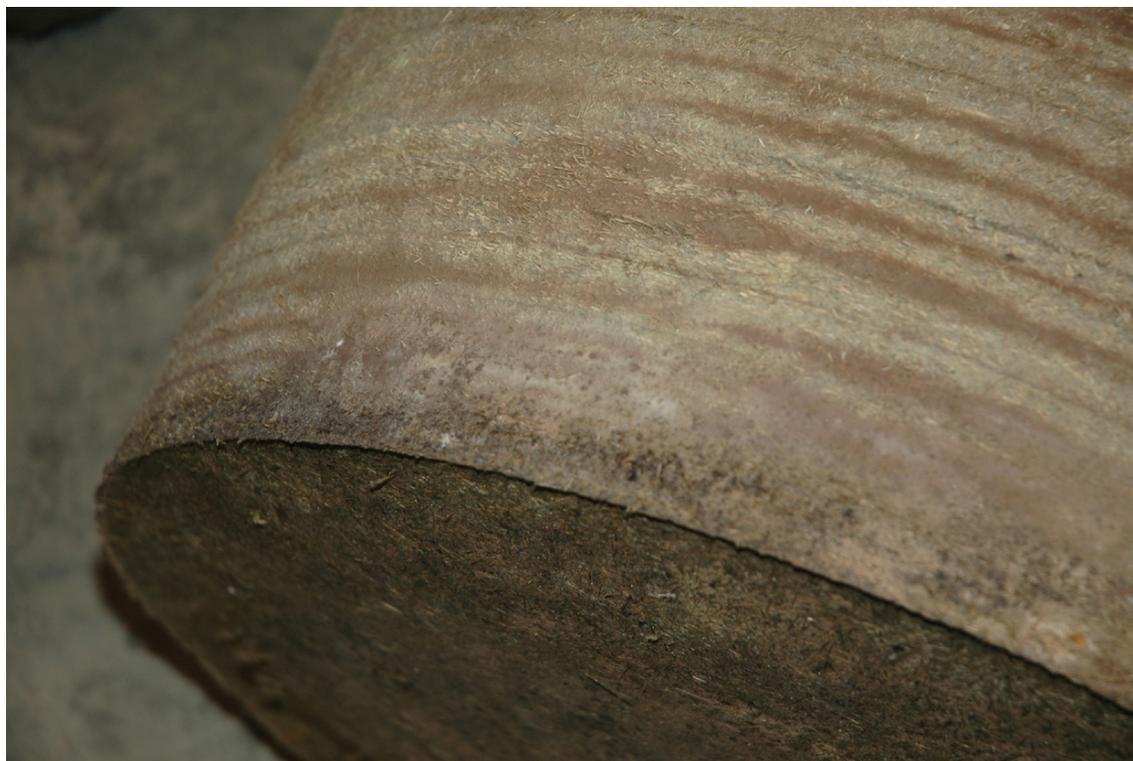
- Lower assembly was sitting 1 inch too low in the drum.
- The overall height of the lower assembly is 1 inch too short (26 vs 27 inches).
- The bottom 1.75 inches of the lower assembly has a moisture content of 100 %WME.
- At other locations that were measured, the remainder of the lower assembly has a moisture content of 20 to 26 %WME on the OD surface, and 16 %WME on the ID surface.
- Structural integrity of the bottom 2 inches of the lower assembly is very diminished, soft and wet to the touch. A liquid film / sheen would form on the surface with modest finger pressure.

Figure 3. Bottom region of lower fiberboard assembly after removal from drum on 2/24/09. Photograph provided by NMM.

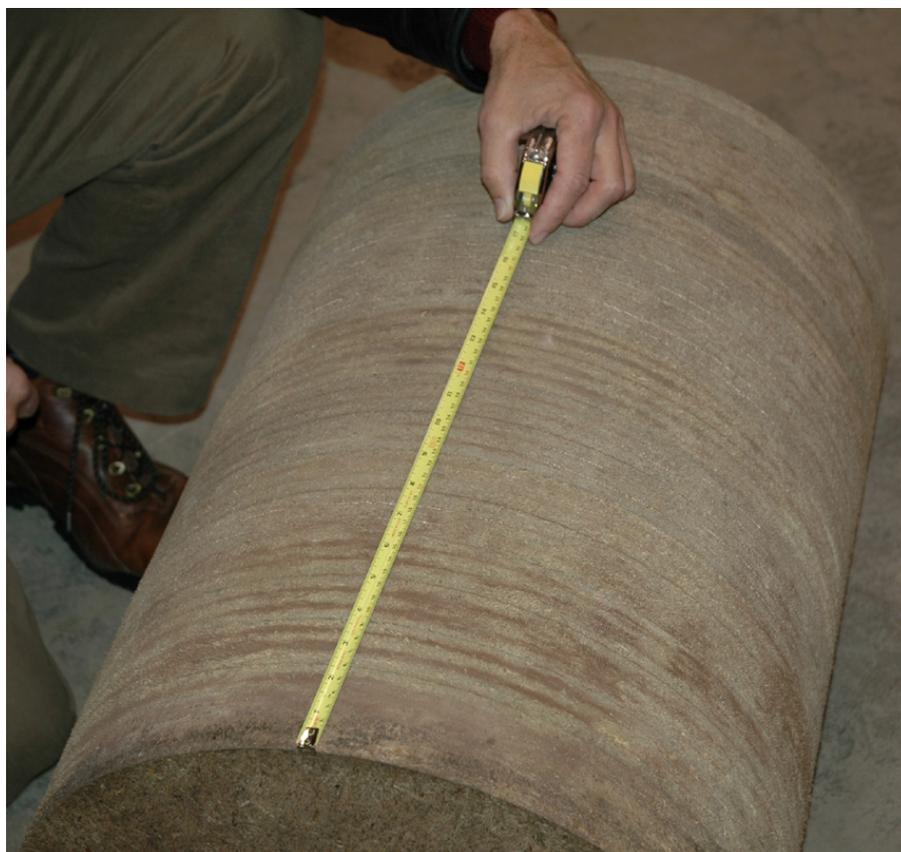
Figure 4. Lower assembly after removal from drum on 2/24/09. Photograph provided by NMM.

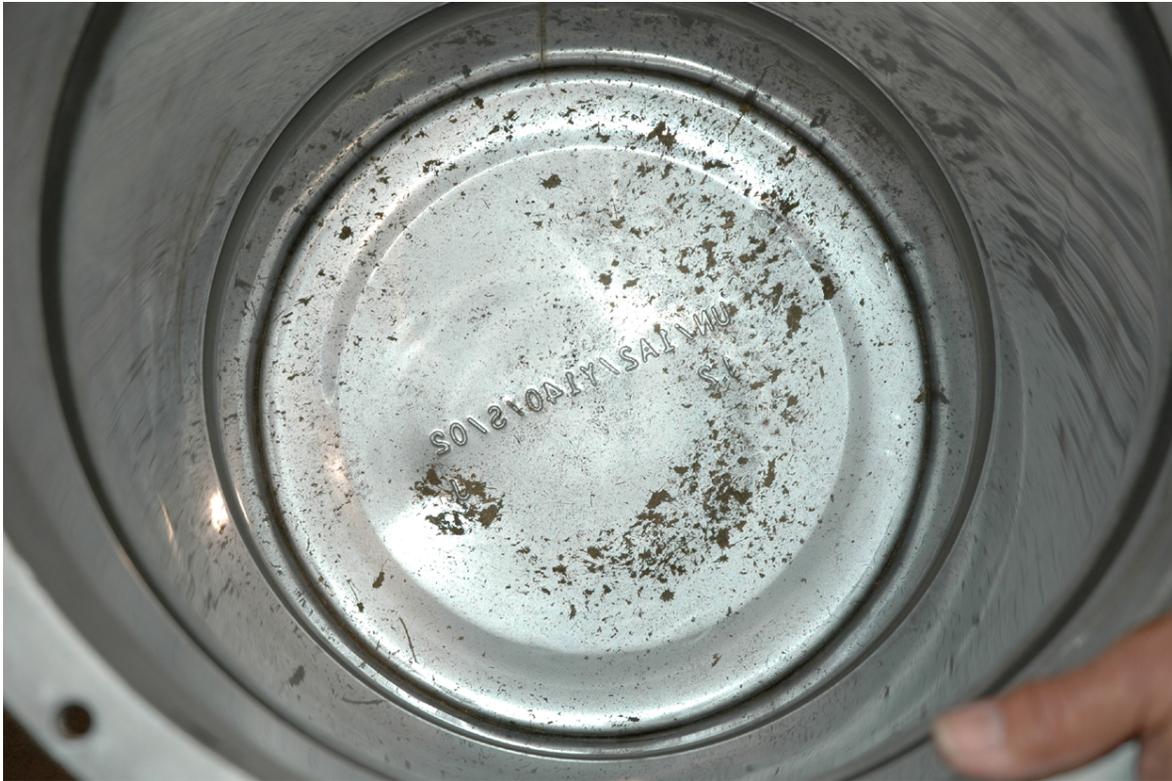
Figure 5. Interior of drum after removal of lower fiberboard assembly on 2/24/09. Photograph provided by NMM.

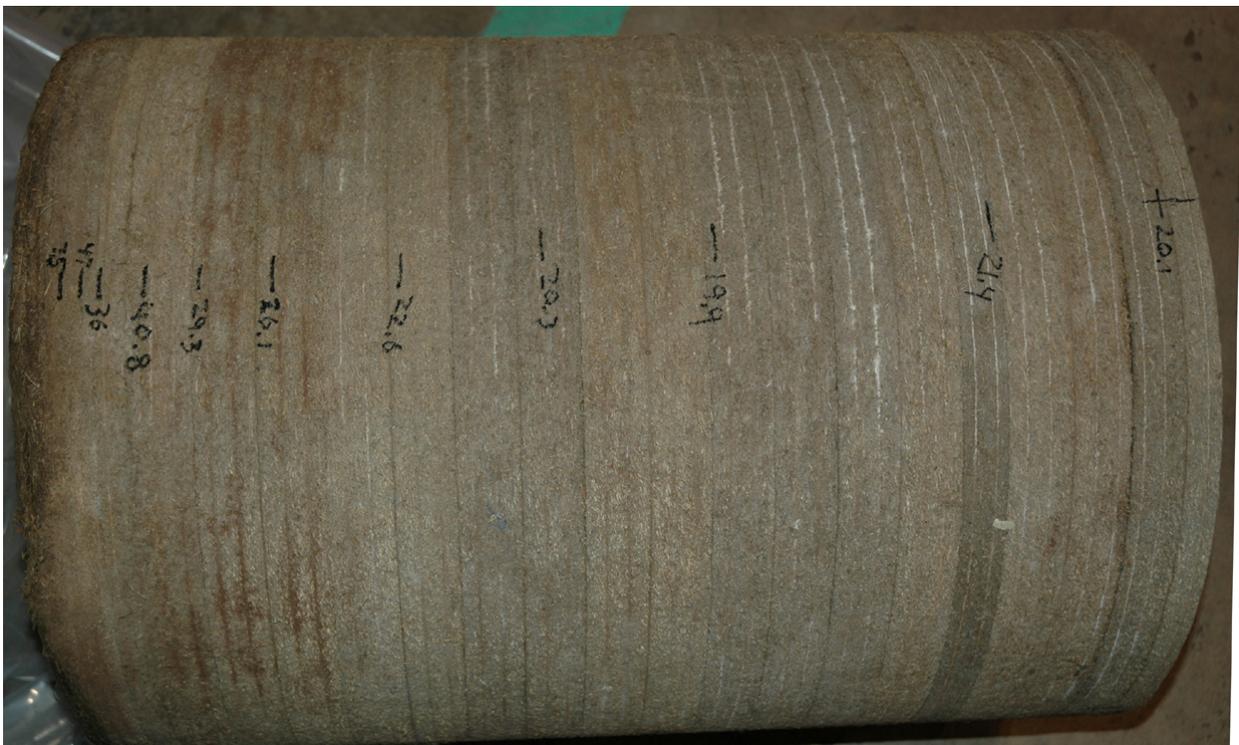
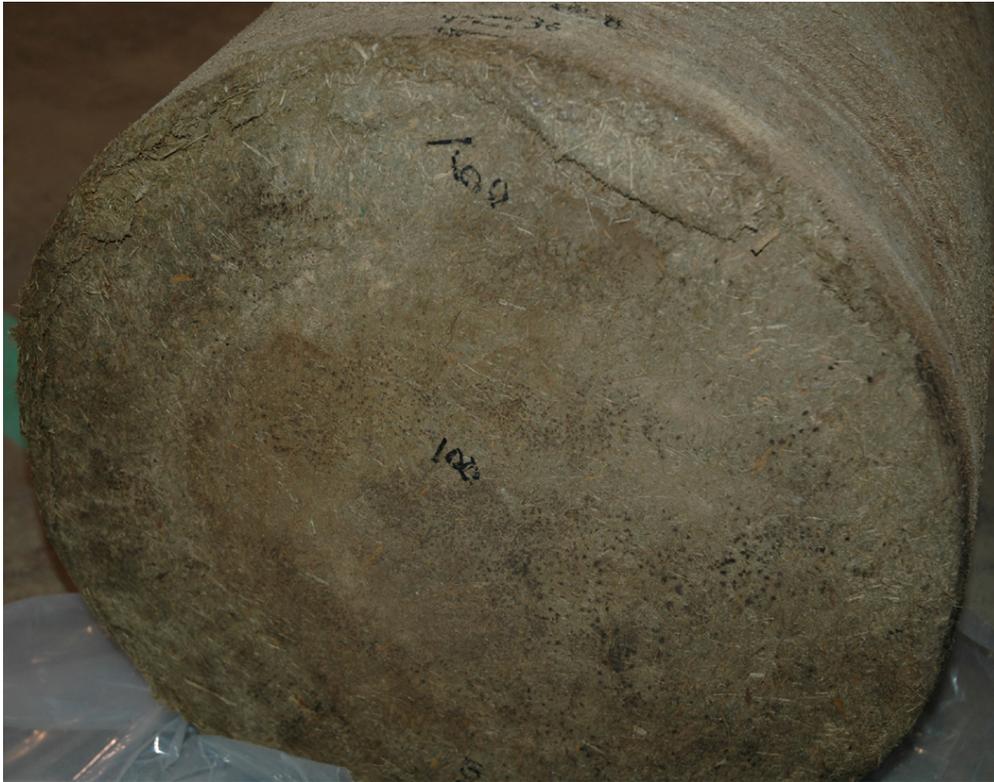
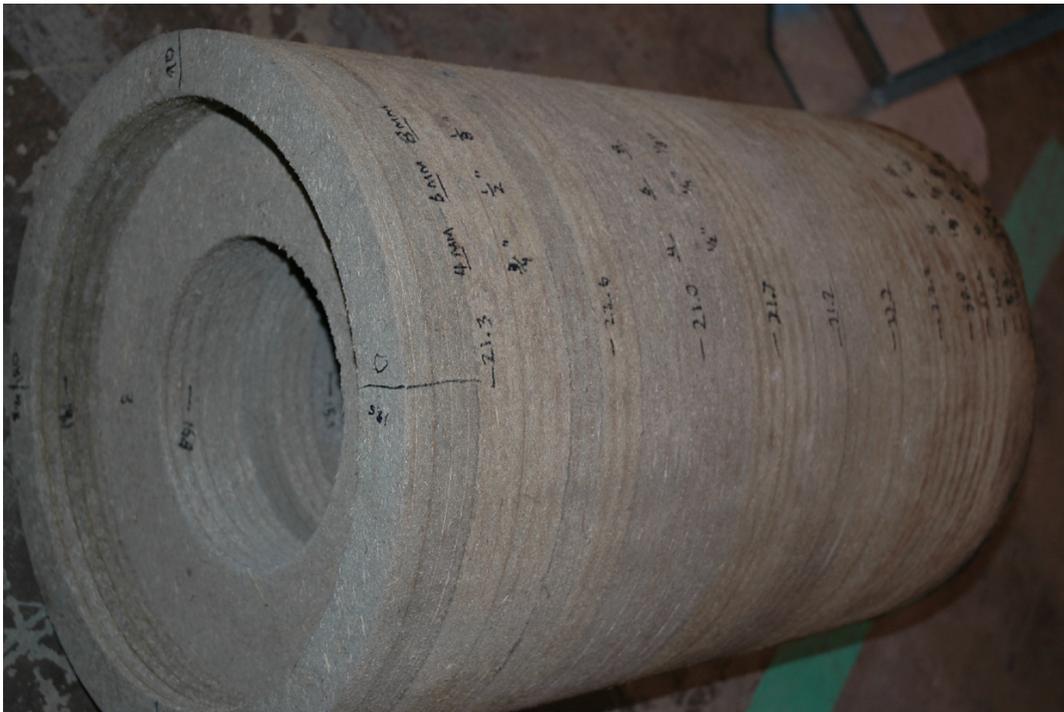
The moisture content of both assemblies was measured in a number of locations on 3/10/09. These values are summarized in Table 2. The height of the region at the bottom of the lower assembly with 100 %WME is smaller than noted in the 2/24/09 examination. This region extends for about 1 inch or less, whereas it was found to extend 1.75 inches in the earlier examination. At the same time, the recorded moisture content at higher elevations is about the same as previously recorded. This provides further evidence supporting the observation that the lower assembly appears somewhat drier than in the second examination. The lower fiberboard assembly, marked with results of moisture measurements, is shown in Figures 6-8.

Figure 6. Lower fiberboard assembly during examination on 3/10/09. The numbers are measured moisture content (%WME). Photograph provided by NMM.

Figure 7. Lower fiberboard assembly during examination on 3/10/09. The numbers are measured moisture content (%WME). Photograph provided by NMM.

Figure 8. Lower fiberboard assembly during examination on 3/10/09. The numbers are measured moisture content (%WME). Photograph provided by NMM.

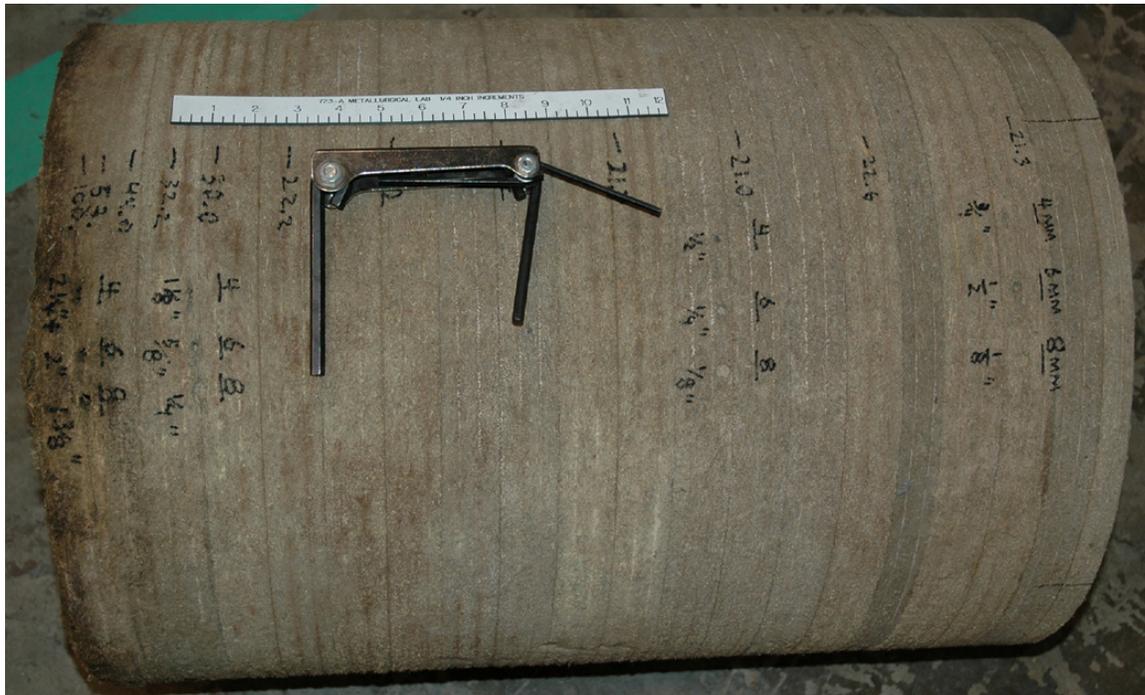
A qualitative test was performed to illustrate the extent to which the compressive strength has been compromised in the lower assembly. At several locations along the OD and bottom surfaces, each of 3 allen wrenches were pressed into the fiberboard with approximately the same force. Each impression on the side was located between glue joints. The wrenches were 4, 6 and 8 mm in size. See Figures 9 - 11. The depth of impression was recorded at each location, along with the moisture content. The same steps were performed on the OD surface of a section of fiberboard removed from a different assembly, for comparison. Results are summarized as follows:

Figure 9. Overview of lower assembly showing allen wrenches used to indent the fiberboard. At each set of indentations, the depth is recorded for each hole. Greater detail of the indentations is shown in Figure 10.

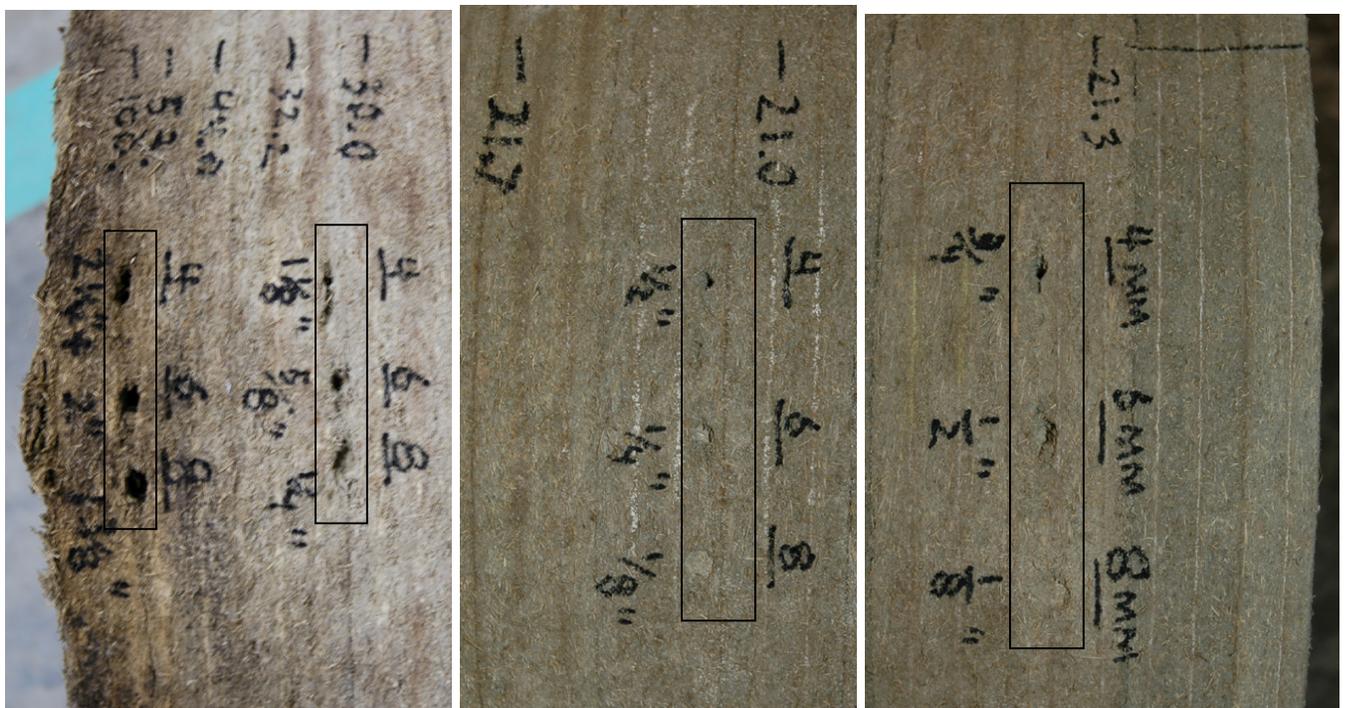
While these results cannot be converted directly into a measure of the fiberboard compressive strength, they do illustrate that significant loss of strength has occurred, especially where the moisture content is 30 %WME and greater.

The impression tests performed on the 9975-01819 lower fiberboard assembly show that significant loss of compression strength has occurred, even in the regions at ~20 %WME (~16 wt% water). The same impressions were made on a control fiberboard section with a moisture content of 8.8 %WME. The area under the stress-strain curve to a strain of 40% for this control material was separately found to be 70 - 78 psi. The impression tests show increasing penetration (and therefore decreasing strength) with increasing moisture content.

Figure 10. Impressions (in boxes) made in side of lower assembly by 3 allen wrenches. For each set of indentations, the depth, wrench size and moisture content is indicated.

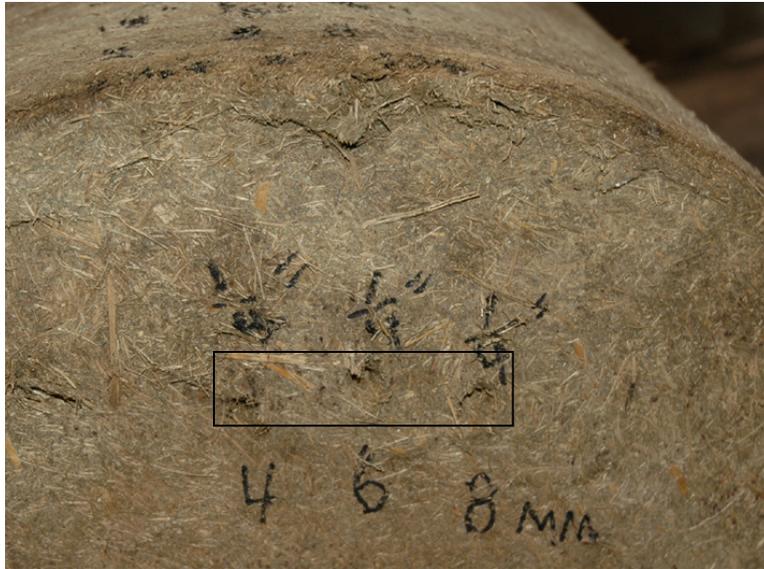
** On the bottom of the assembly, all 3 wrenches stopped at the first glue joint.

Figure 11. Impressions made on the bottom of lower assembly (in box) by 3 allen wrenches. The depth, wrench size and moisture content is indicated for each impression.

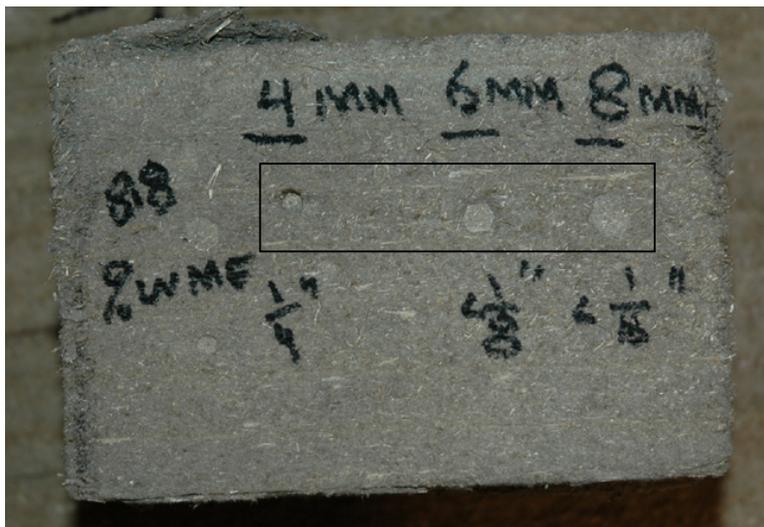
Figure 12. Impressions made in a control fiberboard section (in box) by 3 allen wrenches. This section had 8.8 %WME moisture content. The depth is noted by each impression.

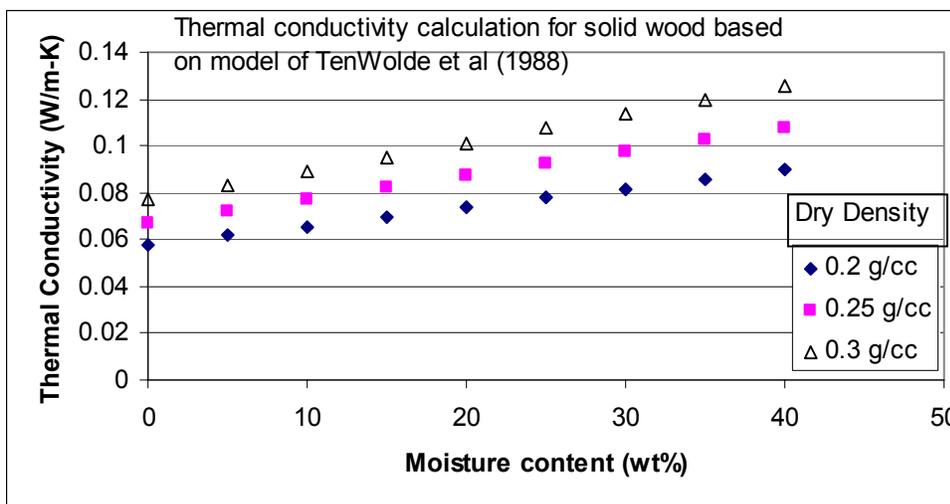
The thermal properties of the fiberboard determine the internal package temperature during normal operation and accident (fire) scenarios. The variation of thermal conductivity of fiberboard with increasing moisture is expected to follow that of solid wood, which is illustrated in Figure 12 (taken from Reference 5). In normal operation (i.e. steady state), an increase in thermal conductivity (resulting from excess moisture) will decrease the internal package temperature, which will reduce the long-term aging rate of the package components (e.g. fiberboard and O-ring seals). However, during a fire scenario, an increased thermal conductivity will lead to a faster increase in internal component temperatures. This undesirable consequence will be at least partially offset by two related effects. As the fiberboard heats up, the excess moisture will be driven off. This will produce an evaporative cooling effect based on the heat capacity of the excess moisture. Once the moisture is driven off, the thermal conductivity will

Figure 13. Calculated thermal conductivity of solid wood as a function of moisture content, for several values of dry density. Based on a model from Reference 5.
