EXAMINATION OF SHIPPING PACKAGE 9975-2130

Savannah River National Laboratory

Publication Date: July 2010

Revision Log**Document No.** SRNL-STI-2010-00402 **Rev. No.** 0**Document Title** Examination of Shipping Package 9975-2130

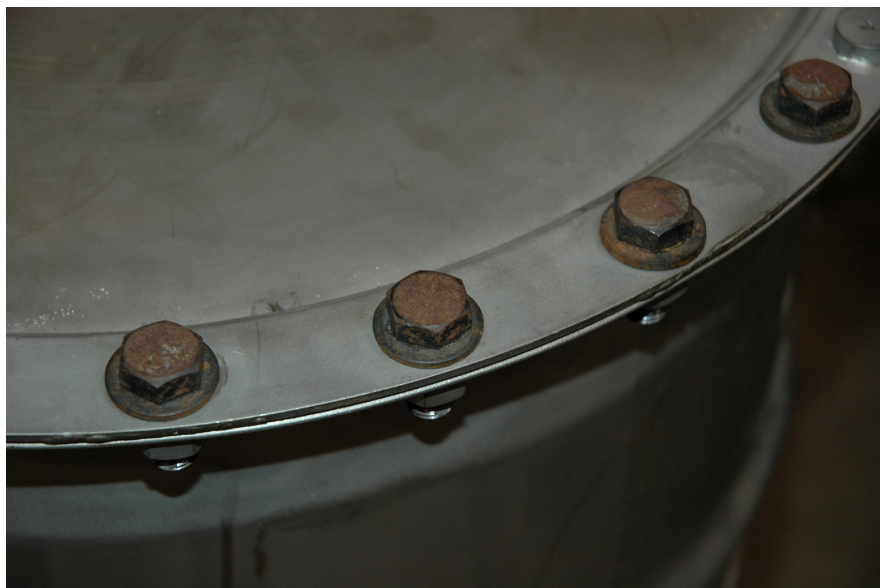
- The drum closure bolts had light superficial rust on top (Figure 1).
- The axial gap between the drum flange and upper fiberboard assembly was 1.099 inch (average of 4 measurements near the edge). The gap at the center was 1.111 inch.

Figure 1. Superficial corrosion on the drum closure bolts. (Photograph by B. Eberhard, NMM)

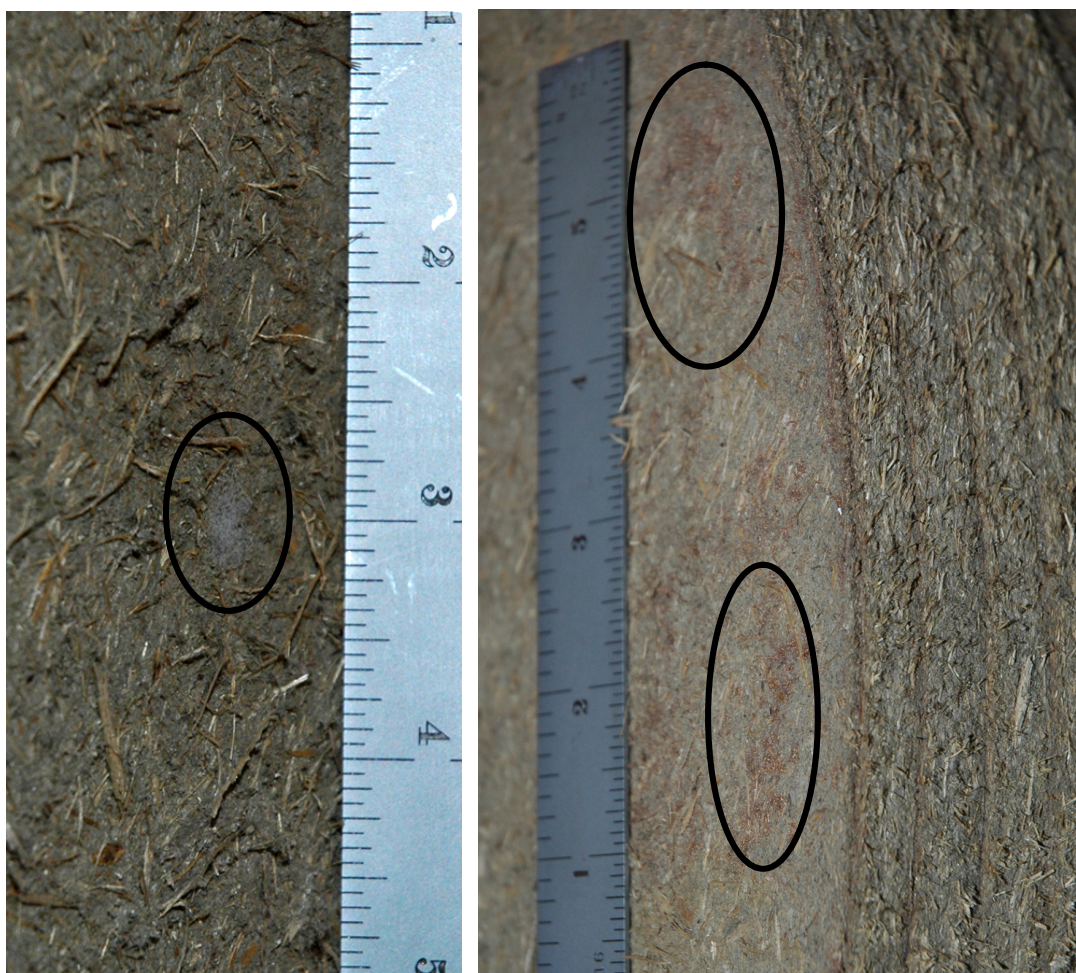
- The package had a moderate musty odor when opened. Numerous regions on the lower fiberboard OD and bottom surfaces assembly had a very light presence of mold. The mold was at an early stage of growth and hard to distinguish from the fiberboard. However, a few locations were more obvious, as illustrated in Figure 2

Package 9975-02130 has been in storage for 7 years. The overall moisture content of the fiberboard is somewhat higher than typically seen in conforming packages. However, the fiberboard still displays a general overall integrity similar to that expected for undegraded material. Some loss of strength would be expected from the elevated moisture levels, and some long-term degradation would be expected from the mold. However, damage from the mold appears to not be very advanced.

Figure 2. Regions of mold (circled) on the lower assembly bottom. (Photographs by B. Eberhard, NMM)

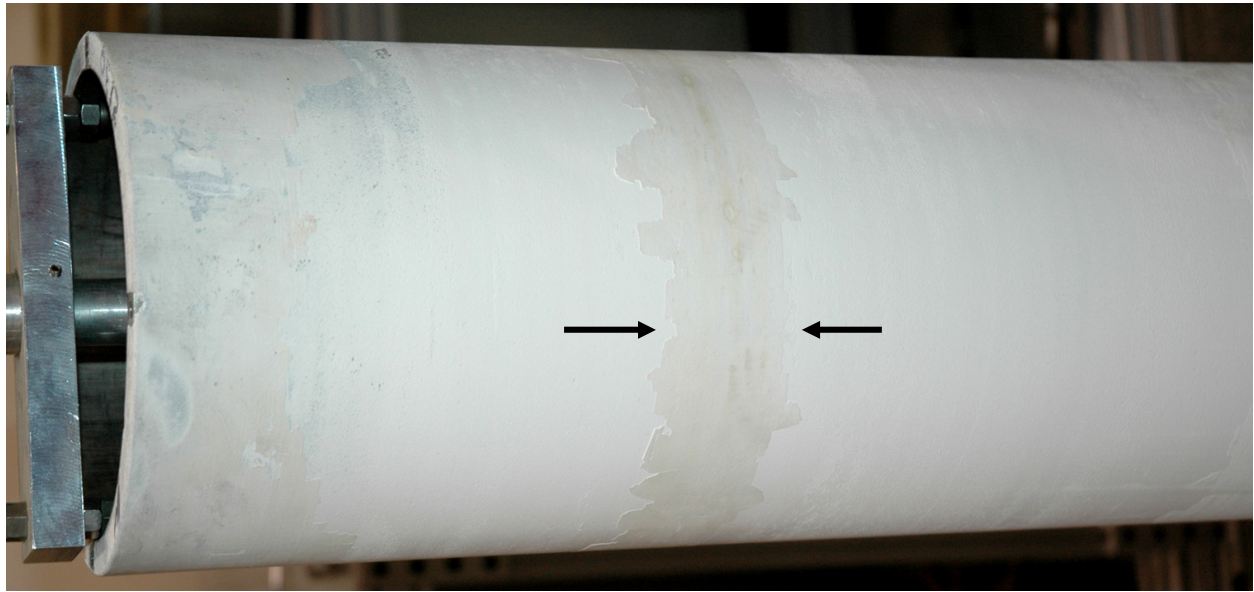
- The shield had a heavy corrosion layer (Figure 3), which flaked off easily. Much of the corrosion product rubbed off onto the lower fiberboard assembly (or fell to the bottom of the lower fiberboard assembly) as the shield was removed (Figure 4). An additional layer of white corrosion product remained after the outer layer flaked off.

- A few flakes of the shield corrosion product were collected to measure their thickness, which ranged from 0.0016 to 0.0031 inch. This is consistent with previous measurements on other shields [5, 6].

Figure 3. Corrosion on lead shield. Corrosion product in the central band (between arrows) has not yet flaked off. Corrosion product has flaked off above and below this band. (Photograph by B. Eberhard, NMM)

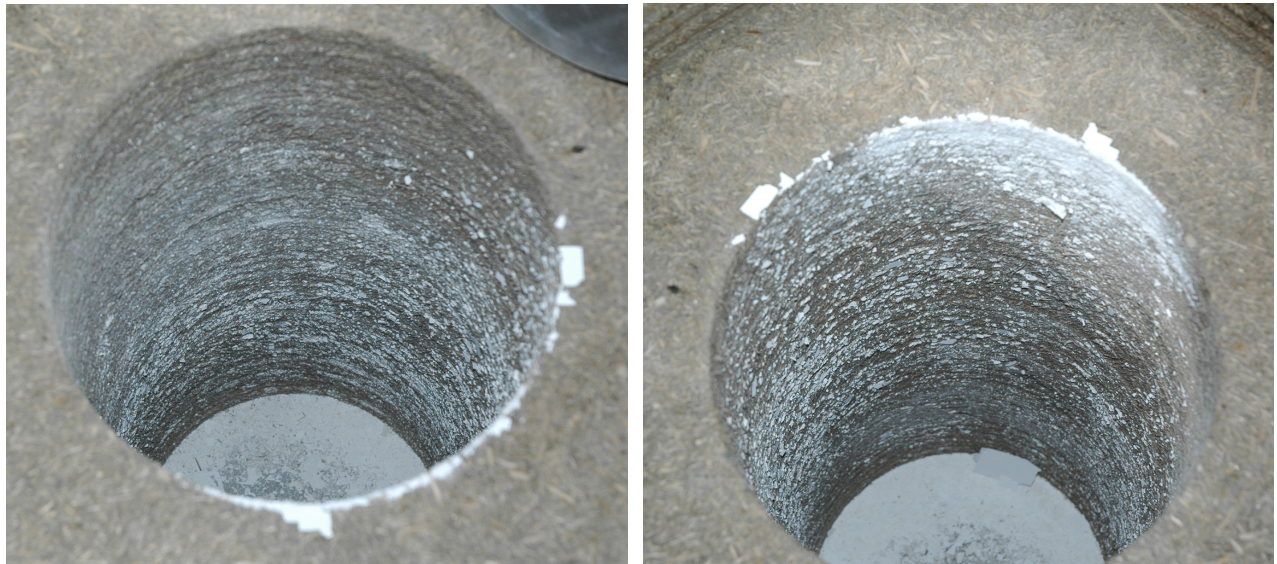
Figure 4. Lead carbonate corrosion product from the shield which remained on/in the lower fiberboard assembly after the shield was removed. (Photographs by B. Eberhard, NMM)

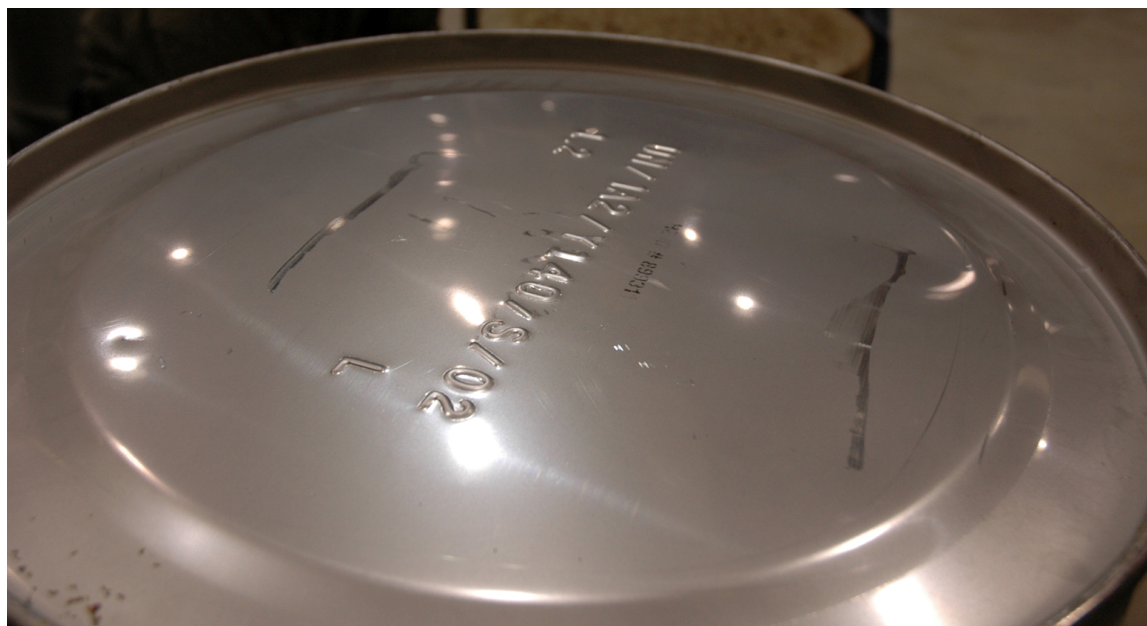
- The drum bottom contained a step (Figure 5), rather than the uniform concave profile seen previously. This created a pronounced compression ring of uniform width on the bottom of the lower fiberboard assembly. Interior to this ring, the lower fiberboard surface held many loose fibers and related debris.

The bottom of the lower fiberboard assembly contained numerous loose fibers protruding from the fiberboard surface within the inner area. This region fit within the step in the bottom of the

drum. The height of these fibers indicates that there was relatively little compression of the bottom layer into the step of the drum bottom. However, there is at least a small amount of compression along the outer ring of the bottom layer where it sits on the drum bottom outside of the step.

Figure 5. Bottom of drum, showing step profile. (Photograph by B. Eberhard, NMM)

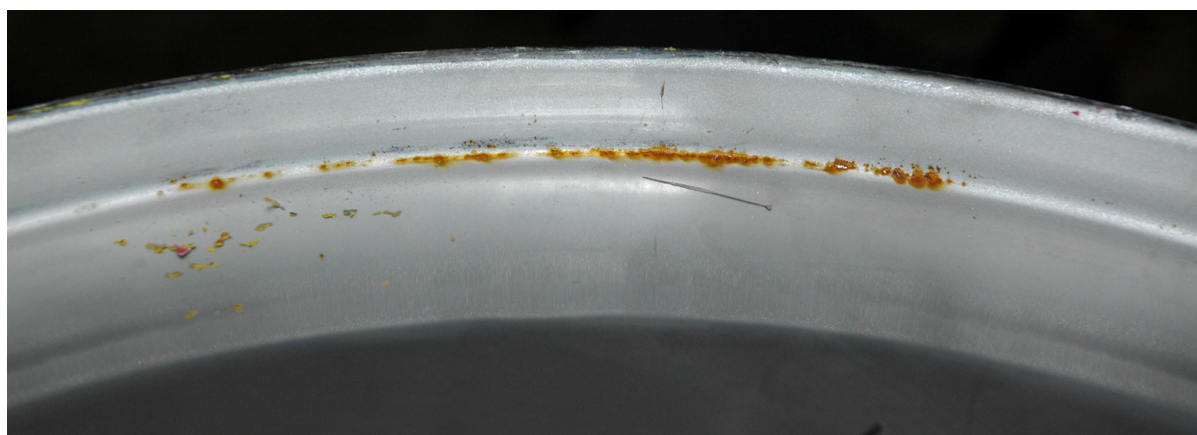
(a)

- On the underside of the drum, several spots of corrosion were noted along the bend between the bottom and the lip on which the drum stands (Figure 6).

Figure 6. Two of the heavier regions of corrosion on the drum bottom, along the edge of the lip the drum stands on. (Photographs by B. Eberhard, NMM)
