EXAMINATION OF SHIPPING PACKAGES 9975-02274 AND 9975-04769

Document No. SRNL-STI-2011-00734

Summary

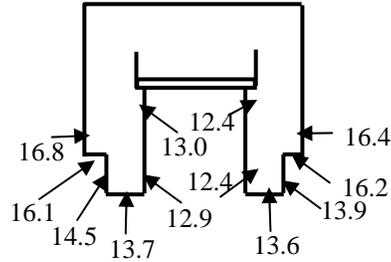
Moisture content
(%WME)

- Fiberboard moisture content was measured on the upper assembly and outer surfaces of the lower assembly. The upper assembly moisture was approximately 12 – 14 % WME on the inner surfaces, and 16 – 17 % WME on the outer surface. The lower assembly moisture was approximately 16 – 19 % WME on the outer surfaces.

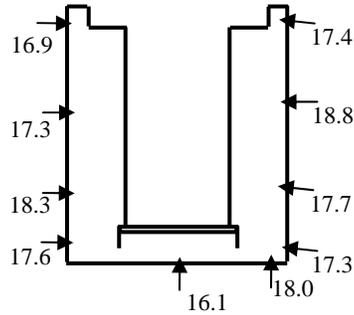
Moisture content
(%WME)

- Dimensional measurements are summarized in Table 1.
- A strong musty odor was associated with the fiberboard. A slight fuzziness in the surface texture in regions of the lower assembly appeared consistent with the presence of mold, although the direct visual evidence of mold was minimal. A few small white spots observed along a glue line is consistent with the presence of mold.

The fiberboard in package 9975-02274 had slightly elevated moisture content, up to 19 % wood moisture equivalent (WME). Other compliant packages have displayed similar moisture levels locally, but not as consistently throughout the entire fiberboard assembly. Evidence of mold was observed on the lower assembly, although it appeared relatively dormant. Relatively little compaction or physical degradation was observed in this package. Due to the mold, it is recommended that the fiberboard in this package not be re-used.

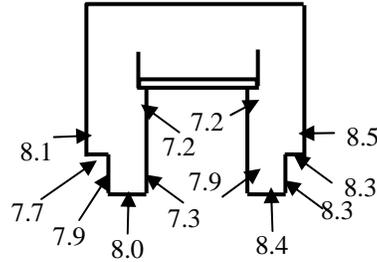
Moisture content
(%WME)

- The axial gap (average of 4 readings) at the top of the package was 1.001 inch.
- Upon re-assembly of the package, the axial gap was 0.943 inch.
- The relative humidity in the top air space was 39 %, with a temperature of 19.6C.
- Fiberboard moisture content was measured on the upper assembly and outer surfaces of the lower assembly. The upper assembly moisture was approximately 7 - 9 % WME. The lower assembly moisture was approximately 8 - 10 % WME on the outer surfaces.
- Dimensional measurements are summarized in Table 2.
- Relatively little corrosion product was present on the shield.

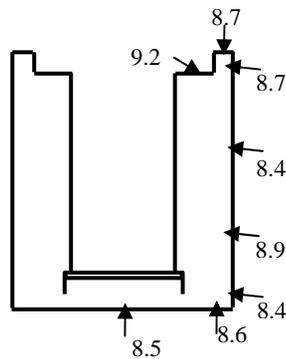
Moisture content
(%WME)

No specific degradation was observed in the fiberboard of 9975-04769. The material remains solid with no significant compaction. There was no indication of mold in this package. The source of the excessive axial gap appears to be variation in the height of the fiberboard assemblies. The height of the upper assembly (dimension UH1) varies by more than 0.2 inch, while the lower assembly varies in height by approximately 0.1 inch. Depending on the relative orientation between the upper and lower assembly, the total fiberboard height could vary. This would account for the varying measurements of axial gap, and the measurement of an axial gap less than 1 inch after reassembly of the package. The fiberboard in this package is relatively dry and physically sound, and appears acceptable for continued use.
