## **SRNL Phase II Shelf Life Studies – Series 1 - Room Temperature and High Relative Humidity**

J. I. Mickalonis  
J. M. Duffey

September 2012

Savannah River National Laboratory  
Savannah River Nuclear Solutions, LLC  
Aiken, SC 29808

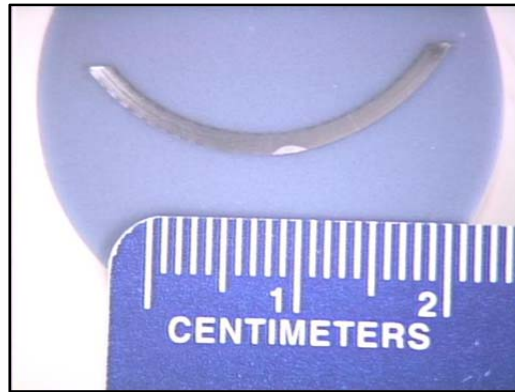
Figure 3-7 Mounted section of coupon TD05 from Vessel B after an 85-day exposure of Series 1 test

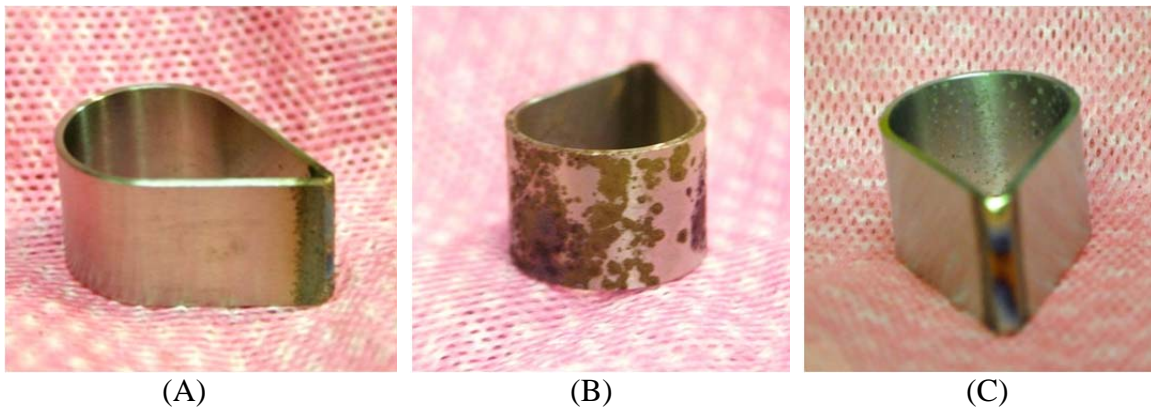
The teardrop coupon in contact with the oxide/salt mixture (TD05) experienced more corrosion than the coupon exposed only in the vapor space (TD04) as shown in Figure 5-1 (A) and (B) for the as-is condition. The TIG closure welds on both coupons, which are in the vapor space, had a buildup of corrosion products, although TD05 appeared to have less corrosion product than TD04. This difference may be associated with the orientation of the coupons' TIG welds, the vapor-exposed coupon TIG weld being closer to the oxide/salt mixture than the salt-exposed coupon TIG weld. Pitting was also observed on the interior surface of TD05 as shown in Figure 5-1 (C), which is after cleaning in the nitric acid solution.

Figure 5-1 Photographs of Vessel B teardrop coupons after 85-day exposure: (A) TD04, vapor exposure, as-is condition; (B) TD05, oxide/salt contact, as-is condition; and (C) TD05, oxide/salt contact, after nitric acid cleaning

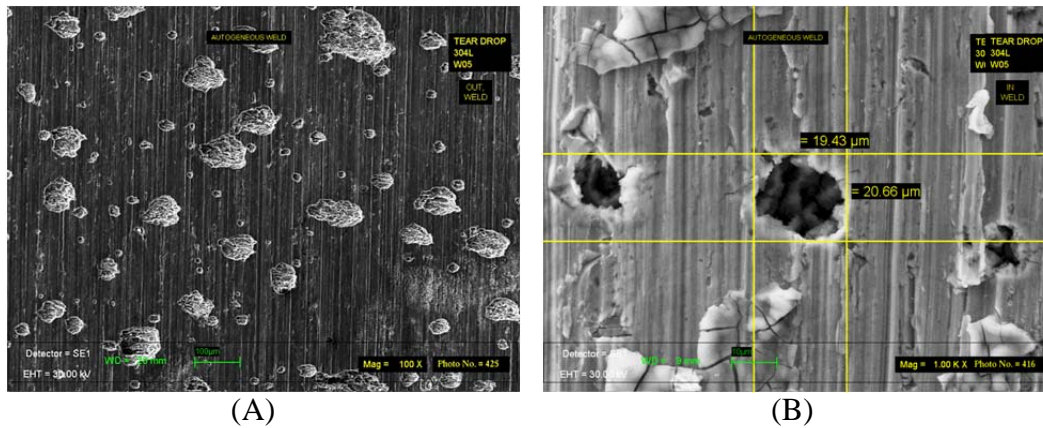
Closer examination of the surfaces of TD05 showed pits that appeared to be of two sizes as shown by the SEM micrograph in Figure 5-2 (A) for pitting outside the weld area. Elongated pits have their long axis perpendicular to the direction of the tensile stress which is parallel to the machine marks. The larger pits were on the order of 100  $\mu\text{m}$  diameter and smaller pits about 5  $\mu\text{m}$ .

Figure 5-2 SEM micrographs of pitting on coupon TD05: (A) pitting in area outside autogenous weld (100x) and (B) pit measurement of small pit in autogenous weld (1000x)

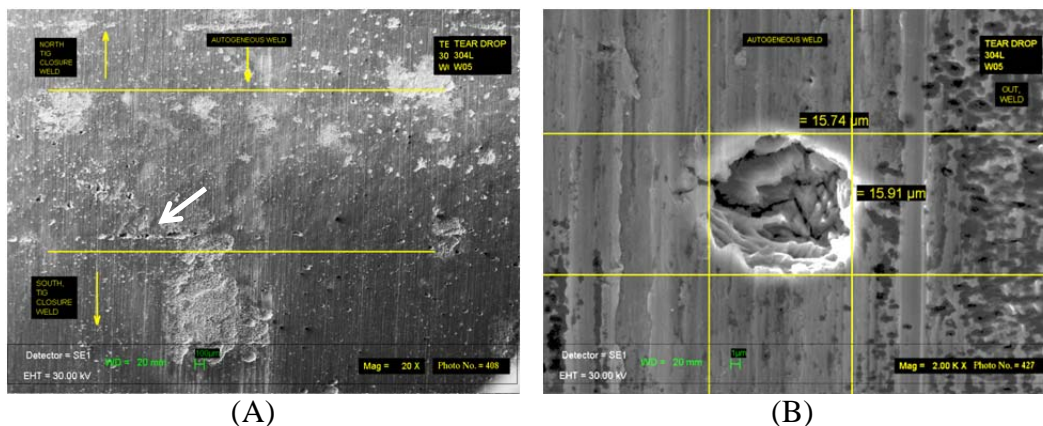
Broad areas of localized corrosion were also observed both in and out of the weld as shown by Figure 5-3 (A). These areas had nominal diameters on the order of 300 to 500  $\mu\text{m}$ . These areas may result from the coalescence of small pits as seem probable from the large population of pits surrounding these areas or from a more general corrosion mechanism as appears in Figure 5-3 (B) to the right of the measured pit.

Figure 5-3 SEM micrographs of pitting and localized corrosion on coupon TD05: (A) broad areas of corrosion near autogenous weld (arrow pointing to linear array

Near the autogenous weld, pits also formed linear arrays as shown by the white arrow in Figure 5-3 (A). These arrays did not extend across the sample but in discrete segments. These pits are believed to be occurring due to preferential corrosion along the heat affected zone (HAZ). In the HAZ, both compositional and microstructural changes occur due to heat input from the welding process. These changes may lead to an increased susceptibility to corrosion. Figure 5-4 shows a cross-sectional micrograph of a pit in the HAZ of the autogenous weld in TD05

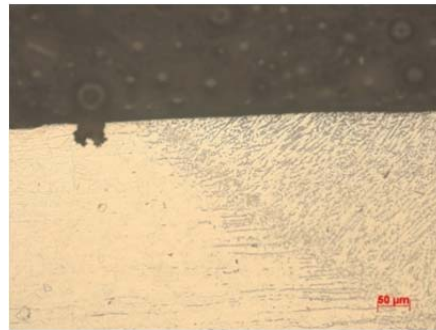
Figure 5-4 Cross-sectional micrograph showing pitting in the heat affected zone of coupon TD05 (200x)

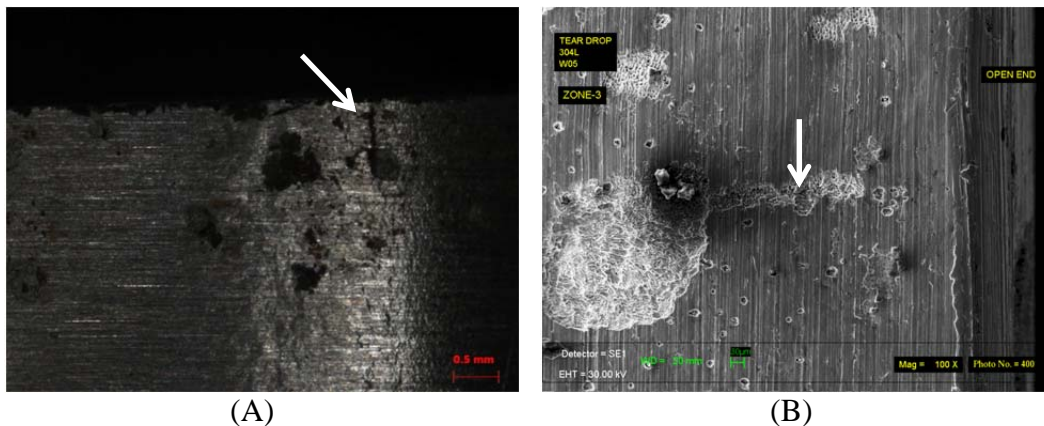
Cracking in TD05 was suspected after examination of the coupon on the stereomicroscope as shown in Figure 5-5 (A), however, corrosion/oxidation products on the surface obscured the suspect crack area. After alkaline cleaning, an array of pits was observed on the surface (Figure 5-5 (B)). Cracking was still suspect because of the indications at the bottom of the pits as shown by the arrow in Figure 5-5 (B). Pits are known to be initiation points of cracks, but further corrosion may also be occurring at the surface as the crack advances. Further evidence for this phenomenon is given below.

Figure 5.5 Suspect cracking (shown by arrow) in coupon TD05: (A) stereo-micrograph (25X) after nitric acid cleaning and (B) SEM micrograph after alkaline cleaning (80x)

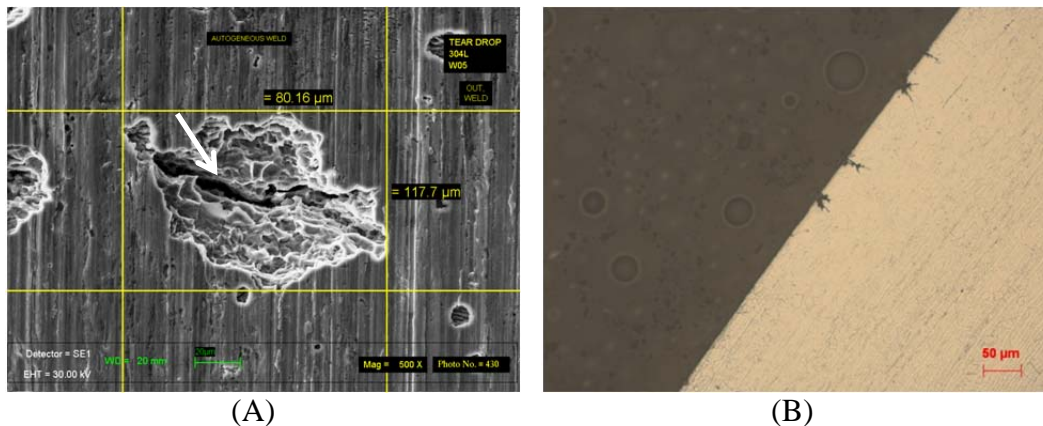
Suspect cracks were also observed in smaller pits as indicated by the arrow in Figure 5-6 (A) and confirmed by cross-sectional metallography of TD05 (Figure 5-6 (B)).

Figure 5-6 Micrographs demonstrating the presence of cracks in coupon TD05: (A) SEM micrograph of single pit with suspect crack (as indicated by arrow) at the bottom (500x), and (B) cross-sectional micrograph of pits and cracks near the surface (200x)

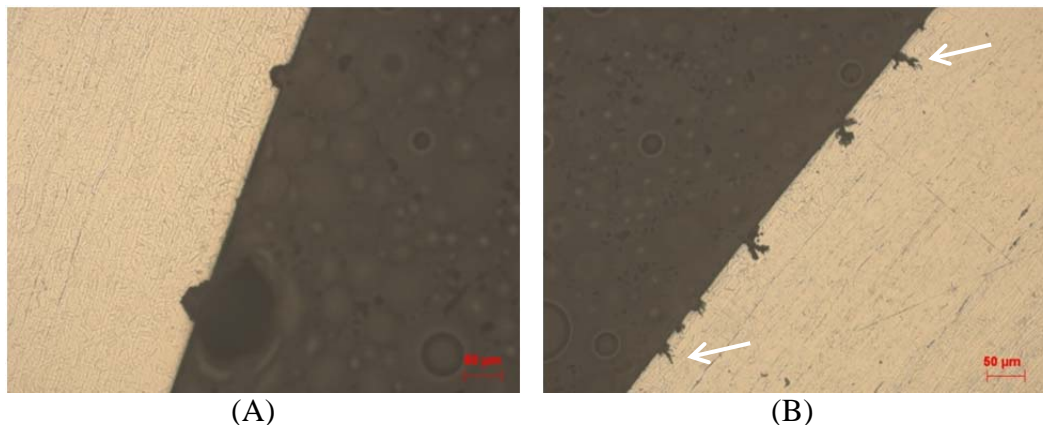
The pit morphology was quite variable with some pits showing the expected hemispherical shape of a classic pit (Figure 5-7 (A)) while others had highly irregular shapes associated with preferential corrosion occurring along an advancing crack wall or along the rolling direction (Figure 5-7 (B)).

Figure 5-7 Cross-sectional micrographs showing pit morphology for coupon TD05: (A) interior surface (200x), and (B) exterior surface (200x)

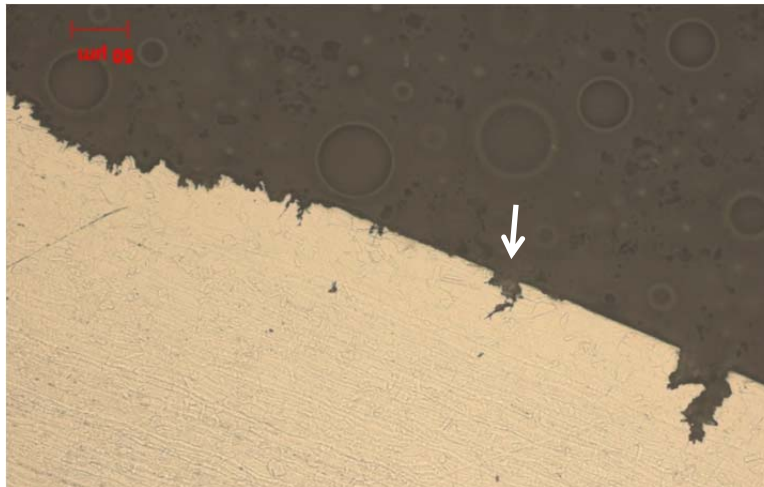
The corrosion morphology of TD05 provides some insight into the crack initiation and propagation within the 85-day exposure. The pit marked by the arrow in Figure 5-8 shows a widening within the crack indicating that the corrosion continues as the crack front is advancing or forming which in this case appears to be by a transgranular mode. The large pit (upper left of Figure 5-8), which is on the order of 500  $\mu\text{m}$  wide and 50  $\mu\text{m}$  deep, has not been shown to be a dominant location of crack initiation. More cracks or crack like features were observed on smaller pits.

Figure 5-8 Cross-sectional micrograph (micrograph inverted for ease of viewing) displaying areas of crack initiation and ongoing corrosion along crack wall in coupon TD05 (200x)

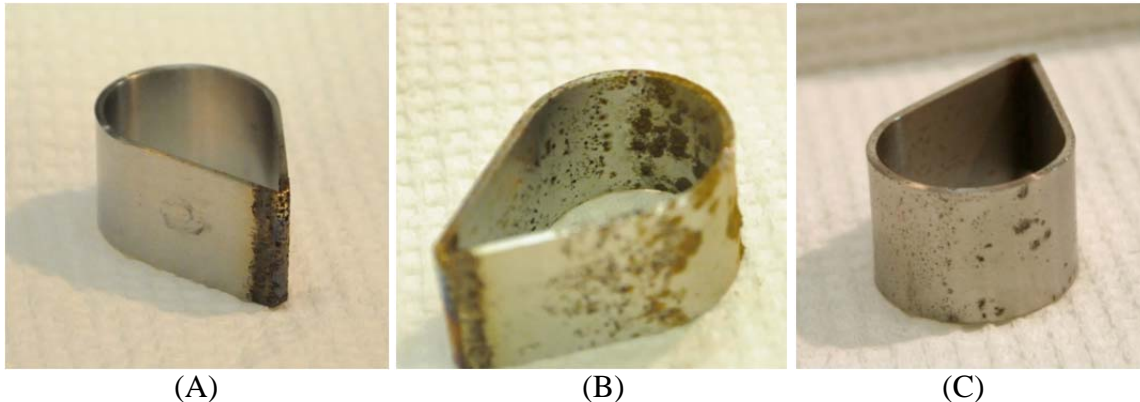
The teardrop coupon in contact with the oxide/salt mixture experienced (TD03) more corrosion than the coupon exposed only in the vapor space (TD09) as shown in Figure 5-9 (A) and (B) for the as-is condition. The TIG closure weld on both coupons had a buildup of corrosion products, although TD03 had fewer corrosion products than TD09. This difference is probably associated with the orientation of the coupon's TIG welds, the vapor exposed coupon TIG weld being closer to the oxide/salt mixture than the salt-exposed coupon TIG weld. As can be seen in Figure 5-9 (B) and (C) the pit-like features appear to have a bimodal distribution similar to coupon TD05 from Vessel B.

Figure 5-9 Photographs of Vessel C teardrop coupons (as-is condition) after 175-day exposure: (A) TD09, vapor exposure, as-is condition; (B) TD03, oxide/salt contact, as-is condition; and (C) TD03 after nitric acid cleaning

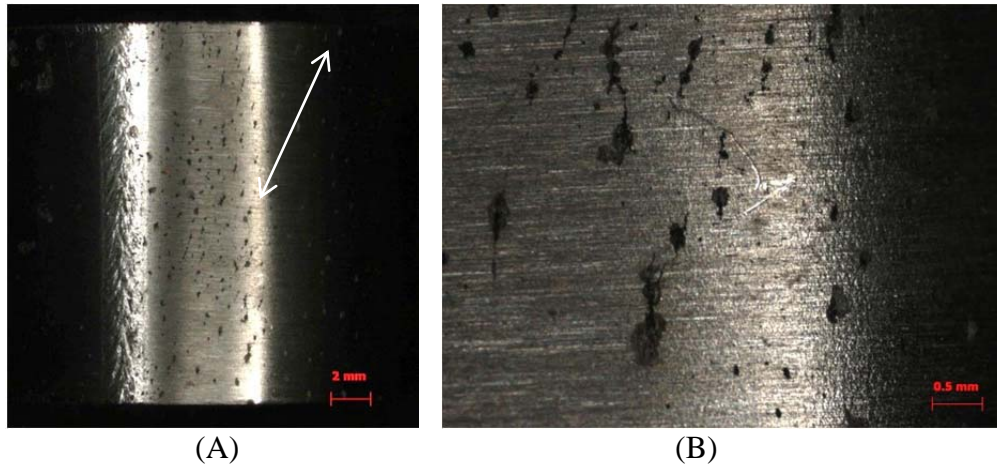
Figure 5-10 Stereo-micrograph of pitting in coupon TD03: (A) pitting directionality (white line indicating direction, 5x) and (B) tiny cracks extending from pits (25x)

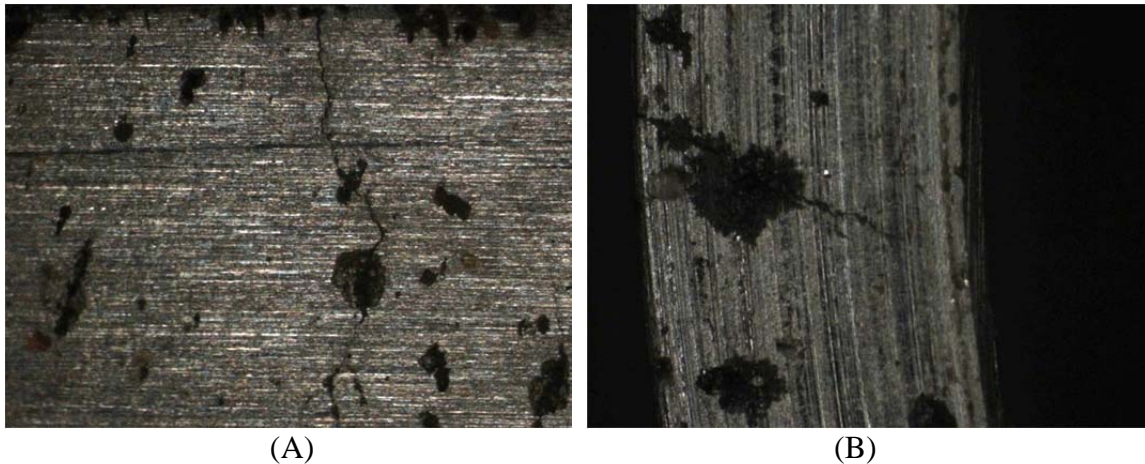
The most significant crack was found approximately 3 mm from the edge of the autogenous weld, which is outside the HAZ. This crack had extended to the edge of the coupon and was longer than any of the others. The crack could be observed on the side as well, which indicated that the crack had extended part way through the coupon thickness (Figure 5-11 (A) and (B)).

Figure 5-11 Stereo-micrographs of largest crack observed in coupon TD03 after 175-day exposure: (A) crack with pit along its length on exterior surface of coupon (63x) and (B) crack with pit along its length on edge of coupon (63x)

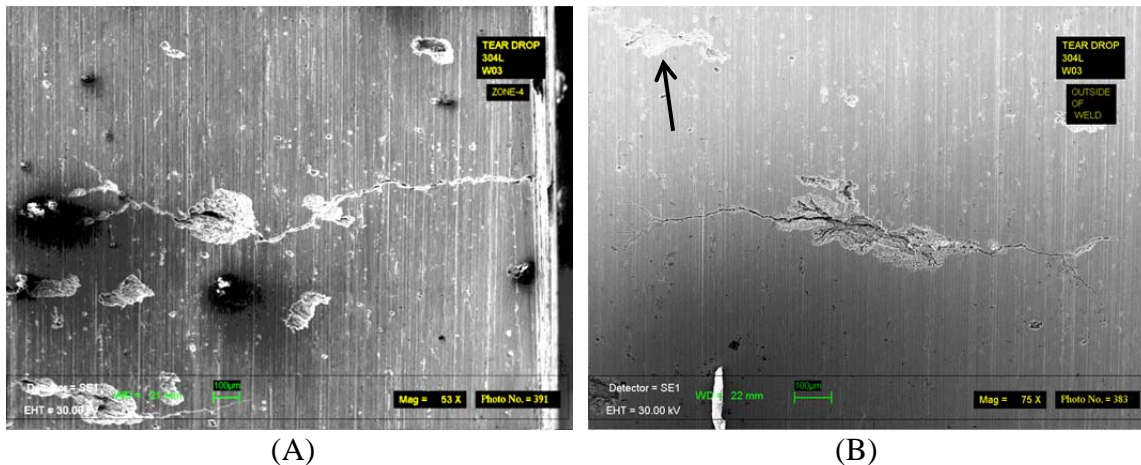
The cracks observed under the stereomicroscope were confirmed with the SEM after further cleaning with the alkaline cleaner to remove all the oxide products. The largest crack shown in Figure 5-11 (A) is shown again in Figure 5-12 (A). The two micrographs are approximately the same magnification. Note in Figure 5-12 (A) that the crack has branched towards the left of the pit and extends to the edge on the right side of the pit, indicating that this crack may have initiated at the pit. Note in the lower left of the micrograph the crack associated with another pit; again similar to that shown in Figure 5-11 (A).

Figure 5-12 SEM micrographs of crack in coupon TD03 after 175-day exposure: (A) crack bifurcating on one end (53x), and (B) crack branching on both sides of a pit (75x)

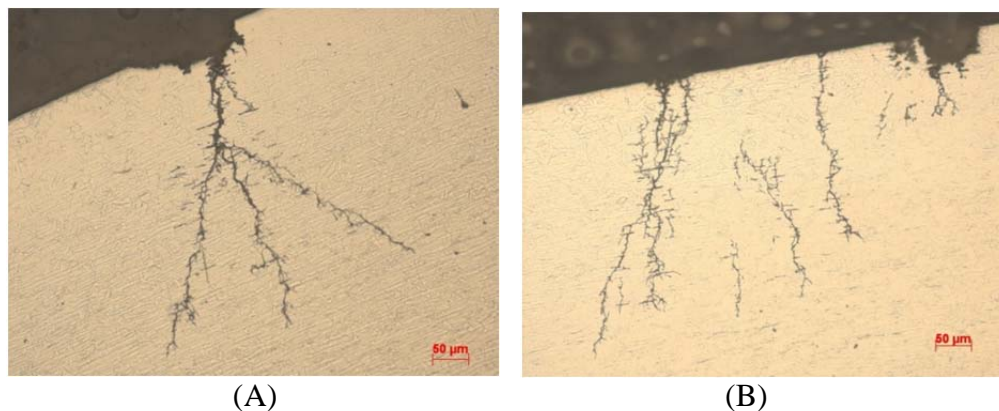
After the 175-day exposure the cracks had clearly progressed well beyond the initiation site unlike after the 85-day exposure. The serial metallography clearly showed well developed cracks with extensive branching as shown in Figure 5-13 (A), a classic crack emanating from a pit. Cracks were also observed not associated with pits (Figure 5-13 (B)). From these micrographs, cracks appear to advance either via the grain boundary, through the grain, or along the rolling direction. Corrosion of the crack side wall also seems to occur as noted by the widening of the crack at locations distant from the initial crack.

Figure 5-13 Cracking observed in coupon TD03 after 175-day exposure: (A) crack associate with pit (200x) and (B) cracks not associated with pits (200x)

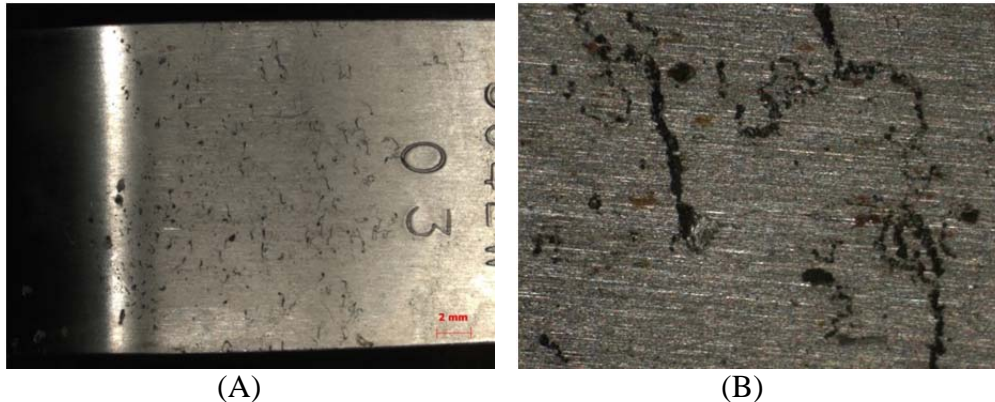
An unusual feature noted for TD03 and in the TIG weld of most coupons was a linear grouping of small pit-like features. Coupon TD03 has this on one part of the coupon facing down towards the oxide/salt mixture but not in it. The stereo-micrographs of Figure 5-14 show these arrays of pit-like features, which had a ‘pearl necklace’ appearance. The higher magnification micrograph gives a clearer indication of the presence of pits. These arrays were either straight or quite curvaceous.

Figure 5-14 Stereo-micrographs of coupon TD03 with pit arrays (A at 5x and B at 63x)

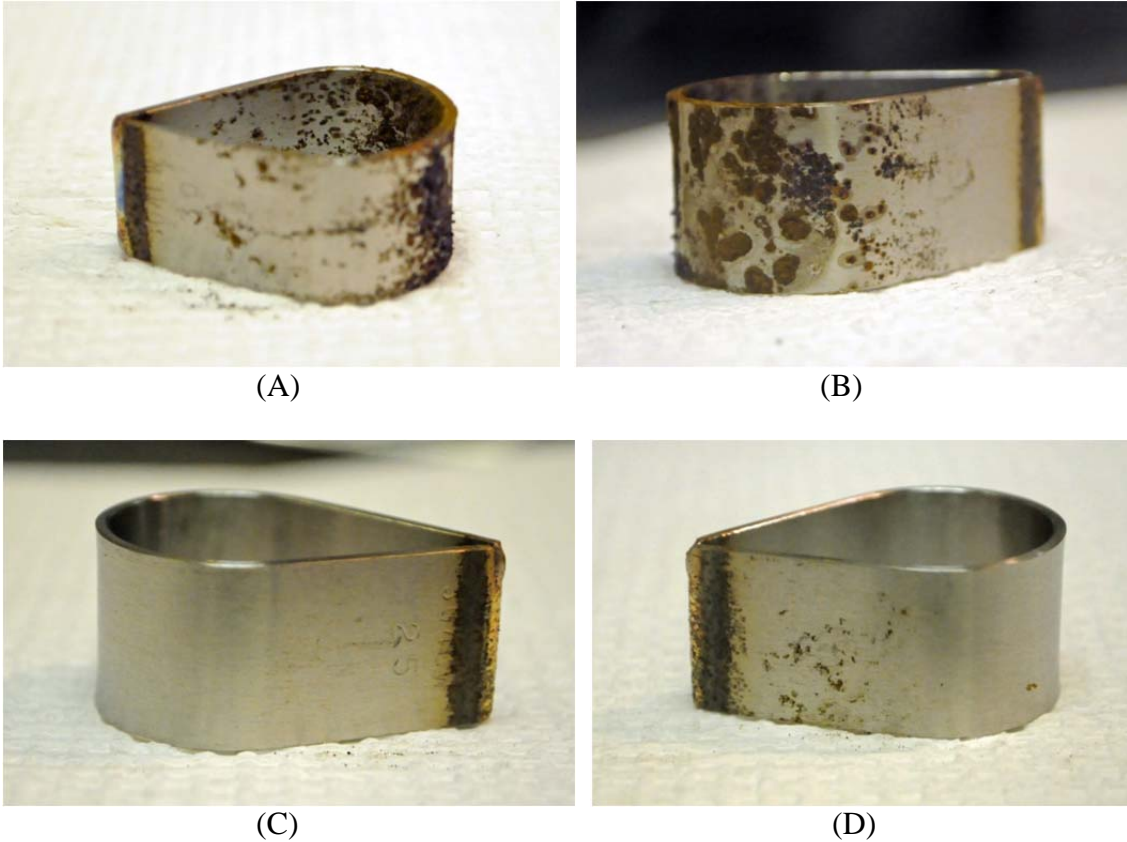
The TIG closure weld on both coupons had a buildup of corrosion products. The degree of corrosion appeared similar for the two exposure conditions unlike shorter duration exposure times where the vapor-exposed coupon TIG weld appeared to have more corrosion products.

Figure 5-15 Photographs of Vessel A coupons after 340-day exposure: (A and B) coupon TD30, oxid/salt contact, as-is condition; and (C and D) coupon TD25, vapor exposure, as-is condition

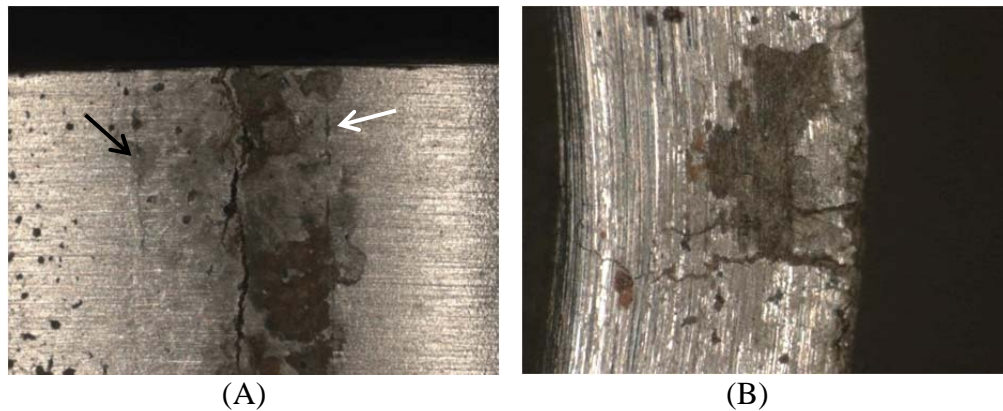
For TD30 a significant near-through wall crack was observed along and through the weld unlike the coupons from shorter exposures. This crack did not grow across the entire width of the coupon. Figure 5-16 (A) and (B) shows the crack on the exterior surface and edge of TD30. Similar to other cracks observed on TD03 from Vessel C, the crack showed extensive branching. An additional crack in the weld was also present as indicated by the white arrow in Figure 5-16 (A).

Figure 5-16 Stereo-micrographs of coupon TD30 after 340-day exposure (arrows indicating secondary cracks): (A) crack on exterior surface (25x) and (B) crack on edge (63x)

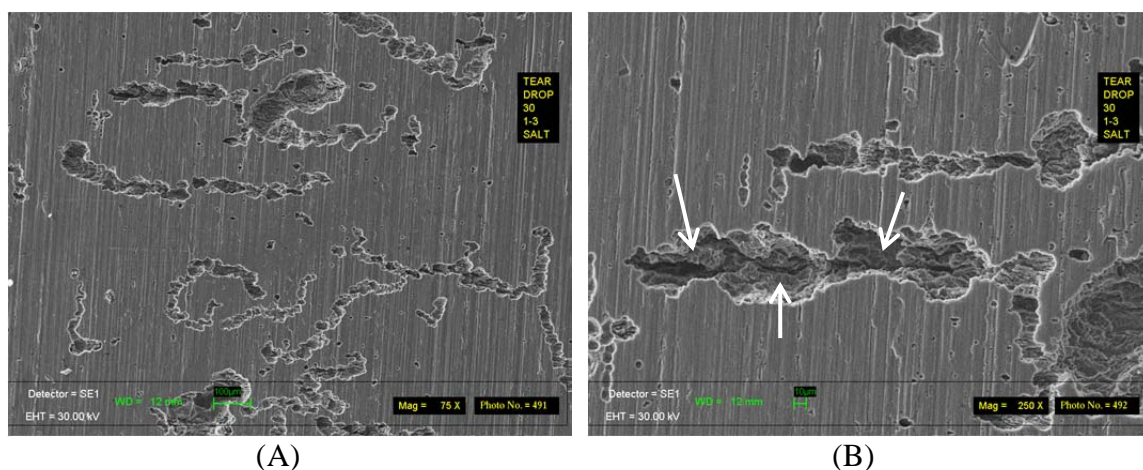
Figure 5-17 Pitting and SCC outside the autogenous weld region of teardrop coupon TD30 after 340-day exposure (A at 75x and B at 250x, arrows indicate crack opening)

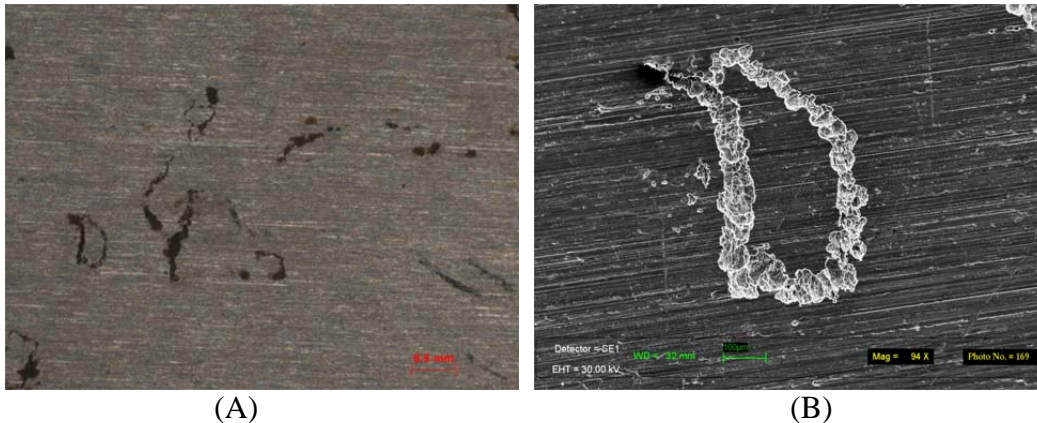
The “pearl necklace” corrosion morphology was also observed for the coupon exposed only in the vapor space. Figure 5-18 shows both the stereo-micrograph of the pitted area as well as a higher magnification SEM micrograph of pitting similar to that shown in Figure 5-17 (A). As will be discussed below, pitting in the TIG weld shows a similar pitting morphology. All TIG welds are vapor exposed only.

Figure 5-18 Pitting morphology of coupon TD25 after 340-day exposure and nitric acid cleaning: (A) stereo-micrograph of pitted area (25x) and (B) SEM micrograph of “pearl necklace” morphology (94x)

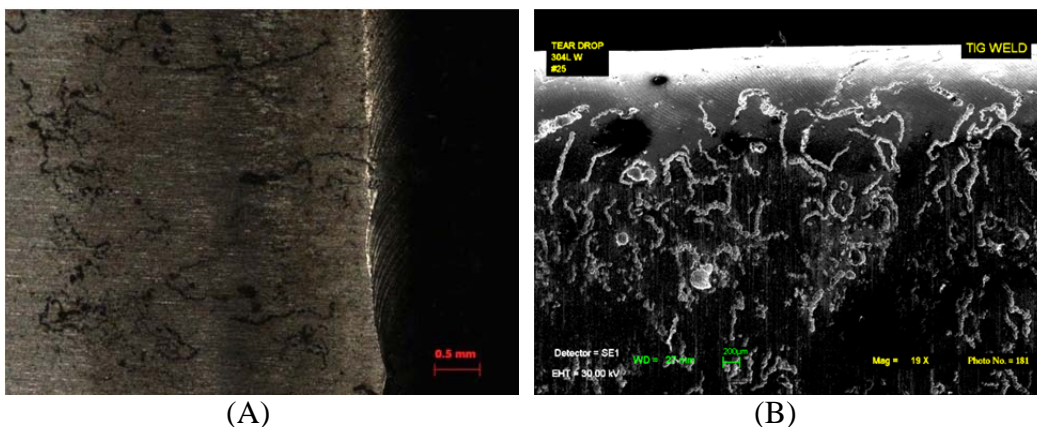
The TIG closure weld on all the teardrop coupons in Series 1 testing had pitting or the presence of pit-like features. As can be seen in Figures 5-1, 5-9, and 5-15, the TIG weld had rust/black colored corrosion products over the surface. Similar to pitting in other vapor-exposed surfaces the pitting had a “pearl necklace” morphology as shown in Figure 5-19 (A) and (B) for TD03 and TD25, respectively. The width of these strings of pits appeared to be fairly uniform. The genesis of this type of morphology is currently unknown. Since in most cases minimal corrosion was observed on the planar vapor-exposed surfaces of the teardrop coupons, the TIG closure weld, which always experienced corrosion, was more susceptible to corrosion. The TIG weld also has oxide tint on the surface that is a residual from the weld process, which tend to be more susceptible to corrosion. These results underline the concern for closure weld as being the more susceptible location for corrosion failure on the 3013 inner can.

Figure 5-19 Micrographs of TIG closure weld: (A) stereo-micrograph of TD03 (25x) and (B) SEM micrograph of TD25 (19x)

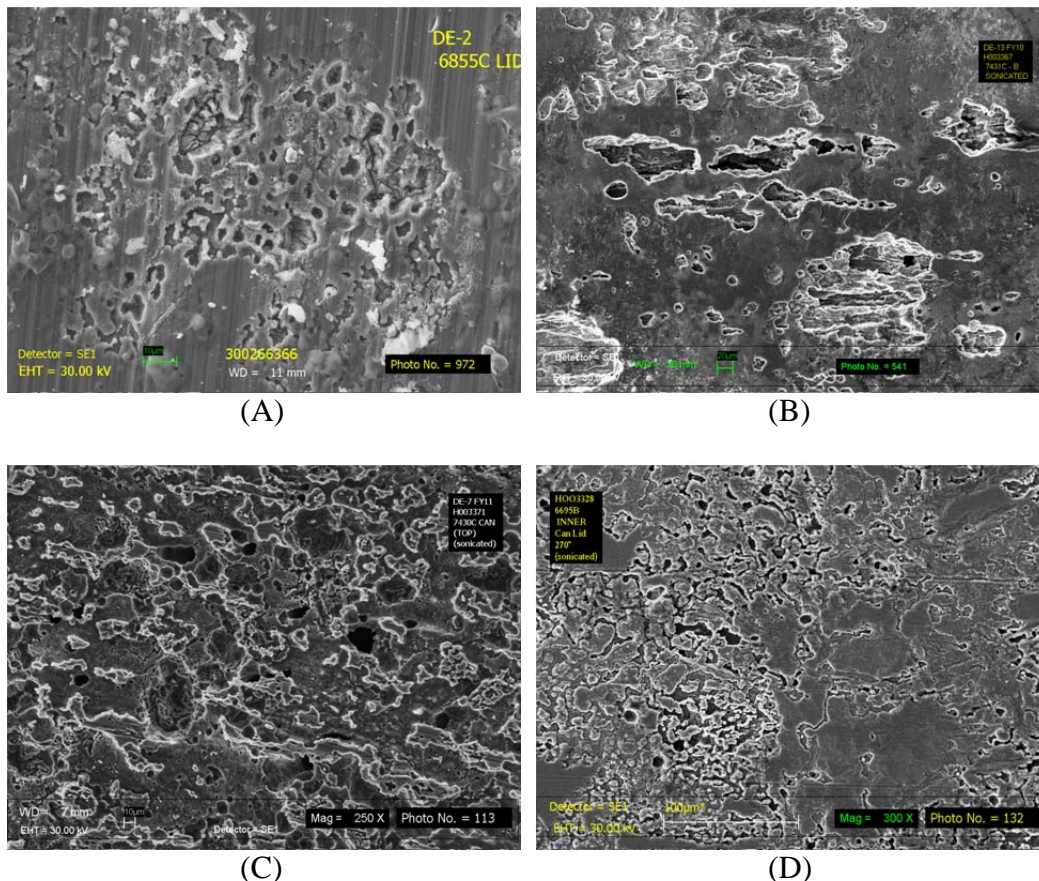
Over 80 3013 containers have been evaluated by destructive examination (DE) as part of the 3013 surveillance program. The analysis conducted as part of DE has included some characterization of pitting in both the convenience and inner cans, although pitting in the inner can has been quite limited. Pitting morphologies are shown in Figure 5-20 for several DE containers. This pitting has occurred in surfaces with oxide/salt contact as well as vapor-exposure only.

Figure 5-20 Pit morphologies observed in DE 3013 containers: (A) FY10 DE2 convenience can lid (750 x), (B) FY10 DE13 convenience can after cleaning (1075x), (C) FY11 DE7 convenience can after cleaning (250x), and (D) FY11 Hanford High Moisture Can after cleaning (300x)

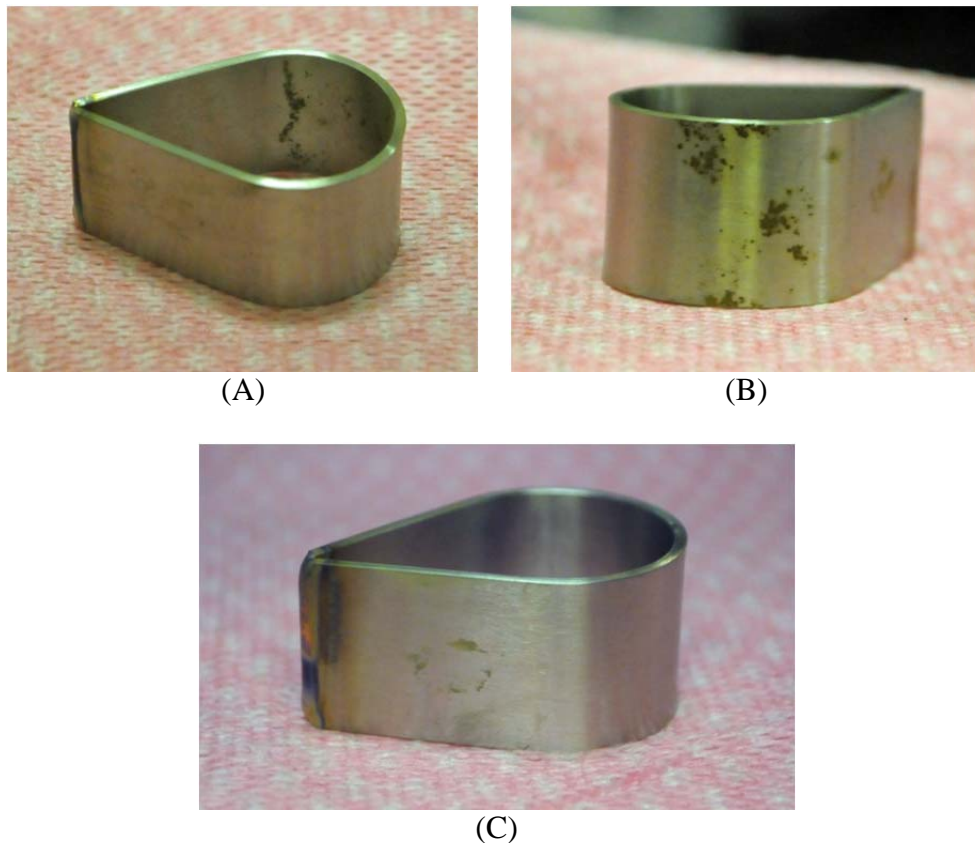
Figure 6-3 Photographs of Vessel A coupons after 105-day exposure in Series 2 testing: (A and B) coupon TD16, oxide/salt contact, as-is condition; and (C) coupon TD18, vapor exposure, as-is condition
