# **Tank Inspection NDE Results for Fiscal Year 2014, Waste Tanks 26, 27, 28 and 33**

**James B. Elder III and Rodney W. Vande Kamp**

September 29, 2014

SRNL-STI-2014-00328

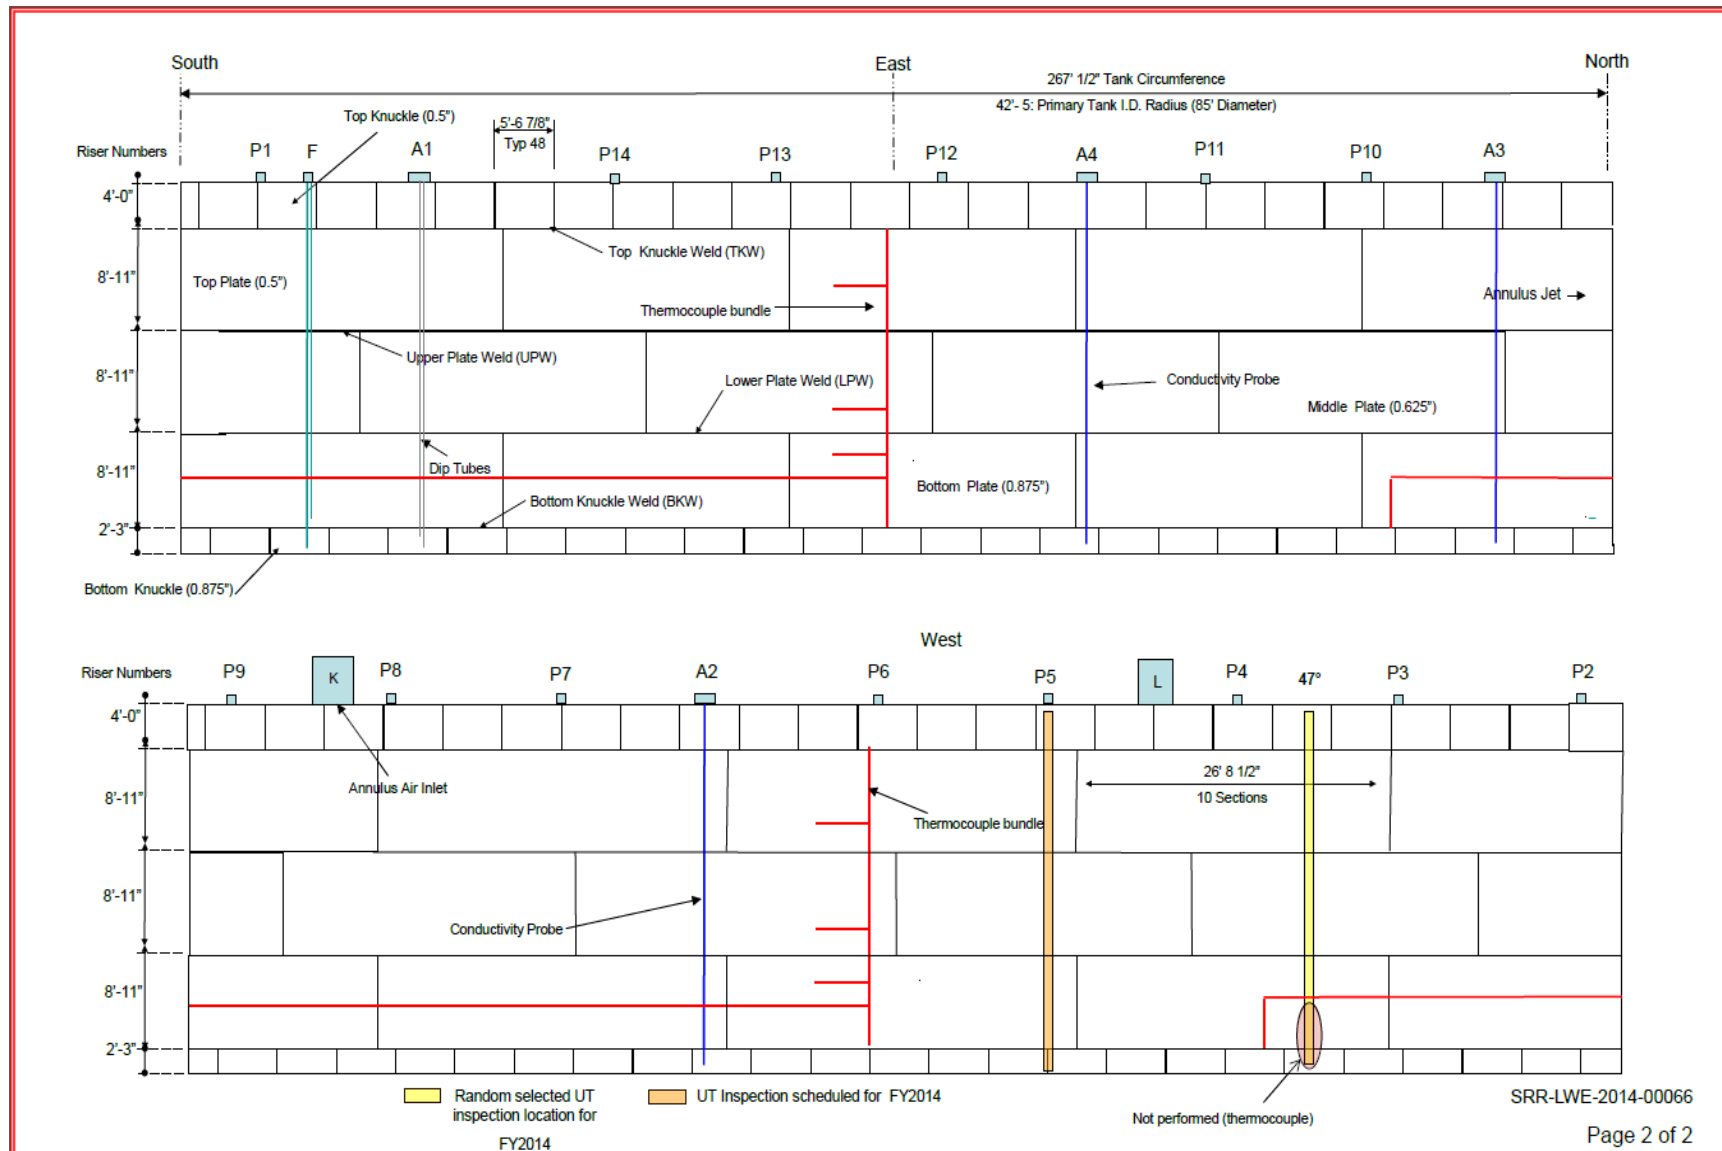
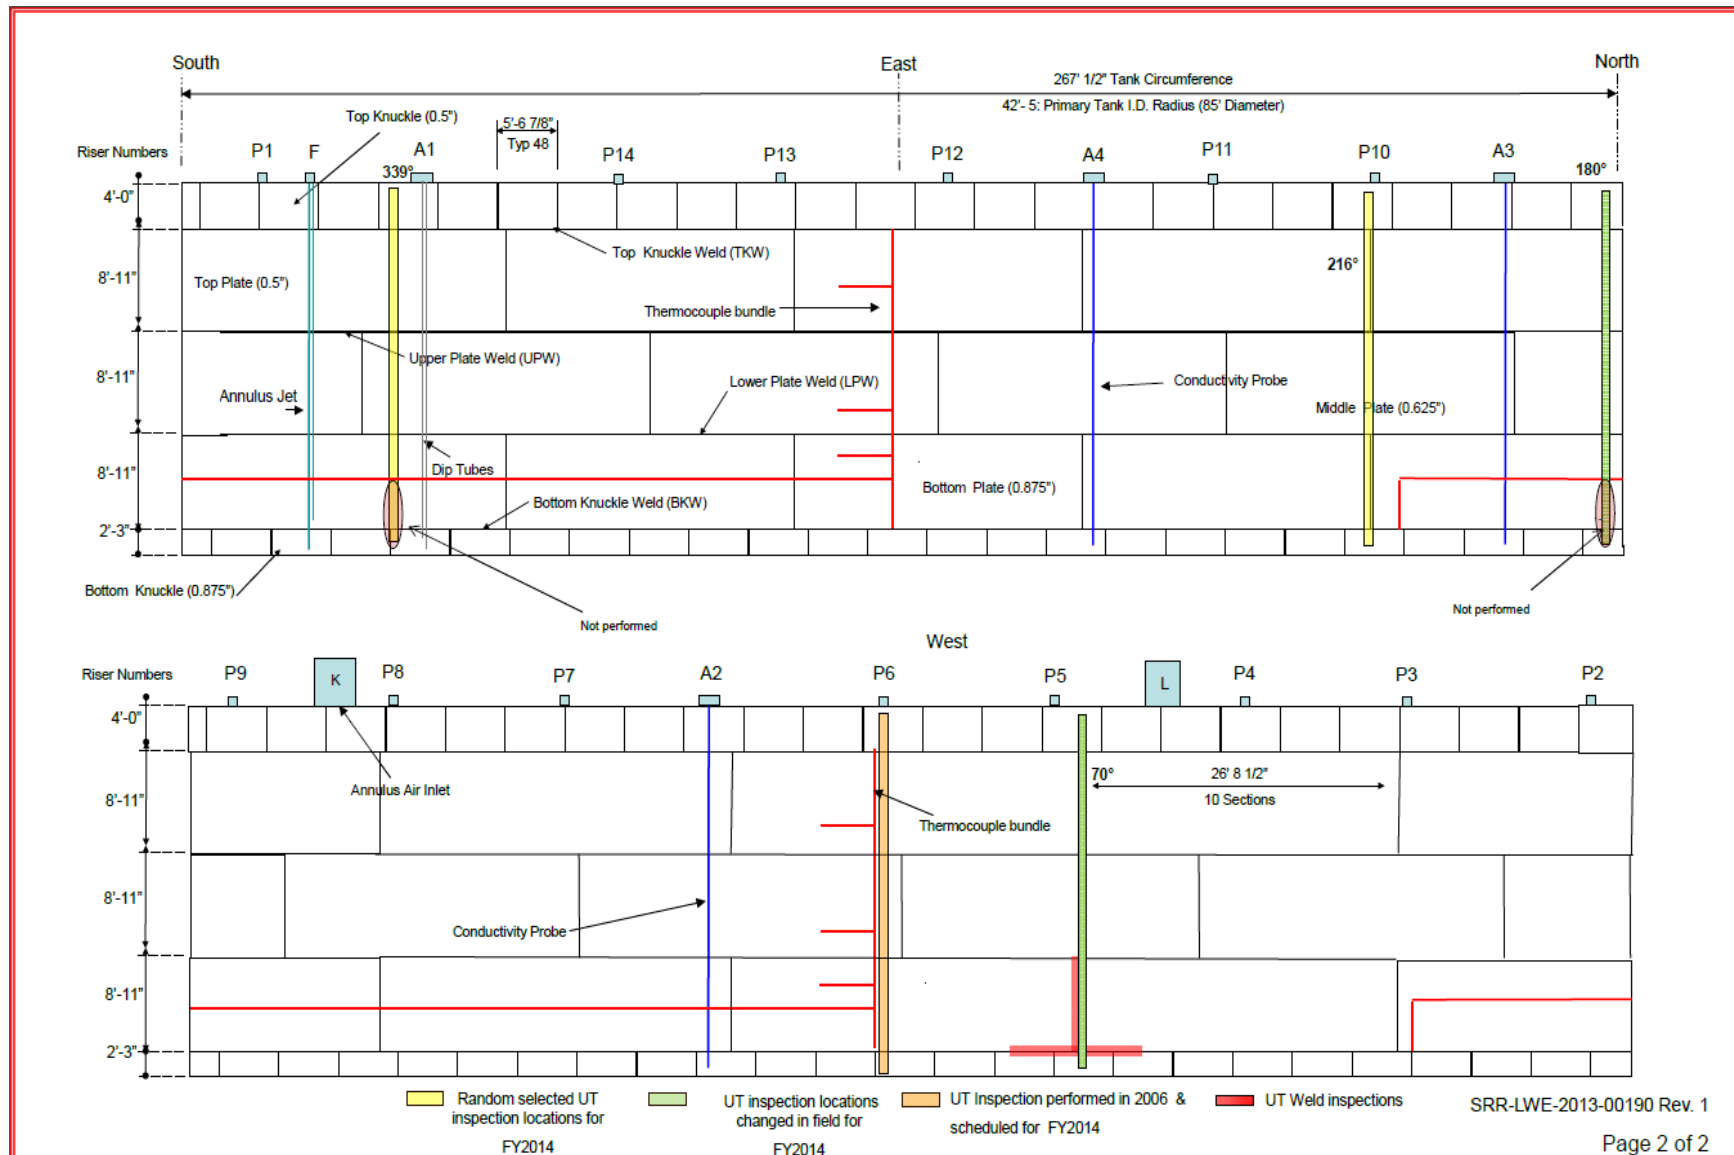
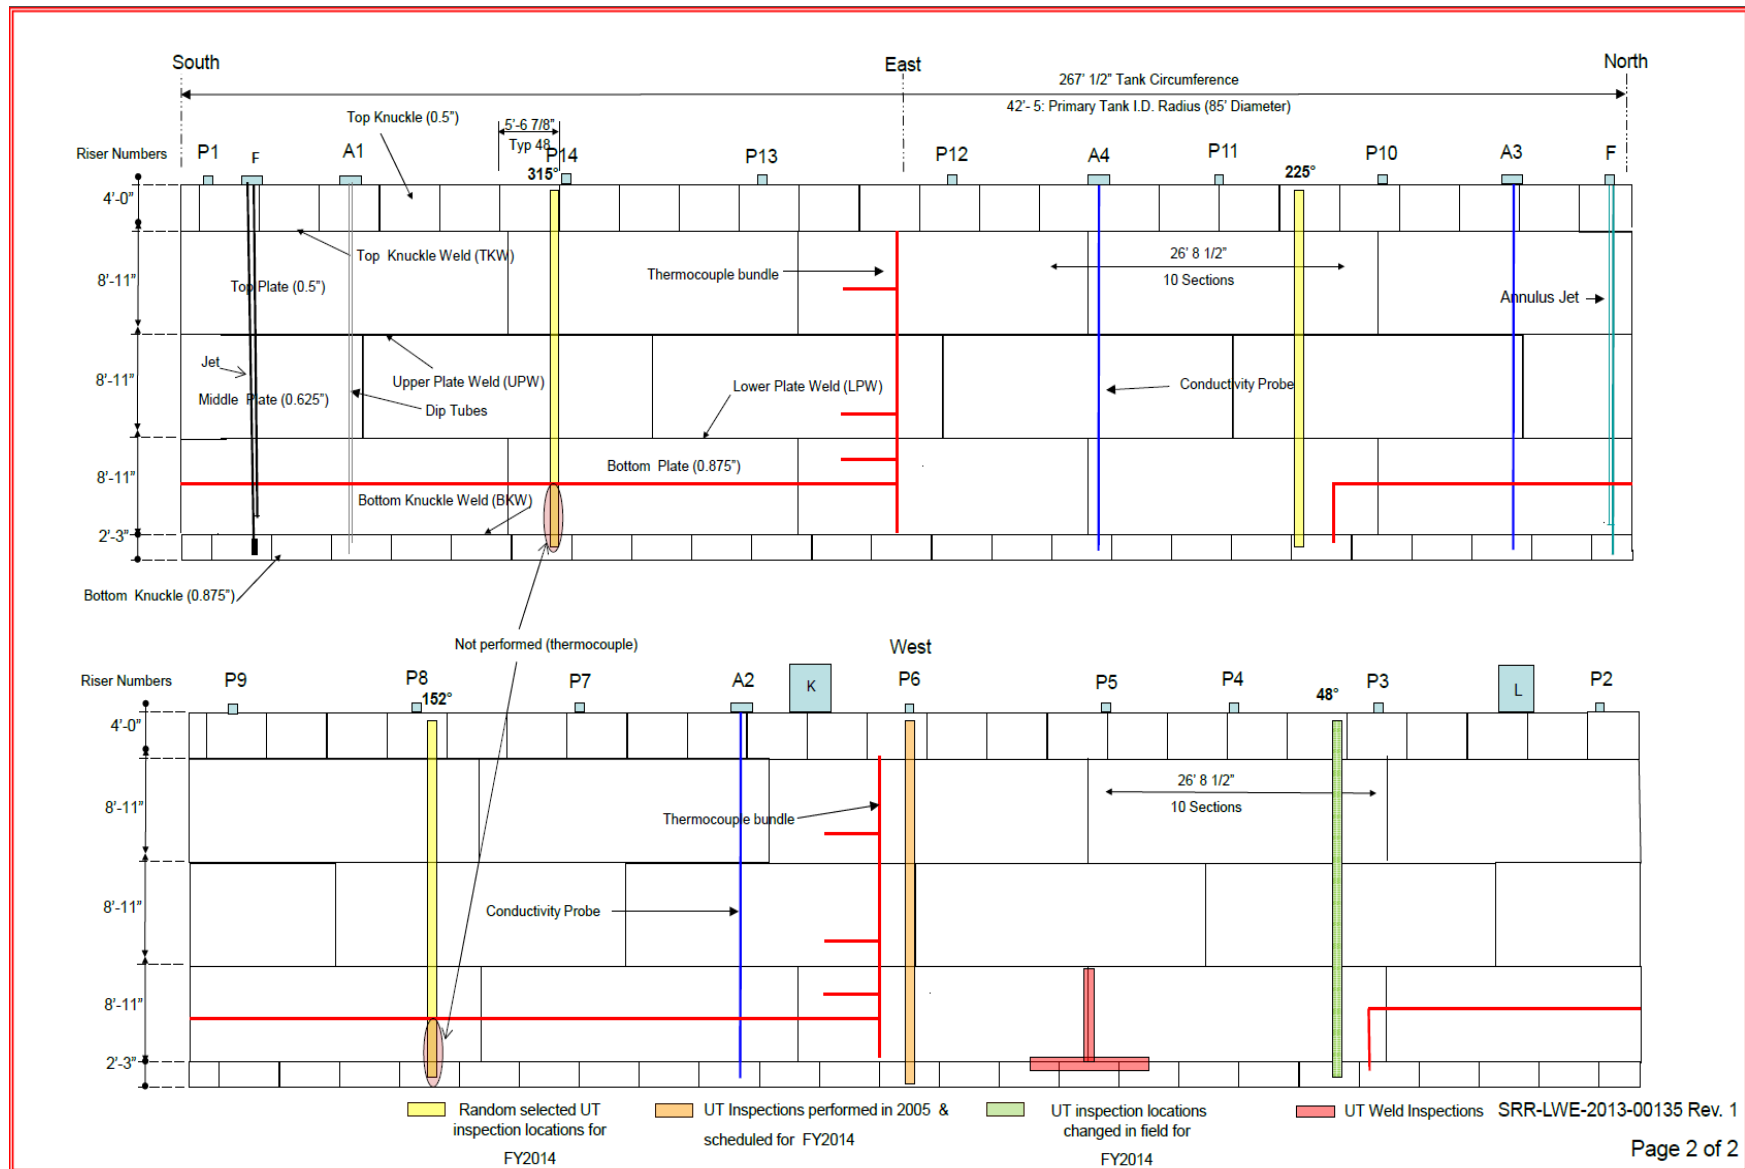
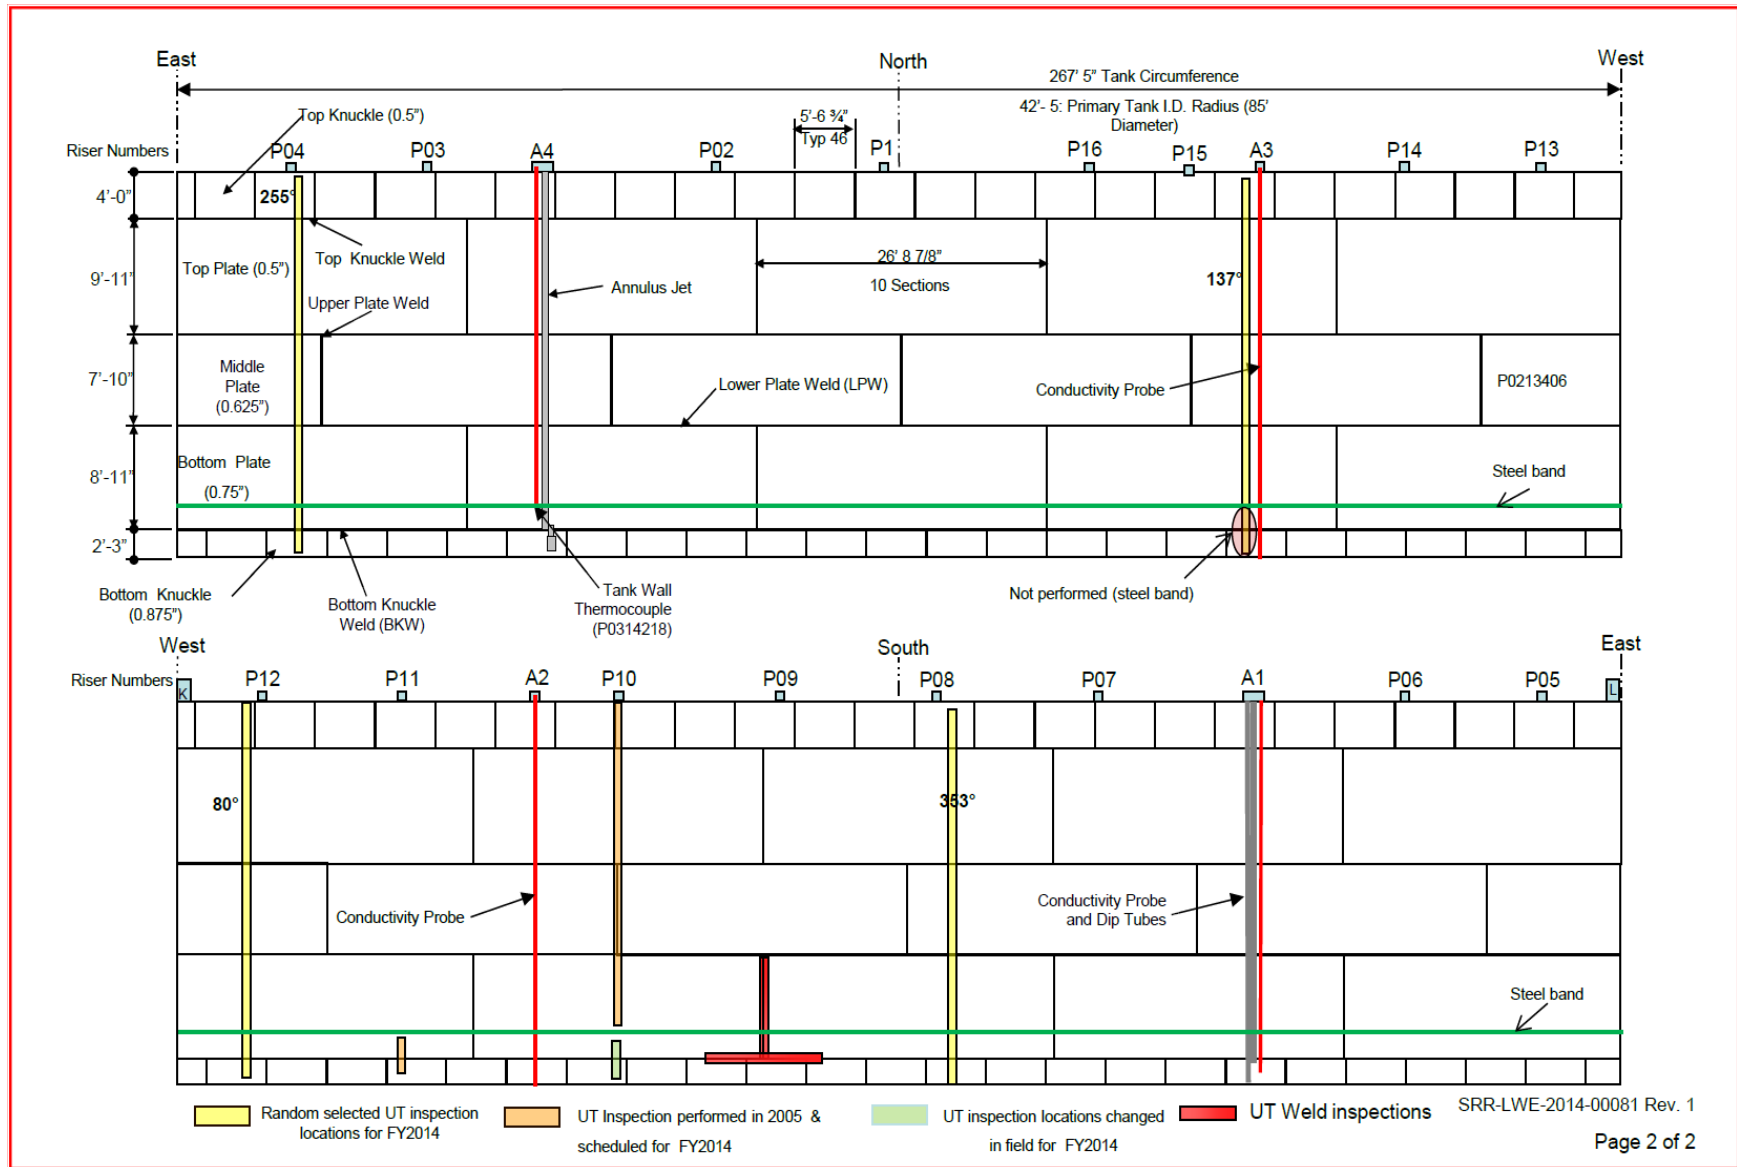
All of the areas prescribed to be inspected in the LWE tank specific scan plans for FY 2014 were completed except for the exceptions noted in figures 5 through 8.

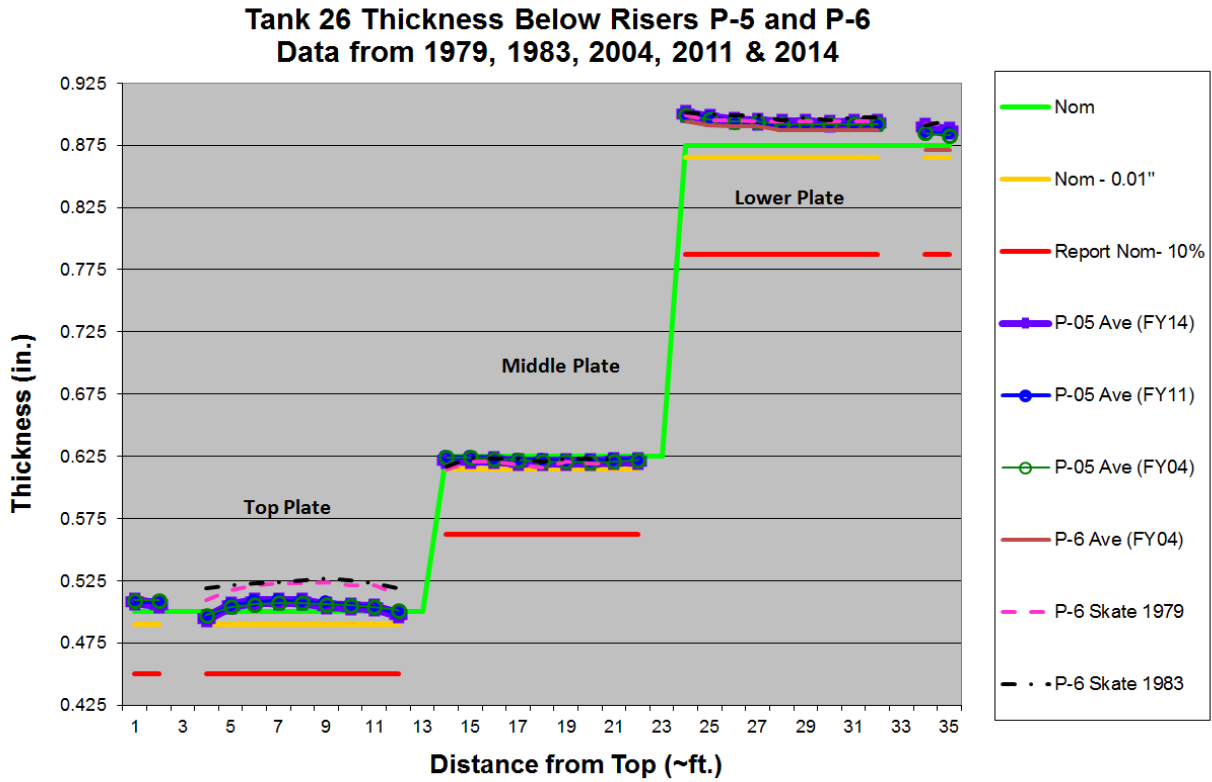
Figure 9: Tank 26 Thickness Data Comparison over 35 Years

Tank 26 was not scheduled for a routine inspection as part of the ISI program this year as it received a full inspection in 2011. In 2014, the previous inspections under riser P-5 were repeated and one randomly selected thickness mapping vertical strip was also collected as required by the ISI Program, due to tank conditions being outside normal chemistry control for greater than 3 months within the past year. All of the average thicknesses are above the minimum design thickness. There were no reportable thickness areas detected. No reportable, service induced thinning or pitting was detected in the areas scanned. No crack-like indications were detected.

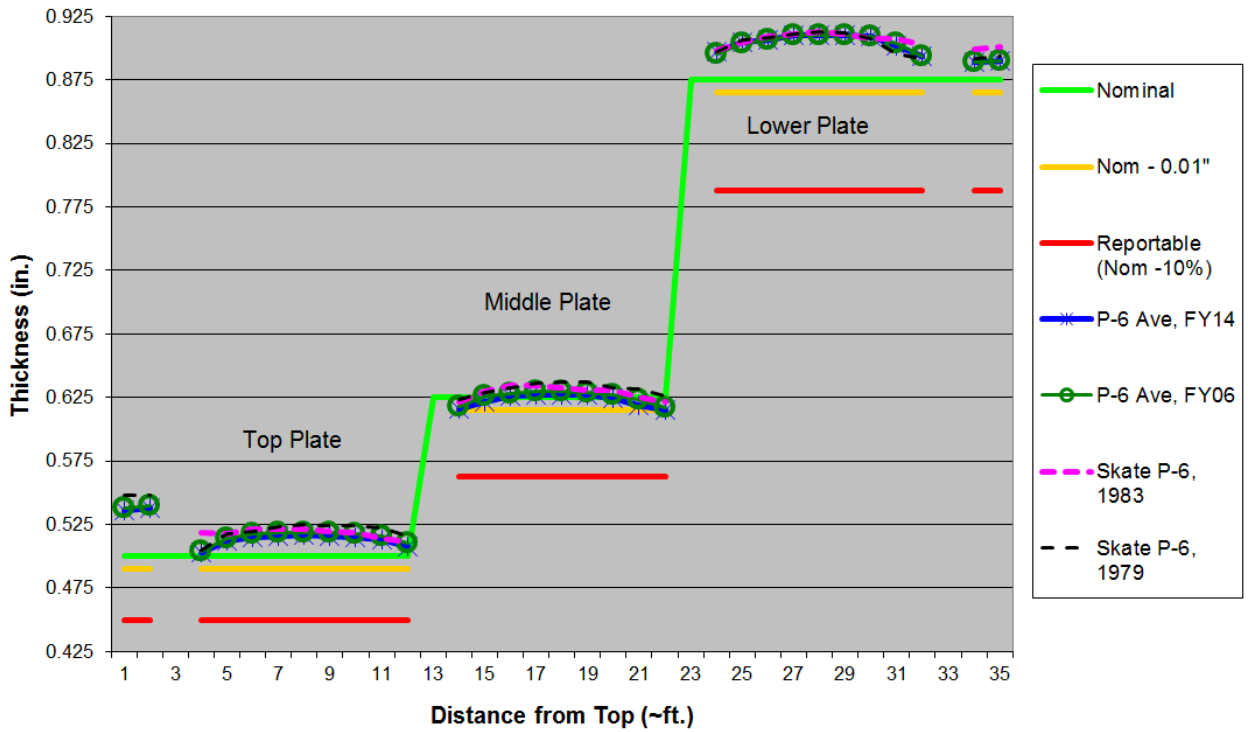
Figure 11: Tank 27 Thickness Data Comparison Over 35 Years

In 2014, the previous inspections under riser P-6 were repeated. Four high speed thickness mapping vertical strips were also collected in Tank 27. In the primary tank, all but one of the plate/strips examined have average thicknesses that remain at or above the construction minimum thickness which is nominal thickness minus 0.010 inches. There were no reportable thickness areas detected. No reportable, service induced thinning or pitting was detected in the areas scanned. No crack-like indications were detected.

No reportable pitting was noted in any of the areas examined, but one pit was greater than the 0.015 inch criteria. A 0.025 inch deep pit (5% through wall) was noted in the top plate during the repeat scan under P-6. This pit was evident in the 2006 data but not reported because it only measured 0.0013 inches deep in the primary pitting evaluation method of the 2006 data. Comparison of the indication with a different evaluation method shows the pit to measure 0.024 inches in 2014 and 0.022 in 2006, so there is no measureable increase in pit depth.

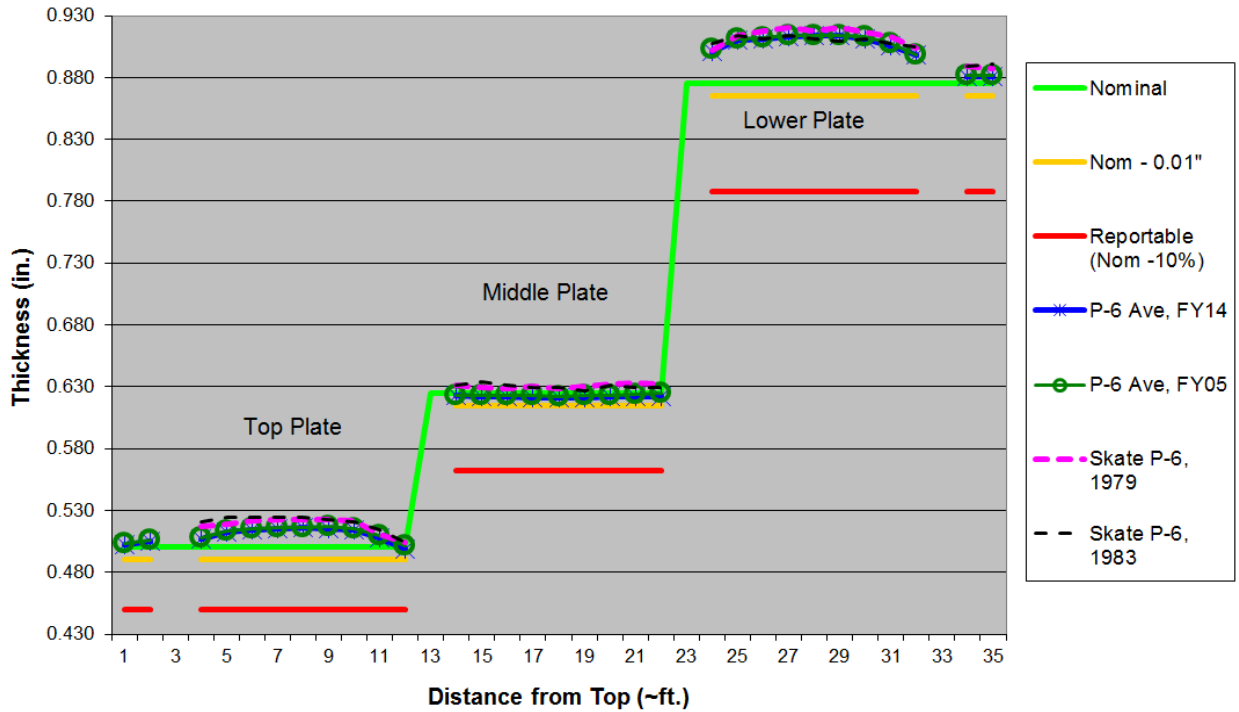
**Figure 13: Tank 28 Thickness Data Comparison Over 35 Years**  
**Tank 28 Thickness 1979, 1983, 2005 and 2014**

In 2014, the previous inspections under riser P-6 were repeated. Four high speed thickness mapping vertical strips were also collected in Tank 28. In the primary tank, all but one of the plate/strips examined have average thicknesses that remain at or above the construction minimum thickness which is nominal thickness minus 0.010 inches. There were no reportable thickness areas detected. No reportable, service induced thinning or pitting was detected in the areas scanned. No crack-like indications were detected.

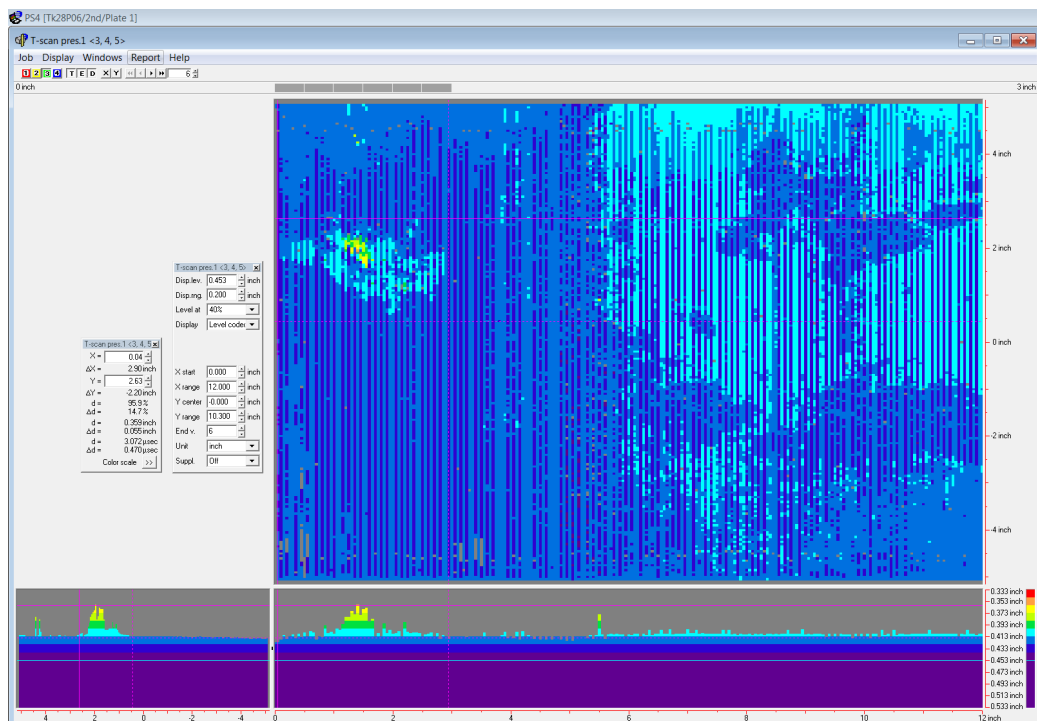
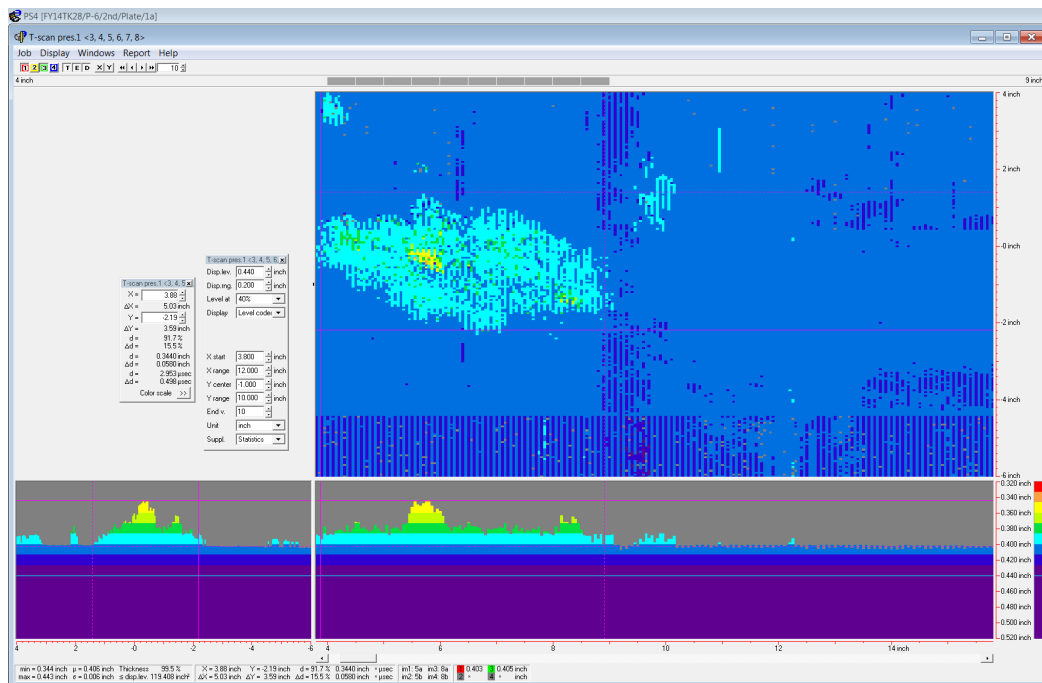
**Figure 15: Tank 28 Secondary Wall Plate 1 Indication Comparison 2005 – 2014**

Tank 28 had an area of localized thinning on the exterior wall of the secondary tank noted during the initial inspections in 2005. That area was inspected again in 2014 and found to be larger and slightly deeper. The deepest area of thinning in the secondary wall is less than 20% wall loss. The maximum length of thinning is less than 24 inches and does not impact structural or leak integrity per WSRC-TR-2002-00063.

The top section shows the indication in 2005 and the lower image shows the same area in 2014.

A localized thinning area was reported in 2005 in Plate 1 (upper plate) of the secondary wall of Tank 28 measures slightly deeper and there is an increase in the size of the area thinning. The maximum depth measures 0.061 inches for a minimum thickness of 0.333 inches remaining metal which equates to 15% loss from the local measured average thickness of 0.394 inches. The maximum length of thinning is less than 24 inches and does not impact structural or leak integrity per WSRC-TR-2002-00063. This area will be reinspected during the next routine inspection.

STAR 2005-CTS-008509 Action 003 was issued to track the Tank 28 secondary wall localized thinning. It reads "Perform Ultrasonic Testing (augmented scope) for Tank 28. Inspection should include the area of localized wall thinning on the secondary liner of Tank 28 to ensure that corrosion mechanism has stopped."

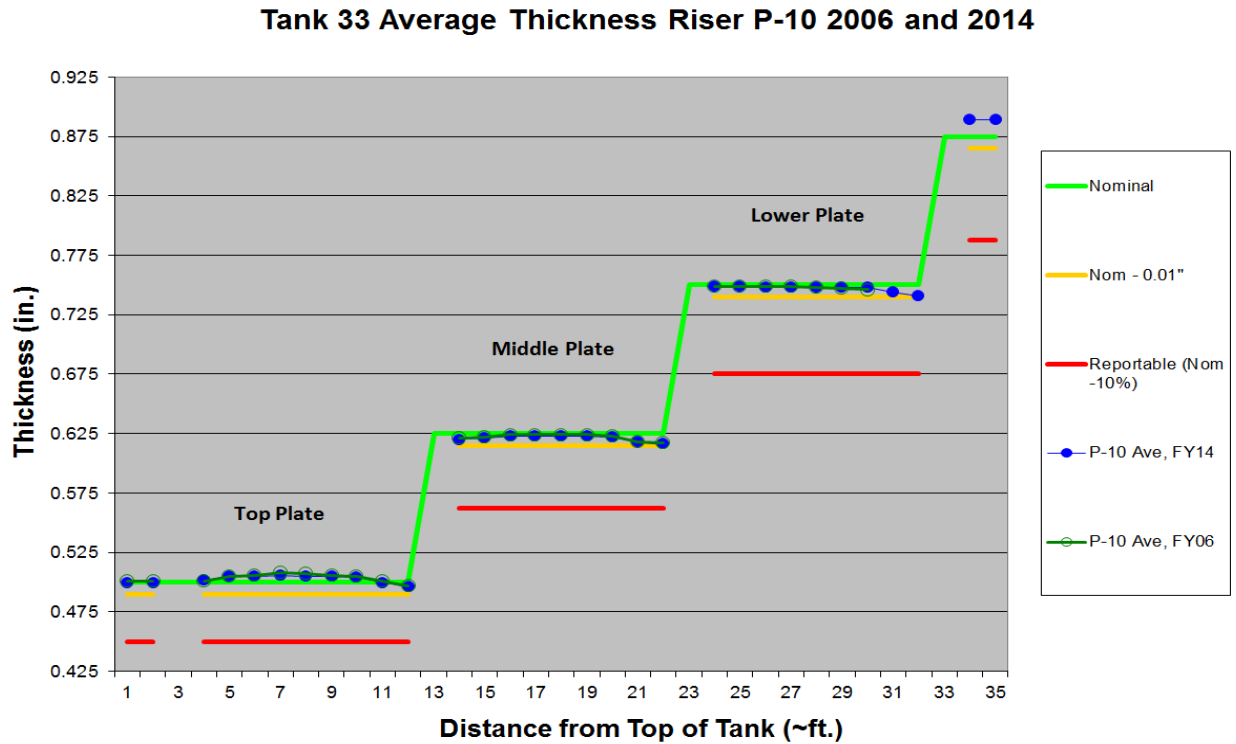
Figure 16: Tank 33 Thickness Data Comparison Over 8 Years

In 2014, the previous inspections under riser P-10 were repeated. Four high speed thickness mapping vertical strips were also collected in Tank 33. In the primary tank, all of the average thicknesses are above the minimum design thickness. There were no reportable service induced thickness areas detected. An internal grinding area on the top knuckle measured 0.448 inches which is below the 10% threshold. No reportable, service induced thinning or pitting was detected in the areas scanned. No crack-like indications were detected.

No reportable pitting was noted in any of the areas examined, but one pit greater than the 0.015 inch criteria was noted. The pit was in the bottom knuckle in the random strip QI and measured 0.032 inches deep or 4% through wall.
