DESTRUCTIVE EXAMINATION OF SHIPPING PACKAGE 9975-06100

W. L. Daugherty

Savannah River National Laboratory
Materials Science & Technology

Publication Date: November 2014

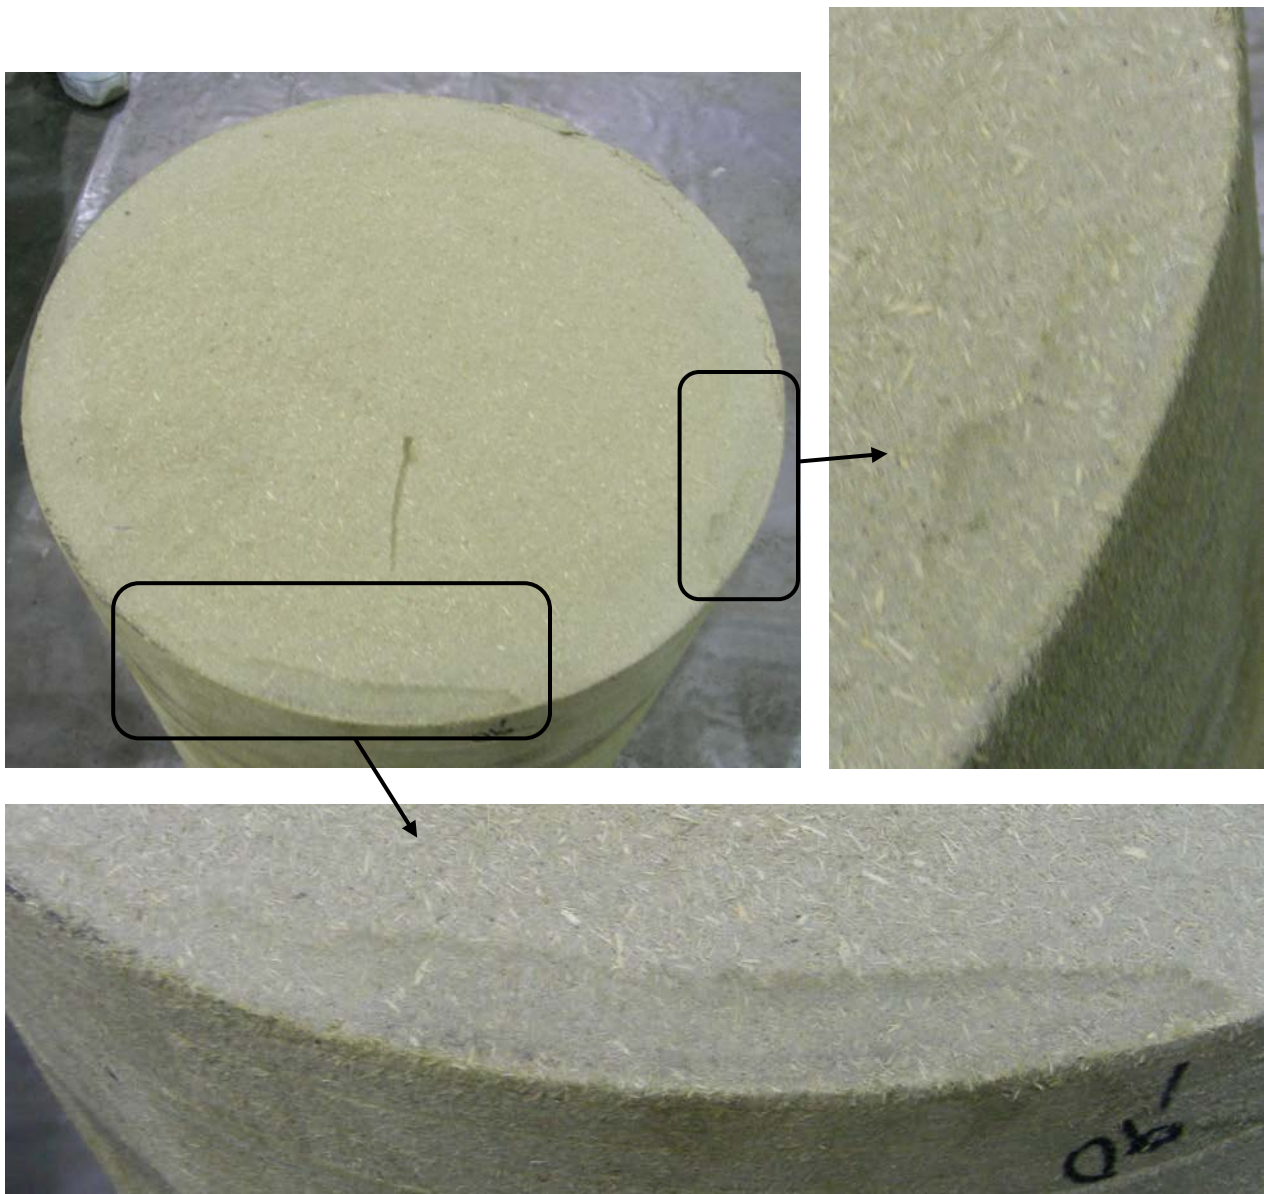
No significant material or physical damage was observed, and layers were well bonded. The lower subassembly was snug within the drum, but came out smoothly without interference. Following removal of both the top and bottom fiberboard subassemblies from the outer drum, both were inspected visually. Two regions were observed on the bottom of the lower fiberboard assembly, consistent with water stains. Matching stains were observed on the drum bottom interior surface. Some vertical stains were also observed on the drum sides, consistent with water movement, although these did not align with the stains on the bottom. It is hypothesized that a modest amount of water may have run down the side, traveled around the bottom crevice to a point where the fiberboard was compressed into the drum bottom crevice sufficiently to wick up the moisture. The fiberboard and drum stains are shown in Figures 1-3.

Figure 1. Water stains on lower fiberboard assembly

Comments: * In destructive examination, 2 regions on the bottom of the lower fiberboard assembly with water stains. Matching stains observed on the drum bottom. The drum interior side had horizontal stains consistent with fiberboard layer contact, and vertical stains consistent with water movement. The vertical stains were not at the same circumferential positions as the fiberboard stains.

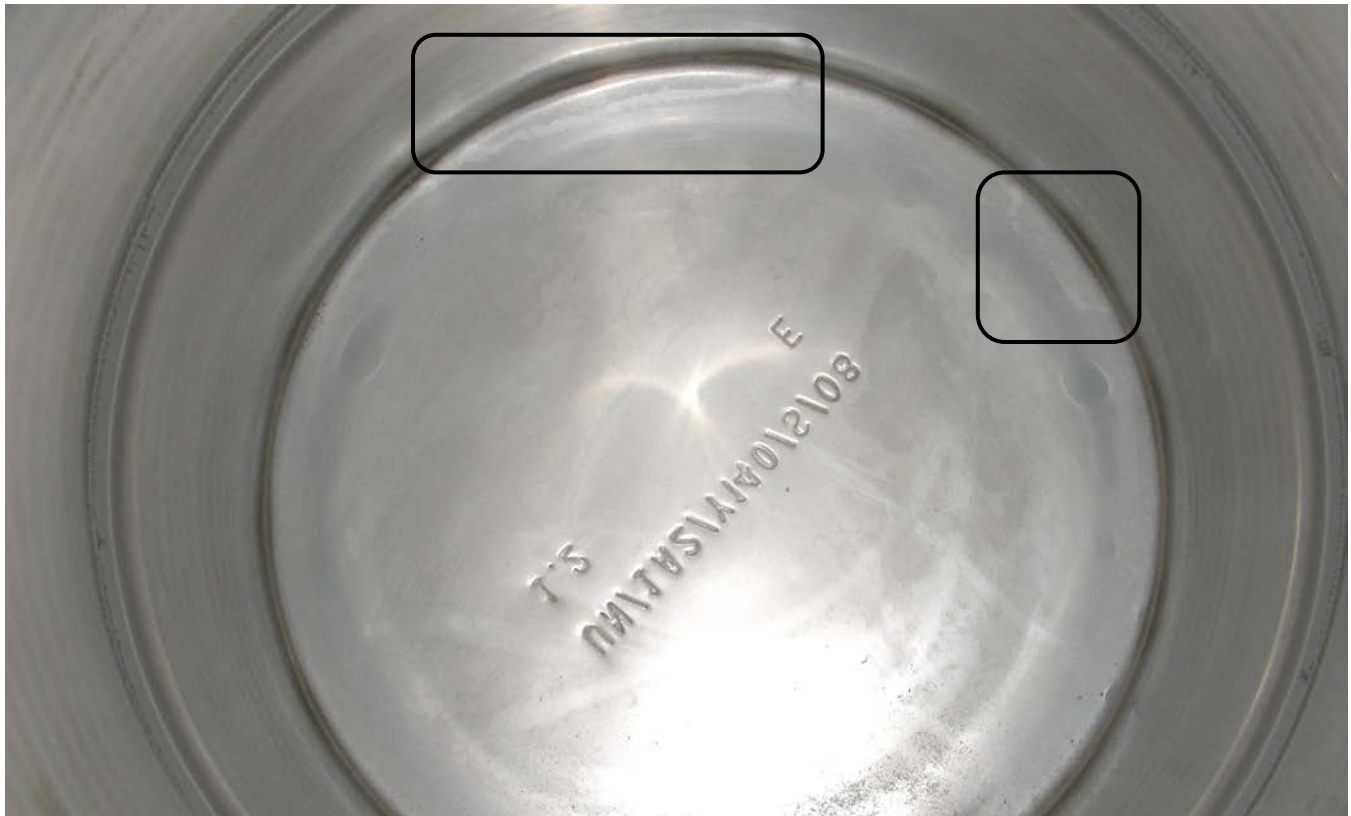
Figure 2. Water stains on drum bottom corresponding to fiberboard stains

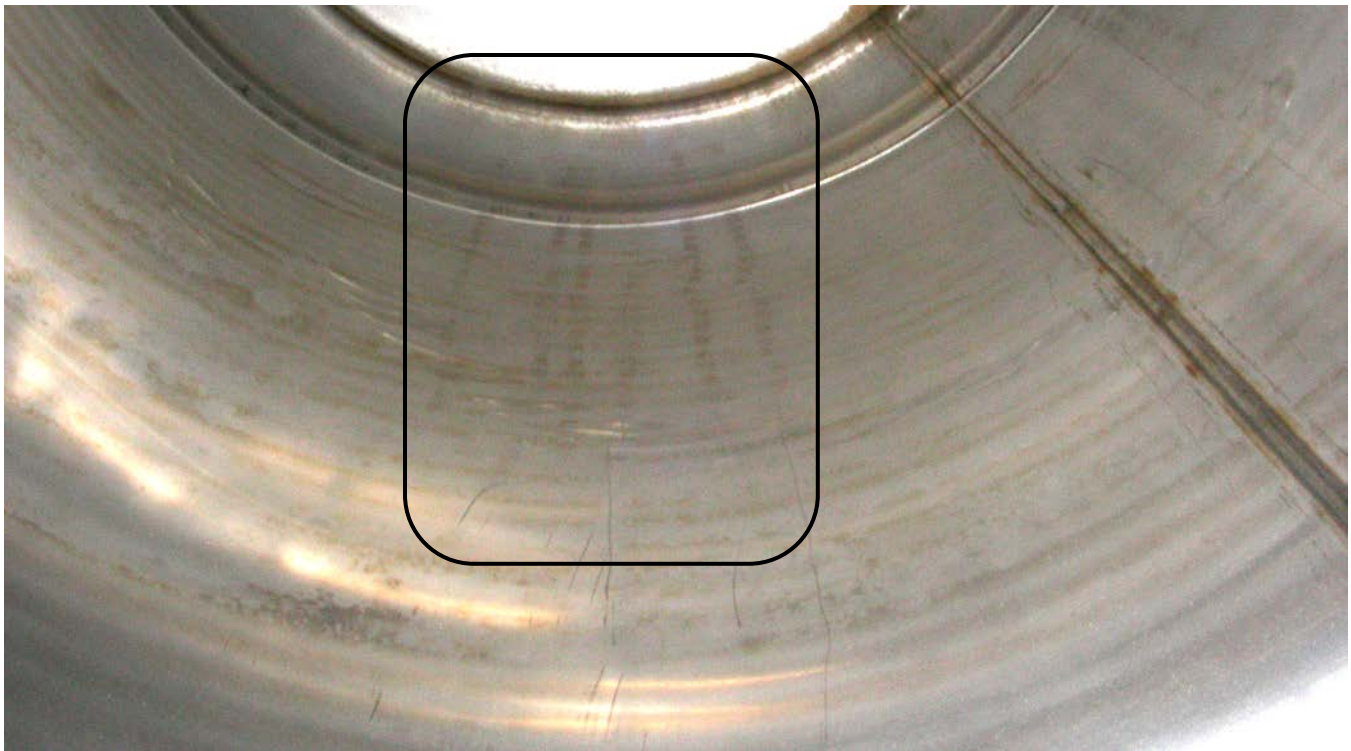
Figure 3. Vertical water stains on drum side

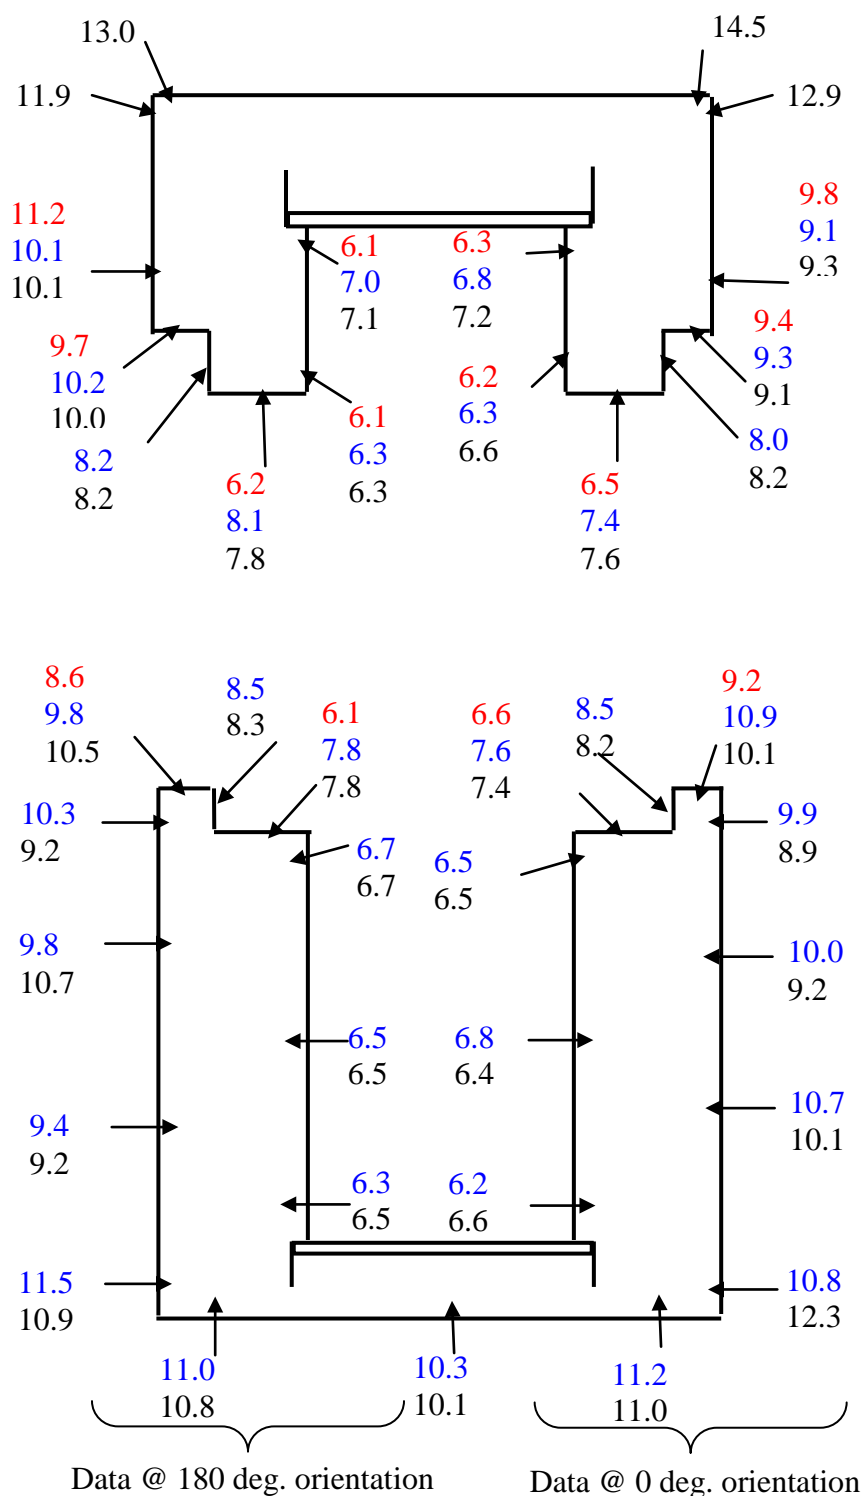
Moisture measurements were compared to those taken during previous destructive examinations [8 – 14]. The readings on 9975-06100 are lower on average than seen on previous DE packages, although 9975-03431 had similar low readings. During field surveillance, the measured moisture content of accessible regions of the fiberboard ranged from 6 to 11 %WME. During subsequent examination, with both upper and lower fiberboard assemblies removed, moisture content ranged from 6.2 to 14.5 %WME. The highest moisture content was measured under the air shield, which was not accessible during field surveillance.

A moisture gradient of 4.3 %WME was observed across the upper fiberboard assembly side wall during field surveillance. During the subsequent inspections, this gradient decreased to 2.9 %WME. The moisture gradient across the lower assembly side wall was not recorded during field surveillance, but was 3.8 %WME 19 days later, and 3.5 %WME 34 days later. This is consistent with other packages examined – the larger moisture gradient tends to develop in the lower assembly, and the gradient in both assemblies decreases gradually after the internal heat load is removed.

Figure 4. Fiberboard moisture content data. The values in red were measured during field surveillance. The values in blue were measured 19 days later, while the values in black were measured 34 days after field surveillance. All values are % wood moisture equivalent.

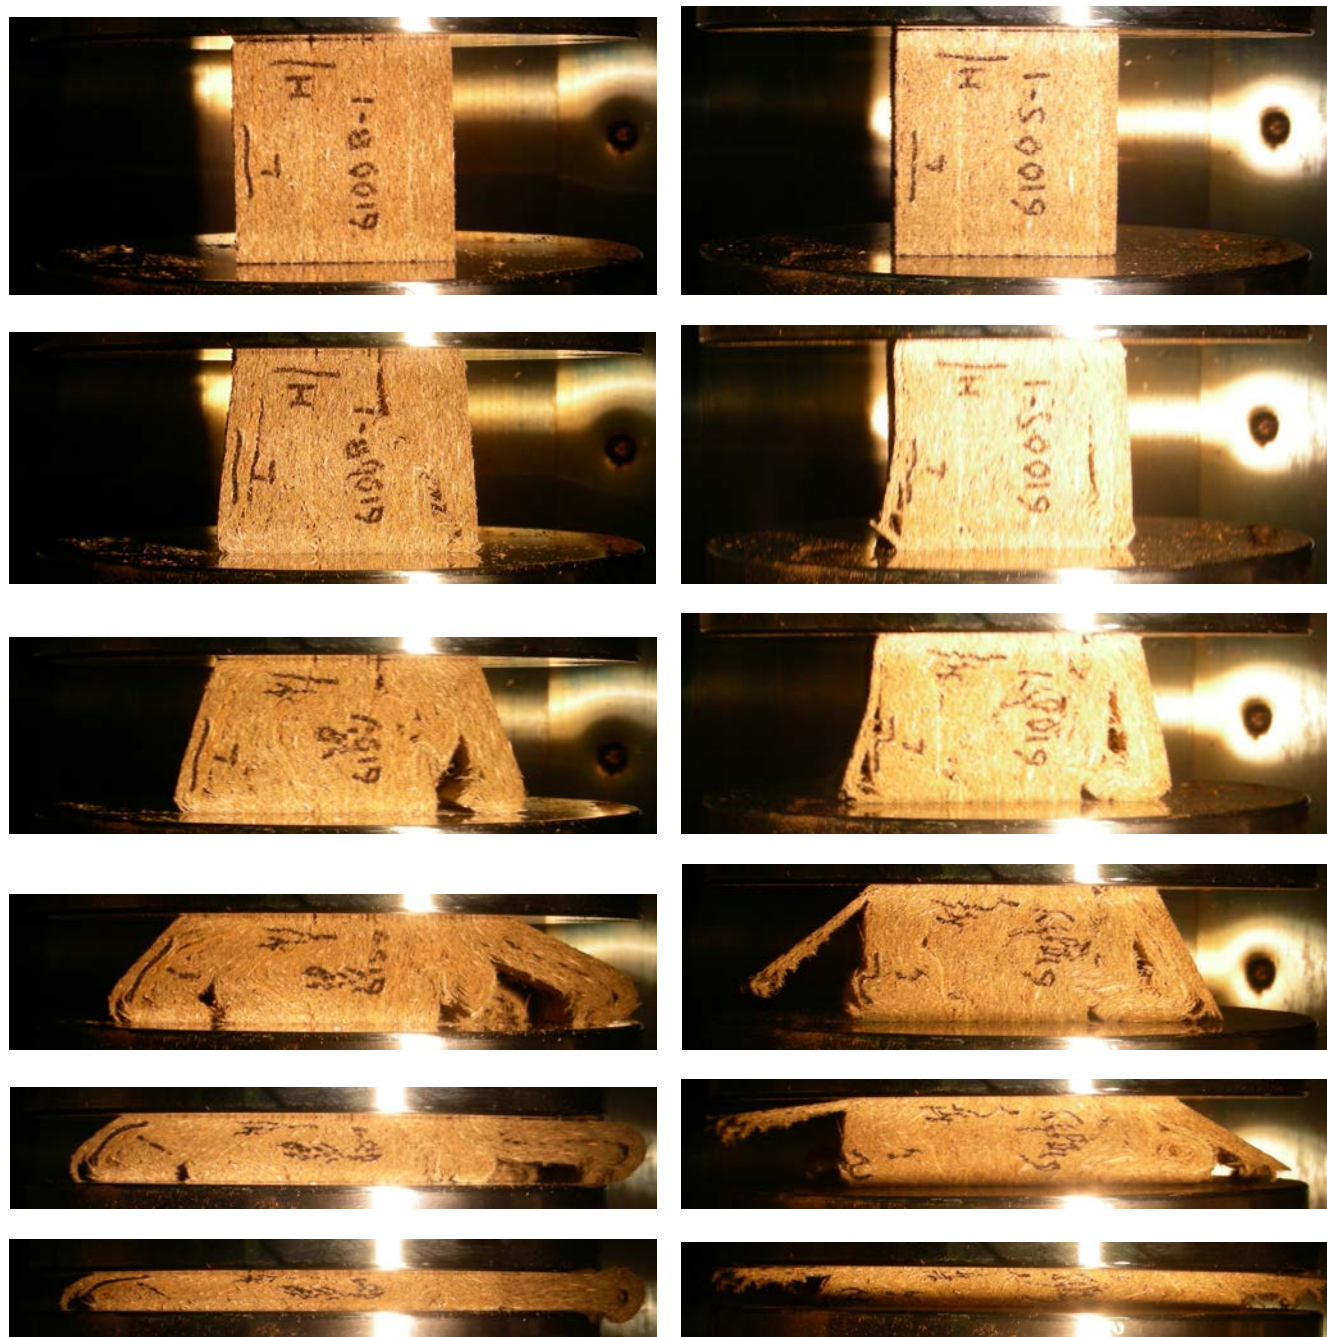
compression strength of the 9975-06100 samples is similar to the baseline samples. A series of photographs showing typical compression behavior under parallel loading is shown in Figure 10. The area under the stress-strain curve up to 40% strain is used as a relative indication of the energy absorption capacity of the fiberboard. This metric is shown in Figure 11 for each destructively examined package as a function of fiberboard moisture content. In general, the energy absorption capacity decreases as the moisture content increases. The results from 9975-06100 are circled in Figure 11. The Figure 11 data collectively show a trend consistent with undegraded softwood fiberboard and with other DE packages.

Figure 10. Photographs of fiberboard samples during compression testing, parallel orientation

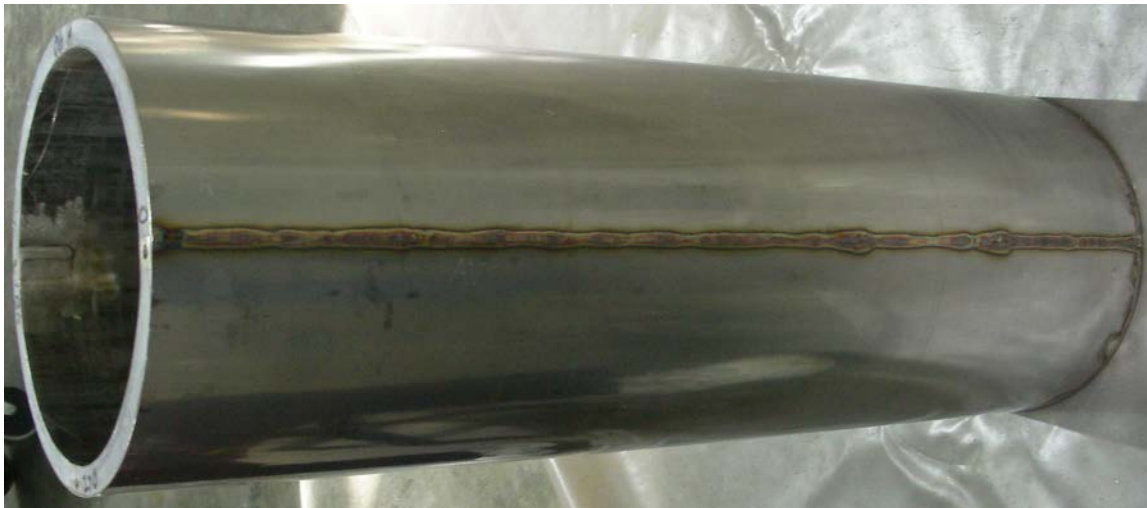
The entire surface of the lead shield was visually examined. It was found to be free from significant deformation and physical damage. The exterior stainless steel sleeve protects the lead surface, and precludes direct visual examination of the lead. Lead is visible only on the top edge, and in this area there was no significant corrosion or degradation (Figure 12).

Figure 12. Jacketed lead shield.

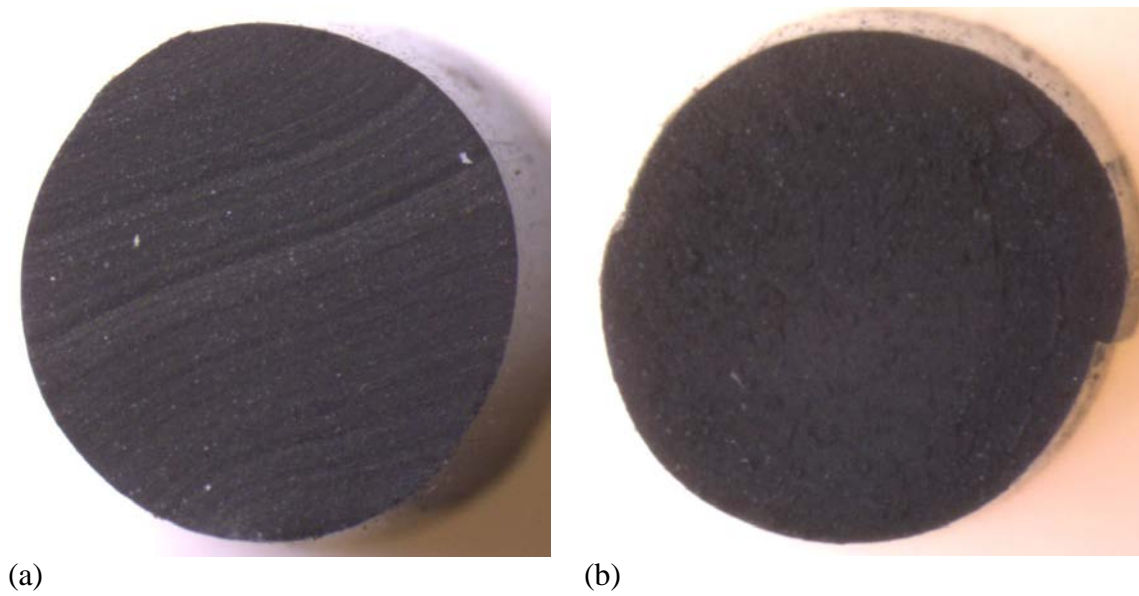
As with previous destructive examinations, visual (Figure 15) and SEM (Figure 16) examination of the cross sections identified a distribution of very small particles throughout each O-ring. Aside from carbon and fluorine (the primary constituents of Viton® fluoroelastomer) the SEM identified small amounts of magnesium, aluminum, silicon, sulfur, calcium, and oxygen. Though the actual compound is proprietary, Viton®-type fluoroelastomer compounds typically contain MgO, CaO, Ca(OH)₂, ZnO or lead compounds as acid acceptors and heat stabilizers [18]. Aluminum is present in hydrotalcite, which is used in both GLT and GLT-S compounds as a filler reinforcing agent. Silicon may be present as a trace contaminant.

Figure 15. Optical cross section of the (a) PCV outer and (b) SCV outer O-rings.

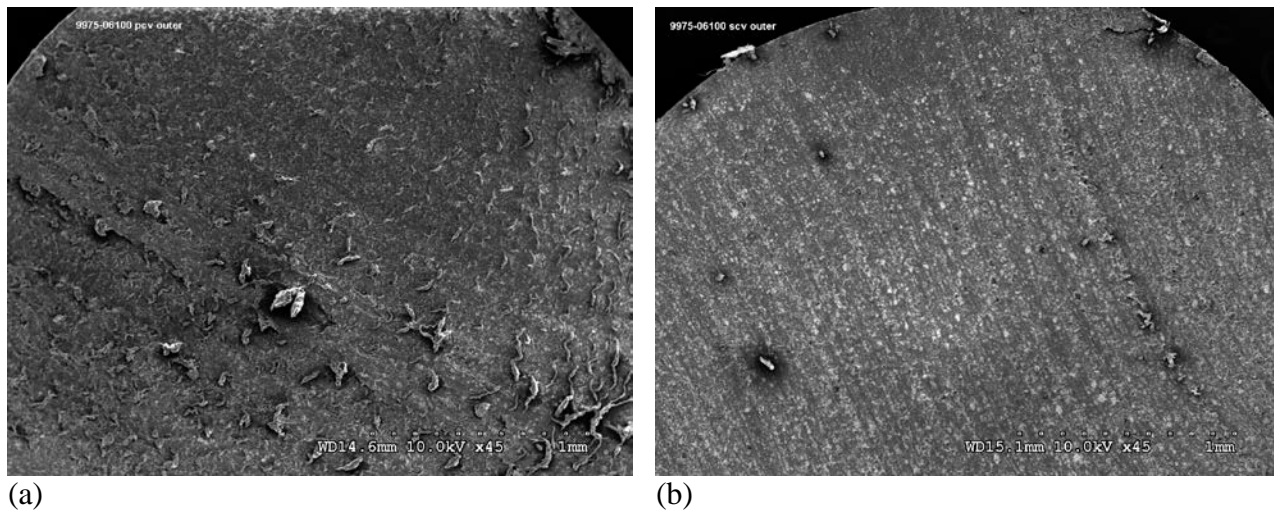
Figure 16. SEM cross section of the (a) PCV outer and (b) SCV outer O-rings.

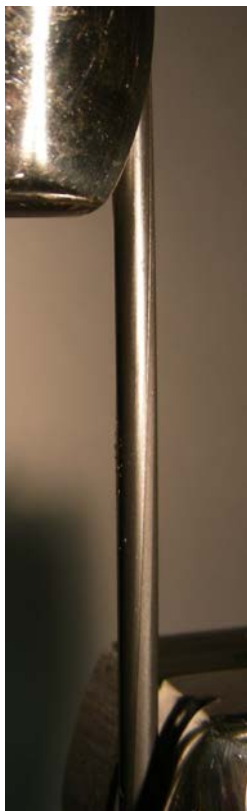
The PCV inner O-ring was tensile tested in accordance with ASTM D1414, using a cut (single strand) sample. The test was interrupted at 50% strain (Figure 17) to visually examine the O-ring for signs of cracking or other degradation. None were observed. The initial stress-strain curve for the PCV inner O-ring is shown in Figure 18. In this first test, the O-rings failed after reaching 600% strain, an unusually high value for any Viton® O-ring (GLT, GLT-S, etc), even compounds without reinforcing fillers. A re-test reached 650% elongation without breaking. Comparison tests performed on the PCV outer O-ring and a new O-ring that was re-installed on the PCV also produced higher elongation than expected (450, 530%). Each of these O-rings was tested using a yarn grip which would allow some stretch beyond the gage section. It is theorized that these GLT-S O-rings experienced significantly more stretch beyond the gage section than previous GLT O-rings. To more accurately measure the elongation, tests were performed with an alternate grip arrangement which does not allow such stretch. These alternate flat grips pose a greater risk of breaking within the grips (which would invalidate the test), but they provide a better measure of the elongation. With this arrangement, the PCV inner O-ring had an elongation of 385%, while the new O-ring had an elongation of 359%. Both of these values are similar to baseline data [17]. These comparison tests are also shown in Figure 18. For each of the O-rings tested, the tensile strength ranged from 2.2 to 2.9 ksi, which is comparable to baseline GLT-S data, but higher than prior GLT data.

Figure 17. 9975-06100 PCV inner O-ring during tensile test, at 50% stretch.

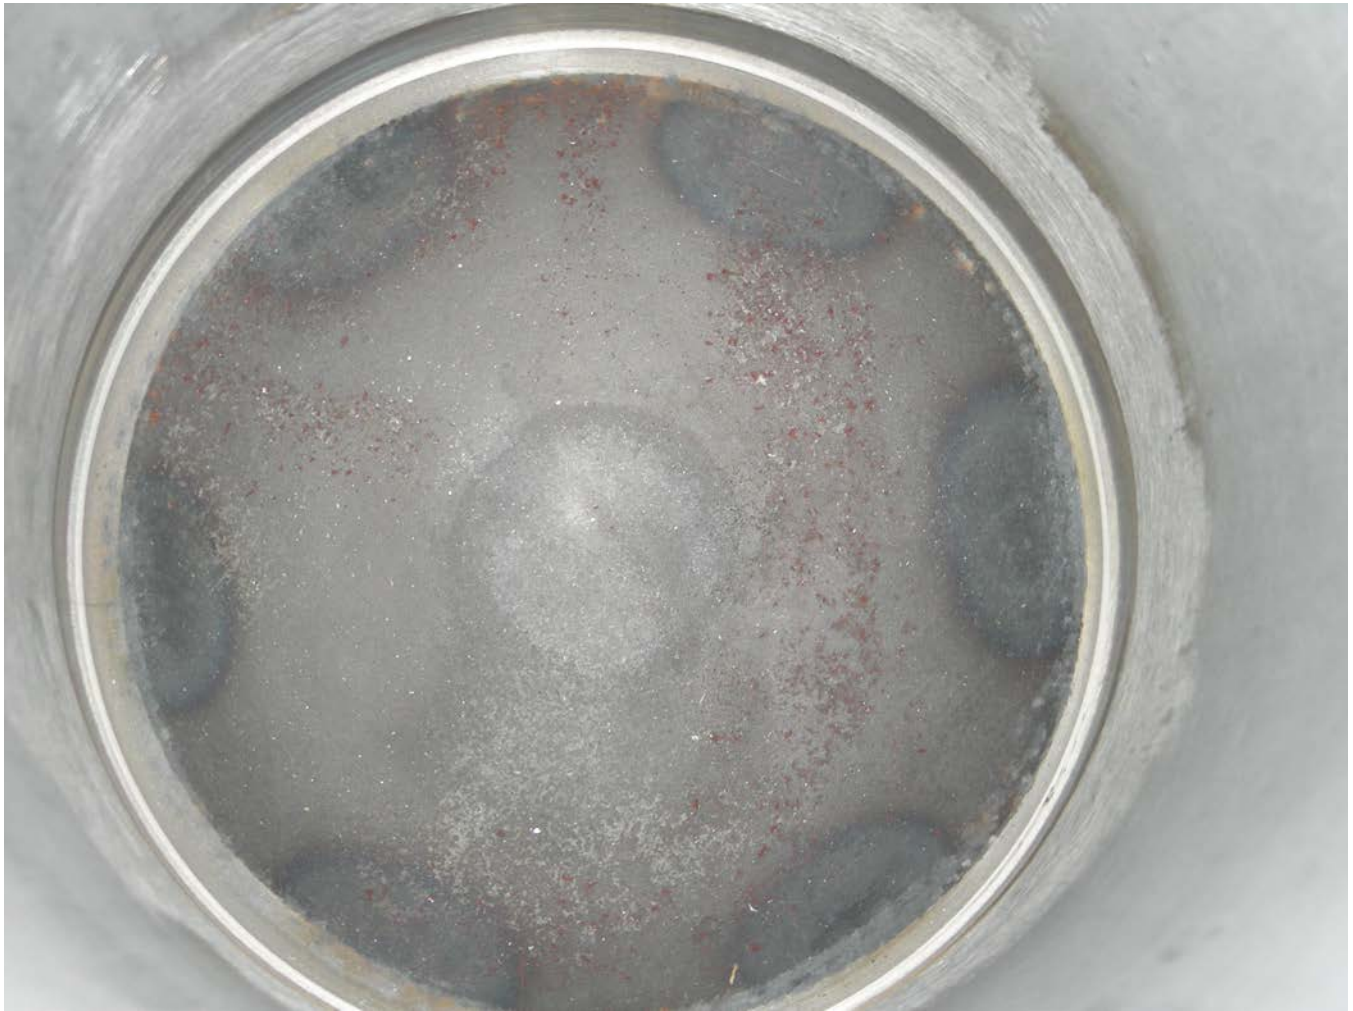
markings appear to be identification numbers used during manufacture, prior to association of the parts with a final package number, and are consistent with those seen in other packages. The bottom head of the SCV is darkened on both the interior and exterior surfaces. The interior surface is even darker opposite the support ring attachment welds (Figure 19).

Figure 19. Darkened surface on the interior of the SCV bottom head.
